## DAILY FIELD ACTIVITY REPORT

| PROJECT | Former Bouchard Junkyard | WEATHER | TIME | TEMP. | PRECIP. | WIND (MPH) | WIND (DIR) |
| LOCATION | Town of New Lebanon, NY | M. Cloudy | 0815 | 70-75 F | None | 0-5 | W |

**PHOTOGRAPHIC LOG**  
**July 15, 2008**  
**D&B JOB NO. 2605**  
**FORMER BOUCHARD JUNKYARD SITE**  
**TOWN OF NEW LEBANON, NEW YORK**

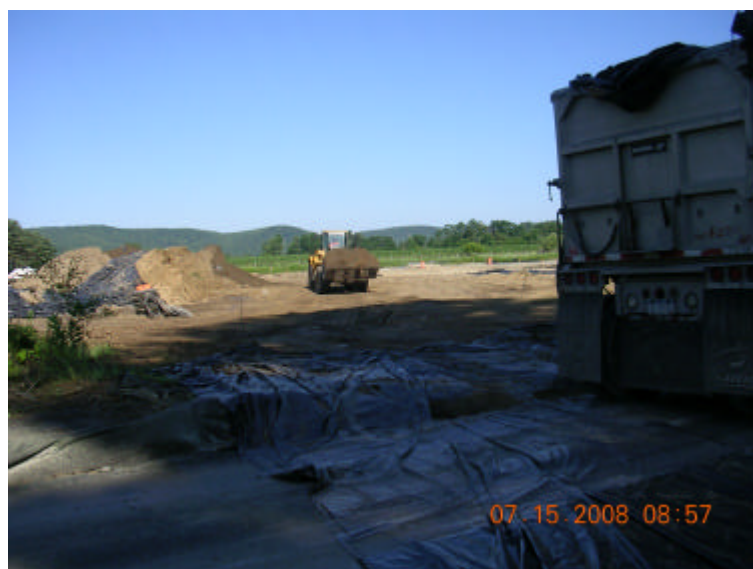
**DSCN4100.JPG**

| PHOTO | DATE | TIME | DESCRIPTION |
|---|---|---|---|
| DSCN 4100 | 7/15/2008 | 0857 | View of DAC loading of non-TSCA PCB contaminated soil using a Kawasaki 80ZV Front Loader from the main soil stockpile in Area 2 looking W. |

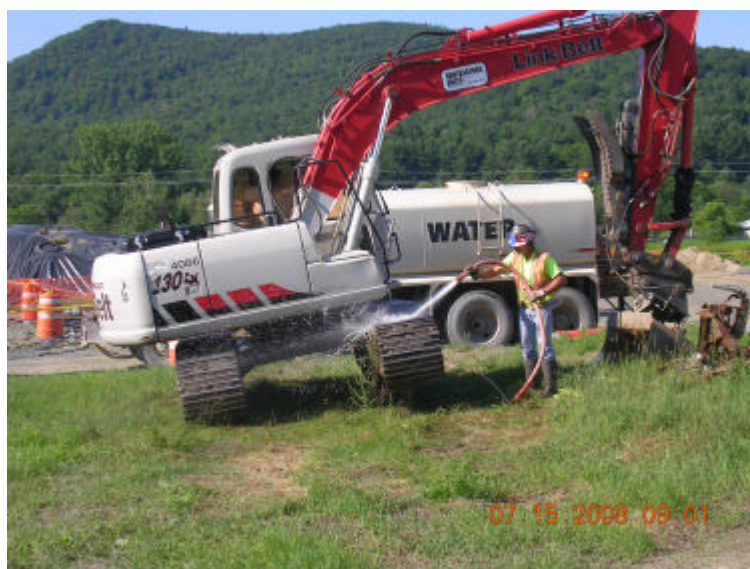
**DSCN4102.JPG**

| PHOTO | DATE | TIME | DESCRIPTION |
|---|---|---|---|
| DSCN 4102 | 7/15/2008 | 0901 | View of decontamination of trackhoe over non-TSCA grid I-12; View of Area 3 looking SSW. |

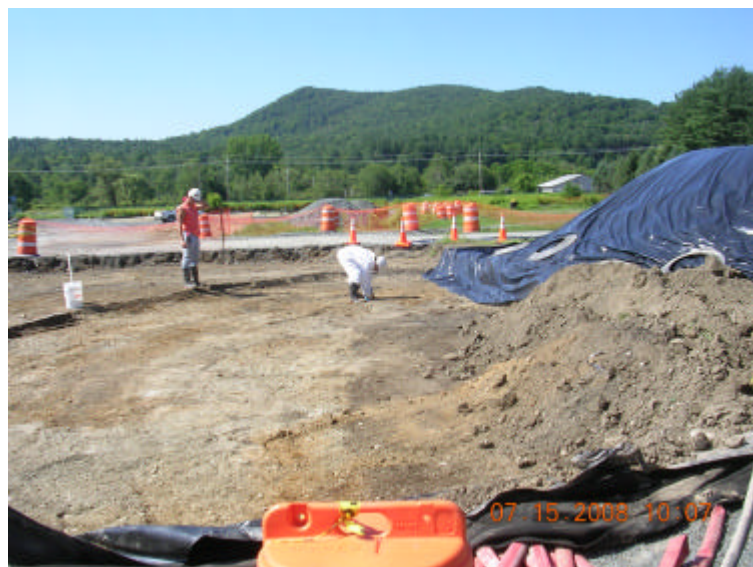
**DSCN4103.JPG**

| PHOTO | DATE | TIME | DESCRIPTION |
|---|---|---|---|
| DSCN 4103 | 7/15/2008 | 1007 | Collection of bottom soil sample EP-F9(18-in.) at 1.5 ft bgs within grid F-9; Area 4 looking S. |

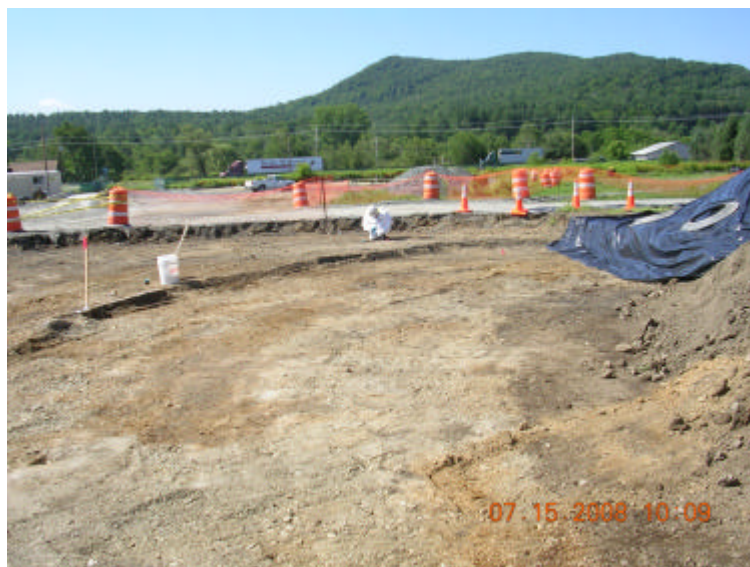
**DSCN4104.JPG**

| PHOTO | DATE | TIME | DESCRIPTION |
|---|---|---|---|
| DSCN 4104 | 7/15/2008 | 1009 | Collection of bottom soil sample EP-F9(12-in.) at 1 ft bgs within grid F-9; Area 4 looking S. |

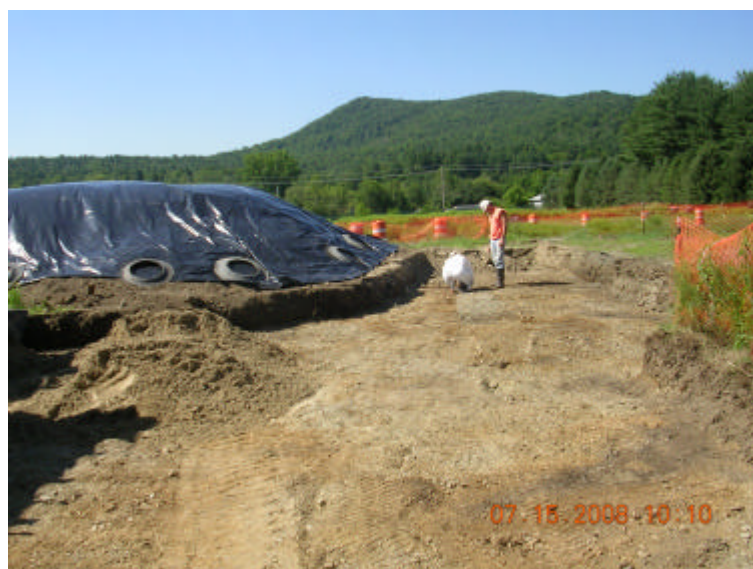
**DSCN4105.JPG**

| PHOTO | DATE | TIME | DESCRIPTION |
|---|---|---|---|
| DSCN 4105 | 7/15/2008 | 1010 | Collection of bottom soil sample EP-E9(18-in.) at 1.5 ft bgs within grid F-9; Area 4 looking S. |

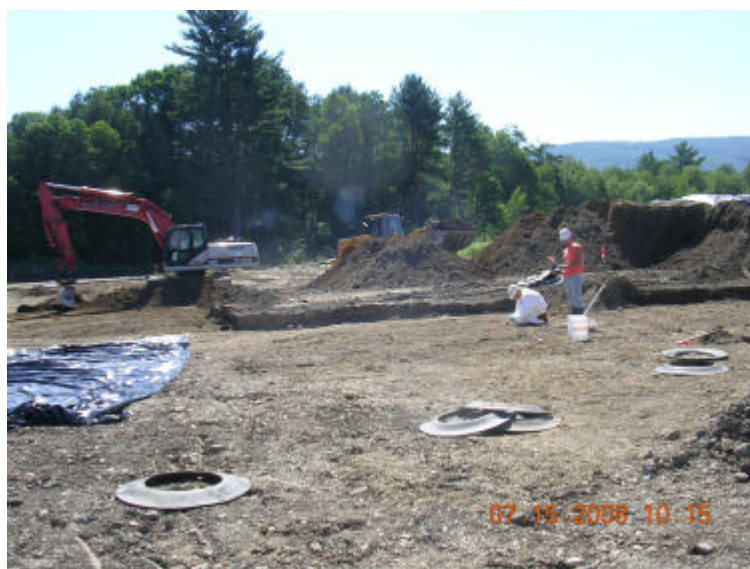
**DSCN4108.JPG**

| PHOTO | DATE | TIME | DESCRIPTION |
|---|---|---|---|
| DSCN 4108 | 7/15/2008 | 1015 | Collection of bottom soil sample EP-I16(12-in.) at 1 ft bgs within grid I-16; Area 2 looking E. |

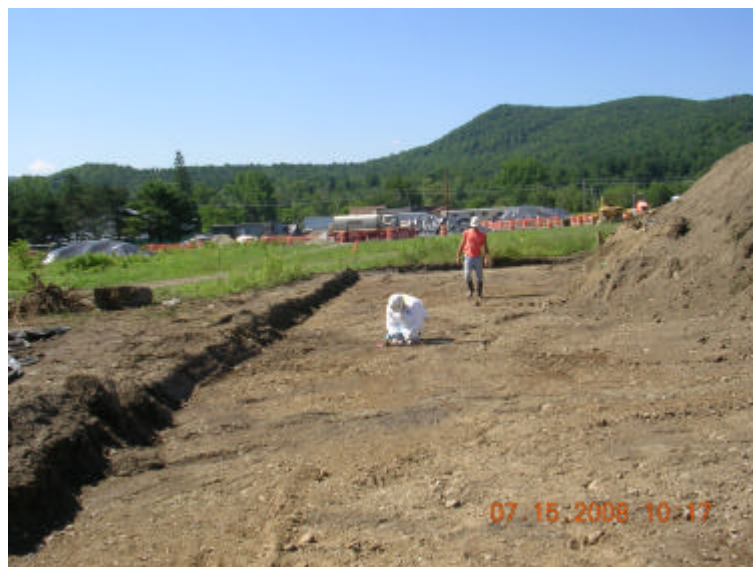
**DSCN4109.JPG**

| PHOTO | DATE | TIME | DESCRIPTION |
|---|---|---|---|
| DSCN 4109 | 7/15/2008 | 1017 | Collection of bottom soil sample EP-I15 at 1 ft bgs within grid I-15; Active dust suppression is being conducted in the background; Area 2 looking S. |

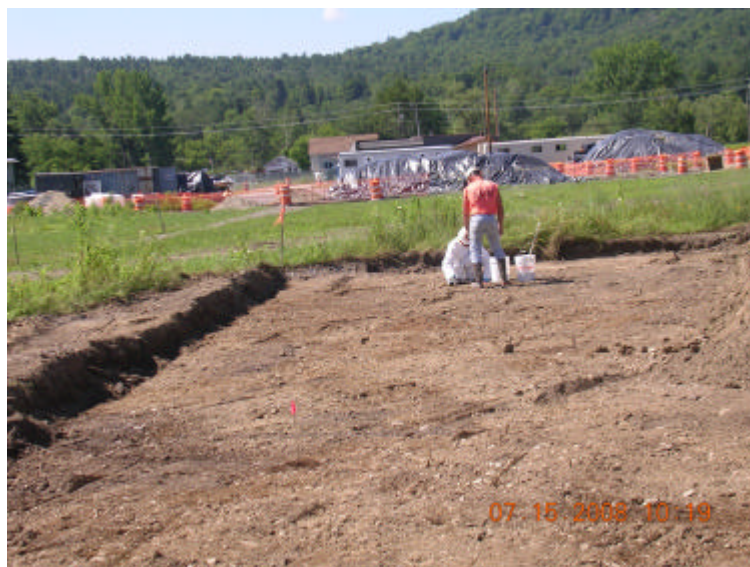
**DSCN4110.JPG**

| PHOTO | DATE | TIME | DESCRIPTION |
|---|---|---|---|
| DSCN 4110 | 7/15/2008 | 1019 | Collection of bottom soil sample EP-I14 at 1 ft bgs within grid I-14; Area 2 looking E. |

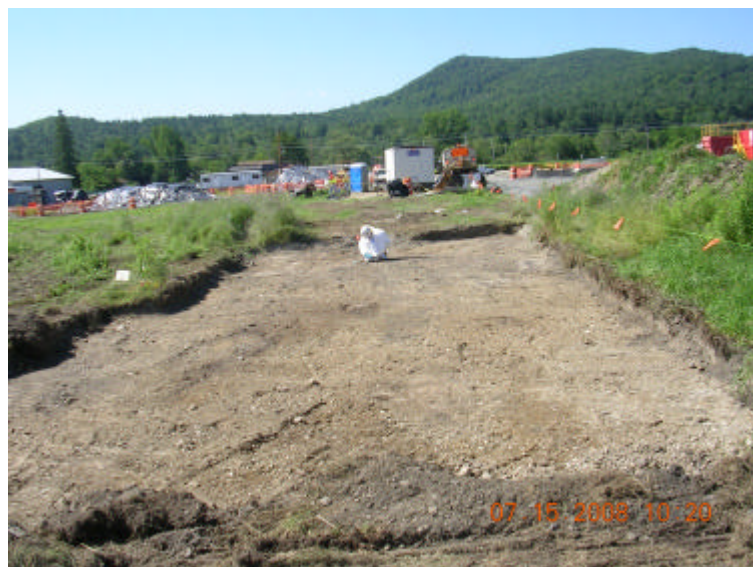
DSCN4111.JPG

| PHOTO | DATE | TIME | DESCRIPTION |
|---|---|---|---|
| DSCN 4111 | 7/15/2008 | 1020 | Collection of bottom soil sample EP-H14(12-in.) at 1 ft bgs within grid H-14; Area 2 looking S. |

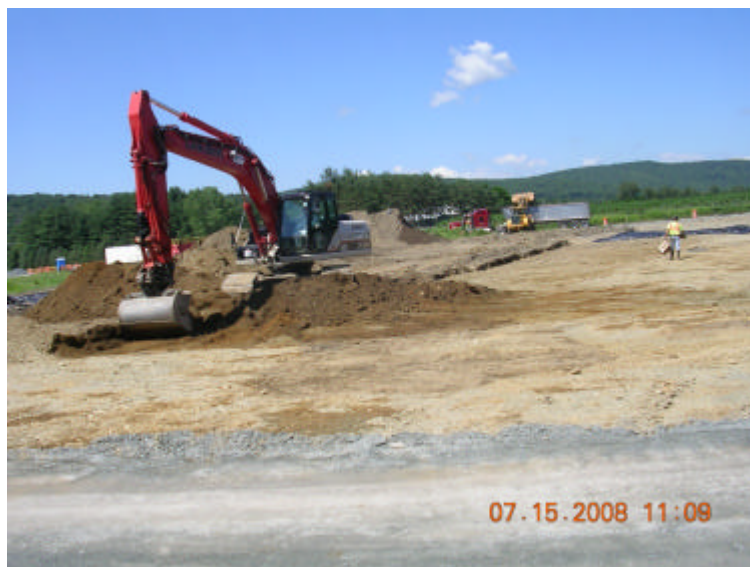
DSCN4113.JPG

| PHOTO | DATE | TIME | DESCRIPTION |
|---|---|---|---|
| DSCN 4113 | 7/15/2008 | 1109 | View of DAC loading of TSCA PCB-contaminated soil in the background of photo using a Kawasaki 80ZV Front Loader from soil stockpile in Area 2 looking W; Link Belt 240 Trackhoe is excavating non-TSCA soil from grid M-16 in the foreground. |

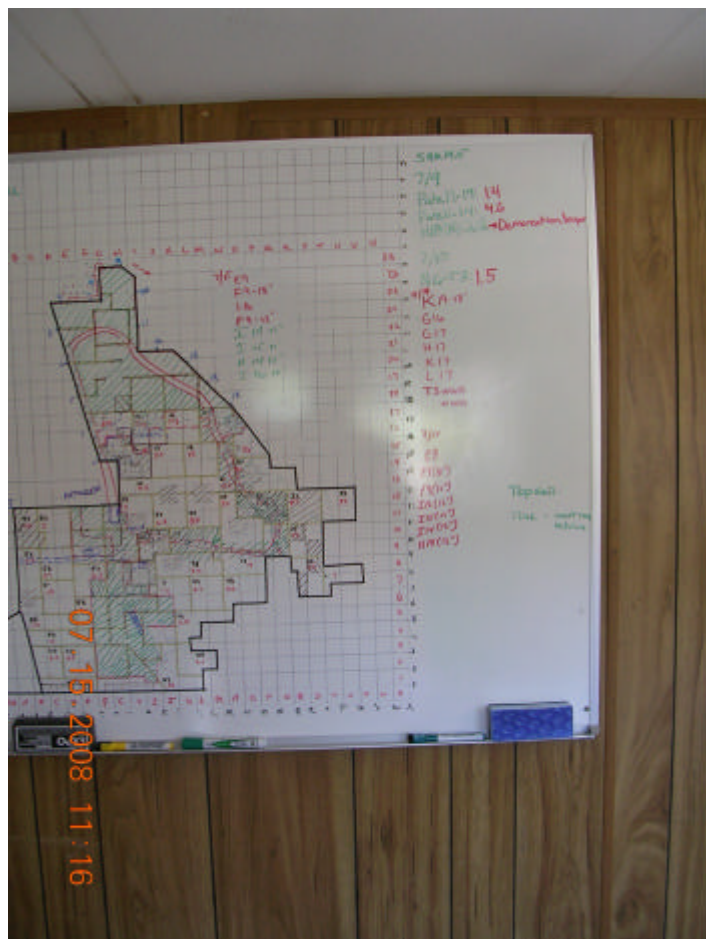
DSCN4115.JPG

| PHOTO | DATE | TIME | DESCRIPTION |
|---|---|---|---|
| DSCN 4115 | 7/15/2008 | 1116 | View of DAC's site meeting board showing current site progress including remedial excavations along the proposed access road. |

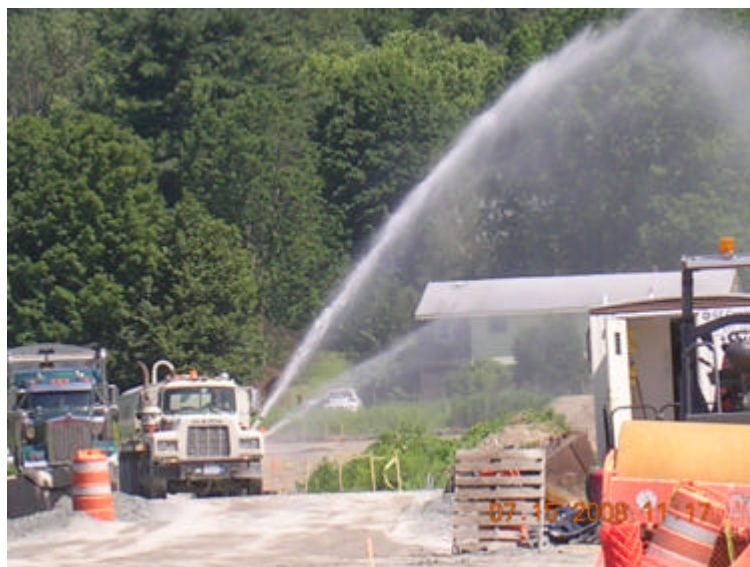
DSCN4116.JPG

| PHOTO | DATE | TIME | DESCRIPTION |
|---|---|---|---|
| DSCN 4116 | 7/15/2008 | 1117 | View of dust suppression in progress onto truck access road and ground surfaces across Area 2 using 4,000 gallon Mack Water Truck to help alleviate visible dust from hauling trucks and in exclusion zone where Front Loader is driving back and forth; View of Area 2 looking N. |

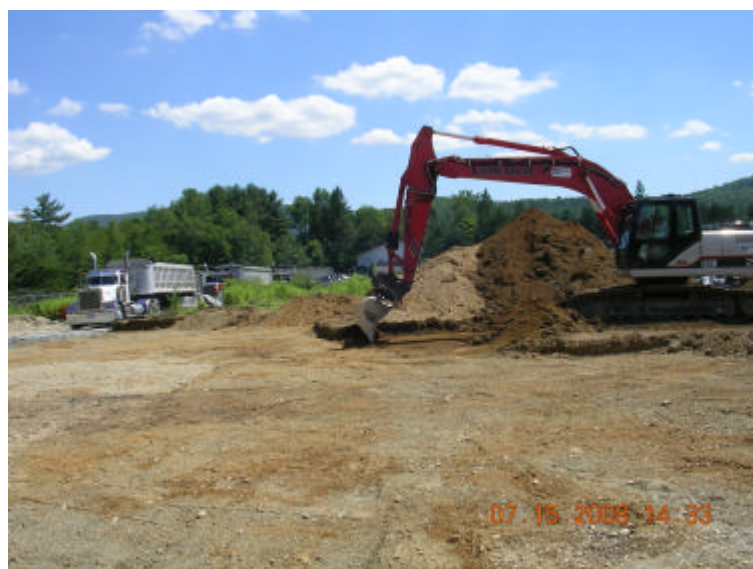
**DSCN4124.JPG**

| PHOTO | DATE | TIME | DESCRIPTION |
|---|---|---|---|
| DSCN 4124 | 7/15/2008 | 1433 | View of DAC loading of non-TSCA PCB-contaminated soil in the background of photo using a Kawasaki 80ZV Front Loader from soil stockpile in Area 2 looking SSE; Link Belt 240 Trackhoe is excavating non-TSCA soil from grid M-15 in the foreground. |

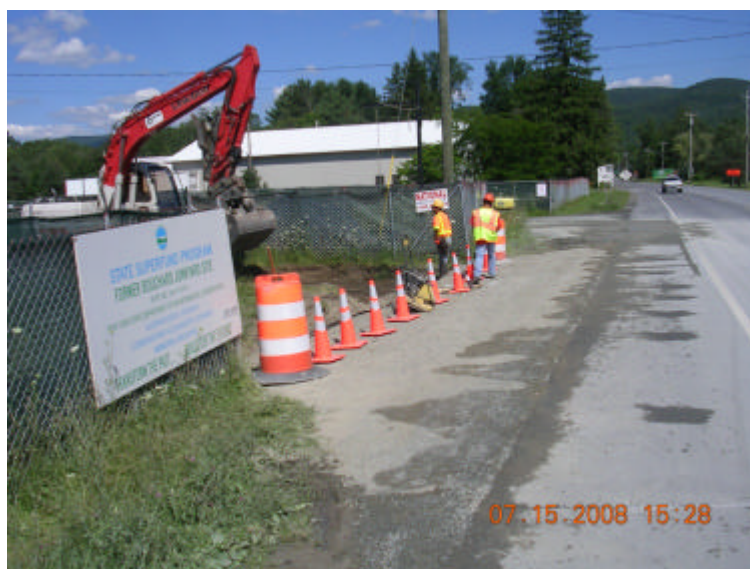
**DSCN4126.JPG**

| PHOTO | DATE | TIME | DESCRIPTION |
|---|---|---|---|
| DSCN 4126 | 7/15/2008 | 1528 | Remedial excavation activities at truck access road entrance at SW corner of Area 9 within Grid I-1 utilizing a Link-Belt 130 LX Trackhoe; Non-TSCA and TSCA soil was segregated into separate stockpiles in the vicinity of digging area; View of Area 9 and Route 20 looking E. |

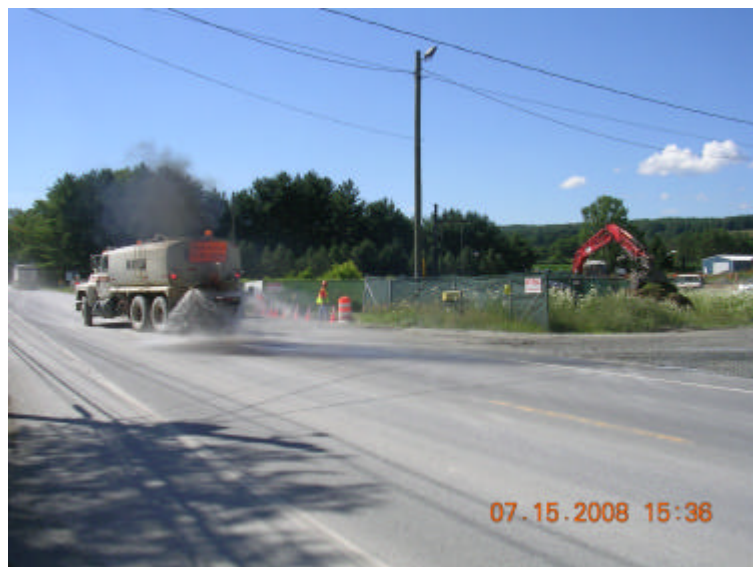
**DSCN4128.JPG**

| PHOTO | DATE | TIME | DESCRIPTION |
|---|---|---|---|
| DSCN 4128 | 7/15/2008 | 1536 | Cleaning of muddy tire tracks in progress onto Route 20 road surface at entrance to driveway to Building 666 using 4,000 gallon Mack Water Truck; View of Route 20 looking WNW. |

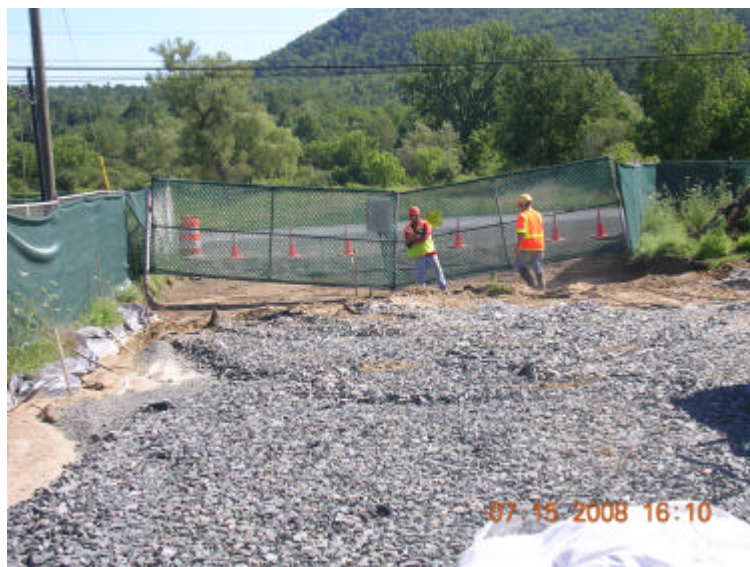
**DSCN4129.JPG**

| PHOTO | DATE | TIME | DESCRIPTION |
|---|---|---|---|
| DSCN 4129 | 7/15/2008 | 1610 | View of finished remedial excavation along truck access road entrance at SW corner of Area 9 within Grid I-1 View of Area 9 and Route 20 looking S. |
