## DAILY FIELD ACTIVITY REPORT

| <b>PROJECT</b> | <b>Former Bouchard Junkyard</b> | <b>WEATHER</b> | <b>TIME</b> | <b>TEMP.</b> | <b>PRECIP.</b> | <b>WIND (MPH)</b> | <b>WIND (DIR)</b> |
| <b>LOCATION</b> | <b>Town of New Lebanon, NY</b> | <b>M. Cloudy</b> | <b>0700</b> | <b>70-75 F</b> | <b>None</b> | <b>0-5</b> | <b>W</b> |

**PHOTOGRAPHIC LOG**  
**July 16, 2008**  
**D&B JOB NO. 2605**  
**FORMER BOUCHARD JUNKYARD SITE**  
**TOWN OF NEW LEBANON, NEW YORK**

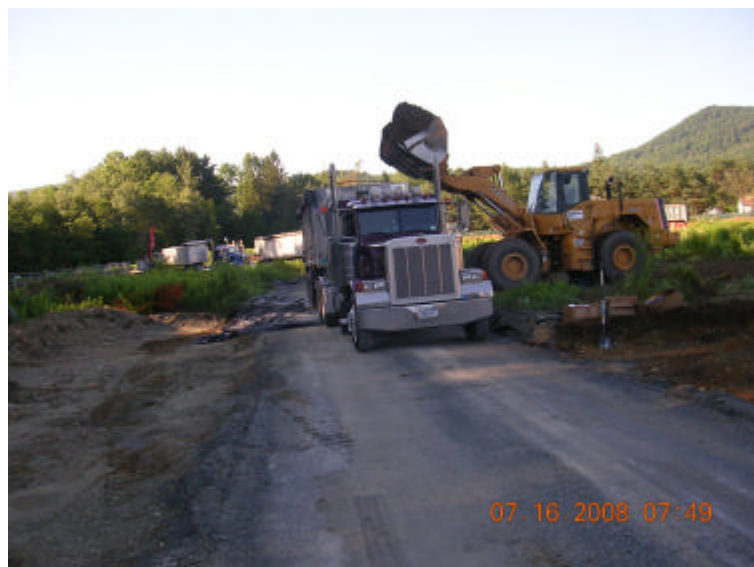
**DSCN4151.JPG**

| PHOTO | DATE | TIME | DESCRIPTION |
|---|---|---|---|
| DSCN 4151 | 7/16/2008 | 0749 | View of DAC loading of non-TSCA PCB contaminated soil using a Kawasaki 802V Front Loader from the main soil stockpile in Area 2 looking S. |

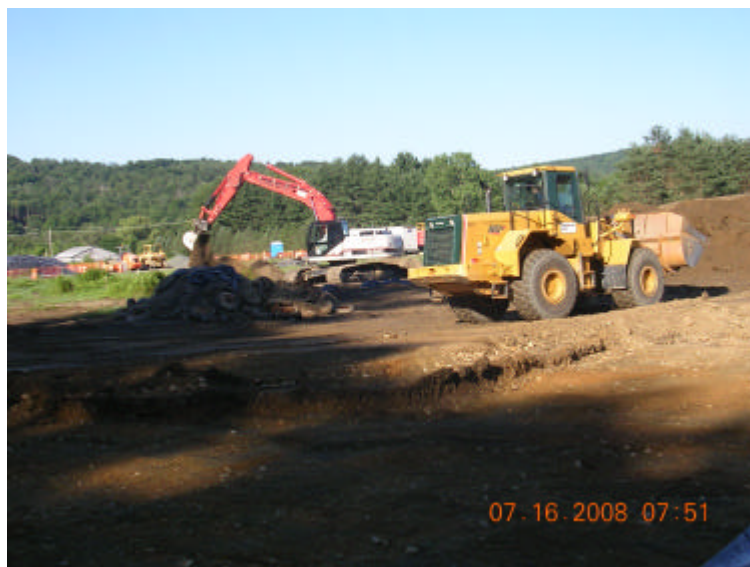
**DSCN4152.JPG**

| PHOTO | DATE | TIME | DESCRIPTION |
|---|---|---|---|
| DSCN 4152 | 7/16/2008 | 0751 | View of DAC loading of non-TSCA PCB contaminated soil in the foreground of photo using a Kawasaki 802V Front Loader from the main soil stockpile in Area 2 looking SW; Link Belt 240 Trackhoe is excavating non-TSCA soil from grid K-12 in the background. |

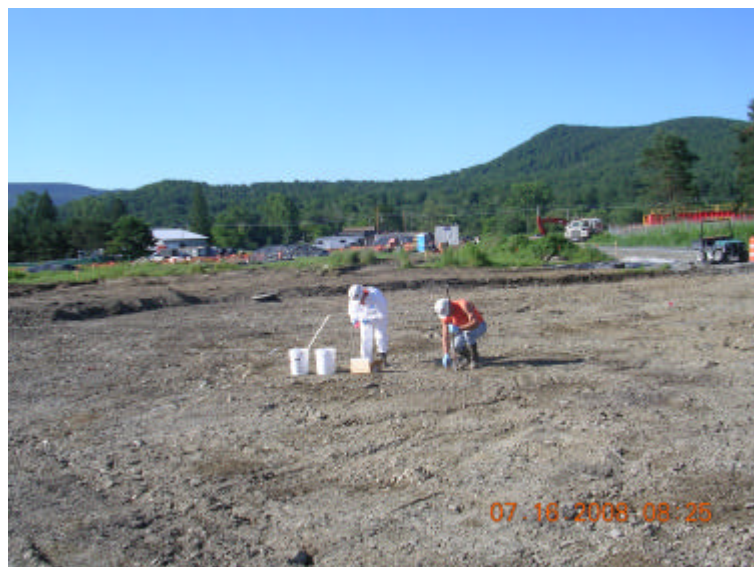
**DSCN4153.JPG**

- Grid G-17; 4-point grid re-sampling protocol employed due to initial sample failure; Sample IDs EP-G17(1) at center of SE quadrant, EP-G17(2) at center of SW quadrant, EP-G17(3) at center of NW quadrant, and EP-G17(4) at center of NE quadrant; All samples collected at 1 ft bgs;

| PHOTO | DATE | TIME | DESCRIPTION |
|---|---|---|---|
| DSCN 4153 | 7/16/2008 | 0825 | Collection of bottom soil sample EP-G17(1) at 1 ft bgs within grid G-17; The sample was grab sample 1 of 4 collected in response to failed analytical result associated with the original soil sample (EP-G17) to further characterize this area and identify the need for additional excavation; Area 2 looking S. |

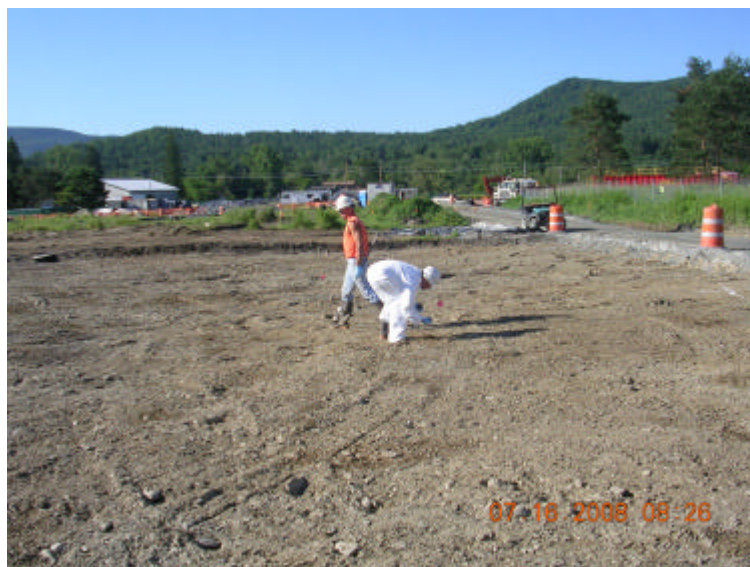
**DSCN4154.JPG**

| PHOTO | DATE | TIME | DESCRIPTION |
|---|---|---|---|
| DSCN 4154 | 7/16/2008 | 0826 | Collection of bottom soil sample EP-G17(2) at 1 ft bgs within grid G-17; Employed 4-point grid resampling protocol in response to failed analytical result associated with the original soil sample (EP-G17) to further characterize this area and identify the need for additional excavation; Area 2 looking S. |

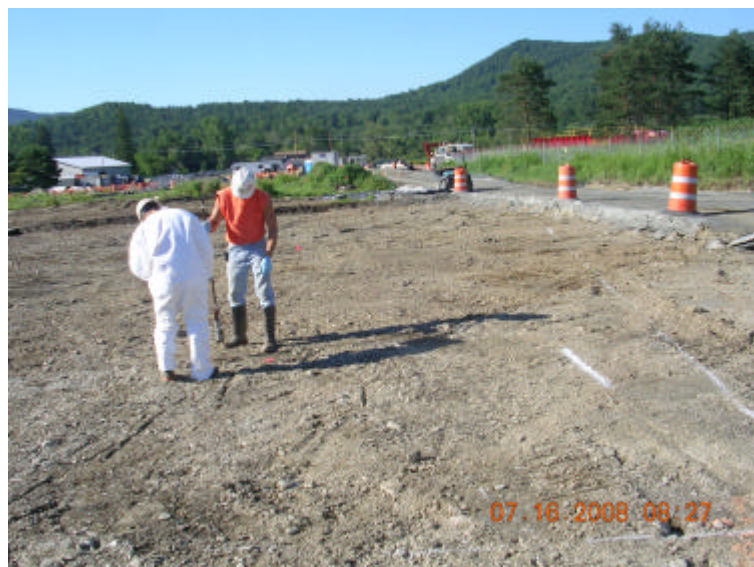
**DSCN4155.JPG**

| PHOTO | DATE | TIME | DESCRIPTION |
|---|---|---|---|
| DSCN 4155 | 7/16/2008 | 0827 | Collection of bottom soil sample EP-G17(3) at 1 ft bgs within grid G-17; Employed 4-point grid resampling protocol in response to failed analytical result associated with the original soil sample (EP-G17) to further characterize this area and identify the need for additional excavation; Area 2 looking S. |

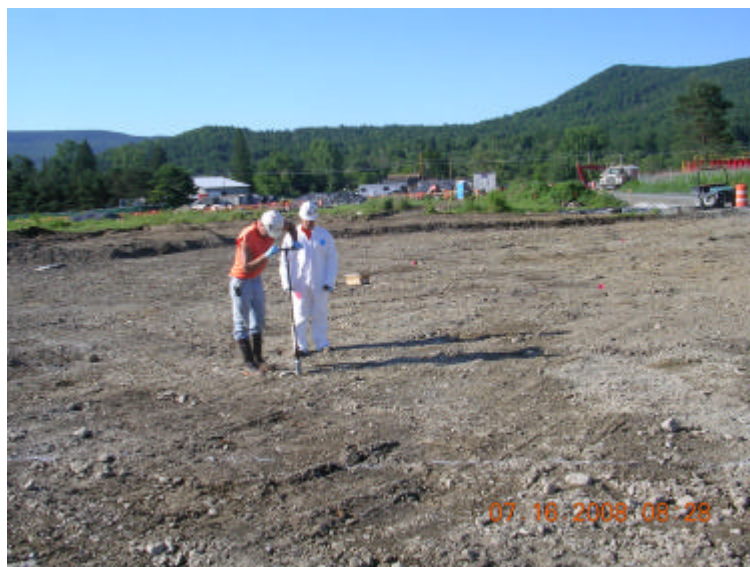
**DSCN4156.JPG**

| PHOTO | DATE | TIME | DESCRIPTION |
|---|---|---|---|
| DSCN 4156 | 7/16/2008 | 0828 | Collection of bottom soil sample EP-G17(4) at 1 ft bgs within grid G-17; Employed 4-point grid resampling protocol in response to failed analytical result associated with the original soil sample (EP-G17) to further characterize this area and identify the need for additional excavation; Area 2 looking S. |

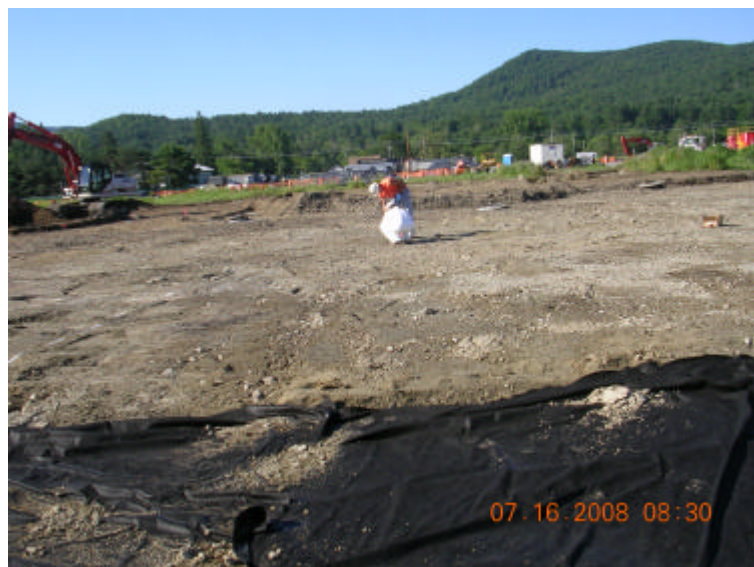
**DSCN4157.JPG**

- Grid H-17; 4-point grid re-sampling protocol employed due to initial sample failure; Sample IDs EP-H17(1) at center of SE quadrant (Duplicate EP-DUP13 collected here), EP-H17(2) at center of SW quadrant, EP-H17(3) at center of NW quadrant, and EP-H17(4) at center of NE quadrant (MS/MSD/MSB collected here); All samples collected at 1 ft bgs;

| PHOTO | DATE | TIME | DESCRIPTION |
|---|---|---|---|
| DSCN 4157 | 7/16/2008 | 0830 | Collection of bottom soil sample EP-H17(1) at 1 ft bgs within grid H-17 (Duplicate EP-DUP13 collected here); Employed 4-point grid resampling protocol in response to failed analytical result associated with the original soil sample (EP-H17) to further characterize this area and identify the need for additional excavation; Area 2 looking S. |

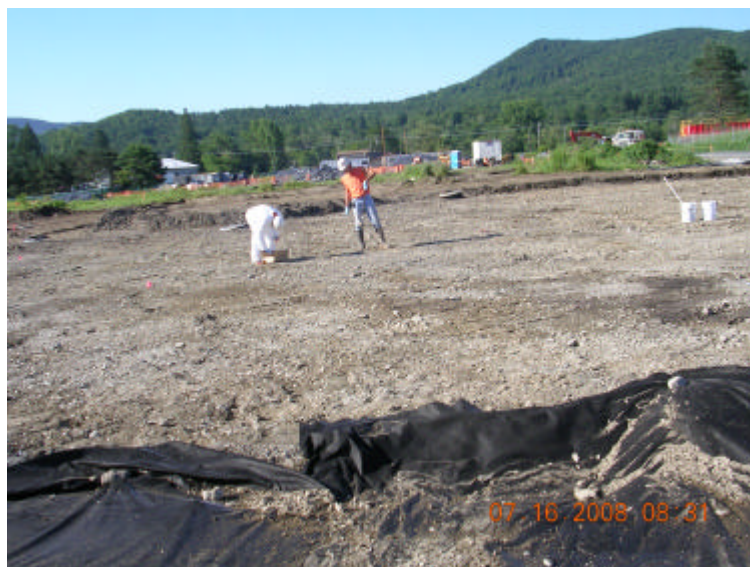
**DSCN4158.JPG**

| PHOTO | DATE | TIME | DESCRIPTION |
|---|---|---|---|
| DSCN 4158 | 7/16/2008 | 0831 | Collection of bottom soil sample EP-H17(2) at 1 ft bgs within grid H-17; Employed 4 point grid resampling protocol in response to failed analytical result associated with the original soil sample (EP-G17) to further characterize this area and identify the need for additional excavation; Area 2 looking S. |

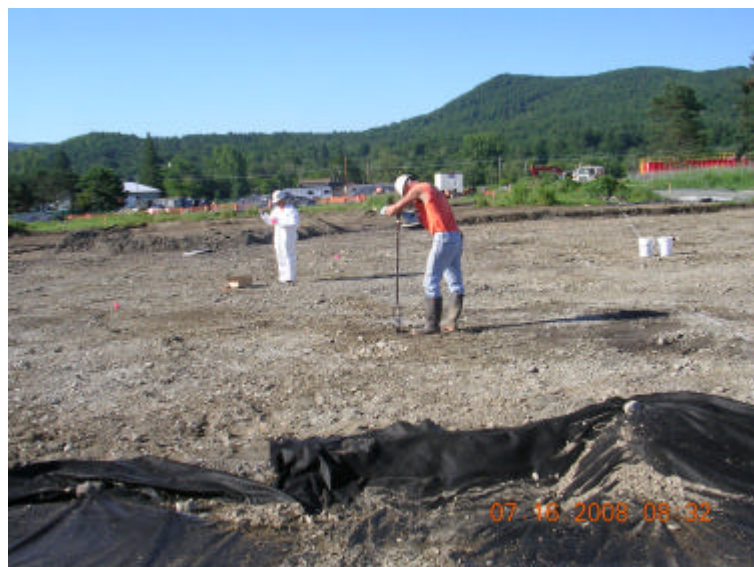
**DSCN4159.JPG**

| PHOTO | DATE | TIME | DESCRIPTION |
|---|---|---|---|
| DSCN 4159 | 7/16/2008 | 0832 | Collection of bottom soil sample EP-H17(3) at 1 ft bgs within grid H-17; Employed 4 point grid resampling protocol in response to failed analytical result associated with the original soil sample (EP-G17) to further characterize this area and identify the need for additional excavation; Area 2 looking S. |

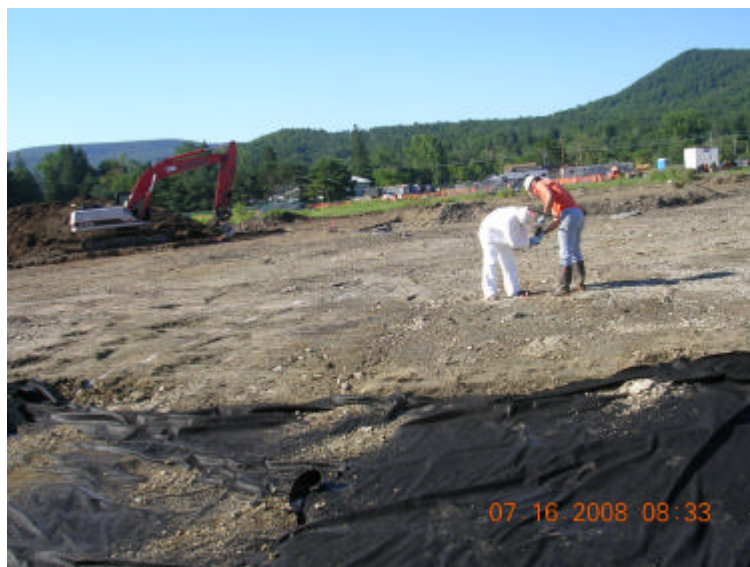
**DSCN4160.JPG**

| PHOTO | DATE | TIME | DESCRIPTION |
|---|---|---|---|
| DSCN 4160 | 7/16/2008 | 0833 | Collection of bottom soil sample EP-H17(4) at 1 ft bgs within grid H-17 (MS/MSD/MSB collected here; Employed 4-point grid resampling protocol in response to failed analytical result associated with the original soil sample (EP-H17) to further characterize this area and identify the need for additional excavation; Remedial excavation in progress at grid J-15 in background; Area 2 looking SSE. |

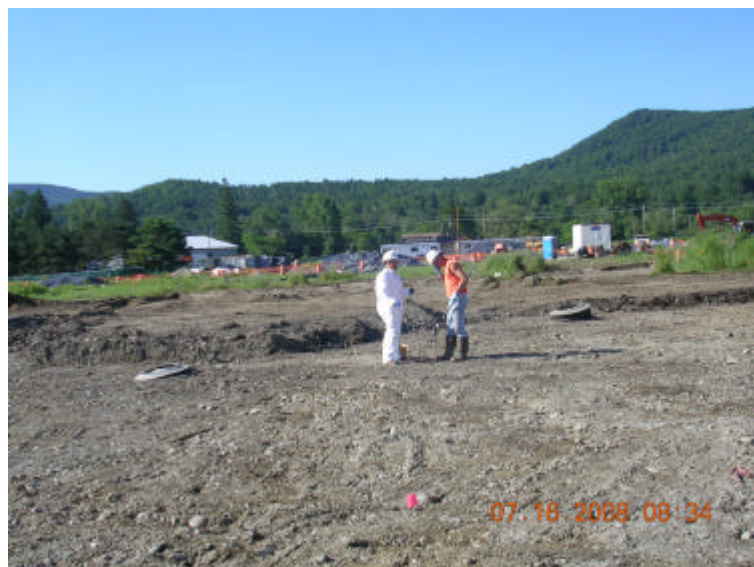
**DSCN4161.JPG**

| PHOTO | DATE | TIME | DESCRIPTION |
|---|---|---|---|
| DSCN 4161 | 7/16/2008 | 0834 | Collection of bottom soil sample EP-H16 at 1 ft bgs within grid H-16; Area 2 looking S. |

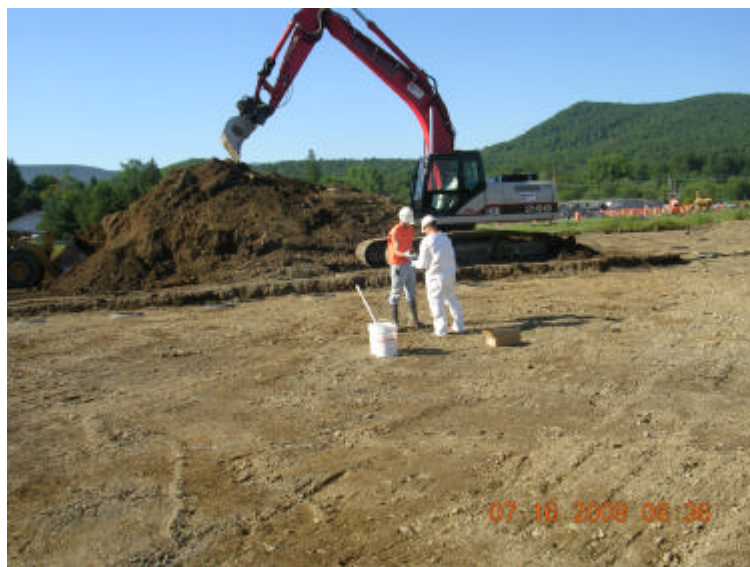
**DSCN4162.JPG**

| PHOTO | DATE | TIME | DESCRIPTION |
|---|---|---|---|
| DSCN 4162 | 7/16/2008 | 0836 | Collection of bottom soil sample EP-J16 at 1 ft bgs within grid J-16; Area 2 looking S. |

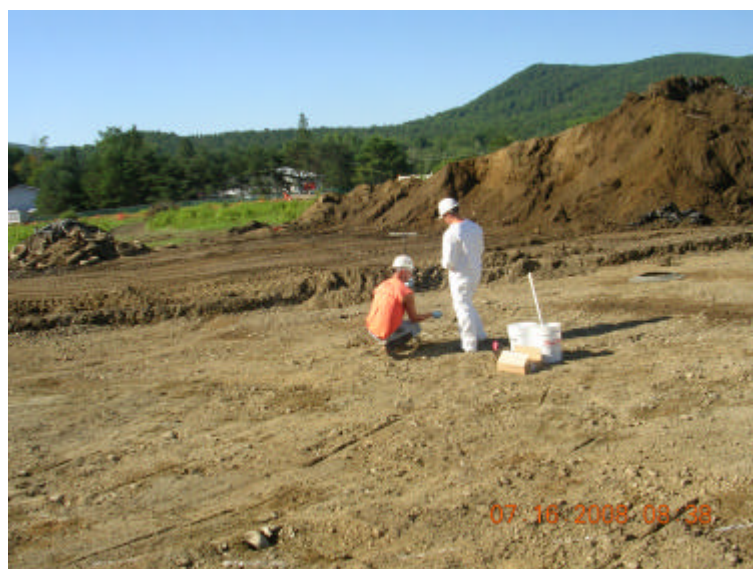
**DSCN4163.JPG**

| PHOTO | DATE | TIME | DESCRIPTION |
|---|---|---|---|
| DSCN 4163 | 7/16/2008 | 0838 | Collection of bottom soil sample EP-K16 at 1 ft bgs within grid K-16; Area 2 looking S. |

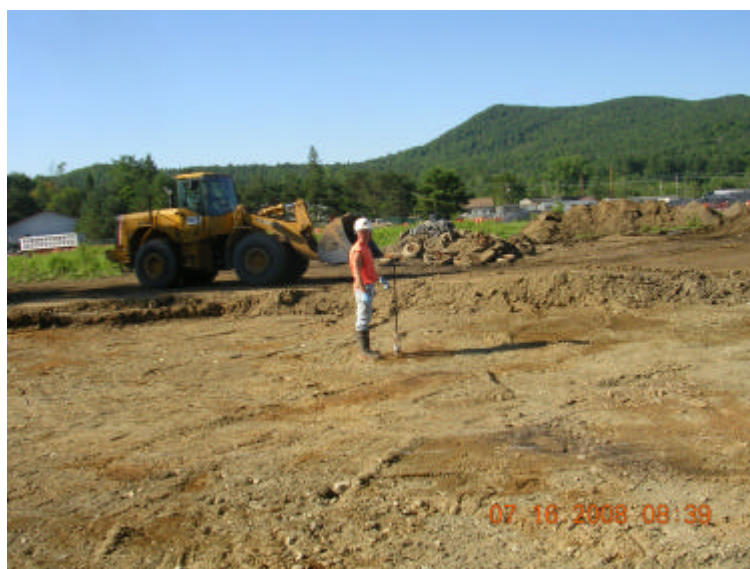
**DSCN4164.JPG**

| PHOTO | DATE | TIME | DESCRIPTION |
|---|---|---|---|
| DSCN 4164 | 7/16/2008 | 0839 | Collection of bottom soil sample EP-L16 at 1 ft bgs within grid L-16; Area 2 looking S. |

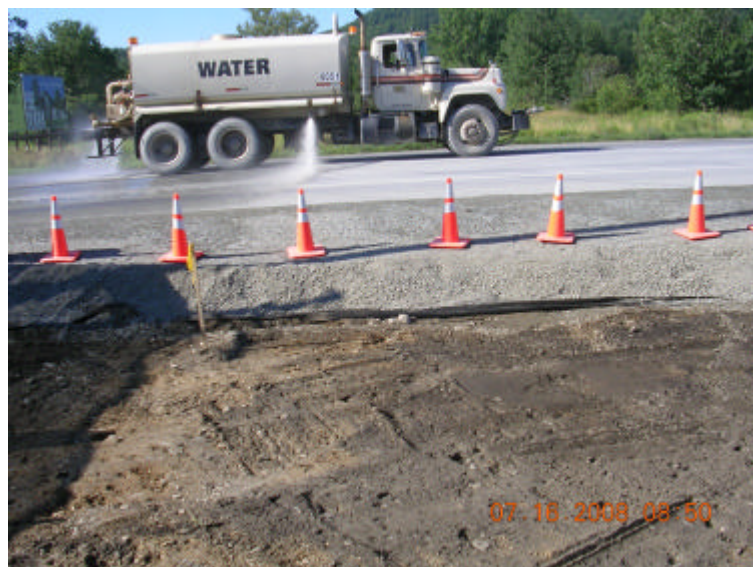
**DSCN4165.JPG**

| PHOTO | DATE | TIME | DESCRIPTION |
|---|---|---|---|
| DSCN 4165 | 7/16/2008 | 0850 | Cleaning of muddy tire tracks in progress onto Route 20 road surface at entrance to driveway to Building 666 using 4,000 gallon Mack Water Truck; View of Route 20 looking S. |

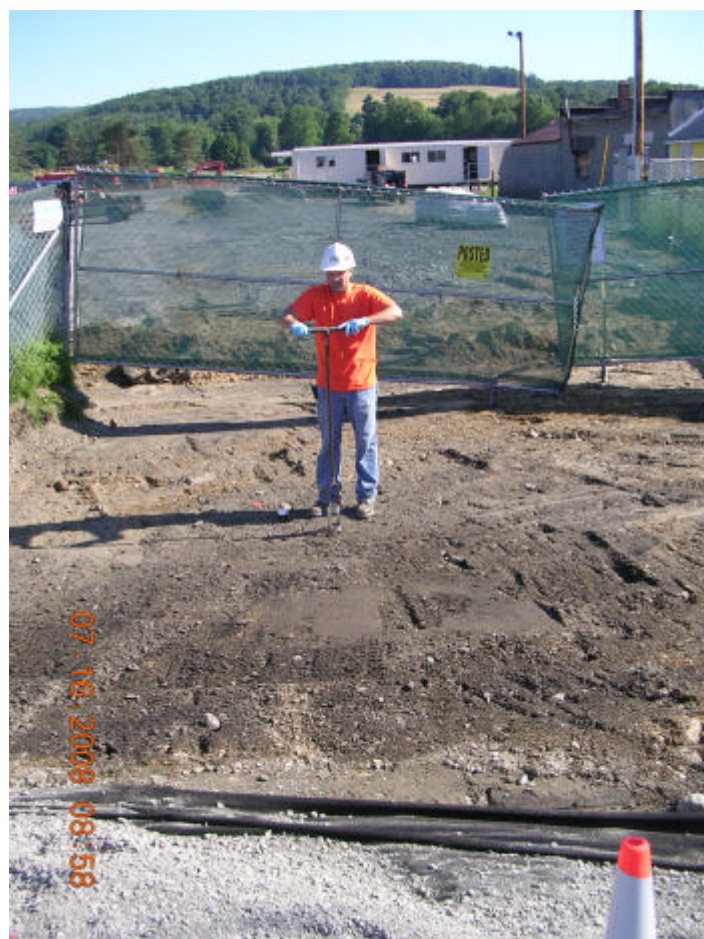
**DSCN4166.JPG**

- Grid I-1; Sample ID EP-I1-T17 (TSCA grid 17) at 1 ft bgs;

| PHOTO | DATE | TIME | DESCRIPTION |
|---|---|---|---|
| DSCN 4166 | 7/16/2008 | 0858 | Collection of bottom soil sample EP-I1-T17 (TSCA grid 17) at 1 ft bgs within TSCA grid 17 (grid I-1); Area 2 looking S. |

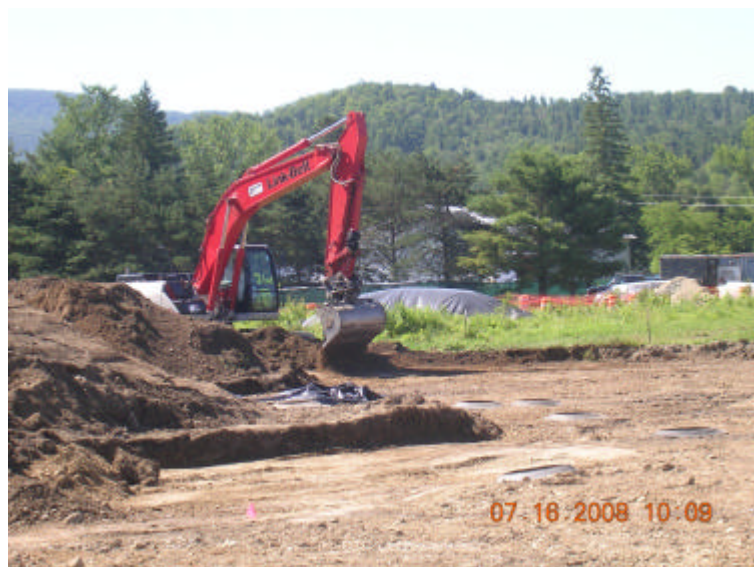
**DSCN4167.JPG**

| PHOTO | DATE | TIME | DESCRIPTION |
|---|---|---|---|
| DSCN 4167 | 7/16/2008 | 1009 | Remedial excavation activities in Area 2 within the non-TSCA portion of Grid L-13 utilizing a Link-Belt 240 Trackhoe; Non-TSCA soil was segregated into a stockpile in the vicinity of digging area; View of Area 2 looking SSW. |

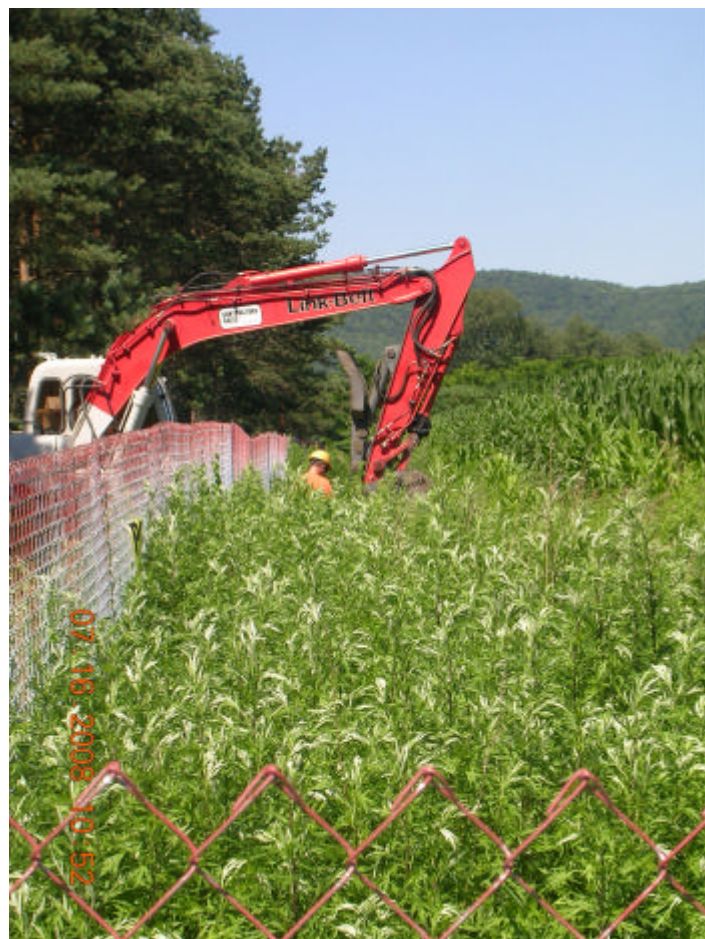
**DSCN4169.JPG**

| PHOTO | DATE | TIME | DESCRIPTION |
|---|---|---|---|
| DSCN 4169 | 7/16/2008 | 1052 | Trenching activities to make improvements to the drainage ditch along northern boundary of Area 4 utilizing a Link-Belt 130 LX Trackhoe; View of Area 4 looking W. |

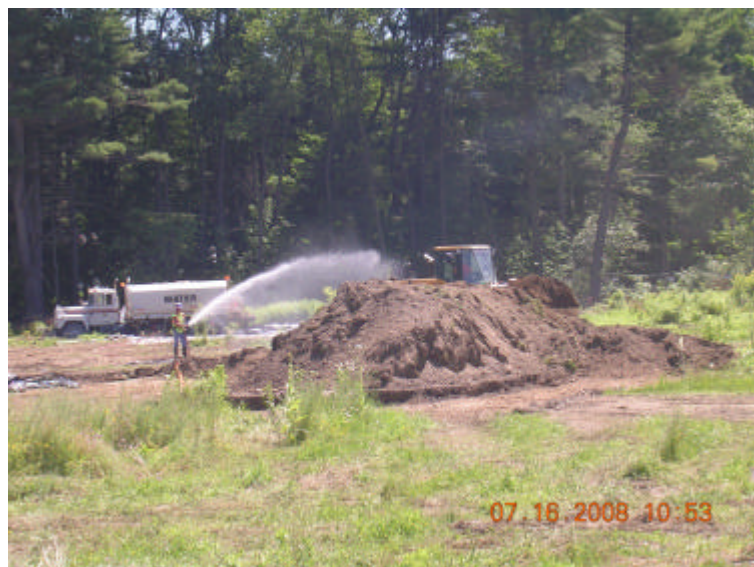
**DSCN4170.JPG**

| PHOTO | DATE | TIME | DESCRIPTION |
|---|---|---|---|
| DSCN 4170 | 7/16/2008 | 1053 | View of dust suppression in progress onto truck access road and ground surfaces across Area 2 using 4,000 gallon Mack Water Truck to help alleviate visible dust from waste hauling and on exclusion zone where Front Loader is driving back and forth; View of Area 2 looking NE. |

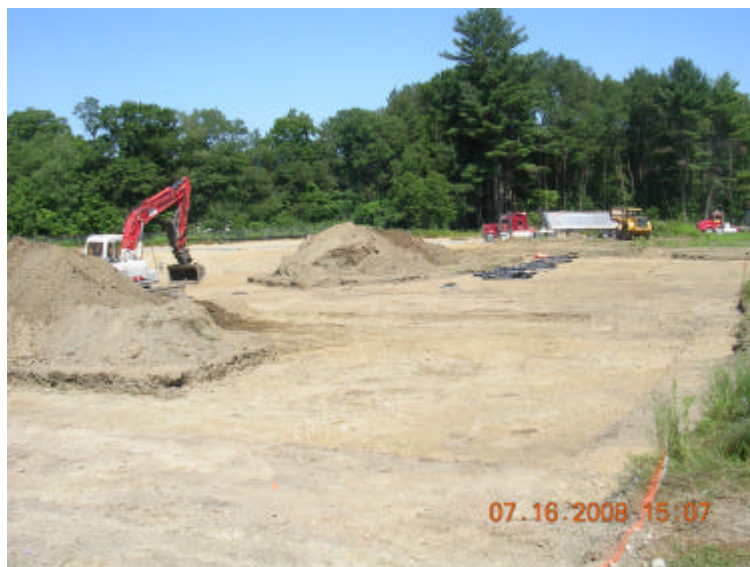
**DSCN4175.JPG**

| PHOTO | DATE | TIME | DESCRIPTION |
|---|---|---|---|
| DSCN 4175 | 7/16/2008 | 1507 | View of DAC loading of non-TSCA PCB contaminated soil in the background of photo using a Kawasaki 802V Front Loader from the main soil stockpile in Area 2 looking SW; Link Belt 240 Trackhoe is excavating TSCA soil from TSCA grid 4 in the foreground. |

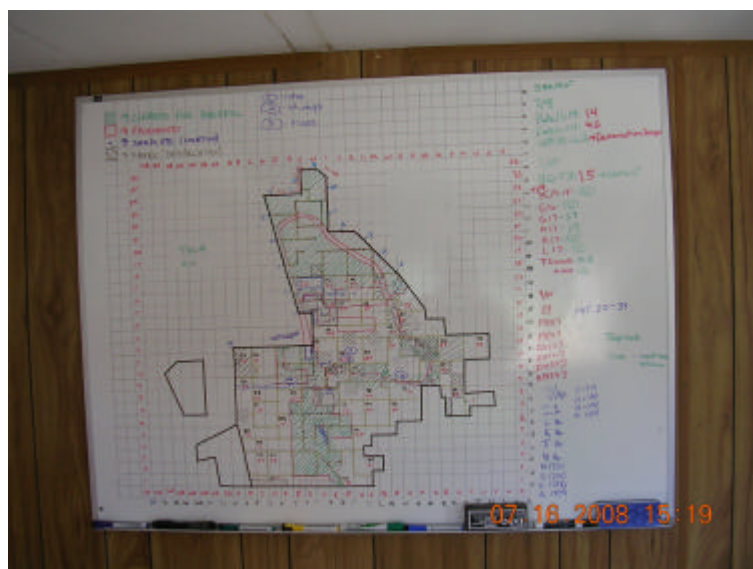
**DSCN4179.JPG**

| PHOTO | DATE | TIME | DESCRIPTION |
|---|---|---|---|
| DSCN 4179 | 7/16/2008 | 1519 | View of DAC's site meeting board showing current site progress including remedial excavations along the proposed access road. |

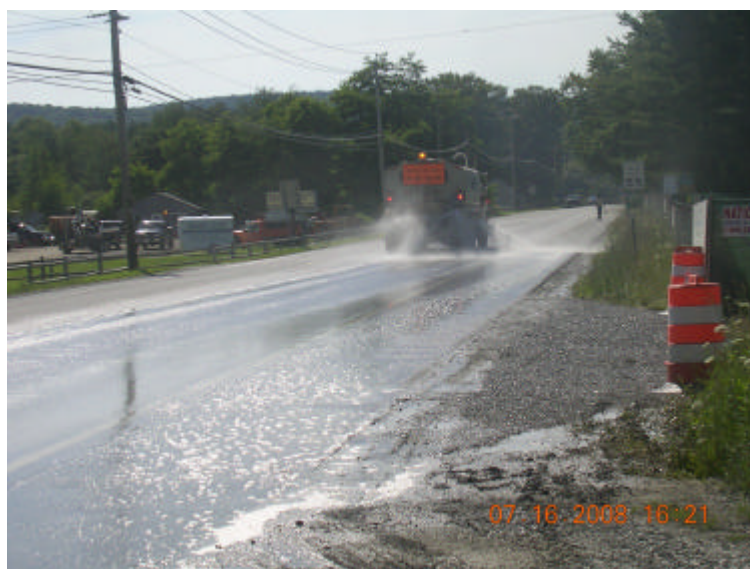
**DSCN4180.JPG**

| PHOTO | DATE | TIME | DESCRIPTION |
|---|---|---|---|
| DSCN 4180 | 7/16/2008 | 1621 | Cleaning of muddy tire tracks in progress onto Route 20 road surface at entrance to driveway to Building 666 using 4,000 gallon Mack Water Truck; View of Route 20 looking W. |

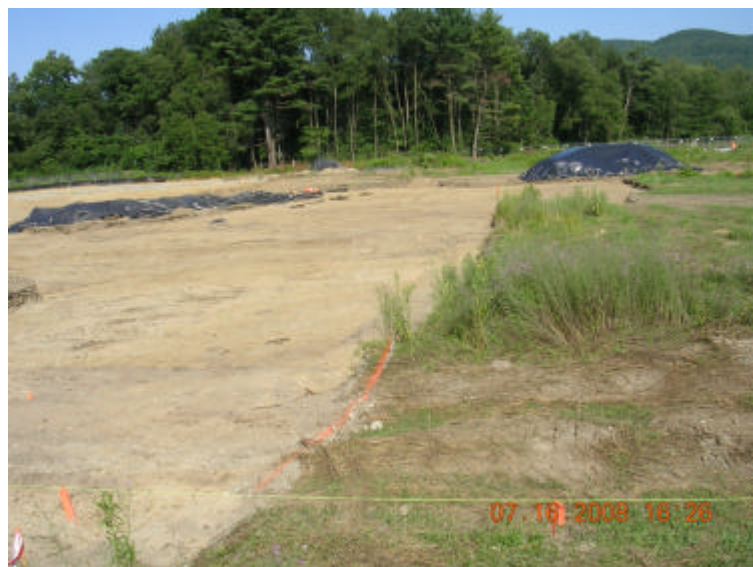
**DSCN4182.JPG**

| PHOTO | DATE | TIME | DESCRIPTION |
|---|---|---|---|
| DSCN 4182 | 7/16/2008 | 1626 | View of finished remedial excavation at close of business in Area 2 looking E; Soil stockpiles have been covered with 6 mil polyethylene sheeting. |
