DAILY FIELD ACTIVITY REPORT

PROJECT	Former Bouchard Junkyard	WEATHER	TIME	TEMP.	PRECIP.	WIND (MPH)	WIND (DIR)
LOCATION	Town of New Lebanon, NY	Overcast	0700	65 F	None	Calm	N/A
ATTACHMENTS	Photo Log and Photos	P. Cloudy	1730	81 F	None	5-10	West

PHOTOGRAPHIC LOG
July 21, 2008
D&B JOB NO. 2605
FORMER BOUCHARD JUNKYARD SITE
TOWN OF NEW LEBANON, NEW YORK

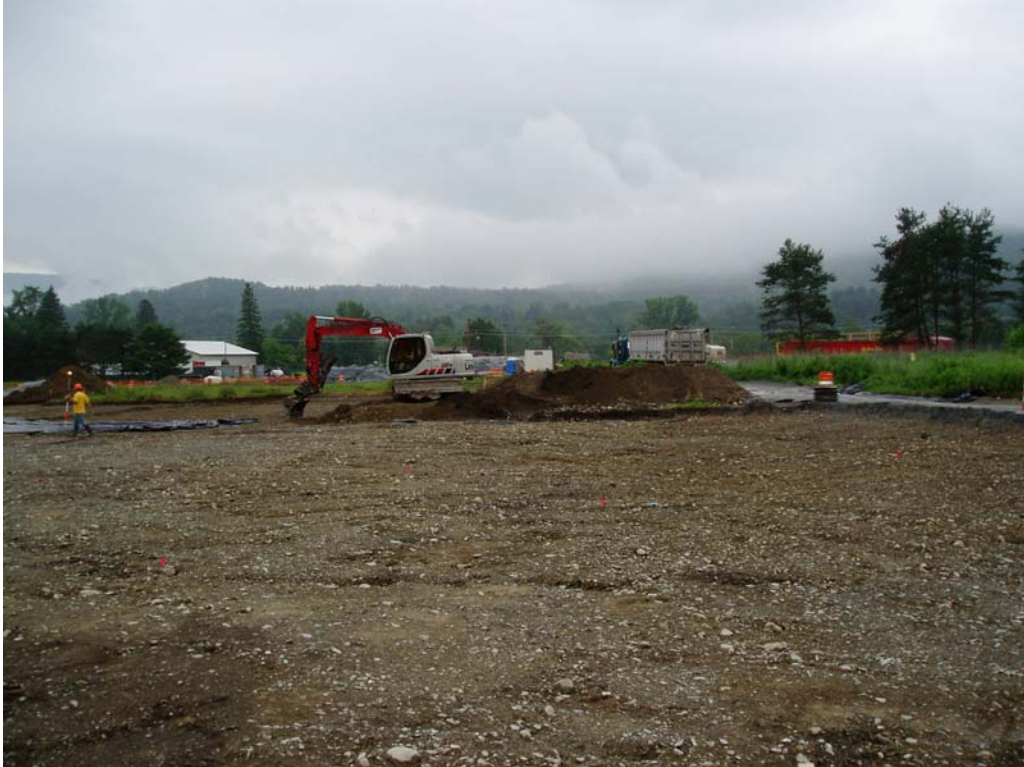
P7210001.JPG

PHOTO	DATE	TIME	DESCRIPTION
P7 210001	7/21/2008	8:15	View to south showing remedial excavation at west side of Area 2 (grid station G-15)
P7 210002	7/21/2008	8:54	View to east showing retention pond located northwest of Chuck's Automotive (water supply for dust control)
P7 210003	7/21/2008	9:54	View to east showing front end loader loading non-TSCA PCB contaminated soil into truck at southeast corner of Area 3 for off-site disposal
P7 210004	7/21/2008	10:08	View to southeast showing remedial excavation at east side of Area 2
P7 210005	7/21/2008	10:11	View to south showing remedial excavation at northeast corner of Area 3 (grid station M-12)
P7 210006	7/21/2008	11:30	View to northeast showing remedial excavation at southwest corner of Area 2 (grid station I-13)
P7 210007	7/21/2008	14:01	View to south showing front end loader loading non-TSCA PCB contaminated soil into truck at southeast corner of Area 3 for off-site disposal

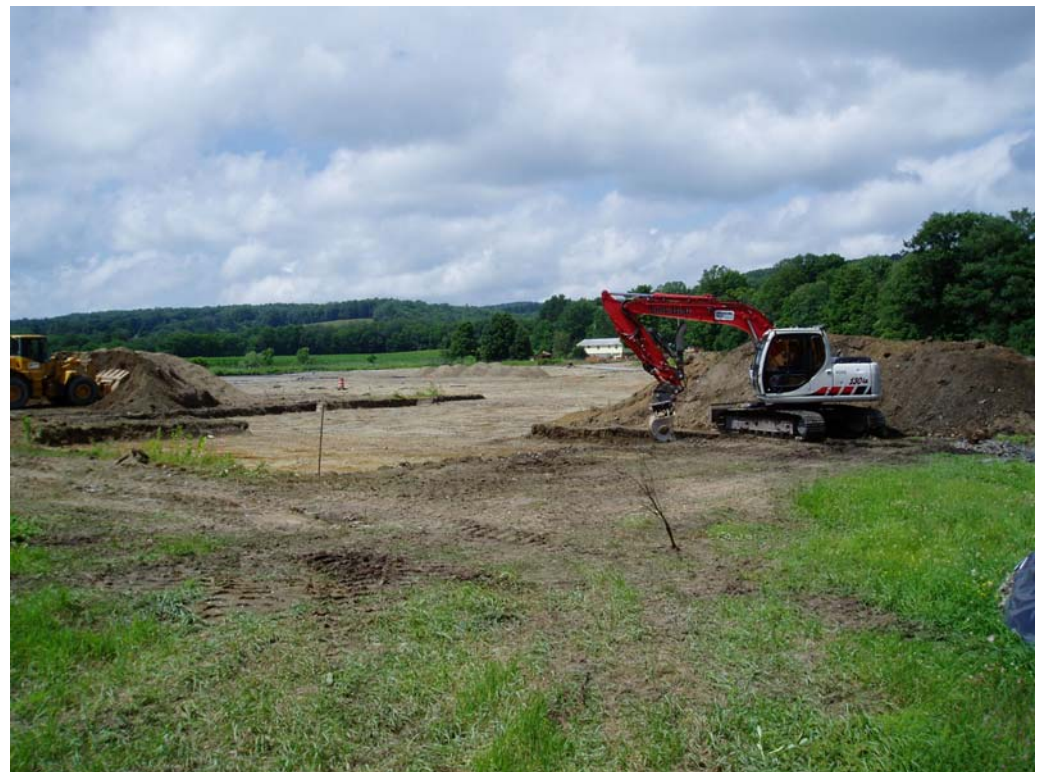
P7210008.JPG

P7 210008	7/21/2008	14:20	View to northwest showing remedial excavation at southeast corner of Area 3 (grid station O-10)
P7 210009	7/21/2008	14:54	View to southeast showing D. A. Collins covering excavated soil pile material with poly sheeting at west side of Area 8
P7 210010	7/21/2008	15:07	View to north showing water truck spraying water onto truck access road at west side of Area 1 and Area 2 for dust control
P7 210011	7/21/2008	16:29	View to west showing backfill material graded into place at south side of Area 1
P7 210012	7/21/2008	16:32	View to east showing stockpiles of excavated PCB contaminated soil covered with poly sheeting after work completed for the day
P7 210013	7/21/2008	16:35	View to northwest showing excavated areas at east side of Area 3
P7 210014	7/21/2008	16:36	View to northwest showing stockpiles of excavated PCB contaminated soil covered with poly sheeting after work completed for the day
