## DAILY FIELD ACTIVITY REPORT

| PROJECT | Former Bouchard Junkyard | WEATHER | TIME | TEMP. | PRECIP. | WIND (MPH) | WIND (DIR) |
| LOCATION | Town of New Lebanon, NY | P. Cloudy | 0730 | 75 F | None | Calm | N/A |

**PHOTOGRAPHIC LOG**  
**July 22, 2008**  
**D&B JOB NO. 2605**  
**FORMER BOUCHARD JUNKYARD SITE**  
**TOWN OF NEW LEBANON, NEW YORK**

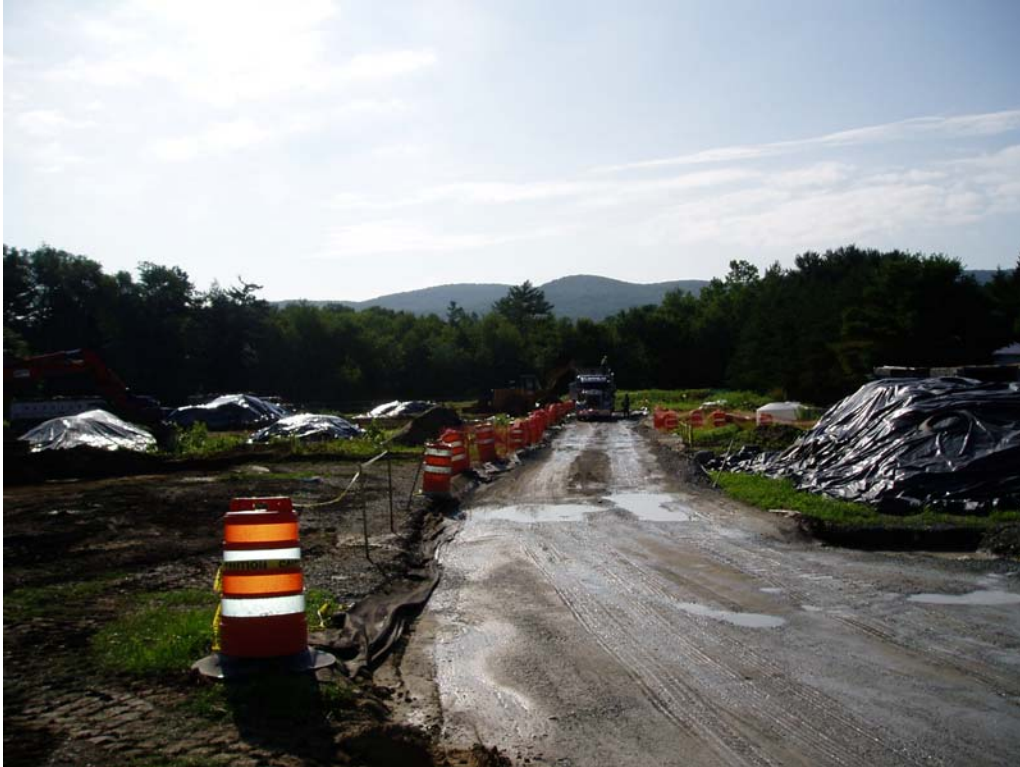
P7220001.JPG

| PHOTO | DATE | TIME | DESCRIPTION |
|---|---|---|---|
| P7 220001 | 7/22/2008 | 8:34 | View to east showing front end loader loading non-TSCA PCB contaminated soil into truck at southeast corner of Area 3 for off-site disposal |

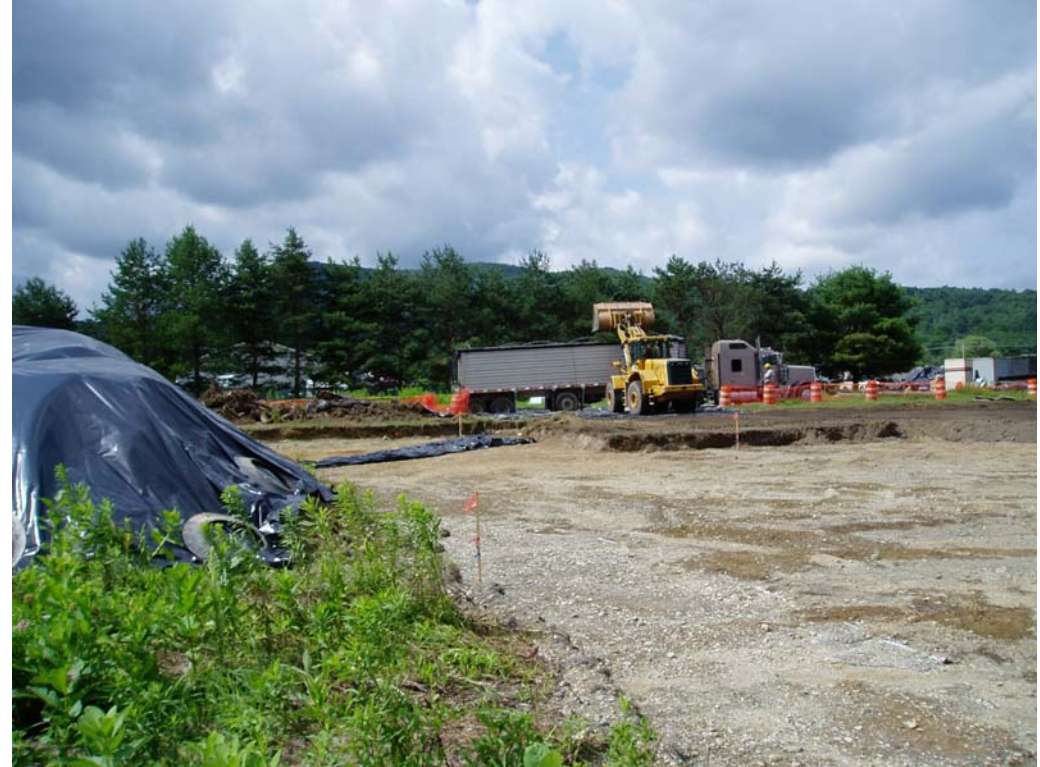
P7220002.JPG

| PHOTO | DATE | TIME | DESCRIPTION |
|---|---|---|---|
| P7 220002 | 7/22/2008 | 10:25 | View to south showing front end loader loading non-TSCA PCB contaminated soil into truck at southeast corner of Area 3 for off-site disposal |

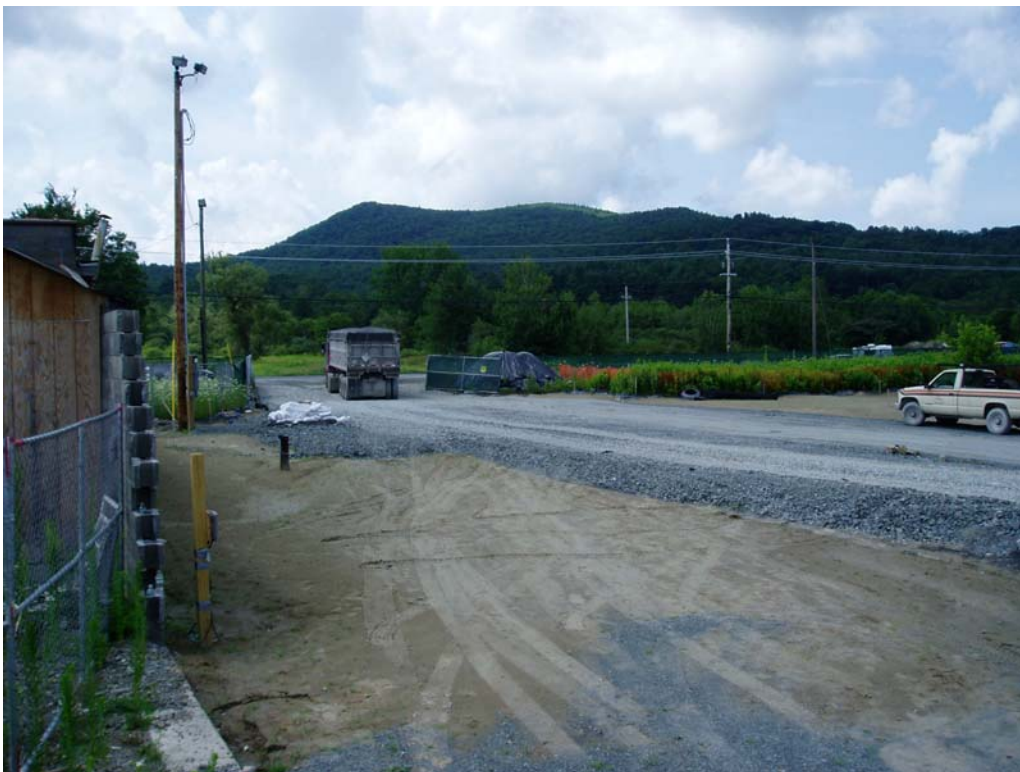
P7220003.JPG

| PHOTO | DATE | TIME | DESCRIPTION |
|---|---|---|---|
| P7 220003 | 7/22/2008 | 11:22 | View to south showing truck moving off-site at new main entrance gate along Rt. 20 |

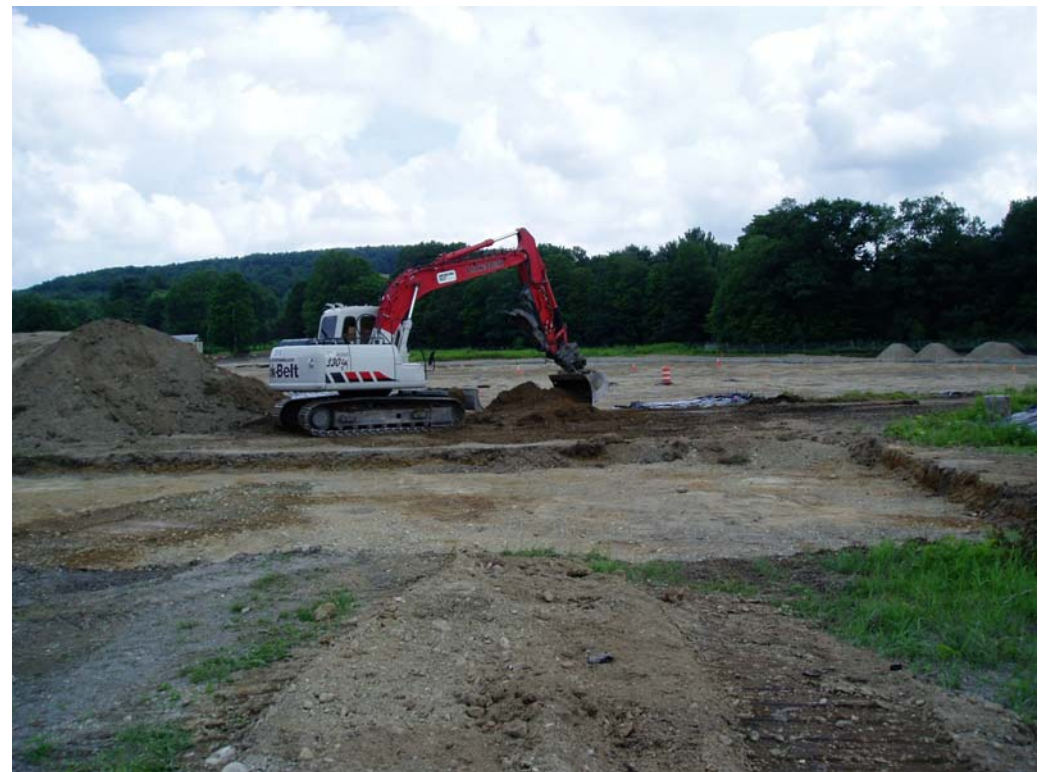
P7220004.JPG

| PHOTO | DATE | TIME | DESCRIPTION |
|---|---|---|---|
| P7 220004 | 7/22/2008 | 11:34 | View to north showing remedial excavation at south side of Area 2 (grid station L-13) |

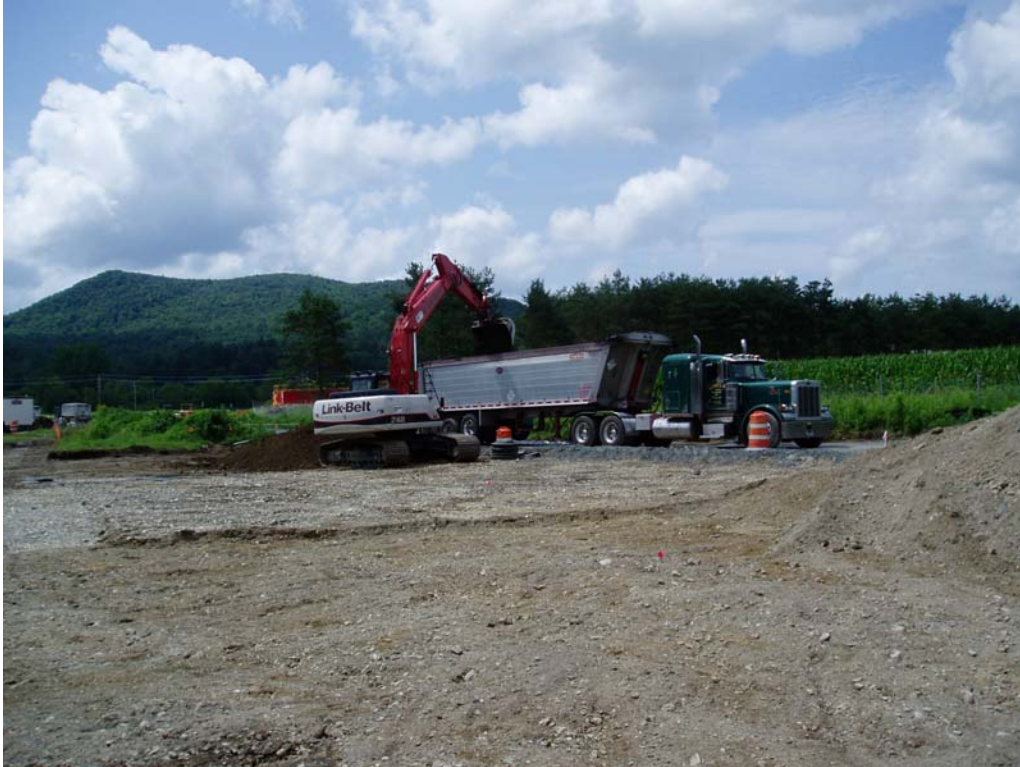
P7220005.JPG

| PHOTO | DATE | TIME | DESCRIPTION |
|---|---|---|---|
| P7 220005 | 7/22/2008 | 11:46 | View to southwest showing excavator loading TSCA PCB contaminated soil into truck at west side of Area 2 for off-site disposal |

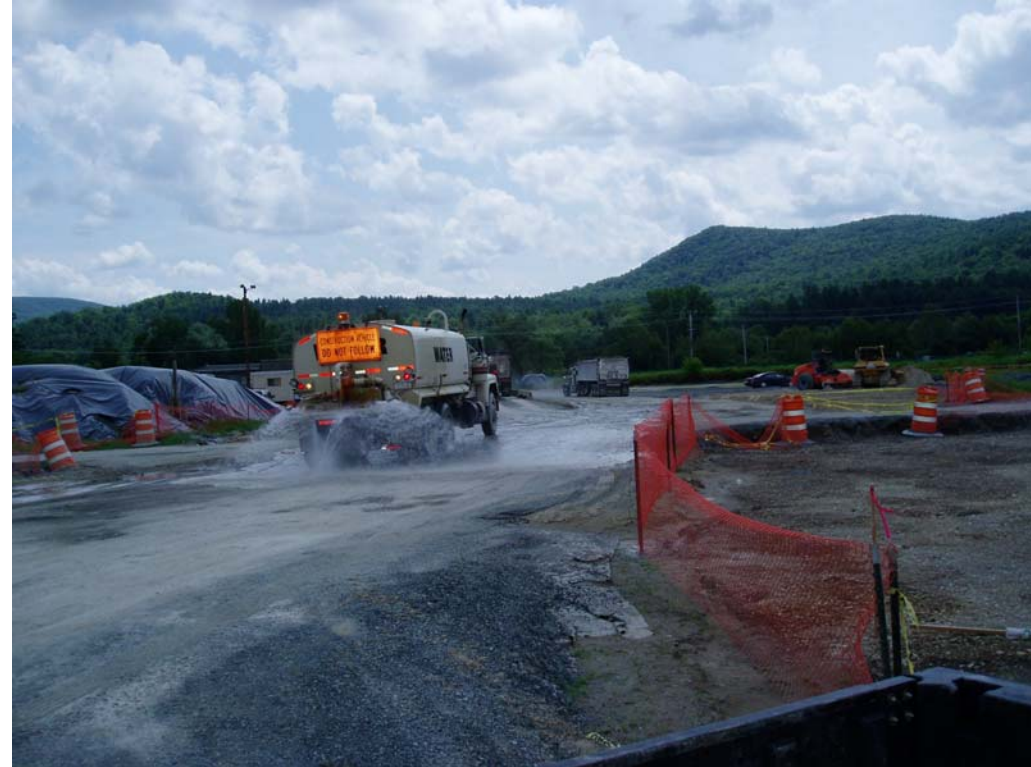
P7220006.JPG

| PHOTO | DATE | TIME | DESCRIPTION |
|---|---|---|---|
| P7 220006 | 7/22/2008 | 13:37 | View to south showing water truck spraying water onto truck access road leading to truck scale and main entrance gate for dust control |

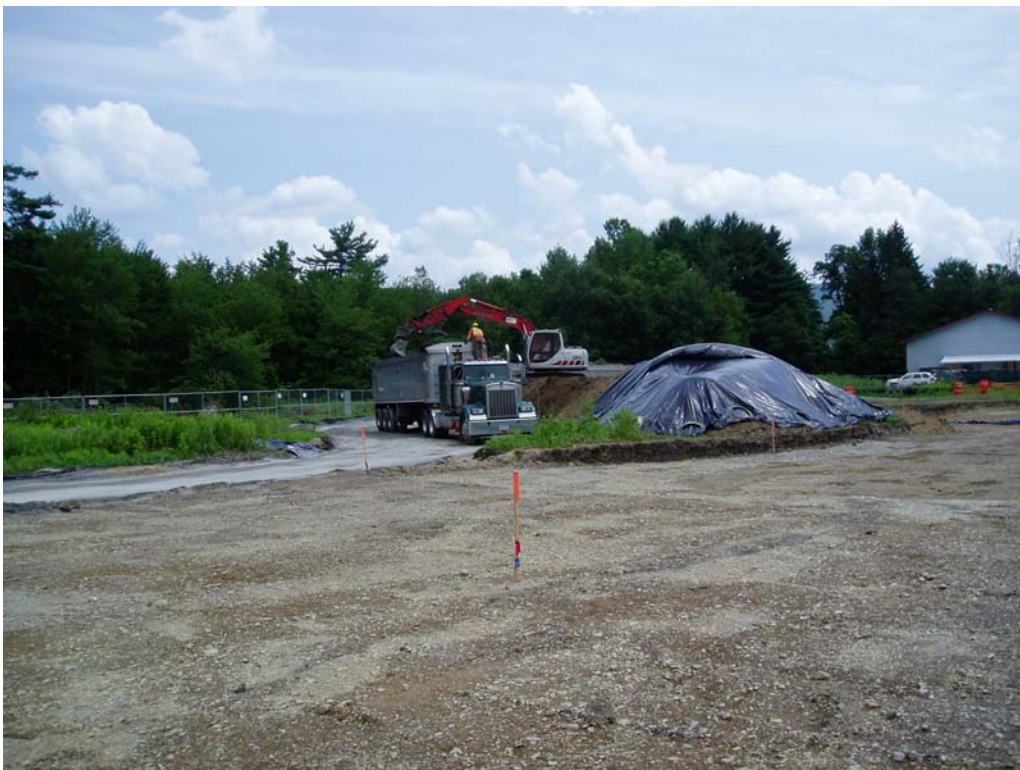
P7220007.JPG

| PHOTO | DATE | TIME | DESCRIPTION |
|---|---|---|---|
| P7 220007 | 7/22/2008 | 14:14 | View to southeast showing excavator loading TSCA PCB contaminated soil into truck at west side of Area 8 for off-site disposal |

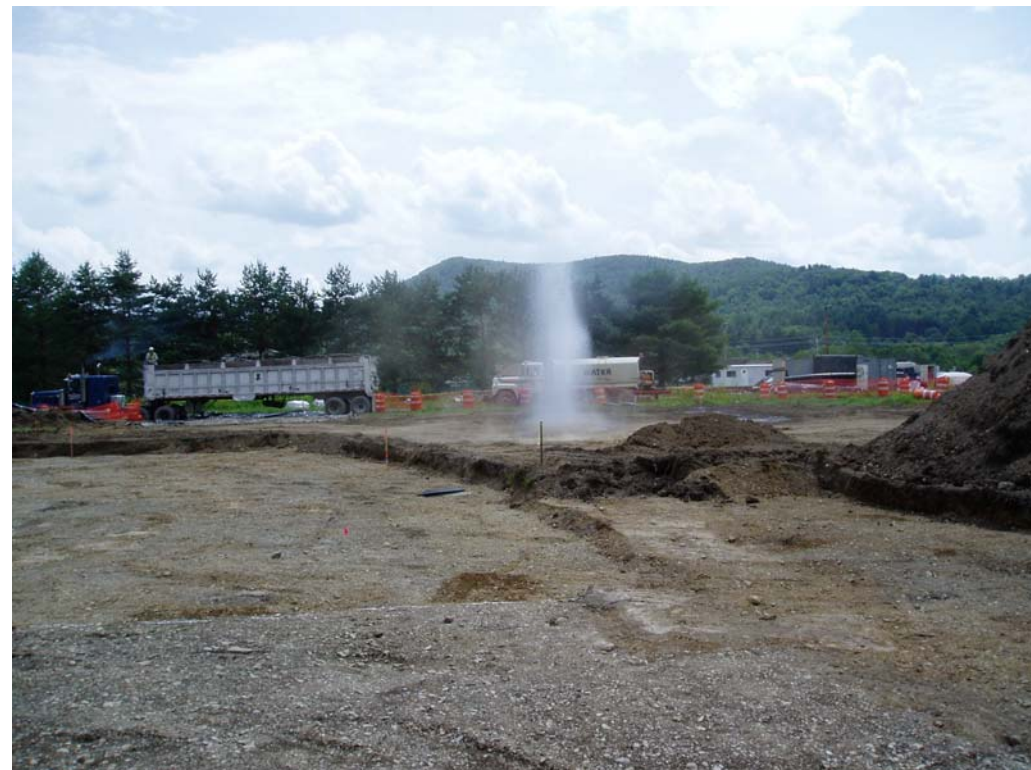
P7220008.JPG

| PHOTO | DATE | TIME | DESCRIPTION |
|---|---|---|---|
| P7 220008 | 7/22/2008 | 14:20 | View to south showing water truck spraying water at truck loading area for dust control (southeast corner Area 3) |

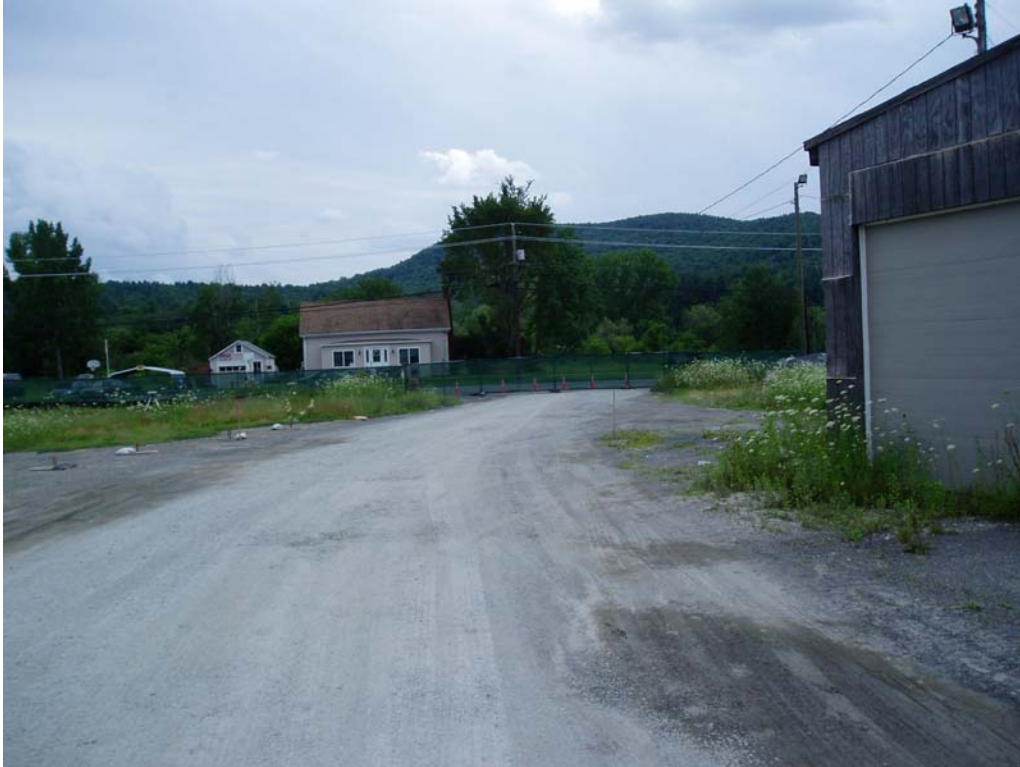
P7220009.JPG

| PHOTO | DATE | TIME | DESCRIPTION |
|---|---|---|---|
| P7 220009 | 7/22/2008 | 14:43 | View to south showing new fence installed across original main entrance gate along Rt. 20 after new entrance gate established |

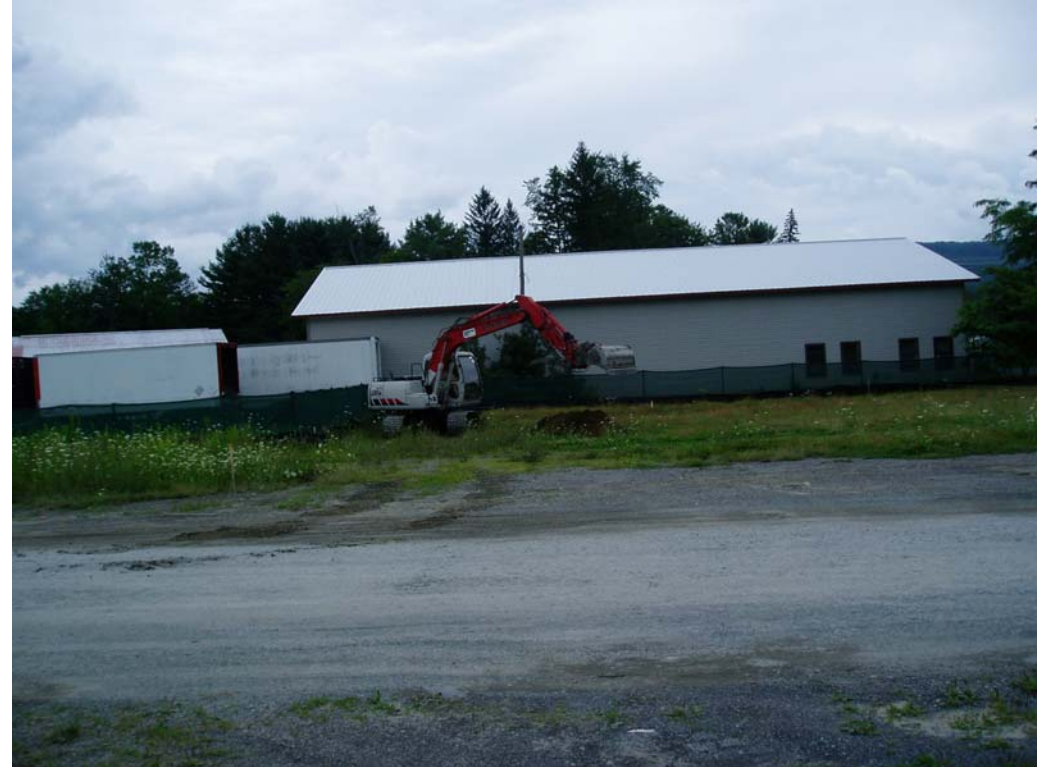
P7220010.JPG

| PHOTO | DATE | TIME | DESCRIPTION |
|---|---|---|---|
| P7 220010 | 7/22/2008 | 15:03 | View to east showing remedial excavation at southeast corner of Area 9 (grid station M-3) |

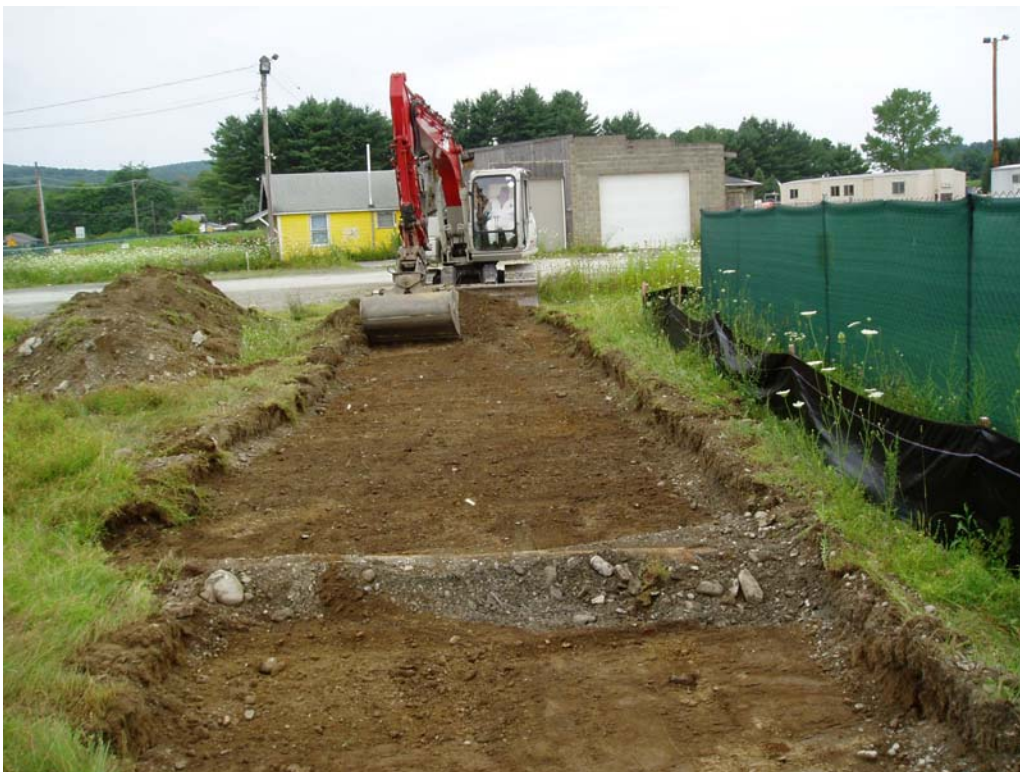
P7220011.JPG

| PHOTO | DATE | TIME | DESCRIPTION |
|---|---|---|---|
| P7 220011 | 7/22/2008 | 15:18 | View to west showing remedial excavation at southeast corner of Area 9 (grid station L-3) |

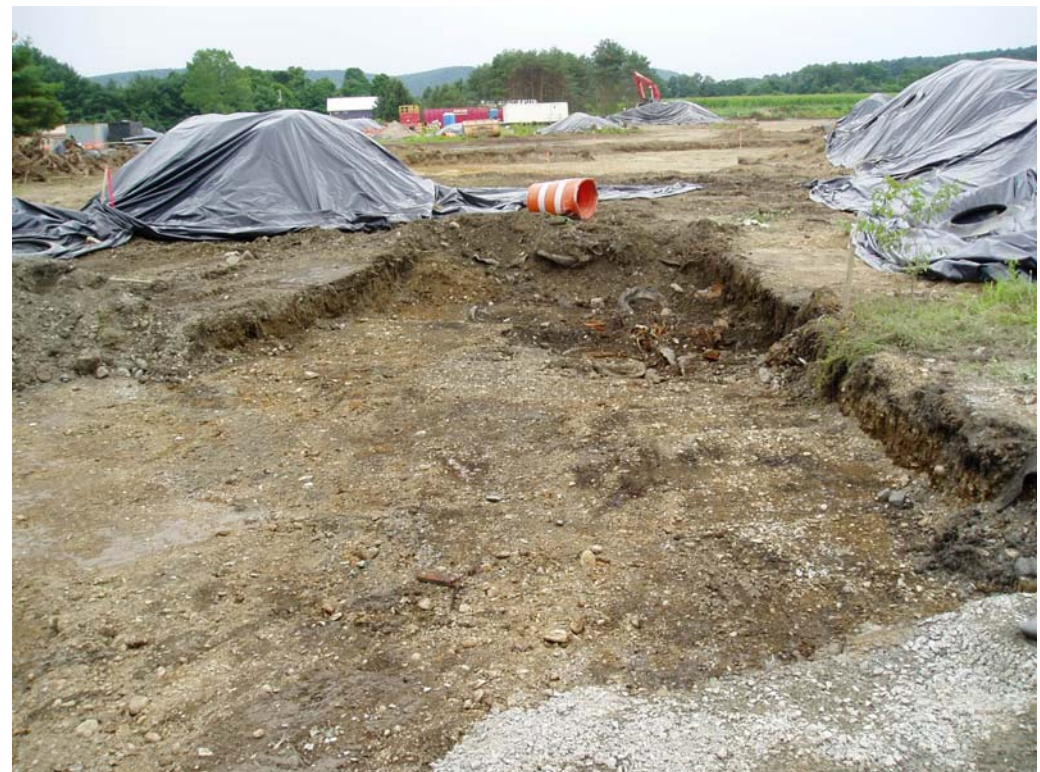
P7220012.JPG

| PHOTO | DATE | TIME | DESCRIPTION |
|---|---|---|---|
| P7 220012 | 7/22/2008 | 15:40 | View to west showing black stained soils and debris at southeast corner of Area 3 (grid station P-10) |

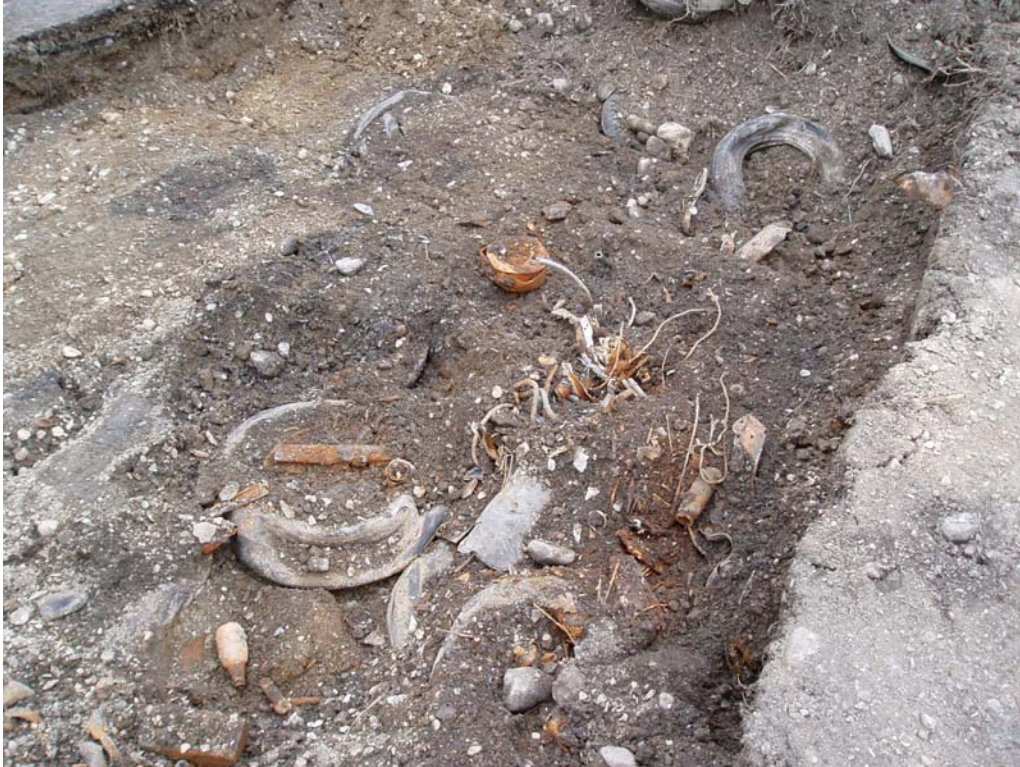
P7220013.JPG

| PHOTO | DATE | TIME | DESCRIPTION |
|---|---|---|---|
| P7 220013 | 7/22/2008 | 15:40 | View of misc. metal and tire debris encountered during remedial excavation at southeast corner of Area 3 (grid station P-10) |

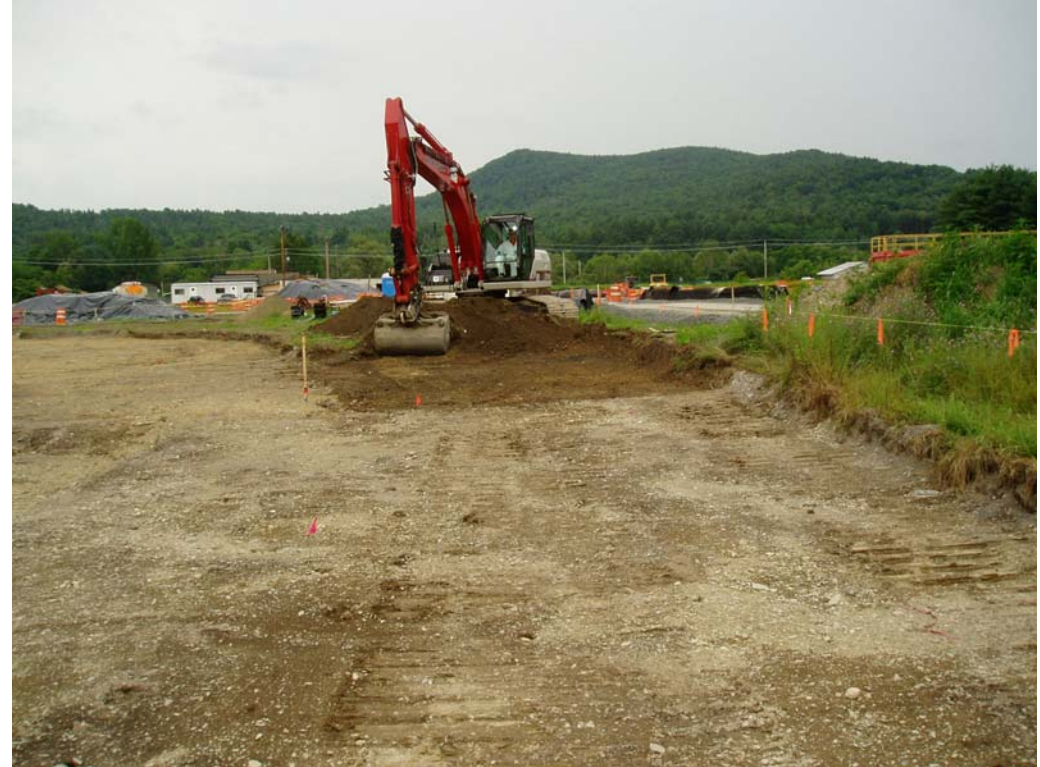
P7220014.JPG

| PHOTO | DATE | TIME | DESCRIPTION |
|---|---|---|---|
| P7 220014 | 7/22/2008 | 15:49 | View to south showing remedial excavation at southwest corner of Area 2 (grid station H-13) |

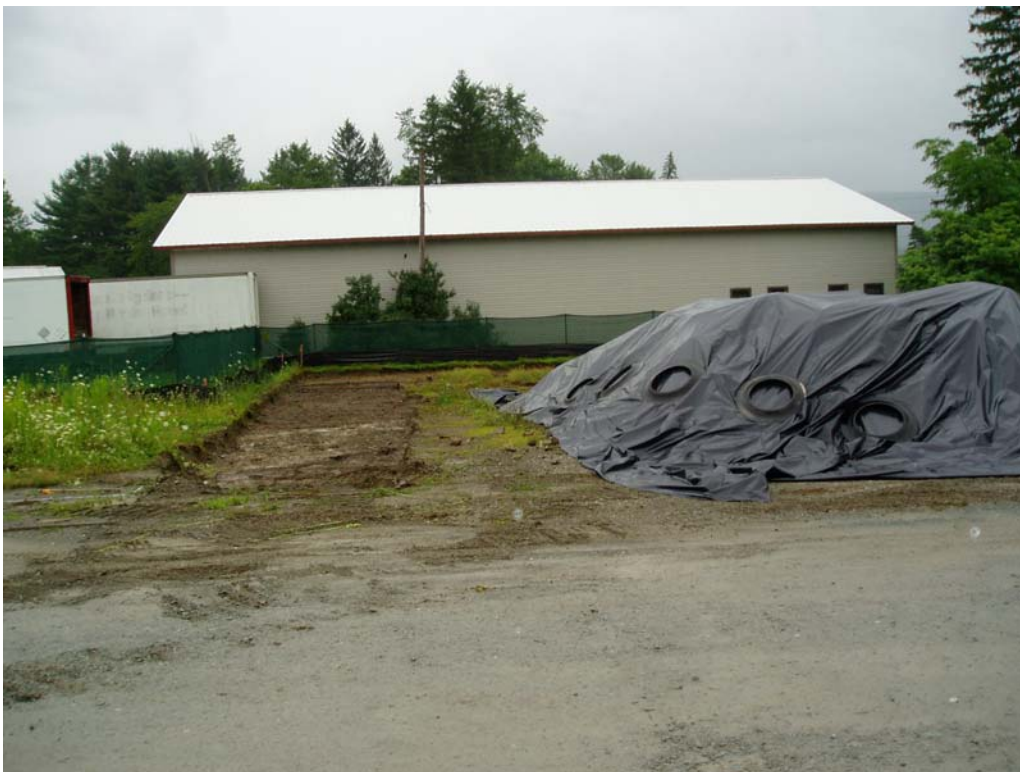
P7220015.JPG

| PHOTO | DATE | TIME | DESCRIPTION |
|---|---|---|---|
| P7 220015 | 7/22/2008 | 16:58 | View to east showing southeast corner of Area 9 (grid stations M-3 and L-3) after remedial excavation completed for the day |

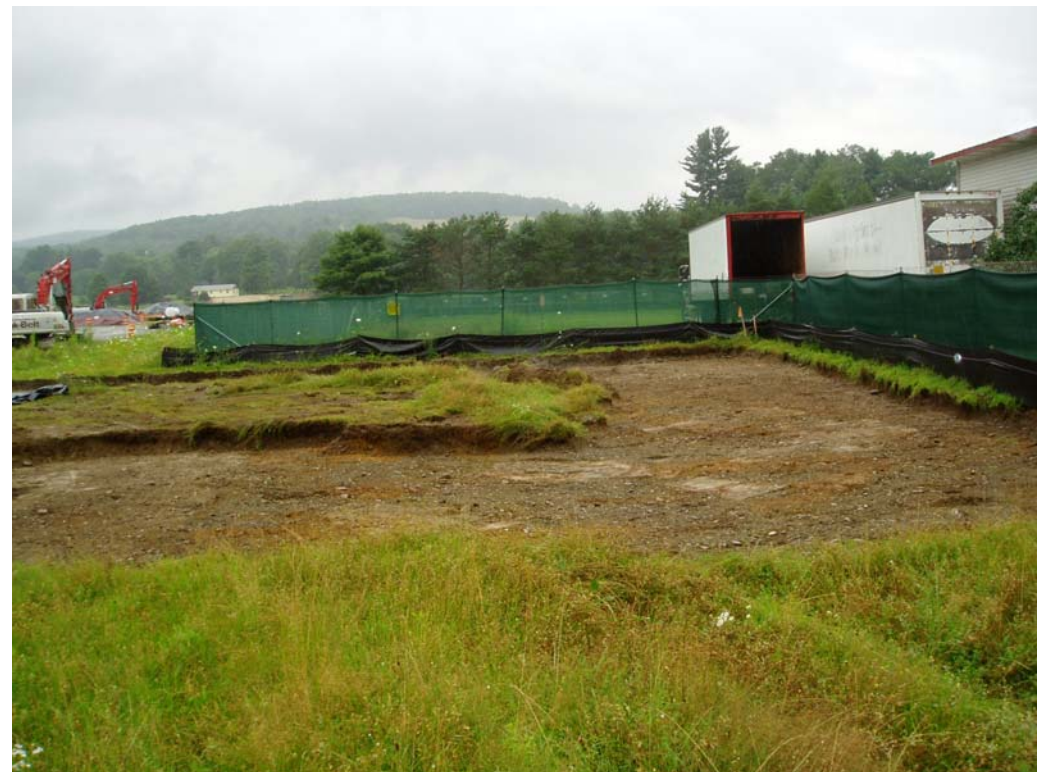
P7220016.JPG

| PHOTO | DATE | TIME | DESCRIPTION |
|---|---|---|---|
| P7 220016 | 7/22/2008 | 16:59 | View to north showing southeast corner of Area 9 (grid stations M-2, M-3 and L-2) after remedial excavation completed for the day |

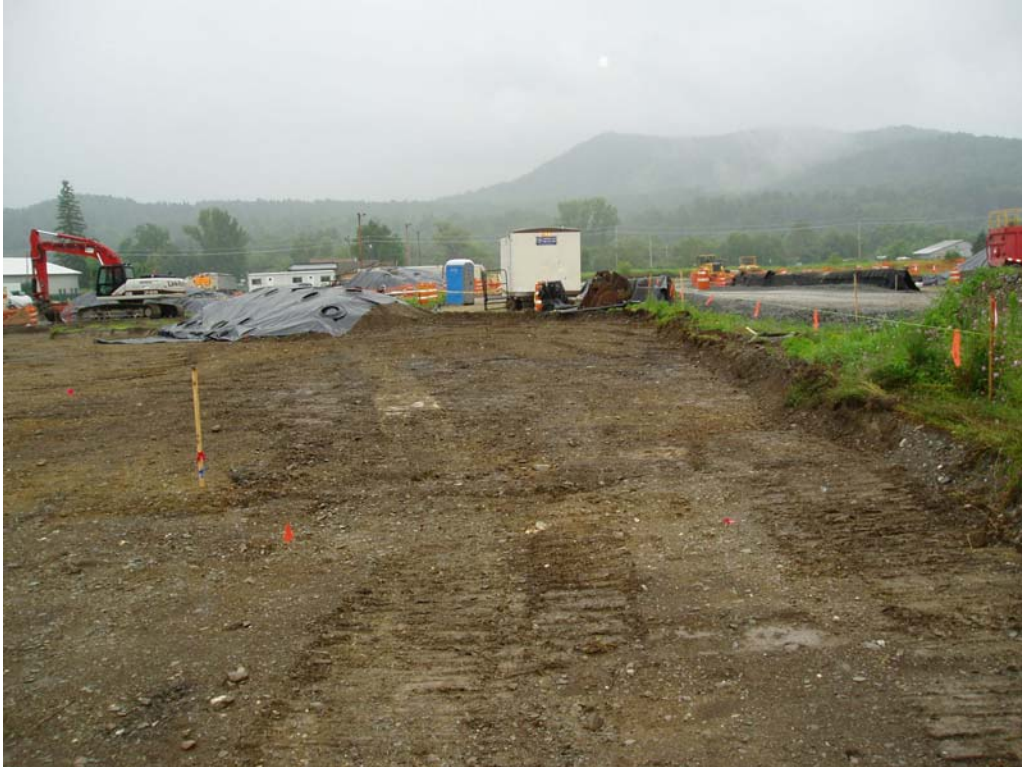
P7220017.JPG

| PHOTO | DATE | TIME | DESCRIPTION |
|---|---|---|---|
| P7 220017 | 7/22/2008 | 17:02 | View to south showing grid stations H-11, H-12 and H-13 after remedial excavation completed for the day (SW corner Area 2/NW corner Area 3) |

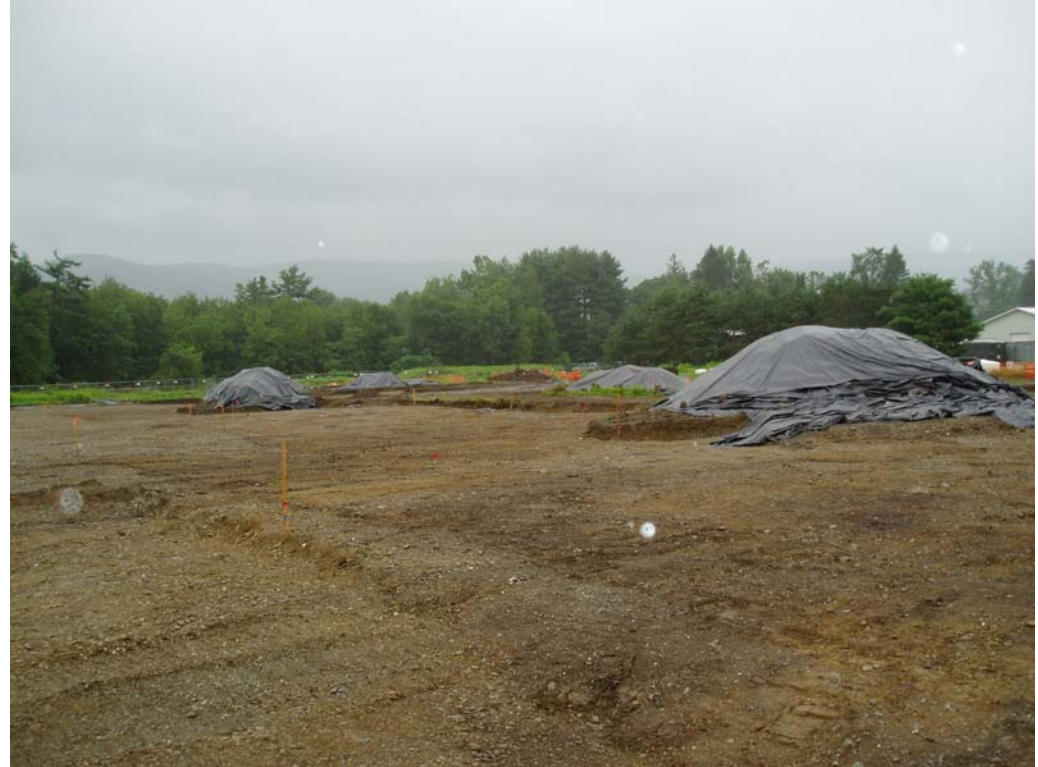
P7220018.JPG

| PHOTO | DATE | TIME | DESCRIPTION |
|---|---|---|---|
| P7 220018 | 7/22/2008 | 17:03 | View to southeast showing stockpiles of excavated PCB contaminated soil covered with poly sheeting after work completed for the day (Area 3) |

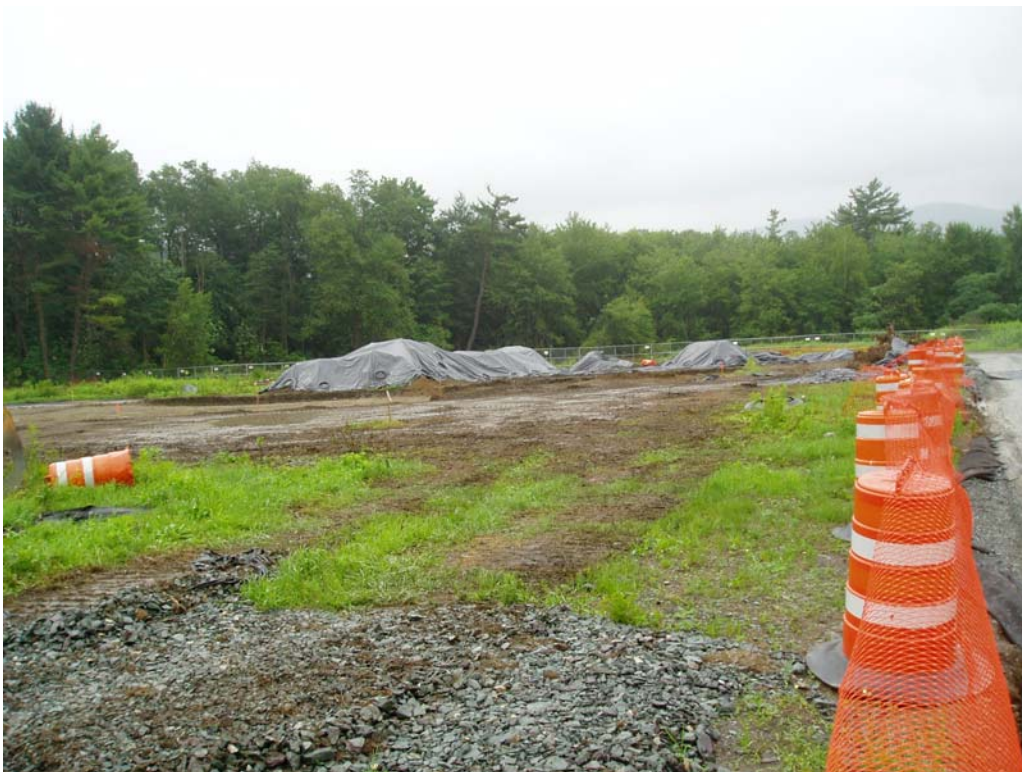
P7220019.JPG

| PHOTO | DATE | TIME | DESCRIPTION |
|---|---|---|---|
| P7 220019 | 7/22/2008 | 17:04 | View to east showing stockpiles of excavated PCB contaminated soil covered with poly sheeting after work completed for the day (Area 3) |

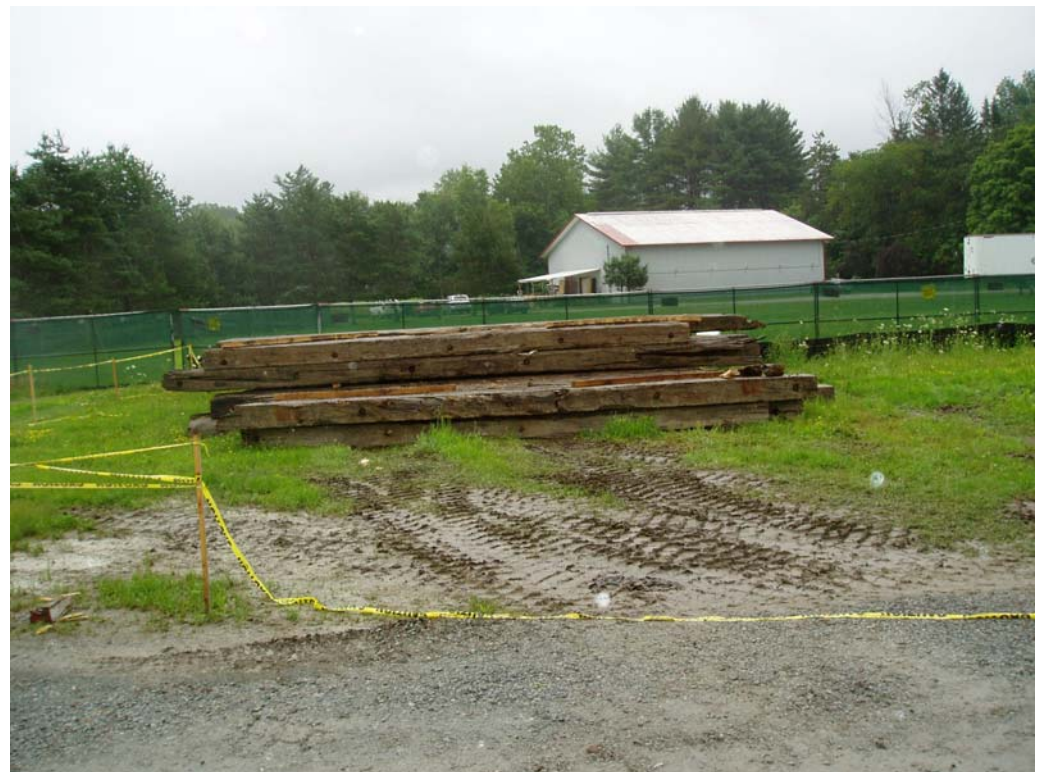
P7220020.JPG

| PHOTO | DATE | TIME | DESCRIPTION |
|---|---|---|---|
| P7 220020 | 7/22/2008 | 17:06 | View to east showing crane mats staged at east side of Area 9 |
