## DAILY FIELD ACTIVITY REPORT

| PROJECT | Former Bouchard Junkyard | WEATHER | TIME | TEMP. | PRECIP. | WIND (MPH) | WIND (DIR) |
| LOCATION | Town of New Lebanon, NY | Overcast | 0715 | 68 F | Rain | 5-10 | SE |

**PHOTOGRAPHIC LOG**  
**July 24, 2008**  
**D&B JOB NO. 2605**  
**FORMER BOUCHARD JUNKYARD SITE**  
**TOWN OF NEW LEBANON, NEW YORK**

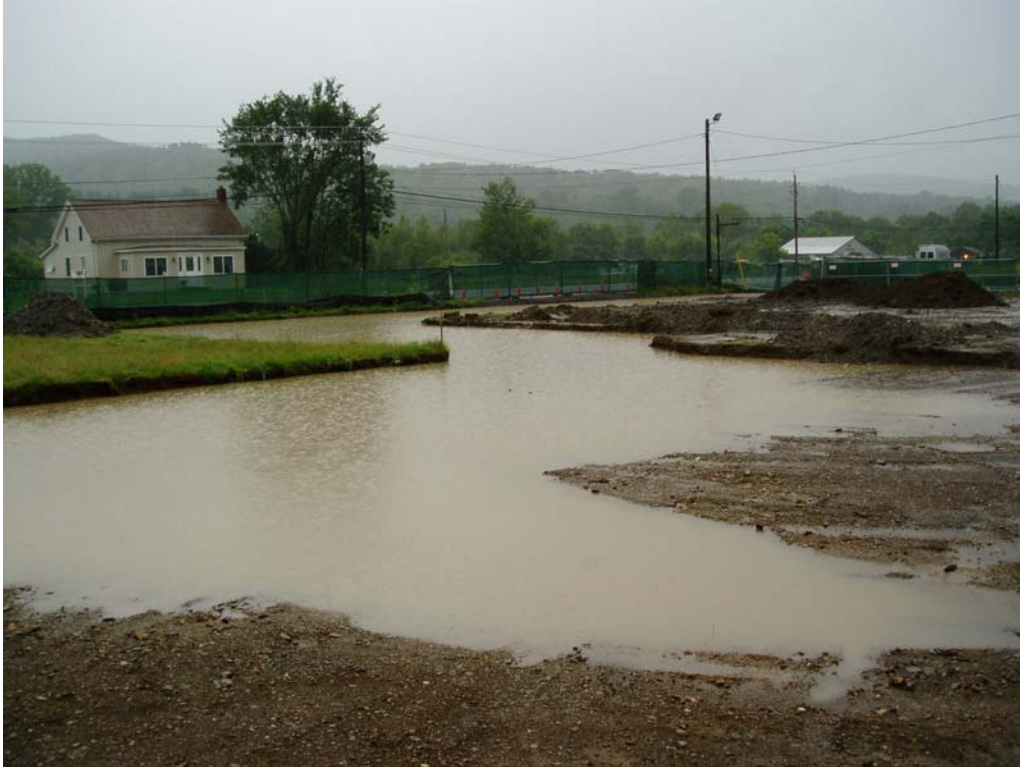
P7240001.JPG

| PHOTO | DATE | TIME | DESCRIPTION |
|---|---|---|---|
| P7 240001 | 7/24/2008 | 8:07 | View to southwest showing standing water in excavated area at south side of Area 9 from overnight rainstorms |

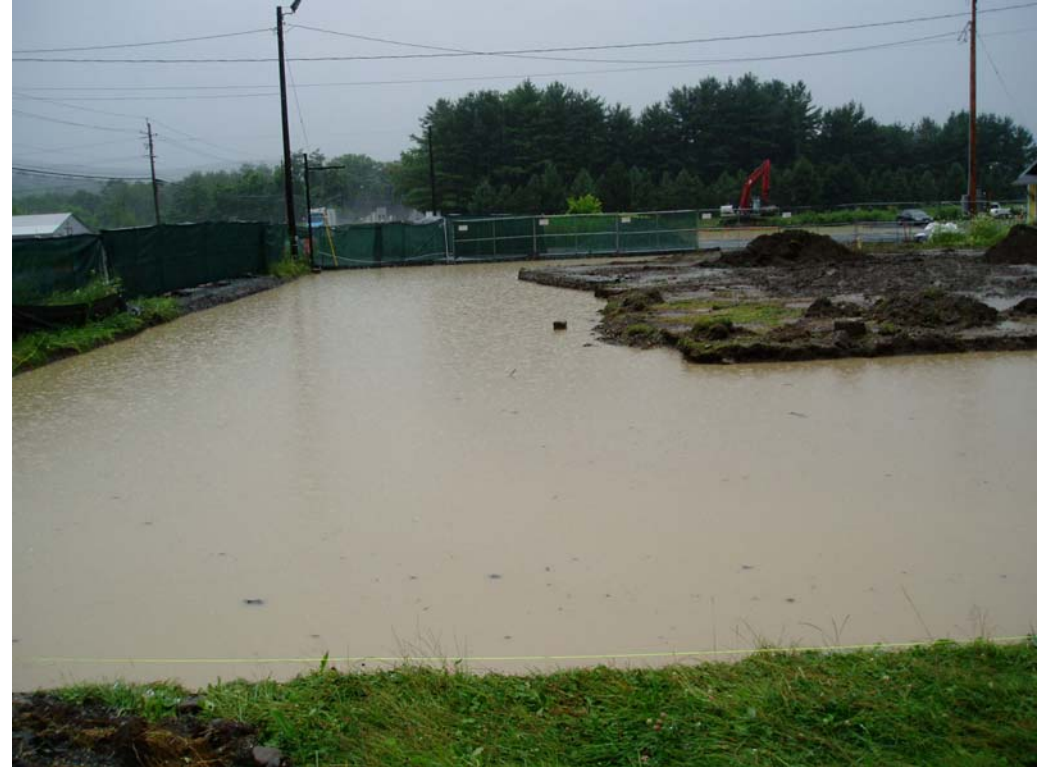
P7240002.JPG

| PHOTO | DATE | TIME | DESCRIPTION |
|---|---|---|---|
| P7 240002 | 7/24/2008 | 8:08 | View to west showing standing water in excavated area at south side of Area 9 from overnight rainstorms |

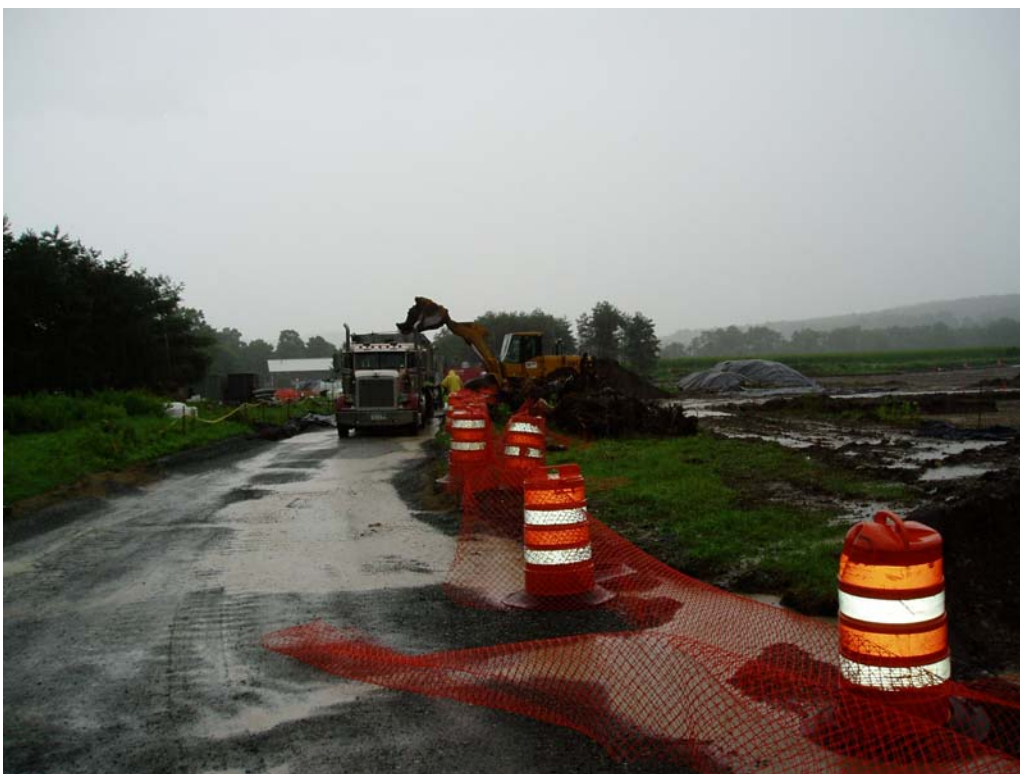
P7240003.JPG

| PHOTO | DATE | TIME | DESCRIPTION |
|---|---|---|---|
| P7 240003 | 7/24/2008 | 8:20 | View to west showing front end loader loading non-TSCA PCB contaminated soil into truck at south side of Area 3 for off-site disposal |

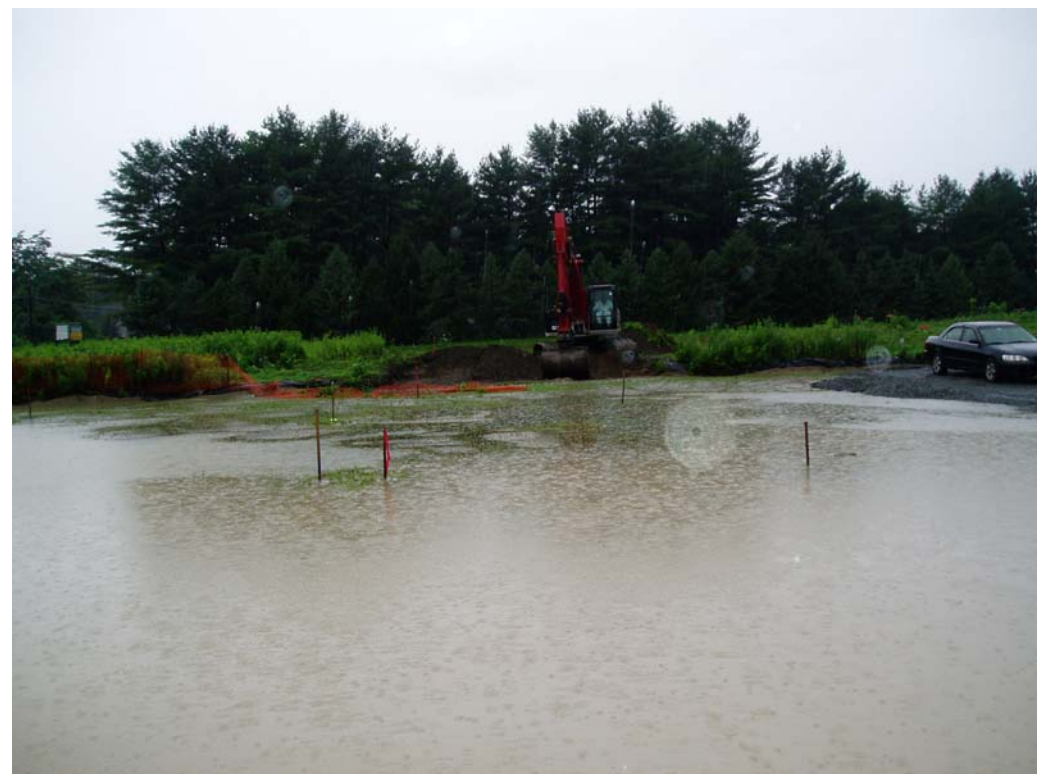
P7240004.JPG

| PHOTO | DATE | TIME | DESCRIPTION |
|---|---|---|---|
| P7 240004 | 7/24/2008 | 8:24 | View to west showing remedial excavation at north side of Area 5 (grid stations D-3, E-3) |

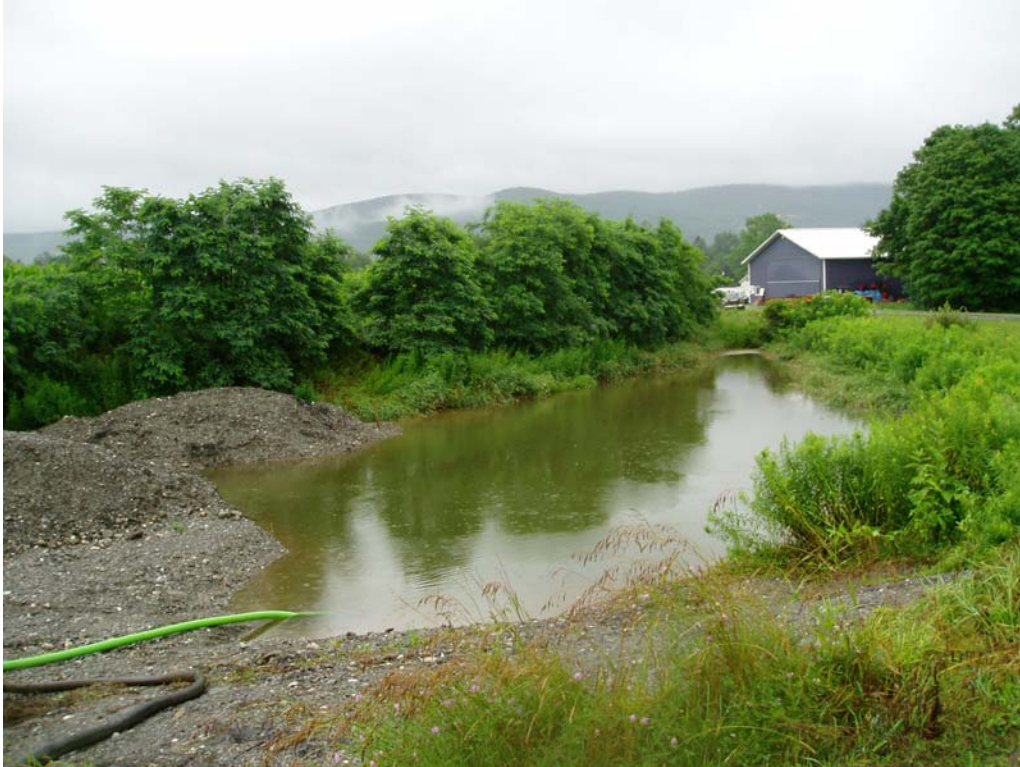
P7240005.JPG

| PHOTO | DATE | TIME | DESCRIPTION |
|---|---|---|---|
| P7 240005 | 7/24/2008 | 8:30 | View to east showing retention pond located northwest of Chuck's Automotive (water supply for dust control) |

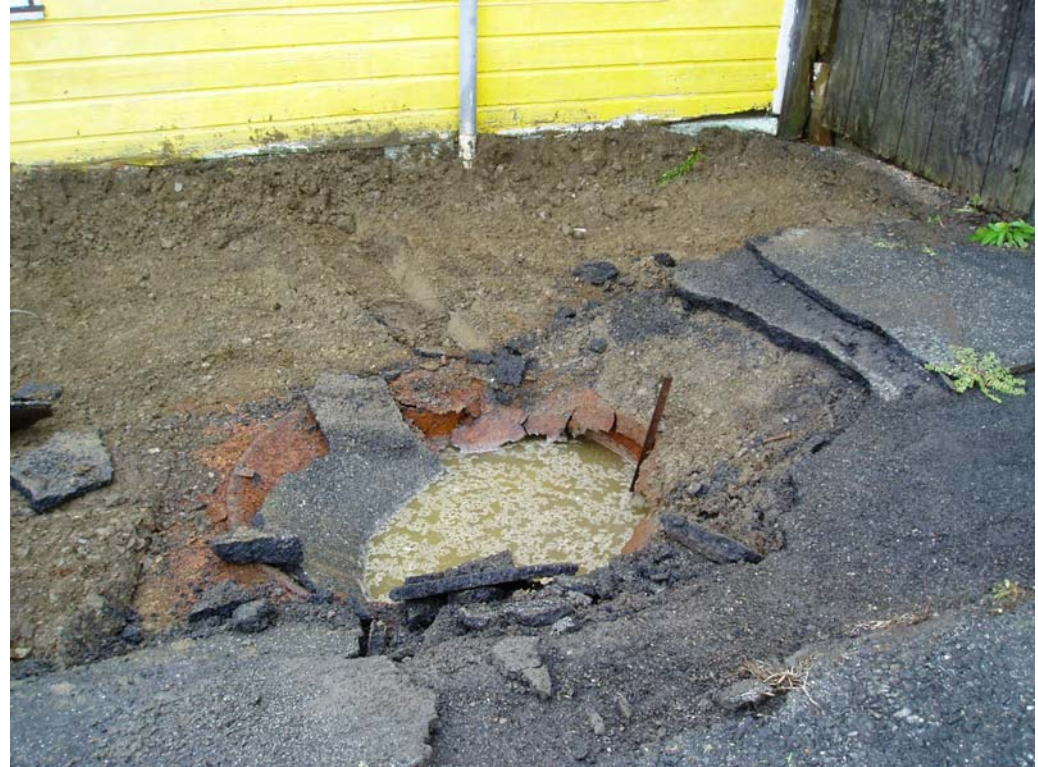
P7240006.JPG

| PHOTO | DATE | TIME | DESCRIPTION |
|---|---|---|---|
| P7 240006 | 7/24/2008 | 9:11 | View of below grade metal tank encountered during remedial excavation along south side of Building 666 (grid station J-3) |

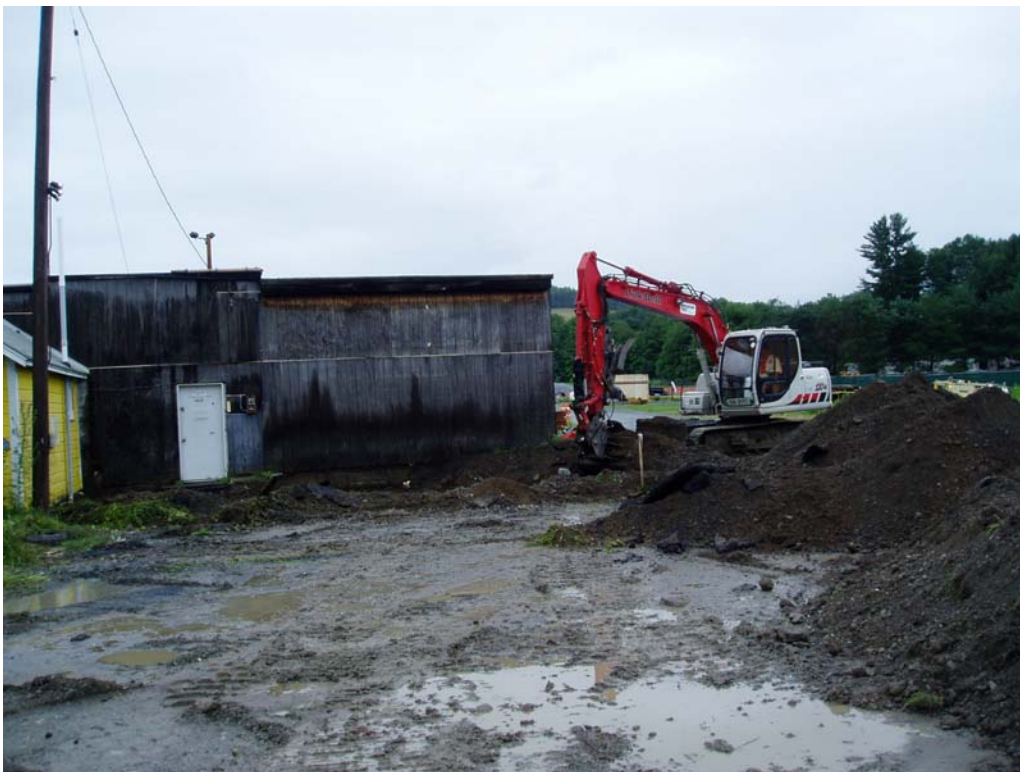
P7240007.JPG

| PHOTO | DATE | TIME | DESCRIPTION |
|---|---|---|---|
| P7 240007 | 7/24/2008 | 10:19 | View to north showing remedial excavation along south side of Building 666 (grid station J-3) |

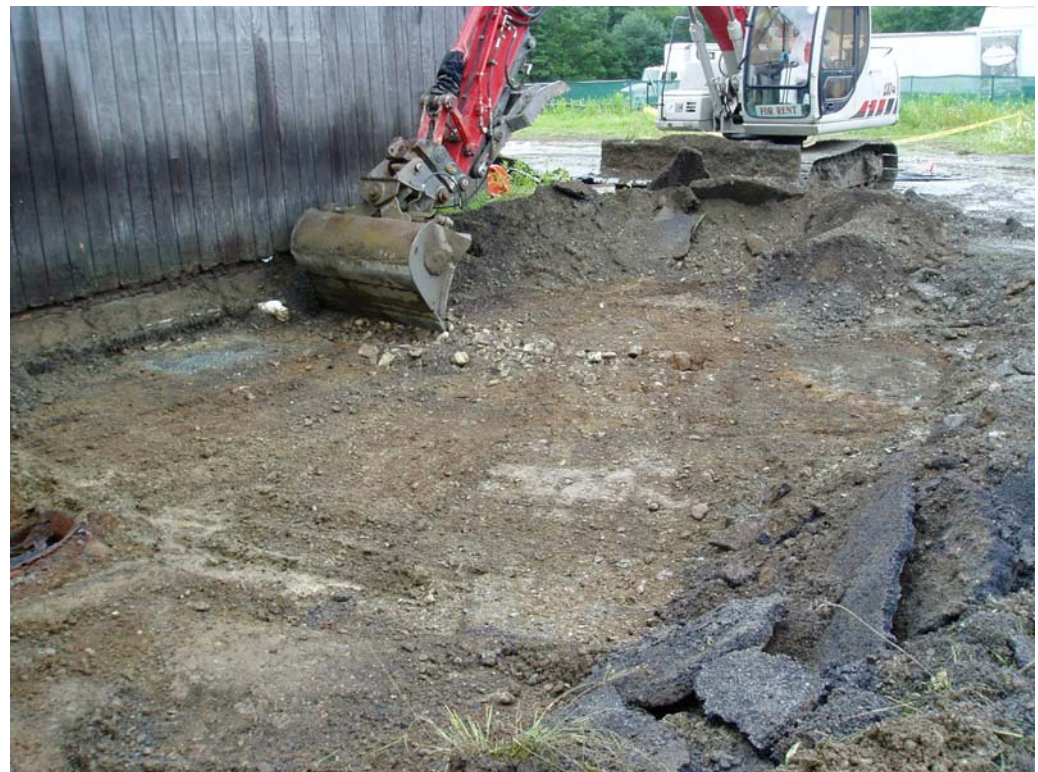
P7240008.JPG

| PHOTO | DATE | TIME | DESCRIPTION |
|---|---|---|---|
| P7 240008 | 7/24/2008 | 10:20 | View to northeast showing remedial excavation along south side of Building 666 (grid station J-3) |

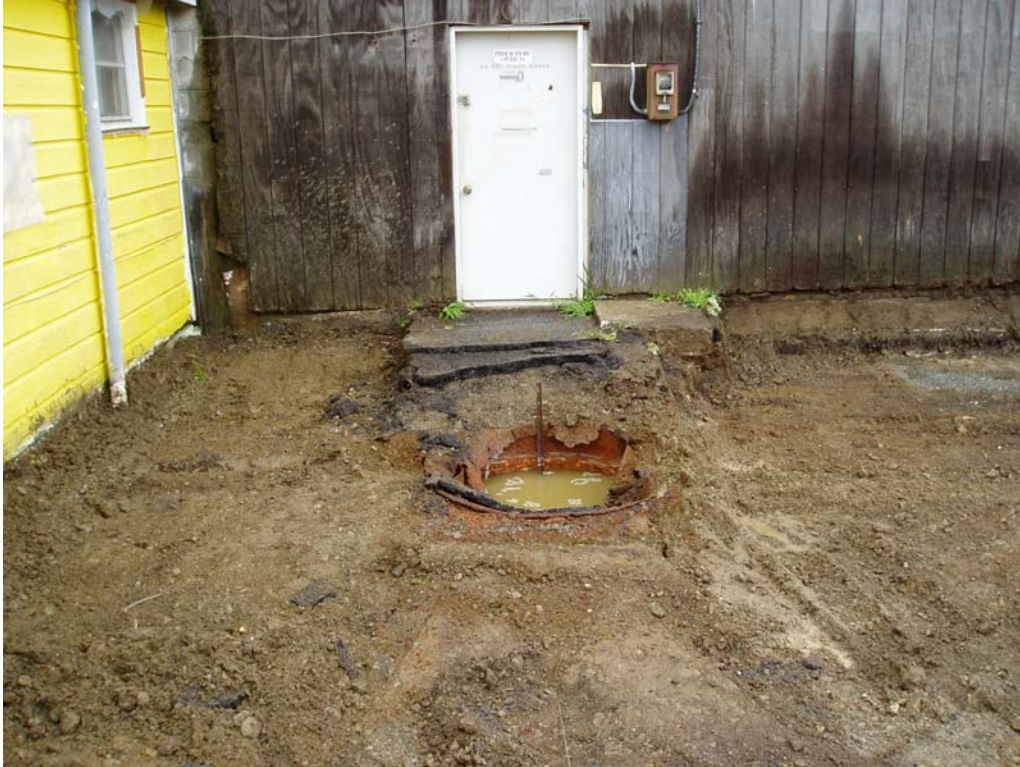
P7240009.JPG

| PHOTO | DATE | TIME | DESCRIPTION |
|---|---|---|---|
| P7 240009 | 7/24/2008 | 10:20 | View to north showing below grade metal tank encountered during remedial excavation along south side of Building 666 (grid station J-3) |

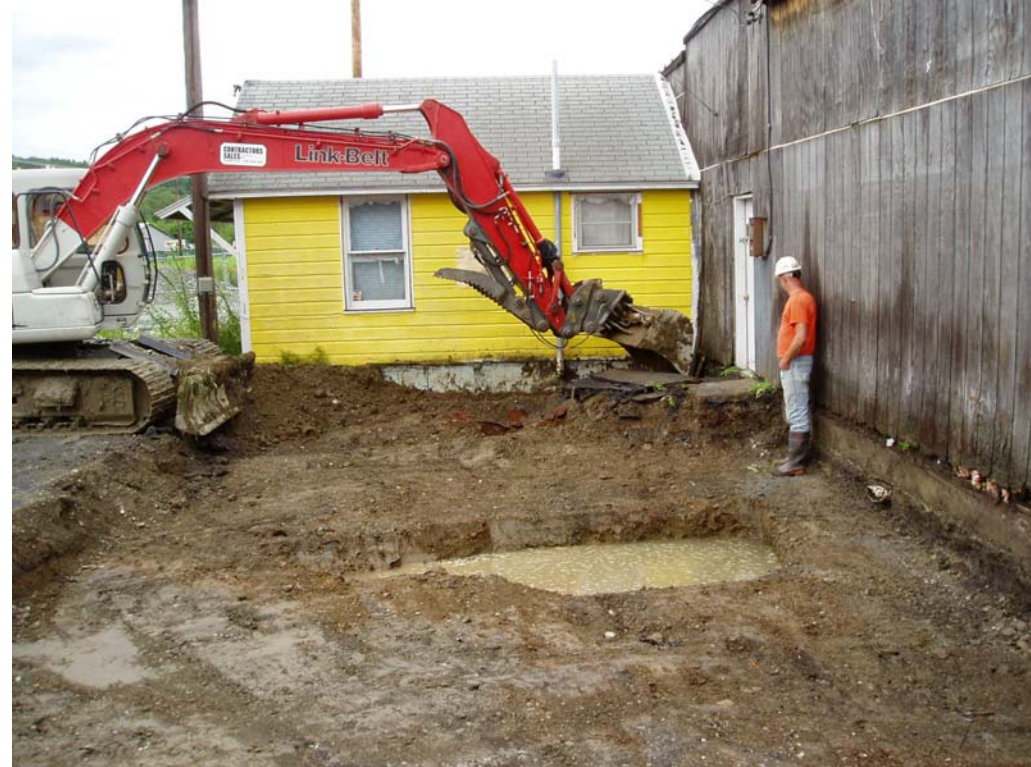
P7240010.JPG

| PHOTO | DATE | TIME | DESCRIPTION |
|---|---|---|---|
| P7 240010 | 7/24/2008 | 11:44 | View to west showing remedial excavation along south side of Building 666 (grid station J-3) |

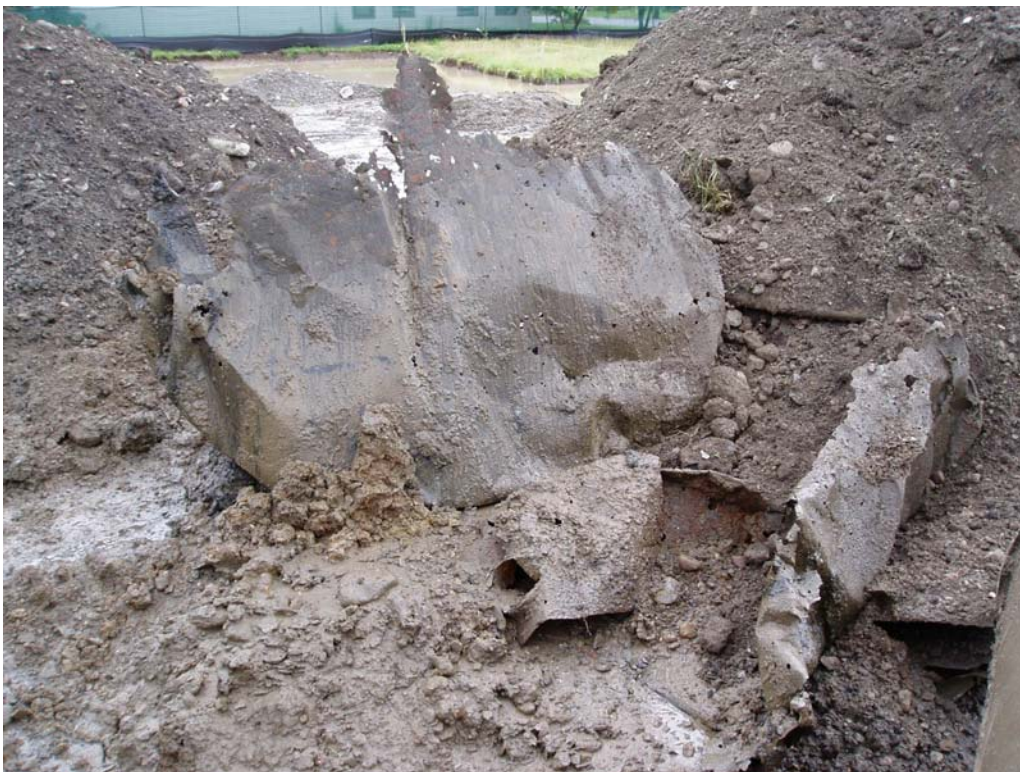
P7240011.JPG

| PHOTO | DATE | TIME | DESCRIPTION |
|---|---|---|---|
| P7 240011 | 7/24/2008 | 12:04 | View of below grade metal tank after tank removed along south side of Building 666 (grid station J-3) |

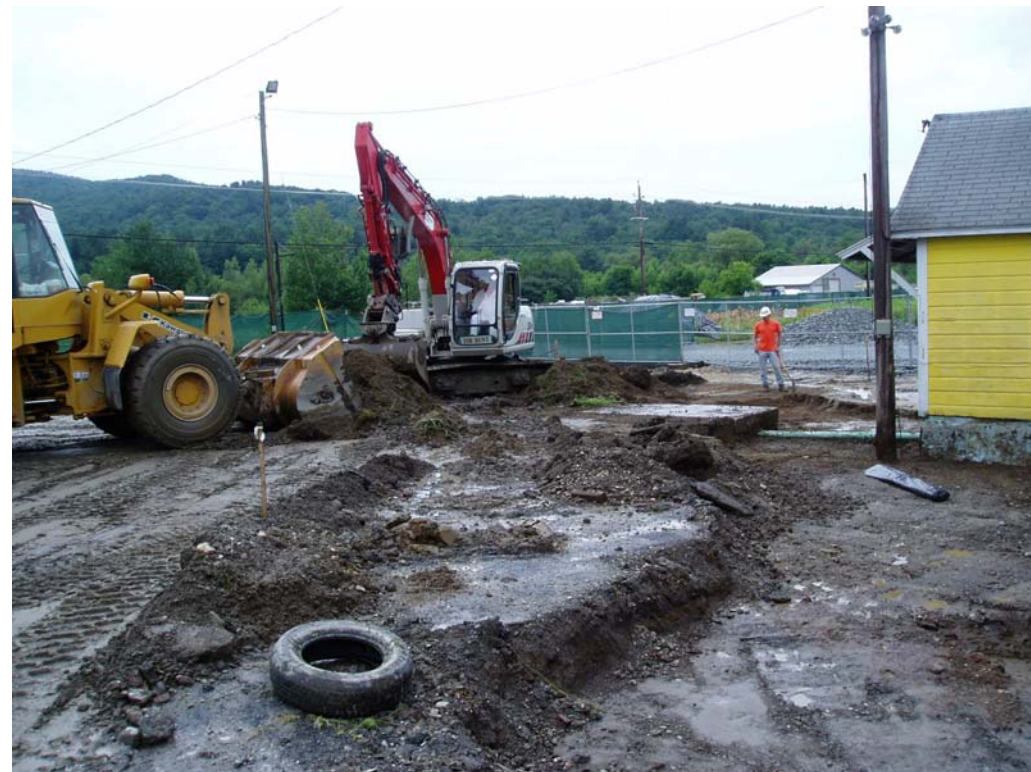
P7240012.JPG

| PHOTO | DATE | TIME | DESCRIPTION |
|---|---|---|---|
| P7 240012 | 7/24/2008 | 13:46 | View to southwest showing remedial excavation around septic tank along south side of Building 666 (grid station J-2) |

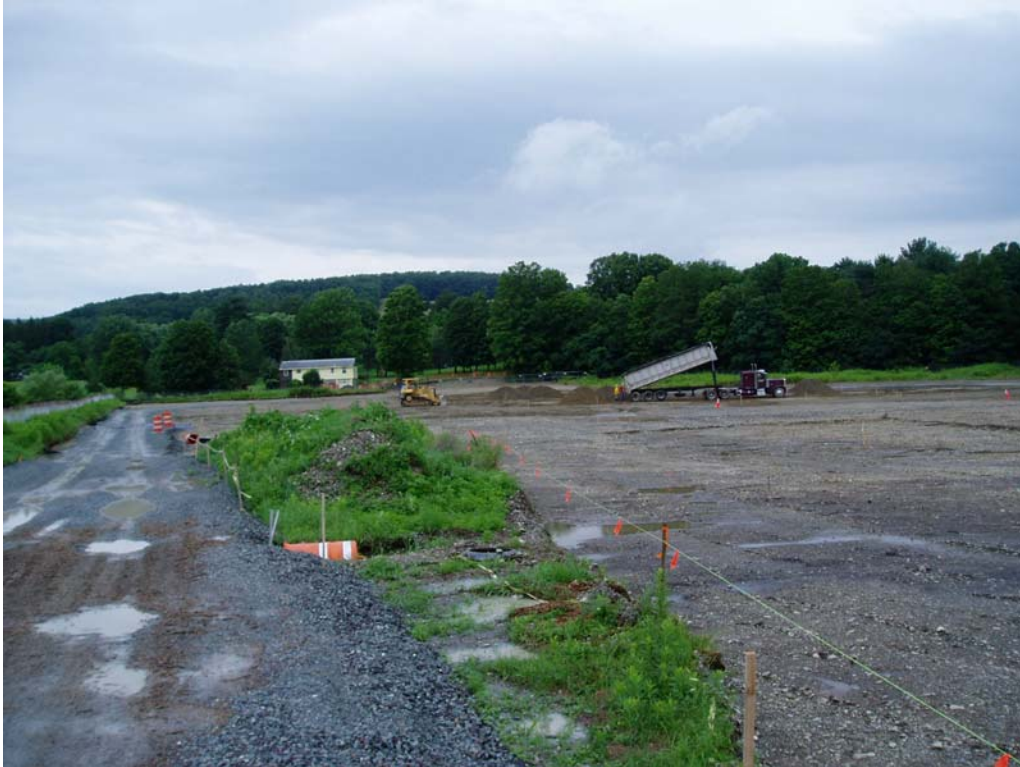
P7240013.JPG

| PHOTO | DATE | TIME | DESCRIPTION |
|---|---|---|---|
| P7 240013 | 7/24/2008 | 13:49 | View to north showing truck unloading approved backfill material at Area 1 |

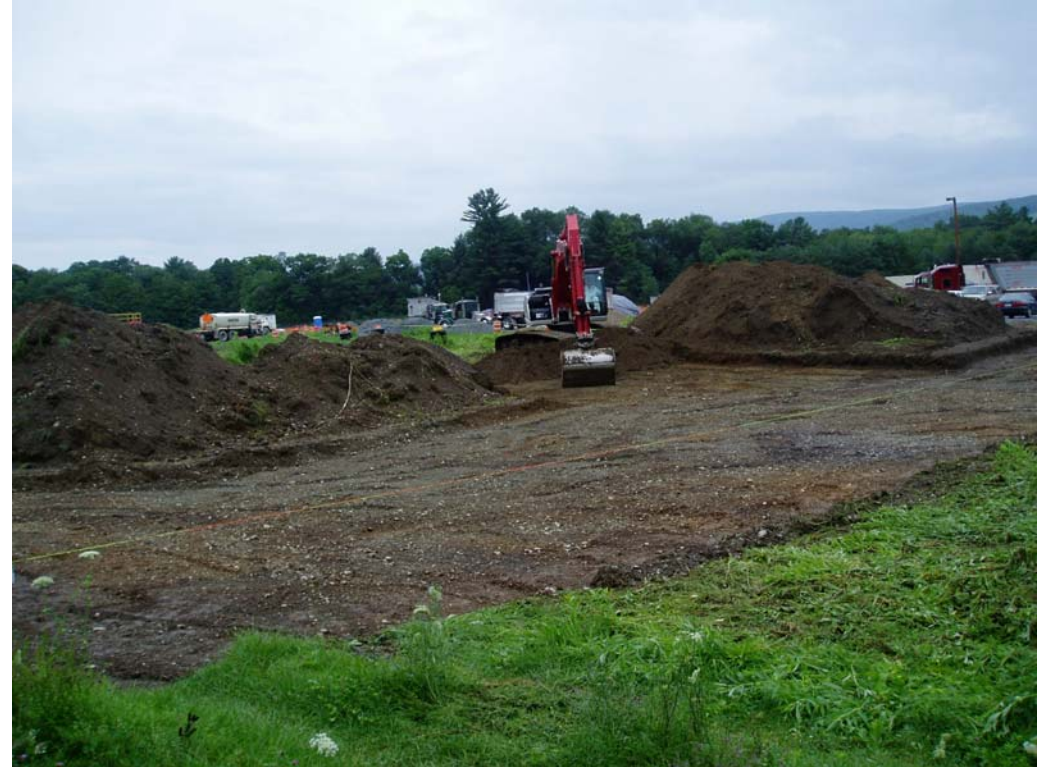
P7240014.JPG

| PHOTO | DATE | TIME | DESCRIPTION |
|---|---|---|---|
| P7 240014 | 7/24/2008 | 13:57 | View to northeast showing remedial excavation at grid stations D-3, D-4 (north side Area 5/south side Area 4) |

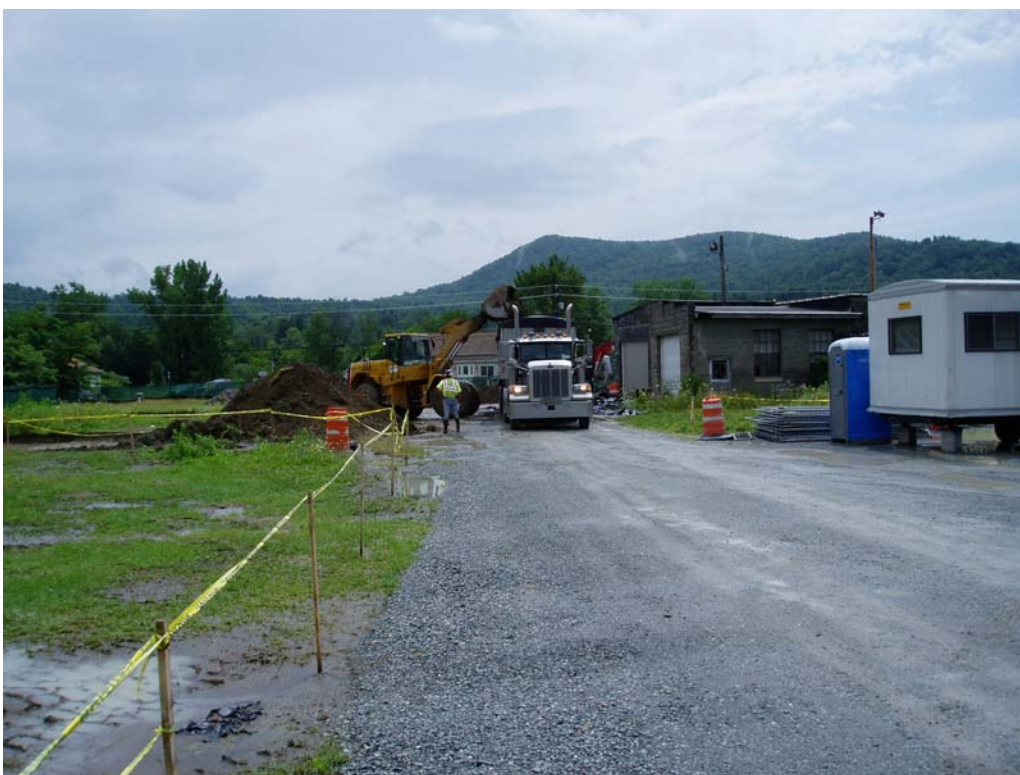
P7240015.JPG

| PHOTO | DATE | TIME | DESCRIPTION |
|---|---|---|---|
| P7 240015 | 7/24/2008 | 14:05 | View to south showing front end loader loading non-TSCA PCB contaminated soil into truck at Area 9 for off-site disposal |

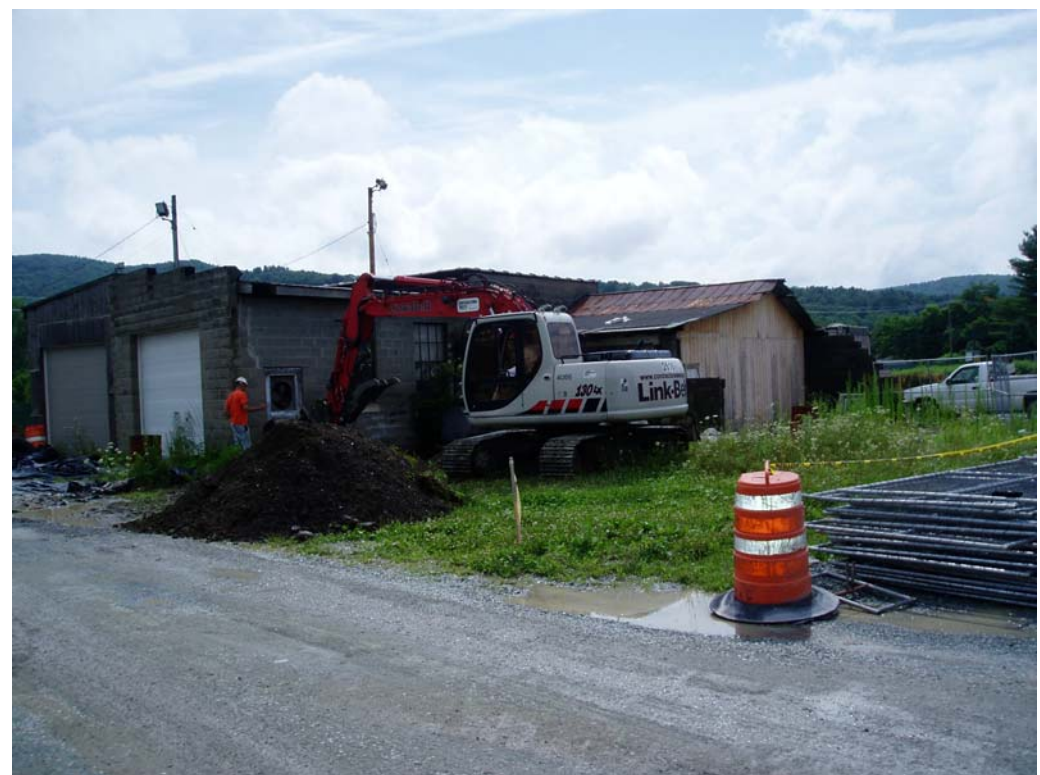
P7240016.JPG

| PHOTO | DATE | TIME | DESCRIPTION |
|---|---|---|---|
| P7 240016 | 7/24/2008 | 15:18 | View to southwest showing remedial excavation along north side of Building 666 (grid station J-4) |

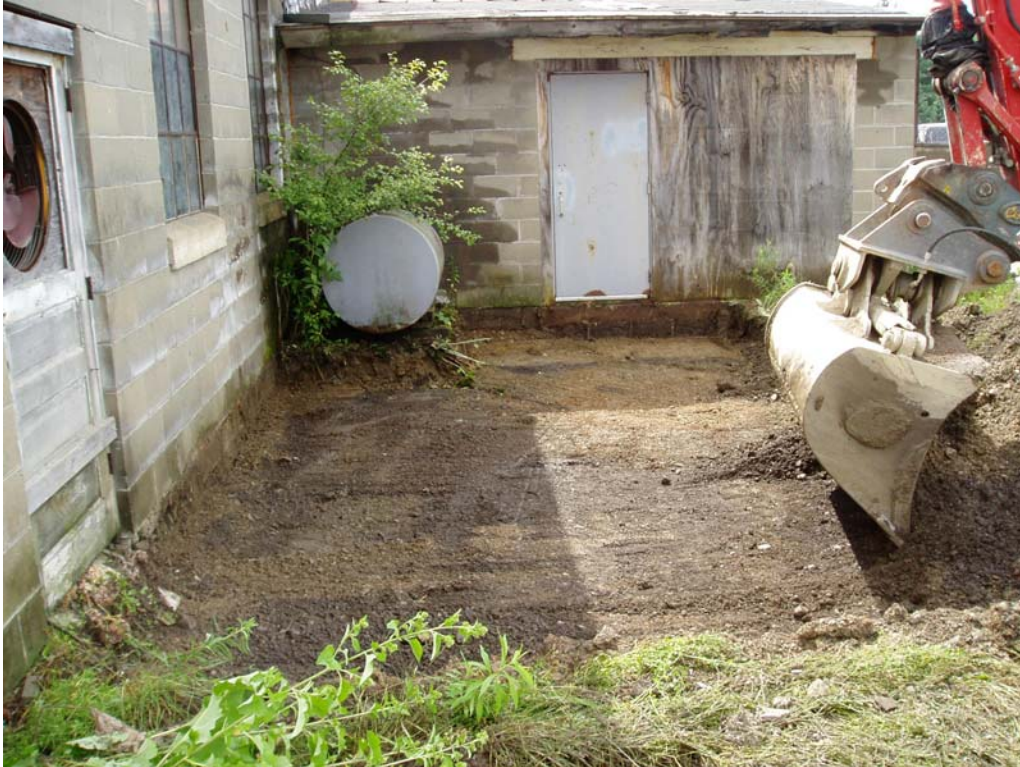
P7240017.JPG

| PHOTO | DATE | TIME | DESCRIPTION |
|---|---|---|---|
| P7 240017 | 7/24/2008 | 15:19 | View to west showing remedial excavation along north side of Building 666 (grid station J-4) |

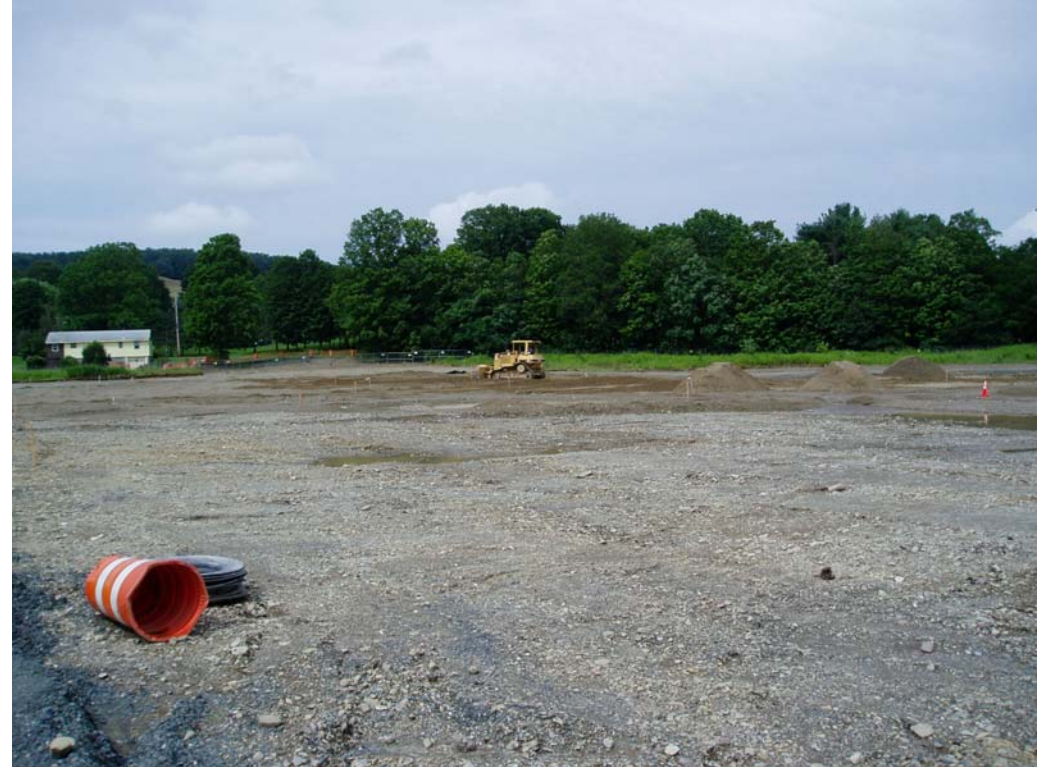
P7240018.JPG

| PHOTO | DATE | TIME | DESCRIPTION |
|---|---|---|---|
| P7 240018 | 7/24/2008 | 15:30 | View to northeast showing dozer grading approved backfill material into place at Area 1 |

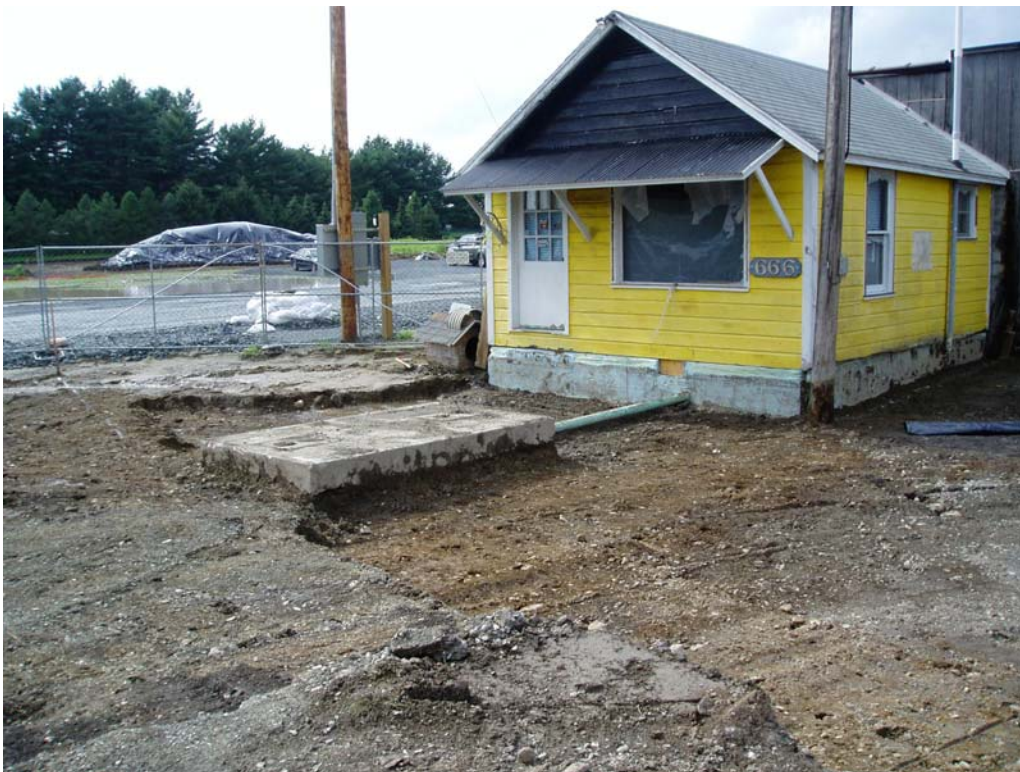
P7240019.JPG

| PHOTO | DATE | TIME | DESCRIPTION |
|---|---|---|---|
| P7 240019 | 7/24/2008 | 16:32 | View to northwest showing grid station J-2 along south side of Building 666 after remedial excavation completed for the day |

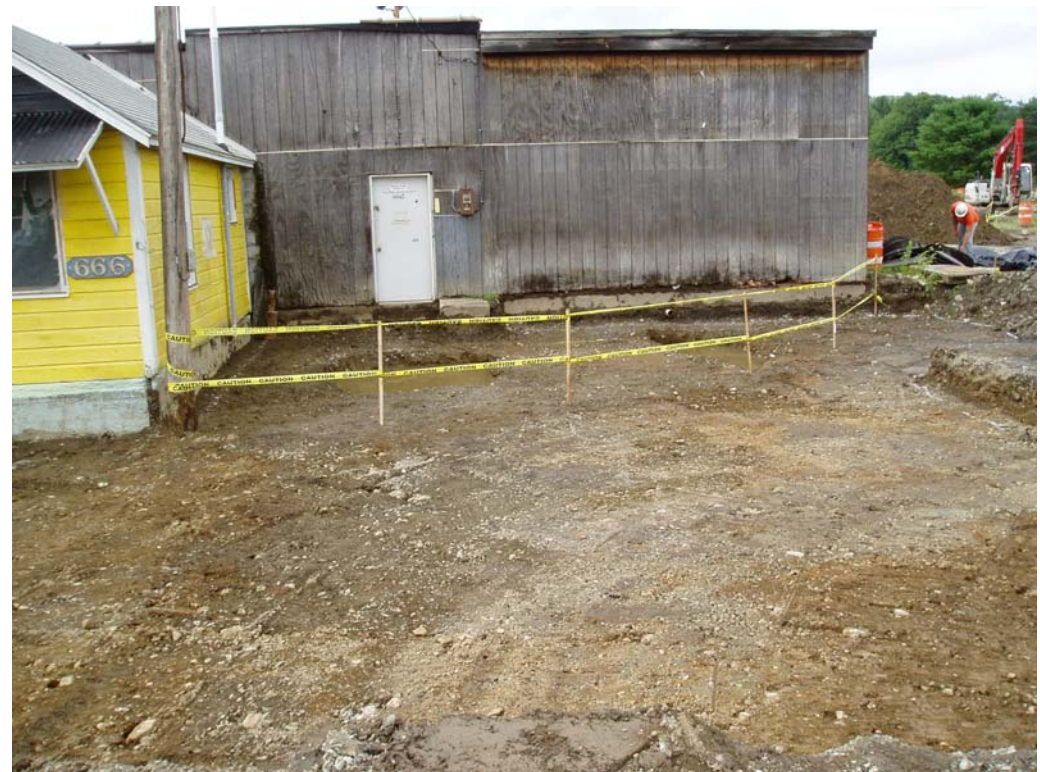
P7240020.JPG

| PHOTO | DATE | TIME | DESCRIPTION |
|---|---|---|---|
| P7 240020 | 7/24/2008 | 16:34 | View to north showing grid stations J-2, J-3 along south side of Building 666 after remedial excavation completed for the day |

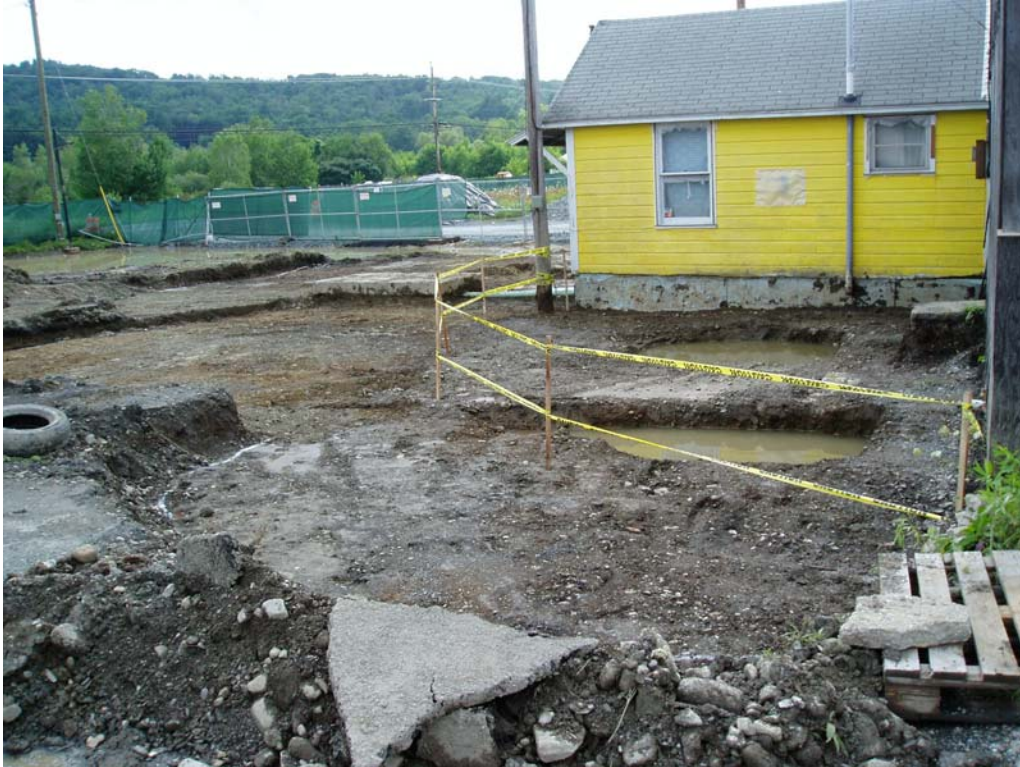
P7240021.JPG

| PHOTO | DATE | TIME | DESCRIPTION |
|---|---|---|---|
| P7 240021 | 7/24/2008 | 16:35 | View to southwest showing grid station J-2, J-3 along south side of Building 666 after remedial excavation completed for the day |

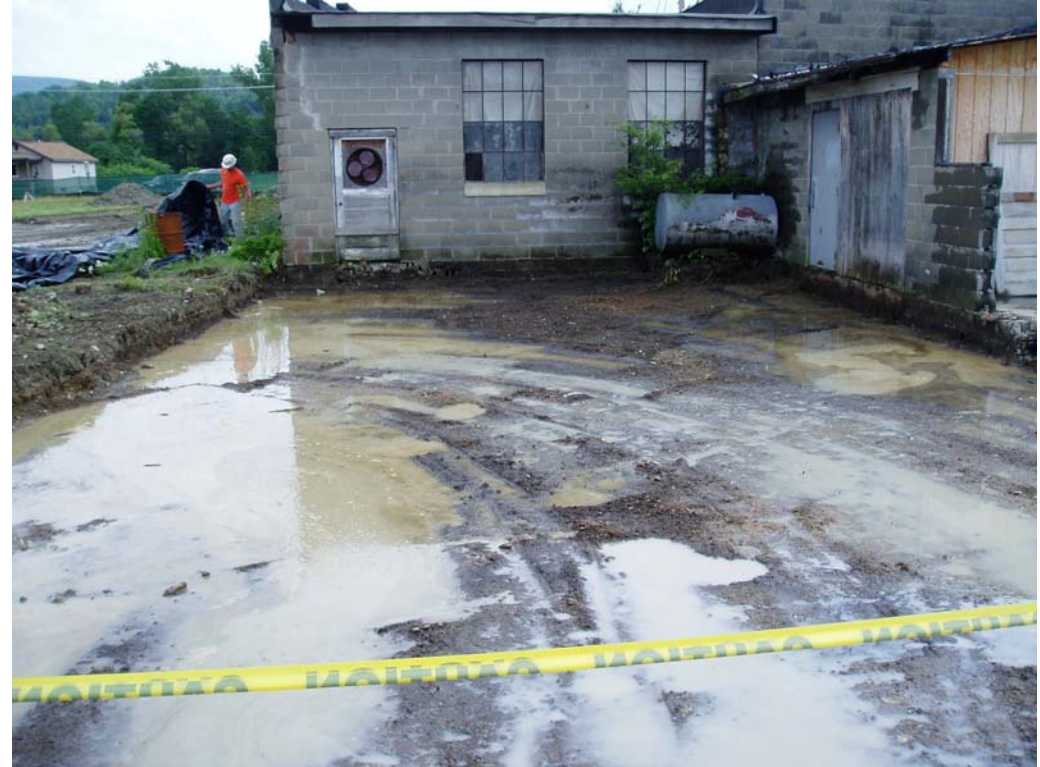
P7240022.JPG

| PHOTO | DATE | TIME | DESCRIPTION |
|---|---|---|---|
| P7 240022 | 7/24/2008 | 16:36 | View to south showing grid stations J-4, J-5 along north side of Building 666 after remedial excavation completed for the day |

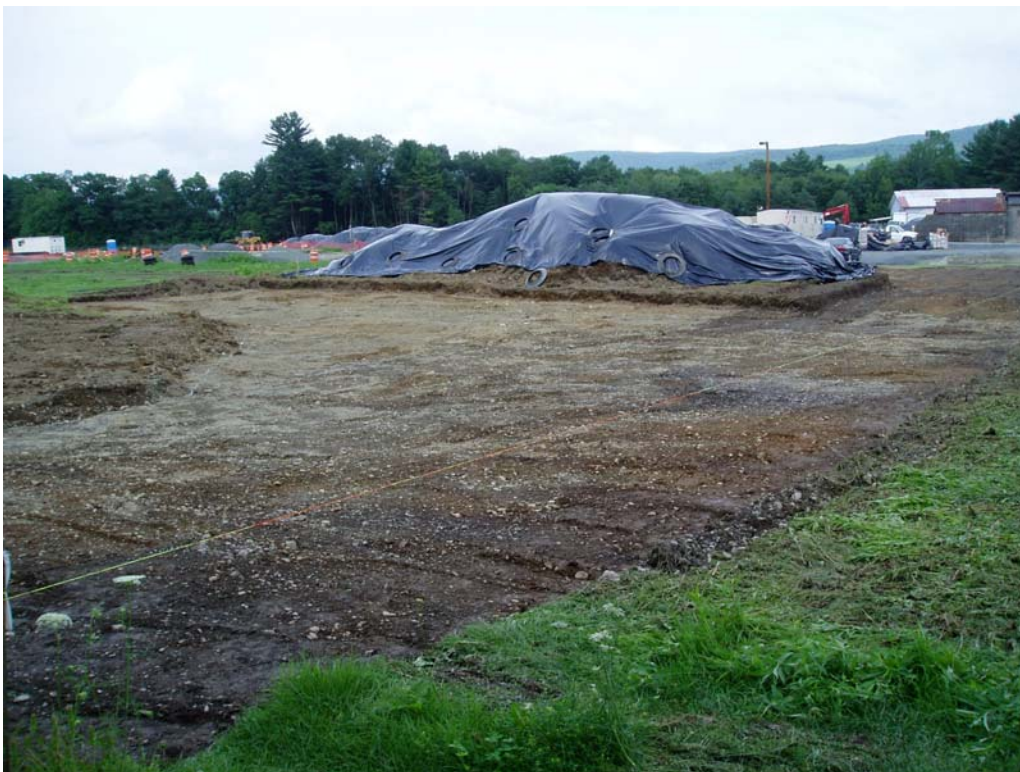
P7240023.JPG

| PHOTO | DATE | TIME | DESCRIPTION |
|---|---|---|---|
| P7 240023 | 7/24/2008 | 16:40 | View to northeast showing grid stations C-3, C-4, D-3, D-4, E-3 after remedial excavation completed for the day (north side Area 5/south side Area 4) |

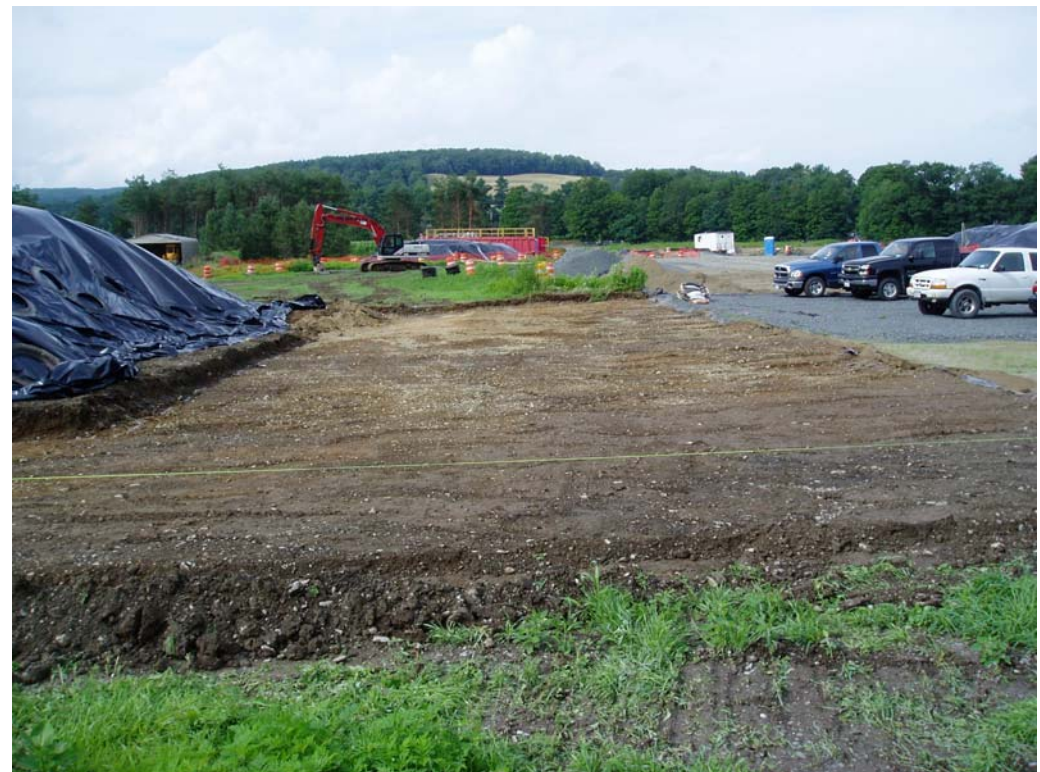
P7240024.JPG

| PHOTO | DATE | TIME | DESCRIPTION |
|---|---|---|---|
| P7 240024 | 7/24/2008 | 16:42 | View to north showing grid stations D-3, D-4, E-3, E-4 after remedial excavation completed for the day (north side Area 5/south side Area 4) |
