## DAILY FIELD ACTIVITY REPORT

| PROJECT | Former Bouchard Junkyard | WEATHER | TIME | TEMP. | PRECIP. | WIND (MPH) | WIND (DIR) |
| LOCATION | Town of New Lebanon, NY | P. Cloudy | 1000 | 70-75 F | None | 0-5 | SW |

**PHOTOGRAPHIC LOG**  
**July 28, 2008**  
**D&B JOB NO. 2605**  
**FORMER BOUCHARD JUNKYARD SITE**  
**TOWN OF NEW LEBANON, NEW YORK**

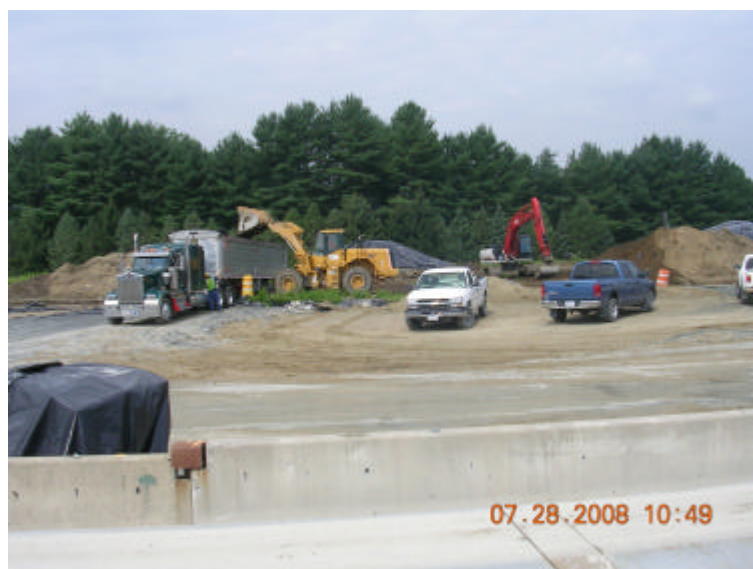
**DSCN4248.JPG**

| PHOTO | DATE | TIME | DESCRIPTION |
|---|---|---|---|
| DSCN 4248 | 7/28/08 | 1049 | View of DAC loading of non-TSCA PCB contaminated soil at left of photo using a Kawasaki 80ZV Front Loader from a soil stockpile in Area 4 looking W; Link Belt 240 Trackhoe is excavating non-TSCA soil from grid D-7 in the background. |

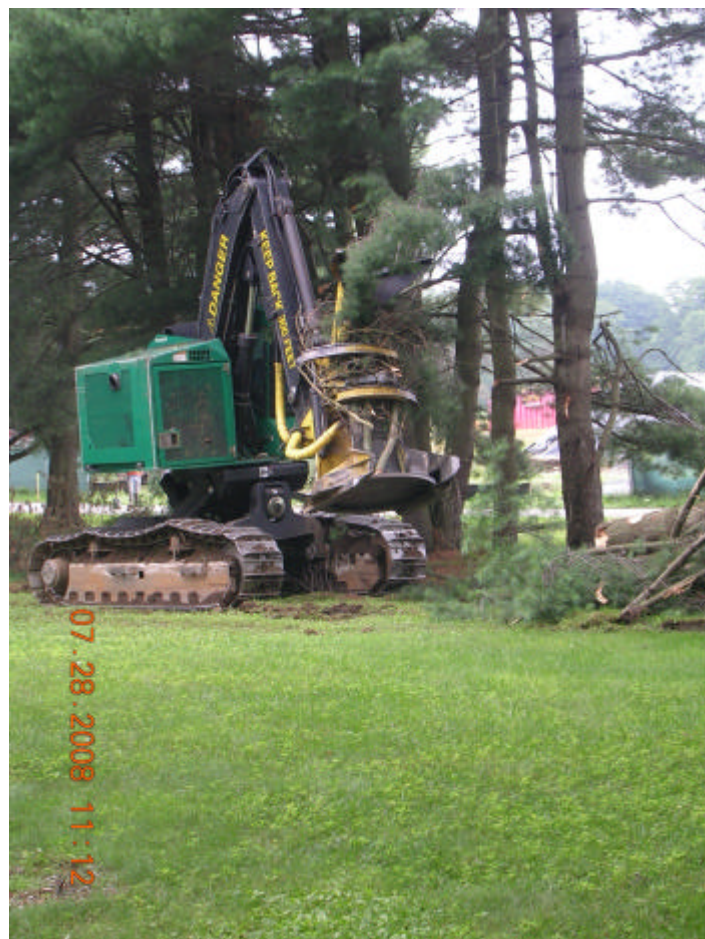
**DSCN4251.JPG**

| PHOTO | DATE | TIME | DESCRIPTION |
|---|---|---|---|
| DSCN 4251 | 7/28/08 | 1112 | View of Timberjack 759G Fellbuncher cutting down trees in Area 7 looking NW. |

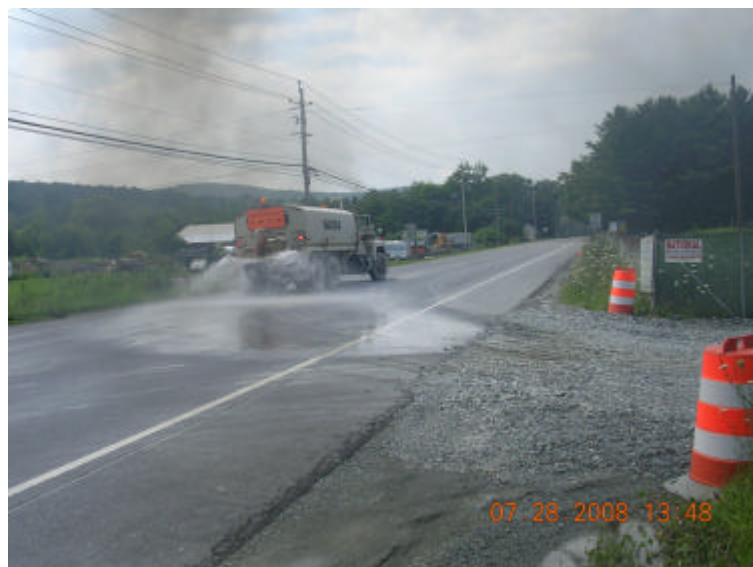
**DSCN4256.JPG**

| PHOTO | DATE | TIME | DESCRIPTION |
|---|---|---|---|
| DSCN 4256 | 7/28/08 | 1348 | Cleaning of muddy tire tracks in progress onto Route 20 road surface at entrance to driveway to Building 666 using 5,000 gallon Mack Water Truck; View of Route 20 looking SW. |

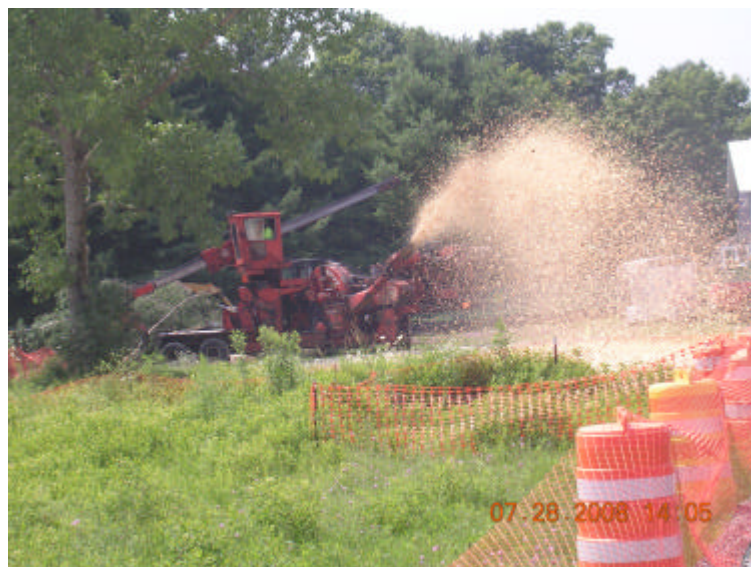
**DSCN4258.JPG**

| PHOTO | DATE | TIME | DESCRIPTION |
|---|---|---|---|
| DSCN 4258 | 7/28/08 | 1405 | View of Mobar Chipharvestor Wood Chipper stockpiling wood chips along the truck access road in Area 4 looking W. |

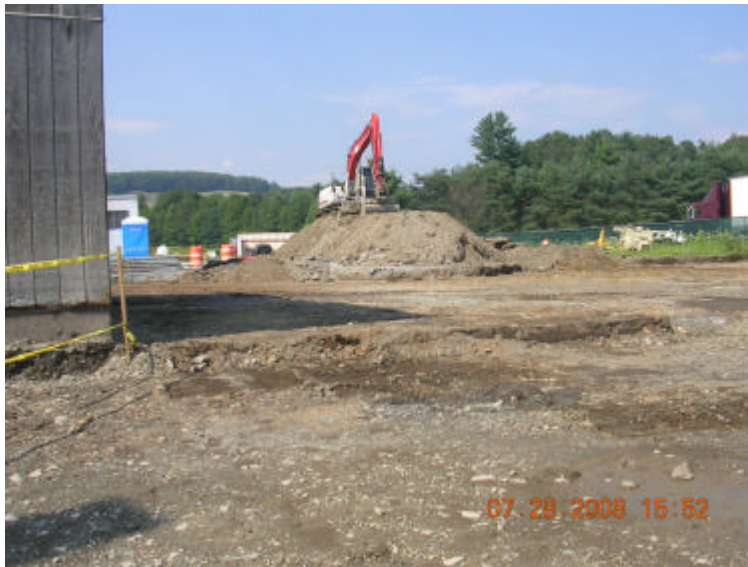
**DSCN4262.JPG**

| PHOTO | DATE | TIME | DESCRIPTION |
|---|---|---|---|
| DSCN 4262 | 7/28/08 | 1552 | Remedial excavation activities within the N-central part of Area 9 within Grids K-5 and L-5 utilizing a Link-Belt 130 LX Trackhoe; Non-TSCA soil was stockpiled on like-material in a centralized location in order to facilitate loading of trucks from the truck access road; View of Area 9 looking NE; Building 666 at left; Grid J-3 in foreground adjacent to building. |

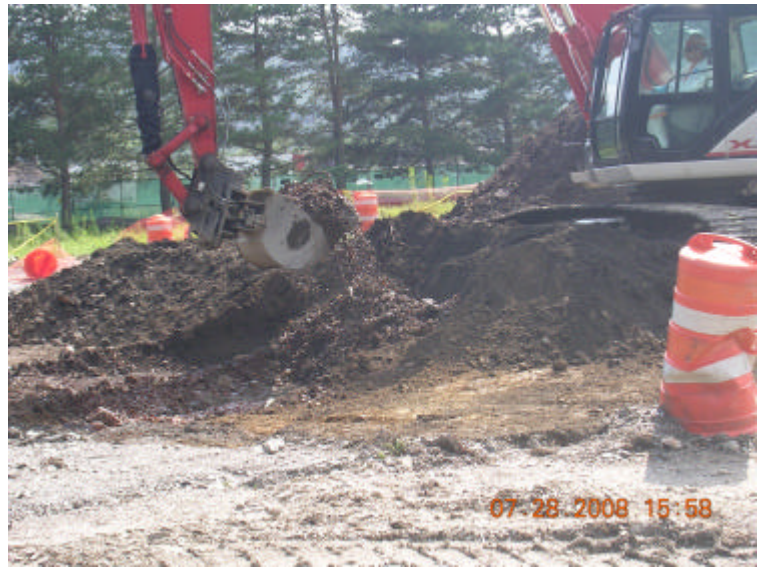
**DSCN4264.JPG**

| PHOTO | DATE | TIME | DESCRIPTION |
|---|---|---|---|
| DSCN 4264 | 7/28/08 | 1558 | View of active remedial excavation within TSCA grid 11 in eastern Area 3 utilizing a Link Belt 240 Trackhoe looking S; Abundant glass and metal debris is visible in the soil. |
