## DAILY FIELD ACTIVITY REPORT

| <b>PROJECT</b> | <b>Former Bouchard Junkyard</b> | <b>WEATHER</b> | <b>TIME</b> | <b>TEMP.</b> | <b>PRECIP.</b> | <b>WIND (MPH)</b> | <b>WIND (DIR)</b> |
| <b>LOCATION</b> | <b>Town of New Lebanon, NY</b> | <b>Sunny</b> | <b>0700</b> | <b>60-65 F</b> | <b>None</b> | <b>Calm</b> | <b>NA</b> |

**PHOTOGRAPHIC LOG**  
**July 29, 2008**  
**D&B JOB NO. 2605**  
**FORMER BOUCHARD JUNKYARD SITE**  
**TOWN OF NEW LEBANON, NEW YORK**

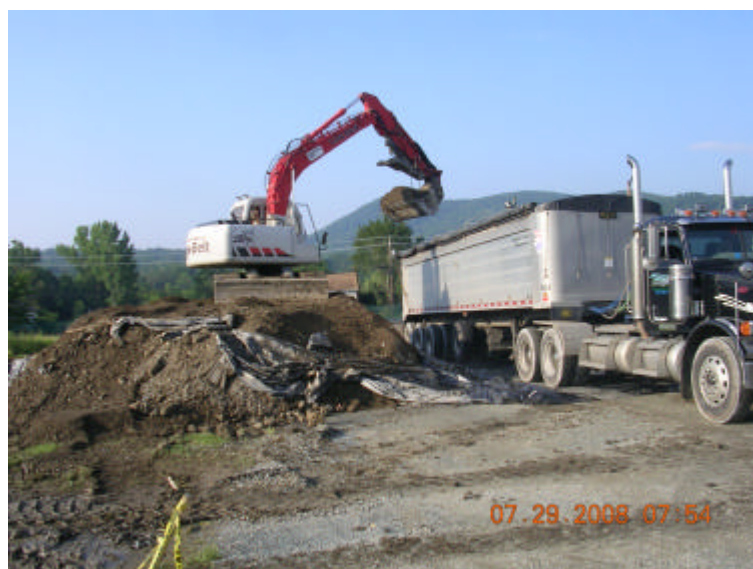
**DSCN4270.JPG**

| PHOTO | DATE | TIME | DESCRIPTION |
|---|---|---|---|
| DSCN 4270 | 7/29/08 | 0754 | View of DAC loading of non-TSCA PCB contaminated soil using a Link Belt 130 LX Trackhoe at the N-central part of Area 9 looking S. |

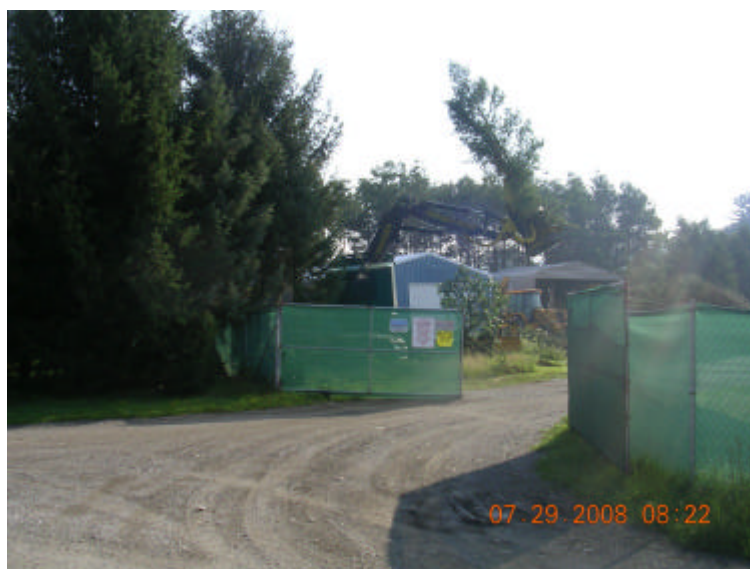
**DSCN4273.JPG**

| PHOTO | DATE | TIME | DESCRIPTION |
|---|---|---|---|
| DSCN 4273 | 7/29/08 | 0822 | View of Timberjack 759G Fellbuncher cutting down trees in Area 4 looking NE. |

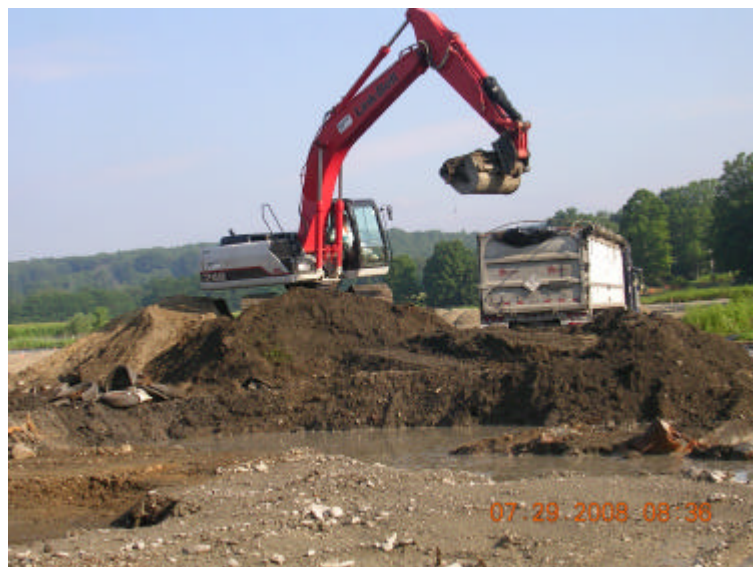
**DSCN4276.JPG**

| PHOTO | DATE | TIME | DESCRIPTION |
|---|---|---|---|
| DSCN 4276 | 7/29/08 | 0836 | Remedial excavation of TSCA soil within TSCA grid 11 at the E side of Area 3 utilizing a Link-Belt 240 Trackhoe; TSCA soil was directly loaded onto waste hauling trucks; Area 3 looking NW. |

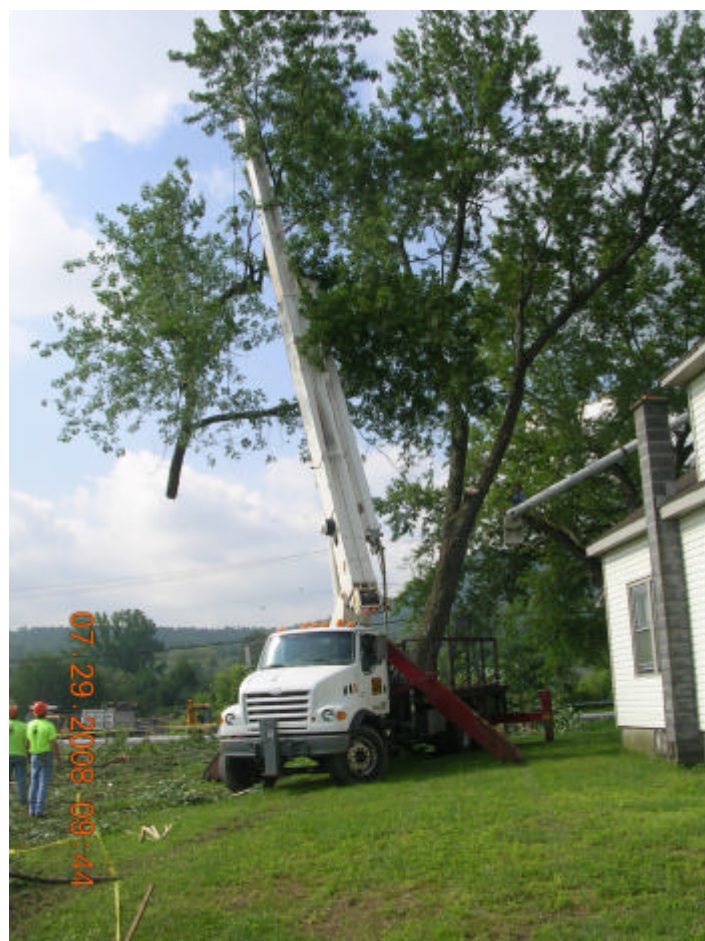
**DSCN4288.JPG**

| PHOTO | DATE | TIME | DESCRIPTION |
|---|---|---|---|
| DSCN 4288 | 7/29/08 | 0944 | View of Donovan Tree Service, Inc. incrementally cutting down sections of a large maple tree on Area 7 looking S. |

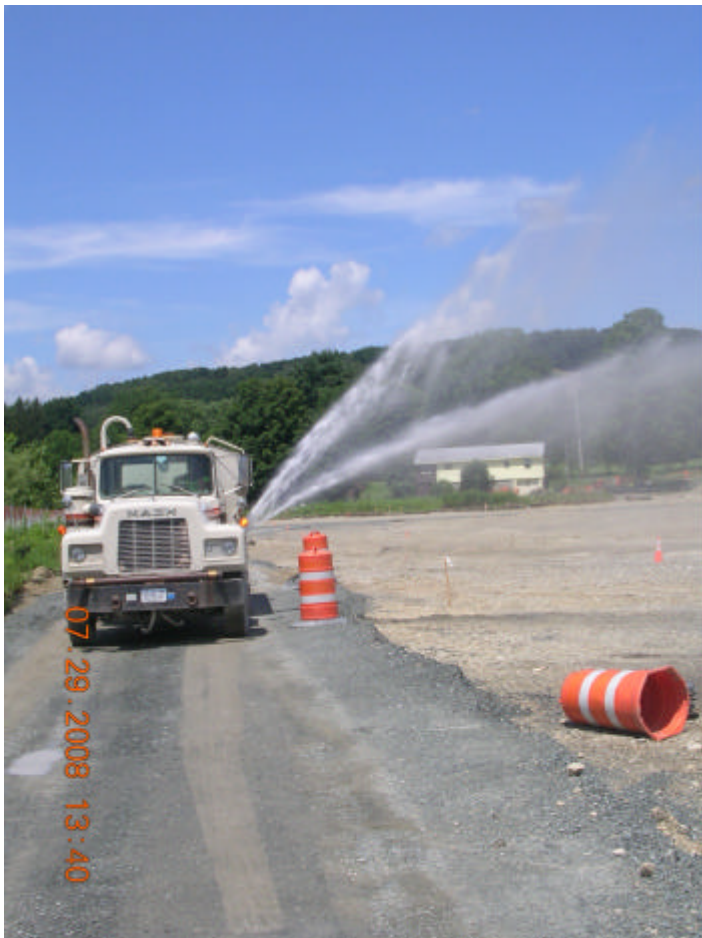
**DSCN4318.JPG**

| PHOTO | DATE | TIME | DESCRIPTION |
|---|---|---|---|
| DSCN 4318 | 7/29/08 | 1340 | View of dust suppression onto remedial excavation areas in Area 3 looking N. |

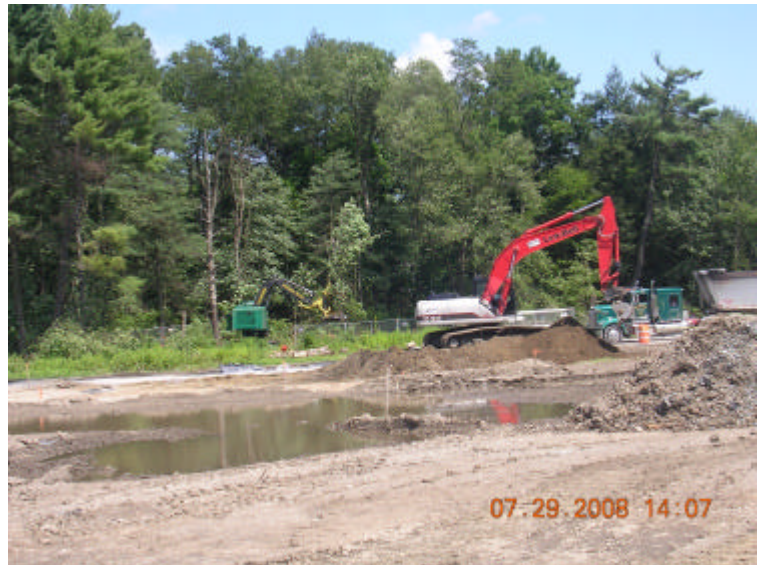
**DSCN4324.JPG**

| PHOTO | DATE | TIME | DESCRIPTION |
|---|---|---|---|
| DSCN 4324 | 7/29/08 | 1407 | Remedial excavation of TSCA soil within TSCA grid 11 at the E side of Area 3 utilizing a Link-Belt 240 Trackhoe; TSCA soil was directly loaded onto waste hauling trucks; Timberjack 759G Fellbuncher cutting down trees in background; Areas 3 and 8 looking NE. |

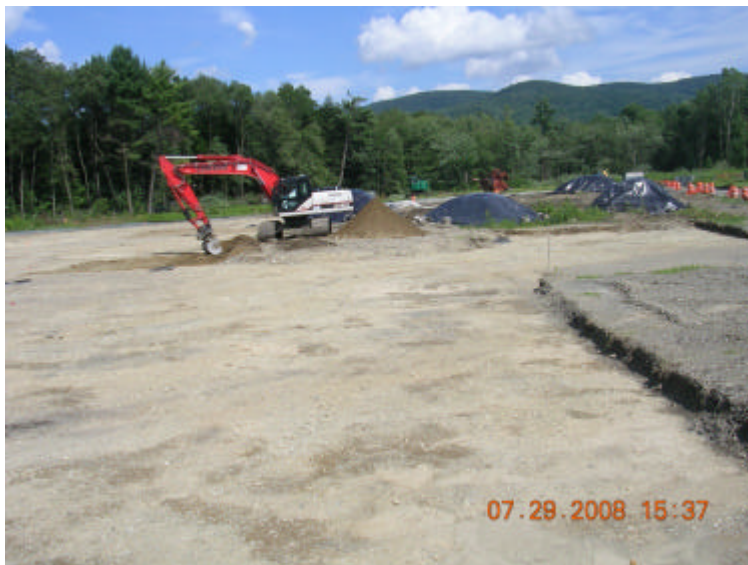
**DSCN4325.JPG**

| PHOTO | DATE | TIME | DESCRIPTION |
|---|---|---|---|
| DSCN 4325 | 7/29/08 | 1537 | Remedial excavation activities within the N-central part of Area 3 within Grids J-12 utilizing a Link-Belt 240 Trackhoe; Non-TSCA soil was stockpiled on like-material in a centralized location in order to facilitate loading of trucks from the truck access road; View of Area 3 looking E. |

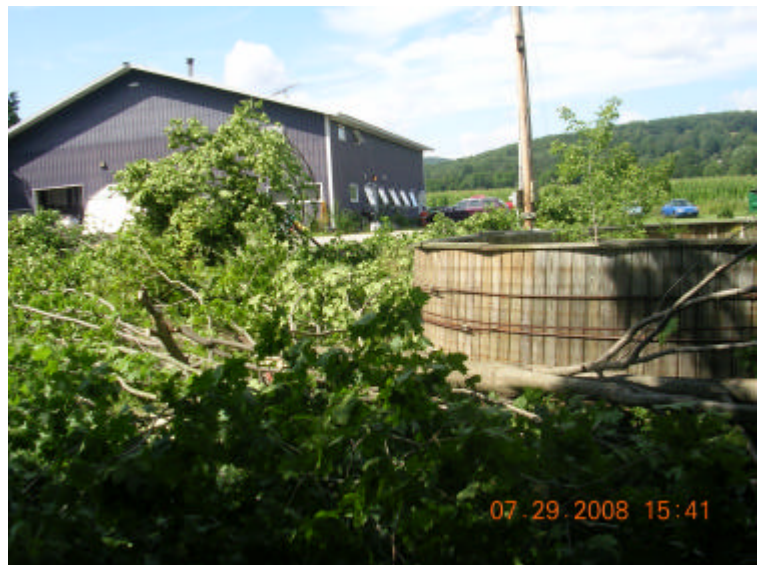
**DSCN4326.JPG**

| PHOTO | DATE | TIME | DESCRIPTION |
|---|---|---|---|
| DSCN 4326 | 7/29/08 | 1541 | View of final tree clearing in Area 6 looking E; Chuck's Automotive building in background. |

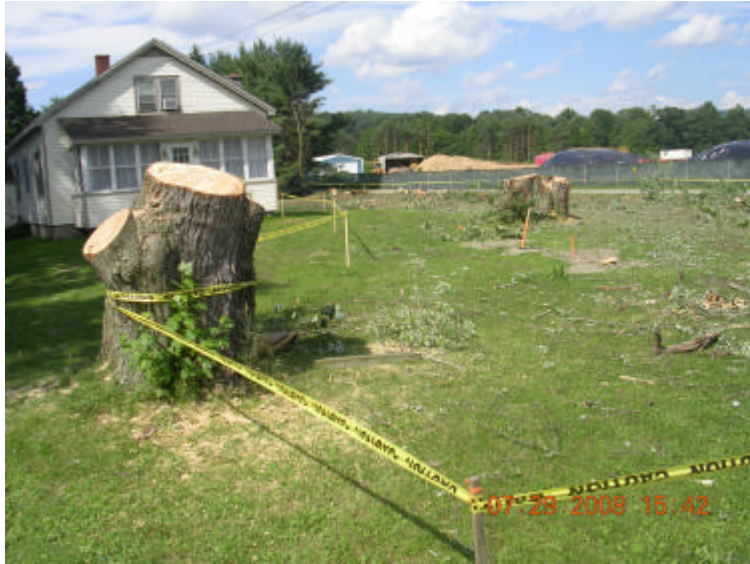
**DSCN4327.JPG**

| PHOTO | DATE | TIME | DESCRIPTION |
|---|---|---|---|
| DSCN 4327 | 7/29/08 | 1542 | View of final tree clearing in Area 7 looking NE; Stumps of large maple trees are visible in the foreground. |

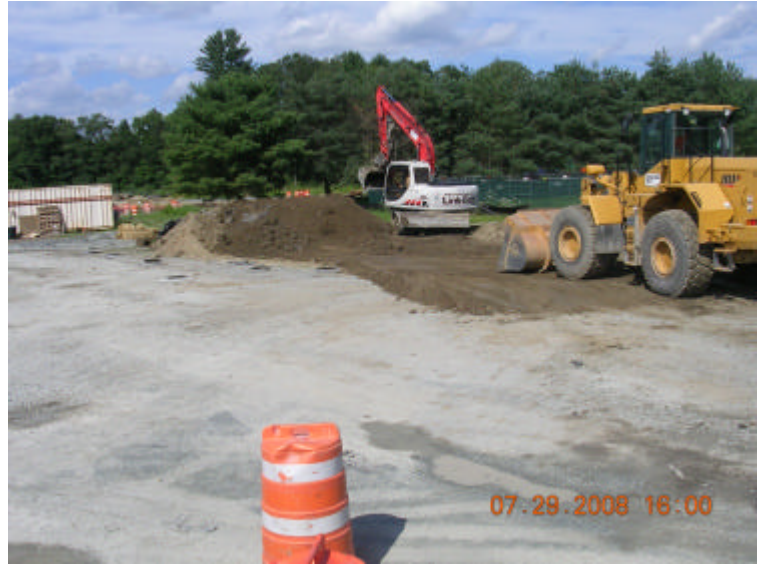
**DSCN4329.JPG**

| PHOTO | DATE | TIME | DESCRIPTION |
|---|---|---|---|
| DSCN 4329 | 7/29/08 | 1600 | View of active remedial excavation within non-TSCA grid L-6 in N-central Area 9 utilizing a Link Belt 130 LX Trackhoe looking NE. |
