**REPORT NO. 080730**

## DAILY FIELD ACTIVITY REPORT

| <b>PROJECT</b> | <b>Former Bouchard Junkyard</b> | <b>WEATHER</b> | <b>TIME</b> | <b>TEMP.</b> | <b>PRECIP.</b> | <b>WIND (MPH)</b> | <b>WIND (DIR)</b> |
| <b>LOCATION</b> | <b>Town of New Lebanon, NY</b> | <b>Sunny</b> | <b>0700</b> | <b>60-65 F</b> | <b>None</b> | <b>Calm</b> | <b>NA</b> |

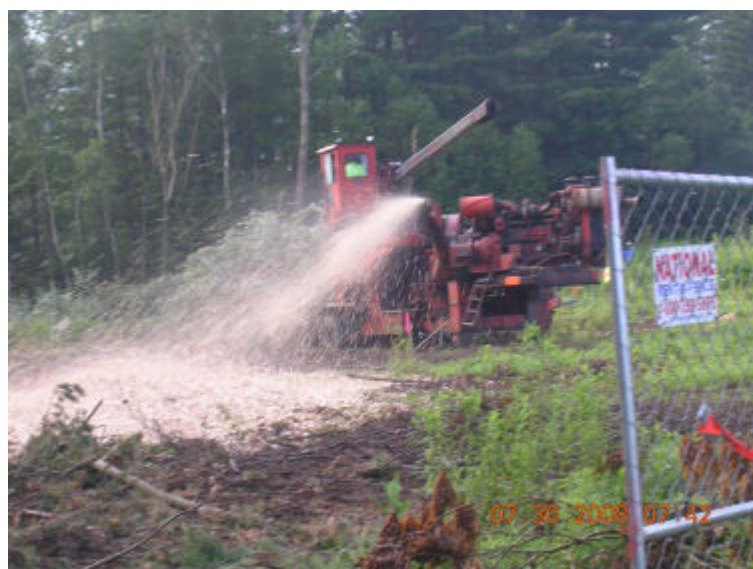
**DSCN4331.JPG**

| PHOTO | DATE | TIME | DESCRIPTION |
|---|---|---|---|
| DSCN 4331 | 7/30/08 | 0742 | View of Mobar Chipharvestor Wood Chipper stockpiling wood chips along the truck access road in Area 8 looking SE. |

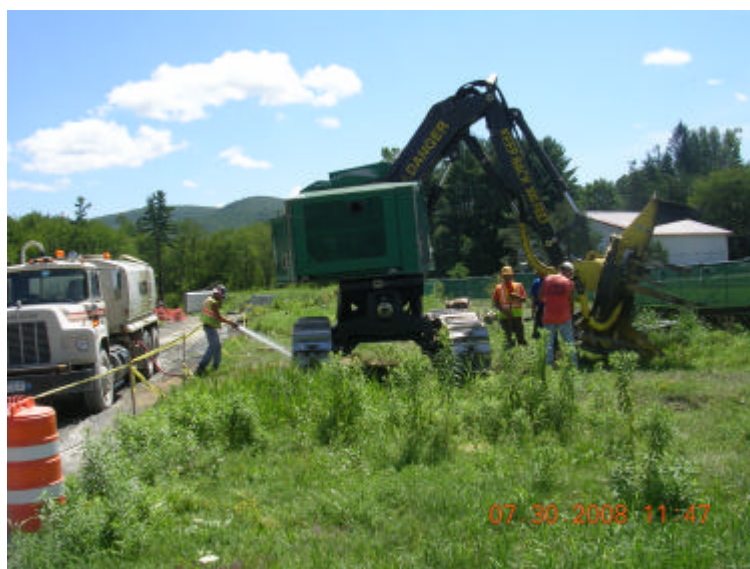
**DSCN4338.JPG**

| PHOTO | DATE | TIME | DESCRIPTION |
|---|---|---|---|
| DSCN 4338 | 7/30/08 | 1147 | View of DAC crew decontaminating Timberjack 759G Fellbuncher using water hose from Mack Water Truck at the northern boundary of Area 9 looking E; Note that row of Scotch Pine trees has been removed in the background. |

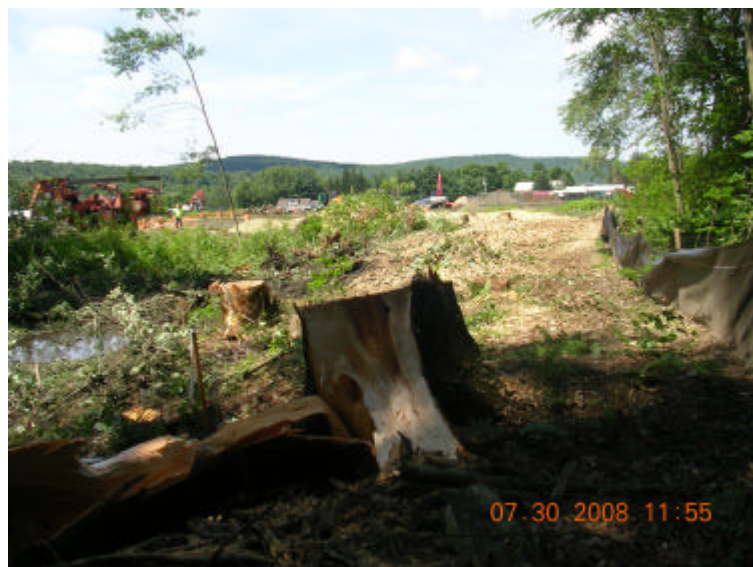
**DSCN4340.JPG**

| PHOTO | DATE | TIME | DESCRIPTION |
|---|---|---|---|
| DSCN 4340 | 7/30/08 | 1155 | View of the wetland section of Area 8 after clearing and grubbing looking ESE. |

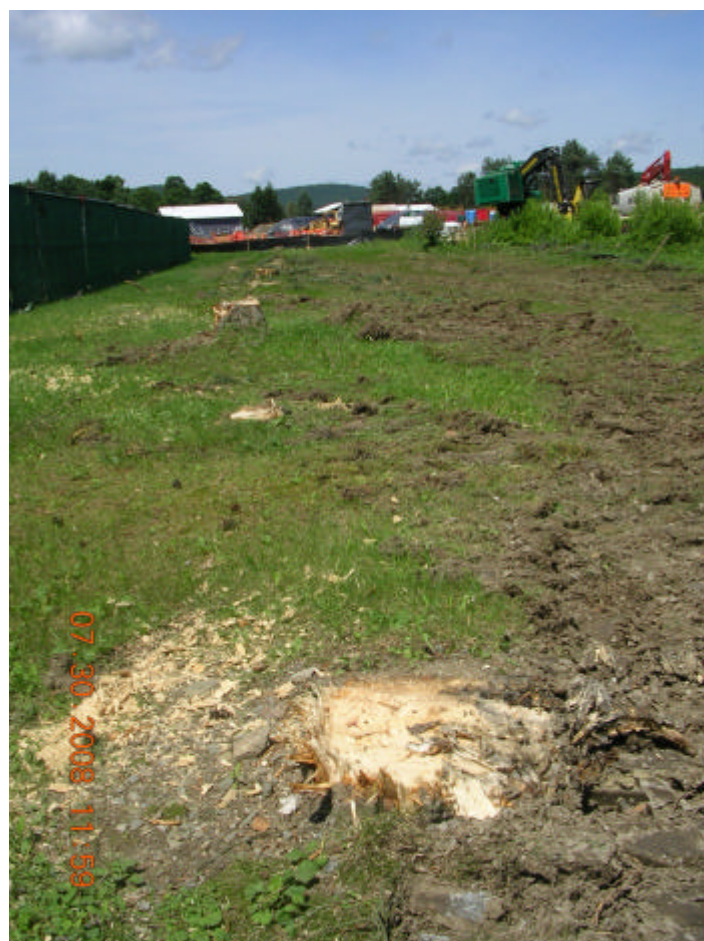
**DSCN4341.JPG**

| PHOTO | DATE | TIME | DESCRIPTION |
|---|---|---|---|
| DSCN 4341 | 7/30/08 | 1159 | View of row of stumps of Scotch Pine trees after removal along the northern boundary of Area 9 looking W. |

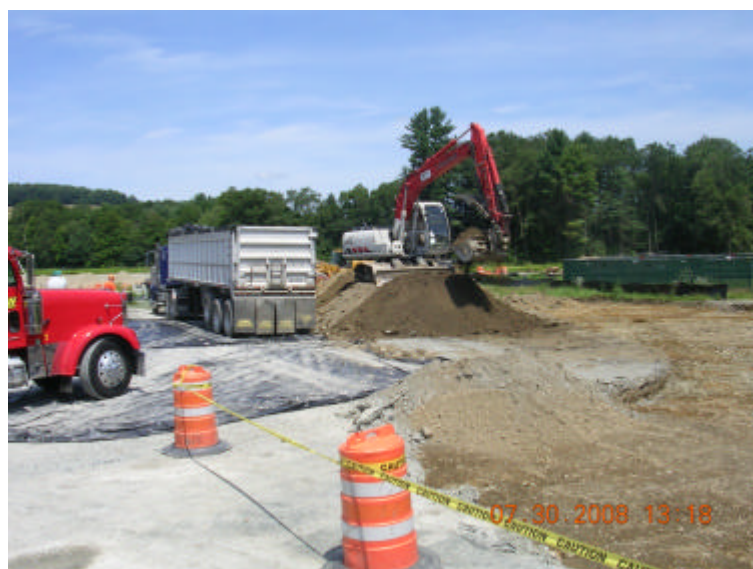
**DSCN4342.JPG**

| PHOTO | DATE | TIME | DESCRIPTION |
|---|---|---|---|
| DSCN 4342 | 7/30/08 | 1318 | View of DAC loading of non-TSCA PCB contaminated soil using a Link Belt 130 LX Trackhoe in N-central Area 9 looking NE. |

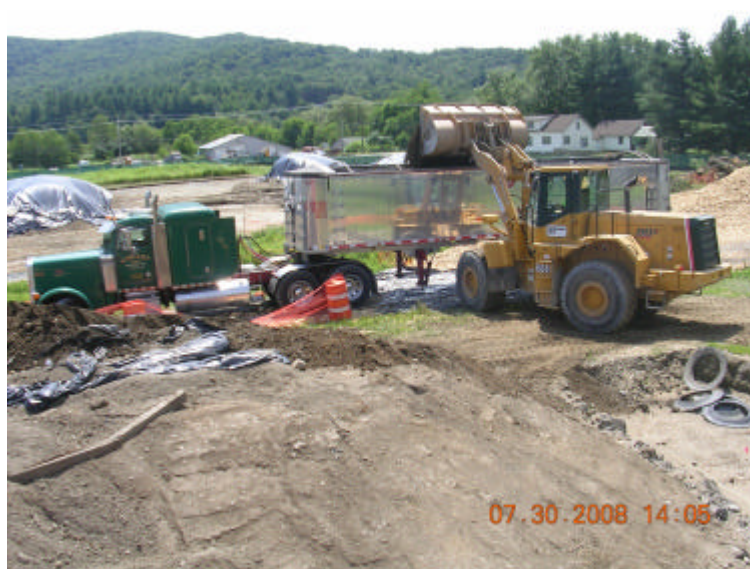
**DSCN4343.JPG**

| PHOTO | DATE | TIME | DESCRIPTION |
|---|---|---|---|
| DSCN 4343 | 7/30/08 | 1405 | View of DAC loading of non-TSCA PCB contaminated soil using a Kawasaki 80ZV Front Loader from a soil stockpile in Area 4 looking S. |

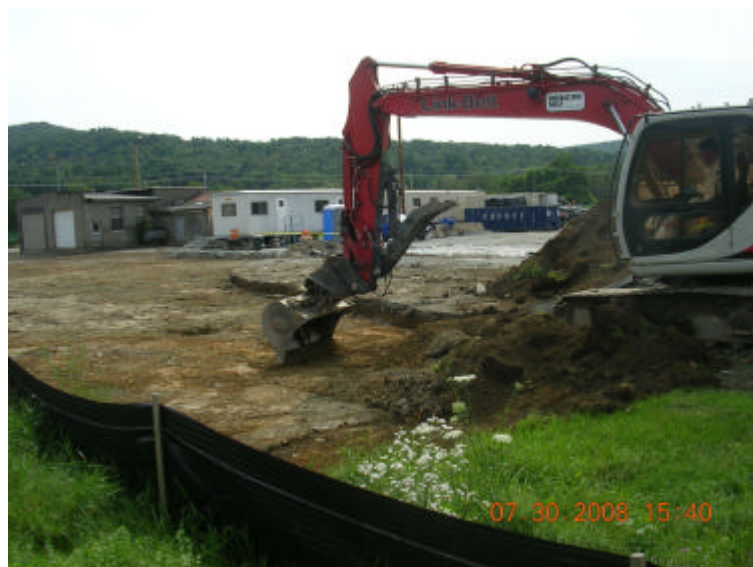
**DSCN4347.JPG**

| PHOTO | DATE | TIME | DESCRIPTION |
|---|---|---|---|
| DSCN 4347 | 7/30/08 | 1540 | Remedial excavation activities within the N-central part of Area 9 within Grid L-8 utilizing a Link-Belt 130 LX Trackhoe; Non-TSCA soil was stockpiled on like-material in a centralized location in order to facilitate loading of trucks from the truck access road; View of Area 9 looking NE; Project trailers and Building 666 in distant background. |
