Subject: **Bouchard Junkyard Site – New Lebanon, New York**  
**NYSDEC Registry Site #411014**  
**Field Inspection Report**

Inspection Date: May 2, 2013

Purpose: To inspect site conditions, site use, controls

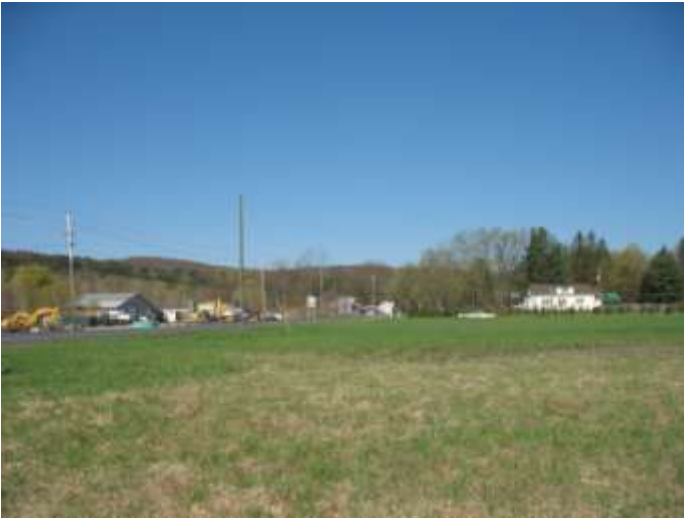
Site #411014 5/2/2013 Photo 1 – Looking W, Rt. 20 at left

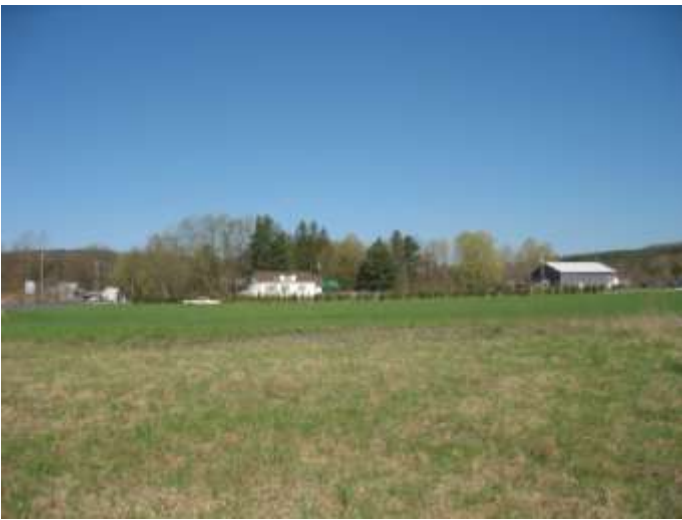
Site #411014 5/2/2013 Photo 2- Looking west

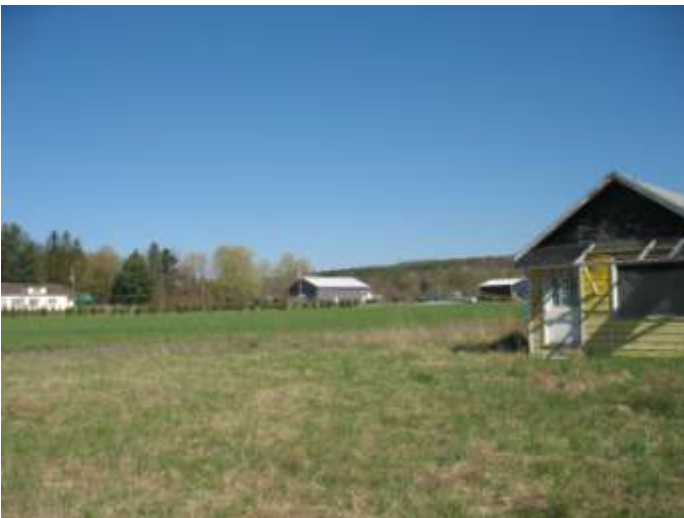
Site #411014 5/2/2013 Photo 3- Looking NW Trucking in distance

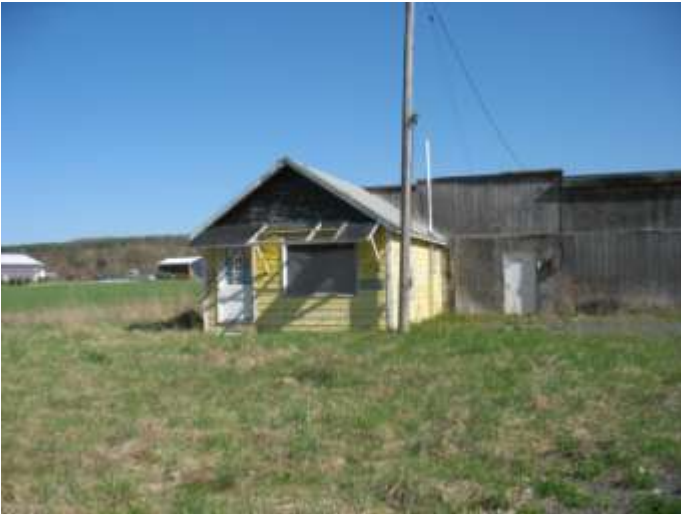
Site #411014 5/2/2013 Photo 4 – Looking N , Yellow building

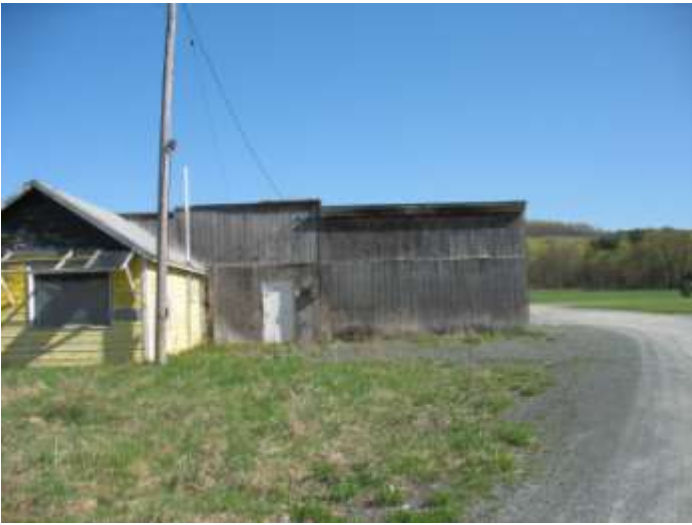
Site #411014 5/2/2013 Photo 5 – Looking N, Yellow building

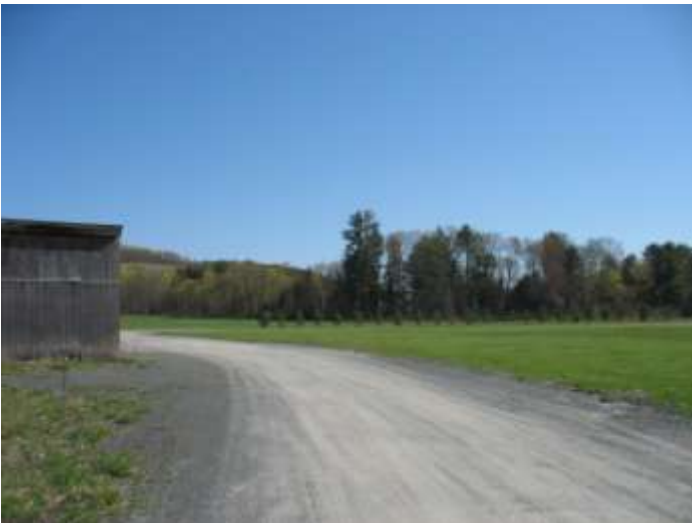
Site #411014 5/2/2013 Photo 6 – Looking N, driveway E of yellow Bldg.

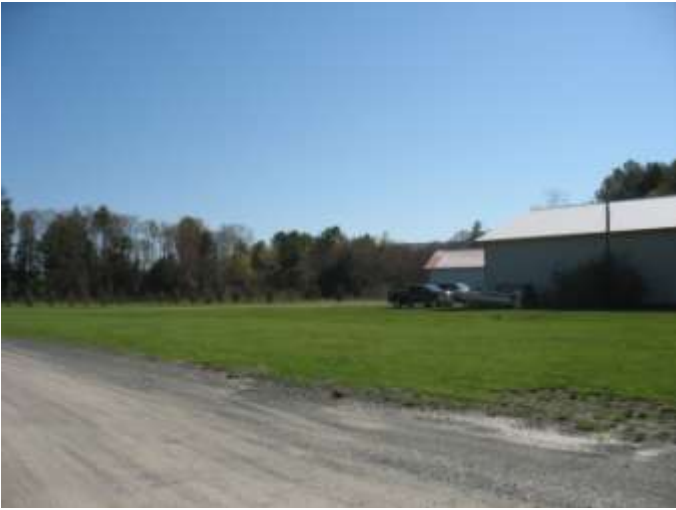
Site #411014 5/2/2013 Photo 7 – Looking NE, N end of Theater Barn at right.

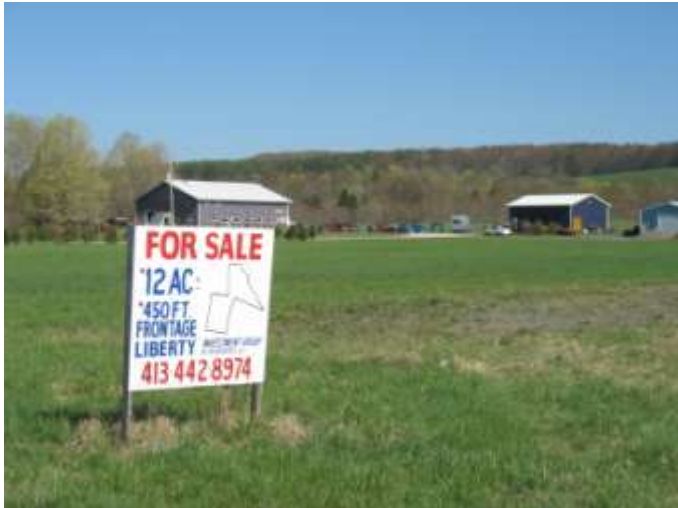
Site #411014 5/2/2013 Photo 8 – Sign posted W of central driveway.

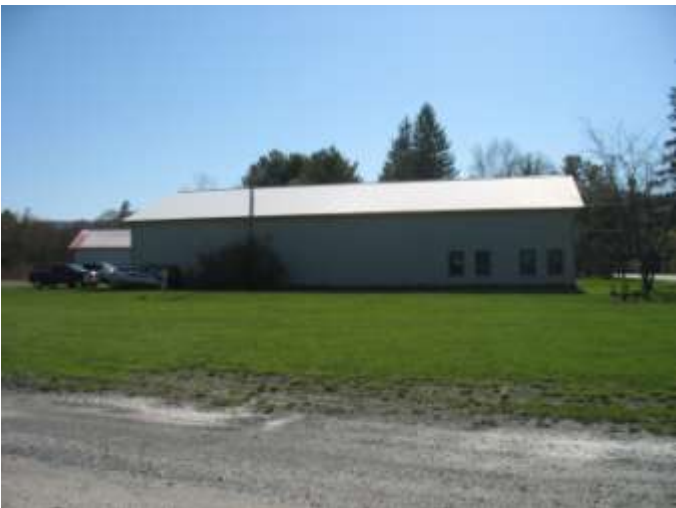
Site #411014 5/2/2013 Photo 9 – Looking E at Theater Barn

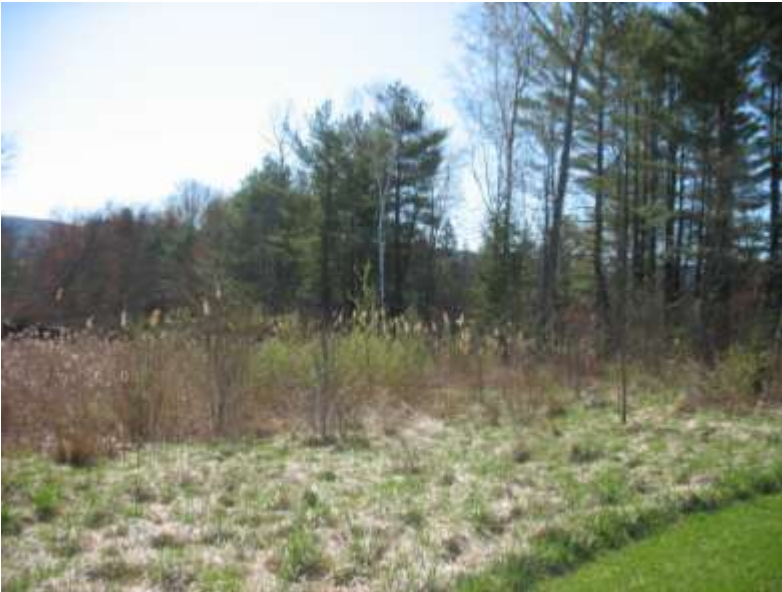
Site #411014 5/2/2013 Photo 10 – Looking E, restored wetland area

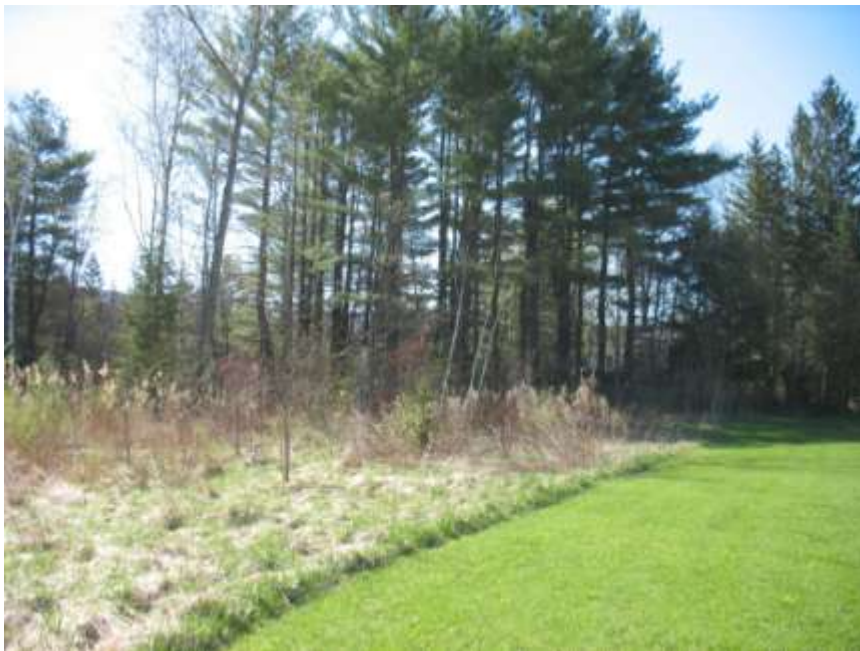
Site #411014 5/2/2013 Photo 11 – Looking SE along wetland area

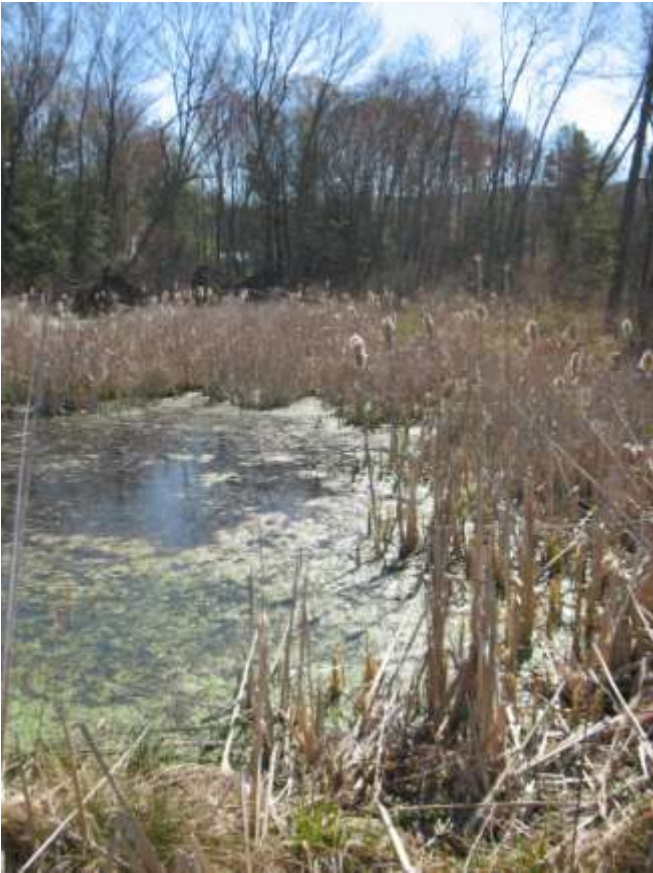
Site #411014 5/2/2013 Photo 12 – Pond in wetland, looking E.

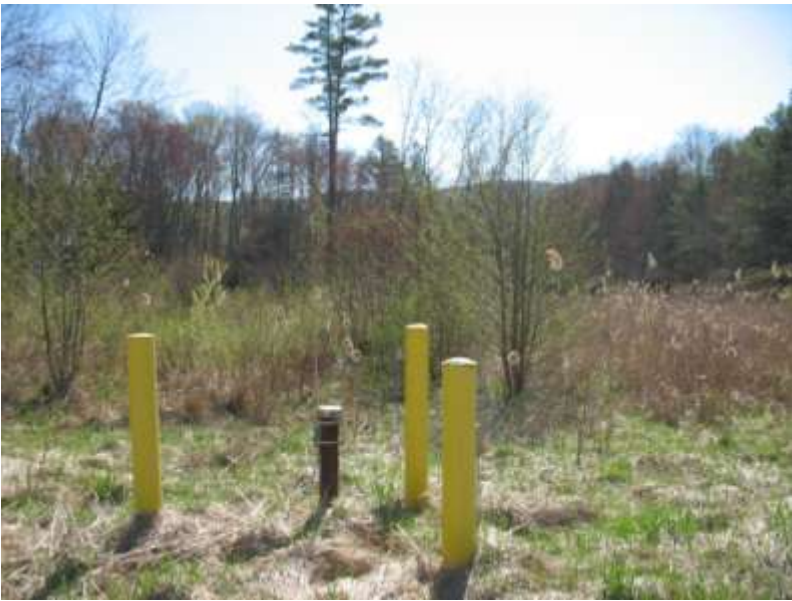
Site #411014 5/2/2013 Photo 13 – Well MW-4, next to wetland area

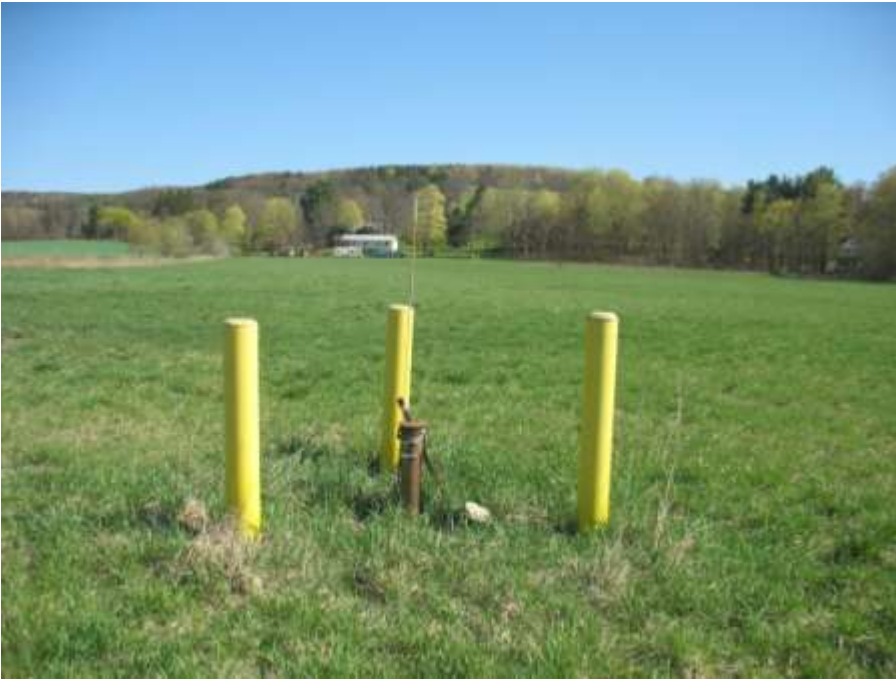
Site #411014 5/2/2013 Photo 14 – Well MW-2R, Looking N.

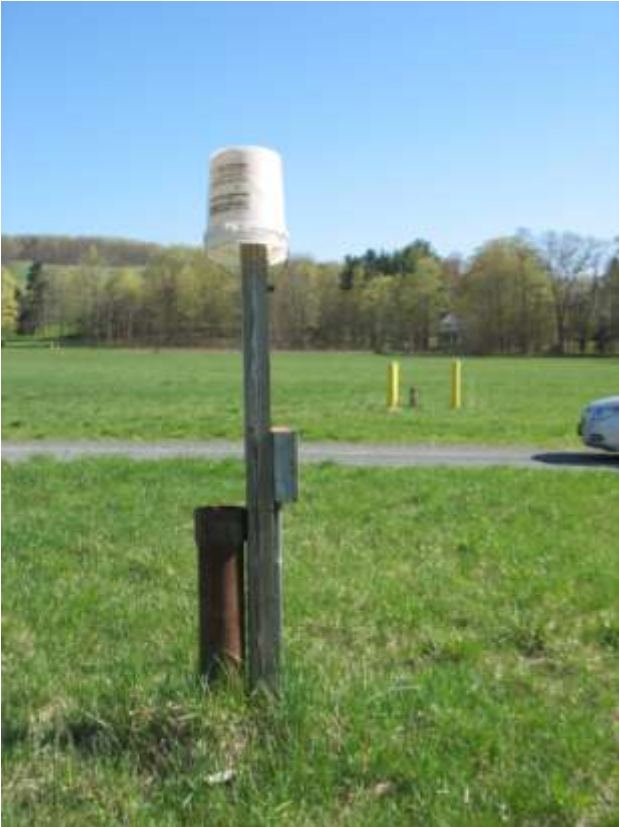
There are several wells at the site. Most have surrounding bollards and were capped/locked. One exception was noted that the well just to the north of the yellow building. This well (WSW-4) is a stick-up completion with no cap or lock. It appears this was previously the supply well for the yellow building; there was an electric service panel next to the wellhead, but there was no piping or electric cable visible inside the protective steel casing or the interior PVC riser, so this well is not in active service.

Site #411014 5/2/2013 Photo 15 – Well WSW-4

Since the remedial action achieved residential use criteria for all areas except for the Route 20 roadbed, and recent groundwater data do not show site related impacts, this site appears to be a good candidate for a delist action. In conjunction with such an action, any wells that were installed by the State should be properly decommissioned.

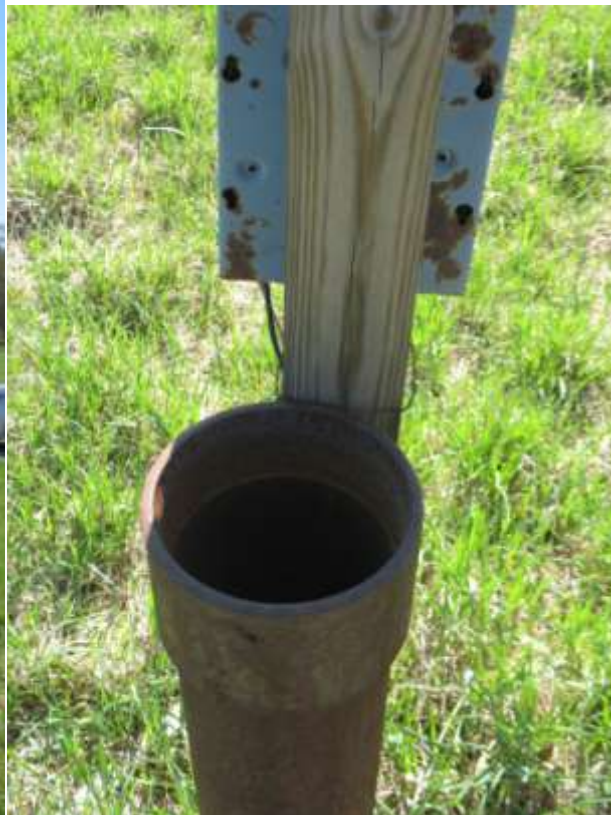
Site #411014 5/2/2013 Photo 16 – Well WSW-4, no cap/lock

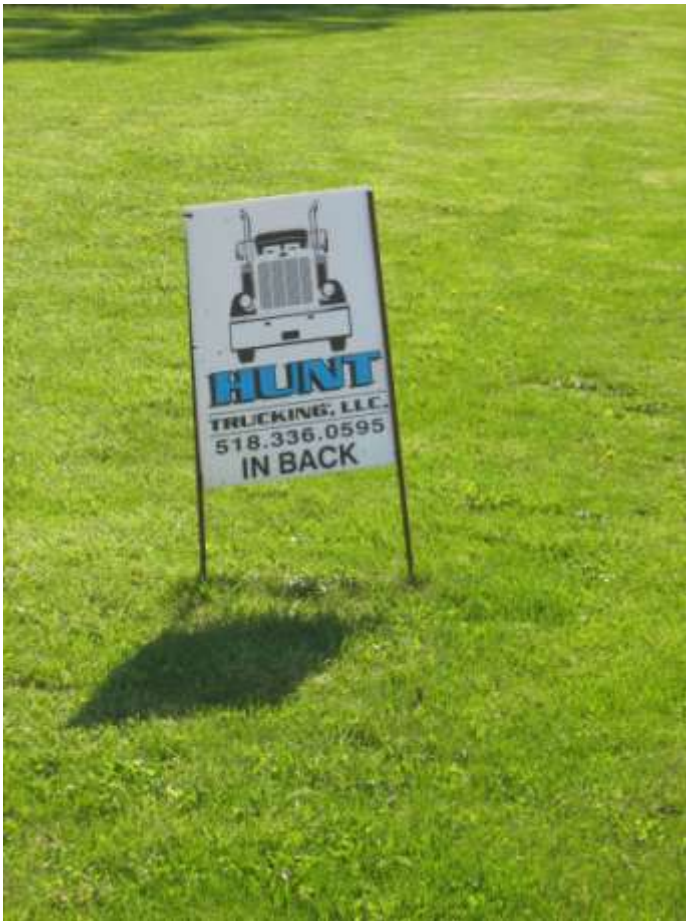
Site #411014 5/2/2013 Photo 17 – Sign posted for trucking company.
