# Herrick Hollow Creek

## Final Remedial Action (RA) Report

### Remedial Action for Herrick Hollow Creek Restoration

March 2009

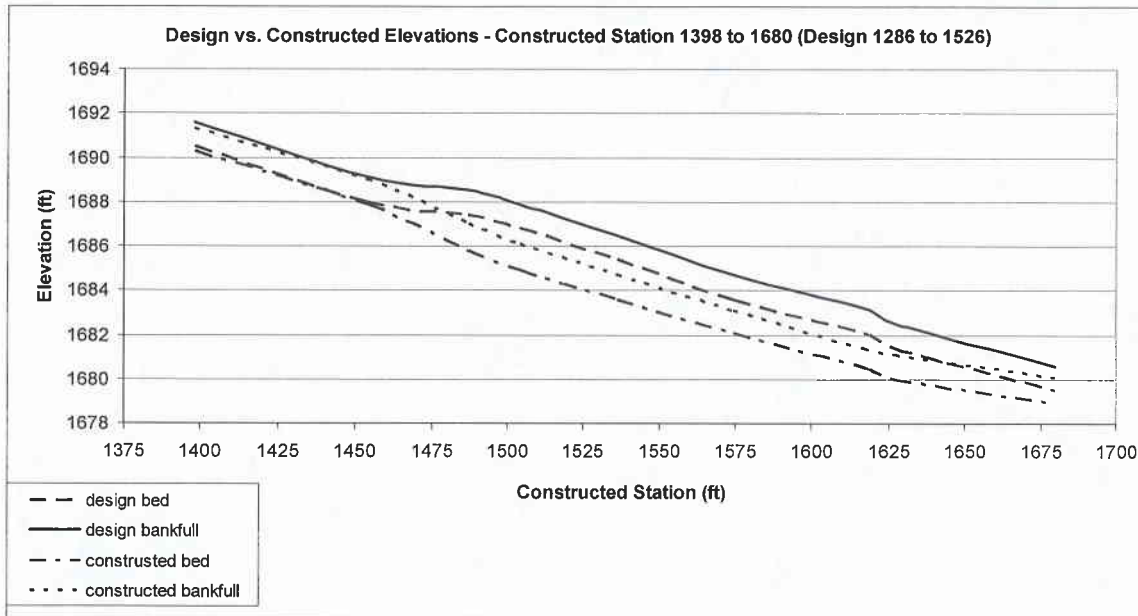
**Figure 1**  
**Design and constructed elevations through stations 13+98 through 16+80.**

The cascade structure originally designed at station 16+27 was eliminated (was not constructed) due to the fact that the structure may have been close enough to the downstream end of the preceding cross vane (located 8 feet upstream at station 16+17) to potentially inhibit the ability of that structure to function properly, especially during high flow events. The constructed channel was 'reconnected' with original design elevations at the construction of a cascade structure prescribed in the design at station 16+80.

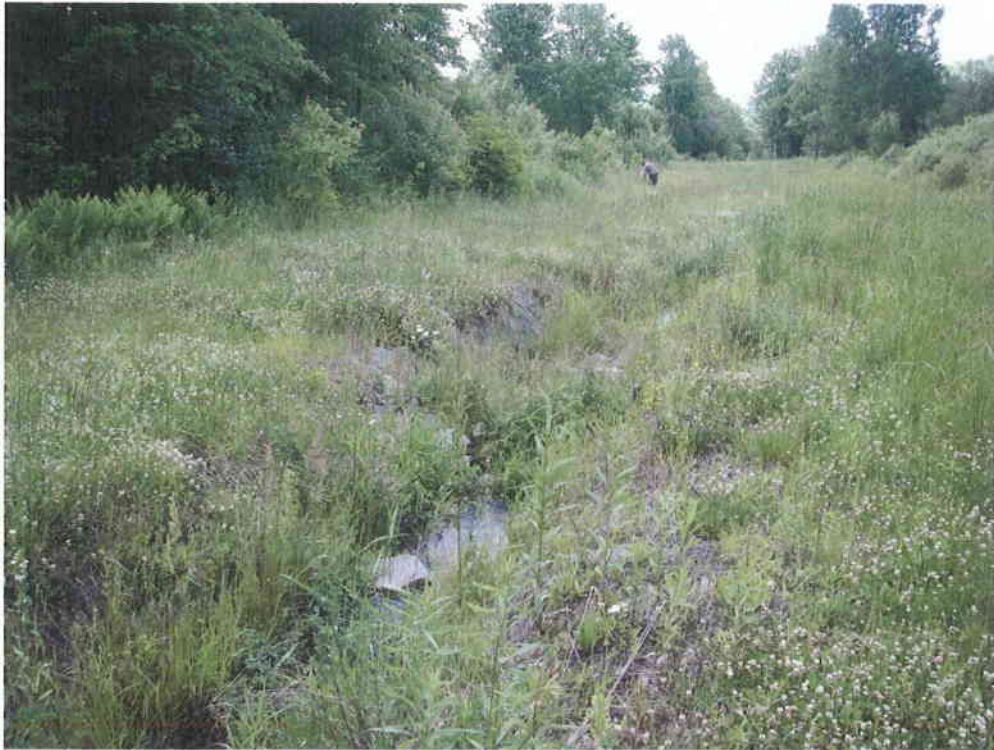
**1. Pre-construction view of stream Segment I. The channel is straightened and incised as a result of impaired morphology and repeated storm events.**

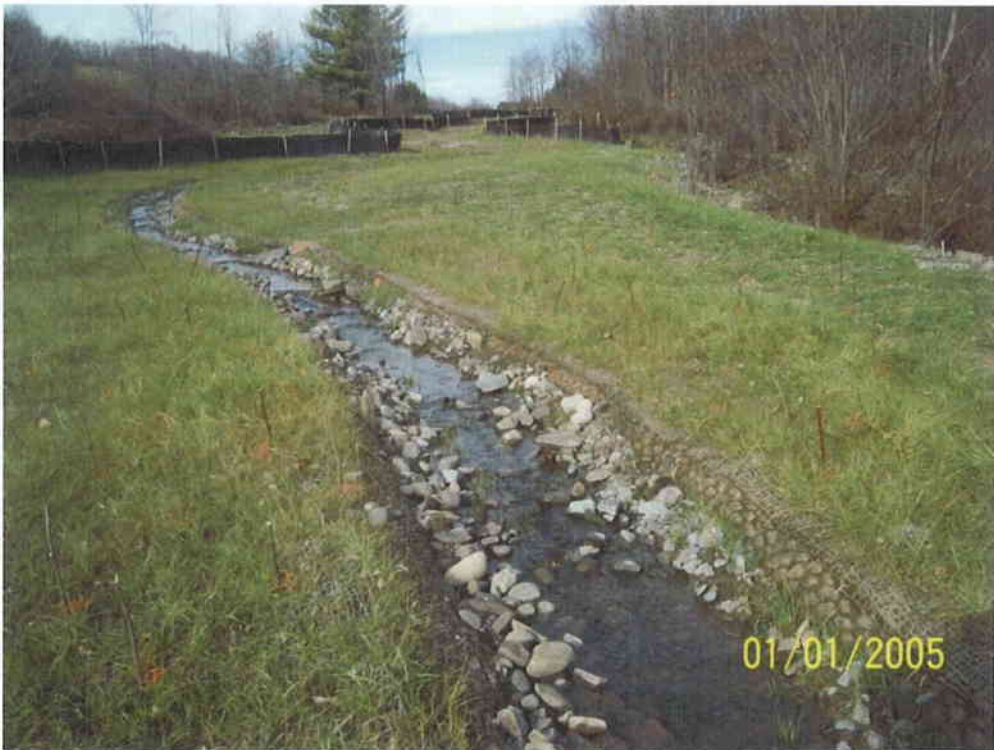
**2. Post-construction view of stream Segment I. Restored channel has ample floodplain access, appropriately sized bed material, and stable channel geometry based upon reference reach conditions.**

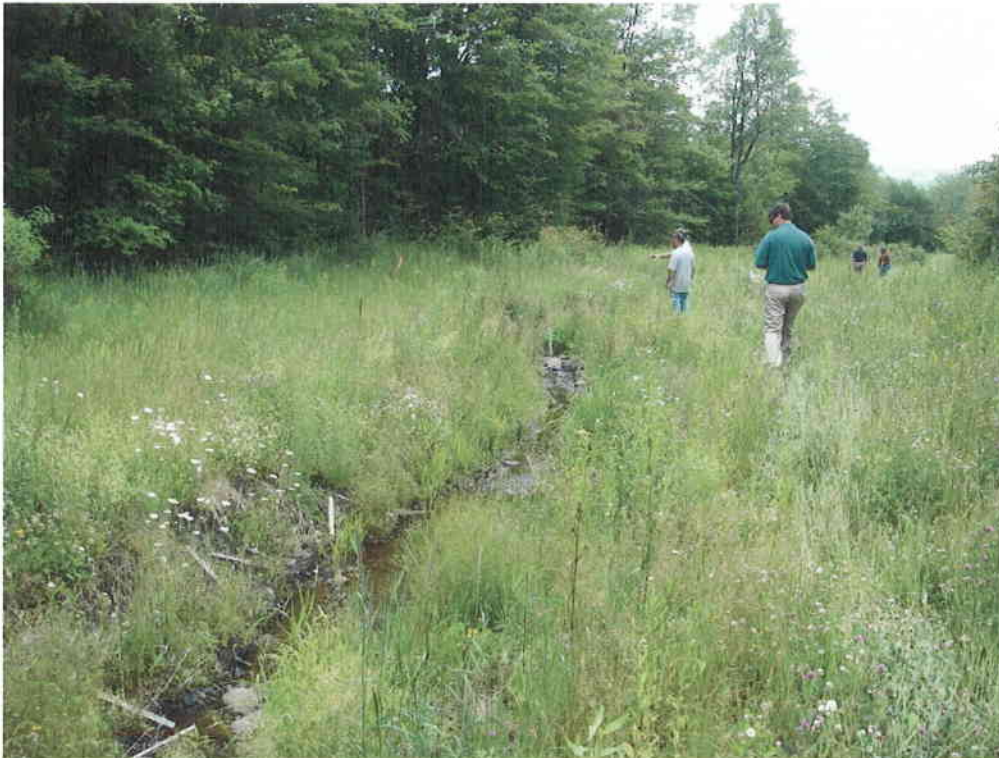
**3. Pre-construction view of stream Segment II. Channel is straightened, incised and entrenched due to impaired morphology subjected to a series of storm events.**

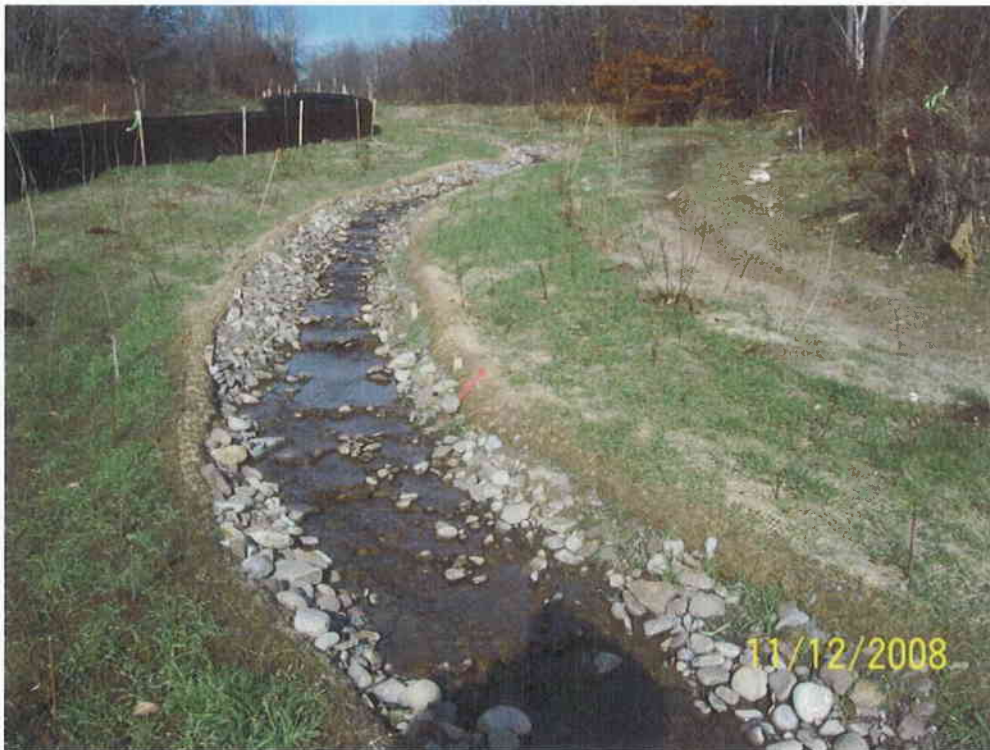
**4. Post-construction view of stream Segment II. Channel has ample floodplain access, and channel sinuosity has been restored to reflect stable reference reach conditions.**

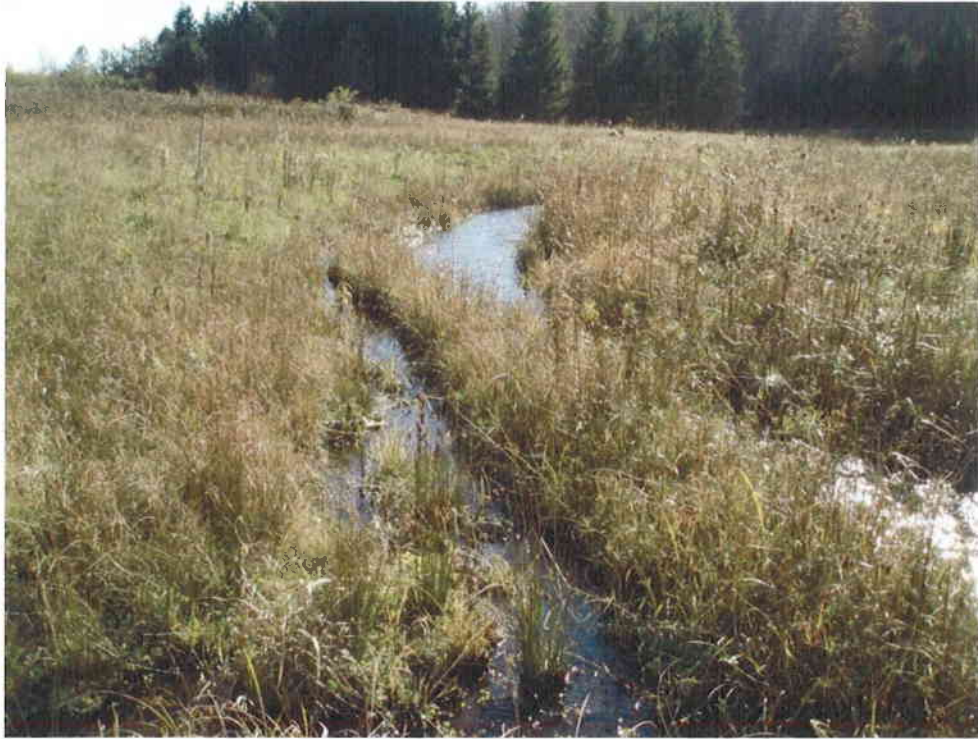
**5. Pre-construction view of stream Segment III, indicating channel braiding due to deposition of sediment from upstream and a lack of bankfull capacity.**

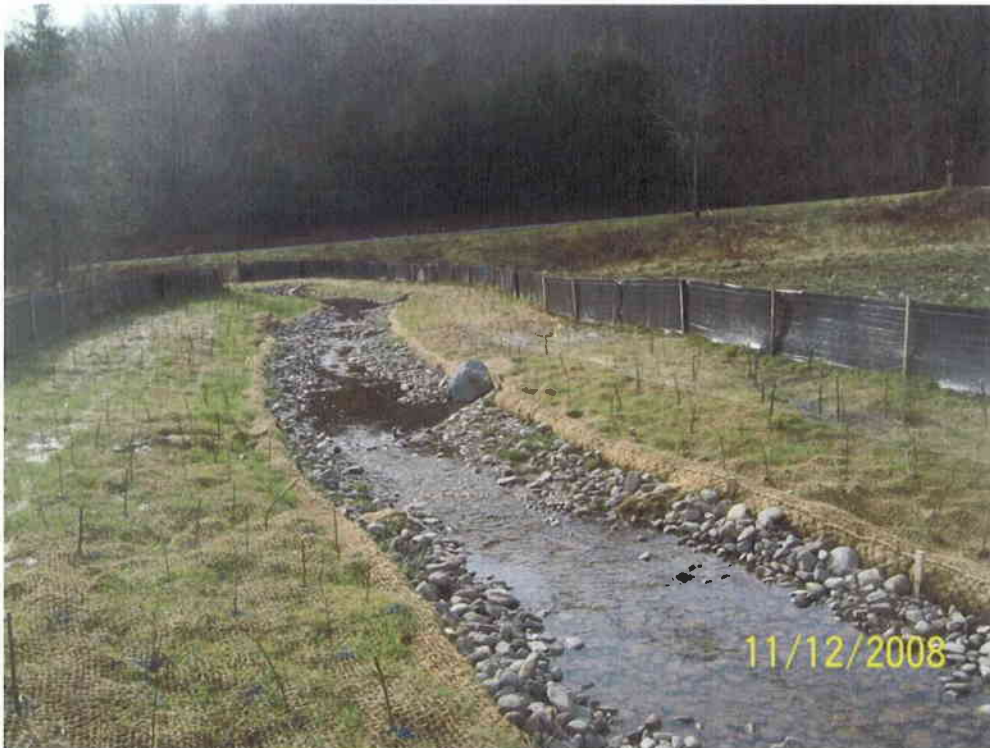
**6. Post-construction view of stream Segment III. Increased bankfull cross-sectional area (derived from stable reference reach conditions) will allow for maintenance of flood flows without excessive sediment aggrading or channel braiding.**

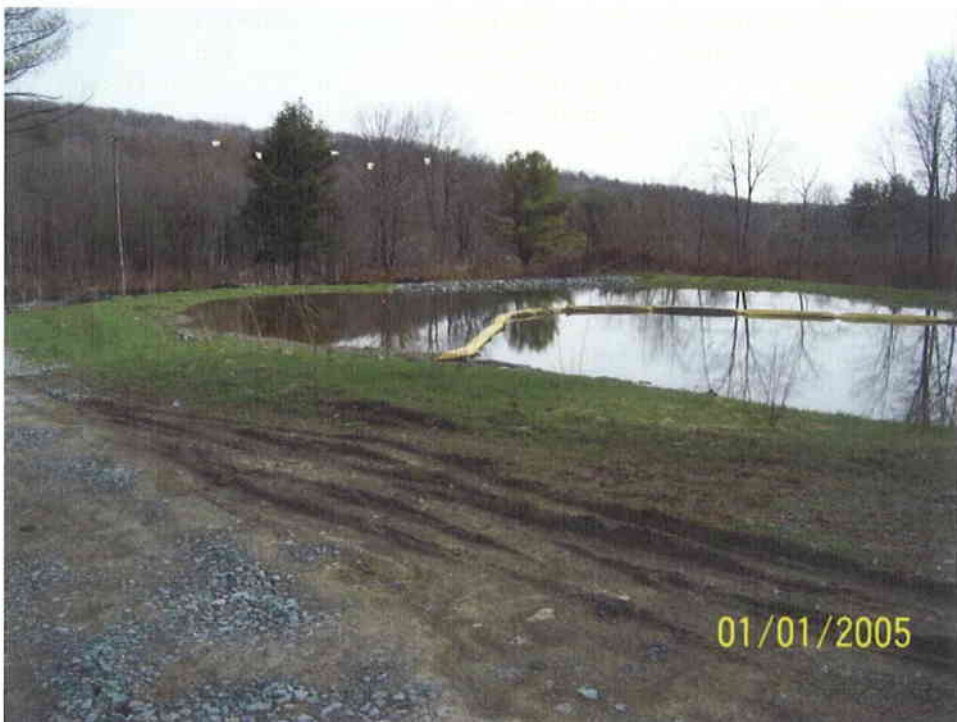
**26. The existing stormwater detention basin near stream station 1+00 was converted to a micro-pool, greatly enhancing it's habitat value.**
