Re: Richardson Hill Landfill Site – Final Stream Restoration Monitoring Report
June, September, and October 2011 Inspection Events

**Final Stream Restoration
Monitoring Report:
June, September, & October 2011
Inspection Events**

April 2012

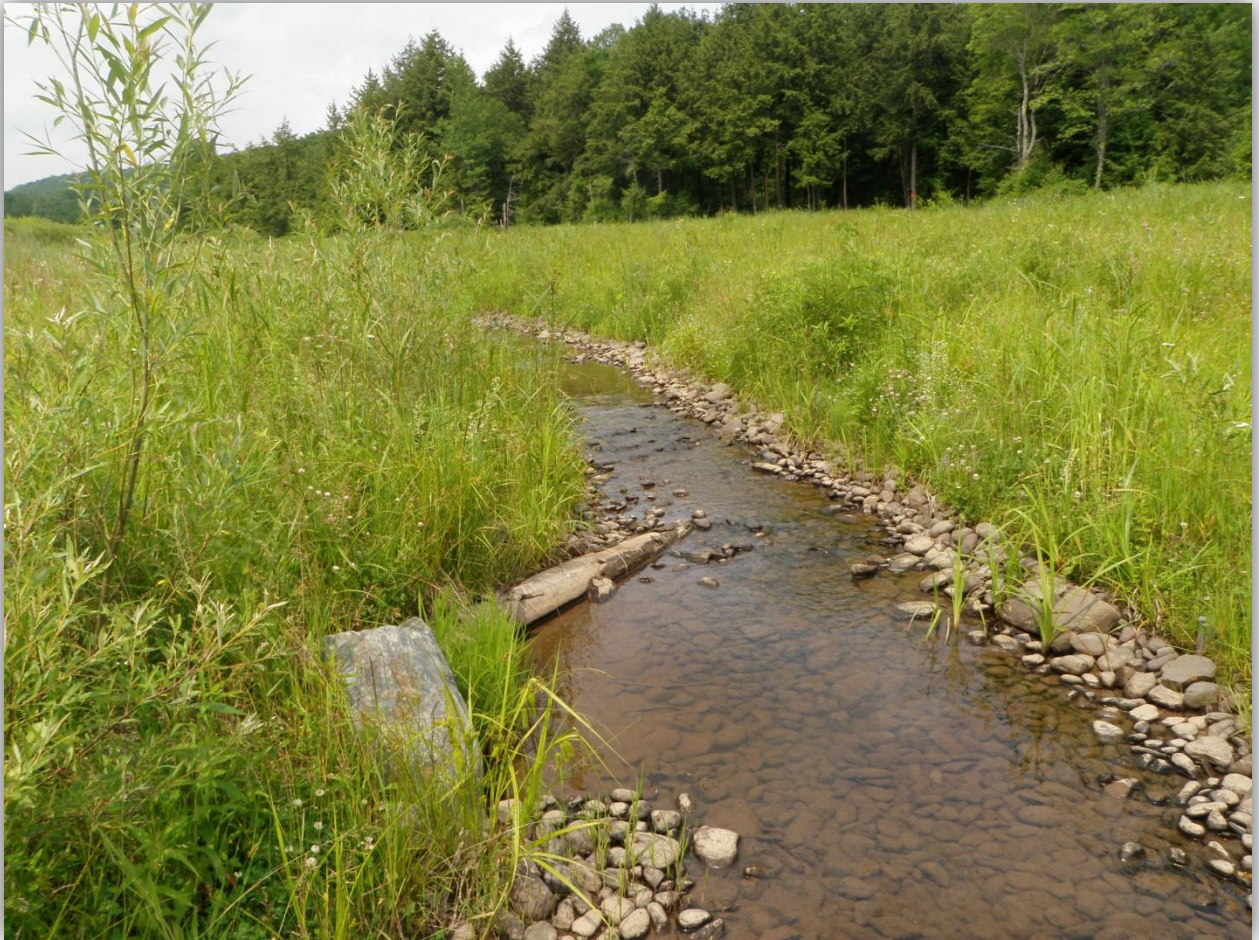
Figure 1. Typical stable riffle/pool sequence through Segment III

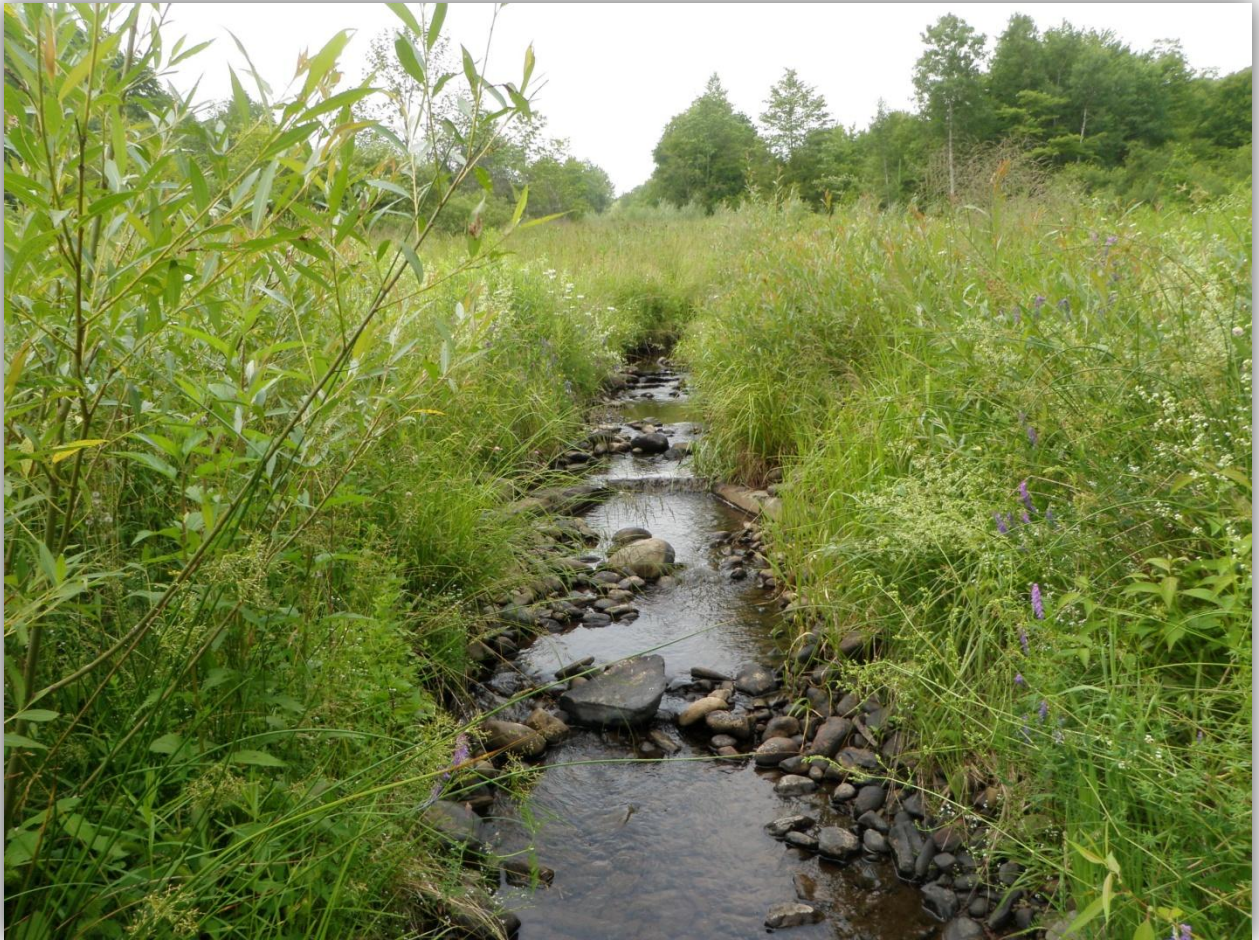
II

Figure 2. Natural establishment and maintenance of minor, frequent grade control through Segment

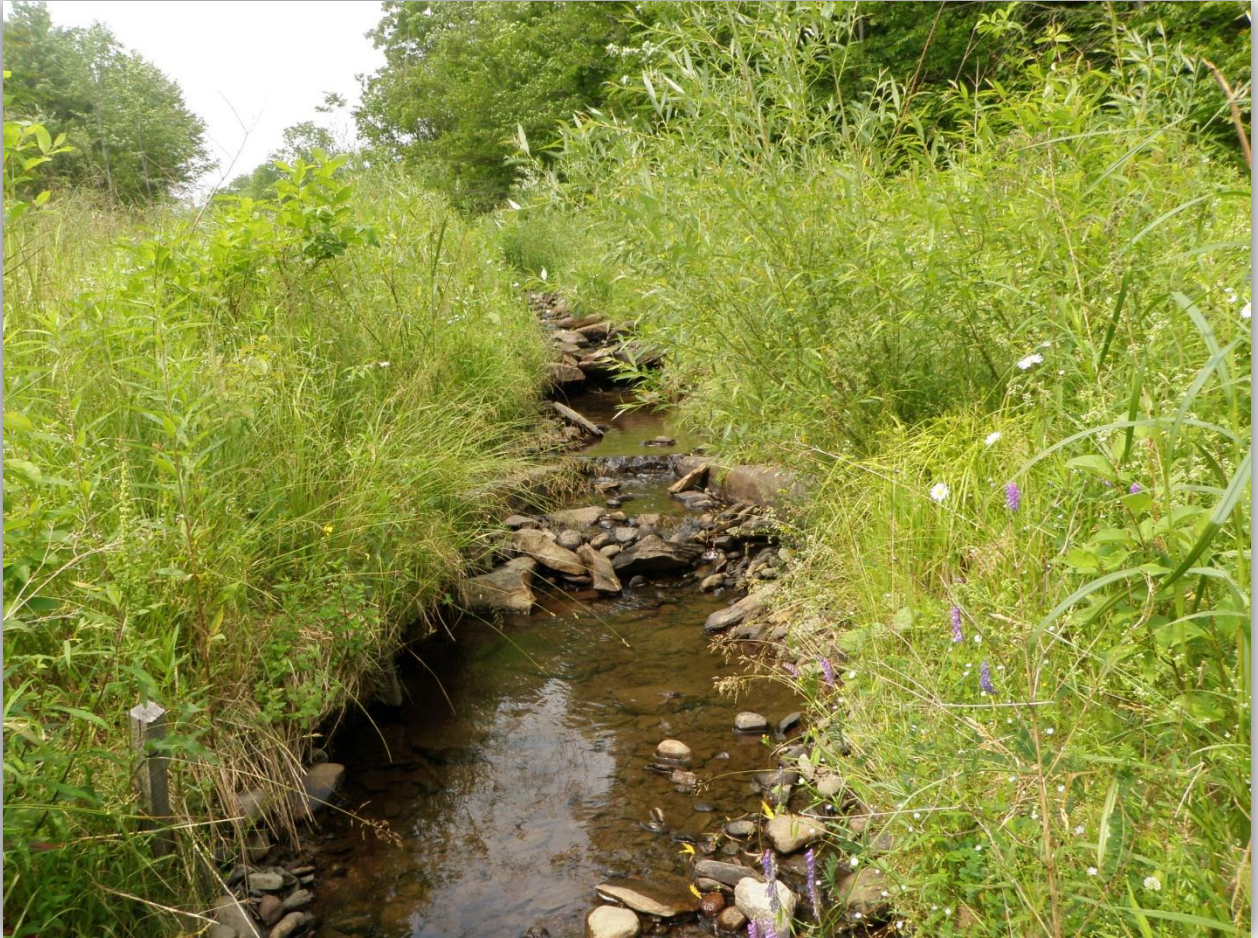
Undercutting of the stream bank is still present in some areas; however, no lengthening or deepening of these features has been observed since previously evaluated in 2010. Supported by vigorous stands of herbaceous and woody vegetation overhead, these areas are stable and provide a necessary and valuable habitat element within the stream channel, reflective of habitats found at the reference reach.

Figure 3. Typical undercut bank feature within Segment II

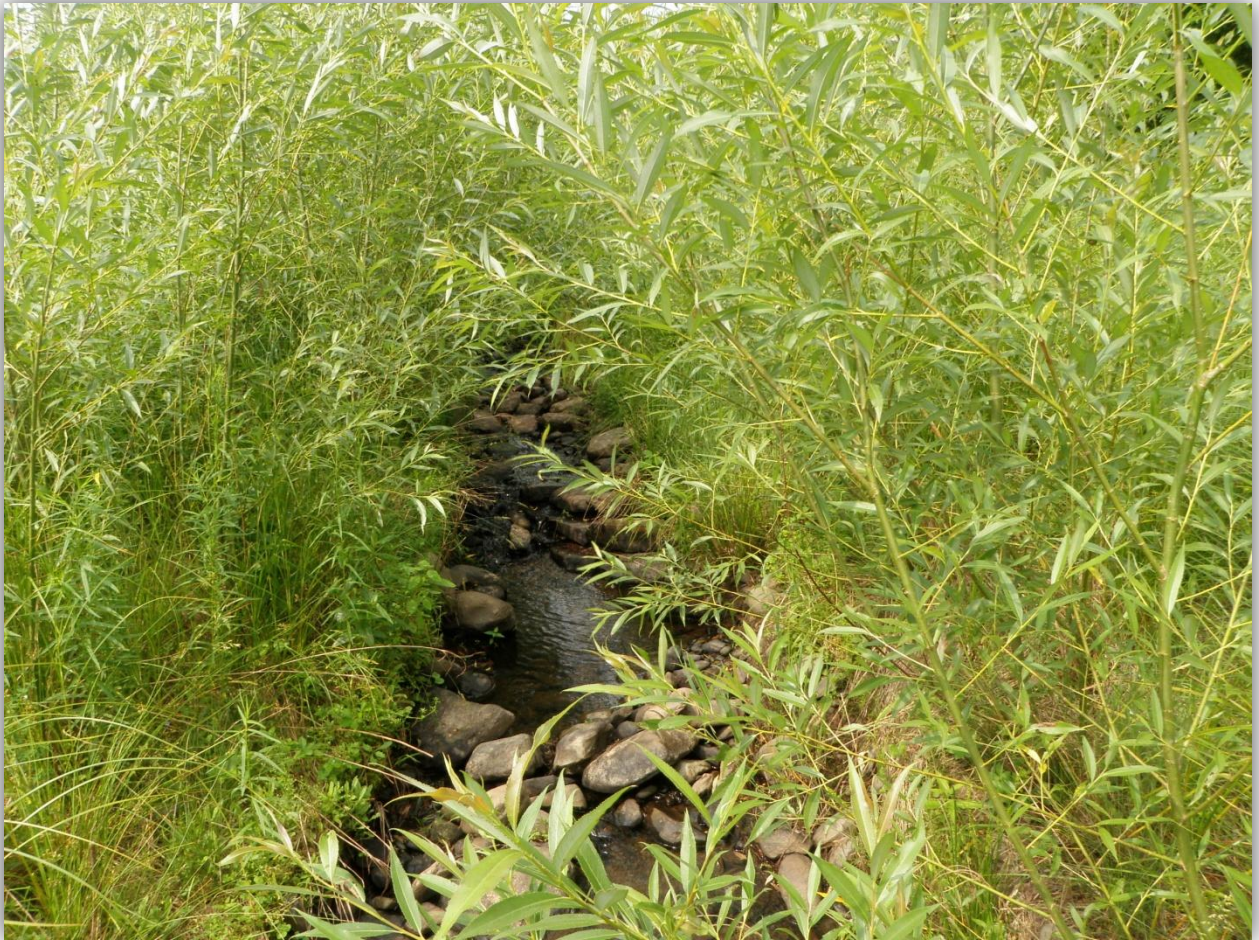
Figure 4. Shading of the stream corridor in Segment II by willows started from live stakes

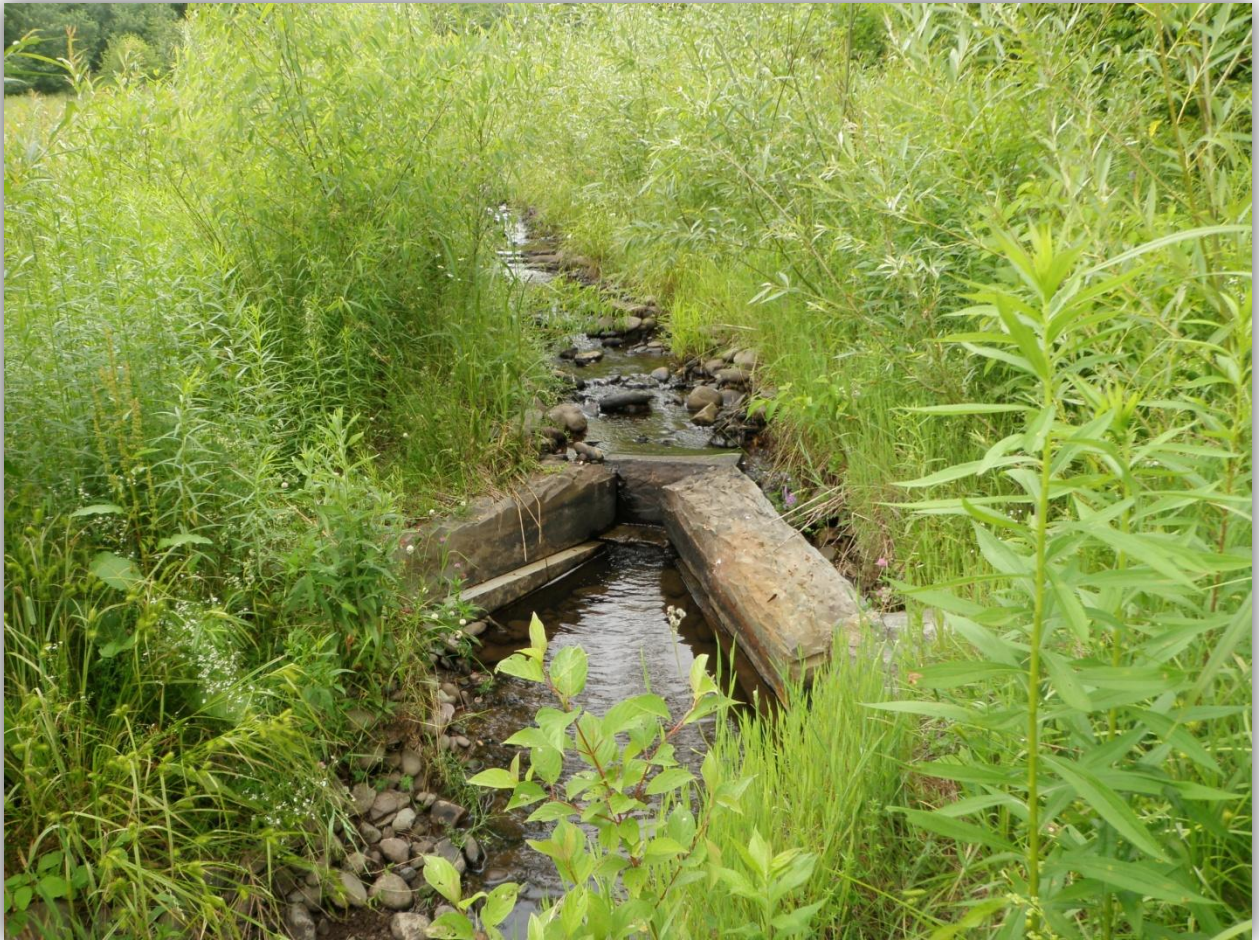
As a result of the flooding experienced in September 2011, portions of the vane arms cross vane constructed at station 13+58 (CV-21) have become undermined, potentially leaving the structure at risk of being displaced if exposed to future flood events that exceed design-storm intensity. In its current condition, the structure continues to provide the intended function of providing grade control at this location. Continued deposition of larger substrate material around the footprint of the cross vane may eventually displace the function of this structure over time, replacing the cross vane with sufficient larger bed material to establish and maintain minor frequent grade control at this location.

Figure 5. Sliding of left vane arm at Cross Vane #21, Station 13+58 (Segment II)

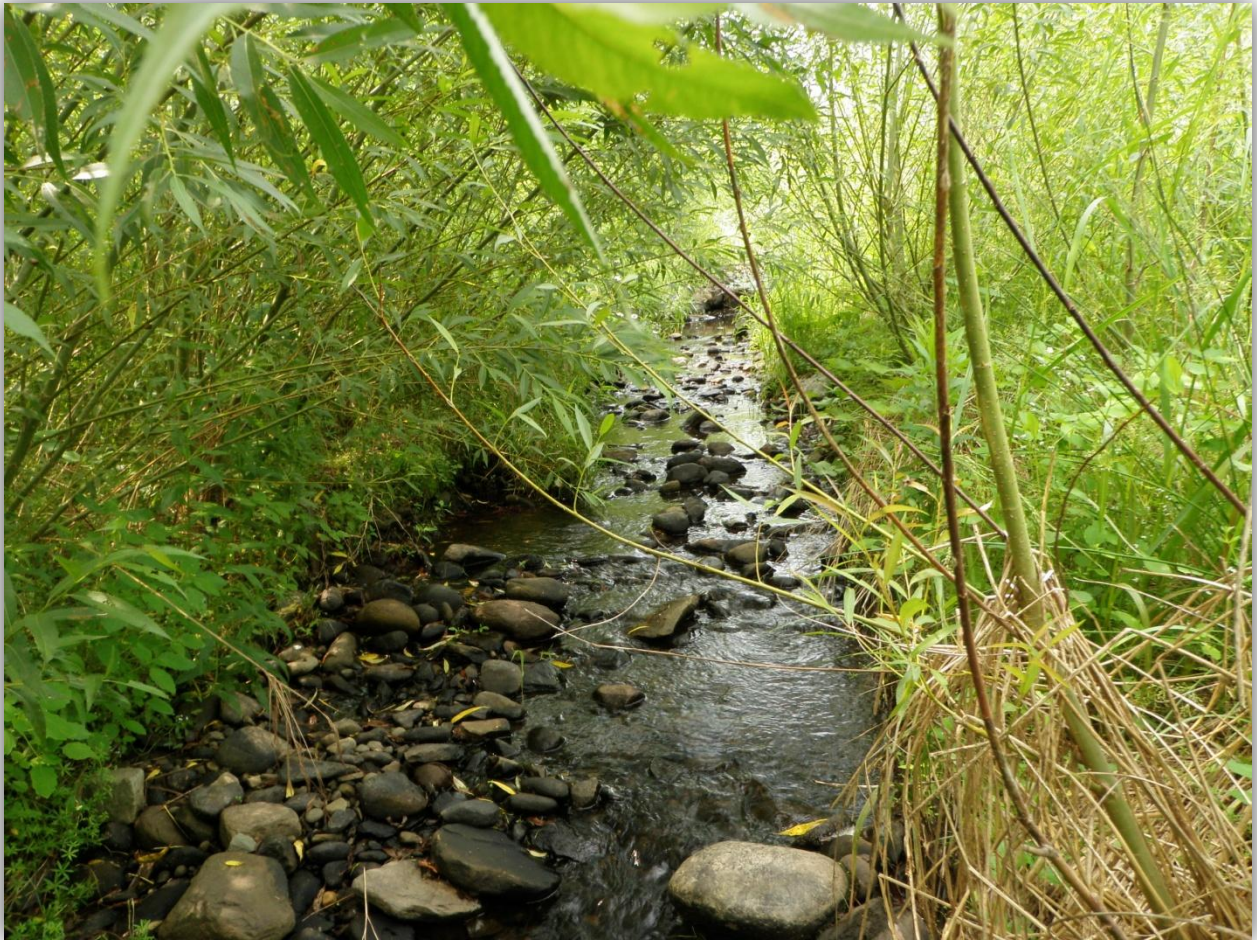
Figure 6. Establishment of healthy, vegetated riparian corridor just downstream of Dimatos Crossing (Segment II)

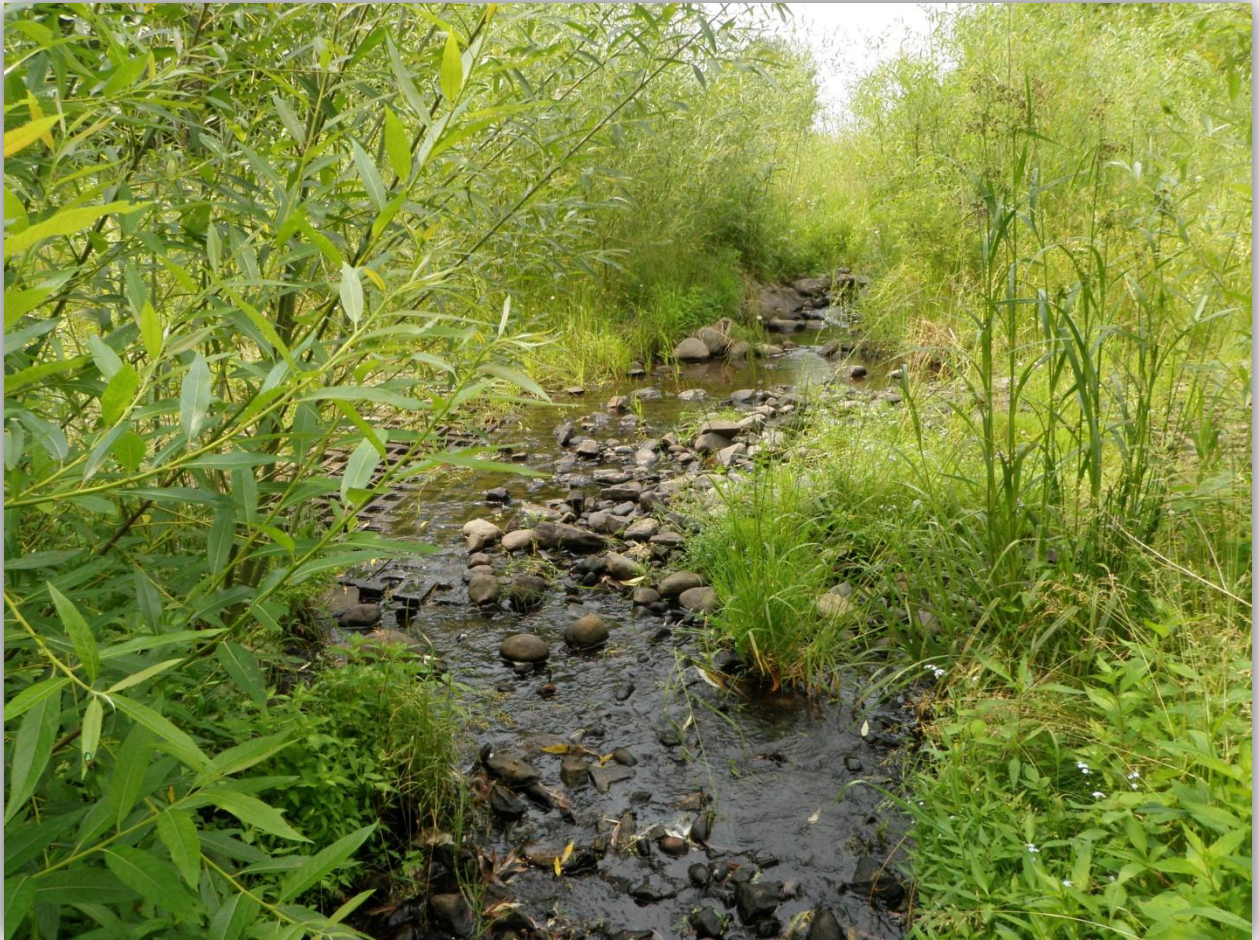
As identified in the previous reports, sediment continues to be deposited along the length of the crossing. This deposition was not observed to be creating unstable conditions at the transition from this feature to adjacent downstream reaches of the stream (Segment II). As of June 2011, vigorous establishment of native vegetation within the ingress and egress areas of the crossing has helped to better integrate the crossing into the surrounding landscape.

Figure 7. View facing upstream showing deposition of bed material at Dimatos Crossing

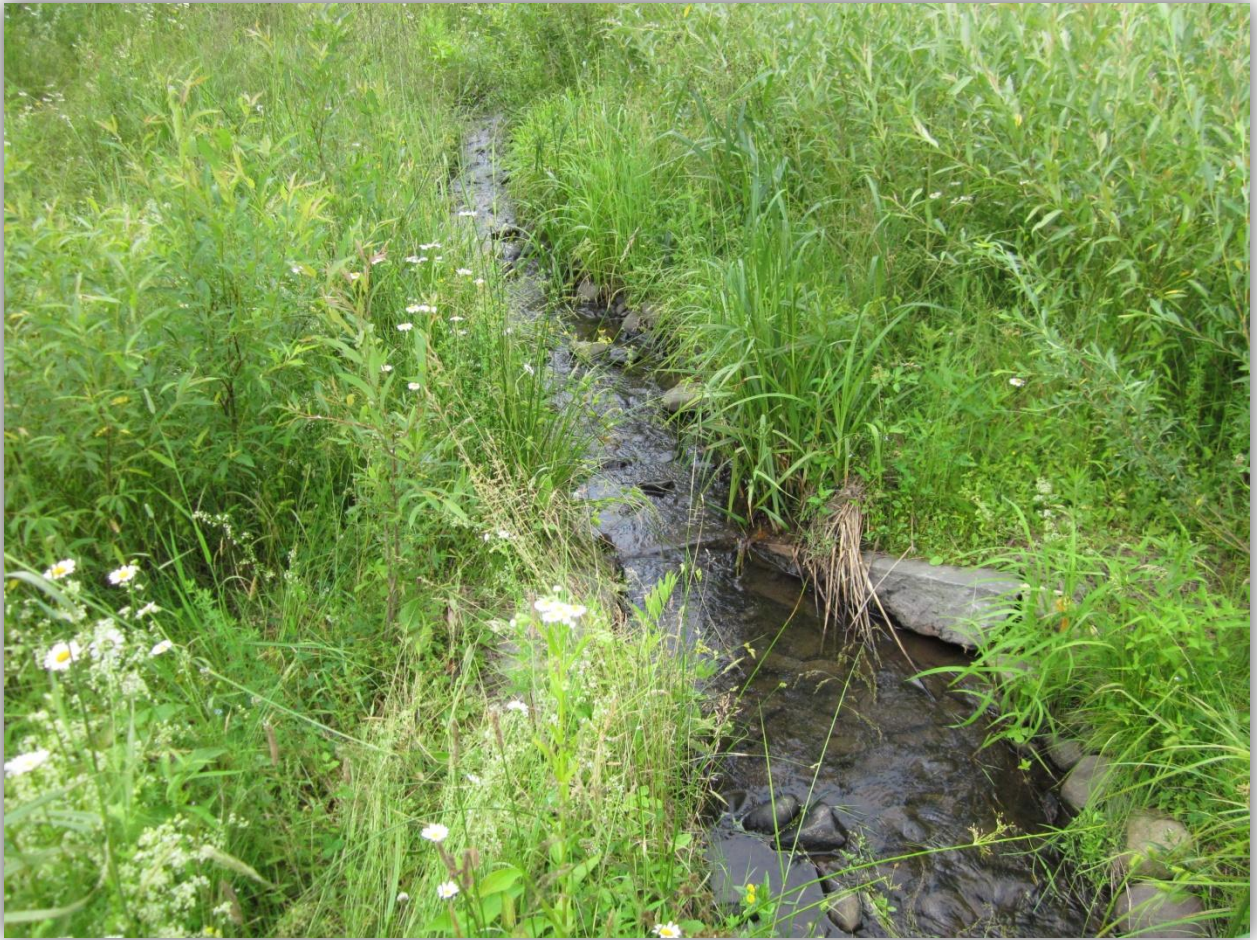
Figure 8. Typical cross vane and channel condition, Segment I

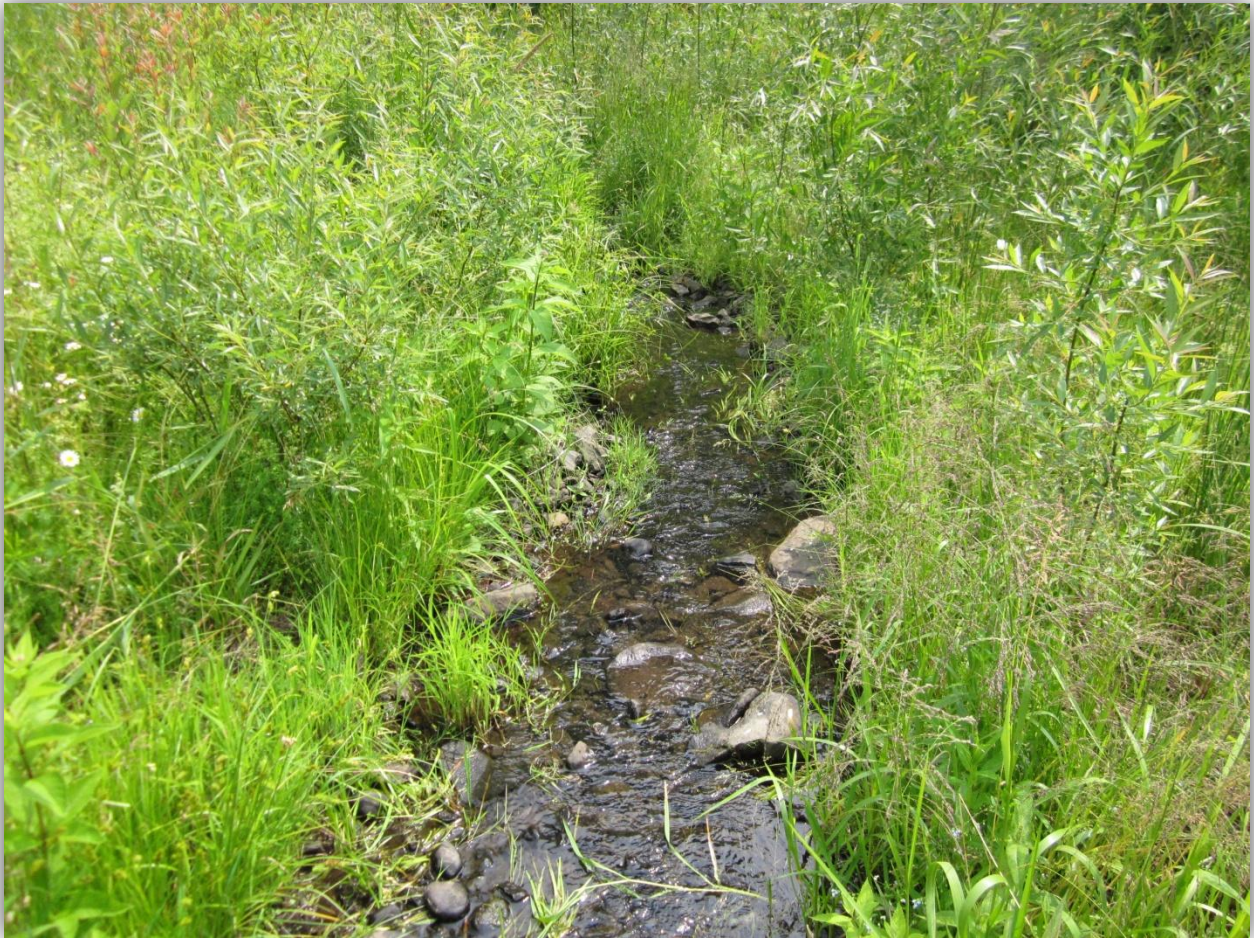
As observed during previous monitoring visits, fewer of these structures were visually observed during field inspections in June and October of 2011, as constructed cascades continually are incorporated into the natural formation of minor, frequent grade control features along the entire length of the restored channel. The stream is continuing to incorporate these structures into longer sequences of natural cascades and riffles, providing stable intermittent grade control between cross vane locations.

Figure 9. Constructed cascades augment the development of minor, frequent grade control through Segment II

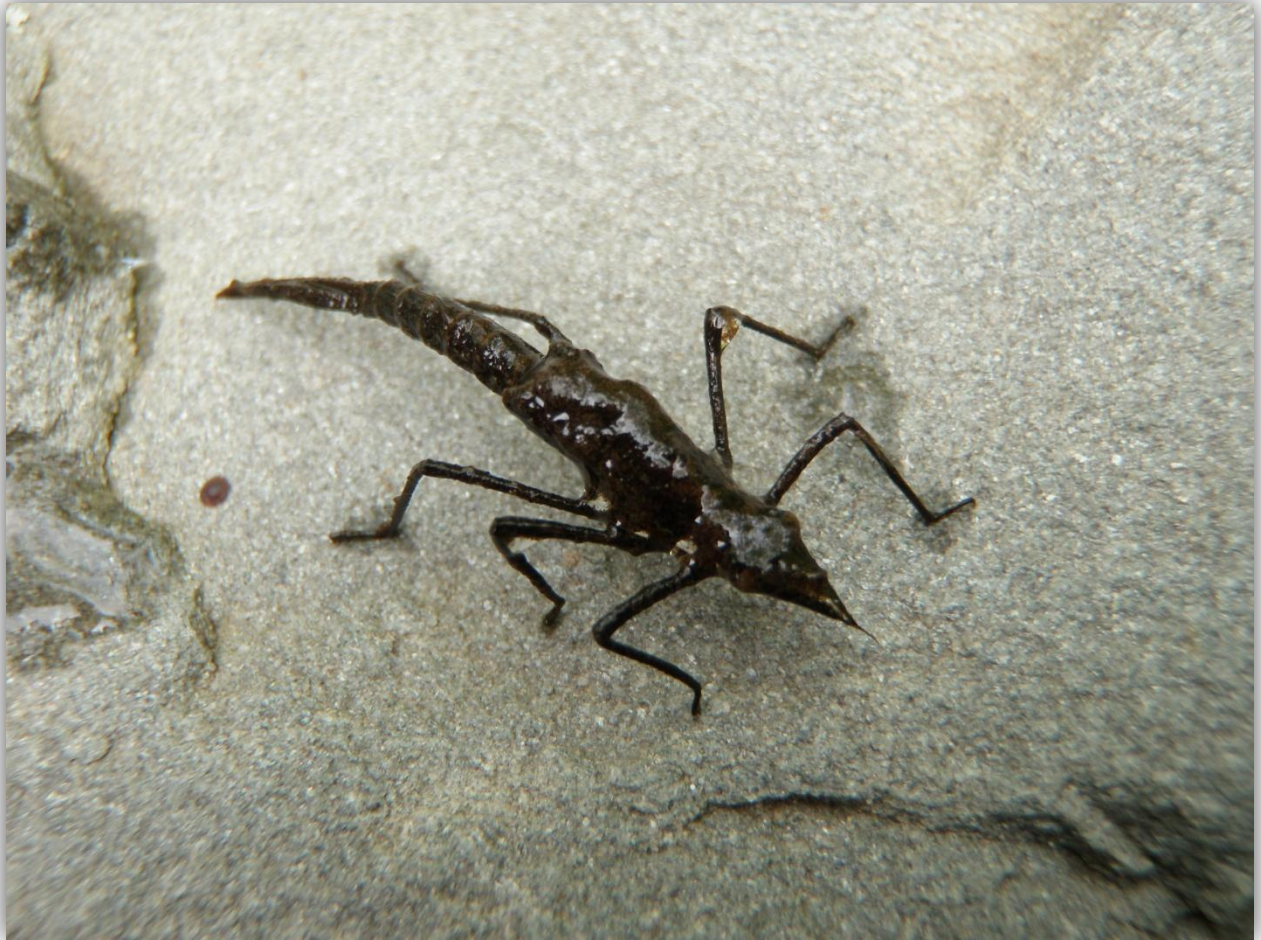
Figure 10. Damselfly (Calopterygidae) nymphs and adults are common inhabitants of the restored stream corridor
