**Village of Sidney, Delaware County, New York**

**Plating Operations  
Wastewater Conveyance System  
Assessment**

**November 2013**

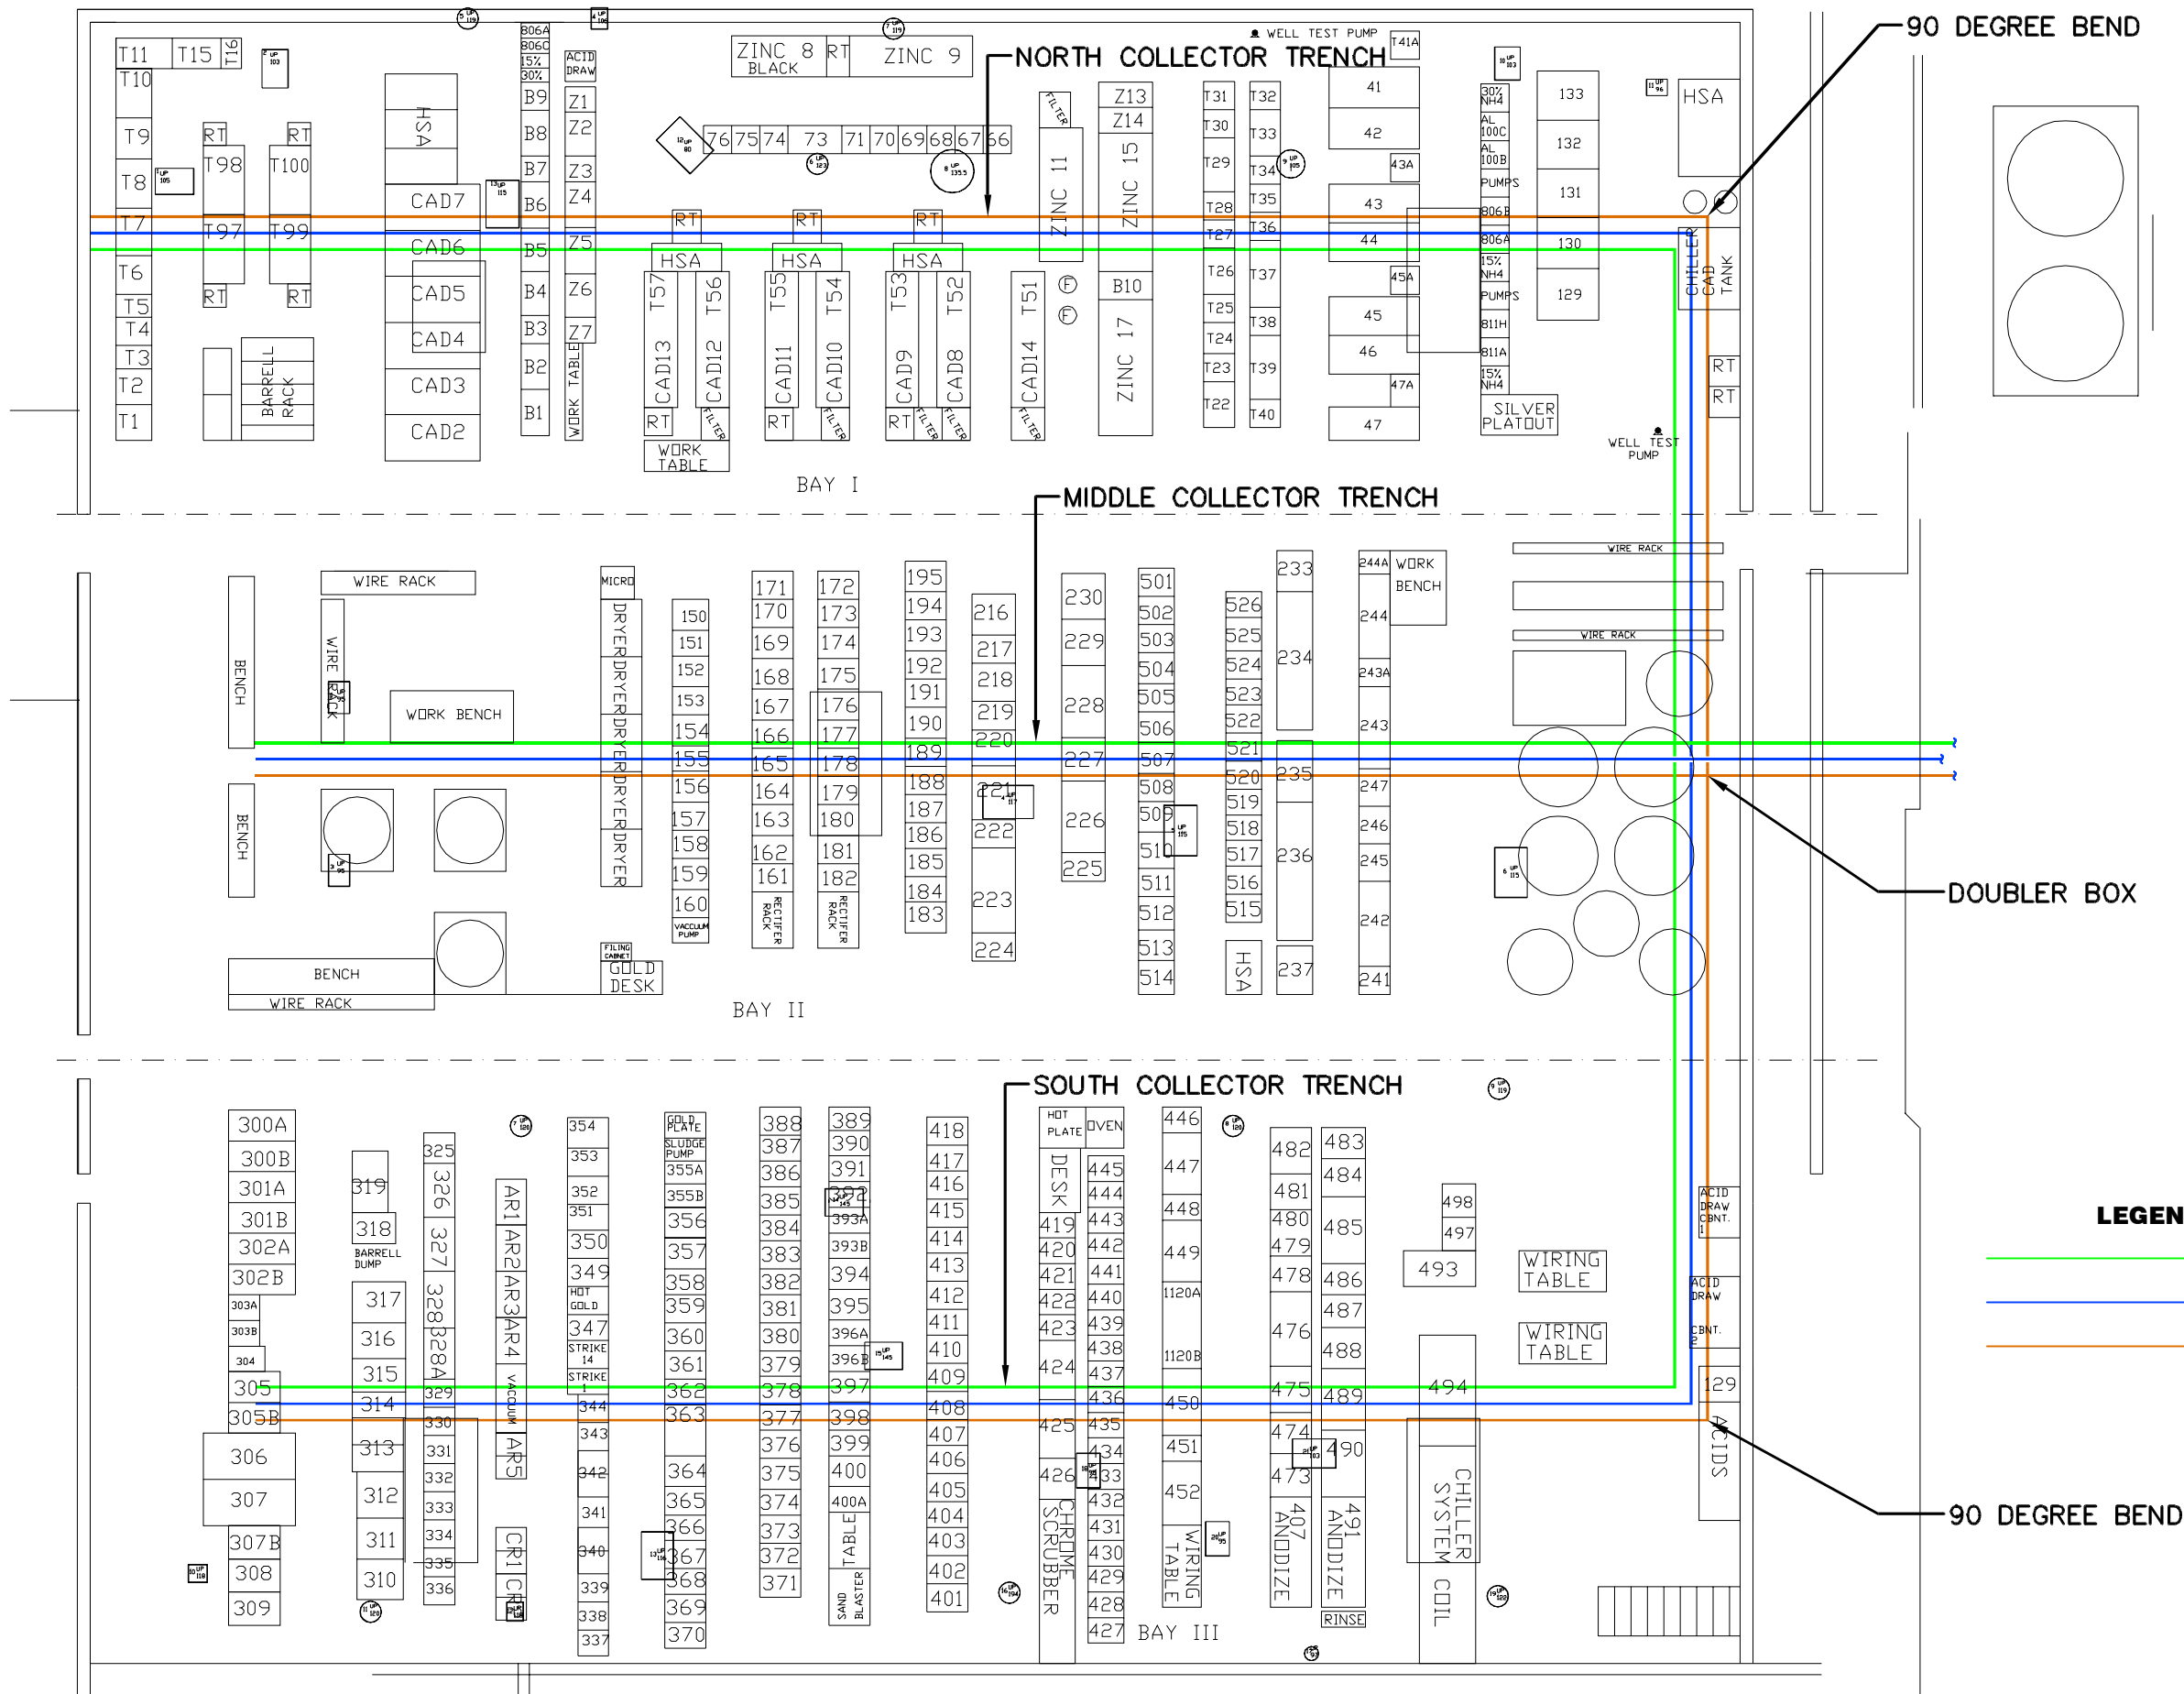
AMPHENOL - AEROSPACE OPERATIONS  
 PLATING WASTE WATER CONVEYANCE ASSESSMENT  
**WASTEWATER CONVEYANCE SYSTEM LAYOUT**  
 DELAWARE COUNTY, NEW YORK  
 VILLAGE OF SIDNEY

The first task of the assessment was to locate and map out the existing wastewater conveyance system within the Plating Operations Building. With the assistance of Amphenol staff, B&L located and measured the locations of all collection trenches. Following the field survey, B&L updated the existing Plating Operations Building Plan to include the wastewater conveyance trenches and the doubler box. The updated Plating Operations Building plan is included as Figure 1 in Appendix 1.

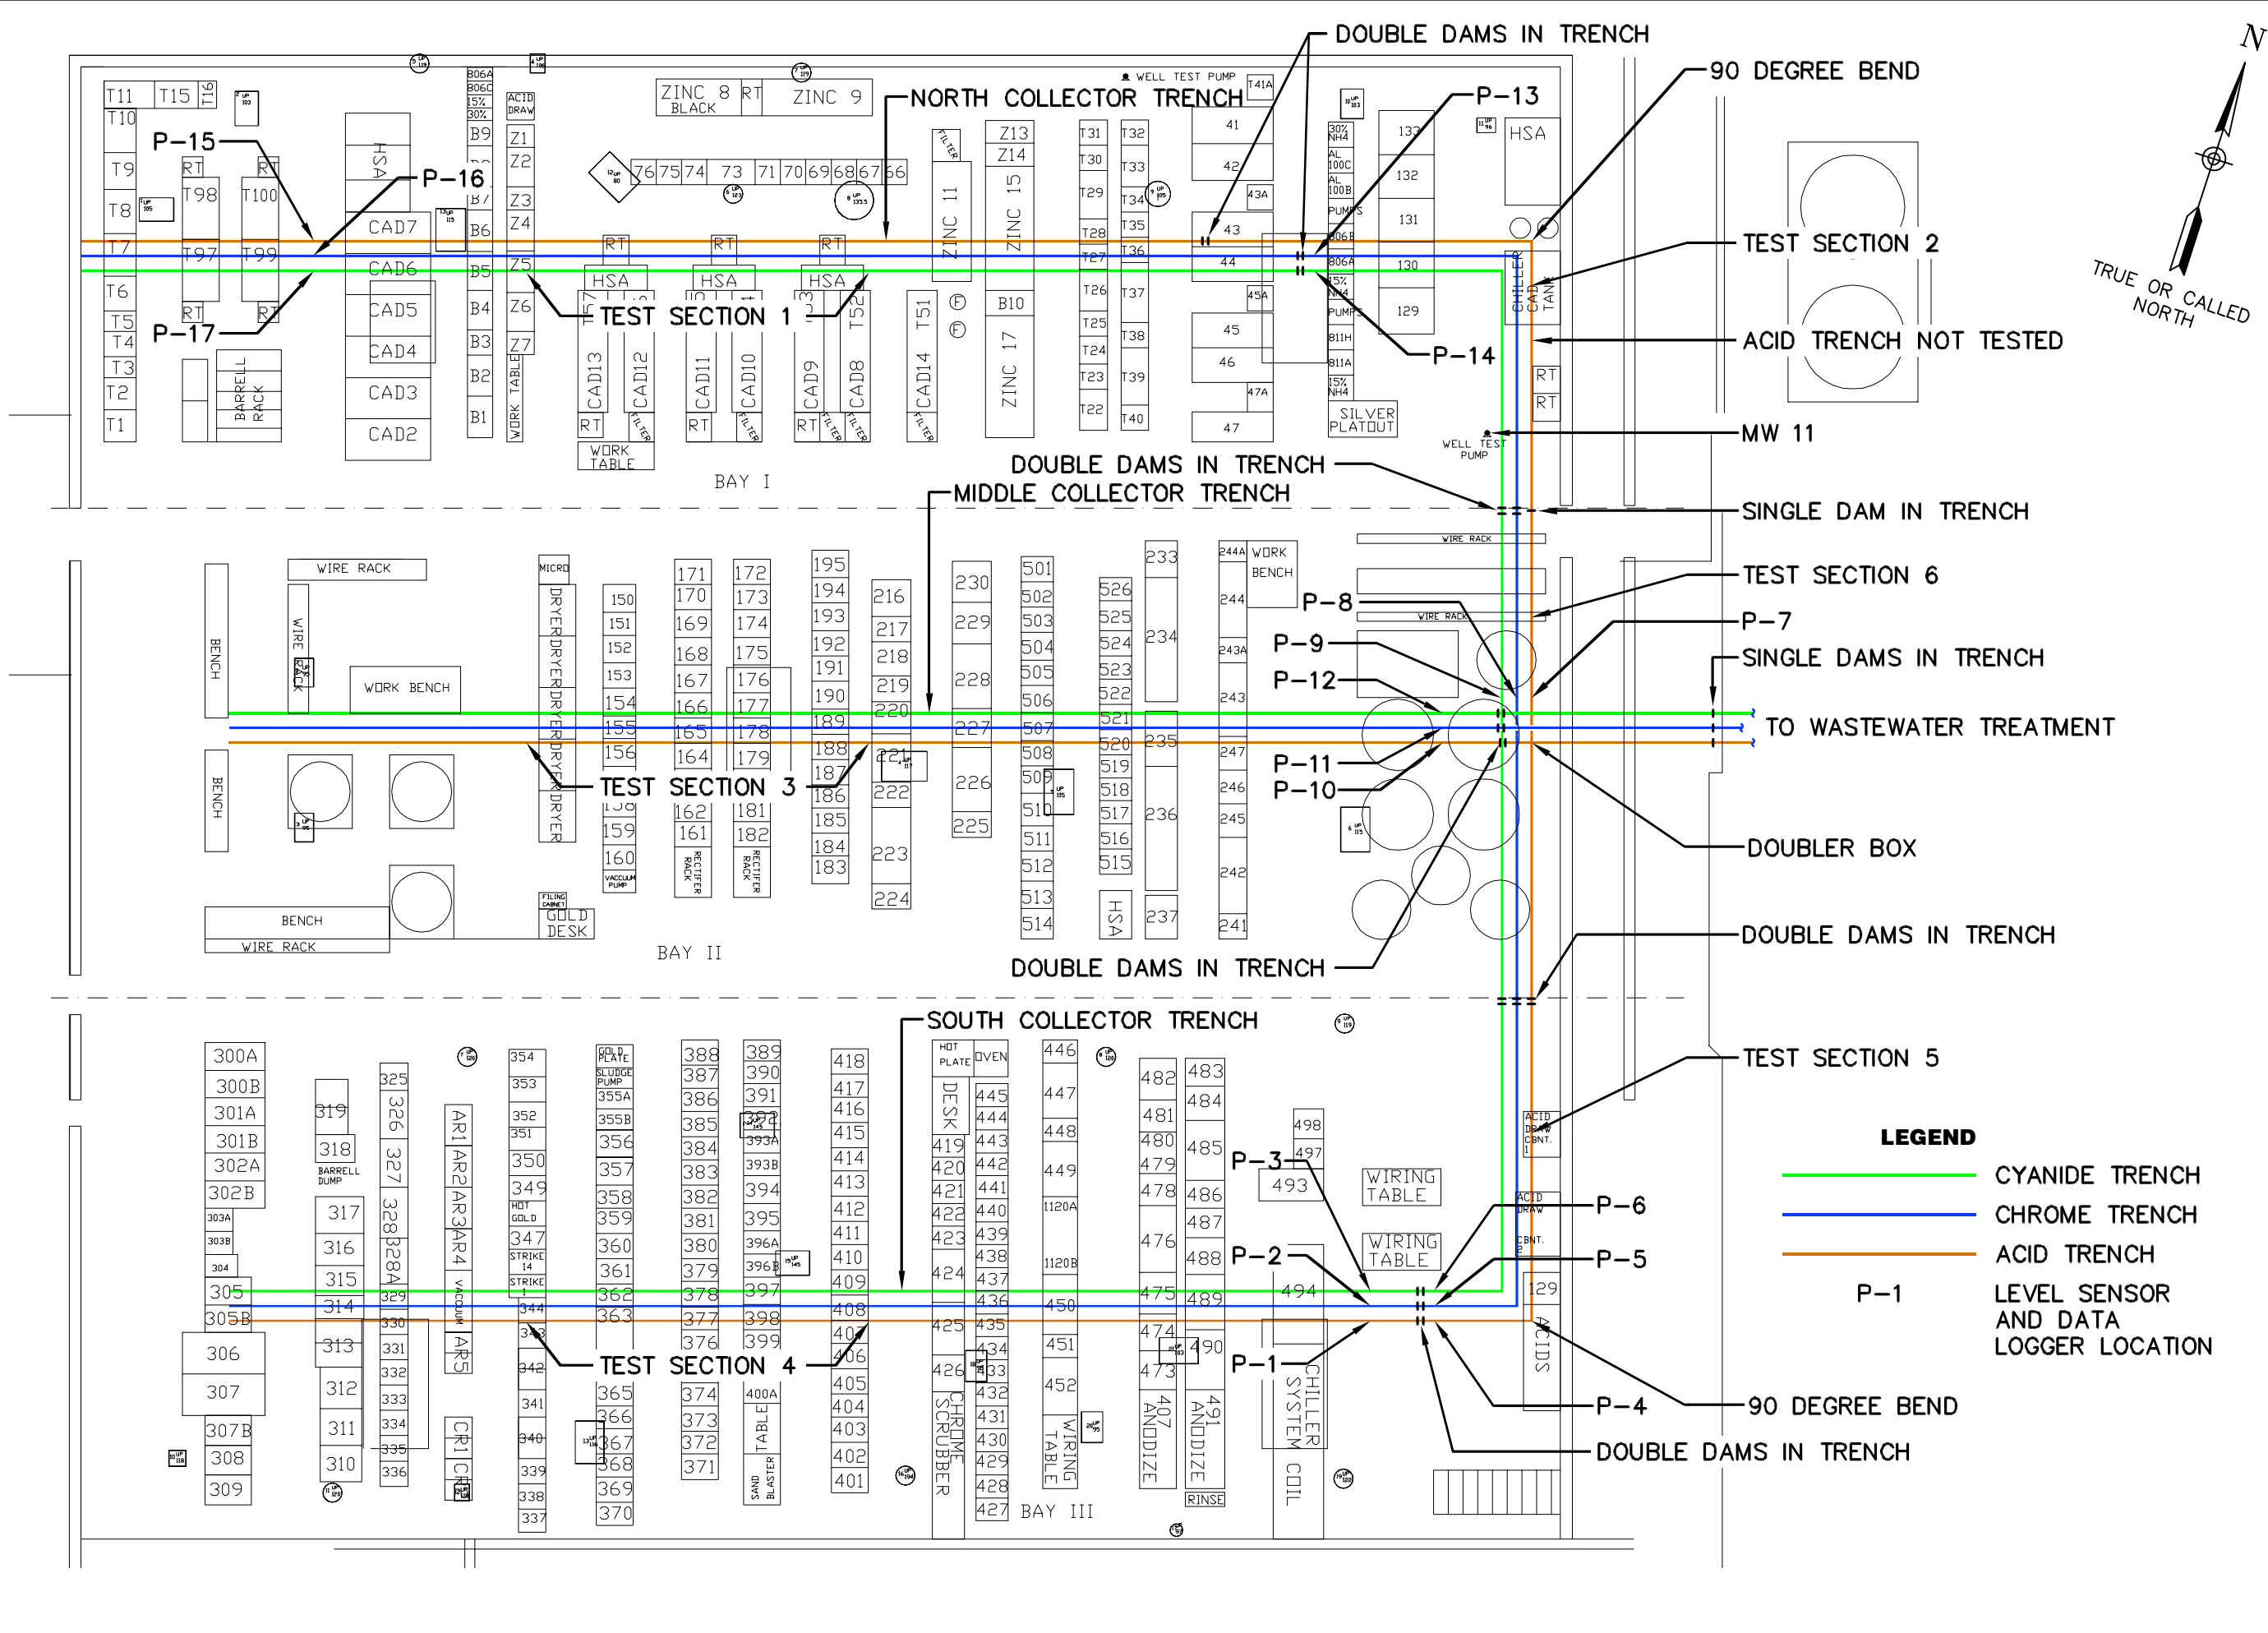
AMPHENOL - AEROSPACE OPERATIONS  
 PLATING WASTE WATER CONVEYANCE ASSESSMENT  
**HYDROSTATIC TESTING PLAN**  
 DELAWARE COUNTY, NEW YORK  
 VILLAGE OF SIDNEY

The wastewater conveyance system was divided into six discrete sections for the hydrostatic testing. Figure 2 contained in Appendix 1, shows the locations of the test sections which were as follows:

- Section 1: North collector trench to 90-degree bend;
- Section 2: North collector trench, 90-degree bend to doubler box (acid trench not tested);
- Section 3: Middle collector trench to doubler box;
- Section 4: South collector trench to 90-degree bend;
- Section 5: South collector trench, 90-degree bend to doubler box;
- Section 6: Doubler box area, including small sections of the north and south collector trenches and easterly conveyance trench to building wall.

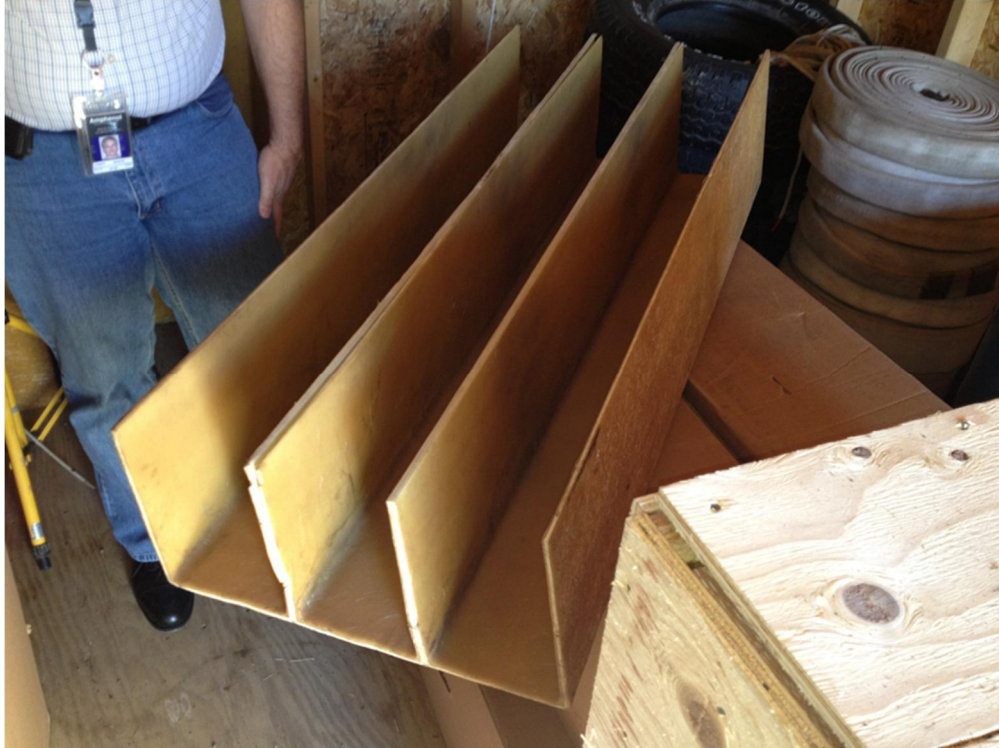
The typical conveyance system construction consists of an “upper” fiberglass over plastic trench which sits in a separate, “intermediate” fiberglass trench; these two trenches are installed within a concrete trench in the concrete floor of the Plating Operations Building. The upper trench is divided into three (3) sections; each trench section is used to convey the separate wastewater streams (containing acid, chromic acid, cyanide). A photo of a typical upper trench section is included in Appendix 2.

**Photo 1 – Typical fiberglass conveyance trench construction**

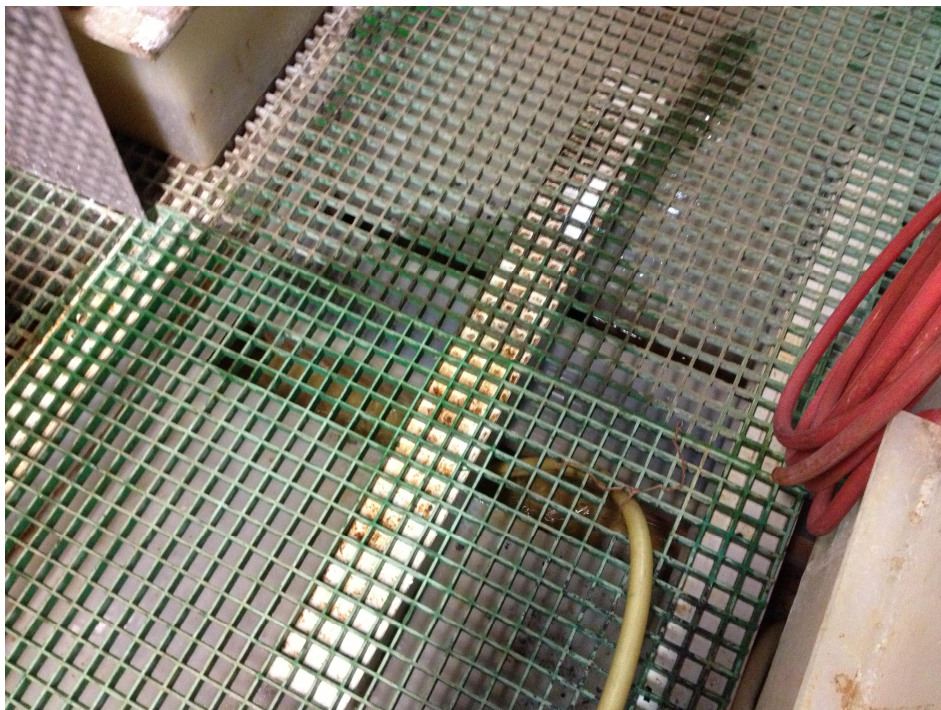
wastewater conveyance system. A photo of a typical installed trench section is included in Appendix 2. In this photo the center, chromic acid collection trench is covered and the acid and cyanide trenches are open.

**Photo 2 – Typical installed trench with poly floor covering (center chromic acid trench covered, acid and cyanide trenches open)**

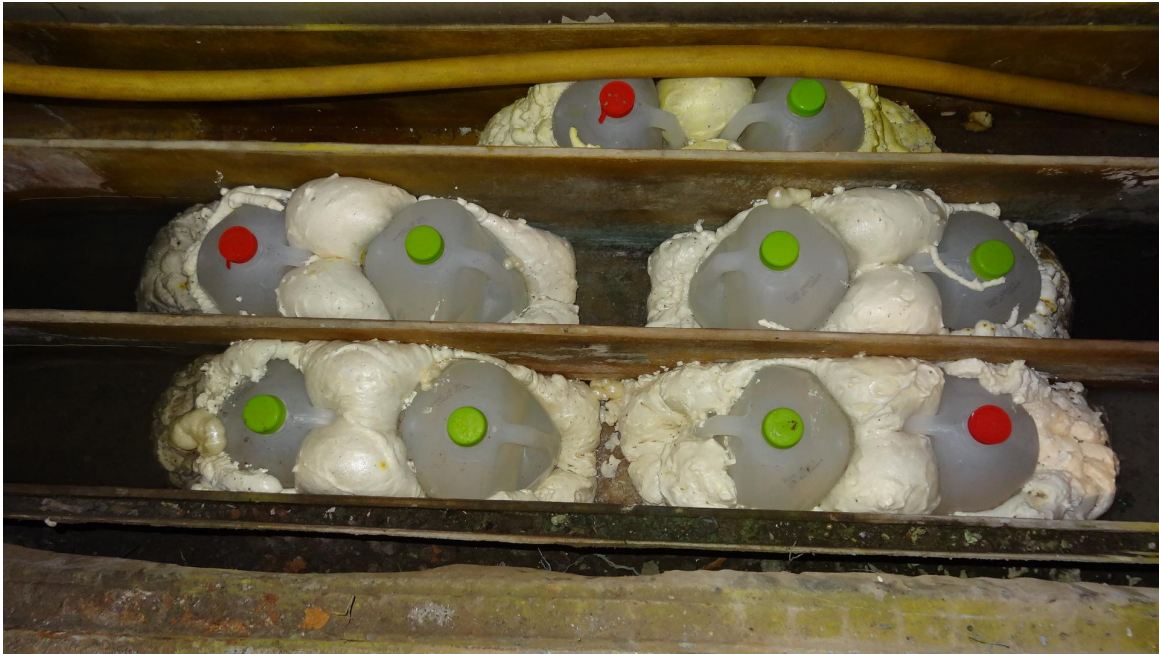
Each test section was isolated with a “double dam”. A single dam consisted of two (2) one (1)-gallon spring water containers sealed in the upper trench with expanding foam sealant. To properly isolate each test section, two (2) single dams were installed adjacent to each other with an air gap in between, forming a “double dam”. By leaving the air gap it would be apparent if one (1) of the dams failed during the test. It is noted

**Photo 3 – Typical trench dams installed for hydrostatic testing**

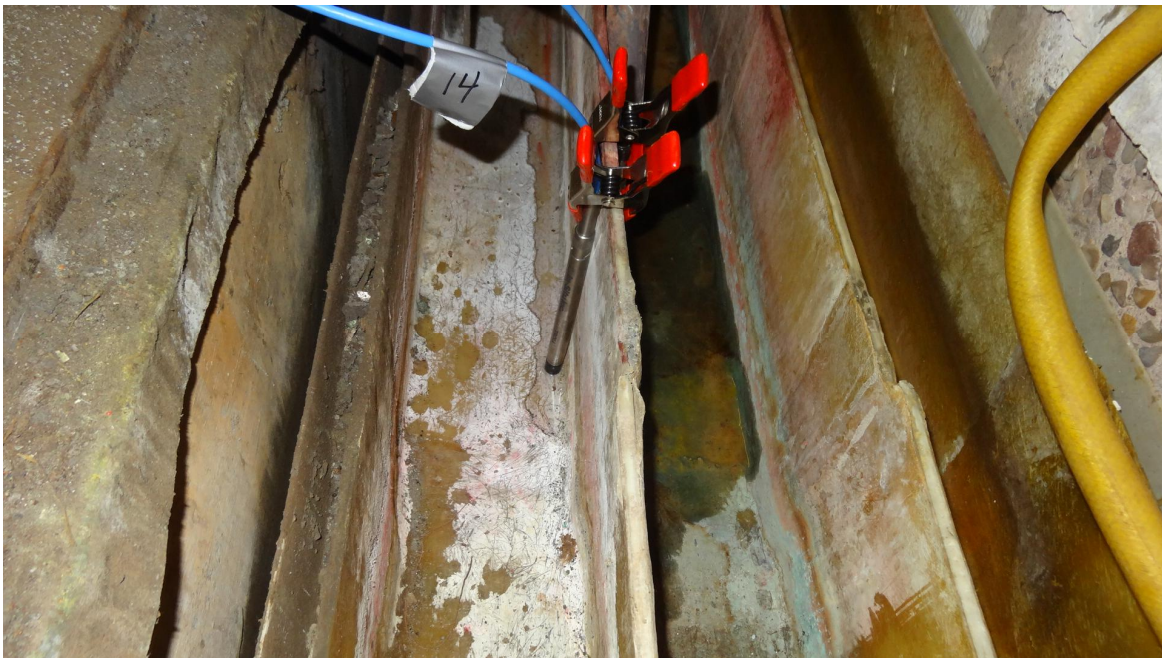
Following installation of the dams, level sensors and data loggers were placed in each trench test section. The level sensors were attached to the side of the trench utilizing spring clamps; a photo of a typical installation is contained in Appendix 2. The data loggers were programmed to continuously log water levels during the test. The level sensor and data logger locations are indicated on Figure 2 in Appendix 1. Once the dams and level sensors were in place, the test sections were flooded with water and left to sit for approximately 24 hours.

**Photo 4 – Typical level sensor installation**

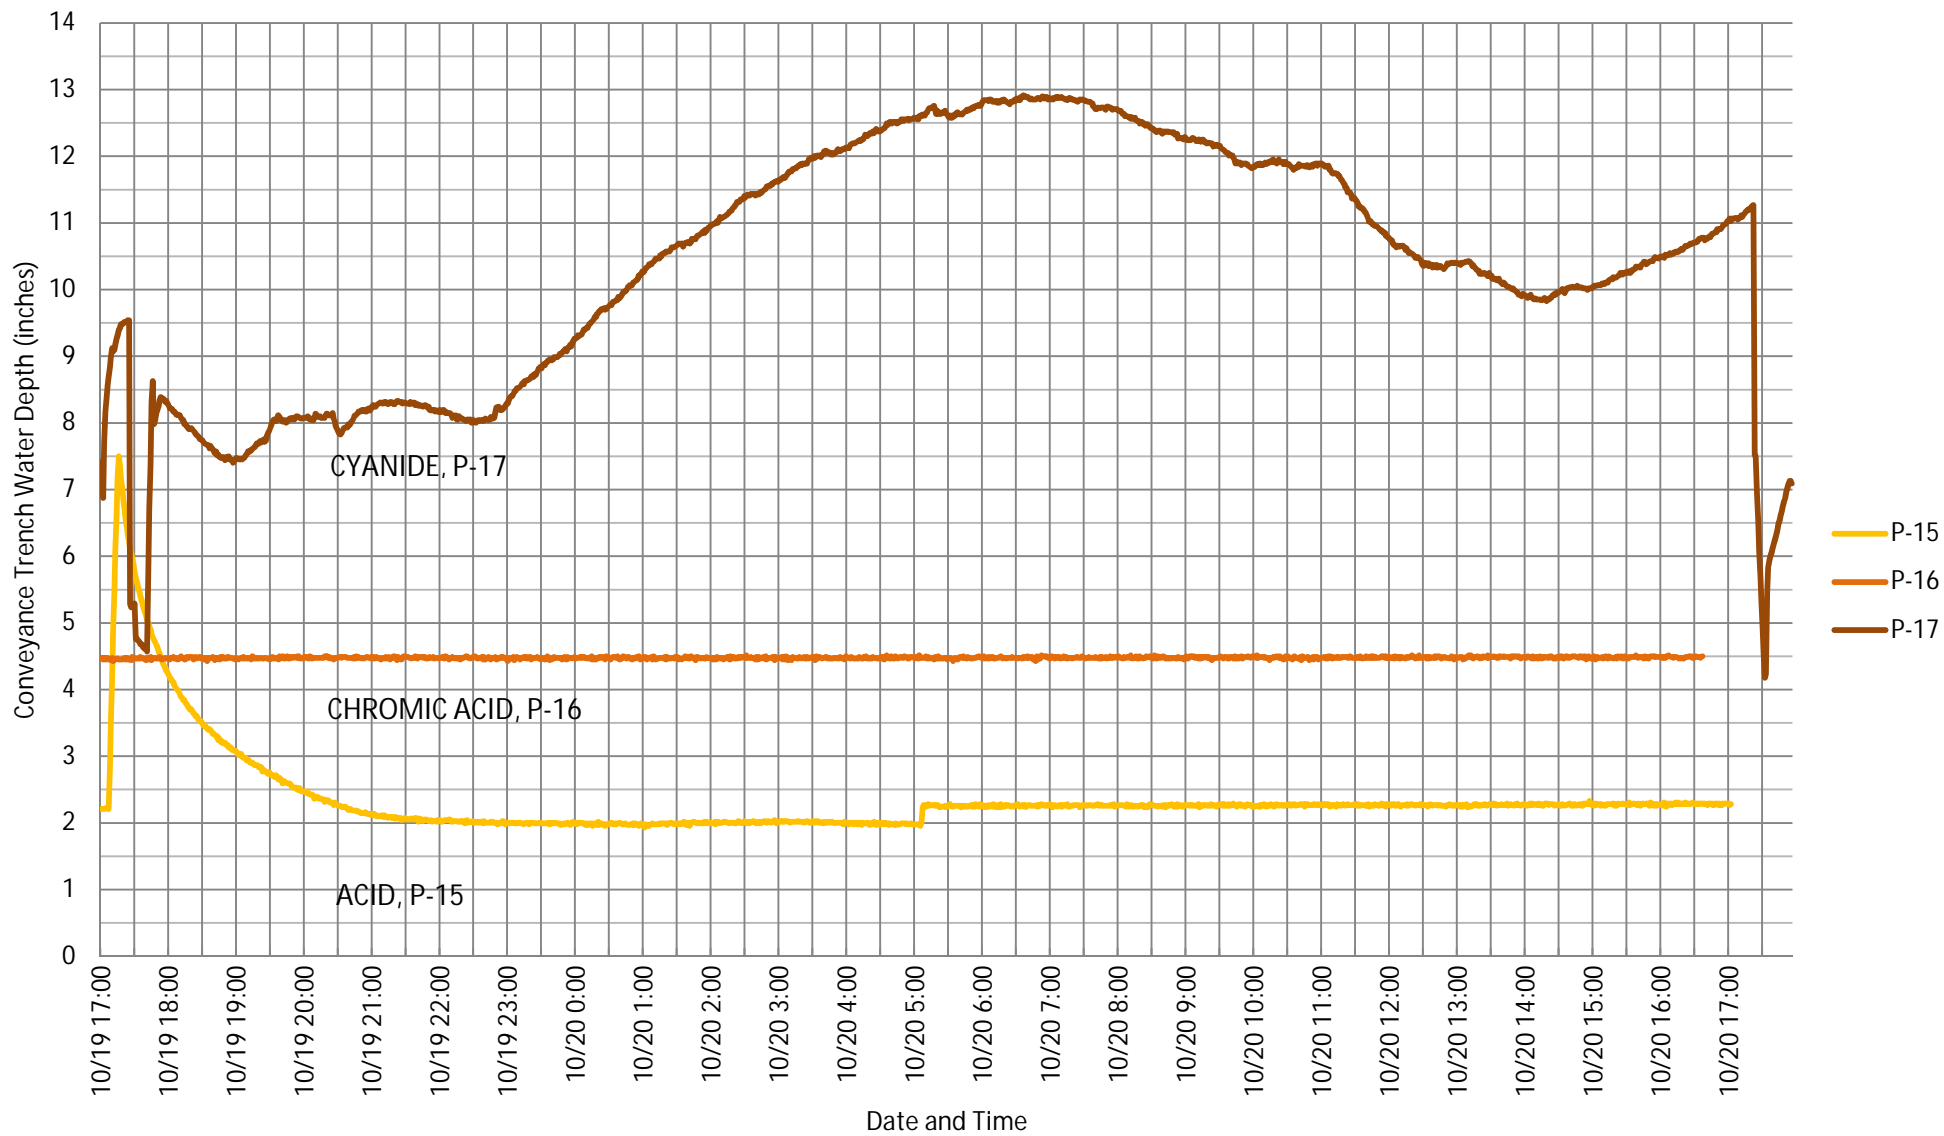
# Test Section 1: North Collector Trench to 90-Degree Bend

The recorded data for this test section gave varying results. The fractional water level drop in the chromic acid trench (P-16) is attributed to evaporative losses. The recorded liquid level in the cyanide trench (P-17) was irregular and varied from 5- to 12-inches during the test. Manual water level measurements confirmed that only a fractional change in water level occurred in the cyanide trench section over the length of the test and that level sensor P-17 malfunctioned. Therefore, it is concluded that both the chromic acid and cyanide trenches in this test section have hydraulic integrity.

The recorded data for the acid trench (P-15) indicates a water level drop of approximately 5-inches during the course of the test. It is noted that B&L staff observed a 3- to 4-inch drop in this trench within the first 45 minutes of the test. The dam isolating the east end of the test section was observed to be watertight so it is assumed that the water drop was due to a leak in the test section. B&L staff observed water entering the acid trench of the dry, untested Section 2 between P-15 and P-7 through a visible crack in the floor of the trench. It is therefore concluded that the acid trench in Section 1 is leaking and is in need of repair.

It is known that routine groundwater monitoring by others has indicated that the pH in groundwater samples at select groundwater monitoring wells has been below historic values. The hydrostatic testing performed by B&L has confirmed that the “upper” portion of the acid conveyance trench is compromised and is leaking in the north collector trench and in the vicinity of the doubler box. As the “intermediate” fiberglass and concrete trenches were not visible for observation and testing, it is inferred that these trenches are compromised as well in a manner such that wastewater containing acid is migrating through the concrete trench and into the groundwater. The intermediate fiberglass and concrete trenches should be inspected during repairs to the upper trench.

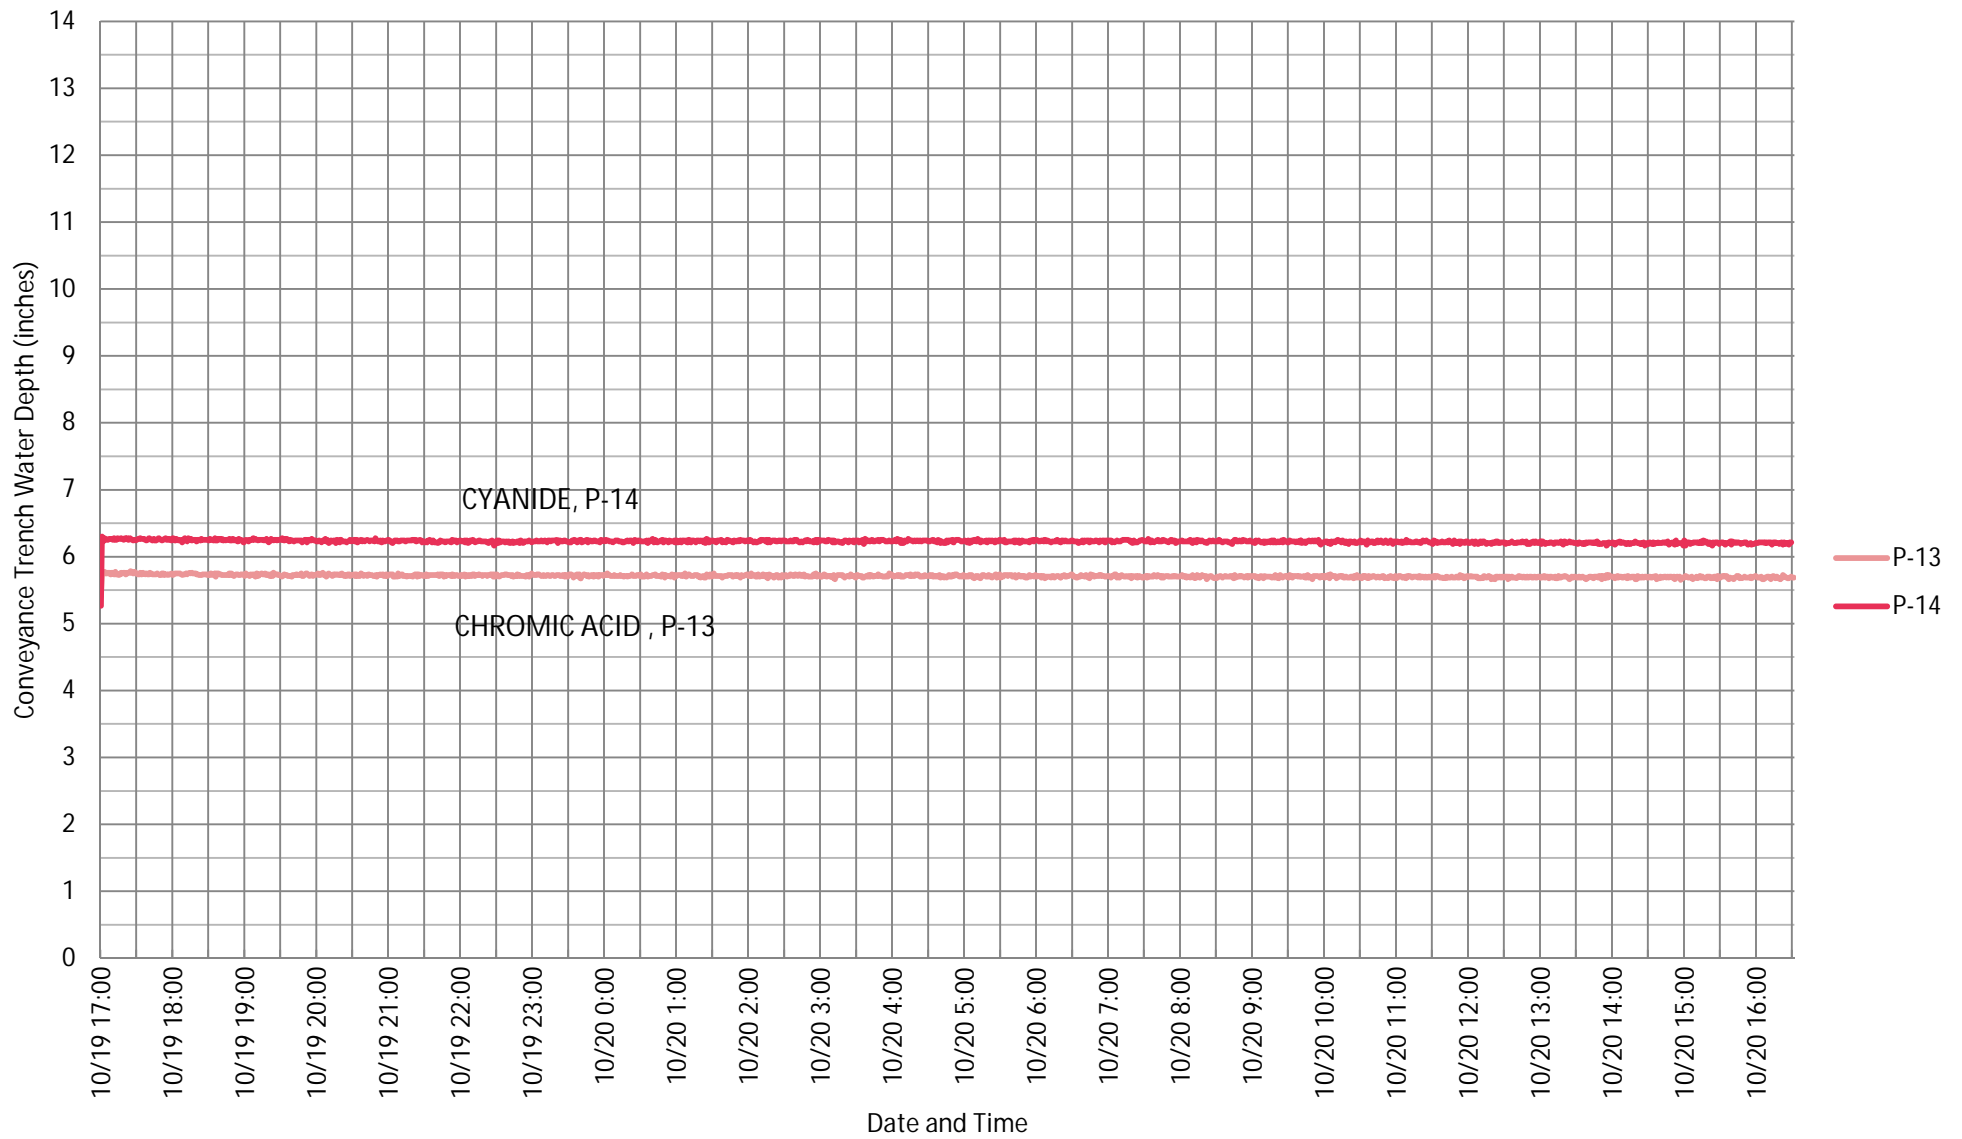
# Test Section 2: North Collector Trench, 90-Degree Bend to Doubler Box

The recorded data for this test section indicates a minimal liquid level drop in the chromic acid and cyanide trenches (P-13, P-14). Any fractional water level drop is attributed to evaporative losses; therefore, it is concluded that the chromic acid and cyanide trenches in this test section have hydraulic integrity. As discussed previously, the acid trench in this section is in need of repair. A visible crack was observed in the floor of the trench. Water was observed flowing up through this trench as the upstream section was filled.

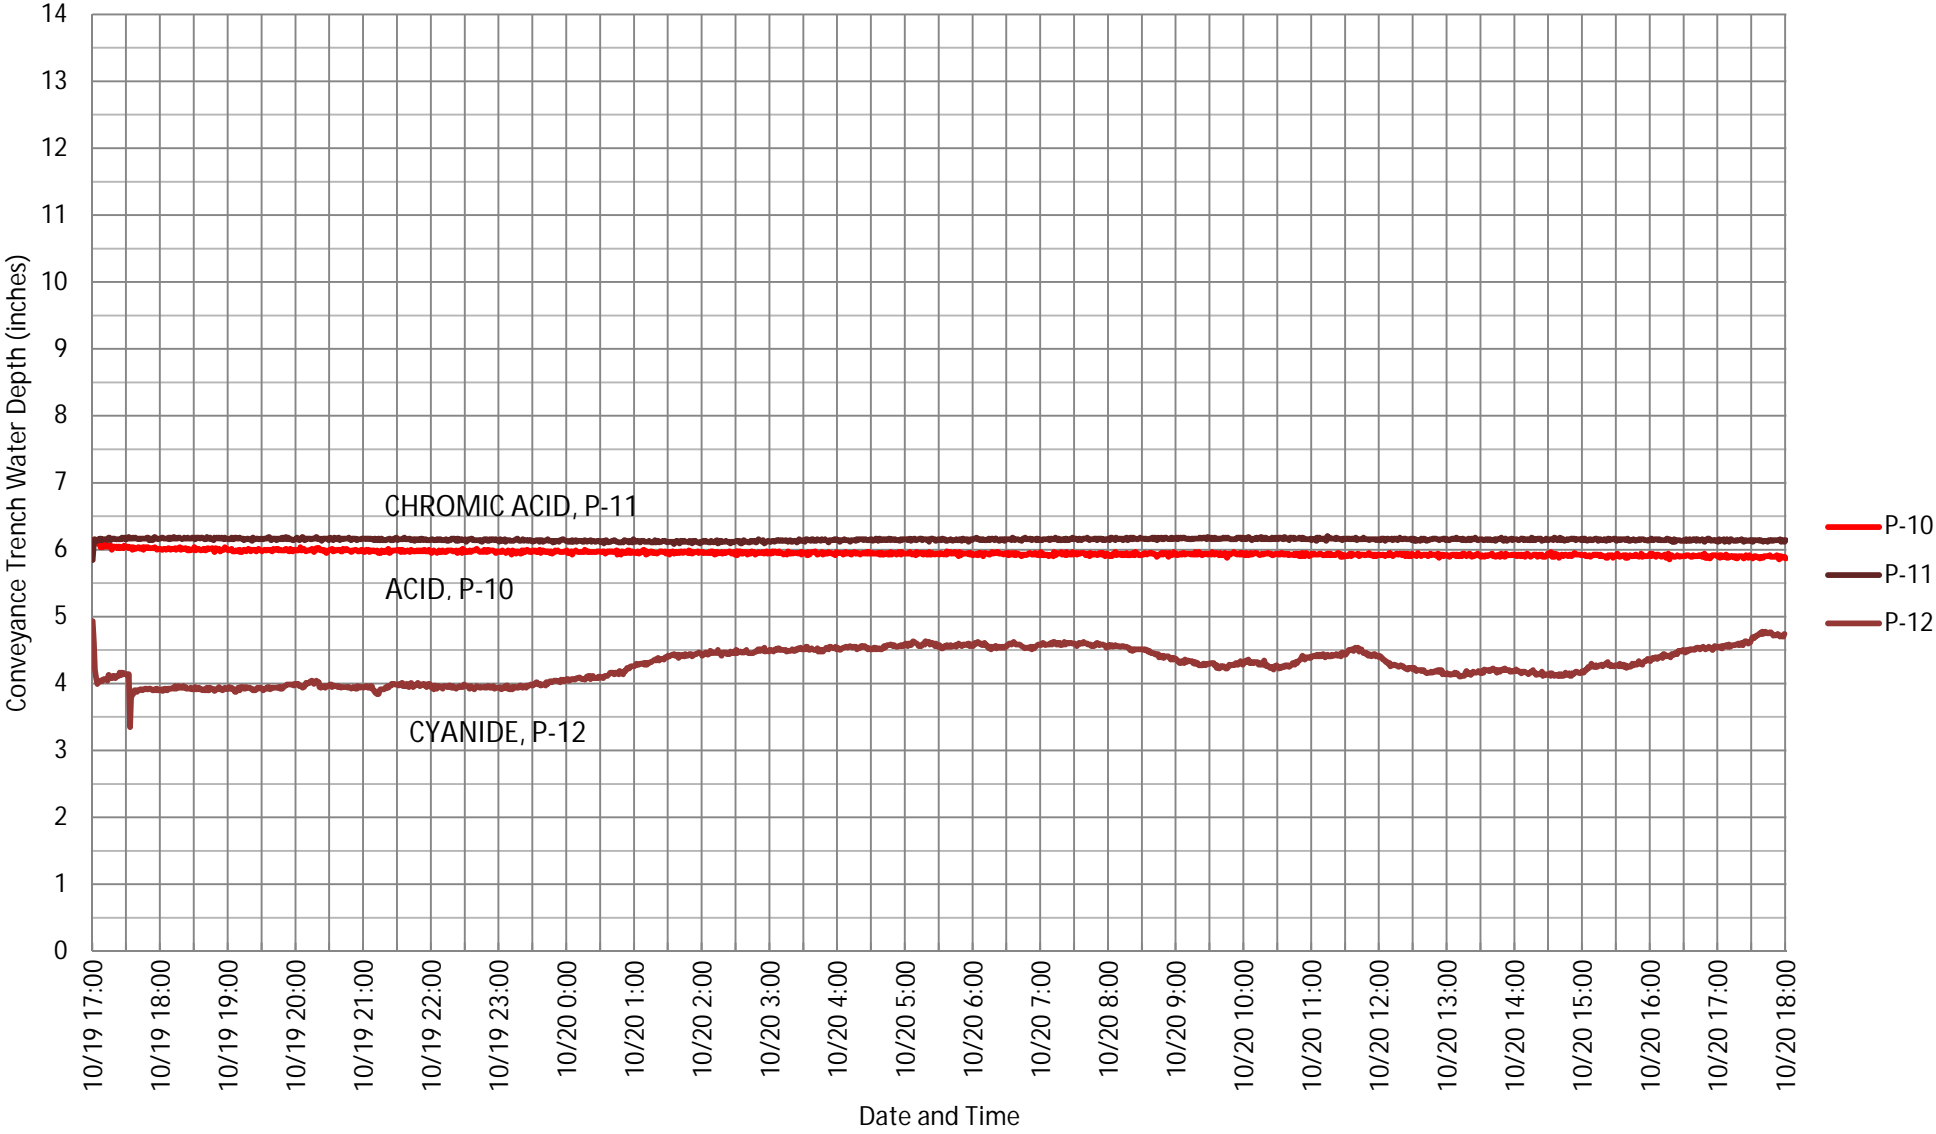
# Test Section 3: Middle Collector Trench to Doubler Box

The recorded data for this test section gave varying results. The fractional water level drops in the acid and chromic acid trenches (P-10, P-11) are attributed to evaporative losses. The recorded liquid level in the cyanide trench (P-12) was somewhat irregular and varied about an inch during the test. Manual water level measurements confirmed that only a fractional change occurred in the water level in this trench section and that level sensor P-12 malfunctioned. Therefore, it is concluded that all three (3) trenches in this test section have hydraulic integrity.

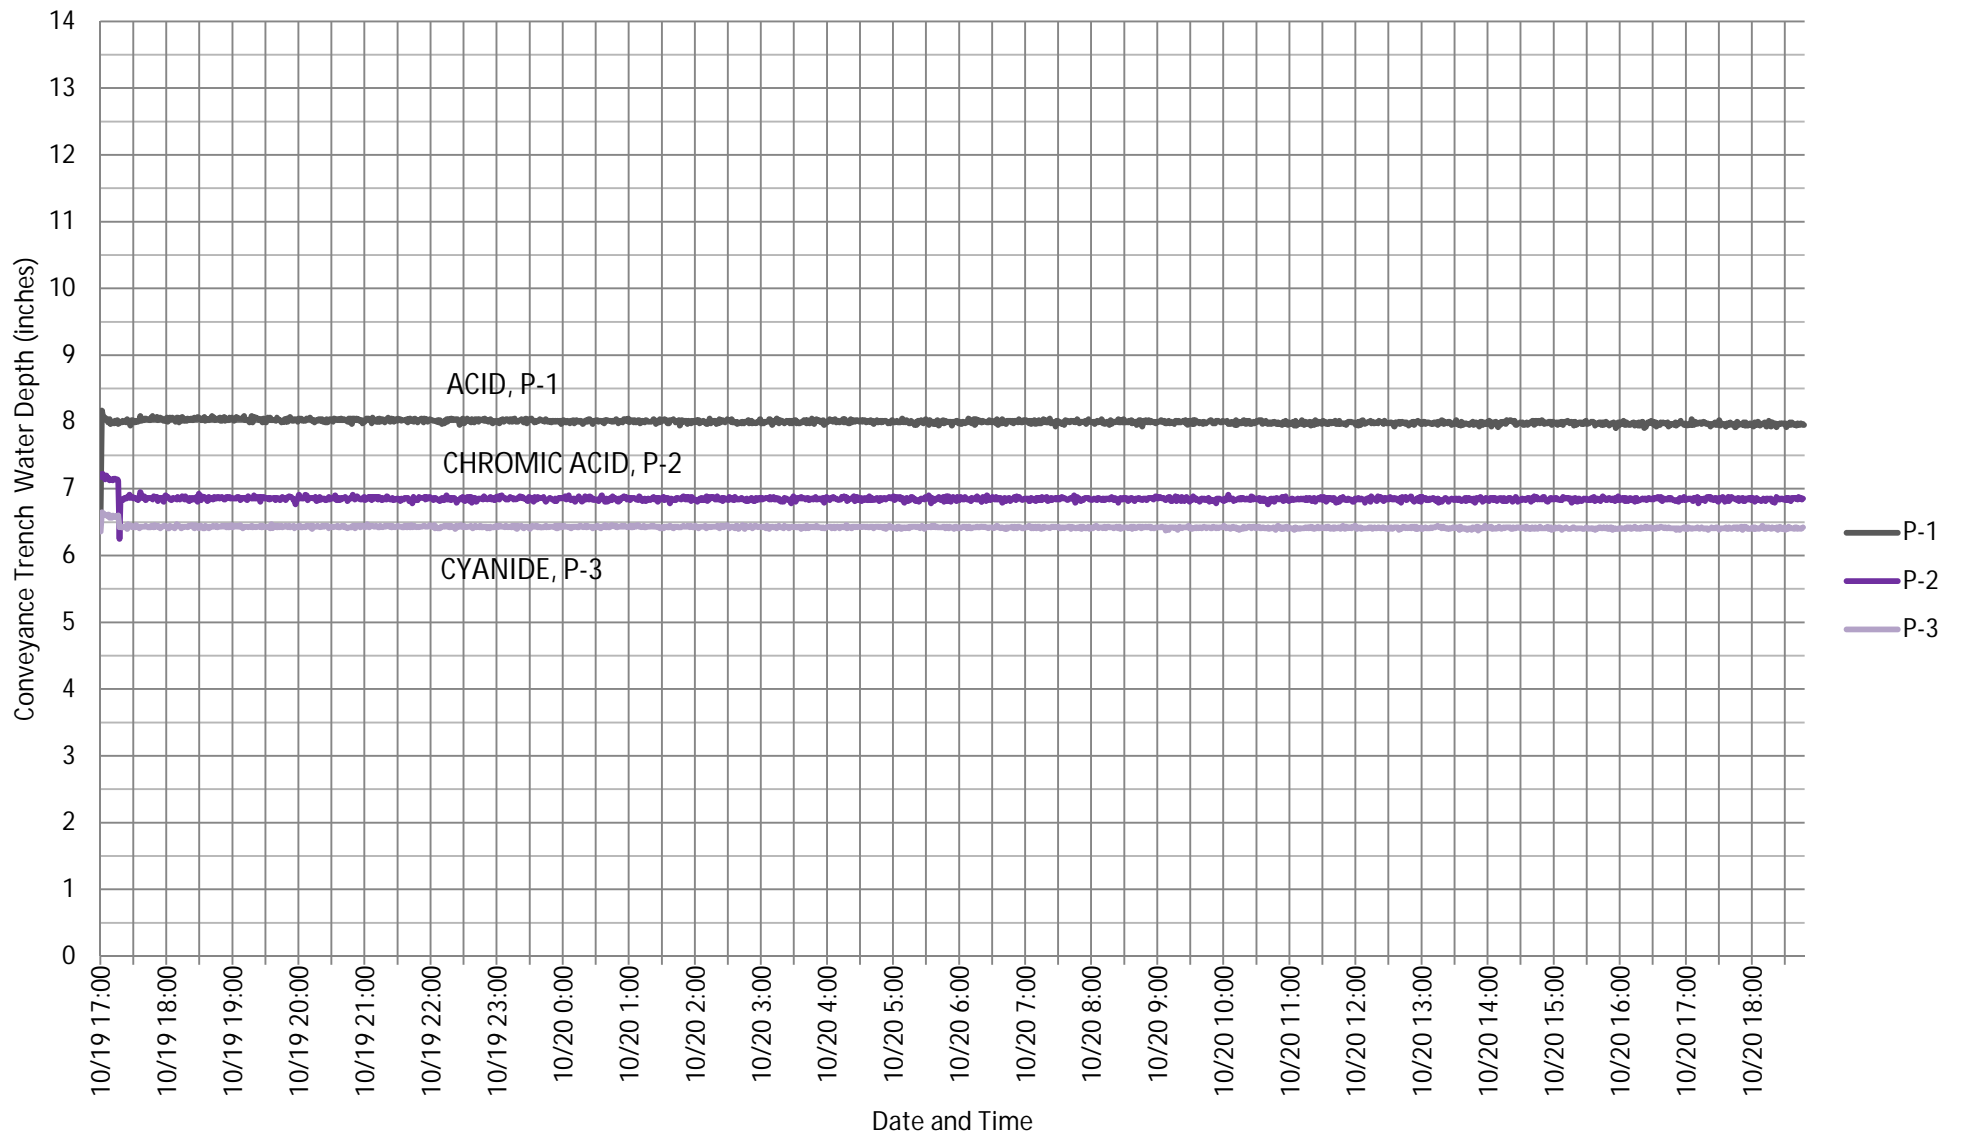
# Test Section 4: South Collector Trench to 90-Degree Bend

The recorded data indicates a minimal liquid level drop in each of the three (3) trenches in this test section. Any fractional water level drop is attributed to evaporative losses; therefore it is concluded that all three trenches in this test system have hydraulic integrity.
