**Village of Sidney, Delaware County, New York**

**Plating Operations  
Wastewater Conveyance System  
Assessment**

**November 2013**

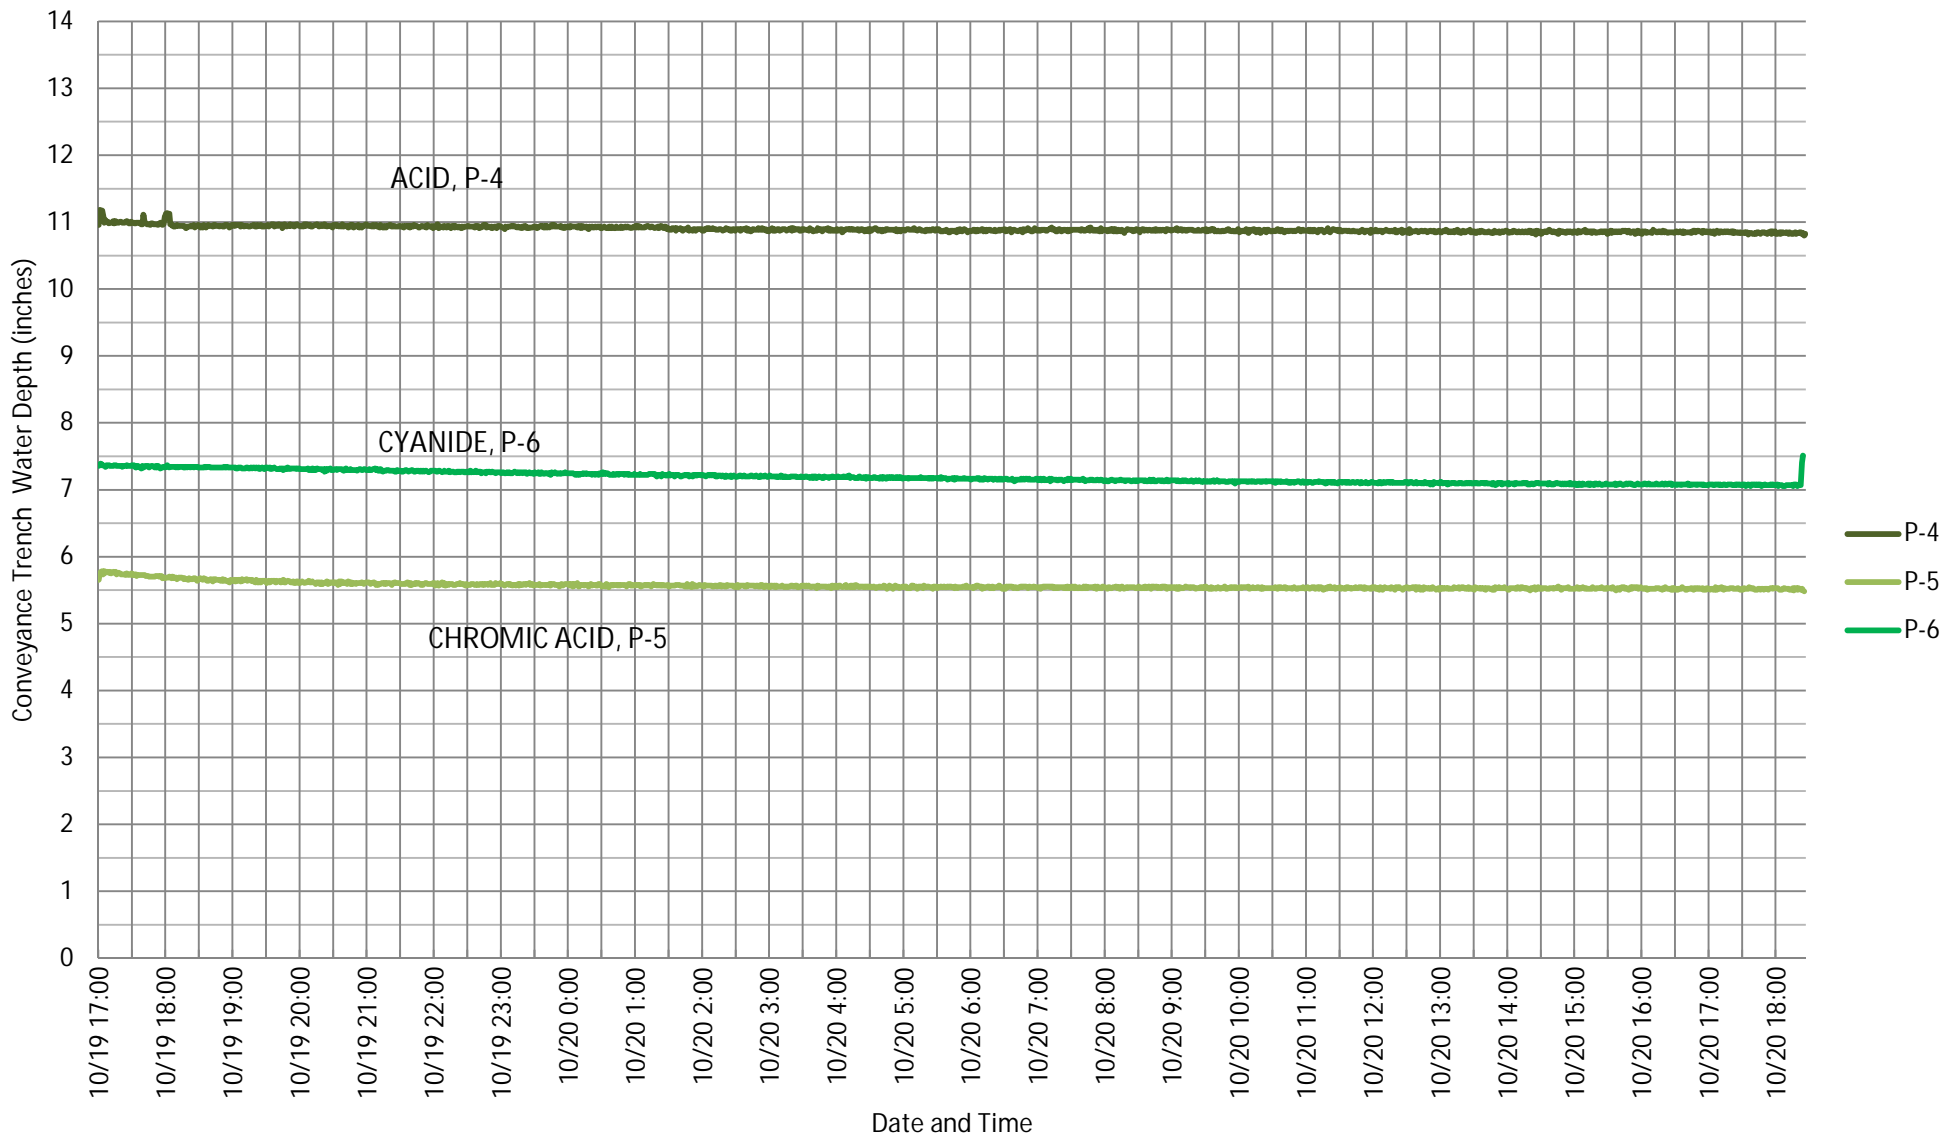
# Test Section 5: South Collector Trench, 90-Degree Bend to Doubler Box

The recorded data for this test section indicates a minimal liquid level drop in each of the three (3) trenches. It is noted that the starting water levels varied between the three (3) trenches; however, each water level remained constant throughout the test. Any fractional water level drop is attributed to evaporative losses; therefore it is concluded that all three (3) trenches in this test system have hydraulic integrity.

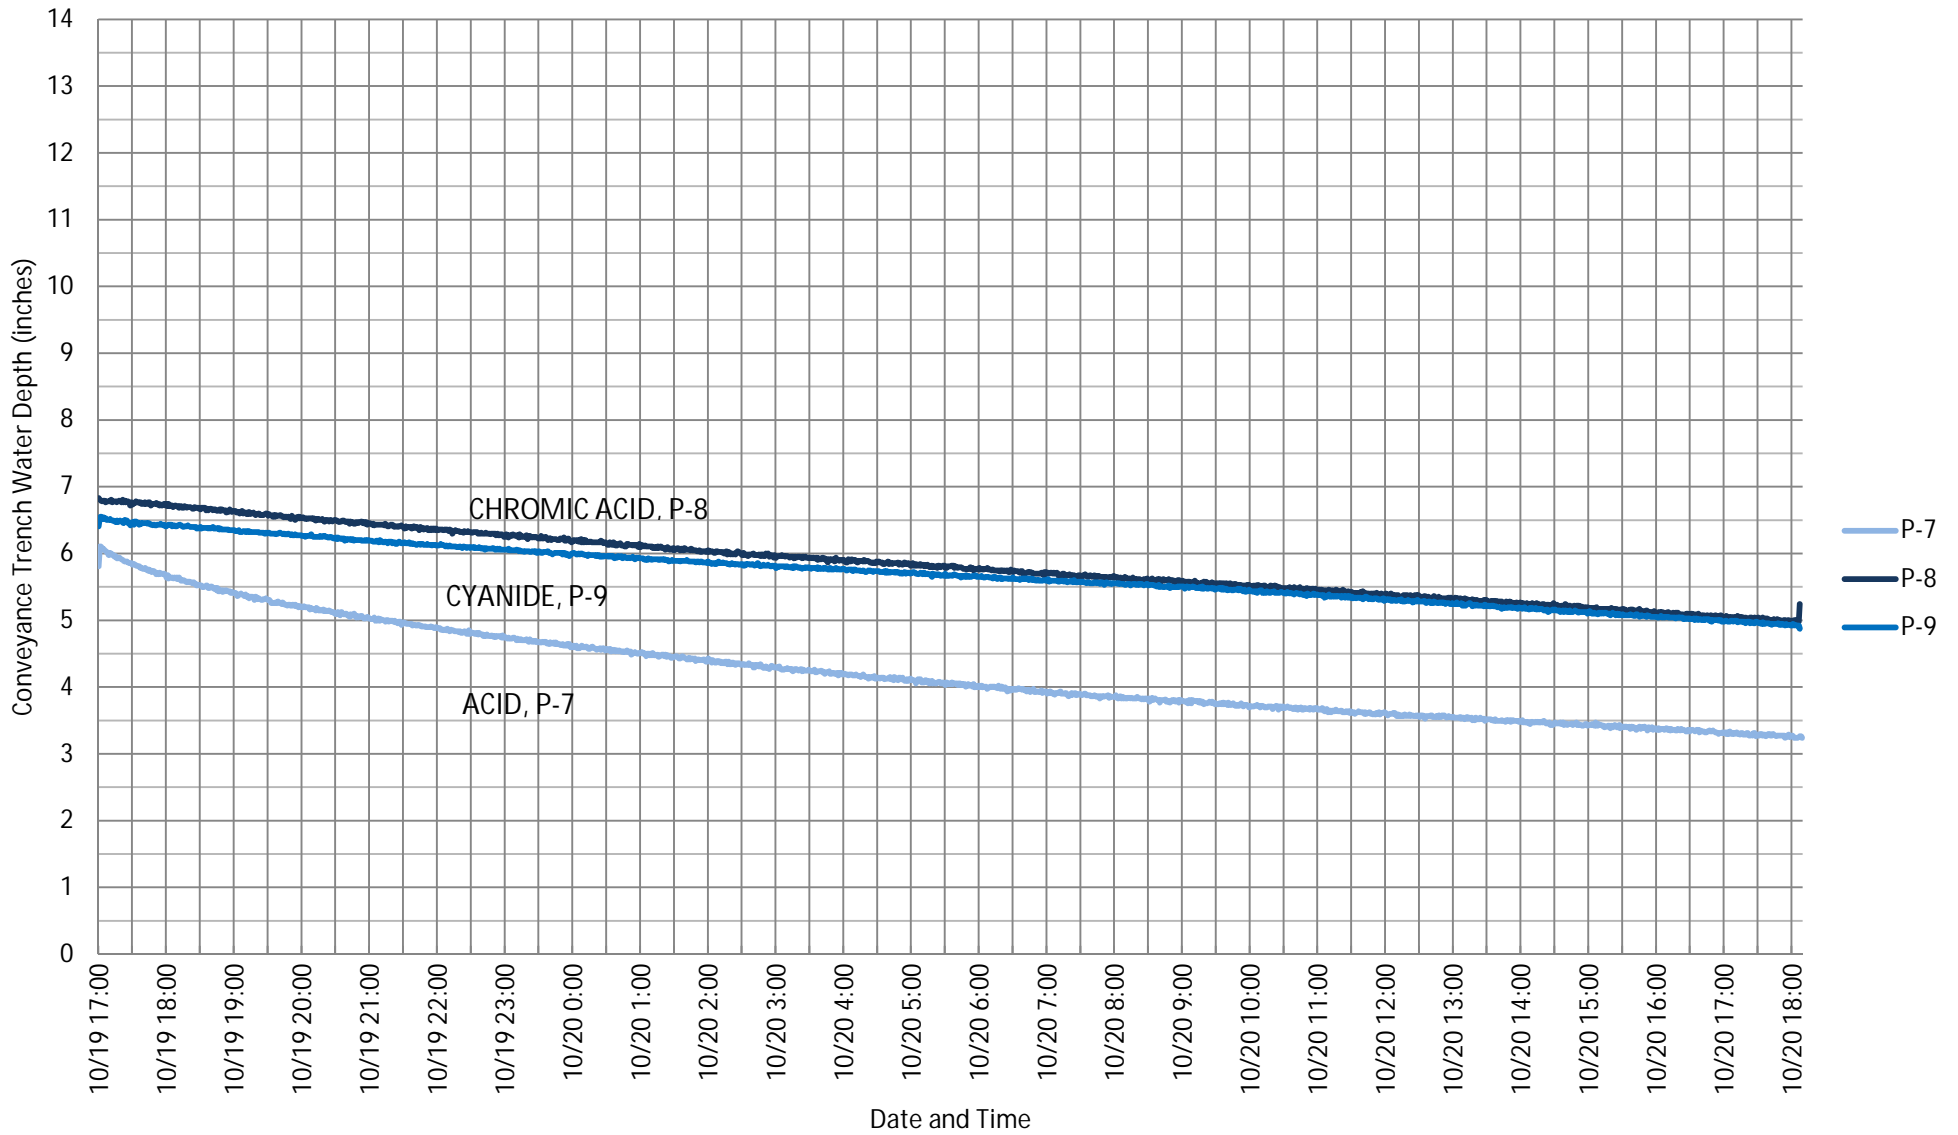
# Test Section 6: Doubler Box

The recorded data for the doubler box area indicates a steady drop in each of the three (3) trenches, with the greatest decline in the acid trench which contained probe P-7. Both the chromic acid and cyanide trenches (P-8, P-9) dropped approximately 2-inches while the acid trench (P-7) dropped approximately 3-inches.

Due to the plating process, the building atmosphere is maintained under a negative pressure and there is a large quantity of air drawn in for ventilation at the east of the building near the conveyance trench. It is assumed that this section exhibits higher rates of evaporative losses due to the air flow into the building. Because the chromic acid and cyanide trenches exhibited a similar water level drop, it is assumed this is due to evaporative losses. The acid trench dropped approximately one-inch greater than these two trenches. It is therefore assumed that the acid trench in the vicinity of the doubler box is compromised and a leak caused the additional one-inch of water loss.
