**PERIODIC REVIEW REPORT (2015)
AMERICAN VALVE MANUFACTURING
NYSDEC SITE NO. 420002**

**MACTEC Engineering and Consulting, P.C.
Portland, Maine**

JANUARY 2016

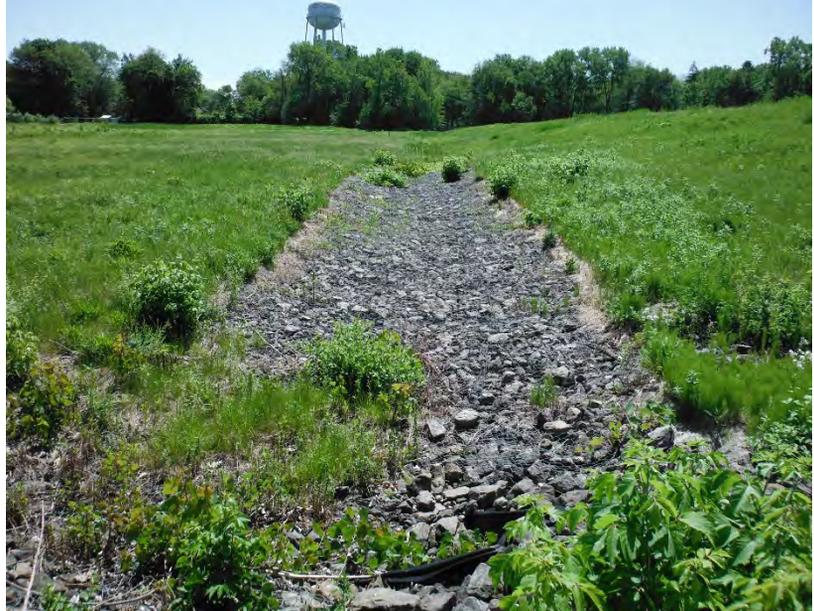
Cover System Onsite?	Yes	No (Proceed to next Section)		Cover System Observations: Small vegetation growing in drainage swale. (see photo)
Vegetative Cover Condition	Good	Poor	NA	
Evidence of Vegetative Stress	Yes	No	NA	
Mowing Required	Yes	No	NA	
Presence of Debris	Yes	No	NA	
Evidence of Pondered Water	Yes	No	NA	
Exposed Geotextile	Yes	No	NA	
Evidence of Erosion Settlement	Yes	No	NA	
Engineered Drainage Swale Condition	Good	Poor	NA	
Evidence of Leachate Seepage	Yes	No	NA	
Evidence of Erosion	Yes	No	NA	
Presence of Woody Growth	Yes	No	NA	
Animal Burrows	Yes	No	NA

Drainage swale view
east

- Infringing vegetation in the drainage swale was removed
- The concrete pad at MW-5S was repaired

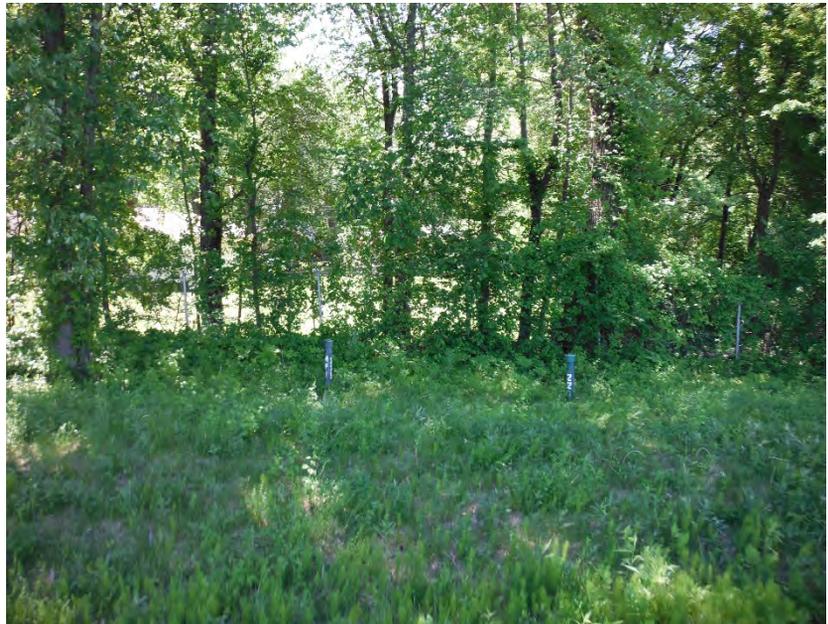
Damage still exists. No top rail present at some sections. needs repair.

South side perimeter
fence has no horizontal
top rail. Waste high
weeds approaching
MPI-22 S/D

Has damage to fence near MPI-22S/D been addressed? *Fence repairs were completed*

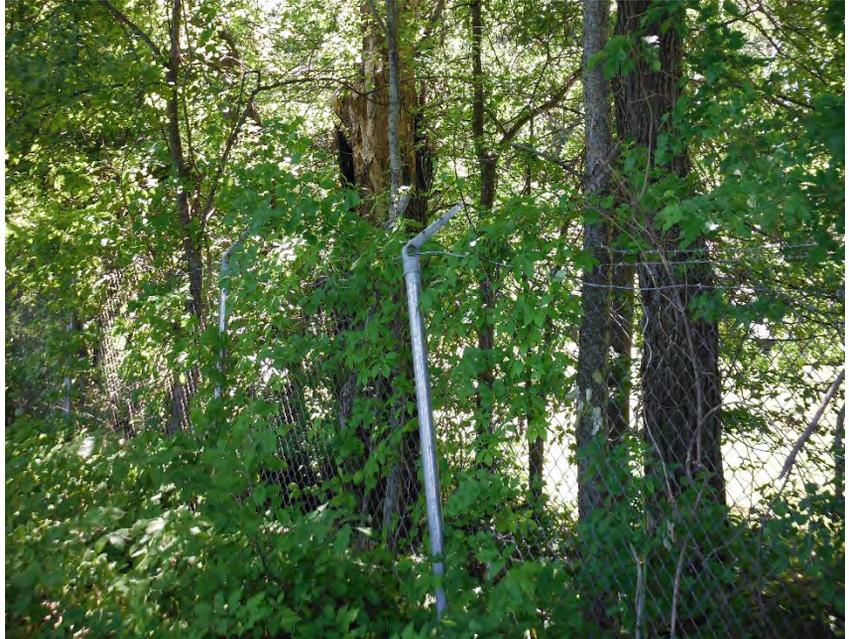
South perimeter fence separated from vertical supports.

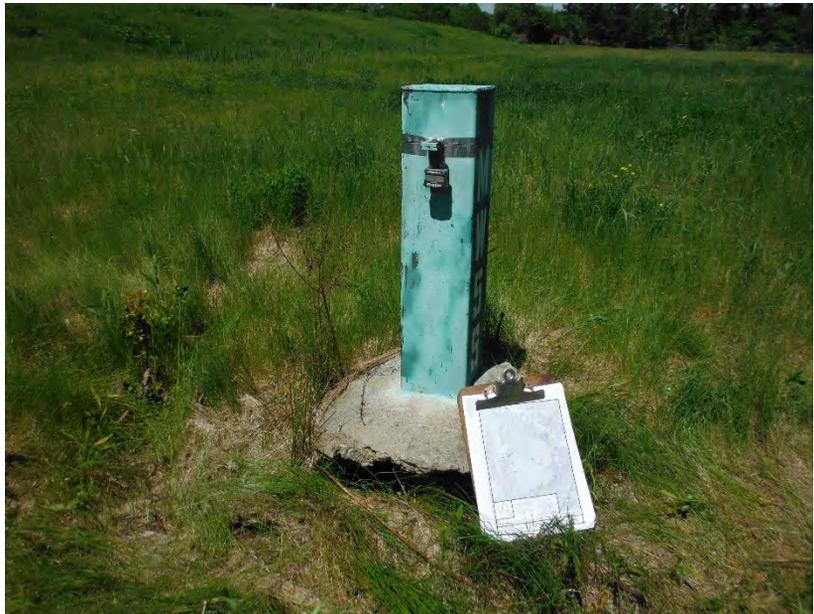
Environmental Monitoring Locations			
Is there a monitoring network at the site?	<input checked="" type="radio"/> Yes	<input type="radio"/> No	(Proceed to next)
Monitoring Wells/Piezometers	<input checked="" type="radio"/> Good	<input type="radio"/> Poor	<input type="radio"/> NA
Soil Gas Monitoring Probes	<input checked="" type="radio"/> Good	<input type="radio"/> Poor	<input checked="" type="radio"/> NA
Landfill Gas Vents	<input checked="" type="radio"/> Good	<input type="radio"/> Poor	<input type="radio"/> NA
List other applicable location types and their overall condition			
			Monitoring Network Observations: mw-55 needs concrete repair. (See Photo)

Concrete pad around MW-5S heaved up due to frost

- The concrete pad at MW-5S, which had risen above ground surface due to frost heaving, was repaired.

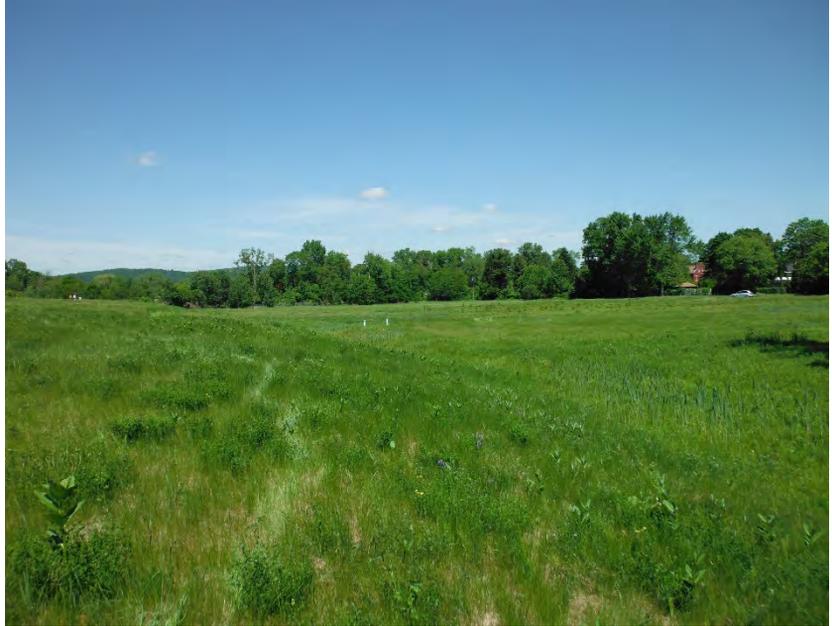
Top of landfill looking east towards the entrance gate.

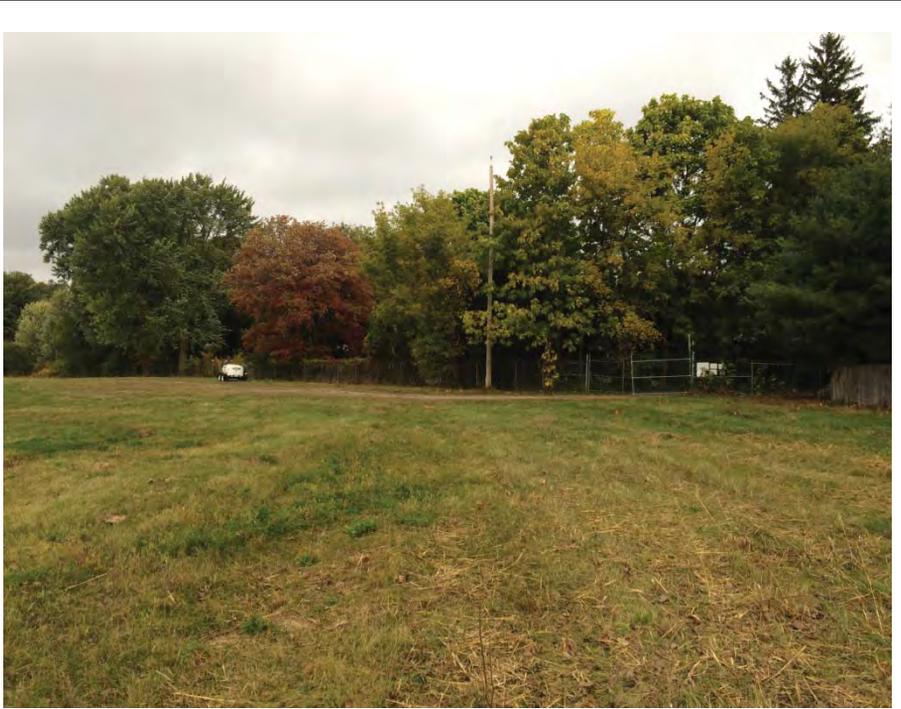
Excavation area prior to excavation

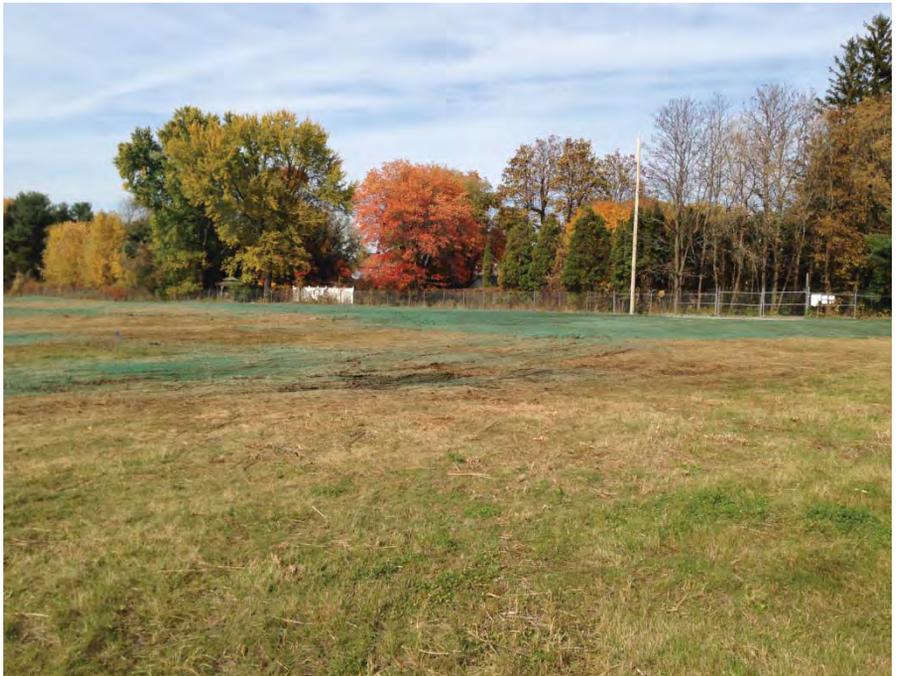
Excavation area after restoration

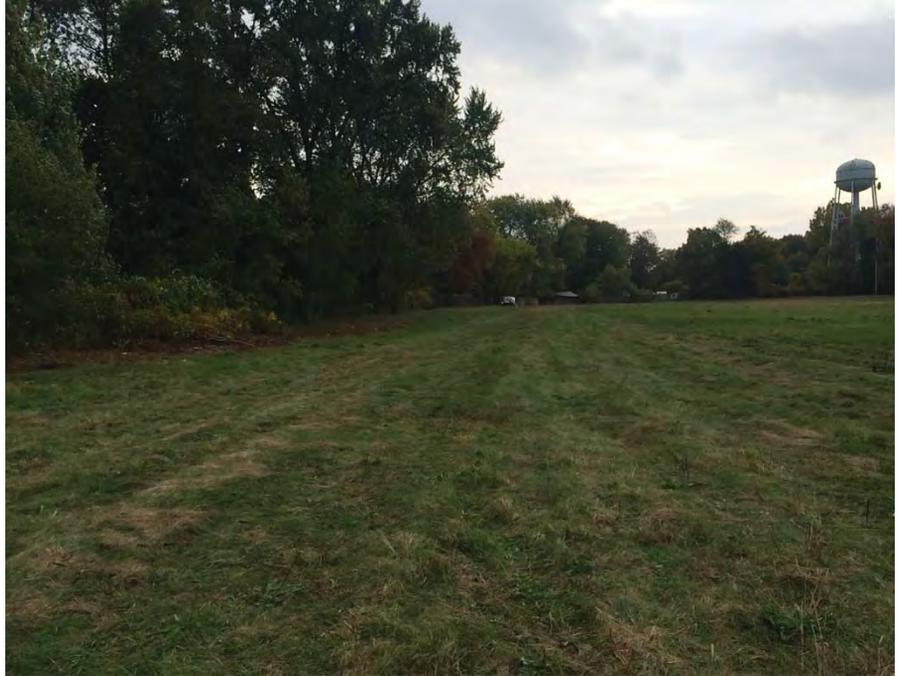
Area prior to excavation

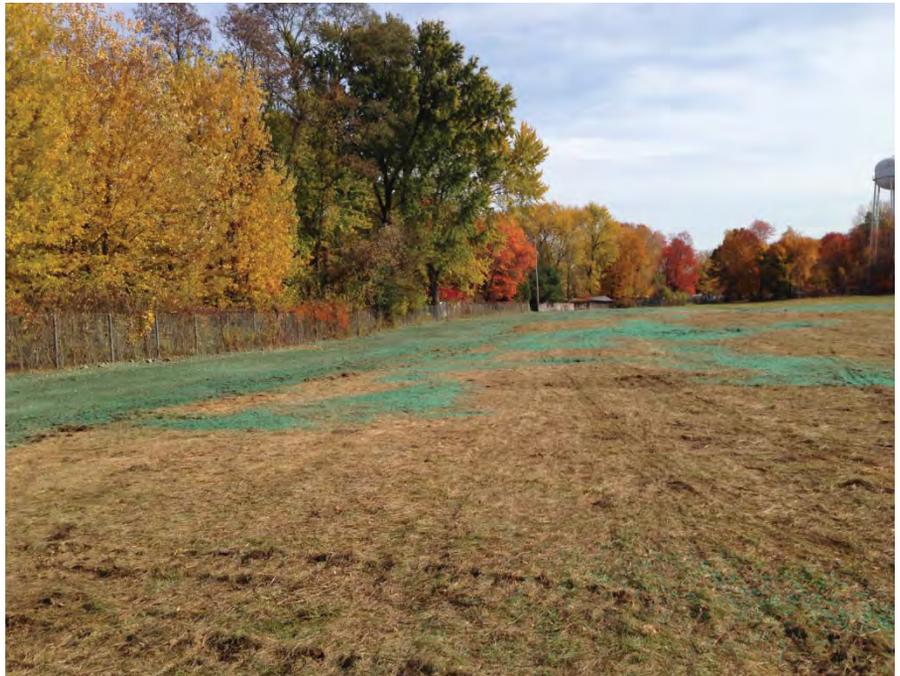
Excavation area after restoration

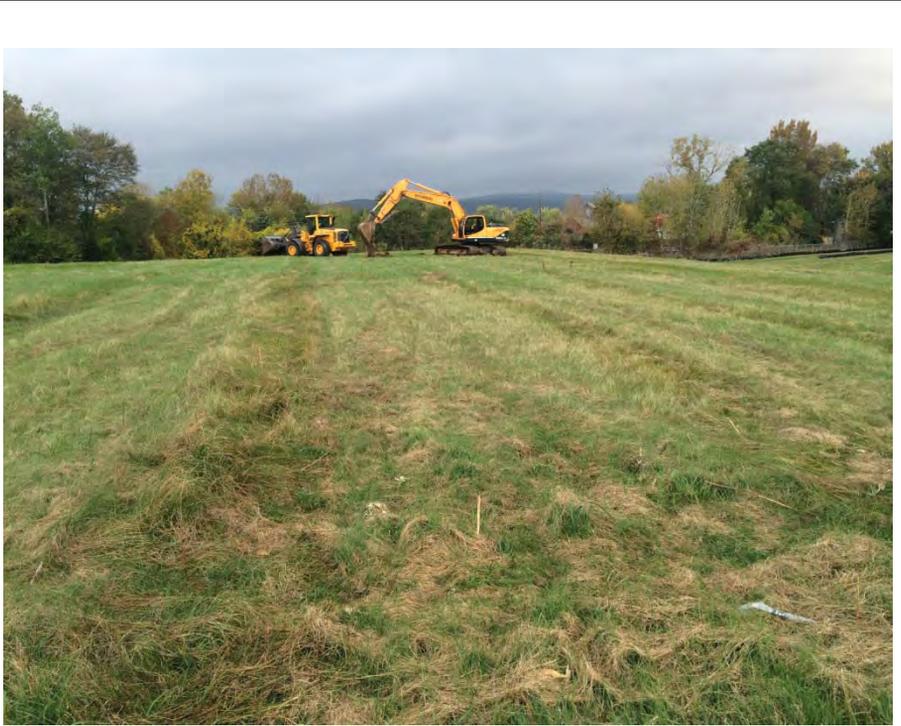
Landfill topsoil
removal

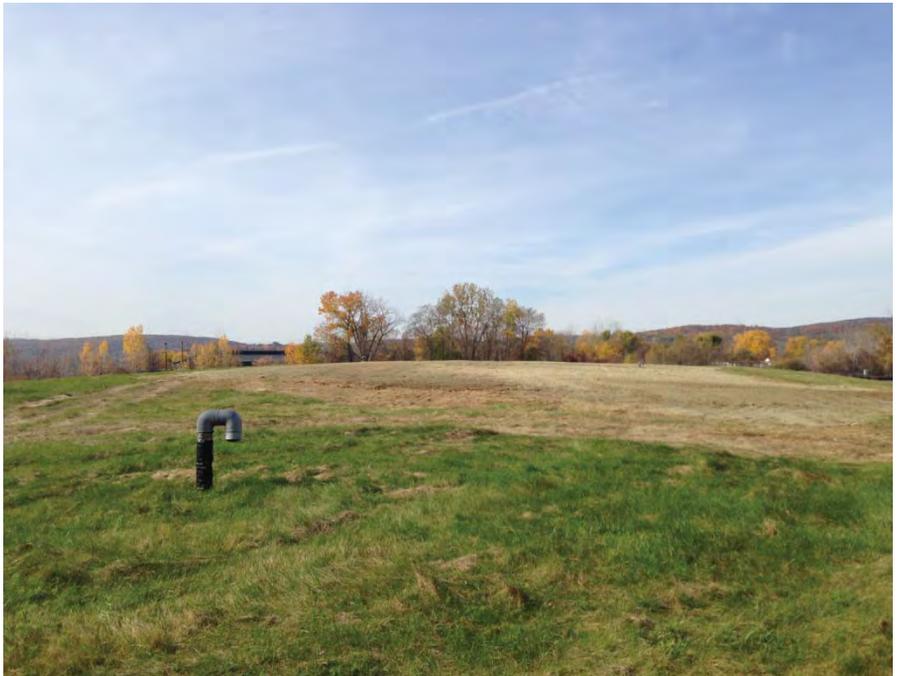
Landfill topsoil
restoration

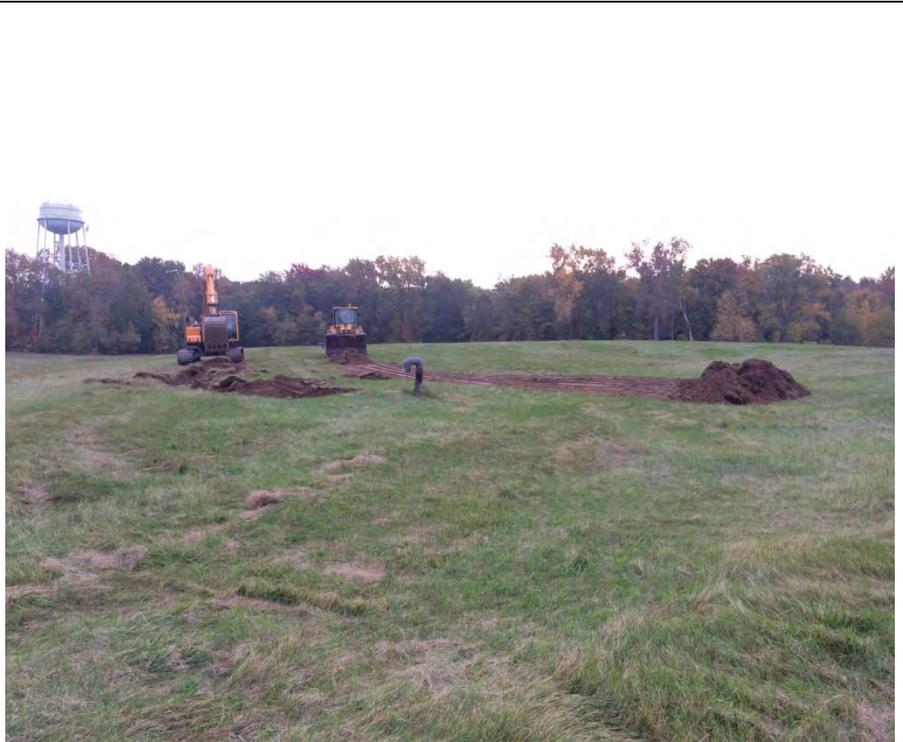
Landfill cap topsoil removal

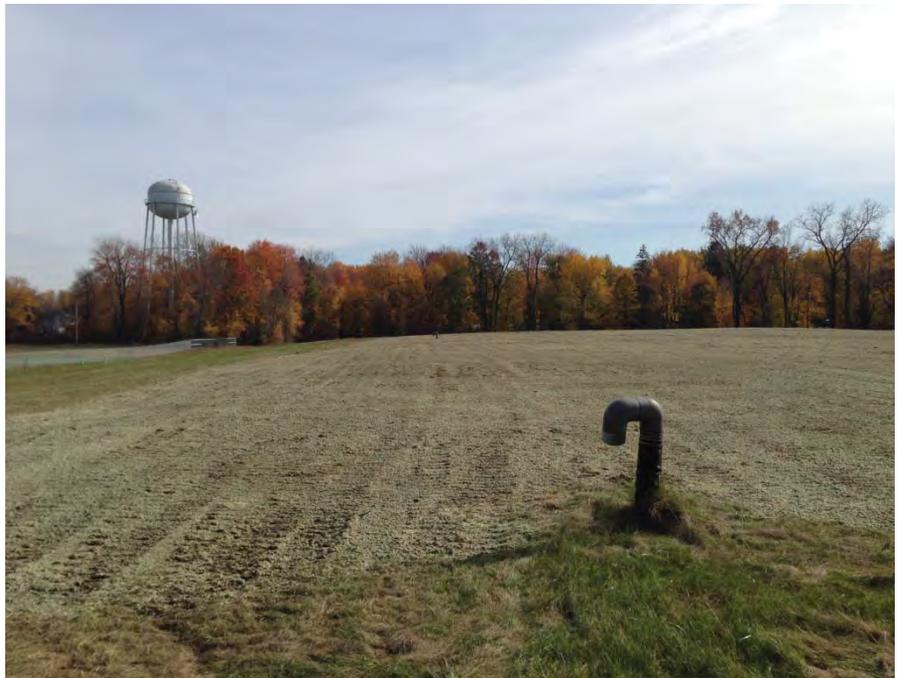
Landfill cap restoration

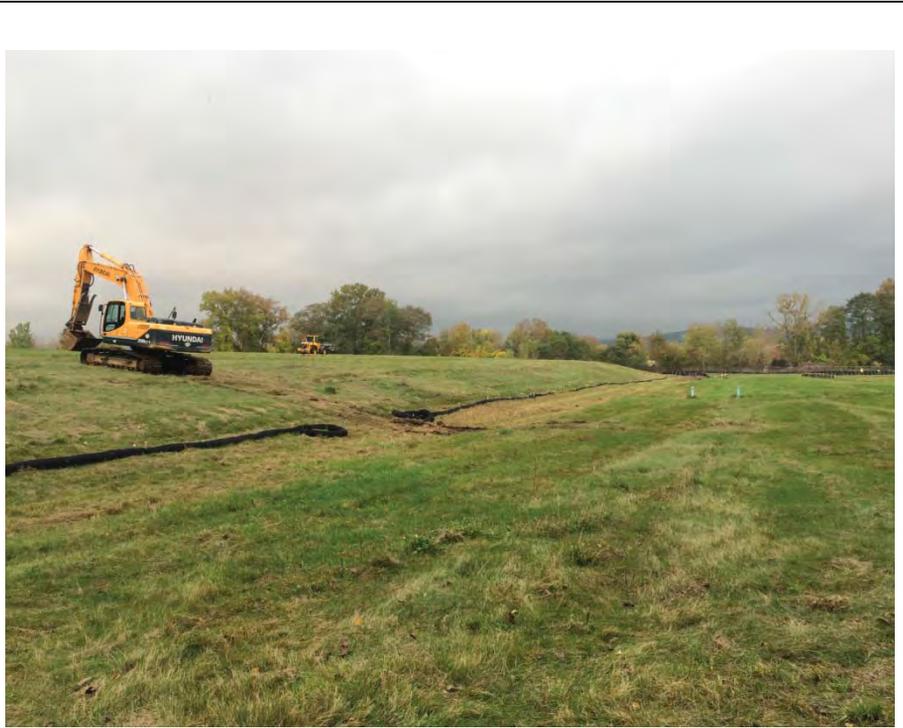
Temporary landfill
access road

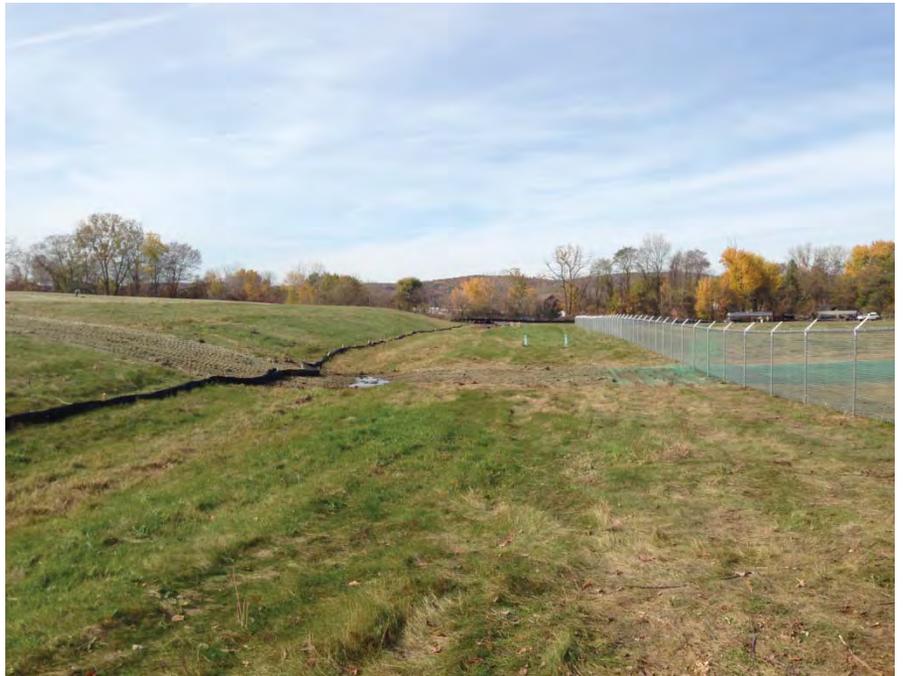
Access road restoration
and fence installation

Corrective Actions were performed prior to inspection.
 New fence was installed, damaged fence repaired and a new gate and access road was constructed off Cato St.
 Disturbed soil was graded and hydroseed installed
 Erosion control will remain in place until disturbed areas have been stabilized with vegetative growth.
