RE: Quarterly Monitoring Report: July 2024 - September 2024

Groundwater Extraction and Treatment System

Ward Products Site, 61 Edson Street, Amsterdam, NY

NYSDEC Site No. 429004

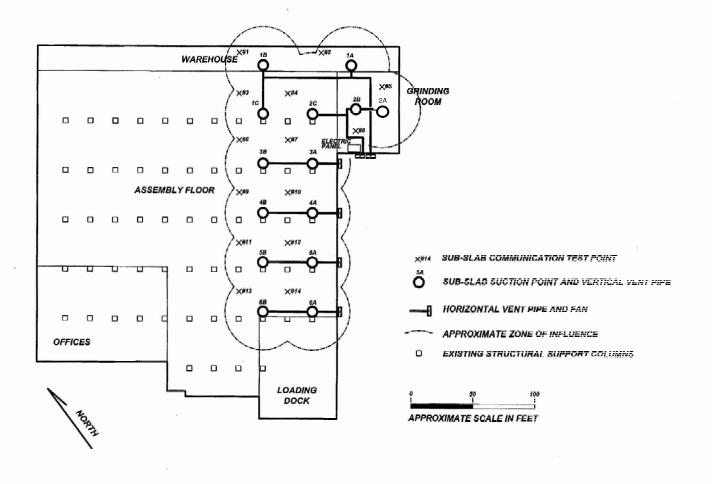
Figure 3
Sub-Slab Depressurization System Layout
61 Edson Street, LLC
Amsterdam, NY
NYSDEC Site No. 429004

As a precautionary measure, a subslab depressurization system (SSDS) operates in the eastern portion of the on-site building (see attached layout). The SSDS fans and pressure meters are inspected occasionally to assure proper operation (note- the SMP only requires annual inspections). All 2024 inspections to date indicate that the system is operating appropriately. Meter readings are attached for reference.

The SSDS is operating appropriately.
