DAILY OBSERVATION REPORT

Remedial Bureau C

Site: NM Fort Plain MGP
Phase: Site Management
Site No.: 429007

Date: 10/19/2023

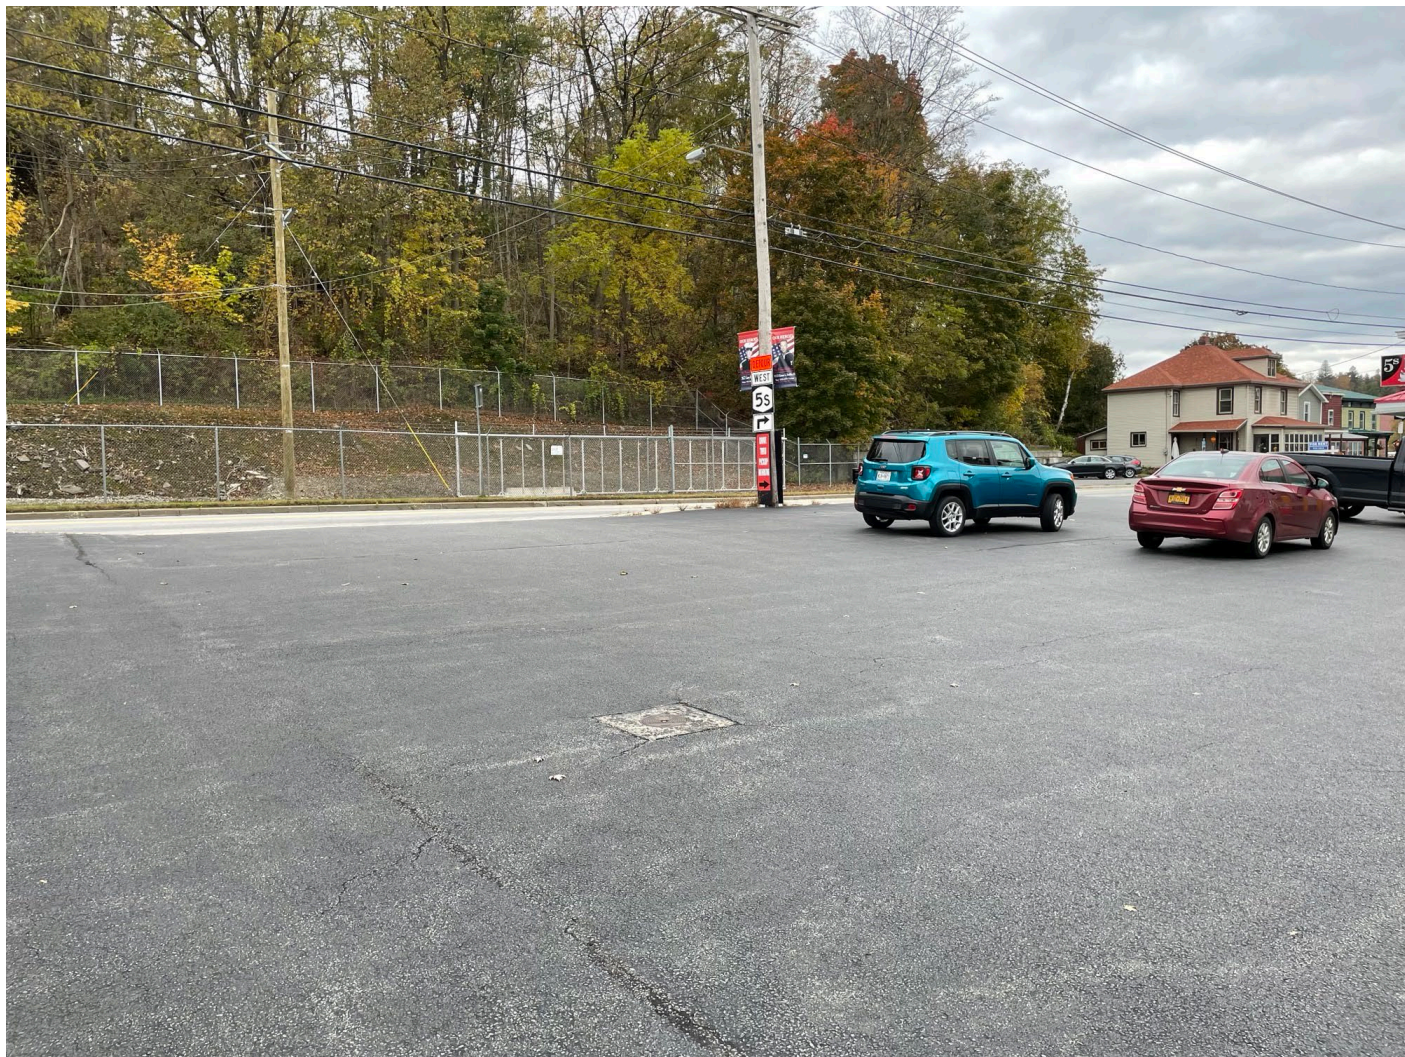
- NYSDEC onsite to observe Groundwater Environmental Services (GES) conduct quarterly site inspection and biannual groundwater sampling
- Asphalt site cover at Route 5S diner and all monitoring/extraction wells in good condition
- One area of minor perimeter fence damage noted
- One area of possible demarcation fabric layer exposure was noted in the middle of the former MGP area and current substation area
- Retaining wall beginning to collapse in southern portion of current substation area

Site conditions/cover system

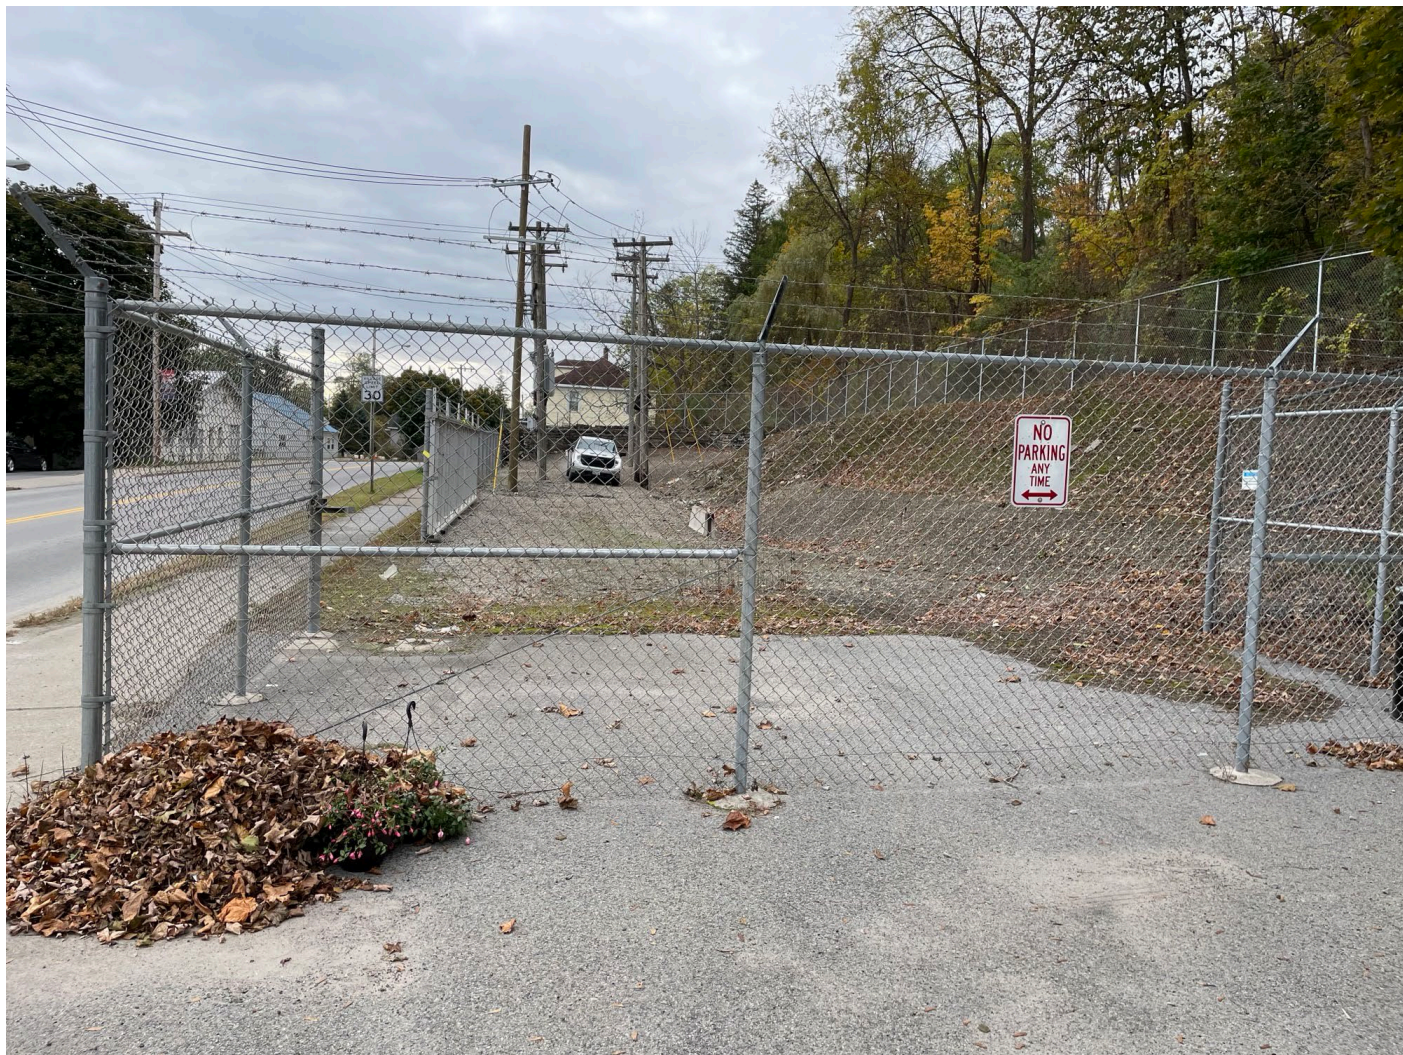
Site conditions/perimeter fencing at substation

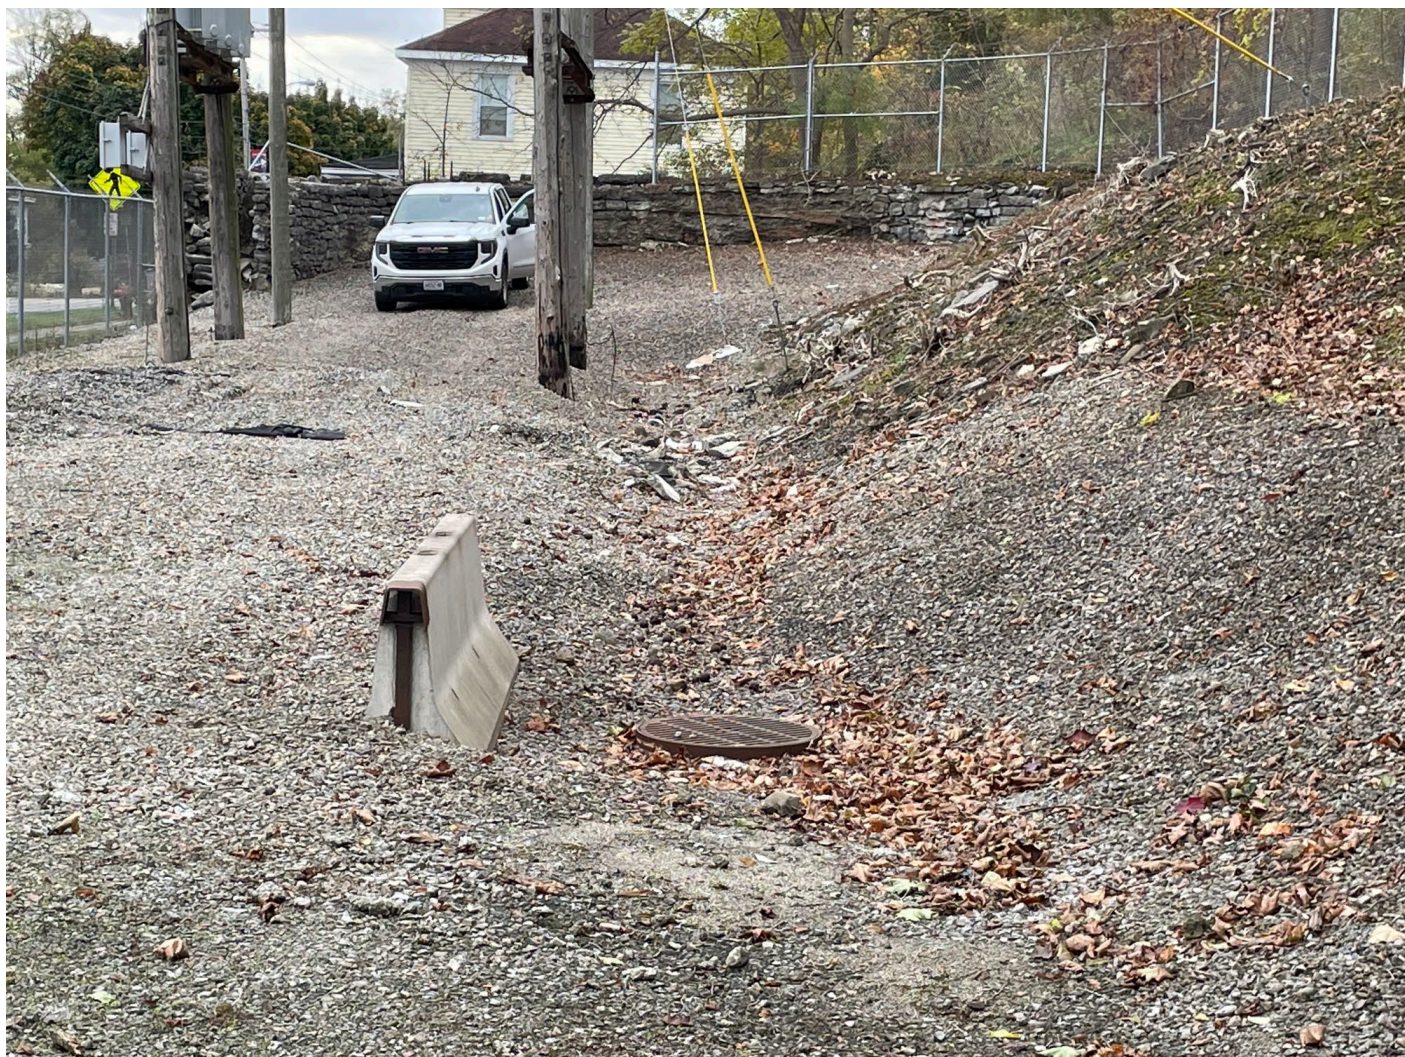
Substation conditions/ drainage swale

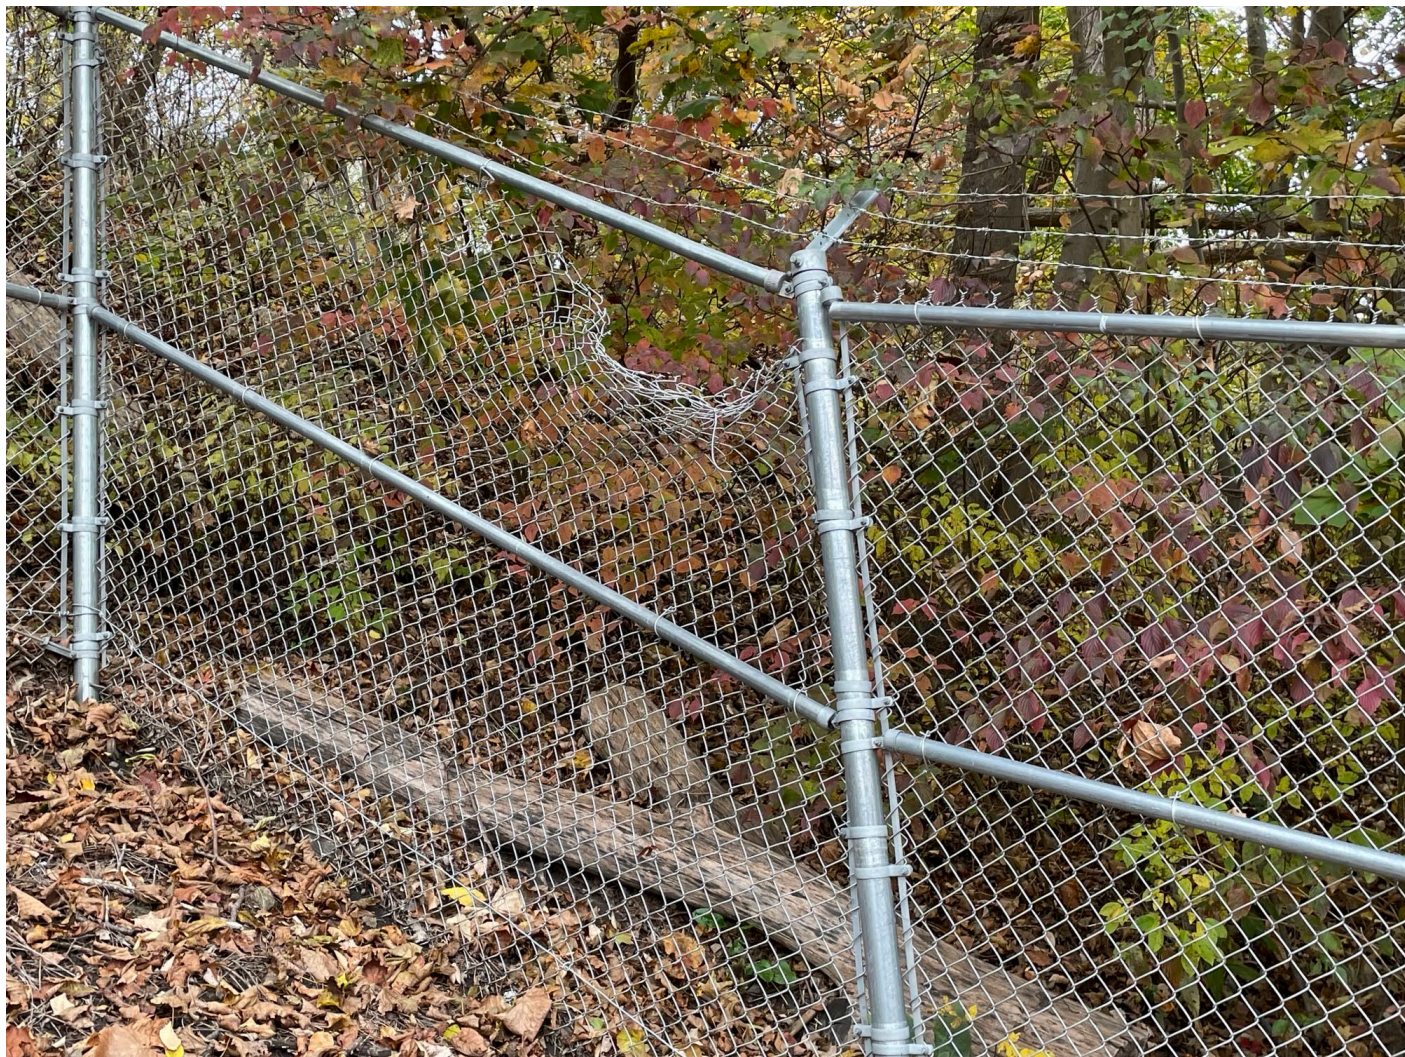
Minor perimeter fence damage

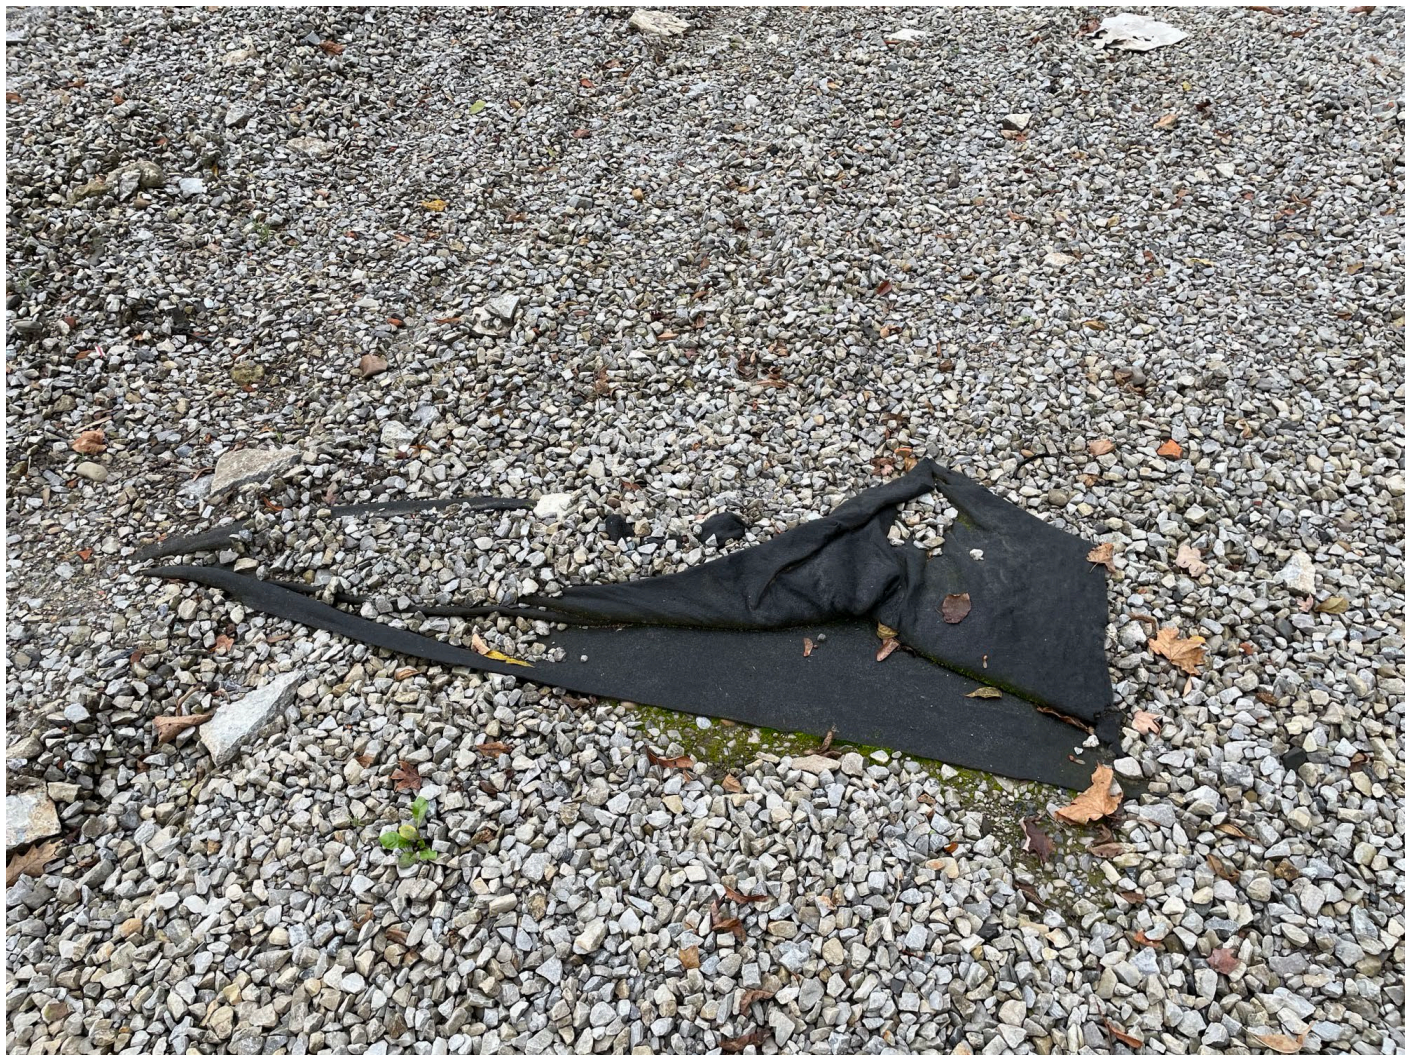
Demarcation layer exposed in middle of substation

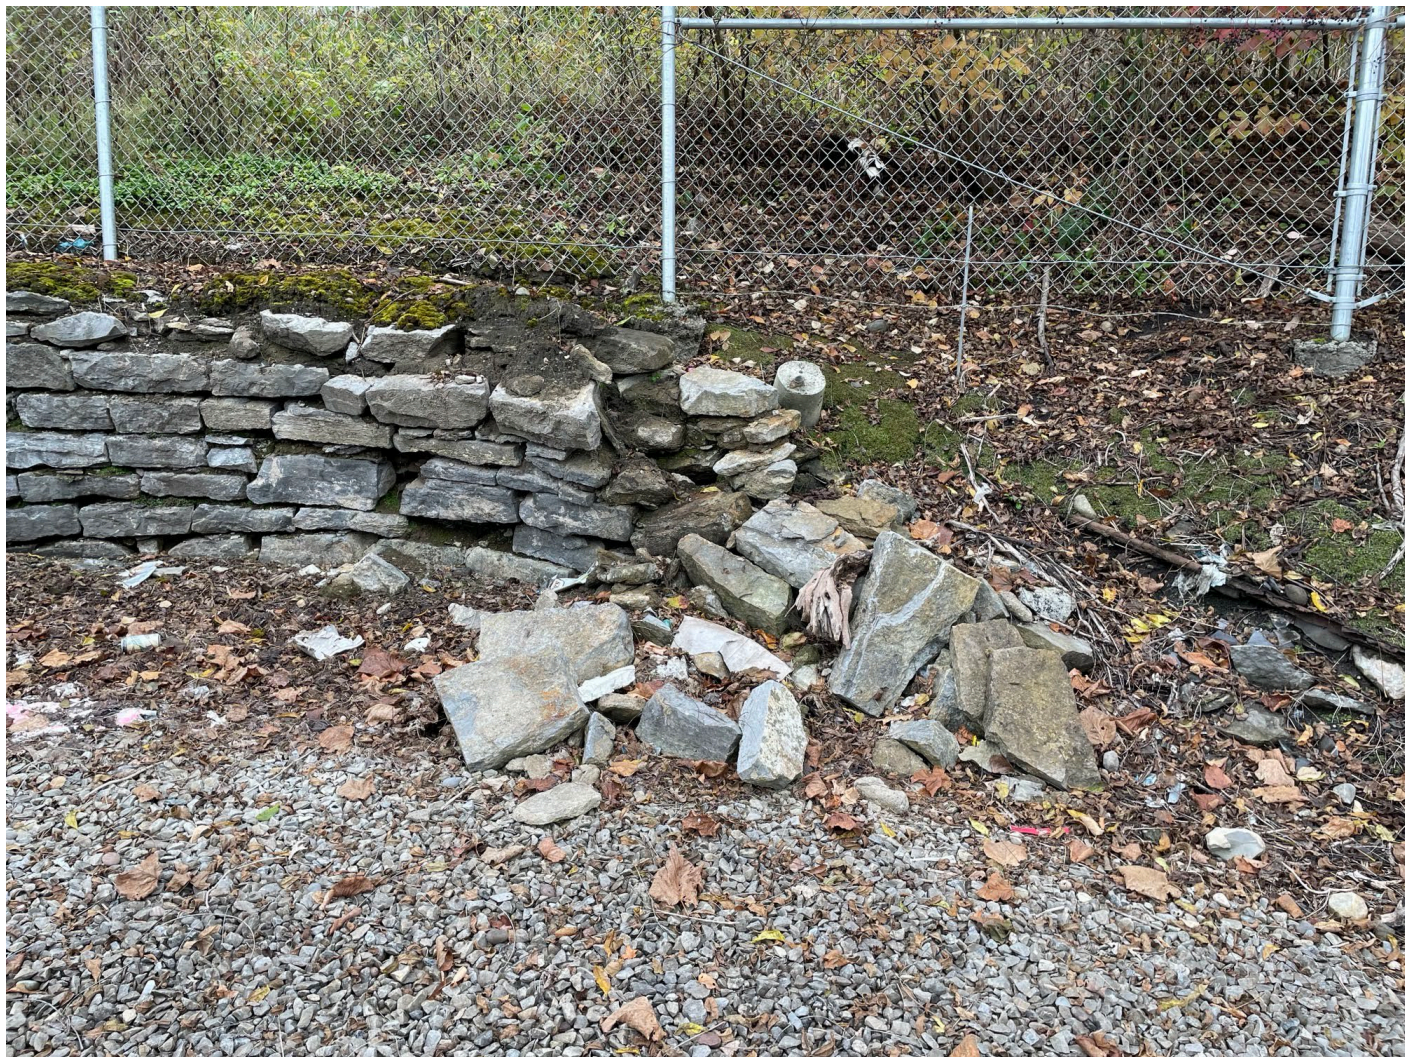
Damaged retaining wall, southern portion of substation

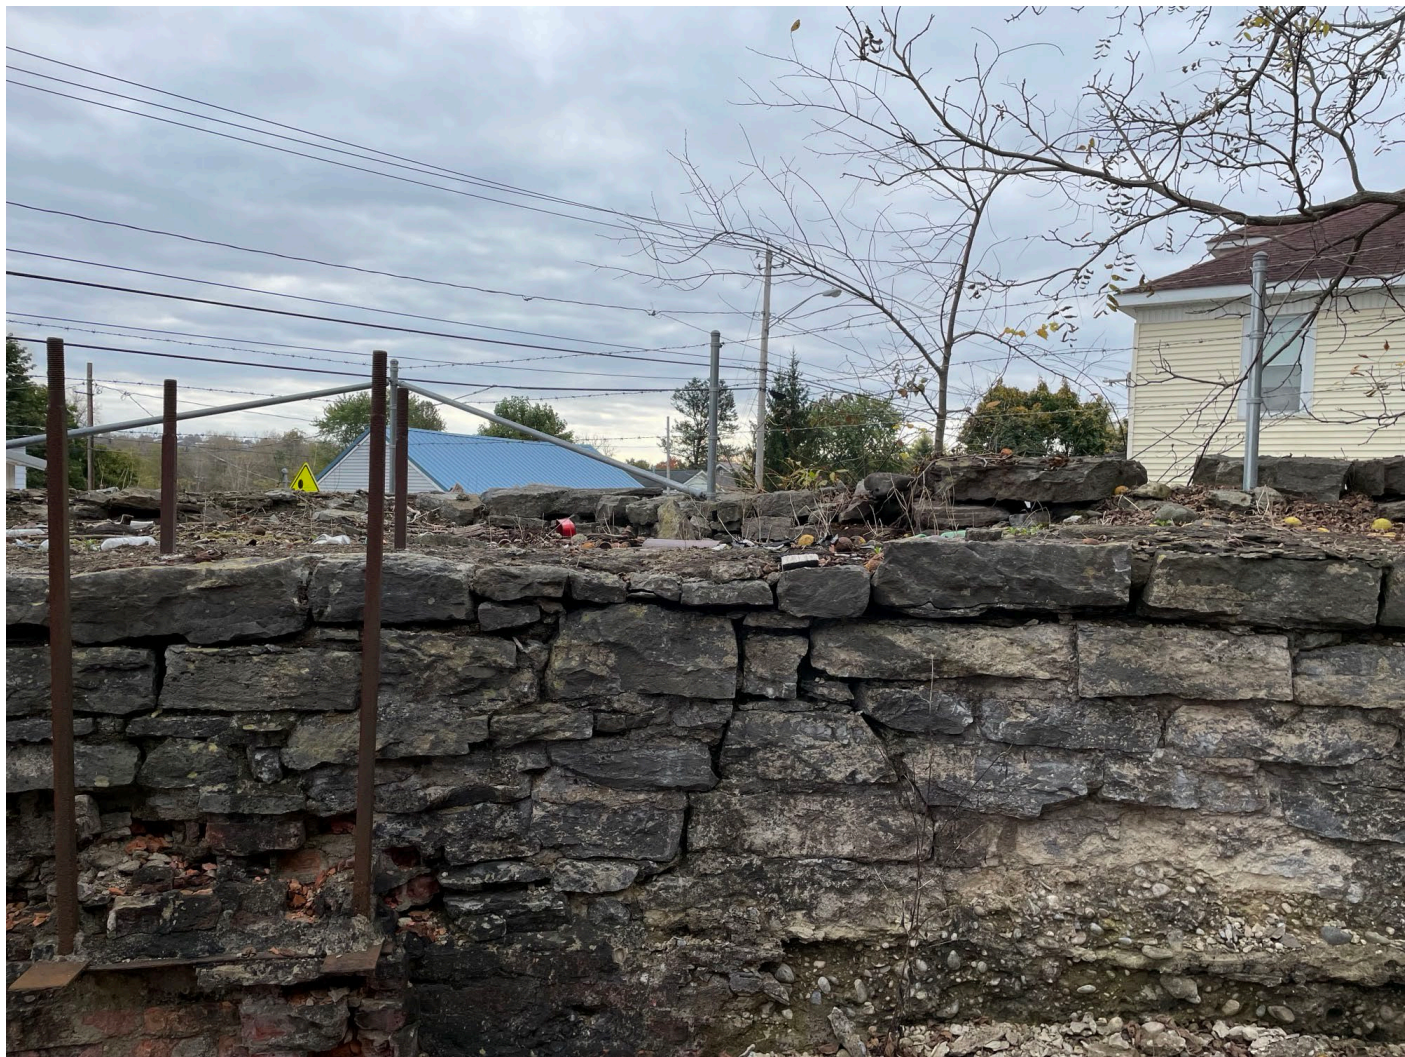
Retaining wall, eastern portion of substation

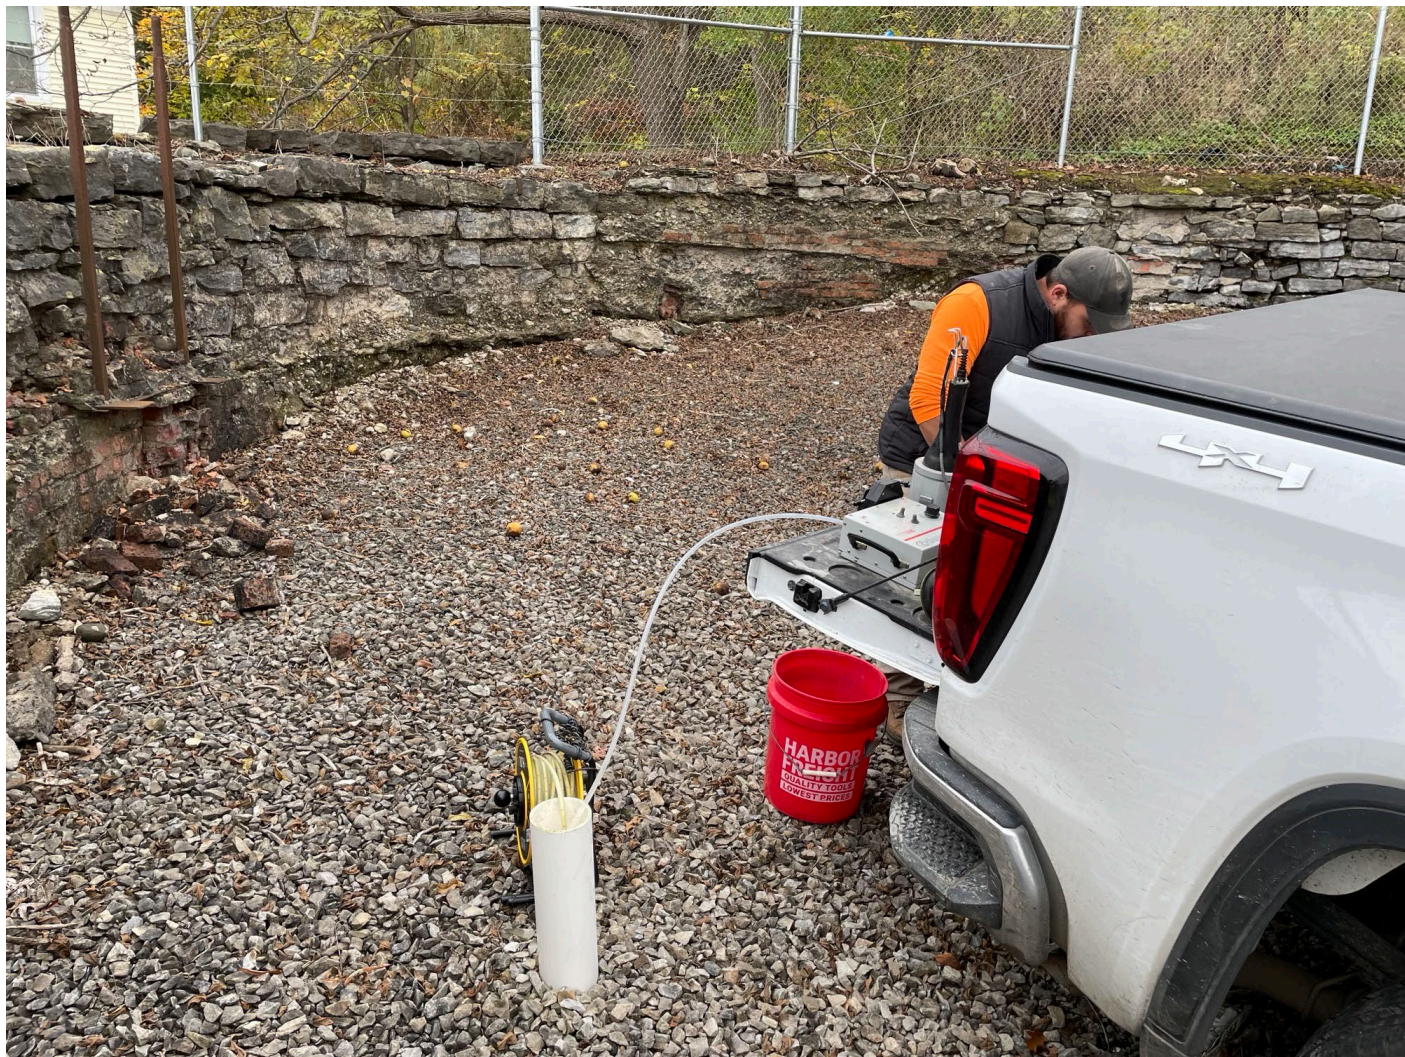
Sampling EW-1, no NAPL was detected

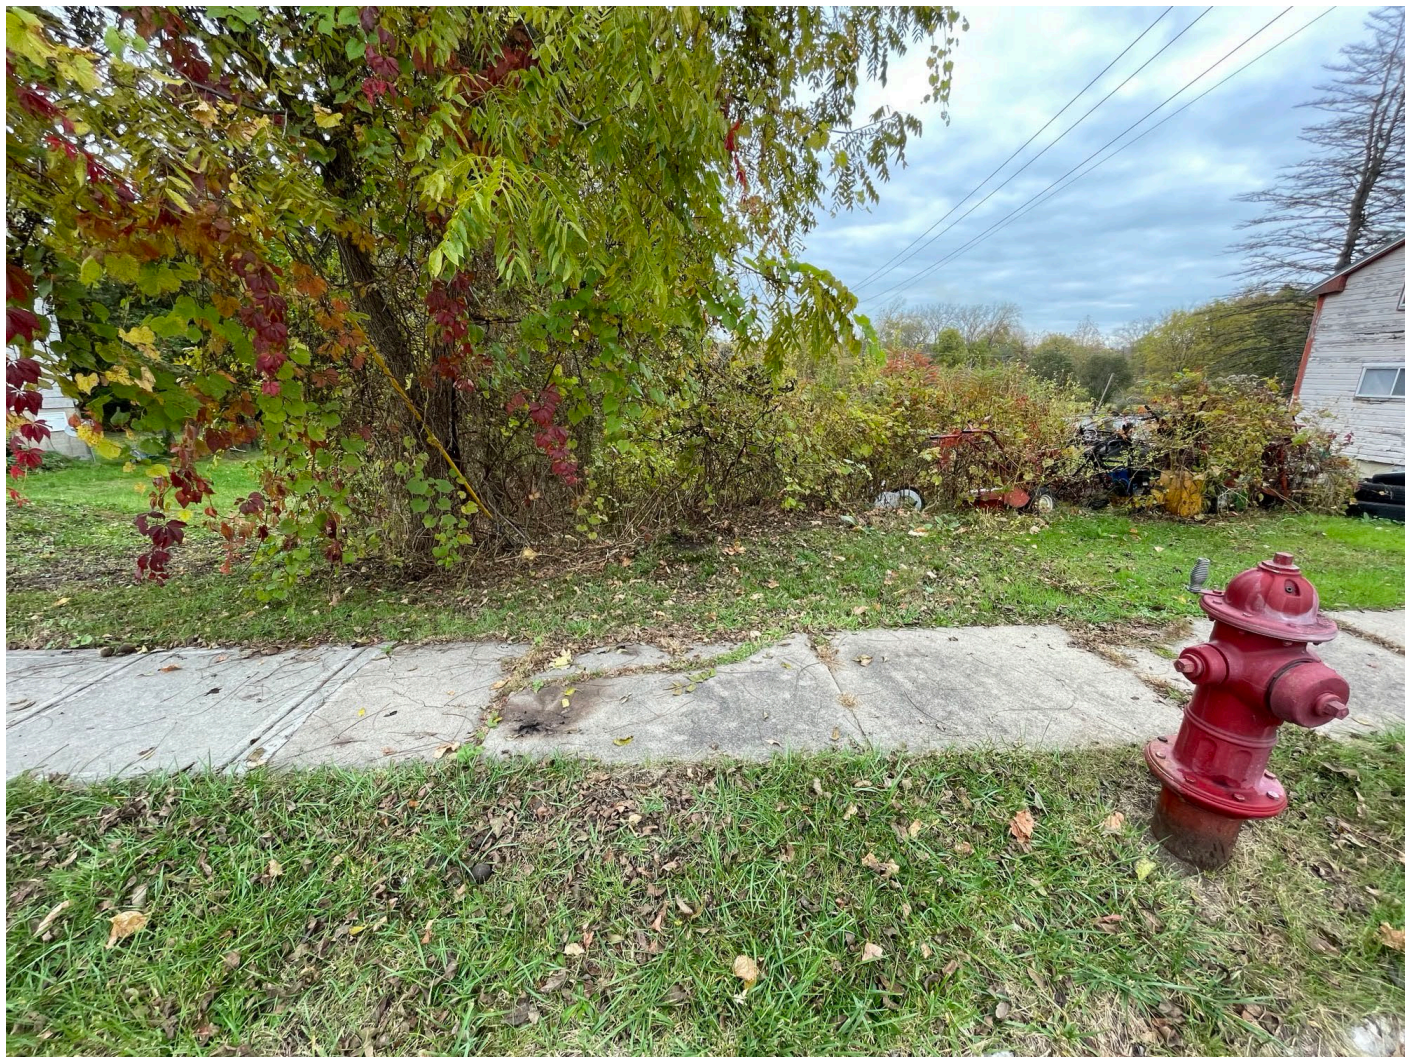
MW-9 location near residence on State St.
