Re: National Grid Fort Plain Former MGP Site

NYSDEC Site No. 4-29-007 Fort Plain, New York 2024 Periodic Review Report, revision 1

2024 Periodic Review Report National Grid Fort Plain Former MGP Site 14 Hancock Street, Fort Plain, NY 13339

Attachment 2 – Quarterly Inspection Checklists

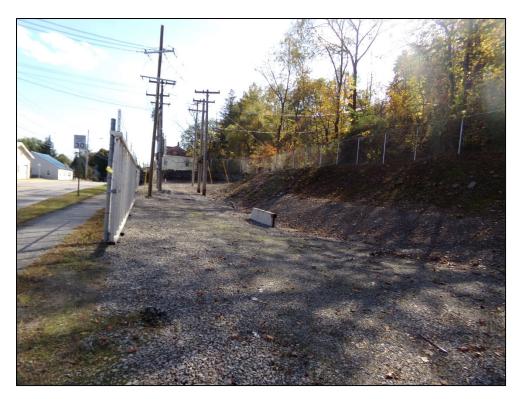
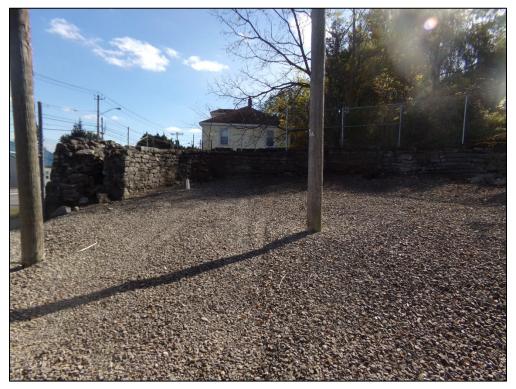
Site Conditions – October 19, 2023

Site Controls							
Fence Condition	GOOD FAIR		DAMAGED	COMMENTS:SW Corner has small damage from tree			
Main Gate Condition	GOOD	FAIR		DAMAGED	COMMENTS:		
Padlock-NG/GES	OPERATIONAL		NON-C	PERATIONAL	COMMENTS:

Southern Gas Holder Retaining Wall				
Condition of Wall	GOOD	FAIR	POOR	COMMENTS:small possible collapse still secure
