**Re: National Grid Fort Plain Former MGP Site
 NYSDEC Site No. 4-29-007
 Fort Plain, New York
 2025 Periodic Review Report**

Enclosed for your review is the 2025 Periodic Review Report (PRR) for the National Grid Fort Plain Former MGP Site in Fort Plain, NY. The PRR pertains to the period from September 13, 2024, through September 13, 2025, and includes a brief report and Institutional Controls/Engineering Controls (IC/EC) Certification Form.

**Field Inspection Form
Former MGP Site
Fort Plain, New York**

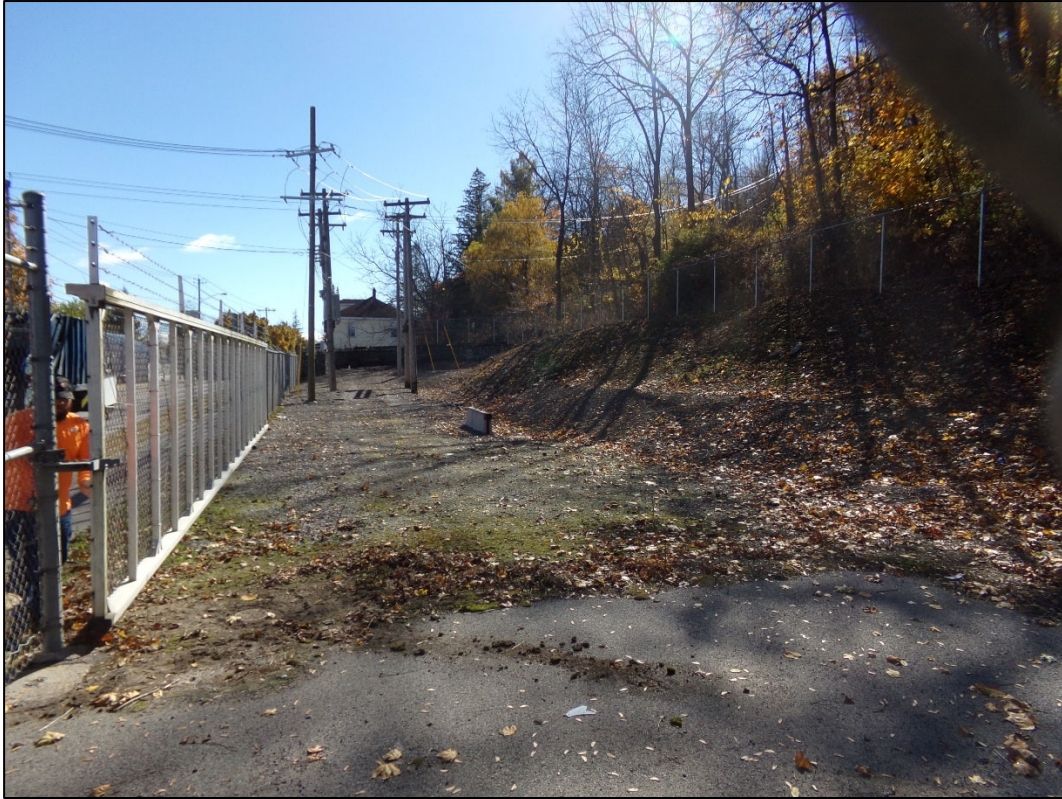
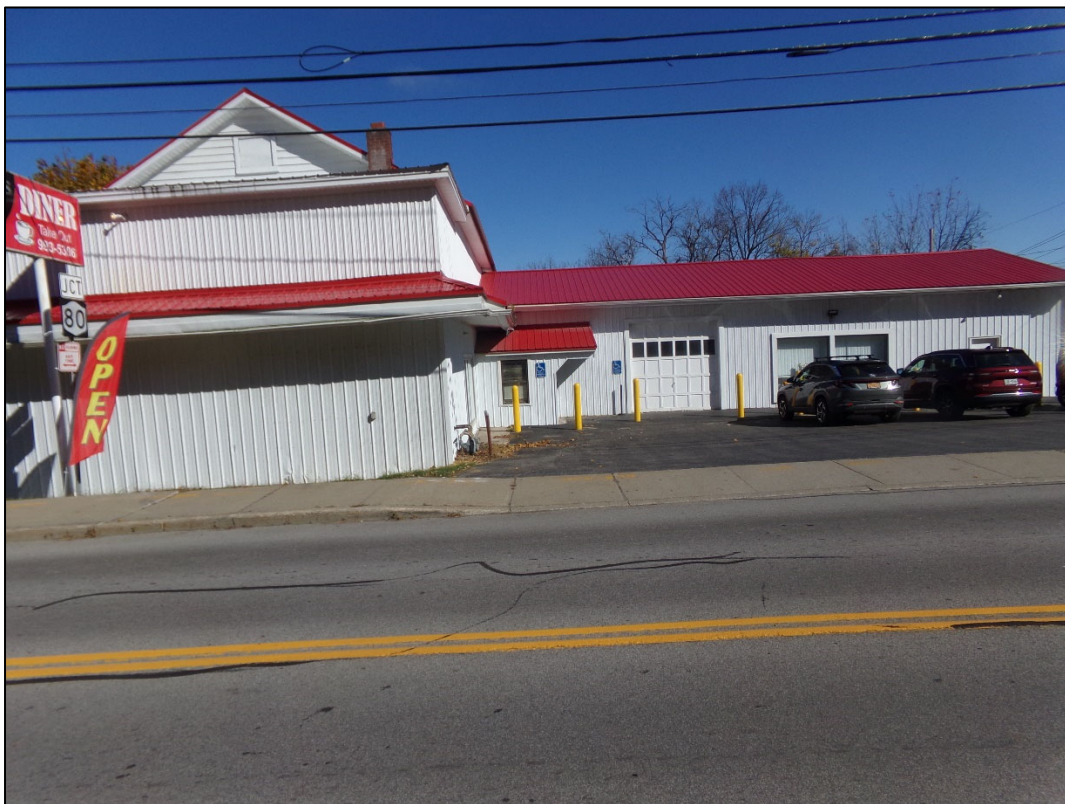
Site Conditions – October 2024

Southern Gas Holder Retaining Wall				
Condition of Wall	GOOD	FAIR	POOR	COMMENTS:small possible collapse still secure
