September 12, 2012

**RE: August 2012 Well Decommissioning Letter Report  
Storonske Cooperage  
2425 Kraft Road  
Schodack, Rensselaer County, New York  
NYSDEC Site No. 442021**

**Storonske Cooperage**  
Well Closure  
Photos

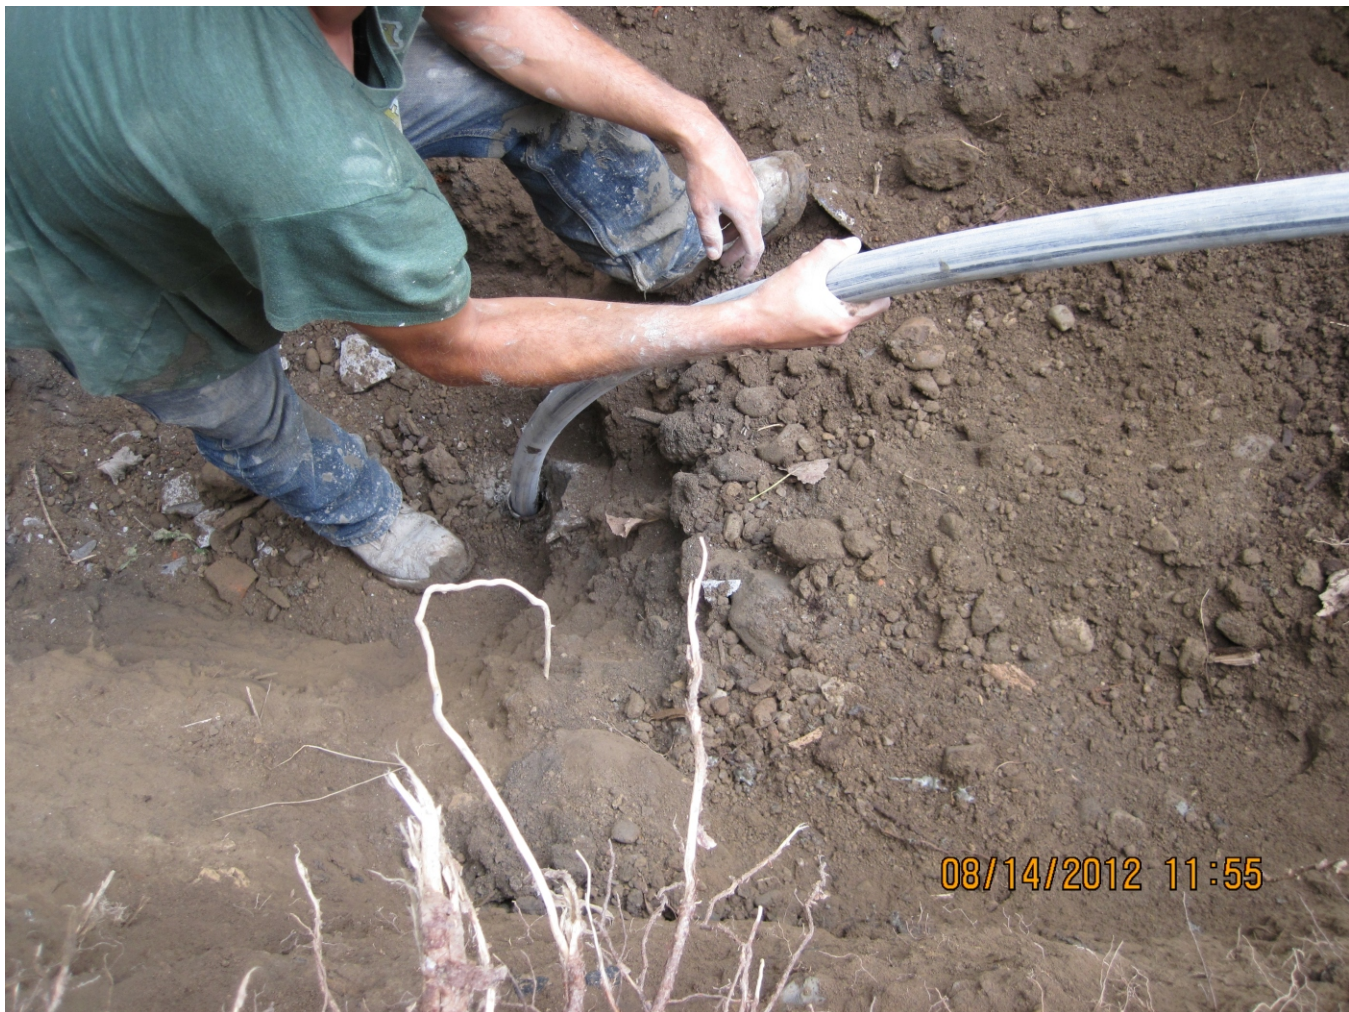
Tremie line installed in 2" well

Typical for all wells

Monitoring wells were filled with grout from the bottom of well to grade via pressurized injection. The grout mixtures were mixed using the Geo-Loop 50-500 until a homogenous, smooth consistency was attained. Using a tremie pipe, grout was injected filling the well from bottom to top. Upon completion of grouting, each well location was excavated to a depth of approximately 5' and the casing was cut off. Site restoration was completed subsequent to all well decommissioning activities. The excavations were backfilled and the grouted monitoring well locations were restored with materials similar to those found in the surrounding location.

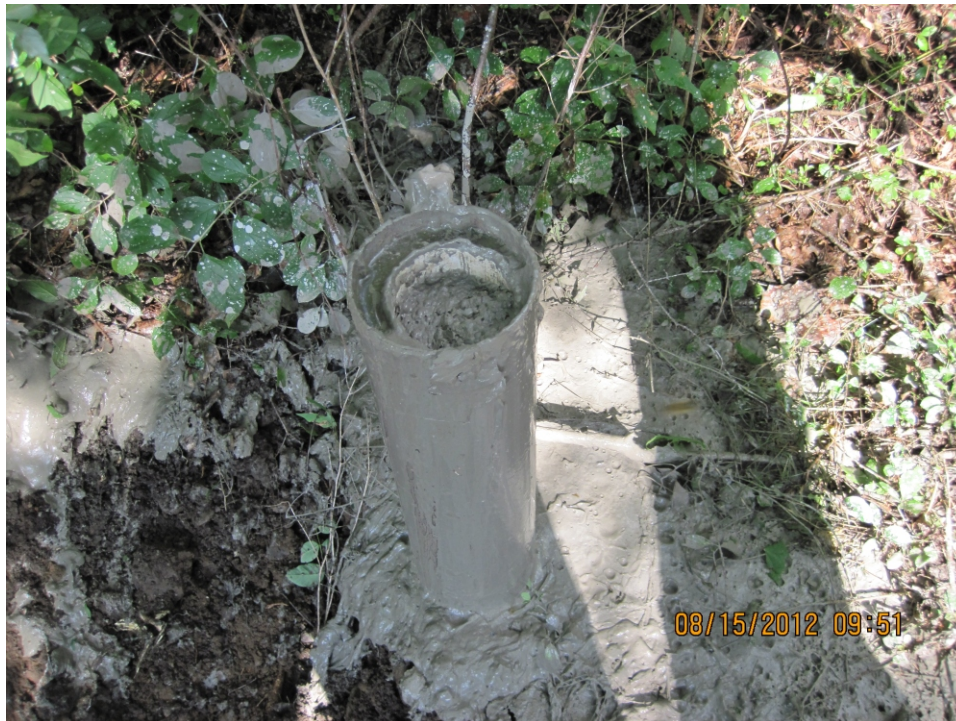
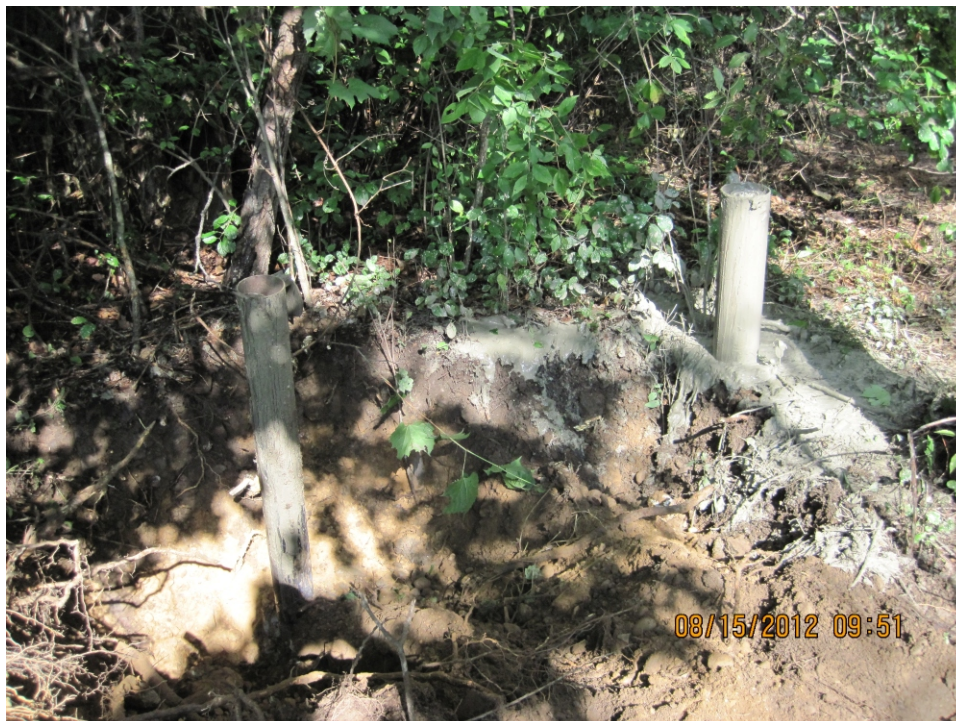
## Grouted wells

Typical for all wells

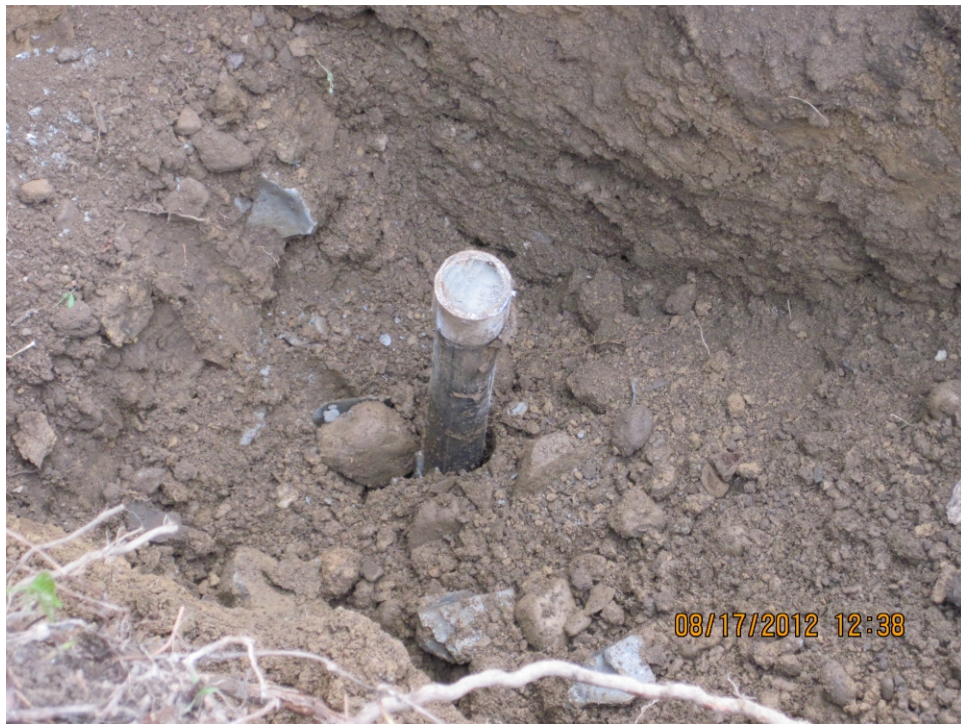
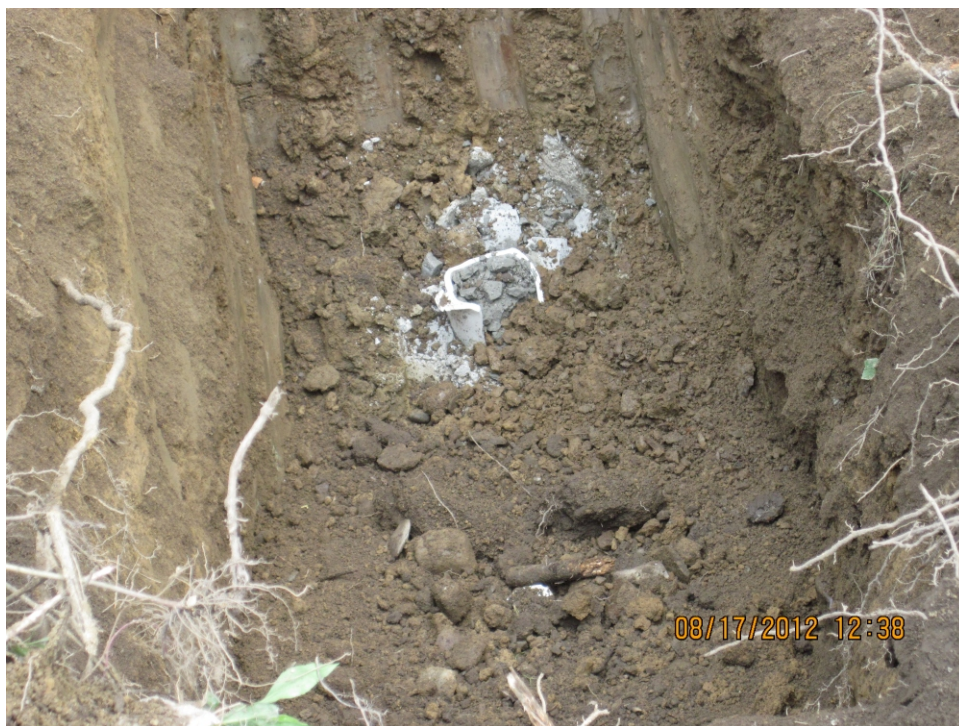
Grouted wells cut ~ 5' below ground surface

Typical for all wells

Following grout injection procedures, PES removed the protective casing (i.e. standpipe) and associated concrete from all monitoring well locations.

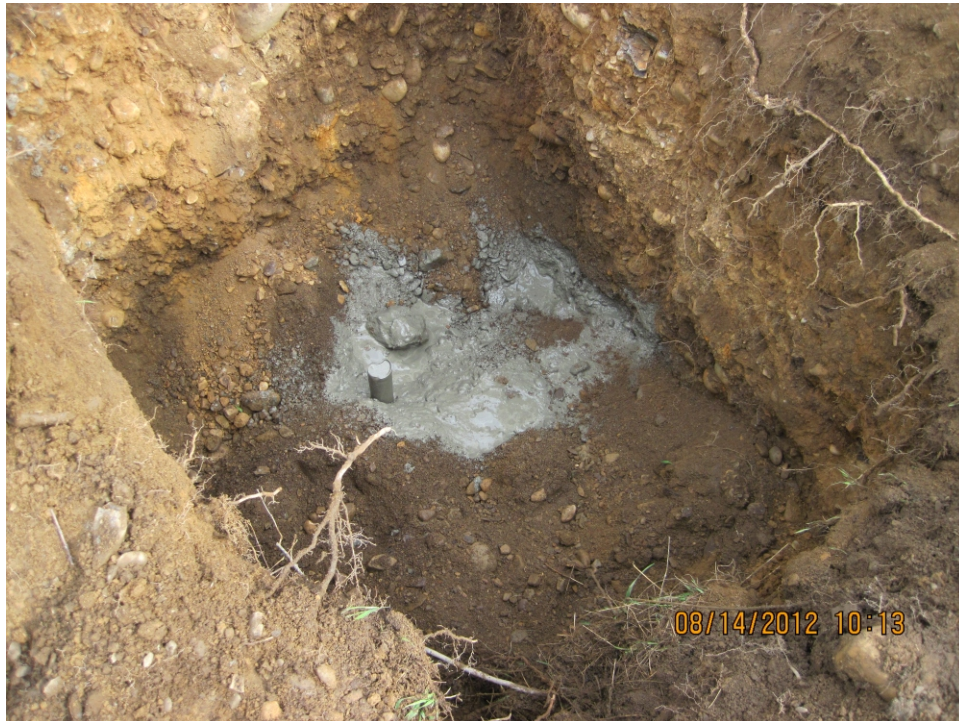
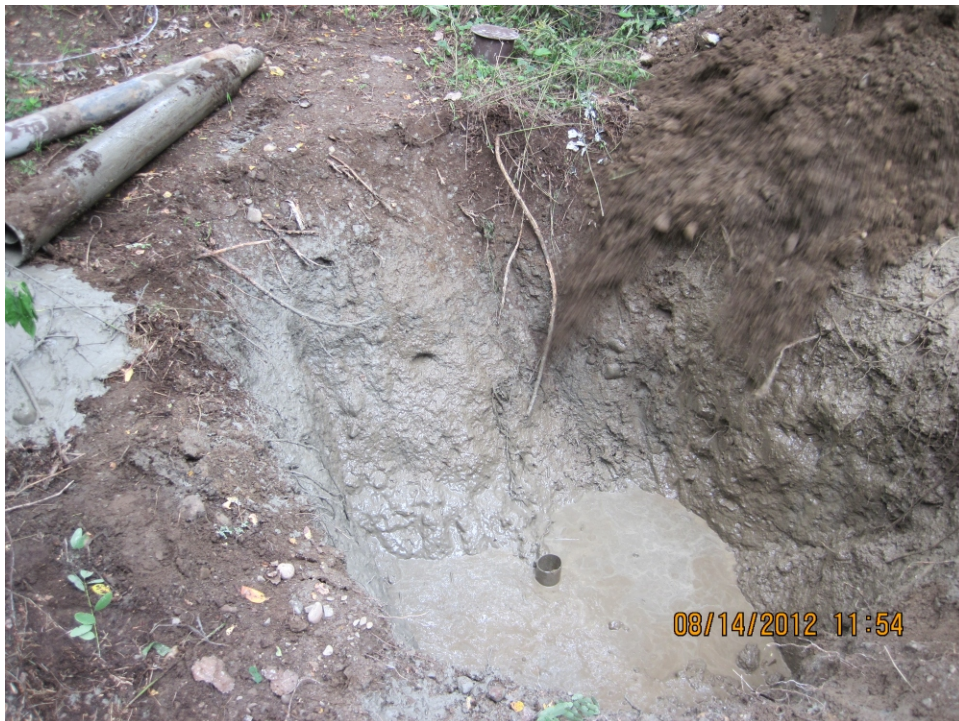
Grouted wells cut ~ 5' below ground surface  
Notice removed upper casings

Typical for all wells

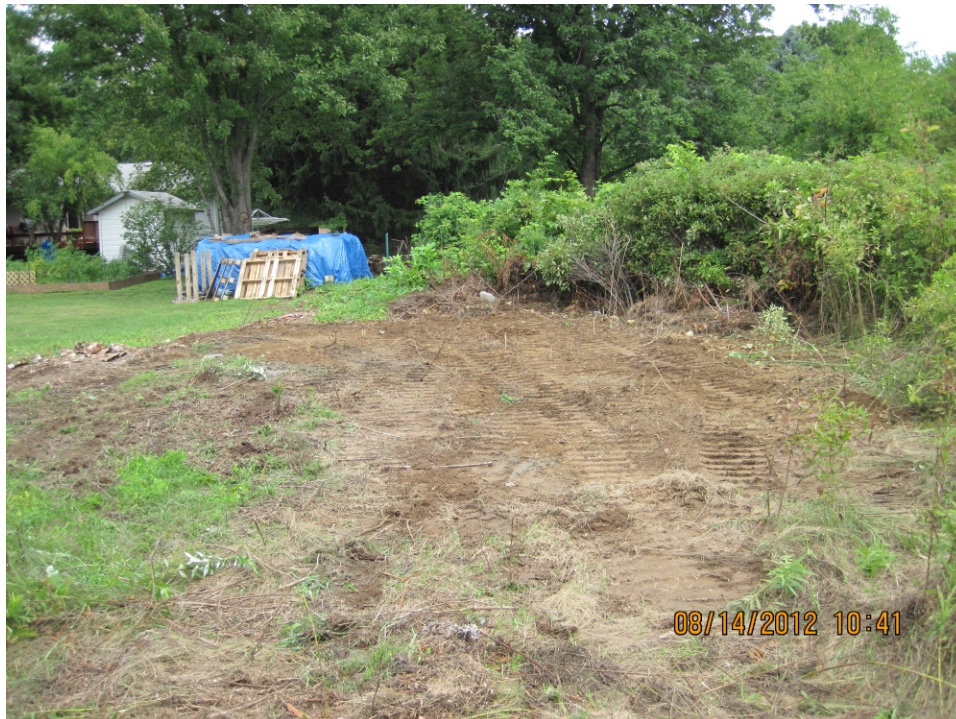
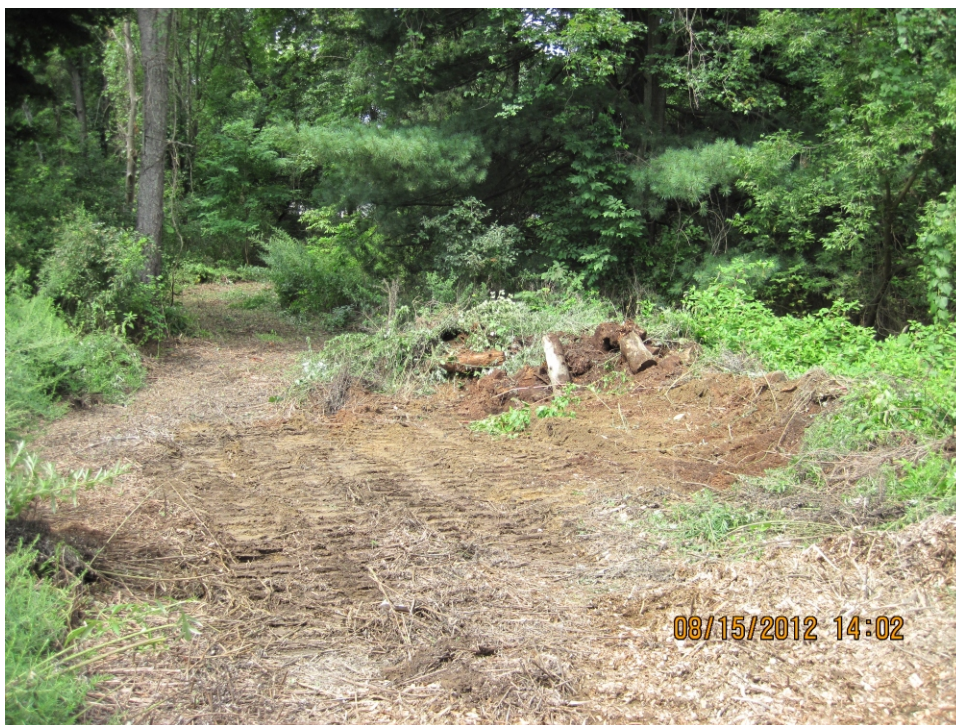
Backfilled and graded well locations

Typical for all wells
