**Brown and Caldwell Associates**

**Letter Report**

Subject: Completion Letter Report  
Gas Utility (PL E-20) Partial Replacement Project  
Troy, Rensselaer County, New York  
NYSDEC Site No. 4-42-029

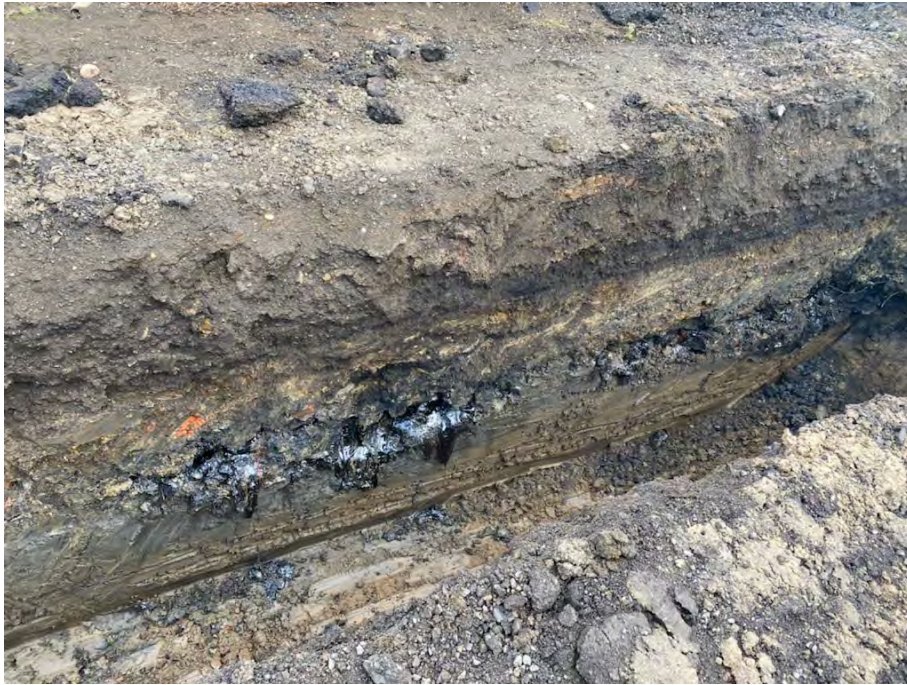
- On June 8, 2022, during trench excavation on CSX property at approximately Station 24+78, a tar-like material was observed along the western sidewall of the excavation at approximately 3 feet below ground surface (bgs) (refer to Photograph 37 in Attachment B). Excavation was temporarily halted, NYSDEC was notified, and NYSDEC Spill No. 2202145 assigned. Following discussions with CSX and the NYSDEC, excavation in this area resumed on August 4, 2022. The tar-like material was observed from approximately Station 24+78 north to approximately Station 23+32 on the western sidewall (approximately 2 to 4-foot thickness), and Station 24+42 to Station 23+32 on the eastern sidewall (approximately 1-foot-thick non-continuous layer). Refer to Section 2.2 for a description of how this section of trench was lined with geosynthetics before backfilling. Refer to Section 2.5 for details on waste management of this material.

Photograph #37 – View looking west. Tar-like material visible on the west wall of the trench of the new gas transmission line on CSX property at Sta. 24+78. The layer of tar-like material is approximately 5 feet (ft.) below ground surface (bgs). (Photo Taken 6/8/2022).

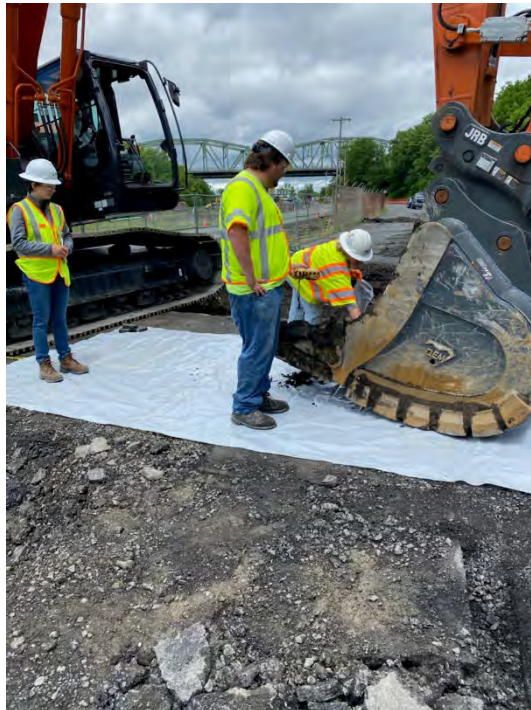
Photograph #38 – View looking north. Collection of waste characterization samples of soils impacted with tar-like material on CSX property. (Photo Taken 6/9/2022).

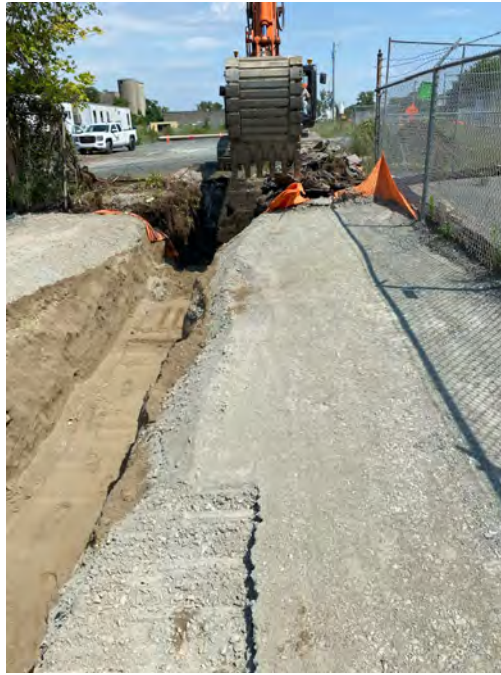
Photograph #43 – View looking north. Photo depicts trench excavation activities on Area 3 and exposure of concrete foundation walls on Area 2 (vicinity of Sta. 13+00). (Photo Taken 7/12/2022).

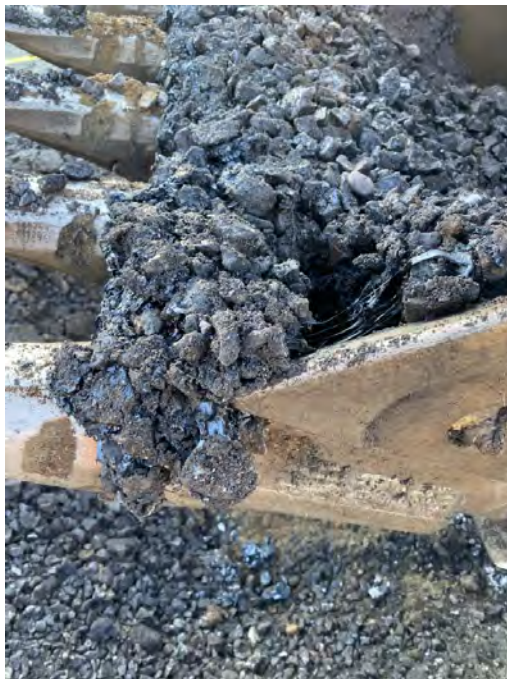
- On July 20, 2022, during trench excavation activities on Troy LDC property at approximately Station 9+80, a tar-like material was observed within the trench at approximately 1.5 feet bgs, with a thickness of 6 inches (refer to Photograph 46 in Attachment B). This material was observed from approximately Station 9+80 north to approximately Station 6+80. Refer to Section 2.5 for details on waste management of this material.

Photograph #46 – Photo depicts tar-like material observed on Area 2 at approximately Sta. 09+80. Tar-like material approximately 18 inches bgs, 6 inches thick, and intermixed with aggregate. (Photo Taken 7/20/2022).

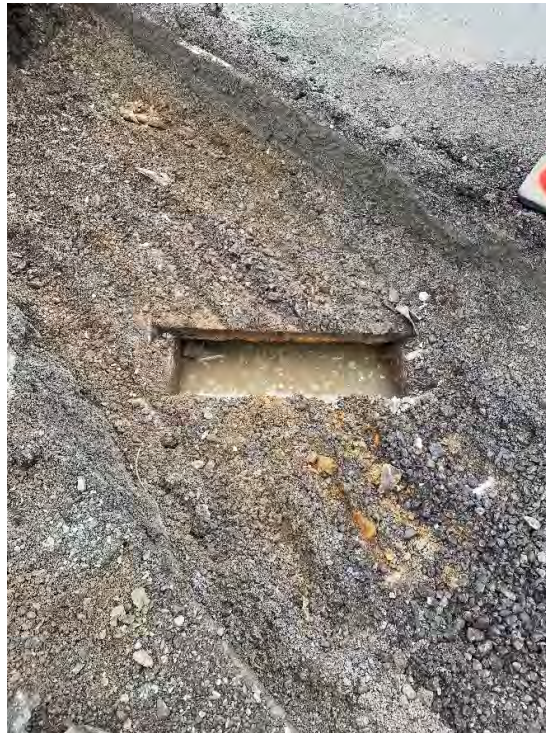
- On July 25, 2022, during trench excavation activities on Troy LDC property at approximately Station 9+00, a historical concrete vault structure was encountered just below existing asphalt (refer to Photograph 48 in Attachment B). The structure was investigated and contained approximately 6 inches of water and clay/soil fill, as well as five 1- to 2-inch diameter pipes oriented northeast to southwest. The historical concrete structure was demolished, and all observed pipes were cut and capped at the sidewalls of the trench. Sediment and debris (following re-sizing) was commingled with soil and transported to the landfill facility. Water generated from the pump out of the vault structure was managed by National Grid SIR's Troy (Water Street) Site Remediation Project. Refer to Section 2.5 for details on waste management of this material.

Photograph #48 – View looking east. Photo depicts a historic concrete structure that was encountered on Area 2 (vicinity of Sta. 09+00). The structure contained approximately 6 inches of water, clay/soil fill, and five pipes (1 to 2-inch diameter, oriented northeast to southwest). (Photo Taken 7/25/2022).

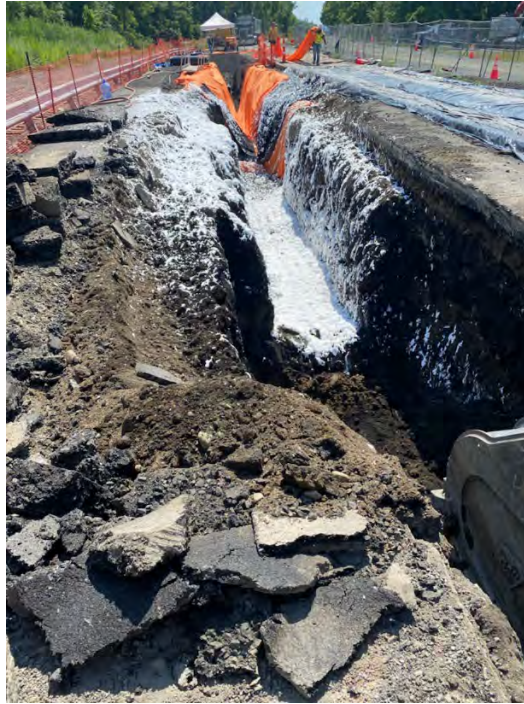
Photograph #55 – View looking south. Application of Rusmar Long Duration Foam within the trench on CSX property where tar-like material was encountered (vicinity of Sta. 23+00). (Photo Taken 8/4/2022).

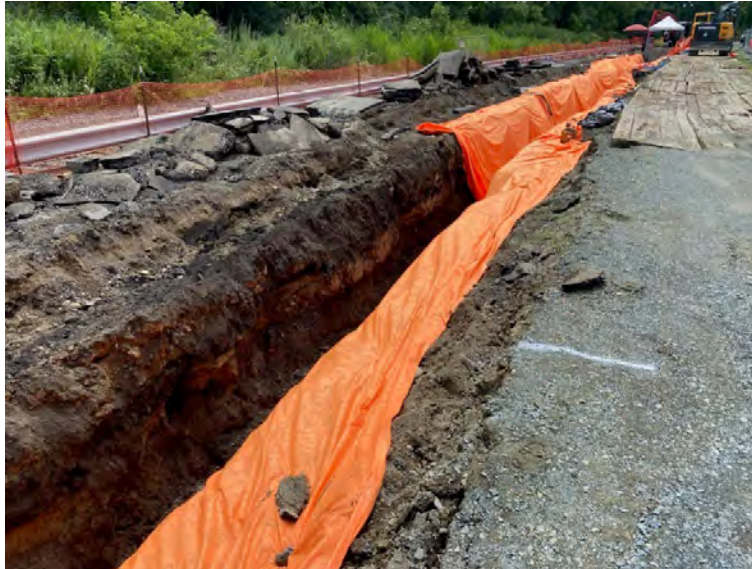
Photograph #56 – View looking southeast. Installation of non-woven, orange-colored geotextile fabric within the trench on CSX property. White line is approximately 10 feet north of last visual observation of tar-like material. LLDPE liner, sandwiched between non-woven, orange-colored geotextile fabric, was installed within the trench up to at least that line (approx. Sta. 23+32) from approx. Sta. 24+78. (Photo Taken 8/5/2022).

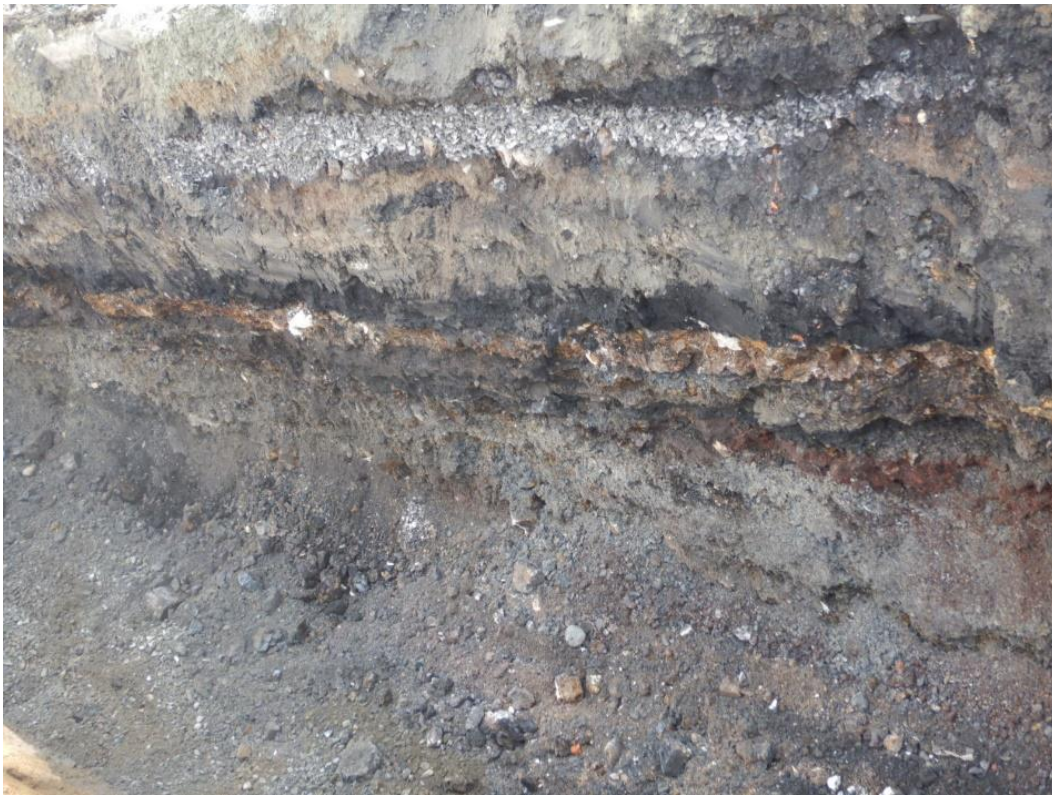
Photo 4. Trench wall with slag levels at bottom. East wall at Station 18+25. View facing northeast.

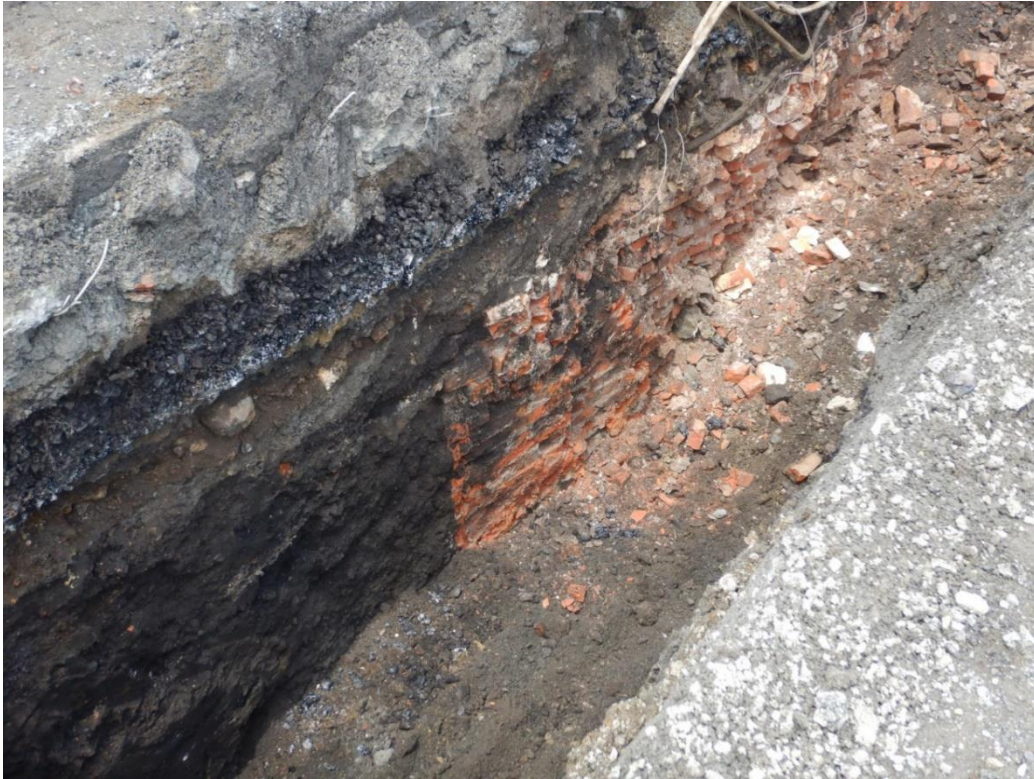
Photo 5. Trench segment with brick wall around Station 9+50 (approx. 700 feet north of the Troy-Menands bridge). View facing northwest.

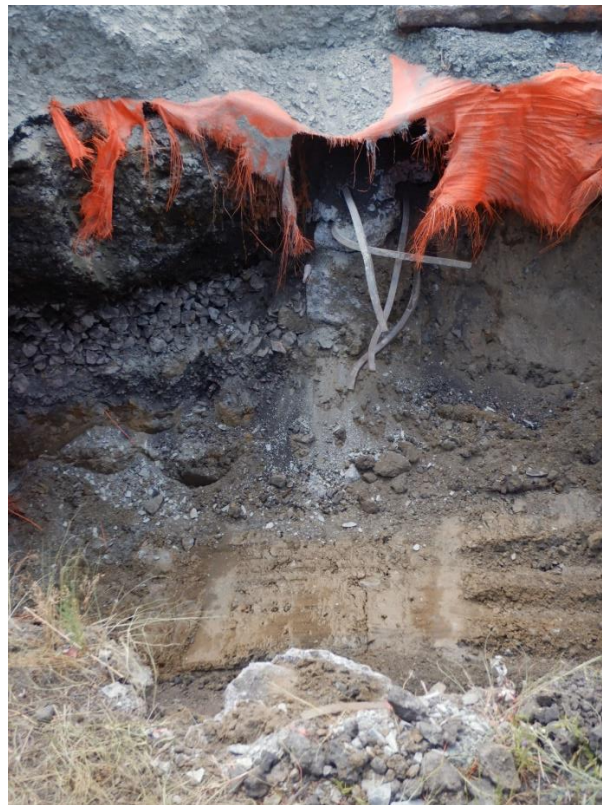
Photo 6. Concrete garage wall foundation crossing the trench at about Station 10+00 (approx. 600 feet north of the Troy-Menands Bridge). Note the rebar in the concrete wall. View facing west.

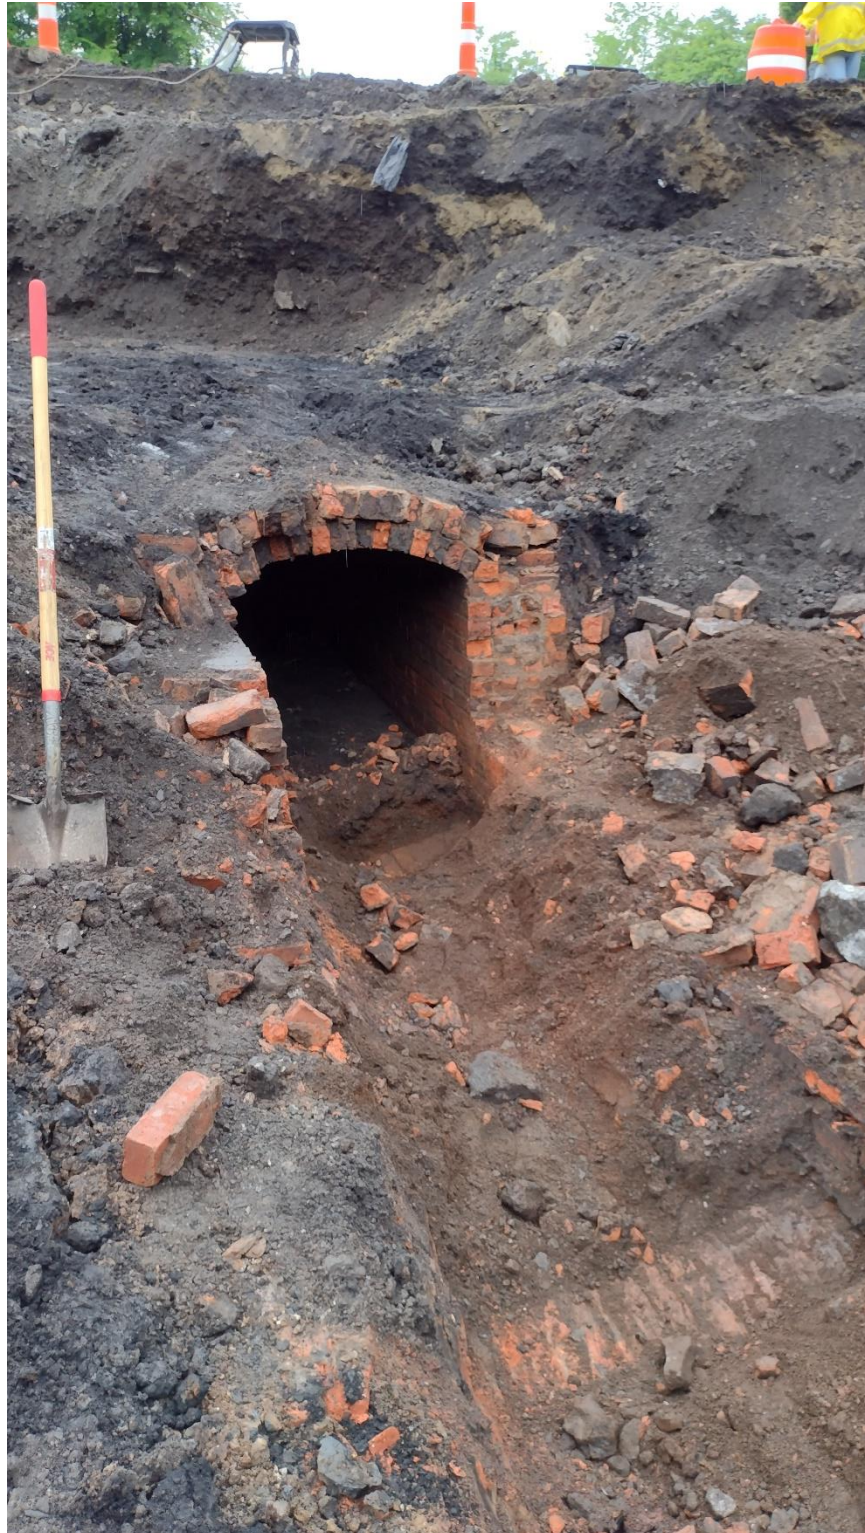
Photo 7. Culvert found perpendicular to trench within Area 3. View facing east

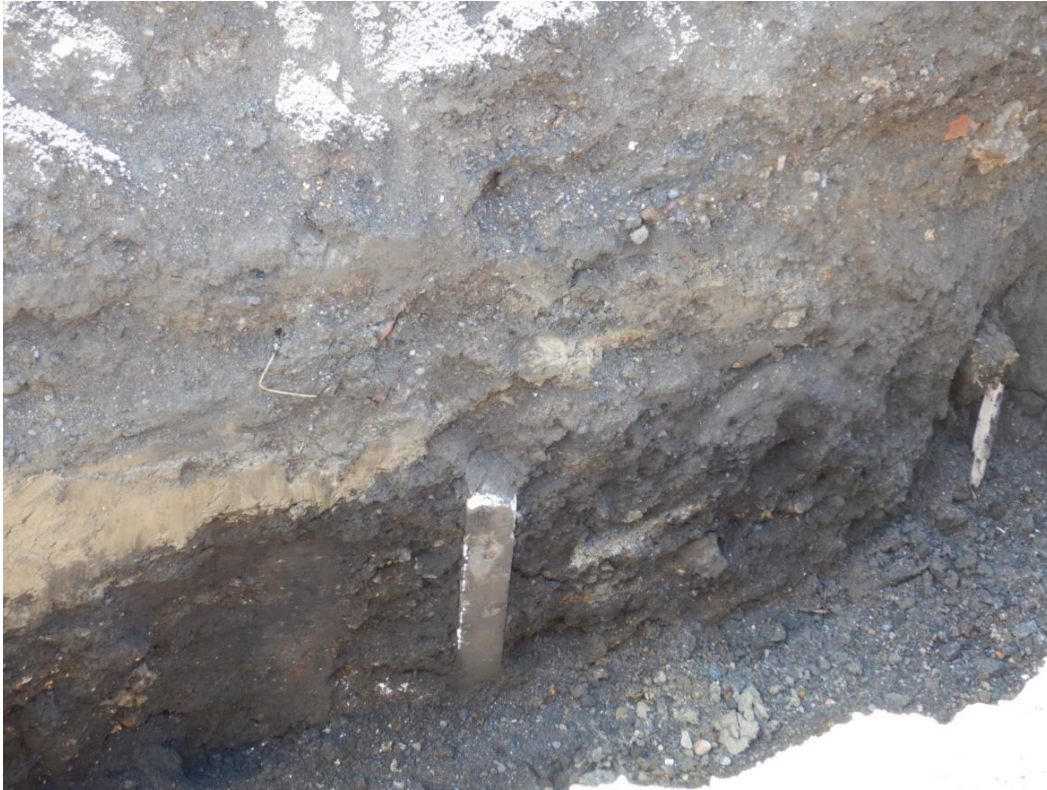
Photo 8. Stone post found in east wall of trench at Station 25+15 (approx. 815 feet south of the Troy-Menands Bridge). See also Photo 9. View facing east southeast.

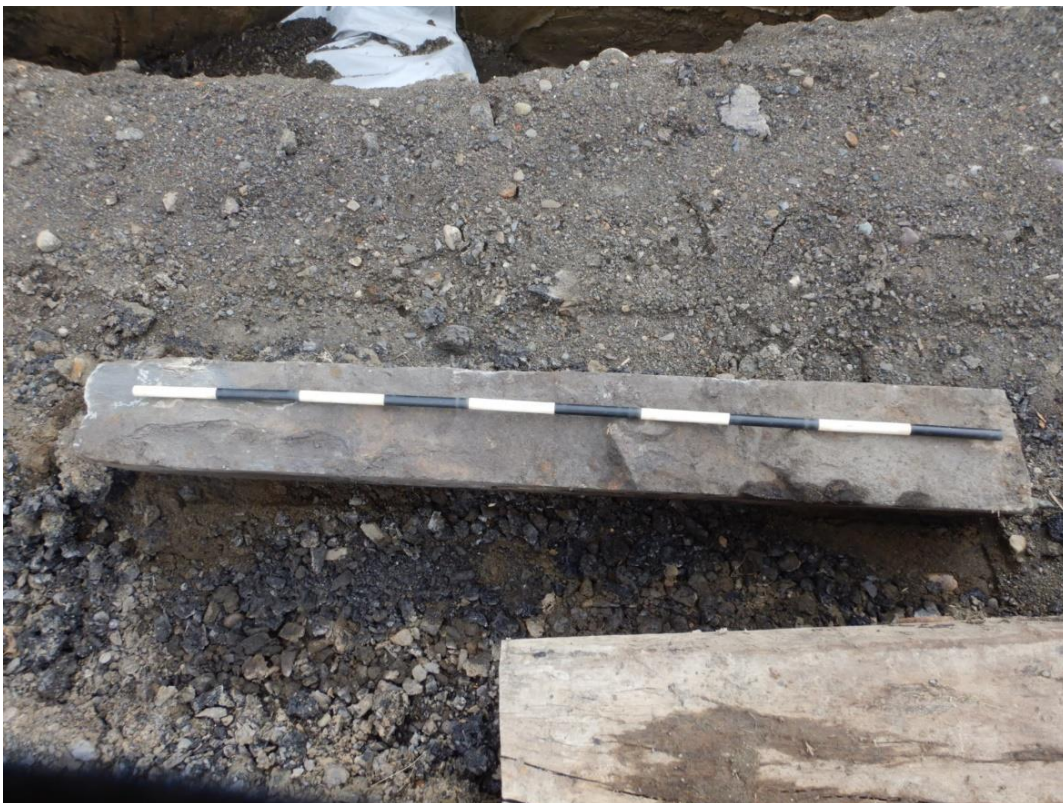
Photo 9. Part of stone post broken off and removed from trench (see Photo 8). At least one side is rough cut. Scale stick is one meter (3.3 feet) long.

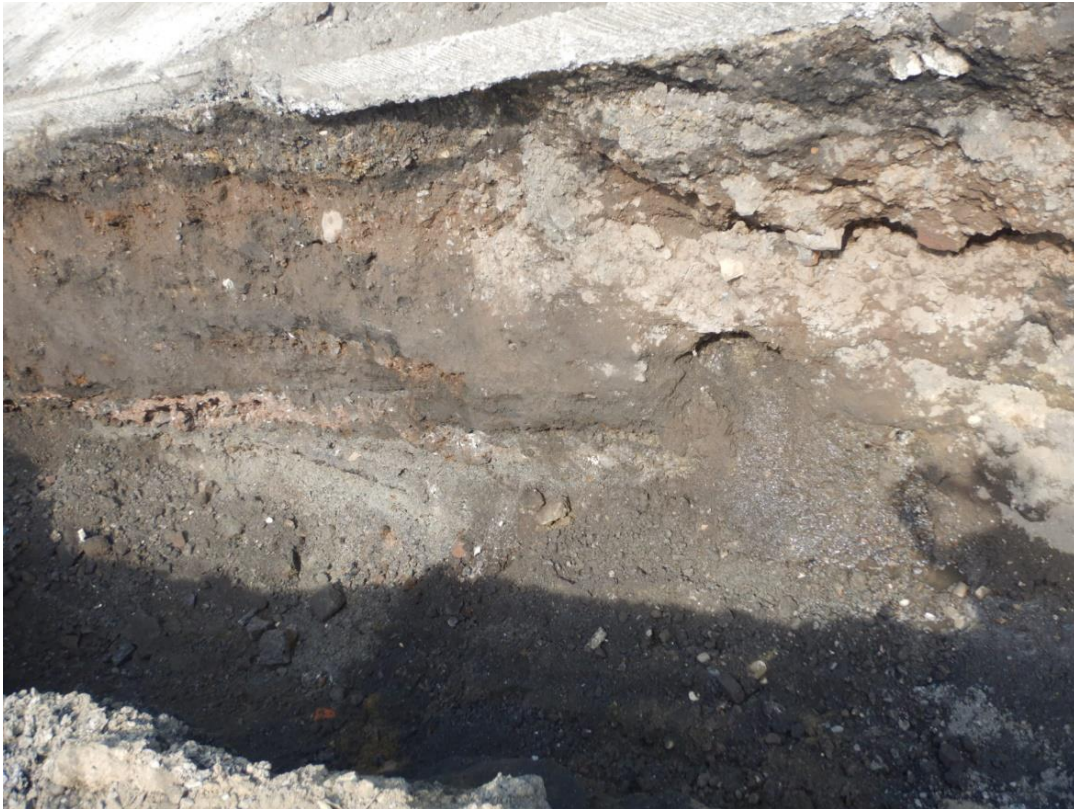
Photo 10. Seep found in east wall of trench (marked by an arrow in this photo) at Station 21+24 (approximately 425 feet south of the Troy-Menands Bridge). View facing east.

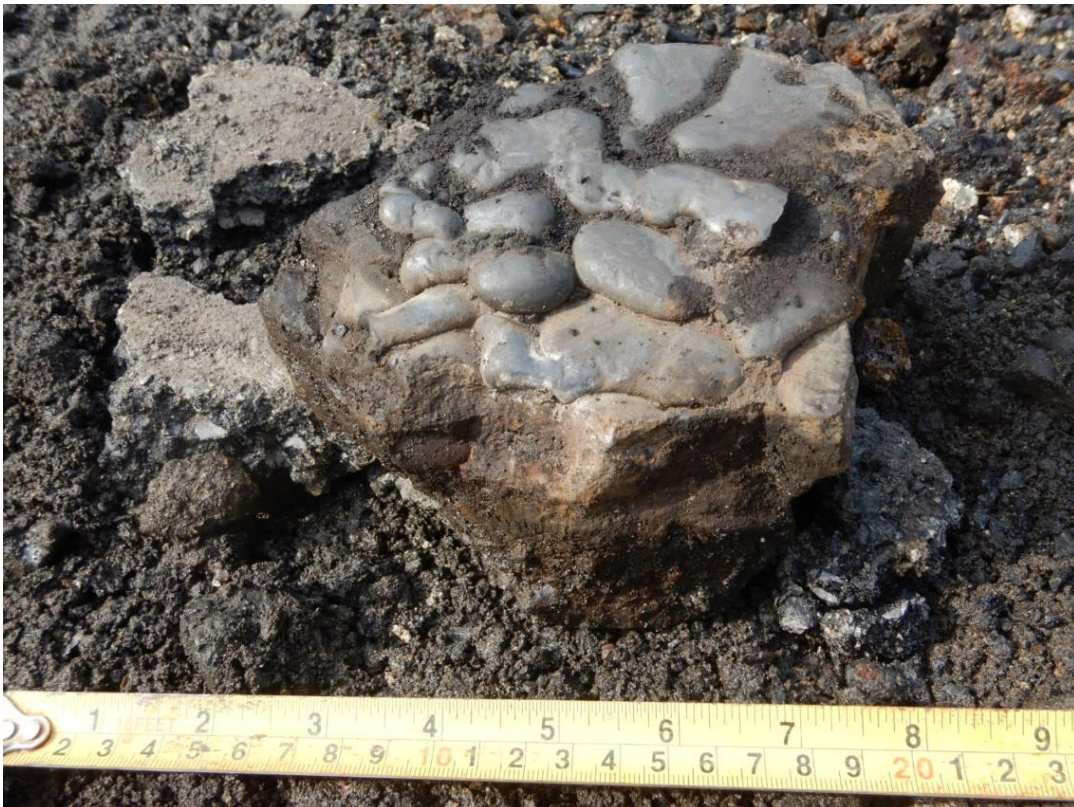
Photo 11. Typical slag chunks and metal cast offs found in the trench.
