STRUCTURAL INVESTIGATION REPORT

UNITED PLATING BUILDING

1742-44, Foster Avenue
Schenectady, New York

M. J. Engineering and Land Surveying, P. C.
1533 Crescent Road
Clifton Park, NY 12065
(518)371-0799

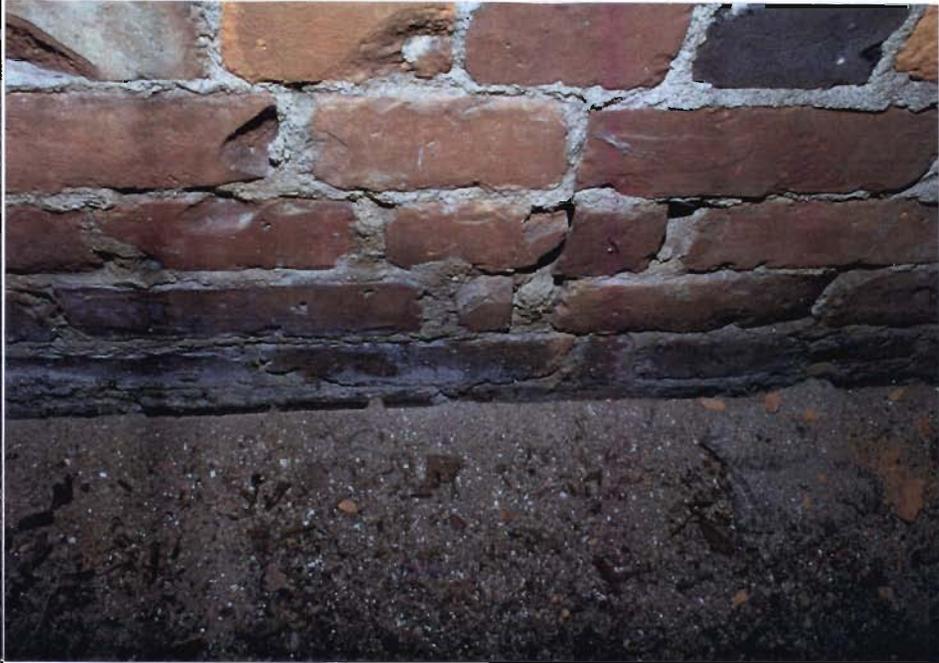
Photo No. 1

Location Level 6, floor at south wall

Description 3/8" gap between floor and wall

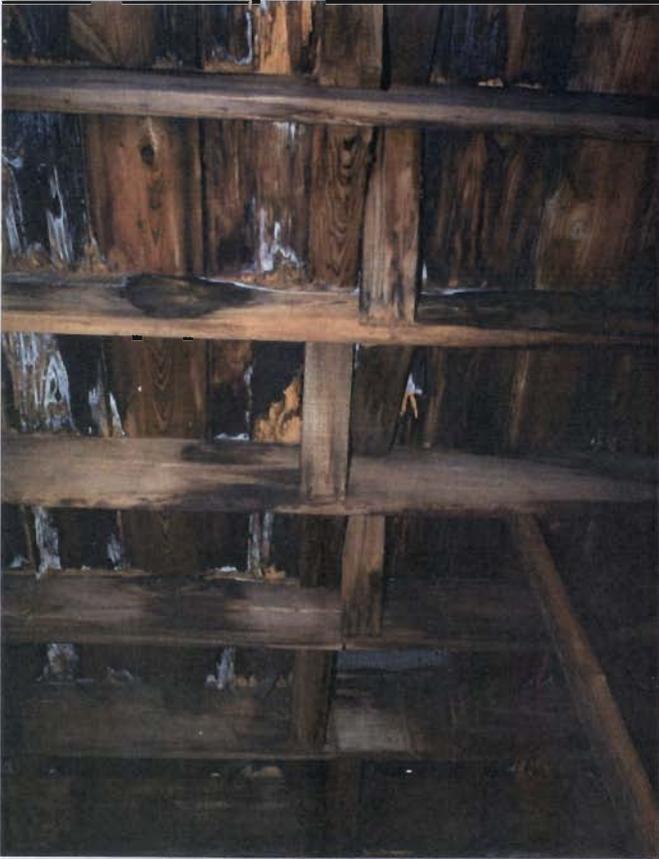
Photo No. 2

The timber plank/joist roof on level 6 shows wet (90%), water-stained and damaged (10%) members (*see photo 2*); active leakage was found in the southeast corner. The timber cross-bracing has slipped off in a few locations. Roof failure appears to be imminent above the spiral stairway due to rotted out planks and bowed rafters (*see photo 3*). The concrete floor has separated about $\frac{3}{8}$ " from the south wall (*see photo 1*). The concrete floor is cracked and delaminated next to a window in the east wall (*see photo 4*).

Location Level 6, roof

Description Timber planks are wet and rotted

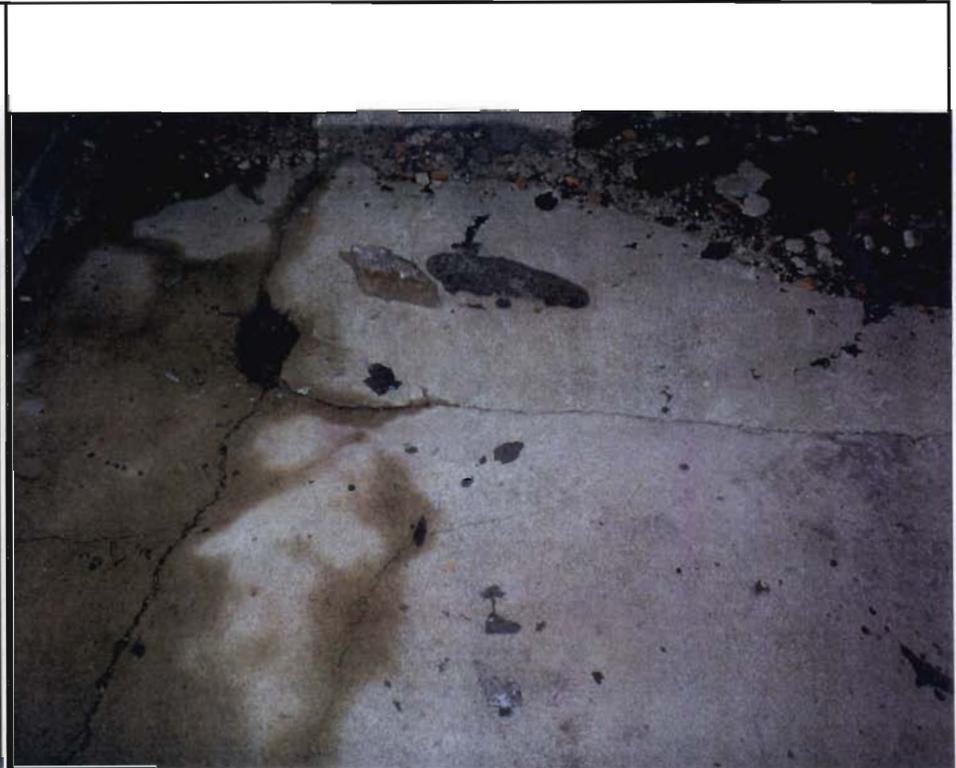
Photo No. 4

Location Level 6, floor at east window

Description Cracked and de-laminated concrete

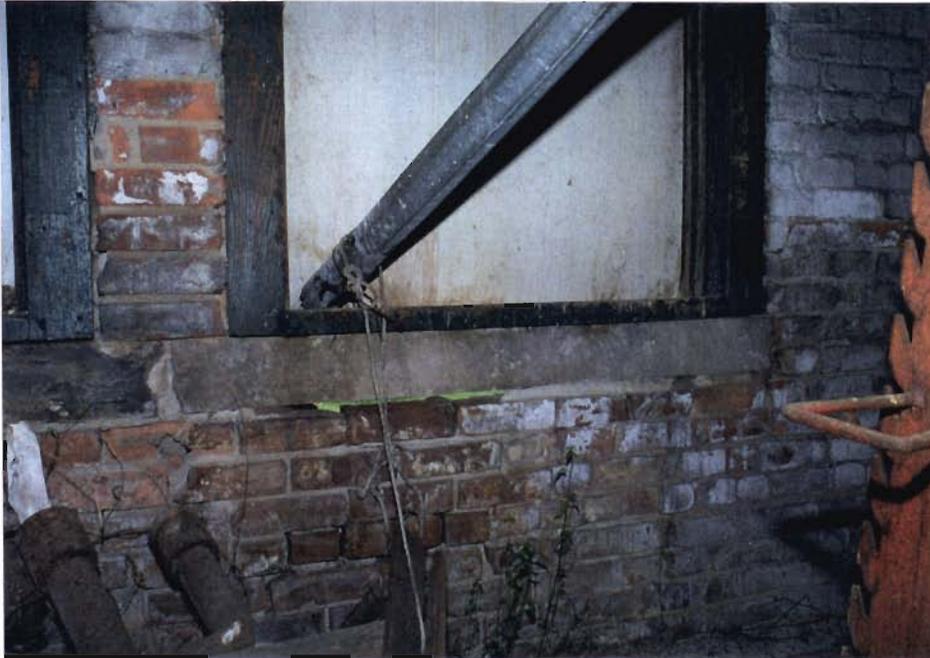
Photo No. 5

At level 5, mortar missing for its full depth was noted in the brick walls at several joints. Some bricks are displaced and can be pulled out by hand, especially at the north door jamb. The entire south wall was wet. The roof for level 4 shows several large chunks of concrete cap stones and bricks that have toppled from above (*see photo 6*), which have penetrated the roof at one location. The concrete ceiling is damp over 60% and has mesh reinforcement exposed at the bottom (caused by leakage in the southeast corner from level 6). Triangular cracks $\frac{1}{2}$ " - 1" wide were found above every window lintel, apparently caused by continuing displacement. The sill for the second window on the east wall has inadequate support from displaced bricks (*see photo 5*). The concrete floor has separated about $\frac{1}{4}$ " from the east wall.

Location Level 5, window at east wall

Description Gap below sill due to displaced bricks

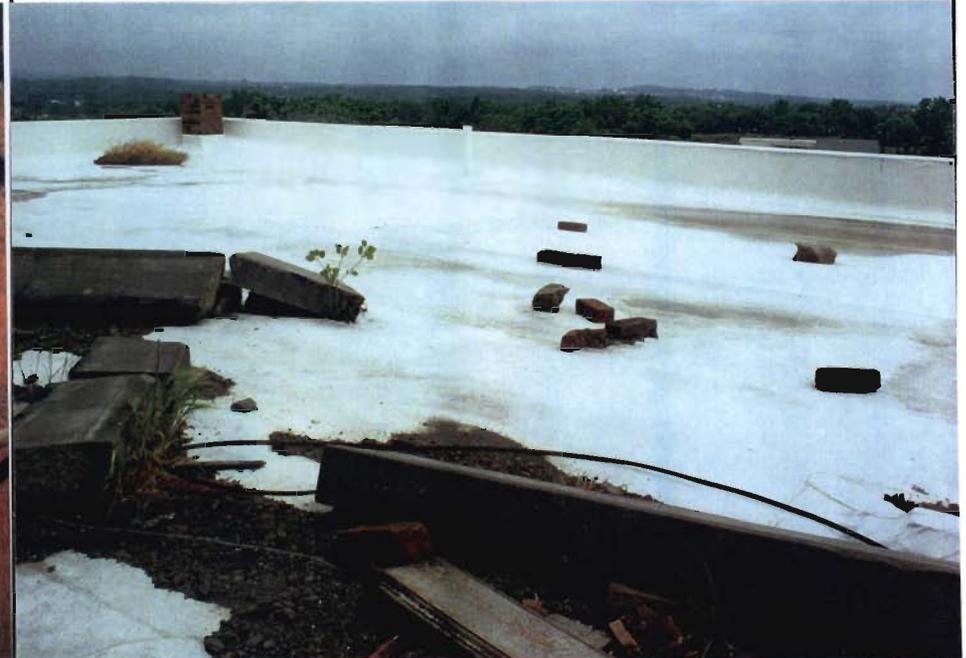
Photo No. 6

Location Level 4, top of roof (from level five)

Description Large pieces of concrete cap-stones fallen from above

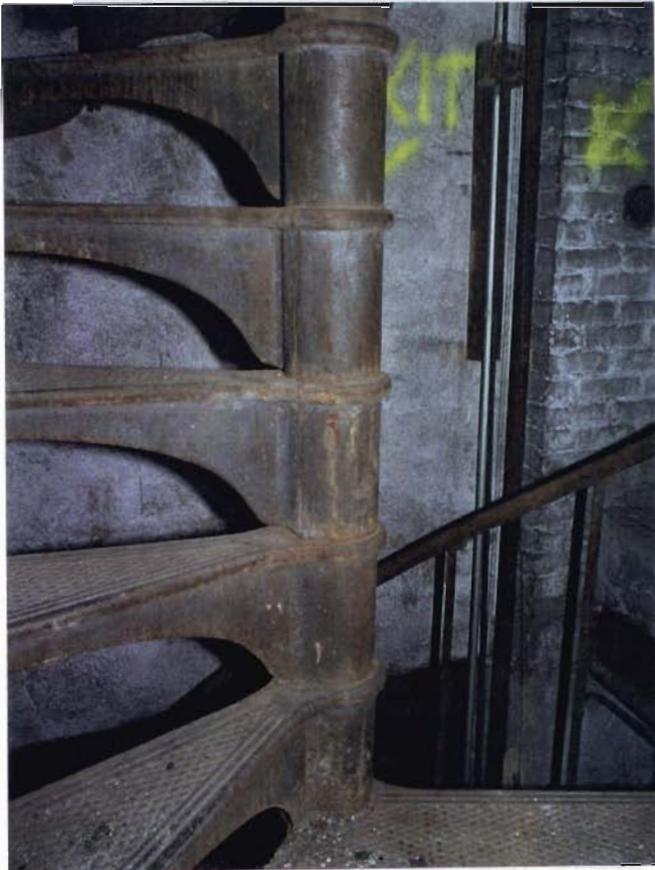
Photo No. 7

Location Level 4, spiral staircase

Description Cracked central sleeve sections

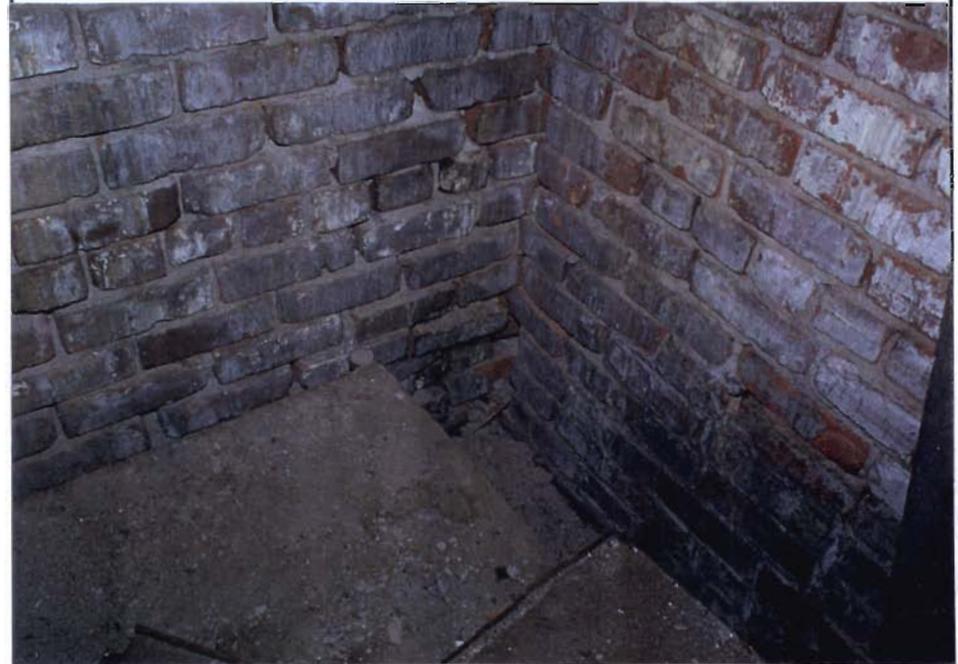
Photo No. 8

Location Level 4, southeast corner at bottom

Description Displaced bricks and open joints

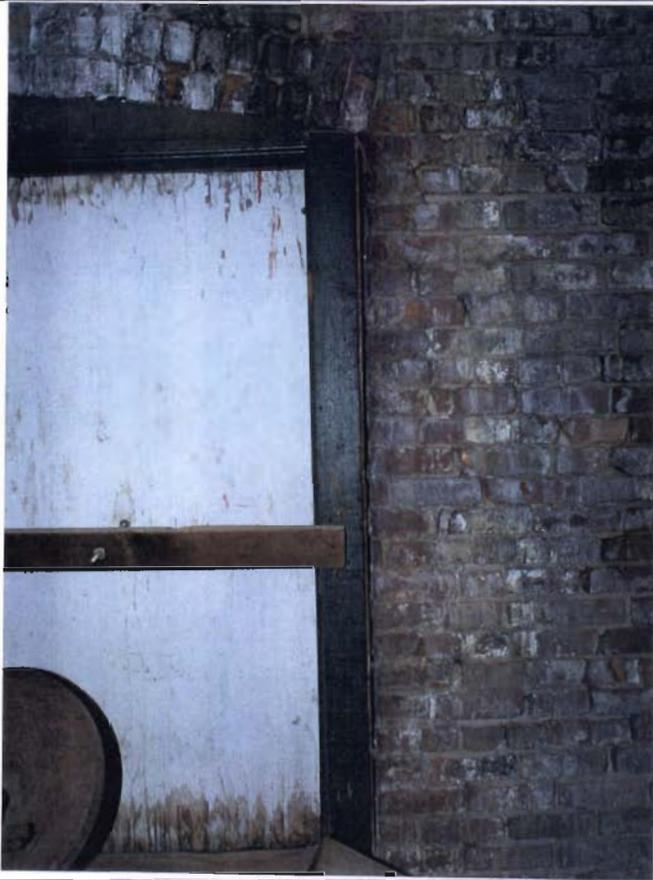
Photo No. 9

Location Level 4, southern window on east wall

Description 1/2" wide gap between frame and adjacent wall

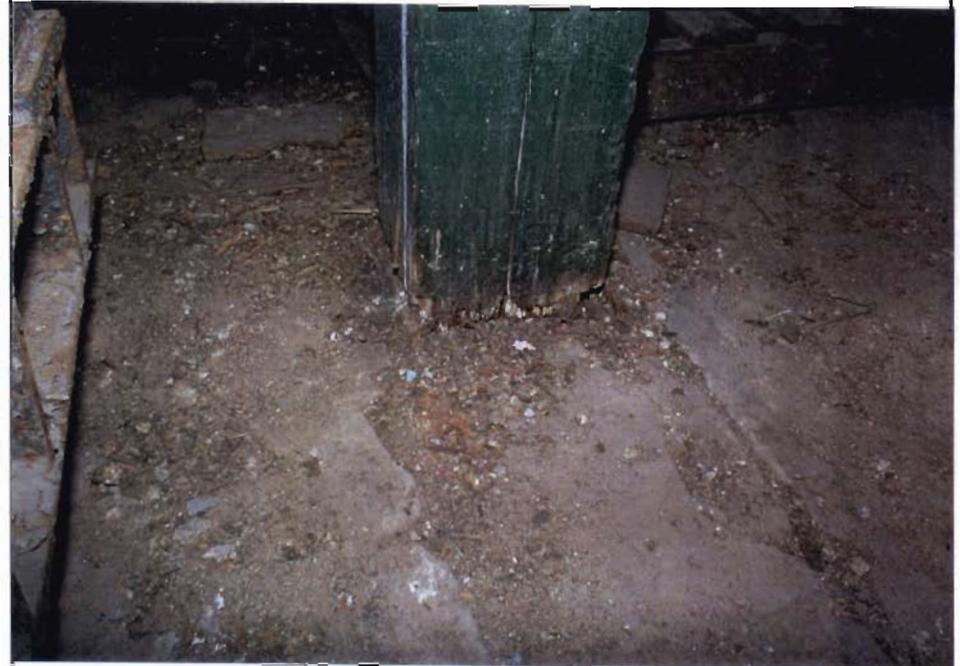
Photo No. 10

2. The concrete floor shows 1/8" separation from the south wall. The lone timber column shows up to 1 1/2" deep rot at its base (*see photo 10*).
3. The concrete roof is wet over most of its area and spalled up to 1" deep on its underside, with exposed reinforcing mesh. The timber framed roof is fair condition, except for numerous holes, checks and notches in the timber rafters. Two adjacent timber rafters on the roof (covered with a fiberglass cloth on top) have severe checks (*see photo 12*), presumably caused by the impact of large chunk of concrete capstone falling from above.

Location Level 4, timber column base

Description Wood rotted up to 1 1/2" deep

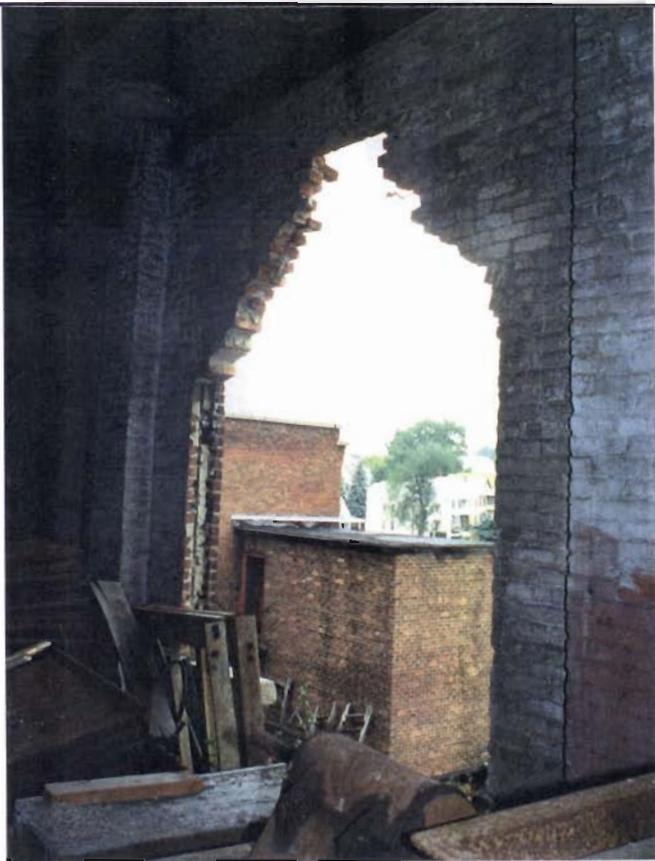
Photo No. 11

Location Level 4, east wall

Description Continued loss of bricks at missing window

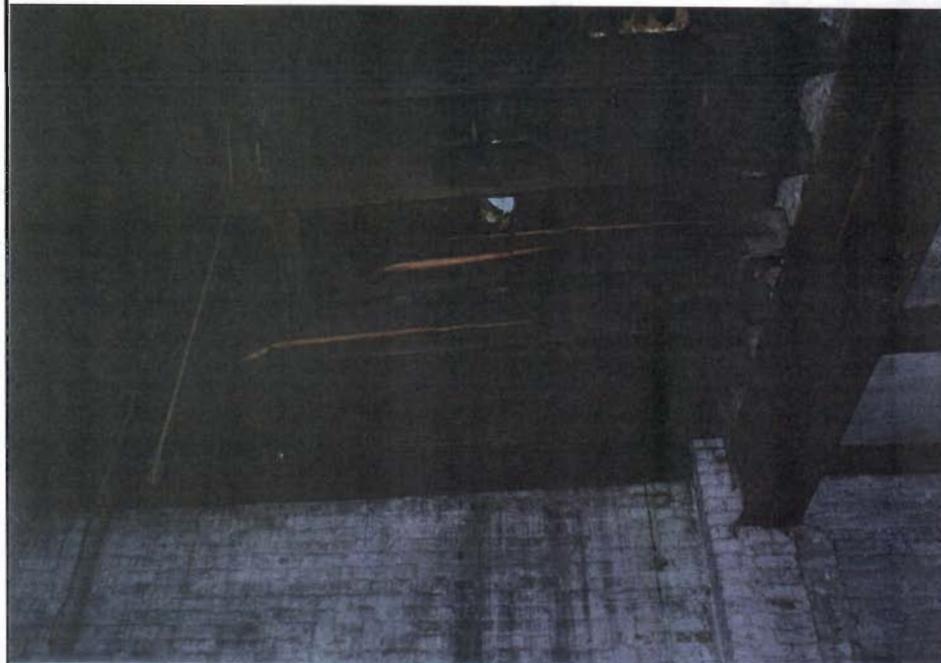
Photo No. 12

Location Level 4, ceiling (see photo 6 also)

Description Two adjacent rafters cracked, concrete cap has partially punched through roof

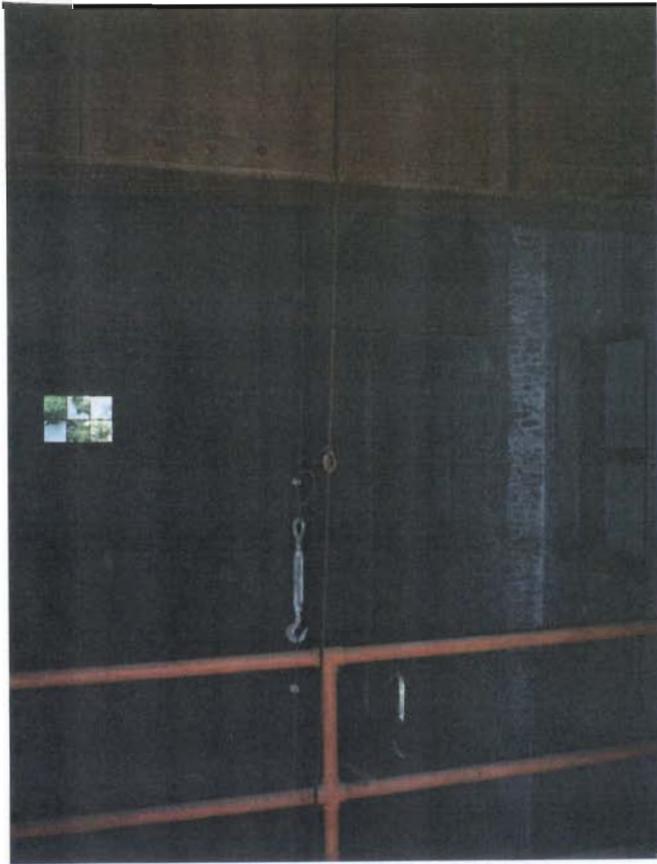
Photo No. 13

Location Mezzanine at level 3

Description Steel cable hung from roof to support floor

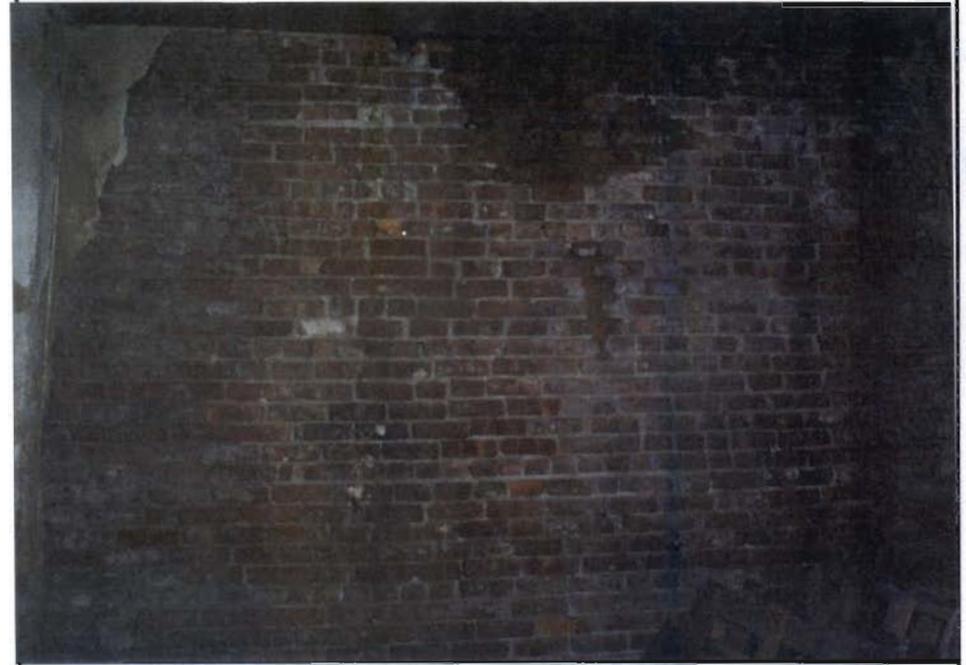
Photo No. 14

concrete is scaled, finely cracked and damp over most of the area. The brick wall at east has several random cracks, with daylight peeking thru at several small areas due to full depth loss of mortar (*see photo 14*). This wall is also wet at the top. The door jamb at the entry to the Kiln Room has been re-plastered since 1995. The continued settlement of the building has caused the header to bear on the closed door which is now tightly wedged and could not be opened (*see photo 16*).

Location Level 3, east wall at mezzanine

Description Open joints, wet and displaced bricks

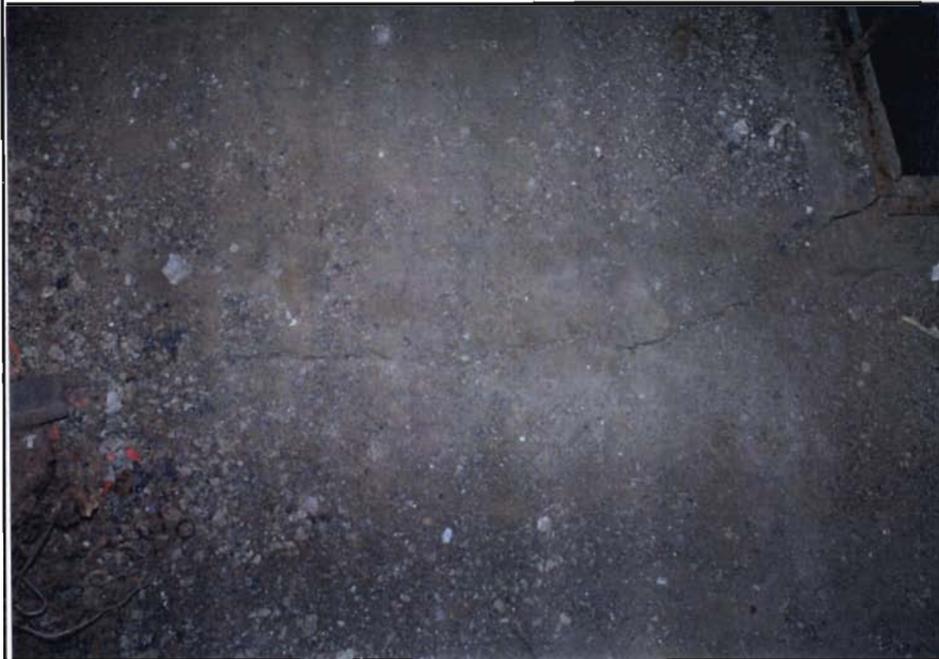
Photo No. 15

2. The Mezzanine: The timber beam at the south edge (overlooking the room) of the new mezzanine is supported by a single timber column which is not connected to it or the slab below by any positive means; this used to be a potentially unstable configuration, that has now (since 11/8/95) been alleviated by the installation of a steel cable sling hung from the steel girder at the ceiling (*see photo 13*). A crack in the floor from the stairwell to a steel column has widened to 3/8", since 1995 (*see photo 15*). The ceiling

Location Level 3, mezzanine

Description 3/8" crack from stairwell corner to steel corner

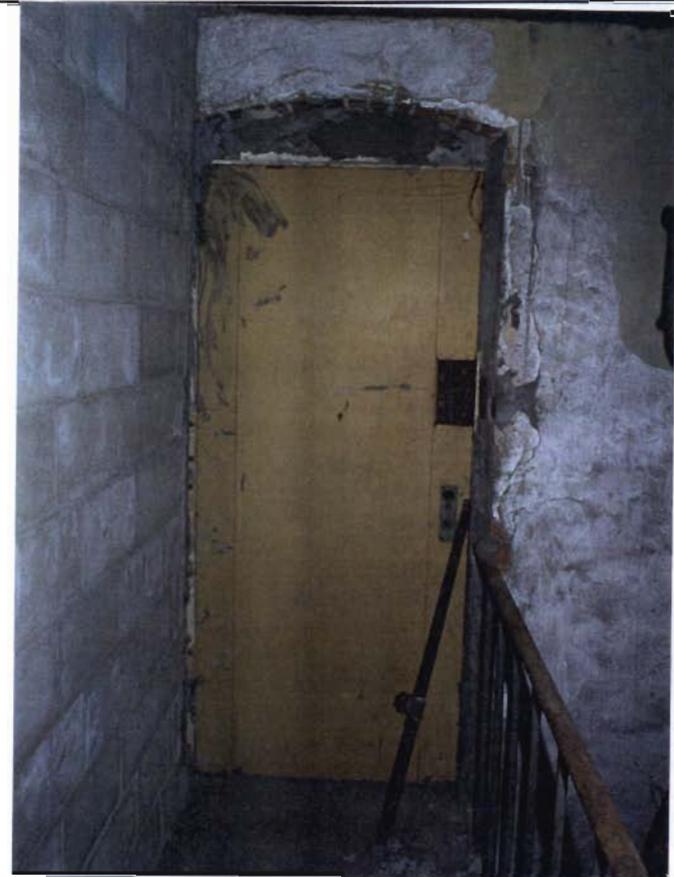
Photo No. 16

Location Level 3, door to kiln room

Description Tightly wedged new door blocks entry

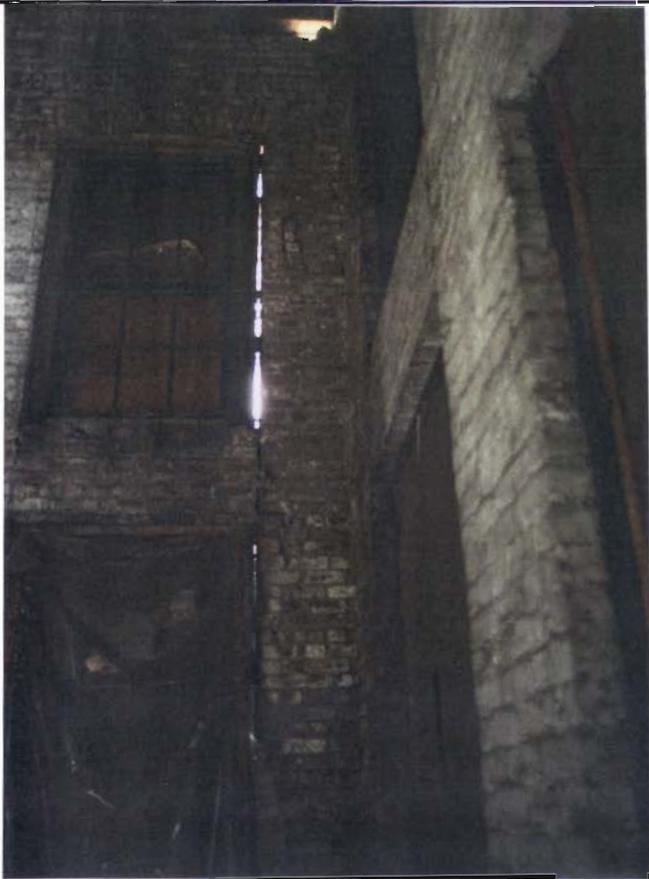
Photo No. 17

Location Level 2, southeast corner wall

Description Full height vertical crack up to 1 1/4"

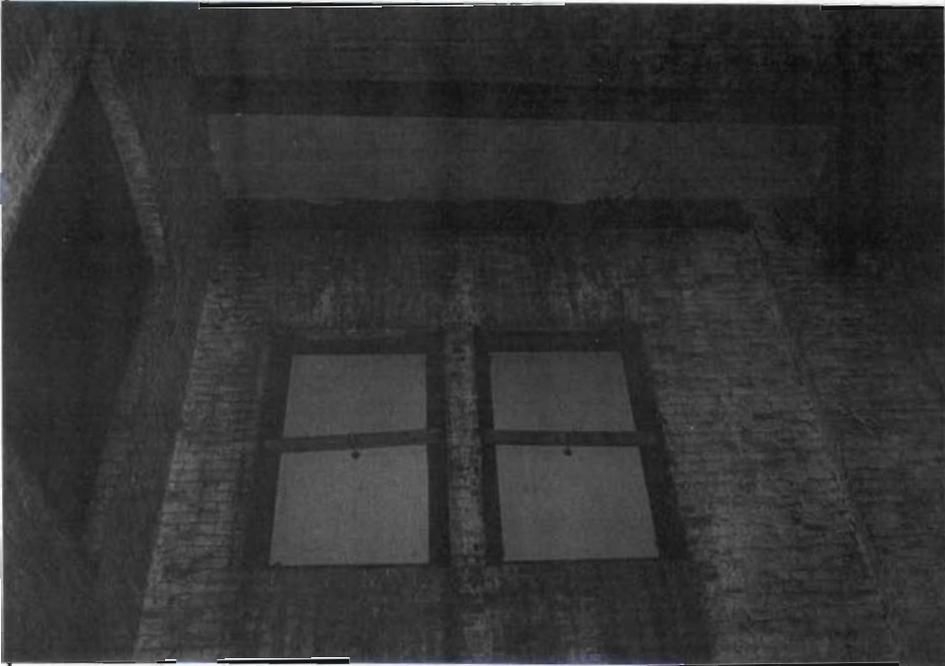
Photo No. 18

Location Level 2, southwest wall

Description 3/4" crack above window lintel

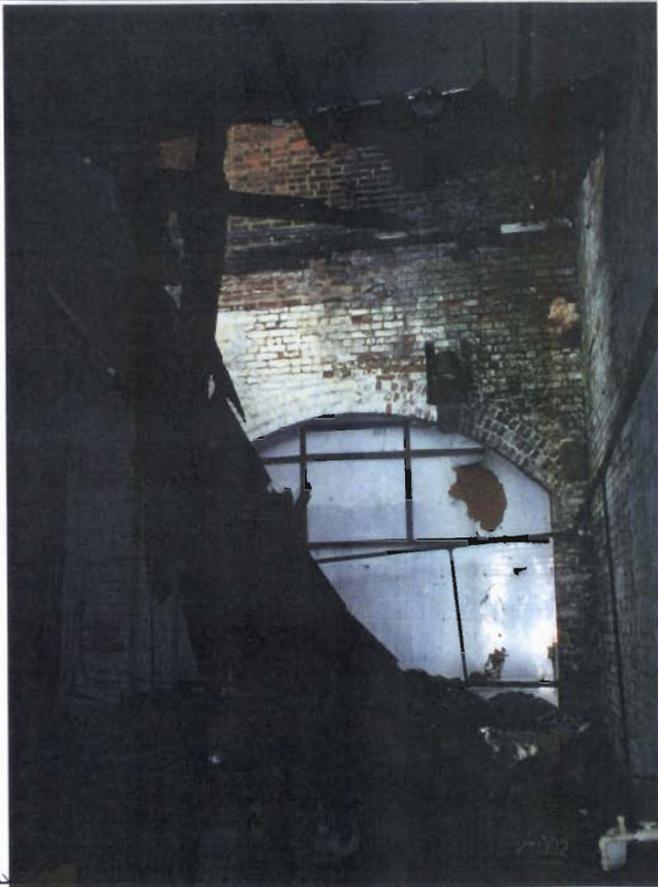
Photo No. 19

3. The Anodizing Room: A 12' x 14' area in the northwest corner of the roof has collapsed due to wet and rotten timber rafters, since 11/8/95, (*see photo 19*). The remaining timber framed roof shows bent, sagging and cracked steel strips (used for retaining the tiles); the tiles are precariously suspended over a 20' x 6' area in the middle of the room. Another 5' x 6' section of the roof next to the east wall has failed due to rotted out timber framing from leaking storm drain pipes. A full height vertical crack was also noted in the south wall of this room. The concrete roof continues to show extensive wet underside of slab over 60 % of the area, with some efflorescence and rust staining. The concrete encasement on the stairwell header (landing) beams is cracked.

Location Level 2, anodizing room ceiling

Description 12' x 15' section collapsed

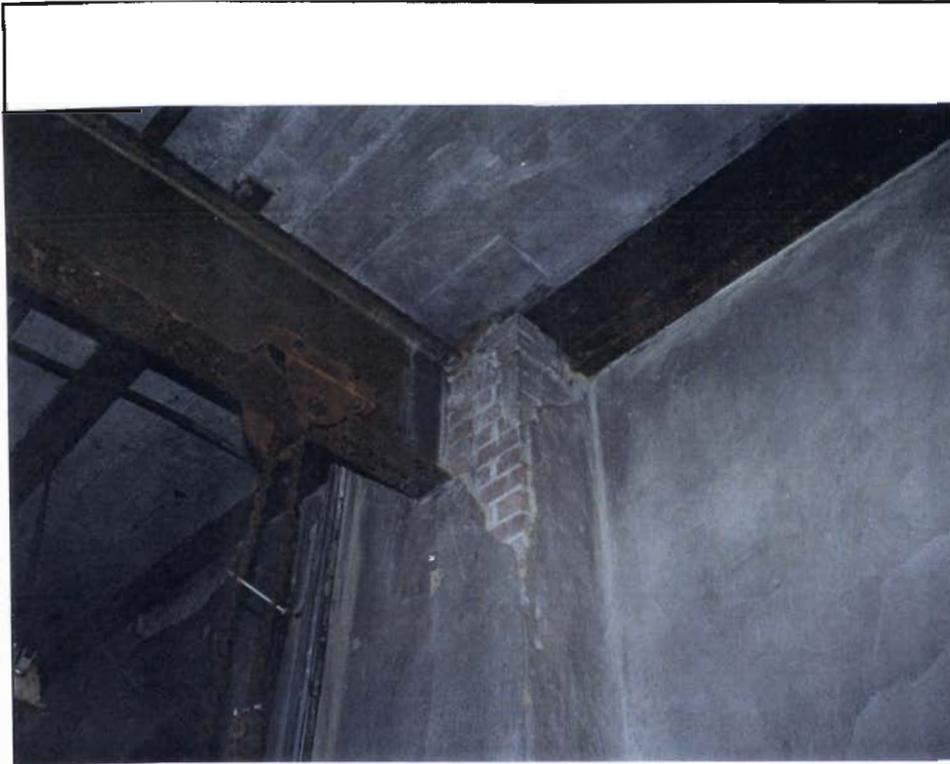
Photo No. 21

Location Level 1, small machine room

Description Displaced bricks at west wall under spandrel beam bearing

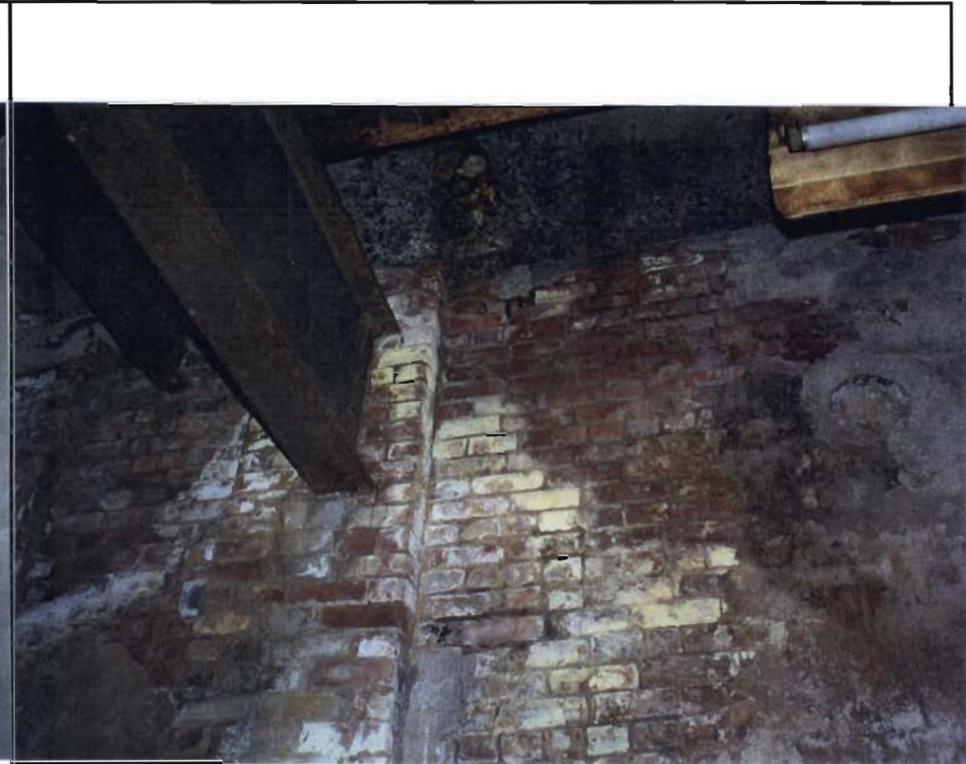
Photo No. 22

4. There is a storage area located to the west of the main plating room; large brick pilasters support the steel girders and spandrel beams in this area. The bearing of one of the spandrel beams, a channel section on the west wall, is jeopardized by the cracked and displaced bricks at the top of the pilaster (*see photo 21*); this condition seems to have worsened since the 11/8/95 inspection. Displaced and loose bricks were also noted at a pilaster supporting a steel cross beam, on the east wall (*see photo 22*).

Location Level 1, small machine room

Description Displaced & missing bricks at top of pilaster on east wall of room

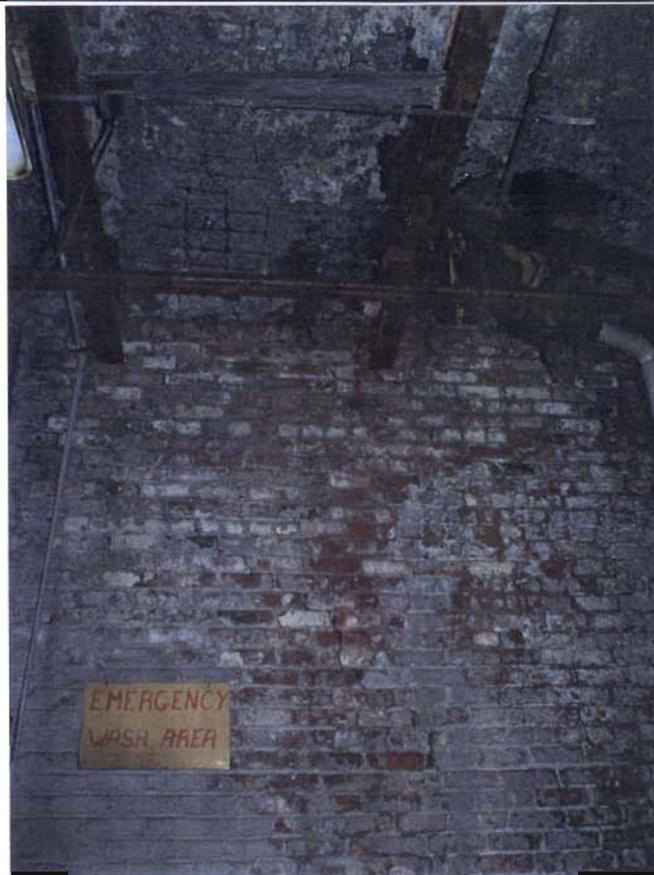
Photo No. 23

Location Level 1, south face of stairwell wall

Description 1/4"-1/2" crack along joints, wet ceiling above

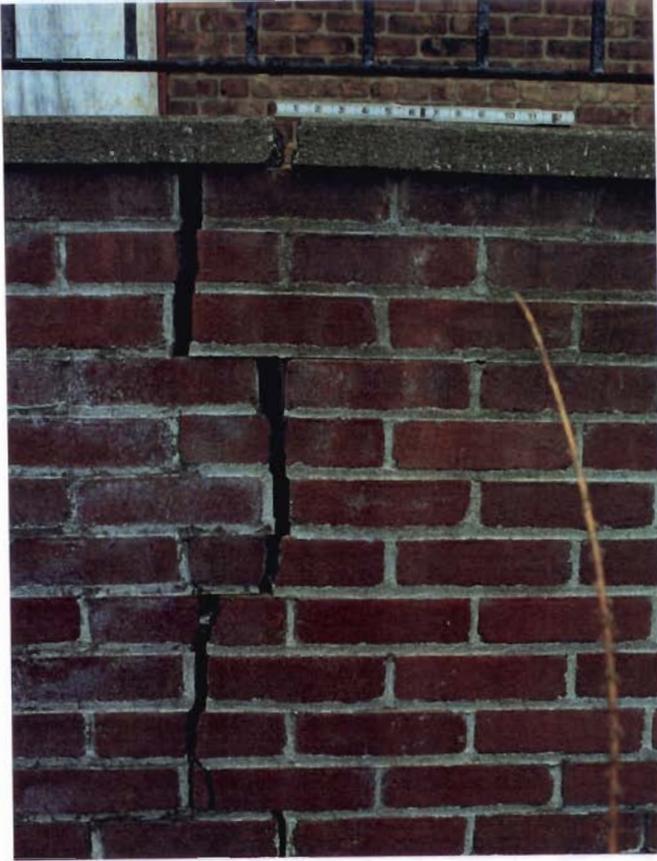
Photo No. 25

No significant change in the conditions noted in the 1995 inspection was found, except for continued settlement of part of the exterior stairway at the northwest corner of the building. The vertical crack separating the two parts of the stairway has widened from 1" in 1995 to 1 3/8" at present (*see photo 25*).

Location Exterior staircase to west entrance

Description Crack is 1 1/4" wide
