NEW YORK STATE DEPARTMENT OF ENVIRONMENTAL CONSERVATION  
DIVISION OF HAZARDOUS WASTE REMEDIATION  
INSPECTOR'S DAILY REPORT

| Site Name: <u>SCHUY SENECA ST. PSA</u> | Sheet <u>1</u> of <u>    </u> | AM | PM |

Figure 2-1  
Site Layout Plan

Schenectady (Seneca St.) Site

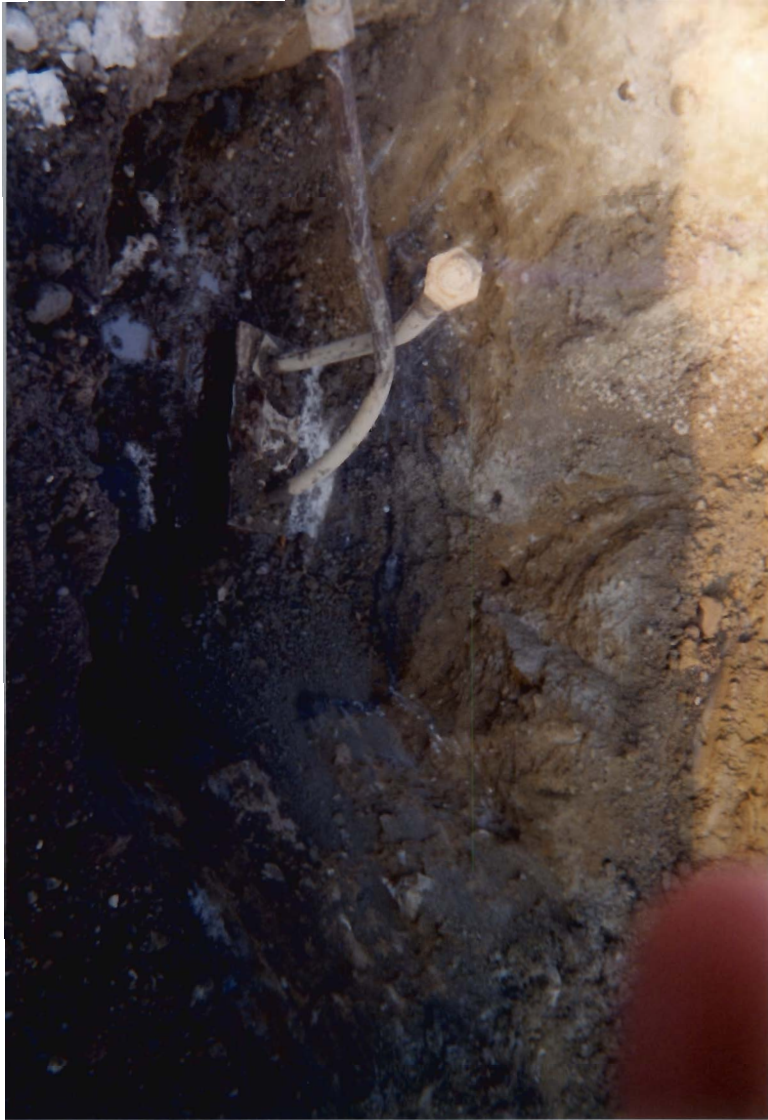
11/19

EXCAVATED AROUND SUPPORT JUST SOUTH OF DIRT PIT. REMOVED CONCRETE DOWN TO ~12' BS; CONCRETE SLAB HT. NO CONTAMINATION SEEN OTHER THAN WHAT HAD TRAVELED DOWN STEEL RODS, OR JUST OUTSIDE OF CONCRETE. A 3-4" BLACK-STAINED LAYER CAN BE SEEN ON OUTSIDE OF CONCRETE SLAB.

EXCAVATION AROUND SUPPORT #6, SHOWING STEEL BULBS AFTER ALL  
CONCRETE REMOVED TO 12' B.S.

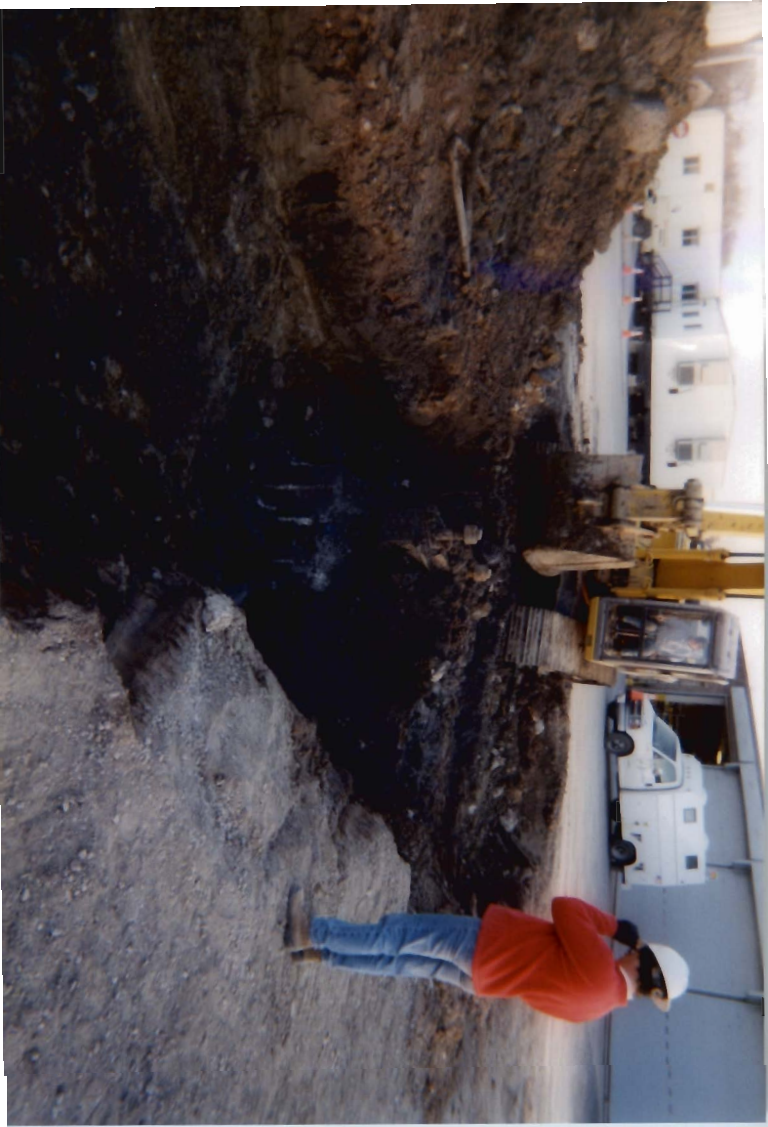
11/19

SUPPORT #2 SHOWING THE FLOWING OUT OF CONCRETE.

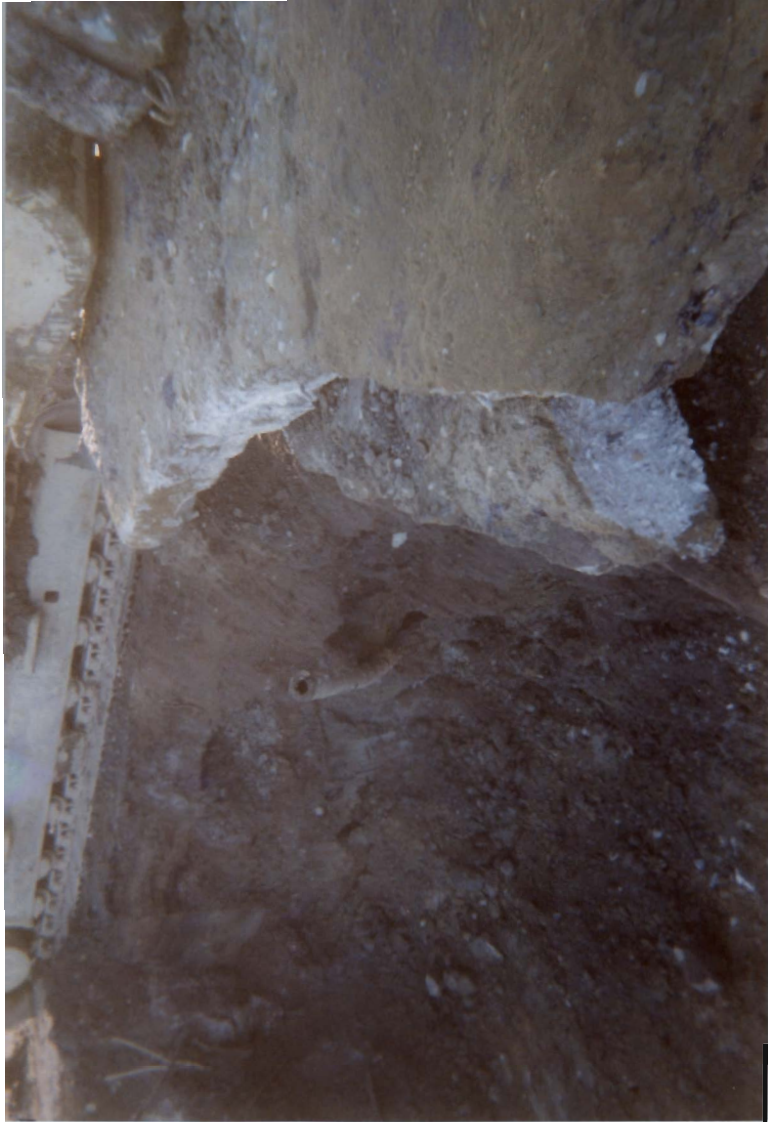
11/20

FIXING SOUTH, 4" CAST IRON PIPE FULL OF TAR, LOCATED  
4' BES, 10' OUTSIDE OF KENNEL ON WEST SIDE OF HALL.

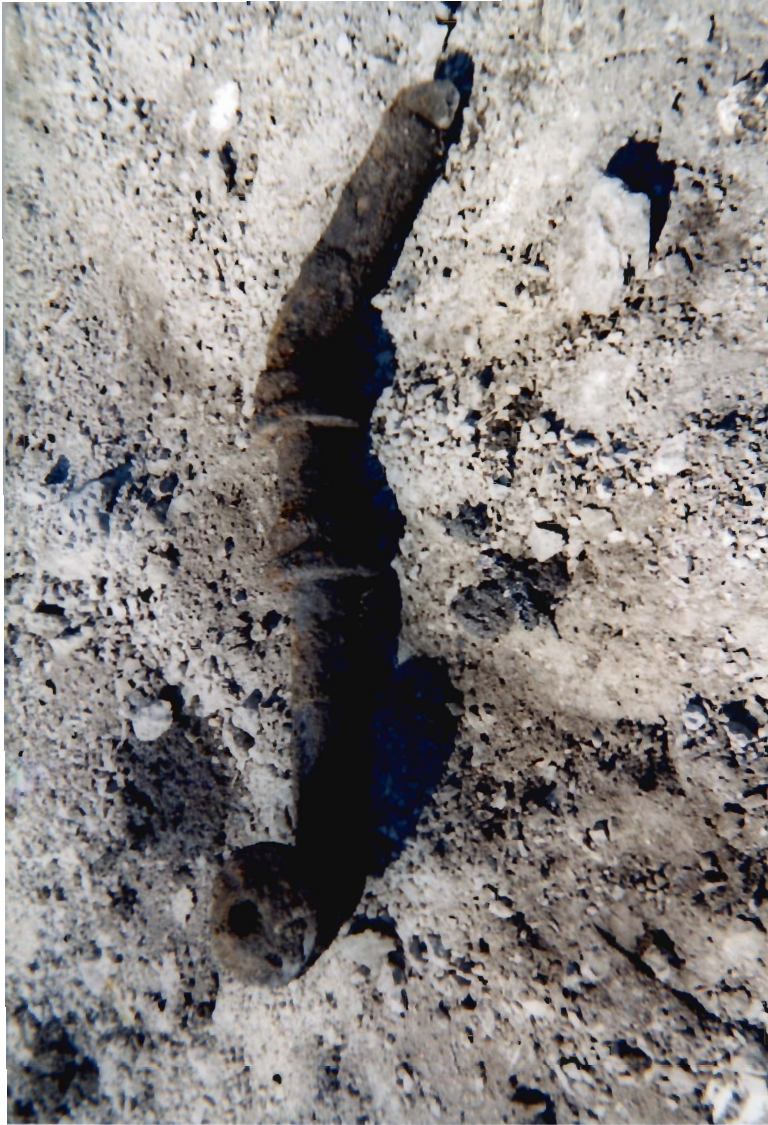
11/20

SECTION OF 4" CAST IRON PIPE REMOVED FROM EXAMINATION.

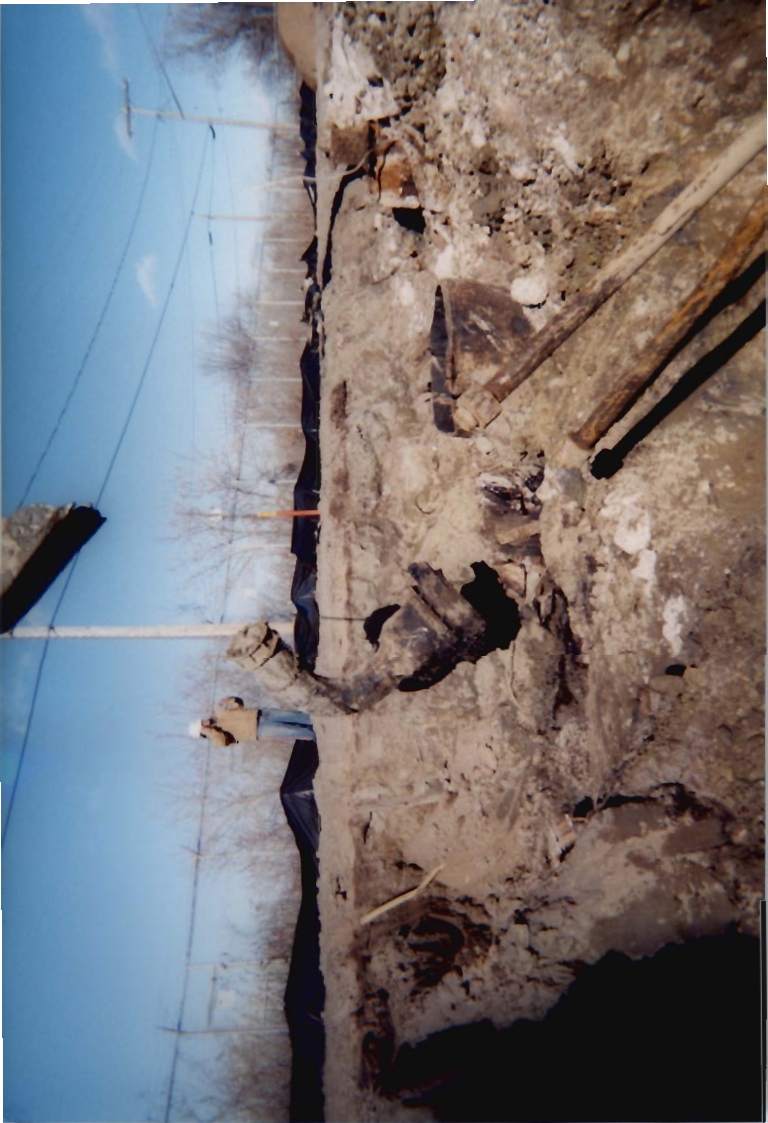
11/20

ELBOW SECTION OF PIPE REMOVED FROM DMS #05.

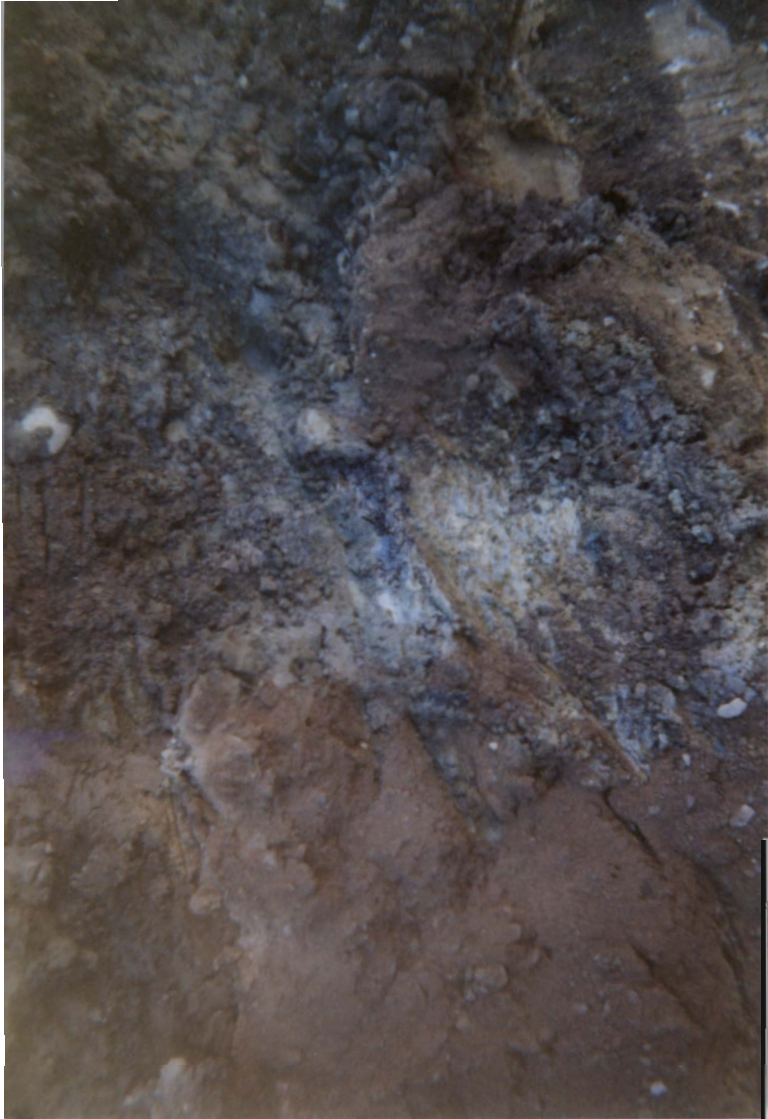
11/20

CHERRY SAND LAYER AT 4-4.5' BGS, TAN THOUGHOUT, ABOUT  
10-12' OUTSIDE OF KINKUML. LAYER APPROXIMATELY 2-2.5' THICK.

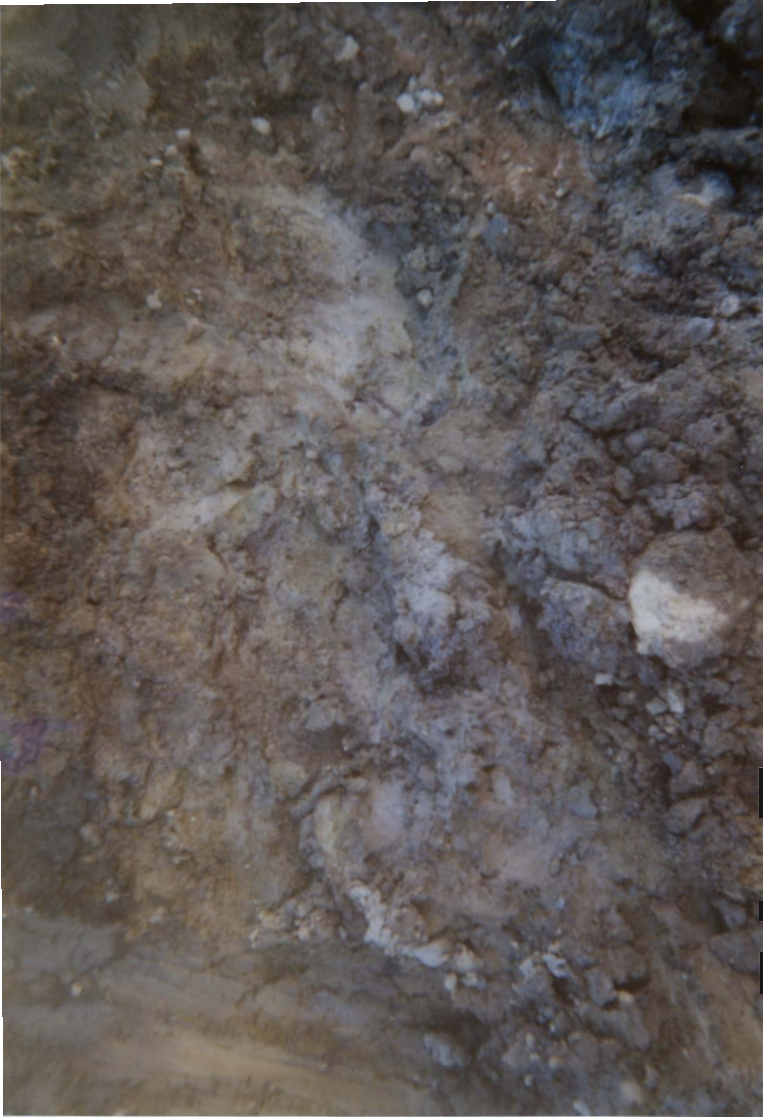
11/20

CLAYED SAND LAYER AT 4-4.5' BGS, THE THICKNESS, ABOUT 10-12' OUTSIDE OF NORMAL. LAYER APPROXIMATELY 2-2.5' THICK.

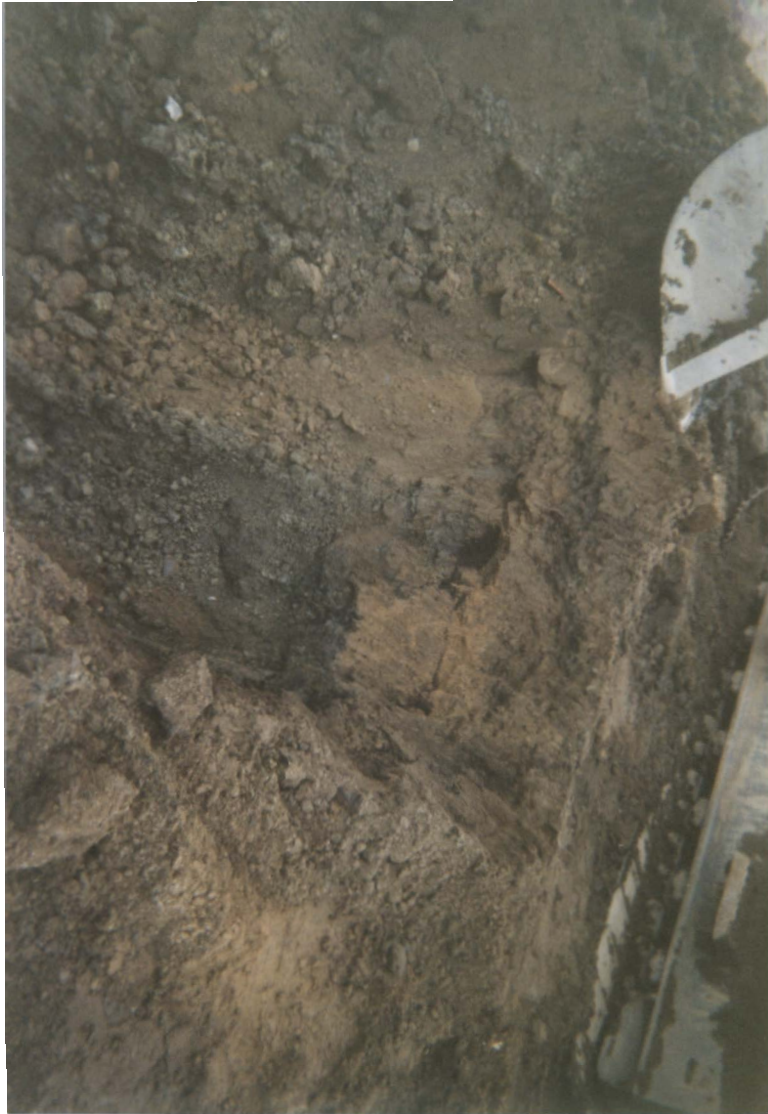
10/26/01

FACING SOUTHWEST, 6" CLAY PIPE BEDDED IN STONE; STONE IS

IMPACTED.

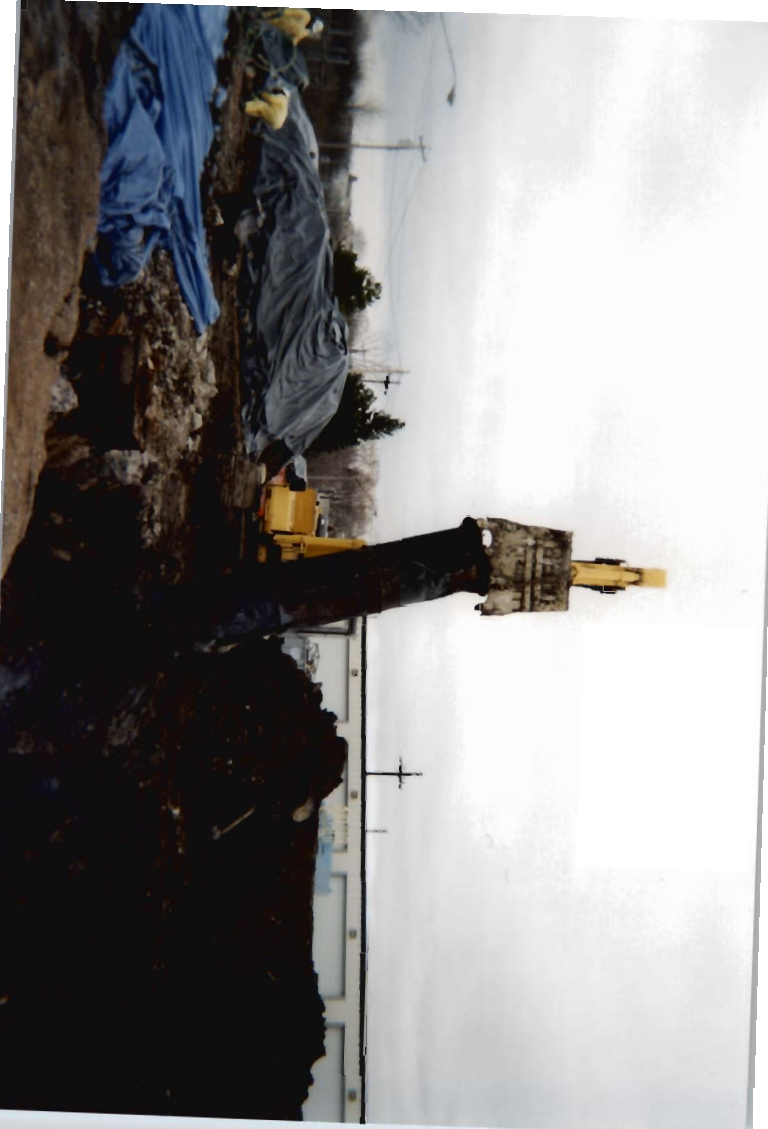
11/26/01

SECTION OF 3" PIPE BETWEEN DRIP POT AND CONCRETE VALVE  
ON WEST SIDE OF HOLDER.

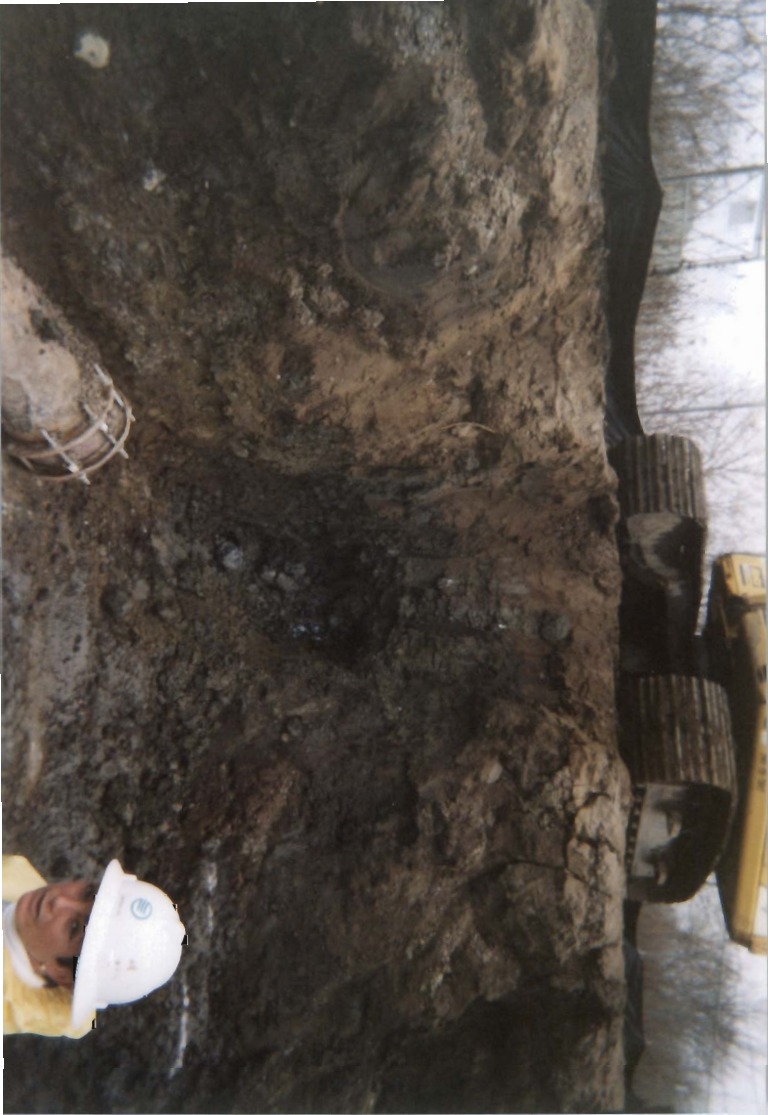
11/26/01

FACING NORTH, TAN LEAKING OUT OF 2.5" CI PIPE AT 5' BGS.

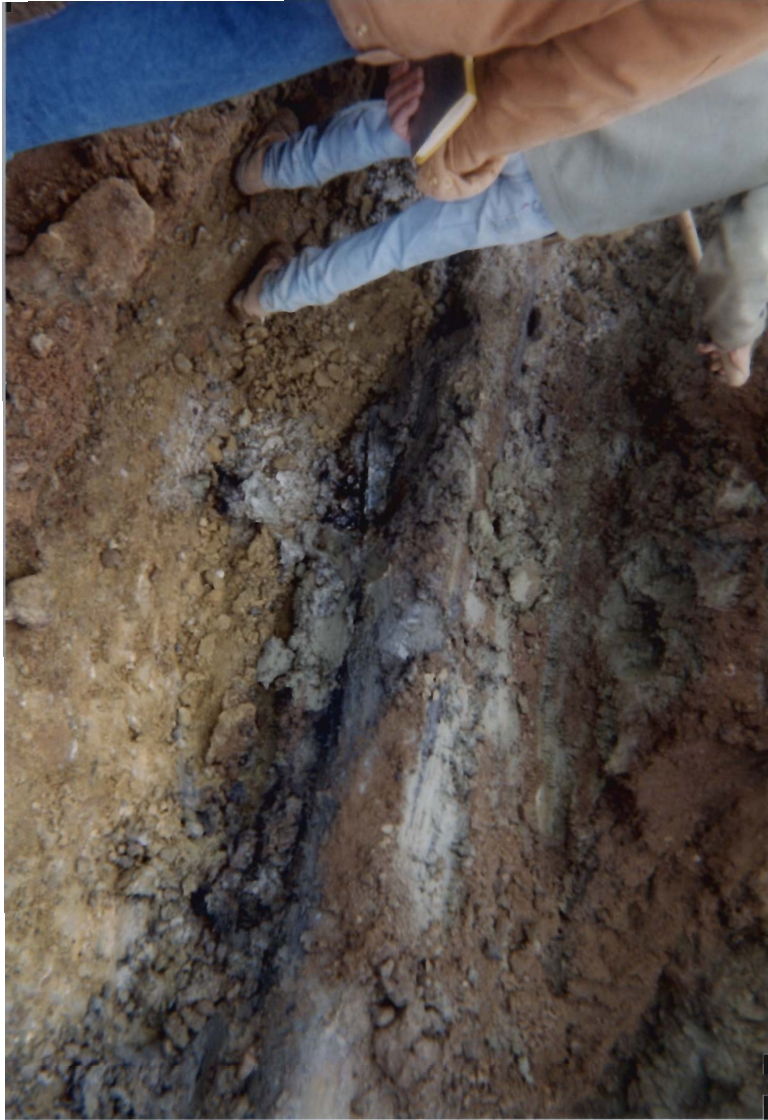
11/26

THE UNDER 12" PIPE ON WEST SIDE OF WOODEN, AT 6' BGS.

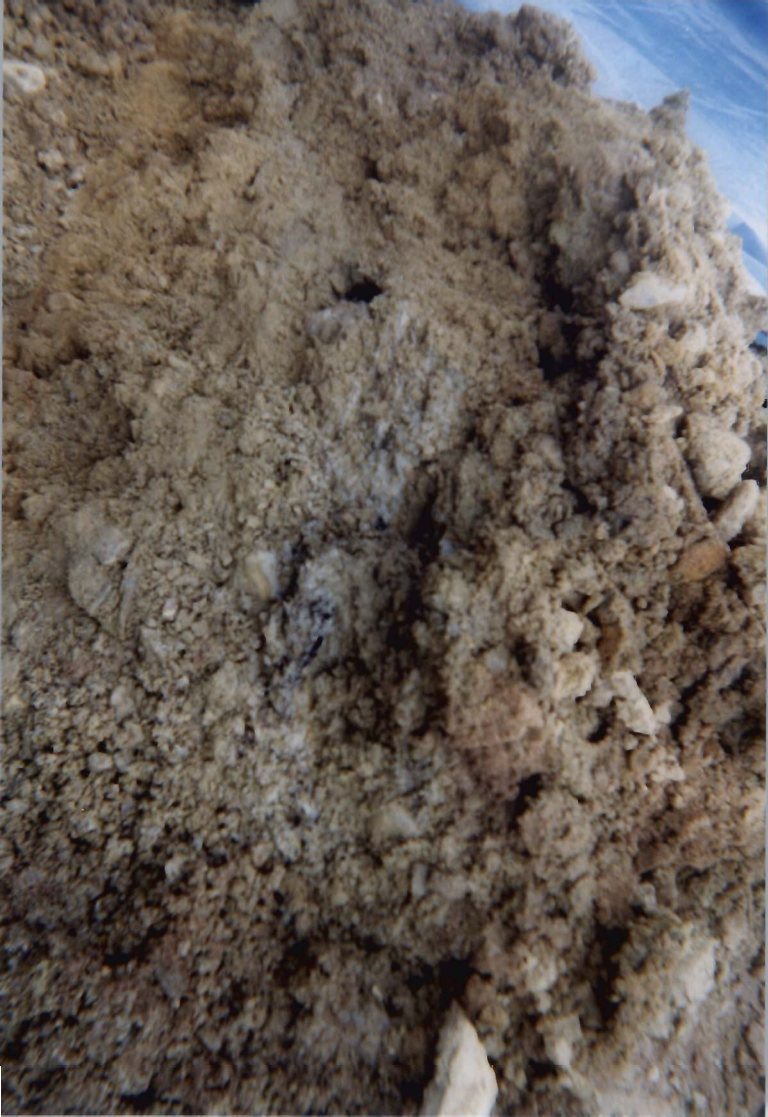
11/26

THE SEAM FOUND AT N' 88S, 6" THICK, 10' INSIDE OF  
RINGWALL BETWEEN SUPPORTS #6 + 7. SEAM WAS 15' LONG.

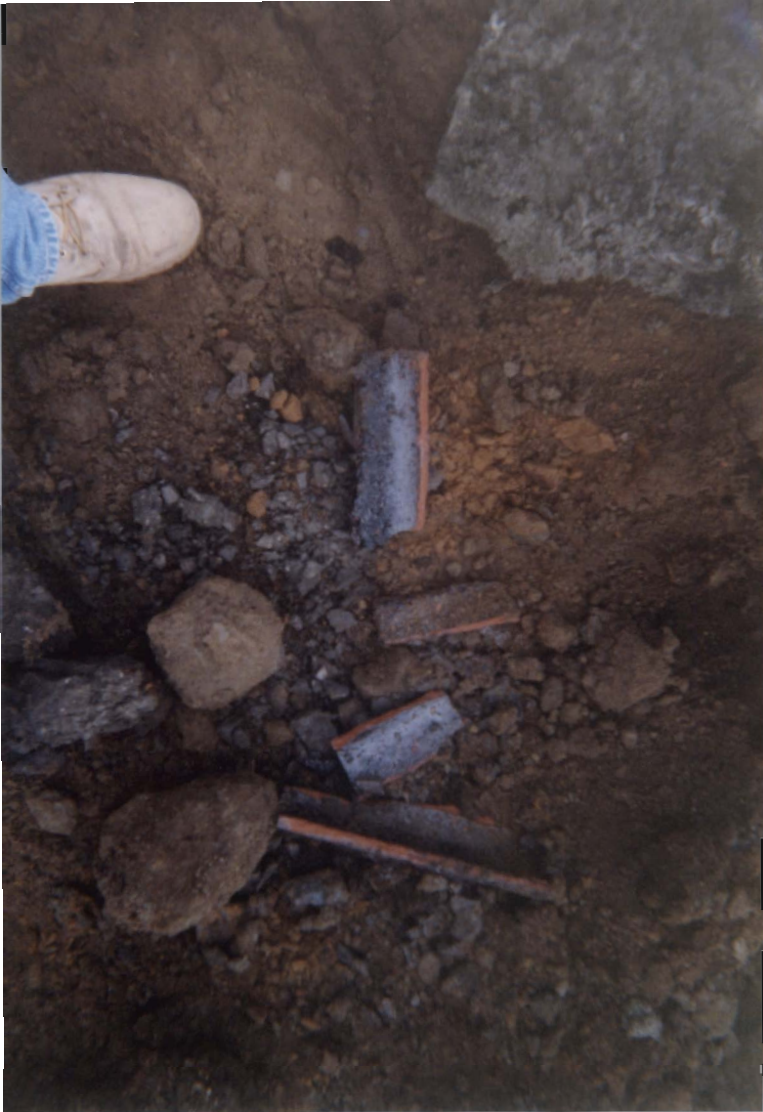
11/26

PIECES OF 6" CLAY PIPE WITH RESIDUAL TAR, FOUND RUNNING  
SOUTH TO NORTH ON SOUTHWEST CORNER OF HOLDER.

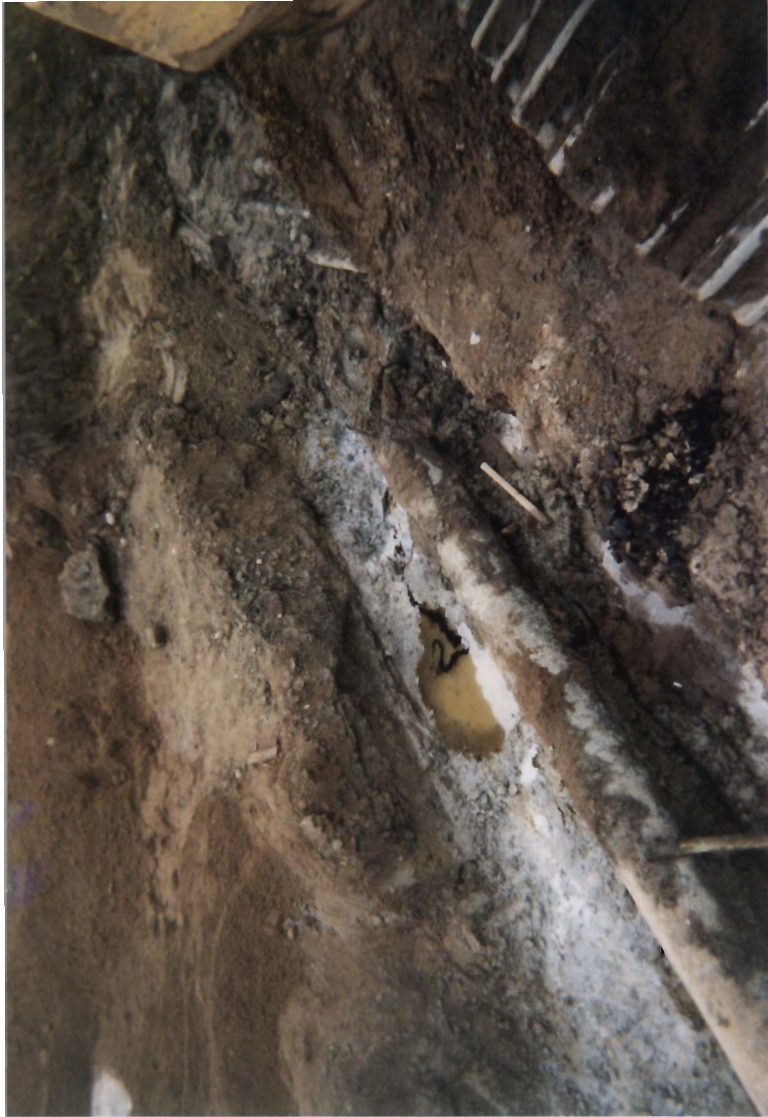
11/27/01

THE LEAKING OUT FROM UNDERNEATH 12" PIPE ON WEST SIDE OF  
HOLDER.

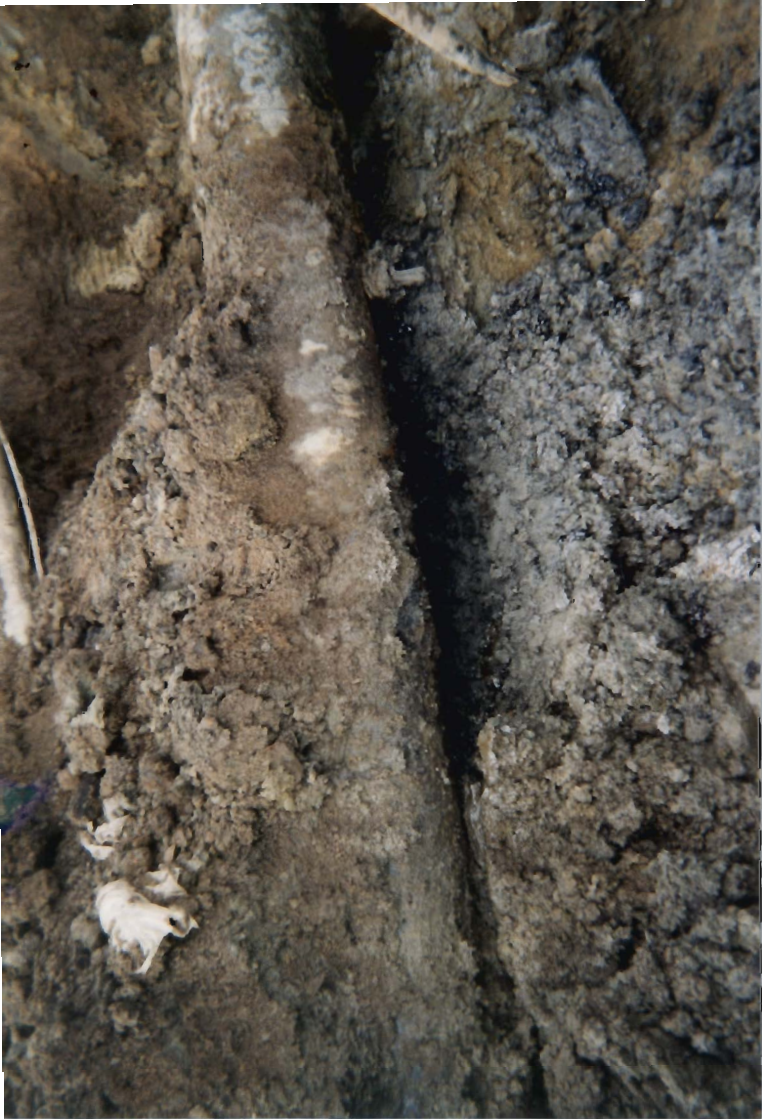
11/27/01

THAN SOIL FOUND WITHIN 12" CI PIPE.

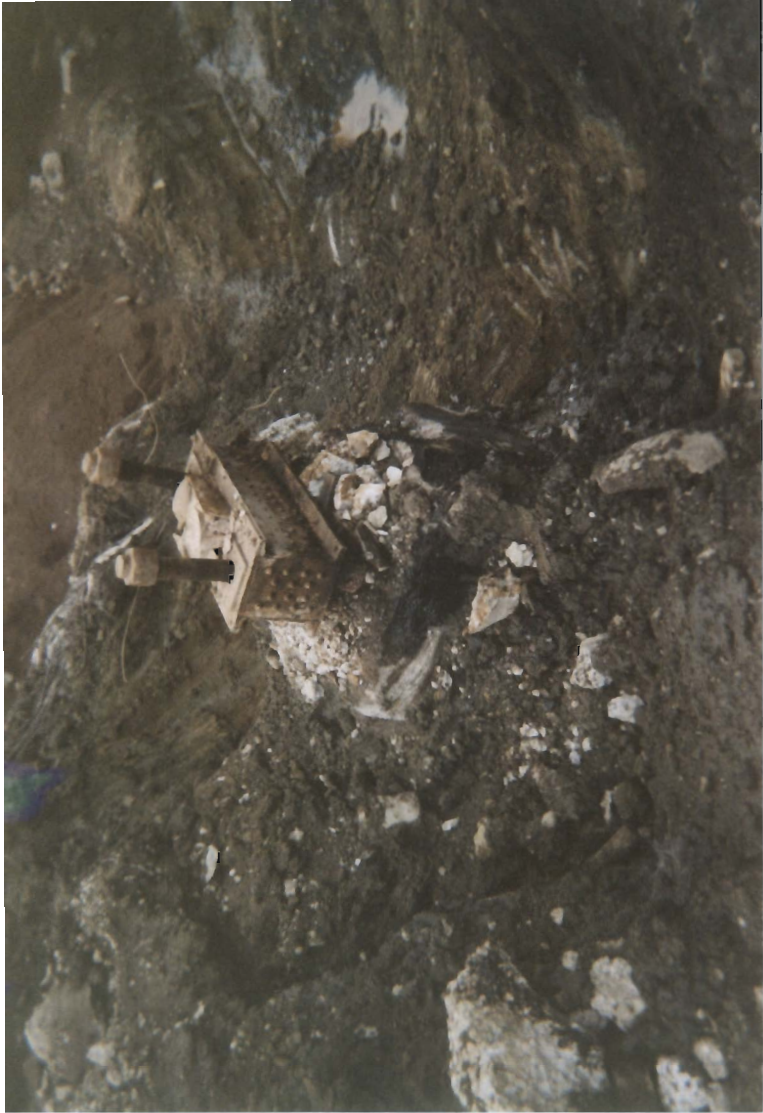
11/27/01

PEN #3 WITH TRAIL ON OUTSIDE OF CONCRETE.

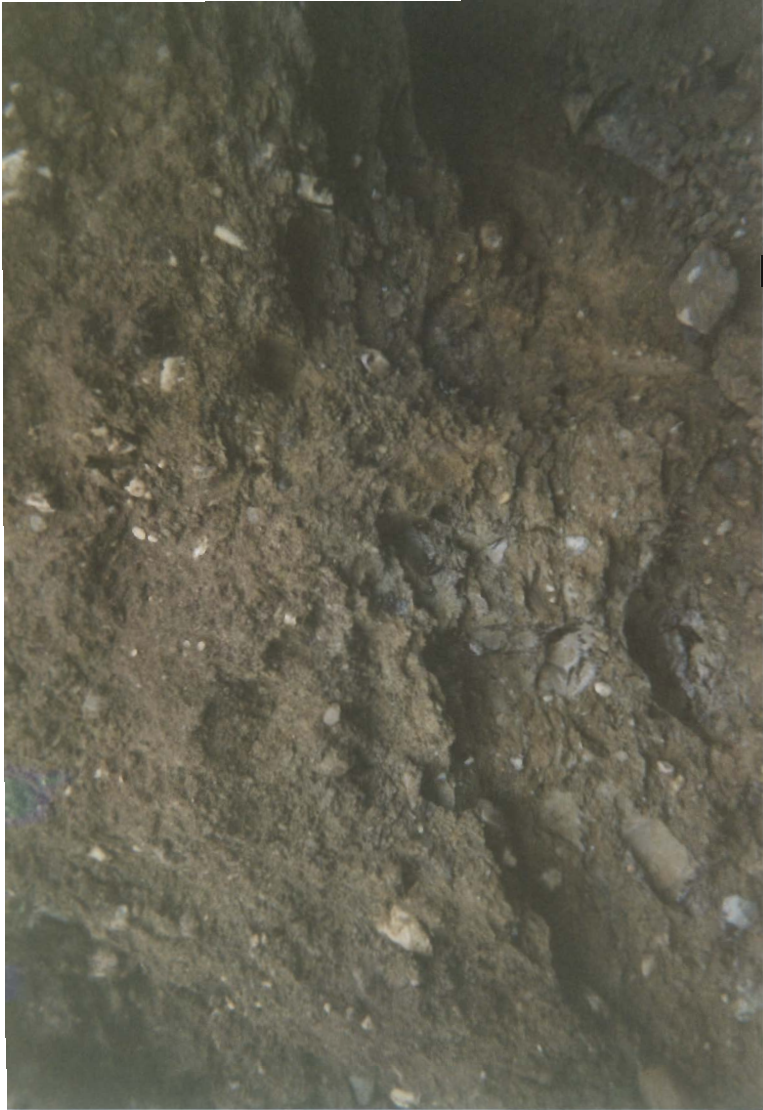
11/27/01

SPAD SEPM WITH MA, 4-4.5' BGS, JUST NORTHWEST OF  
DEEP PIT LOCATION.

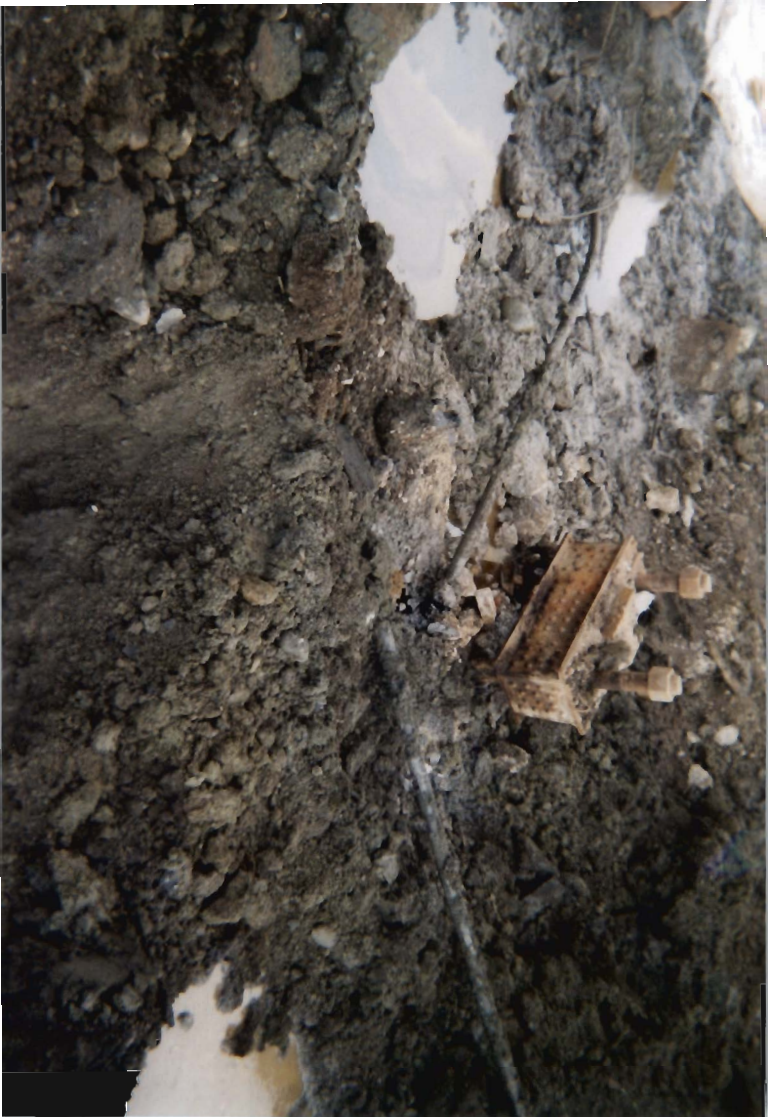
11/28/01

THE LEAKING OUT OF 2.5" CI PIPE AFTER REMOVAL FROM  
WEST SIDE OF HOLDER.

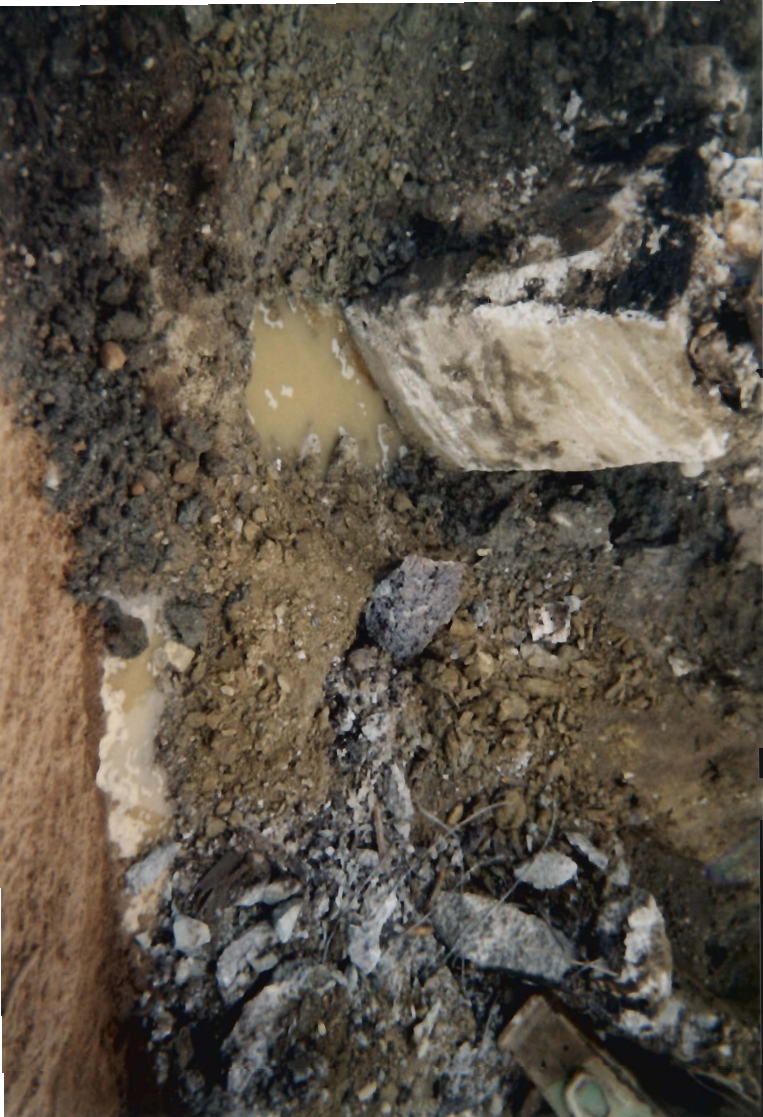
11/28/01

PIECE OF CONCRETE COVERED WITH TAR FROM PIPE VAULT WALL.

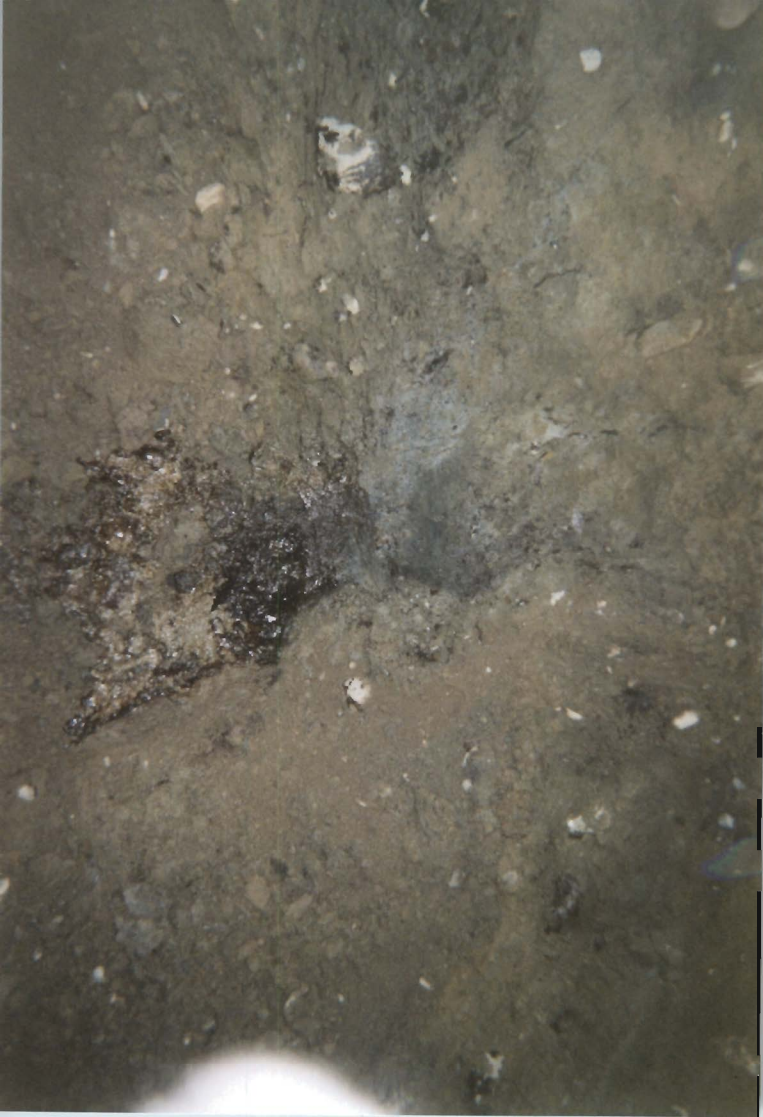
11/28/01

FAUNG EAST, TAN IN SAND AT 3.5-4' BGS, EAST OF POPE MARLT.

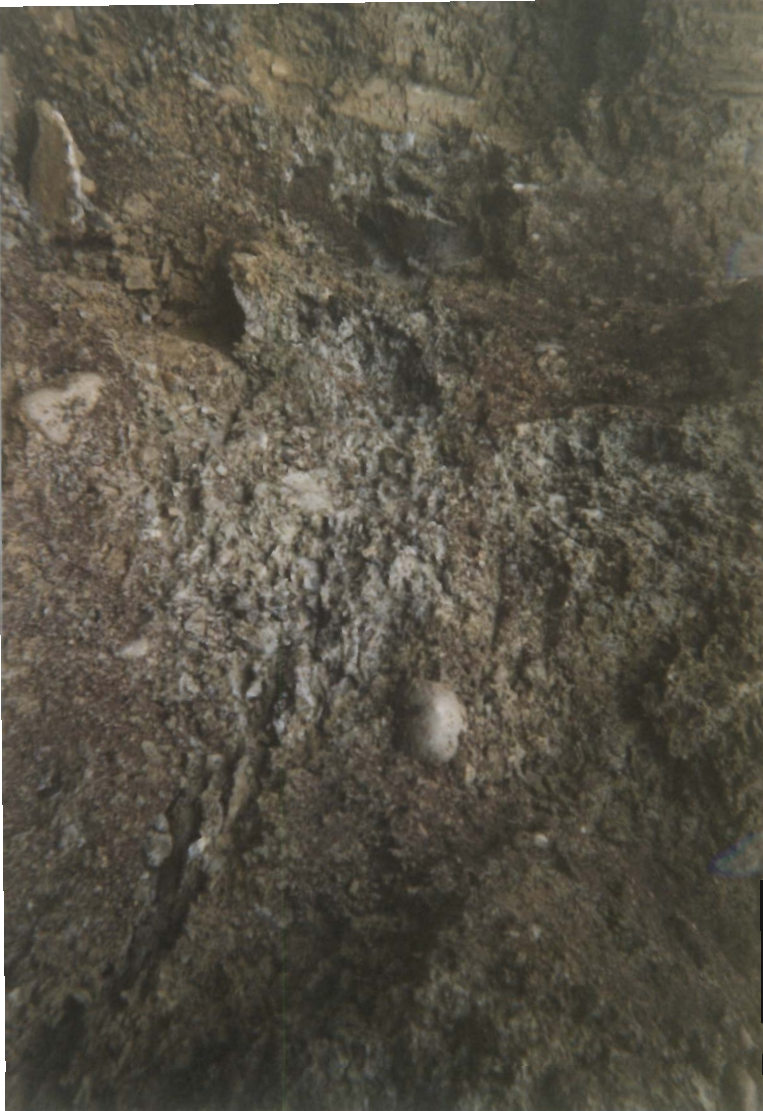
11/28/01

FACING NORTHWEST NEAR CONCRETE VIADUCT, TAP IN SAND STRAIN AT  
3.5-4' BGS.

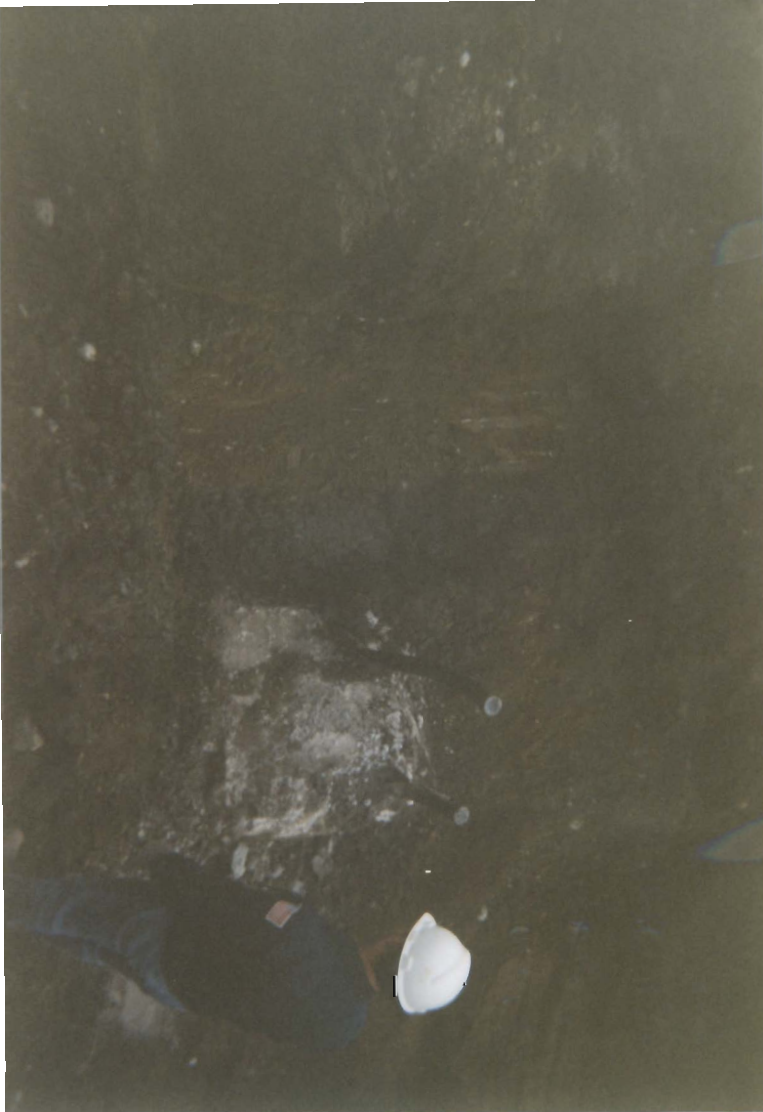
11/28/01

NORTH SIDE OF PULX #3, SHOWING DIFFERENTIATION IN SOIL.

SOIL AGAINST SUPPORT IS SOFT CLAYEY SAND WITH TALL THRUWELLS;  
AND ADJACENT TO CLAY SOIL IS DENSE BROWN SAND AND GRAVEL.

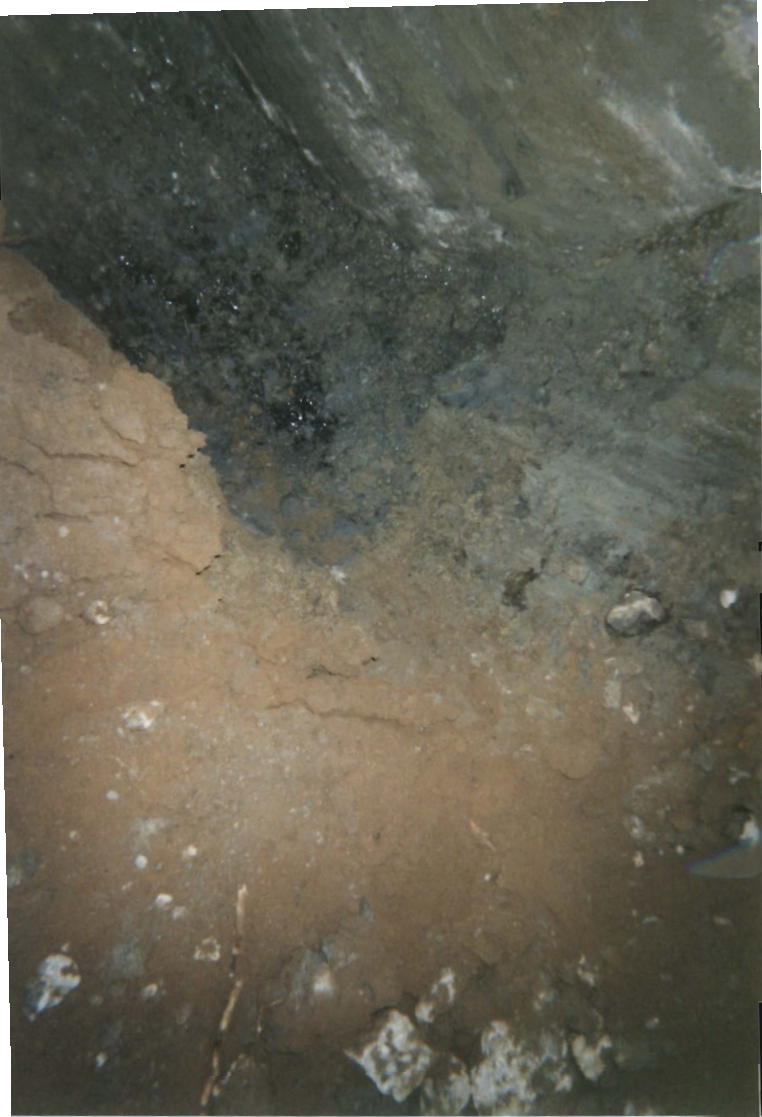
11/28/01

FACING NORTHEAST, DISTANCE TO PILE #3, THE LENGTH OF  
CLAYEY SAND LAYER ~ 4' BGS, WITHIN HOLDER.

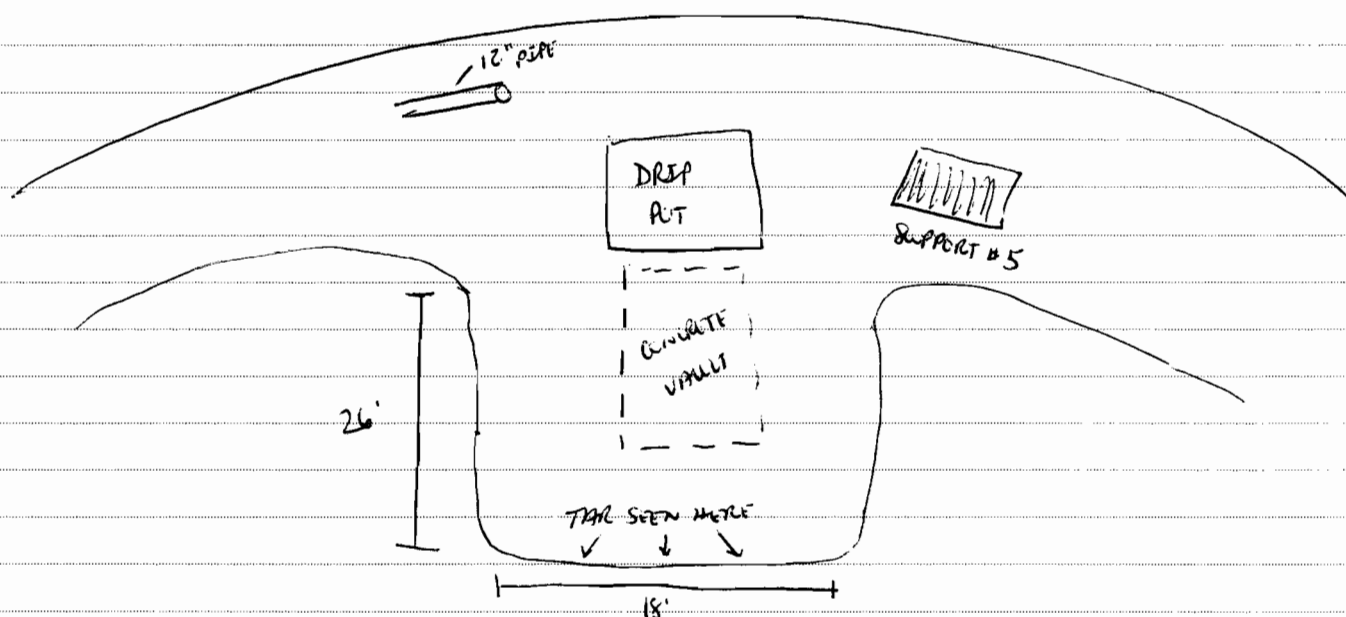
CREW OVER-EXCAVATED WITHIN RINGWALL CHASING TAR AROUND CONCRETE VAULT LOCATION (SEE DIAGRAM). TOTAL EXCAVATION IS 26' LONG (INTO HOLDER), 18' WIDE, AND 8.5' DEEP. AFTER STOPPING AT THIS POINT, TAR BEGAN SEEPING INTO EXCAVATION FROM EAST WALL AT 3.5-4' BLS. INFORMED FW THAT FURTHER EXCAVATION REQUIRED IN THIS AREA. HE AGREED ONCE SOIL STOCKPILE WAS REMOVED.

EMRTECH PUMPED ALL WATER FROM EXCAVATIONS INTO FRAC TANK. WATER HAS HEAVY NAPEL LAYER, SHOWN.

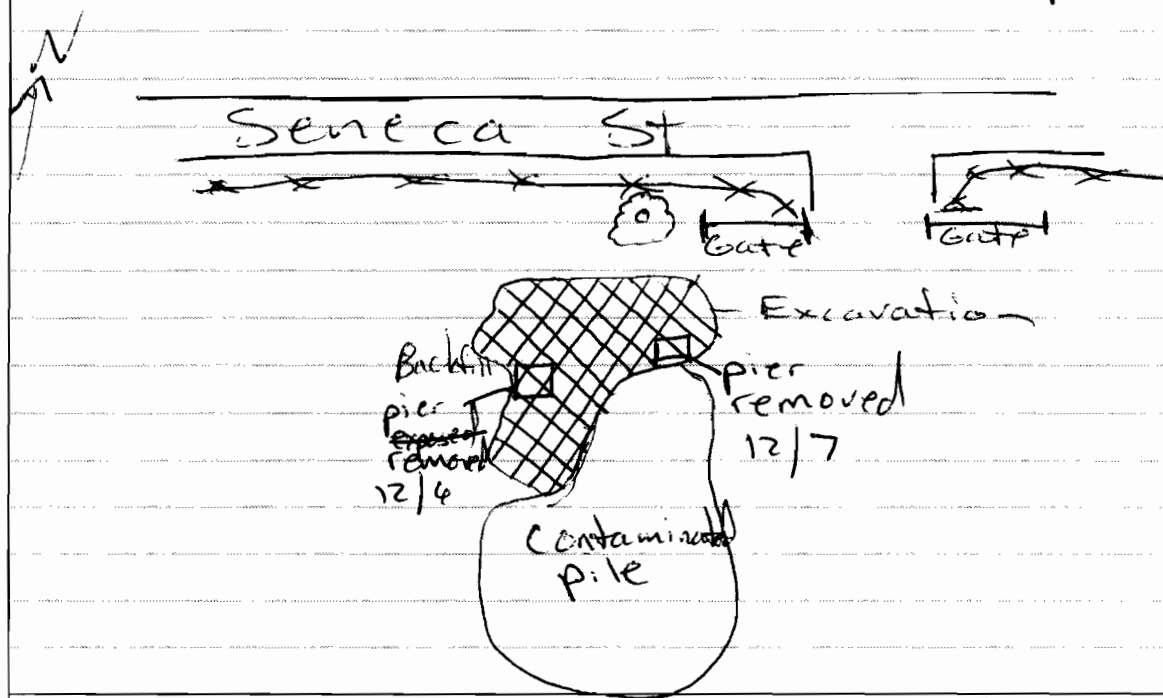
- Trace of ~~old~~ odor was being removed
- wanted Earth Tec to work from Ring Wall out
- I informed him that only soil containing visible ~~top~~ seams was being treated as contaminated and that DEC had no problem working from Ring Wall out.
- Backfilled up to pier removed on Thursday
- checked lower till layer on inside of pier scrape 1' back and found it clean backfilled around that pier

- When left - ~~middle seam + lower seam~~  
 lower seam in excavation had  
 not been exposed  
 - middle seam was found on West face  
 but not on North face

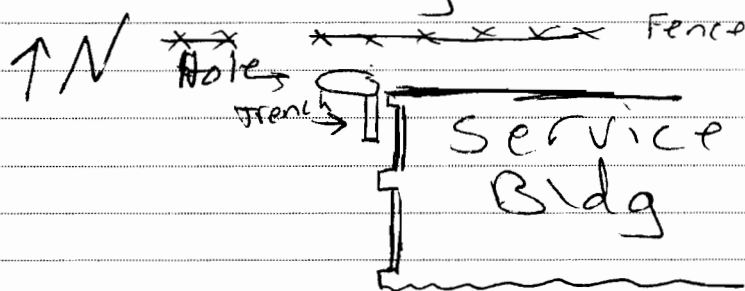
stained soils found on Building side of trench and under buried concrete slab on opposite side, •

Trench was dug down to top of Till  
≈ 8 ft

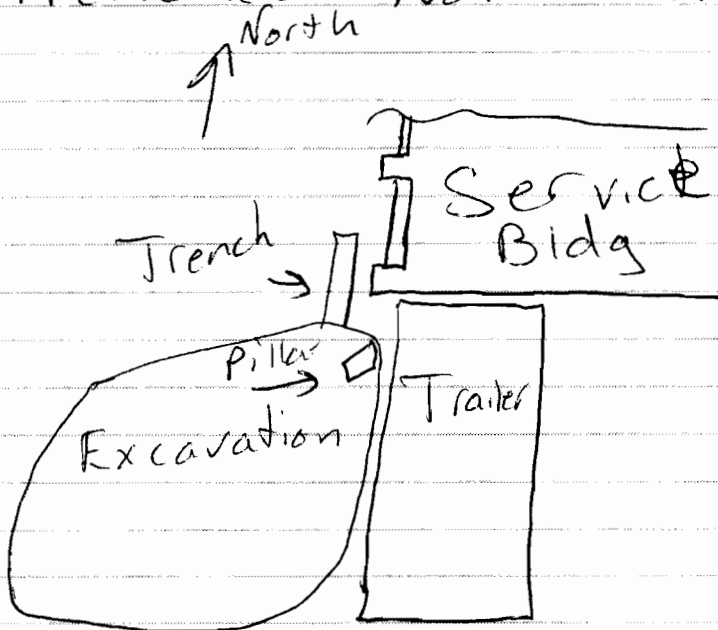
- Trench was clean

- Tar seen by pillar in excavation
