Re: National Grid NM Seneca St. – Schenectady MGP (447025)  
Periodic Review Report [Reporting Period – September 1, 2013 – September 30, 2016]

**Periodic Review Report – NM Seneca St. Schenectady MGP (447025)**  
**Reporting Period – September 1, 2013 to September 30, 2016**

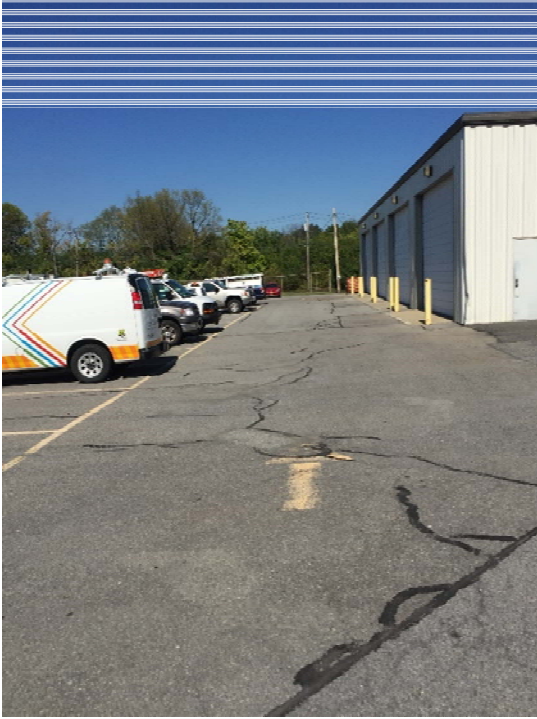
Asphalt condition - September 2016

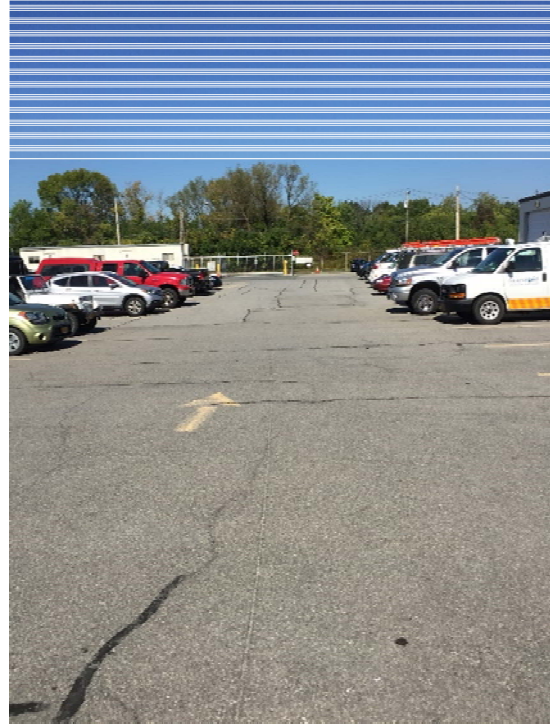
Asphalt Condition - September 2016

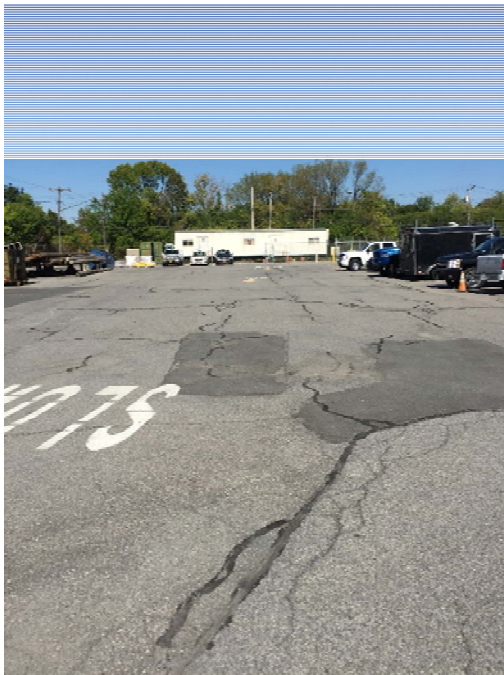
Asphalt Condition - September 2016

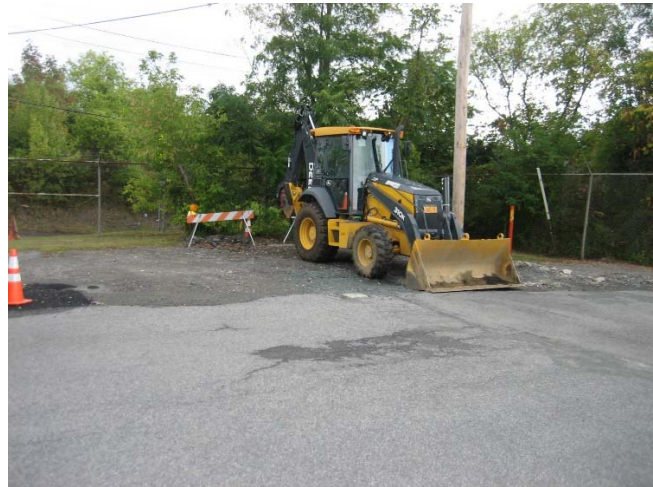
Monument #2 - September 2015

| <b>Area Boundary Controls</b> | | | | | |
|---|---|---|---|---|---|
| Monument - 2 | PRESENT | | MISSING | | COMMENTS: Monument had been hit by snowplow. The concrete base is loose. But Secure. |

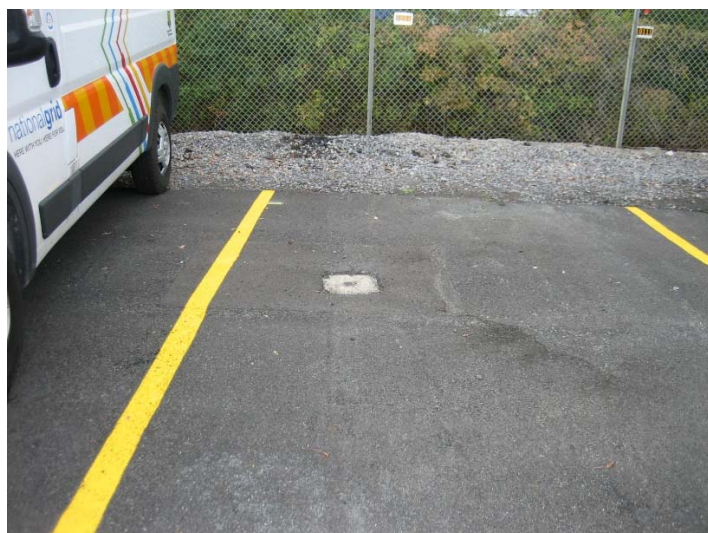
Monument #4 - September 2015

- In December 2013, it was discovered that Monument #4 was inadvertently covered by new asphalt. The monument was exposed and found to be intact on the September 2014 inspection date.
