PHASE I
ENVIRONMENTAL SITE ASSESSMENT
OF

DAMBROSE CLEANERS
1517 VAN VRANKEN AVENUE
SCHENECTADY, NEW YORK

October 1997

CHA Project No. 6833.07.01

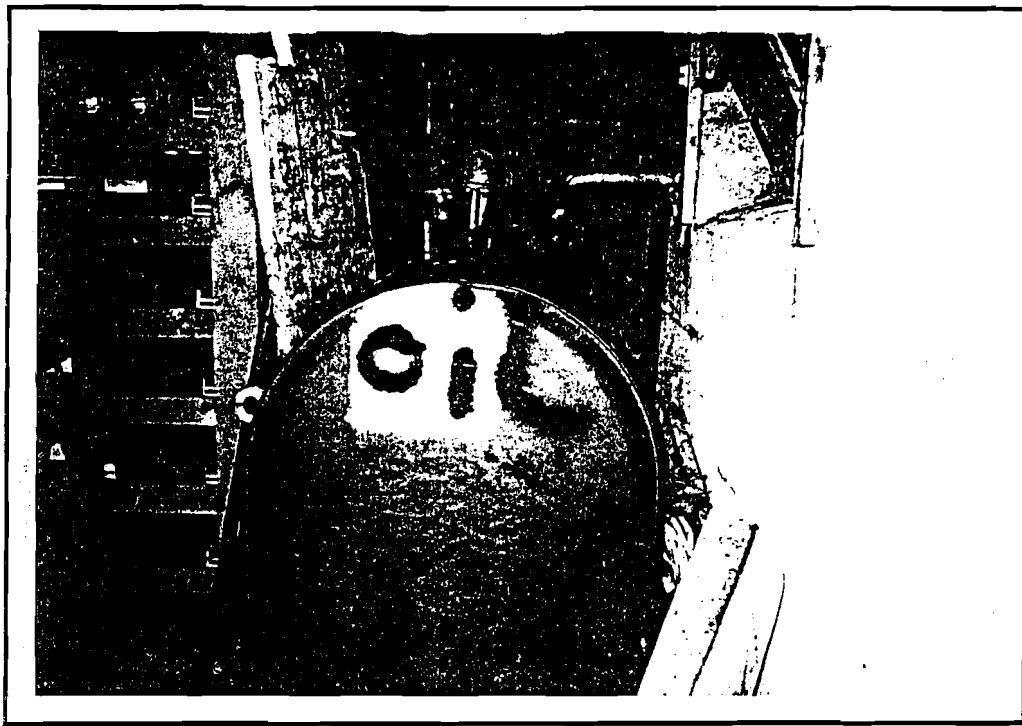
Two aboveground storage tanks (ASTs) were located along the southern wall of the basement of the building (Photos 2 & 3). The tanks are used for storage of fuel oil which fires the heating system for the structure. The tanks appeared in good condition at the time of the site inspection. Fill and vent pipes were located along the southern exterior wall (Photo 4) and appeared in good condition at the time of the subject site. There was no evidence of underground storage tanks (USTs) noted at the time of the site inspection.

OIL TANK IN BASEMENT

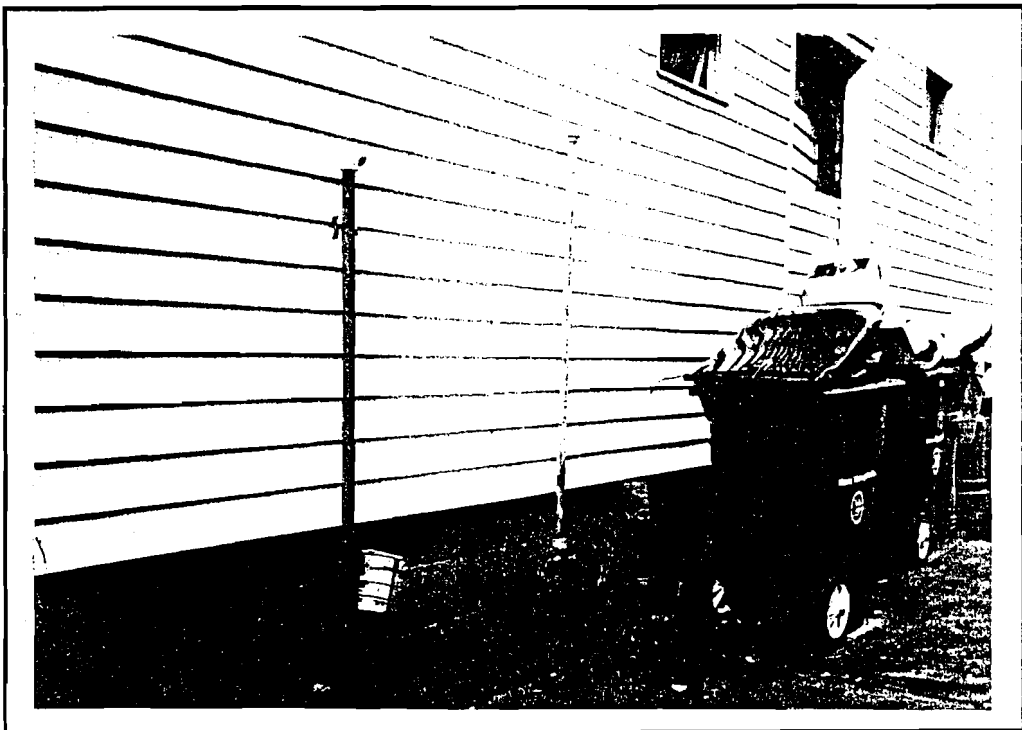
PHOTO #4

- Floor staining was noted in the basement in the area of the boiler/heating system and appeared to be the result of minor leaking of fuel oil from connections and/or piping to the system. The concrete floor underlying the boiler system generally appeared to be intact, however, accumulation/leaking of these materials over an extended period of time may potentially become an area of concern. Slight floor staining was also noted on the surfaces in the area of the distillation tank. These stains were most likely the result of spillage during the manual removal of sediments from the distillation tank. These materials are considered hazardous waste and spillage to building surfaces could present an area of concern. In addition, surface staining around the fuel oil fill pipes is an indication of overfills or spillage at the time of oil delivery.

OIL TANK FILL & VENT PIPES

CHA also recommends that the heating system be serviced/repaired to eliminate dripping/leaking materials currently collected in coffee cans, as potential sources of odor and contamination concerns. Based on staining noted in the area of the AST fill pipes and the solvent distillation tank, good housekeeping procedures should be adhered to as closely as possible during delivery of fuel oil and

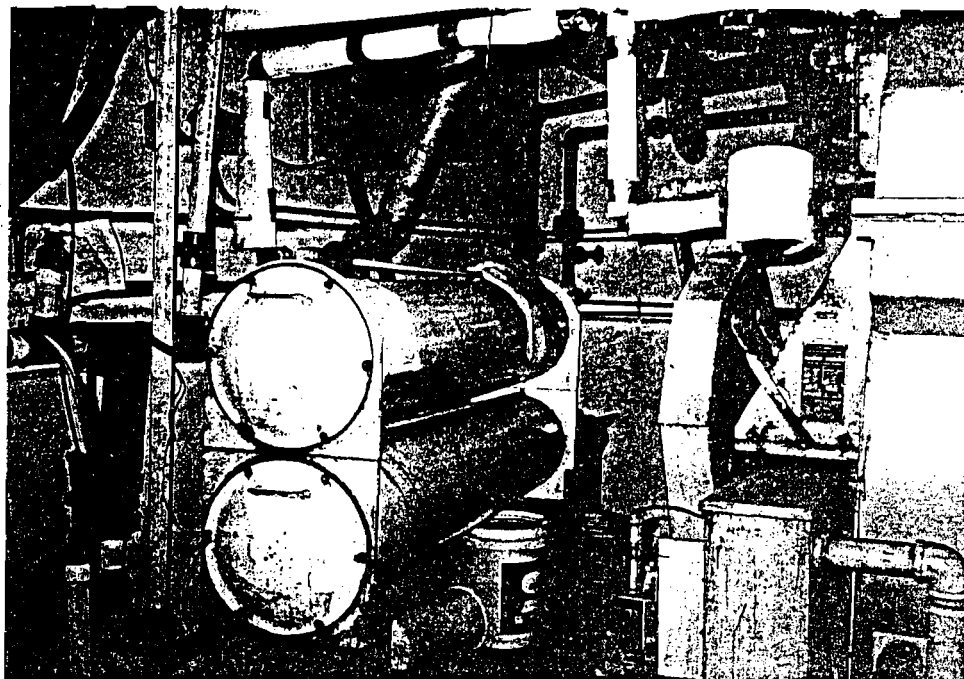
PHOTO #5

Two tetrachloroethylene storage tanks were present on site, associated with the dry cleaning machine (Photo 5). These tanks have a total capacity of 90 gallons and were located along the interior western wall of the building. No bulk inventory of tetrachloroethylene was maintained on the subject site. The site operator utilizes an on-call delivery service which maintains the levels of solvents within the tanks of the dry cleaning machine as needed. There are several filters within each tank which are periodically replaced within the tanks. Prior to removal, the filters are allowed to drain within the empty tanks for several days. The drained solvents are transferred to a distillation unit for distillation and re-use. The waste filters are removed from the tank and placed into plastic disposal containers for pick up and off-site disposal. The disposal containers are stored on a concrete surface within the garage structure to the rear of the dry cleaning building.

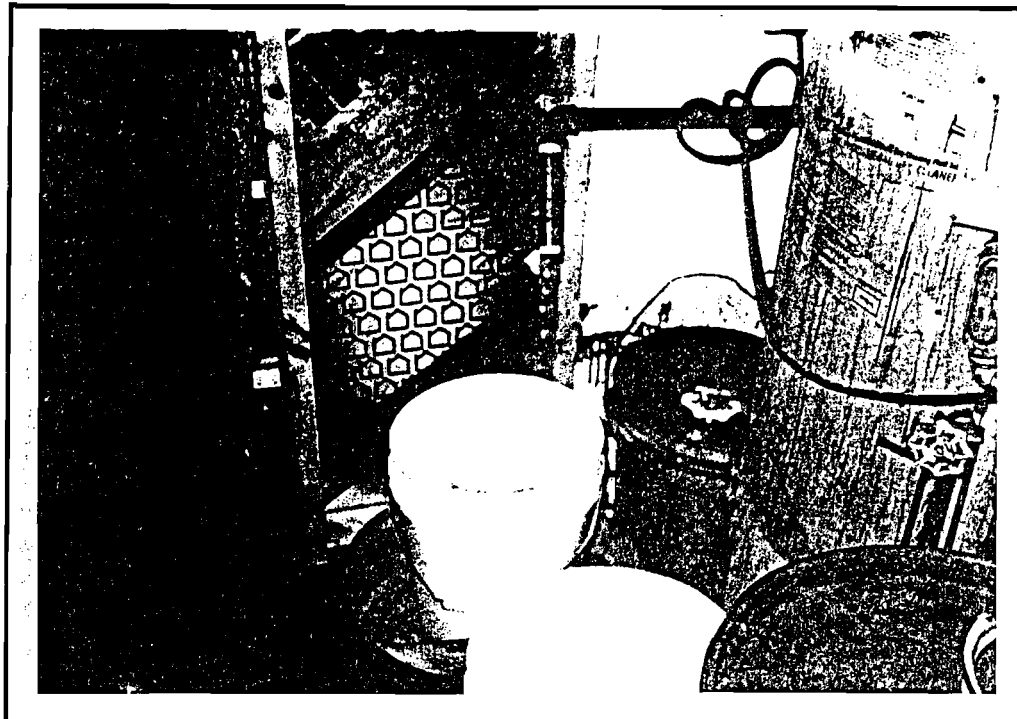
There was a slight petroleum odor noted in the basement. In addition, solvent fumes were noted in the area of the distillation tank, apparently originating from the open distilled tetrachloroethylen collection container.

- Petroleum odors were noted in the basement and solvent odors were evident in the rear portion of the first floor. The odors appear to be the result of open, uncovered containers

DISTILLED TETRACHLOROETHYLENE
COLLECTION VESSEL

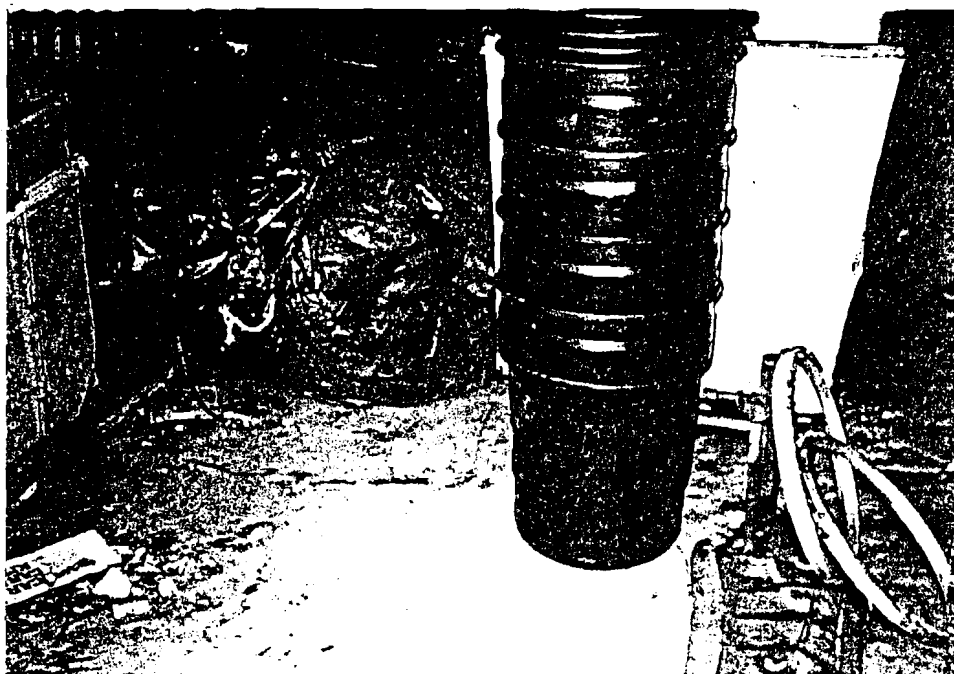
PHOTO #12

No evidence of improper waste disposal was noted on the subject site at the time of the site inspection. Spent filters and distillation sediments are collected in plastic containers furnished by the hazardous waste disposal contractor (Photo 12). The containers are stored on a concrete surface in the garage and are removed from the subject site monthly by Safety Kleen. Hazardous waste manifests are completed for each pick up and maintained on site by the facility operator. It should be noted that the current operator has manifests dated since 1995. The subject site was operated by another entity from 1993 to 1995. Reportedly, when the current operator regained operation in 1995, the manifest files for all previous years were gone. Solid waste generated at the subject site is removed by the City of Schenectady.

- Hazardous wastes, consisting of spent filters and distillation sediments, are accumulated in appropriate containers supplied by the hazardous waste transporter and stored in the garage. The area on which the containers sit is covered by concrete. The garage building is kept locked at all times. Condensate waters from the distillation unit and air filter unit are disposed of via the sanitary sewer system. Solid wastes are removed from the subject site by the City of Schenectady. *arrow (use must it system)*

HAZARDOUS WASTE COLLECTION
CONTAINERS (THESE ARE EMPTY)

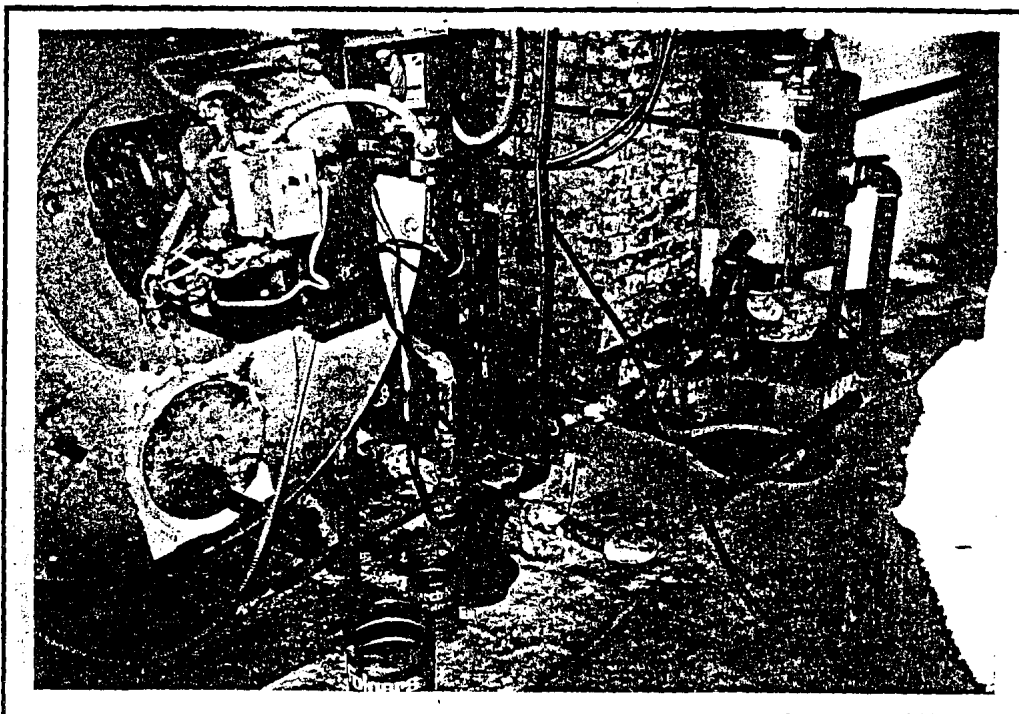
PHOTO #15

Floor staining was noted in the basement in the area of the boiler and boiler condensate tank (Photo 15). The staining is most likely the result of oil leaking from supply lines. Open coffee cans were observed

being used as collection containers for dripping oil. Slight floor staining was also noted on the surfaces in the area of the distillation tanks. Surface staining around the fill pipes on the southern exterior wall was also noted.

STAINING & OIL "CATCH" CONTAINERS
ADJACENT TO BOILER
