MOOERS LANDFILL CLOSURE

CONSTRUCTION CERTIFICATION REPORT

APPENDIX D

PHOTOGRAPHS

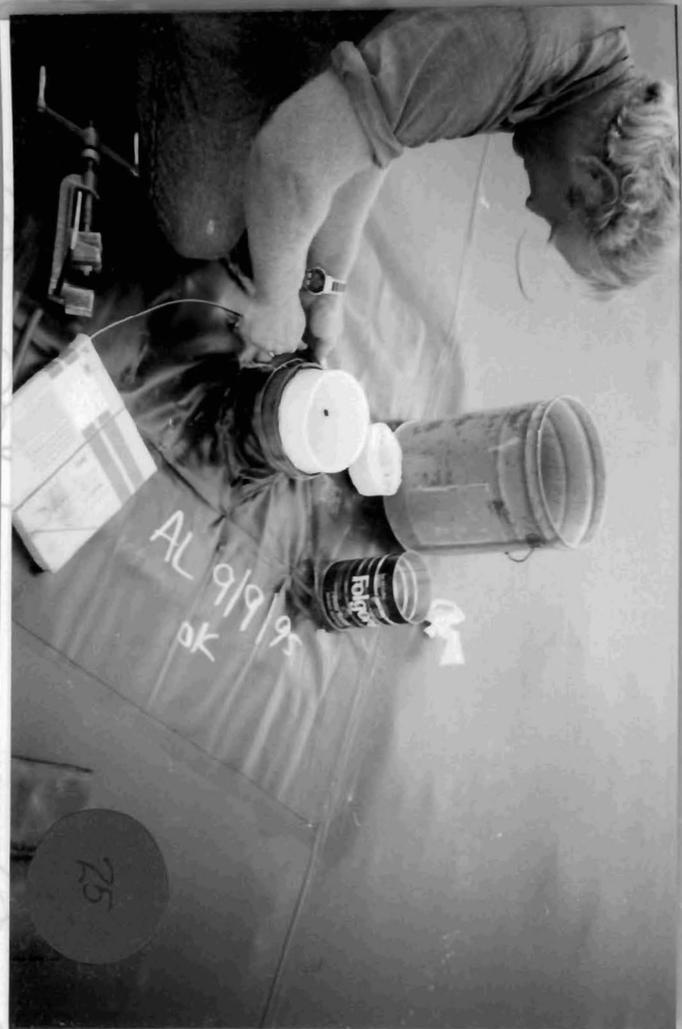
- 21 Deploying PVC panel.
- 22 Applying solvent to PVC seam.
- 23 Rolling PVC seam after solvent applied.
- 24 PVC penetration boot at gas vent.
- 25 Completed PVC penetration boot being clamped to gas vent pipe.

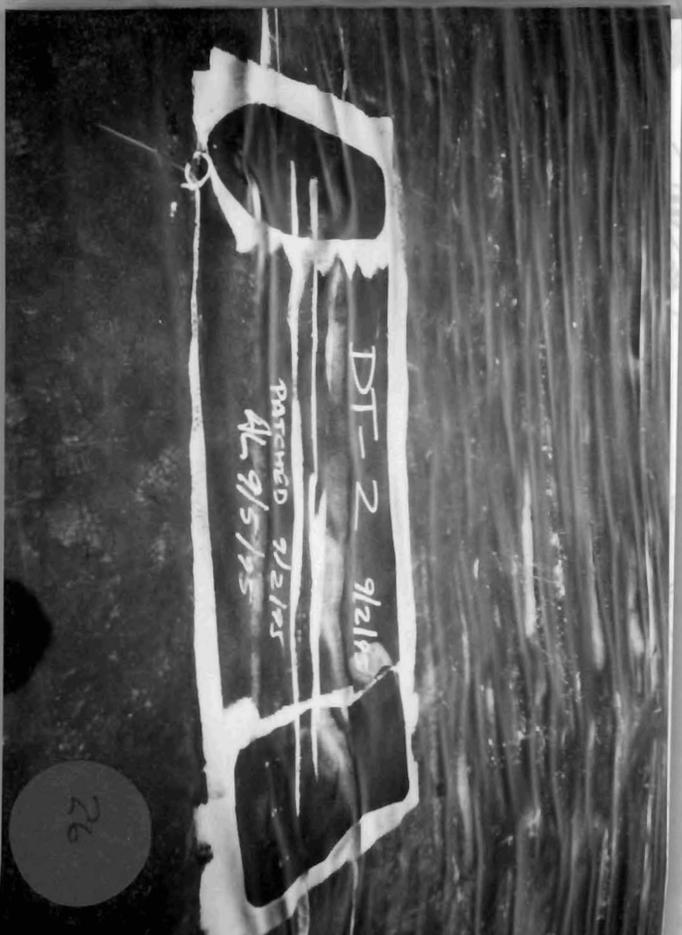
- 26 PVC seam destructive test patch.
- 27 Air lance (non-destructive) testing of PVC seam.
- 28 Repairing a "fishmouth" in PVC seam.
- 29 Excavation of anchor trench for PVC at toe of slope.

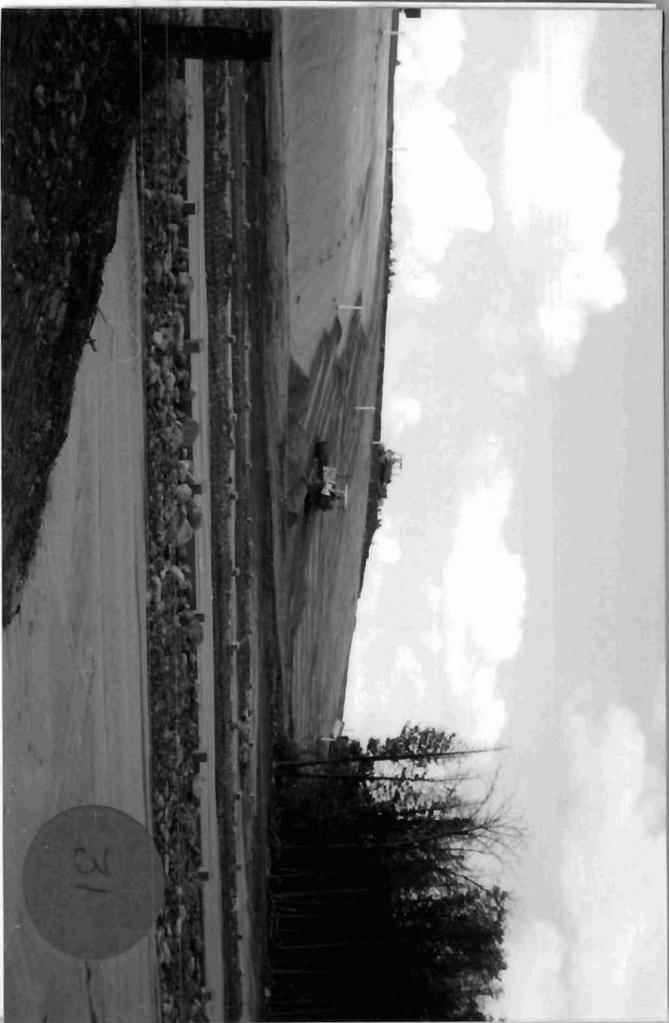
- 30 Placing first lift of protective cover soil (drainage layer) on PVC.
- 31 Placing first lift of protective cover soil on PVC on north slope. Note stepped impoundments in foreground.

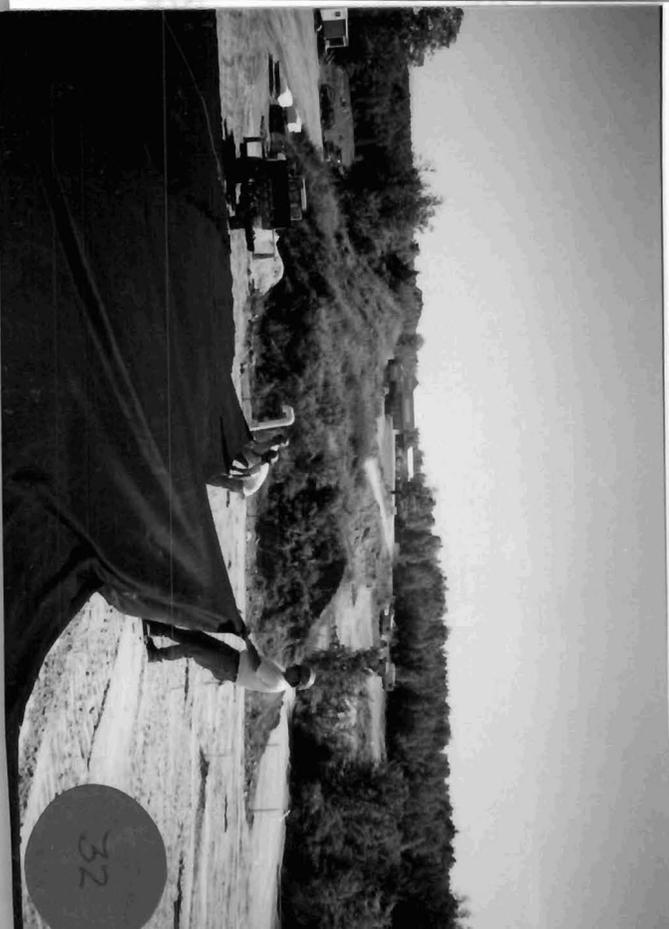
- 32 Placing geotextile over drainage layer material on slopes.
- 33 Building access road to top of landfill out of common fill protective cover. Note cross section above PVC of drainage layer, geotextile and common fill.

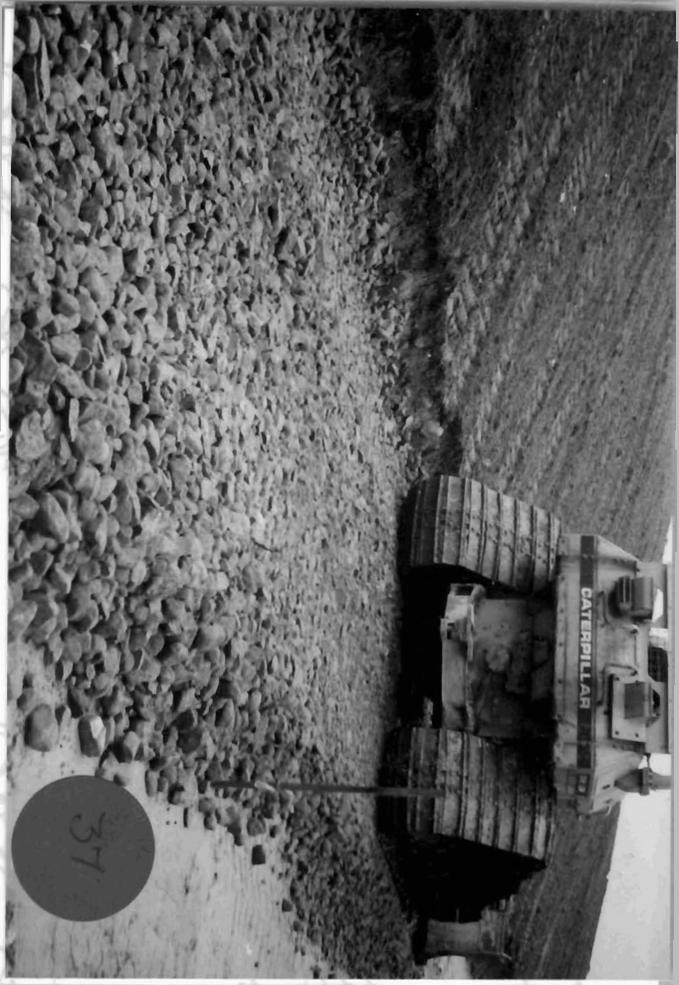
| 37 | Placement of toe drain material beneath new access road along south side of landfill. |

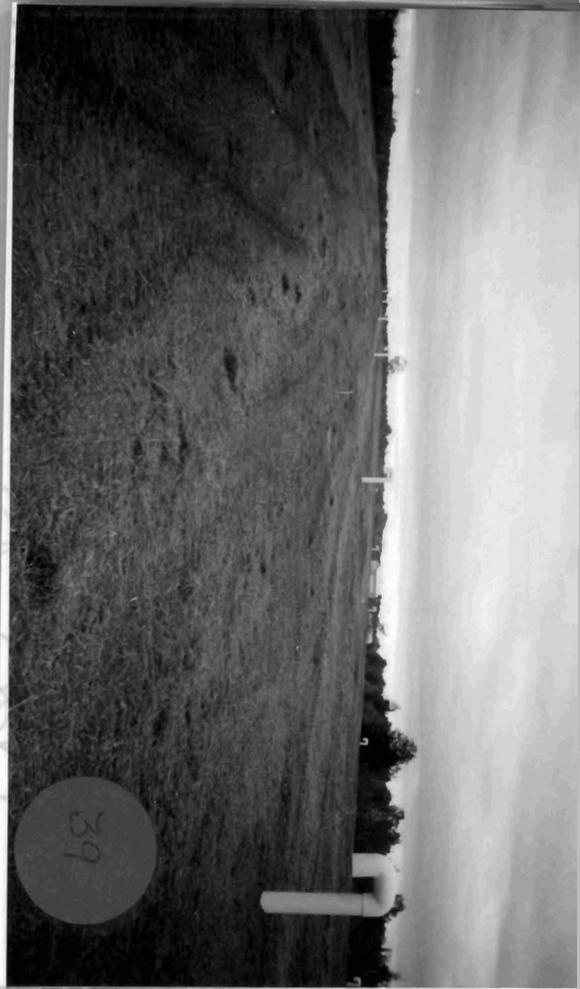
| 39 | Top of landfill following seeding and mulching. |

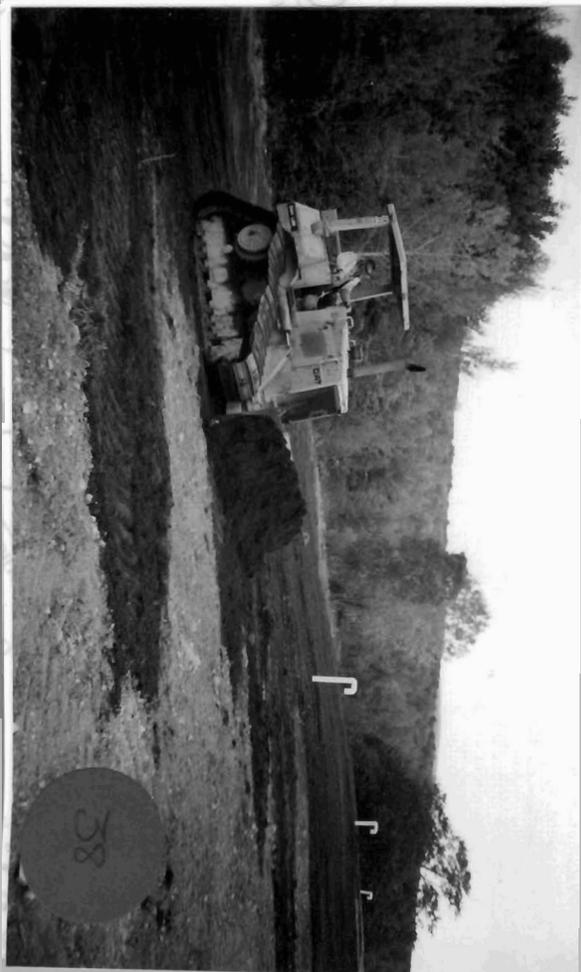
| 38 | Spreading topsoil. |

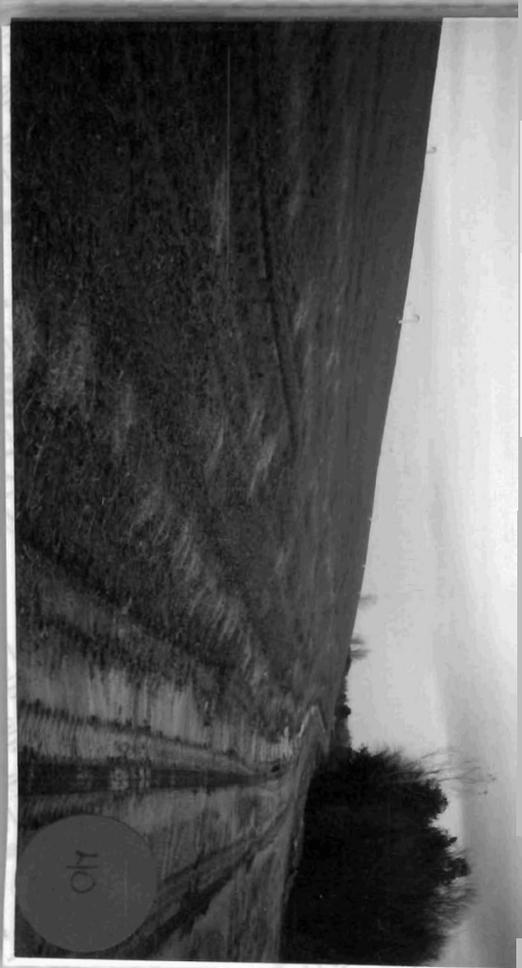
| 40 | Grass growth on south slope of landfill. |
