Subject: 2022 Post-Construction Monitoring Report

Plattsburgh (Saranac Street) Former Manufactured Gas Plant Site, Operable Unit No. 1

NYSDEC Site No. 5-10-007

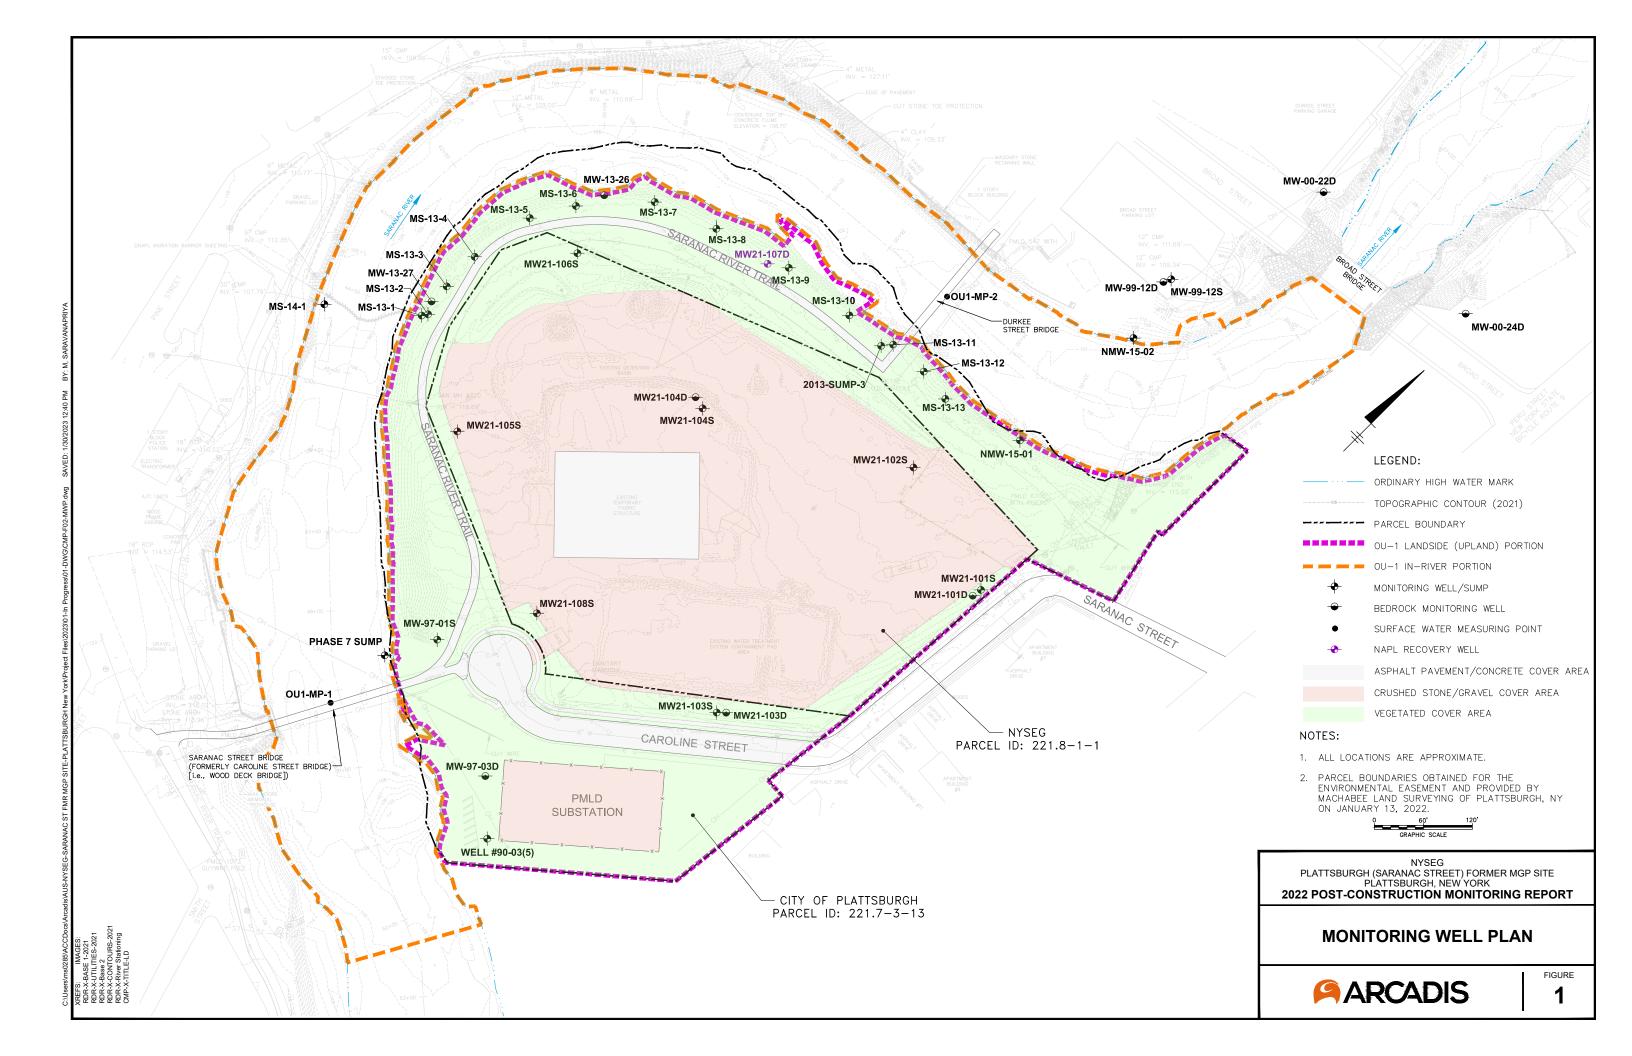
Figure 1 – Monitoring Well Plan

Arcadis inspected monitoring wells and sumps during gauging activities and conducted a site inspection to evaluate site usage and general site conditions. Site cover consists of asphalt pavement/concrete, crushed stone/gravel, and vegetated areas (shown on Figure 1). Monitoring wells and sumps are currently in satisfactory condition. The November 2022 site inspection form is included as Attachment 2.

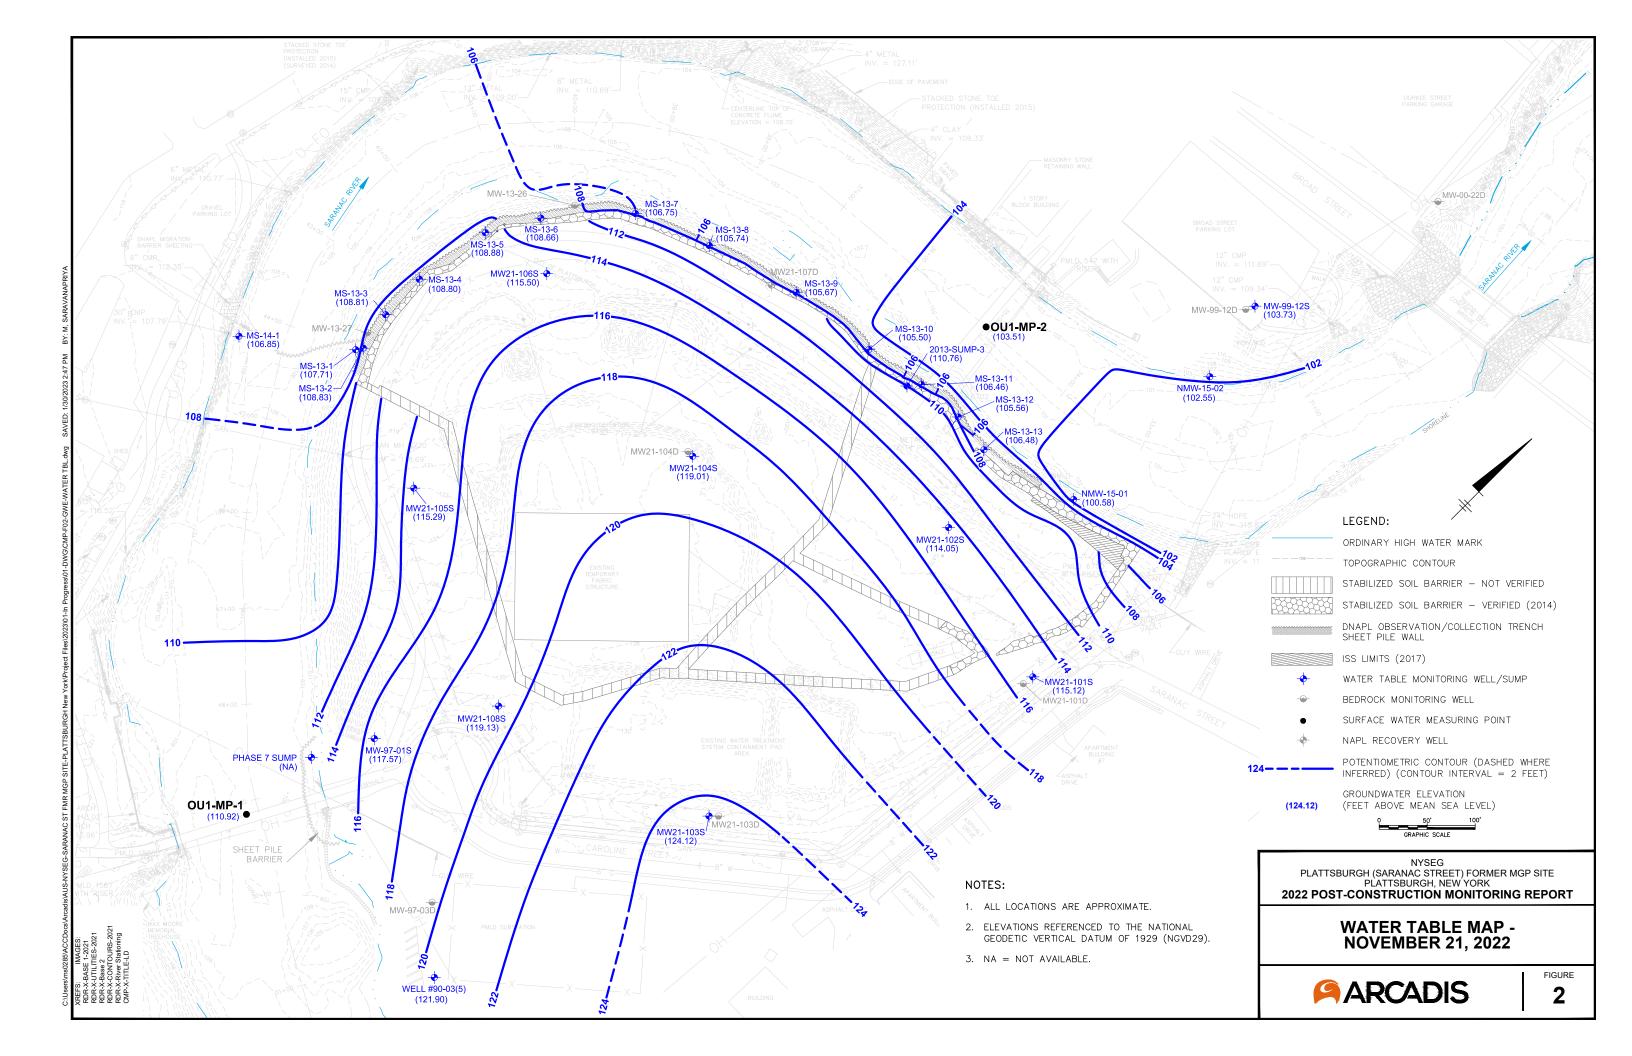
Figure 2 – Water Table Map

Historically, the water table mimicked the Site's topography (peninsula), with groundwater elevations highest east of the peninsula and remaining higher along the approximate centerline of the peninsula, gradually declining toward the riverbank (see RI Figures 9 and 10 in Attachment 1). The November 2022 water table (Figure 2) follows a similar overall pattern; however, there are a few differences imparted by the installed remedial components.

- Groundwater has mounded slightly behind the portion of the SSB wall that parallels the riverbank.
- Based on surveyed elevations of the SSB top located parallel to the Saranac River (identified on Figure 2 as "Stabilized Soil Barrier – Verified"), groundwater overtops the SSB along most of its length, except for the area between monitoring sumps MS-13-1 and MS-13-5.

- Groundwater overtopping the SSB (parallel to the river) enters the DNAPL observation/collection trench.
 Once in the trench, groundwater follows the trench slope (which parallels the slope of the river) toward monitoring sump MS-13-10. In this area, groundwater in the trench overtops the sheet pile barrier and seeps into the river.

- Near the ISS monolith (identified as "ISS Limits (2017)" on Figure 2), the monolith top is above the water table, therefore, groundwater flow diverges around the monolith, eventually entering the river.

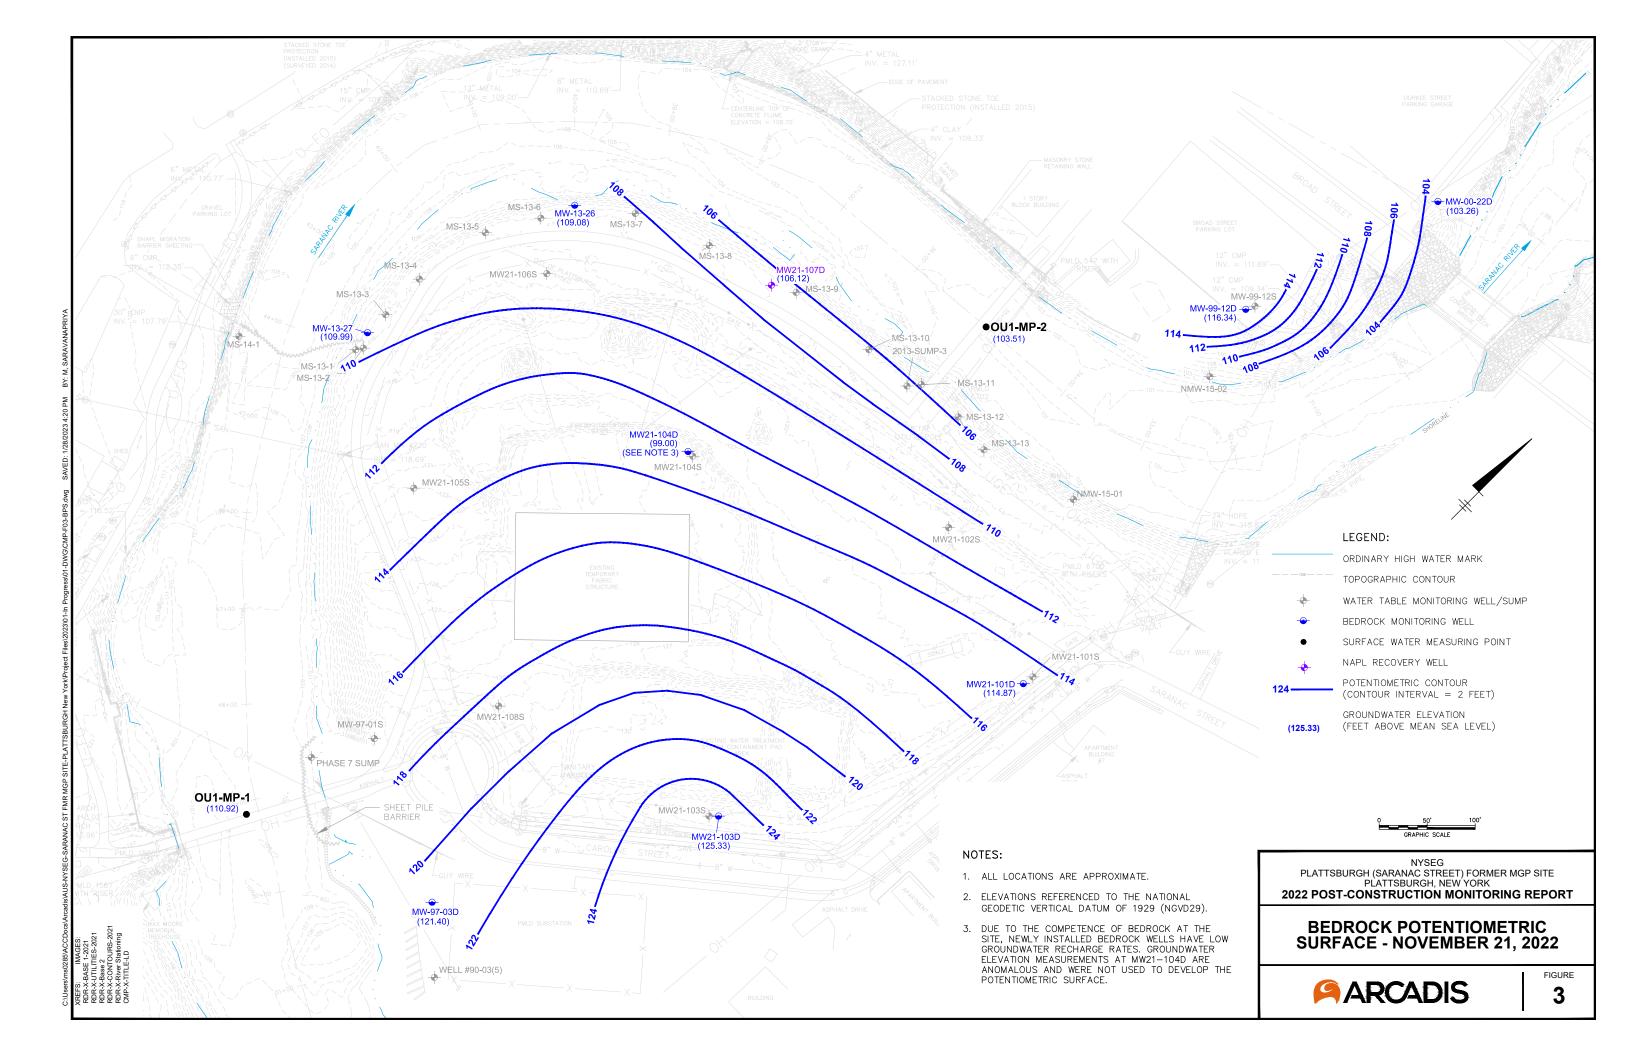
Figure 3 – Bedrock Potentiometric Surface Map

Similar to the water table configuration, the bedrock potentiometric surface generally mimics the peninsula topography, with groundwater moving from the center of the peninsula radially outward, toward and discharging to, the river. Bedrock groundwater north of the river also moves toward, and discharges to, the river. Data in this area demonstrate that the river represents a groundwater discharge boundary for the bedrock flow system, i.e., there is no "underflow" of bedrock groundwater beneath the river. Rather, bedrock groundwater on both sides of the river moves toward and discharges to the river.
