APPENDIX E
PHOTOGRAPHS

Photographs – NYSEG Bridge Street Well Abandonment

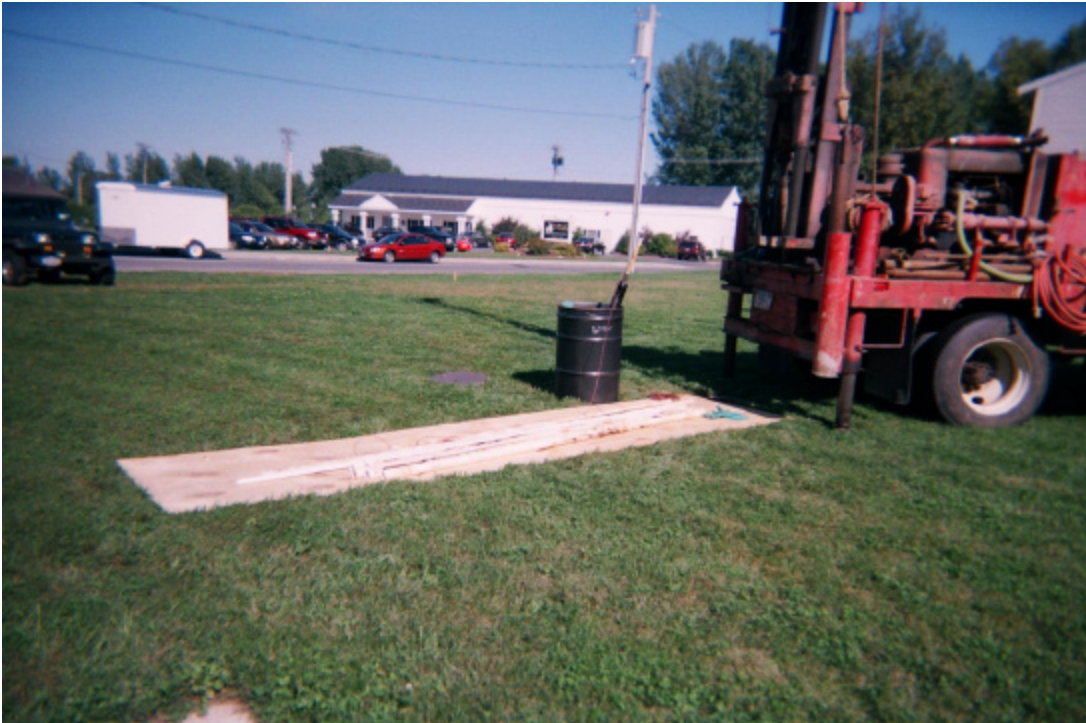
Photo 1: Angle Well packer removal.

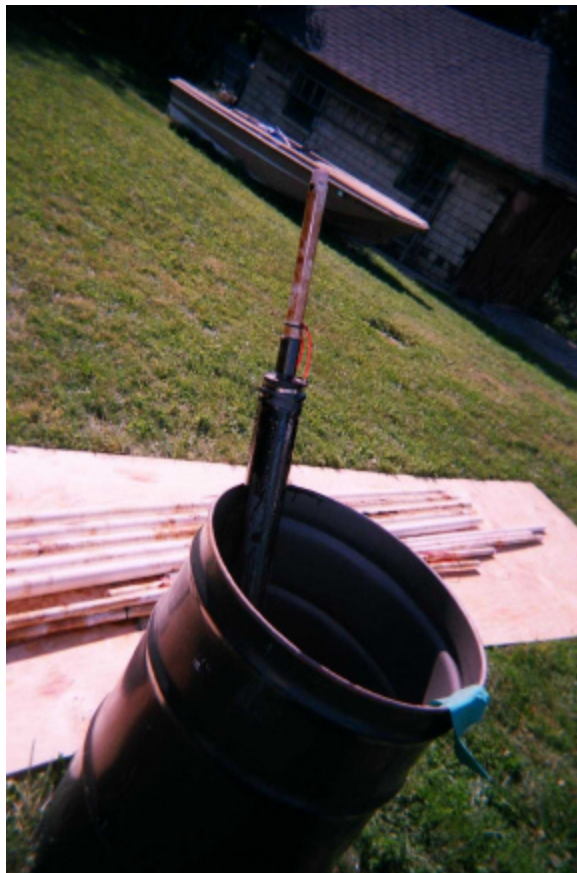
Photo 2: Packer removed from Angle Well.

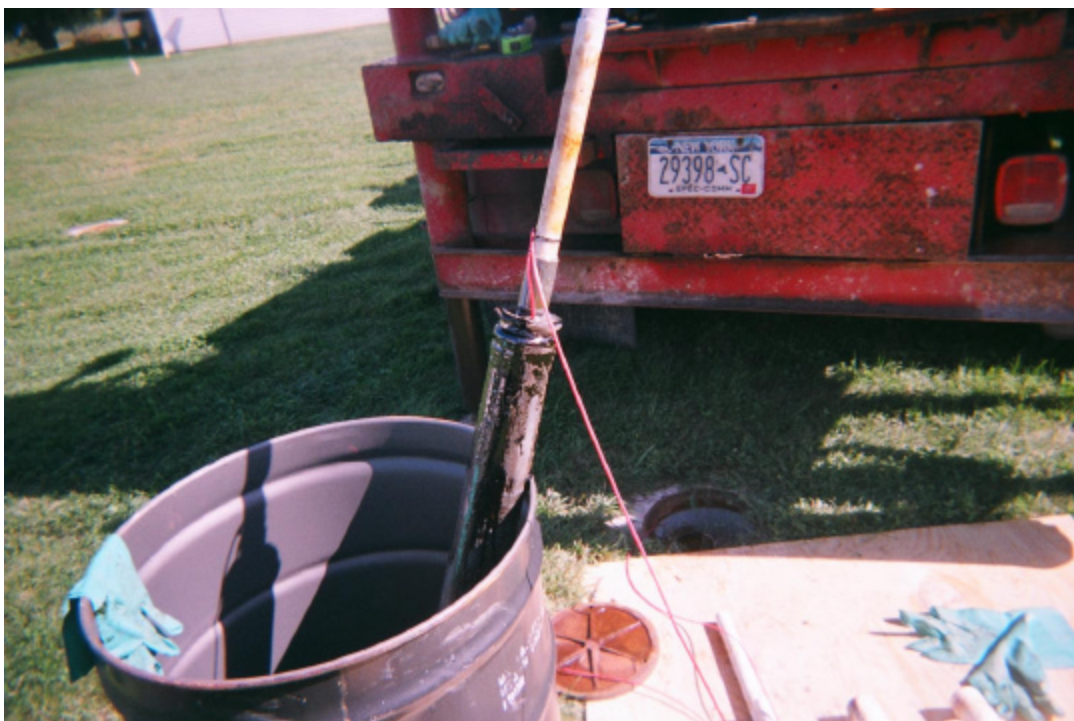
Photo 3: Angle Well packer.

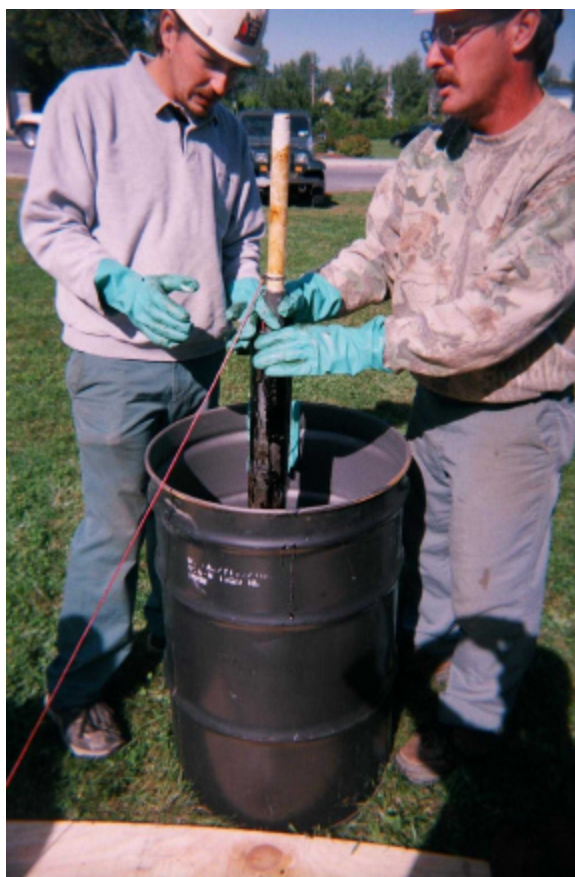
Photo 4: Angle Well packer.

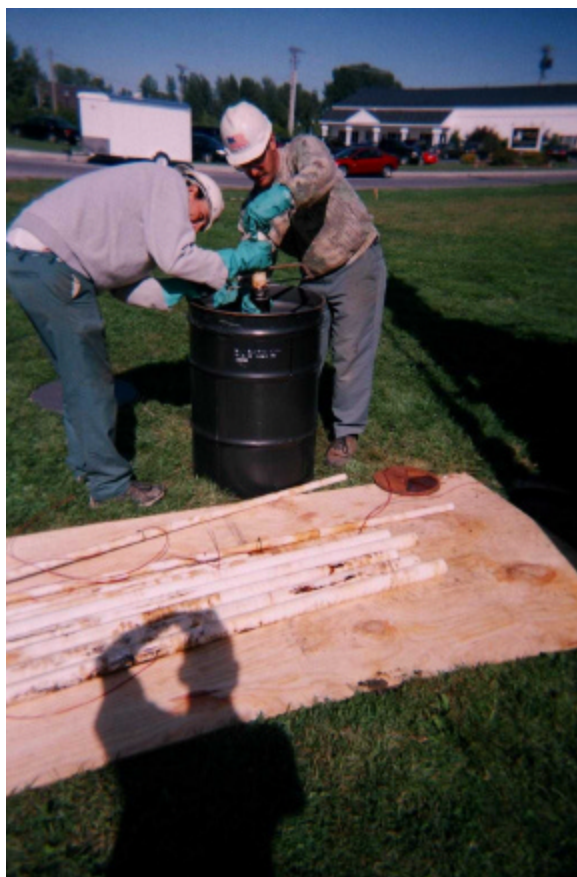
Photo 5: Angle Well packer.

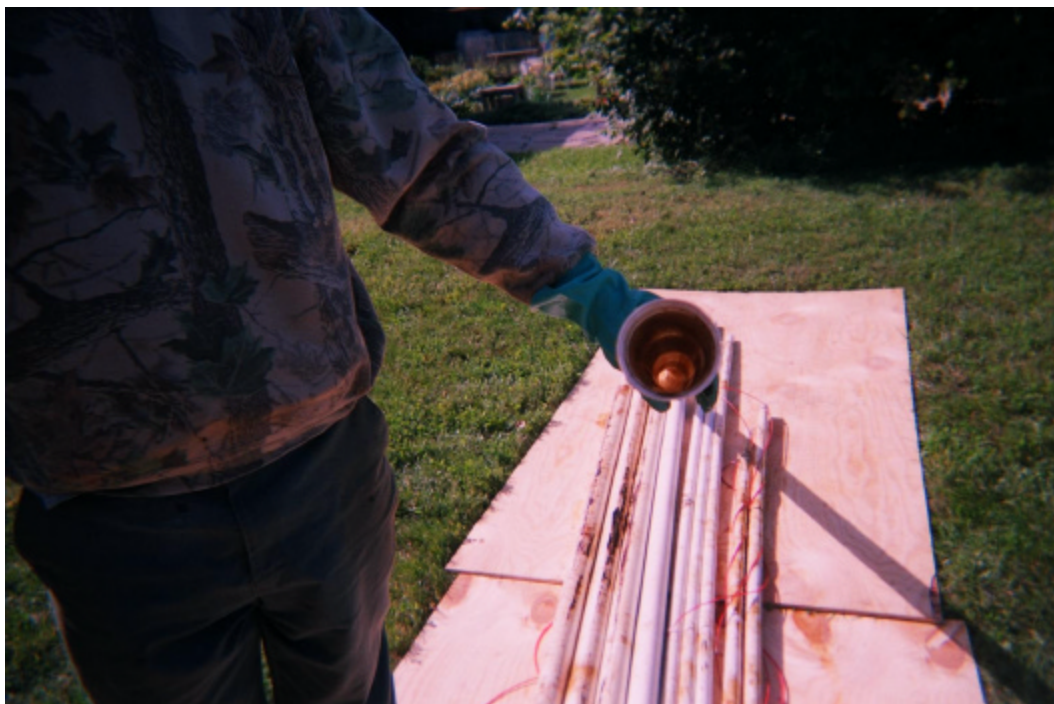
Photo 6: View of inside of 2" PVC (above packer) from Angle Well.

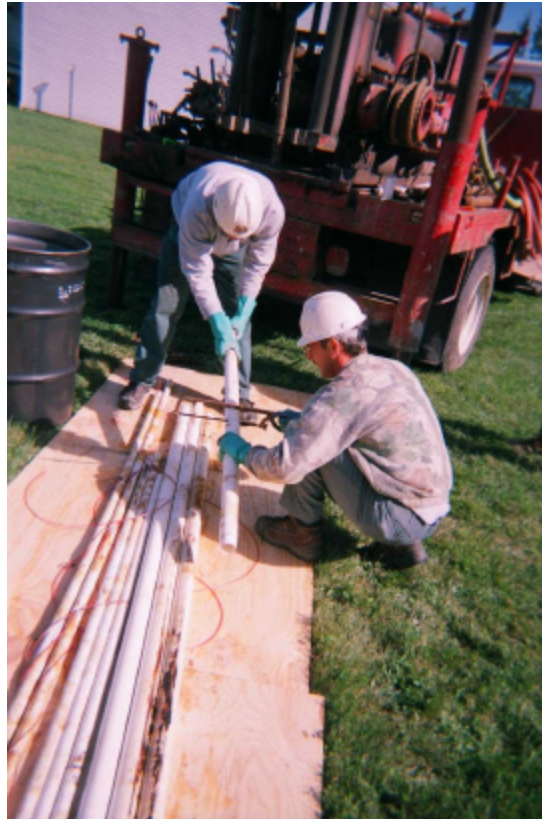
Photo 7: Disposing of PVC from Angle Well packer.

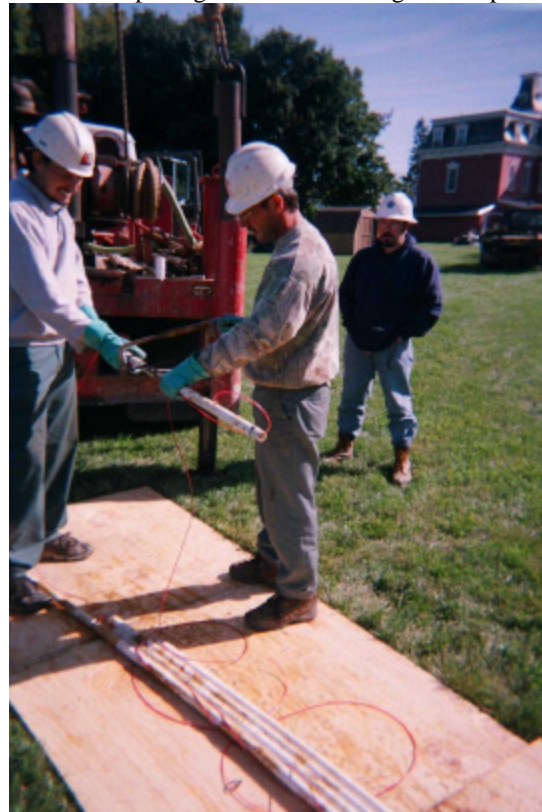
Photo 8: Disposing of PVC from Angle Well packer.

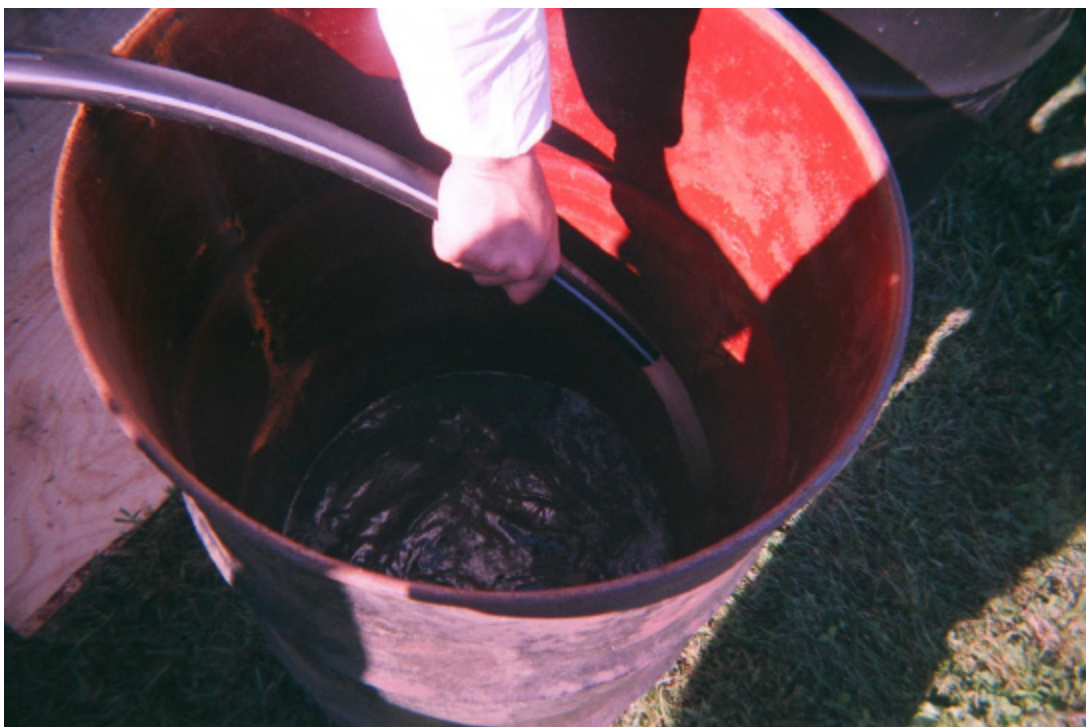
Photo 9: Purge out standing water in Angle Well.

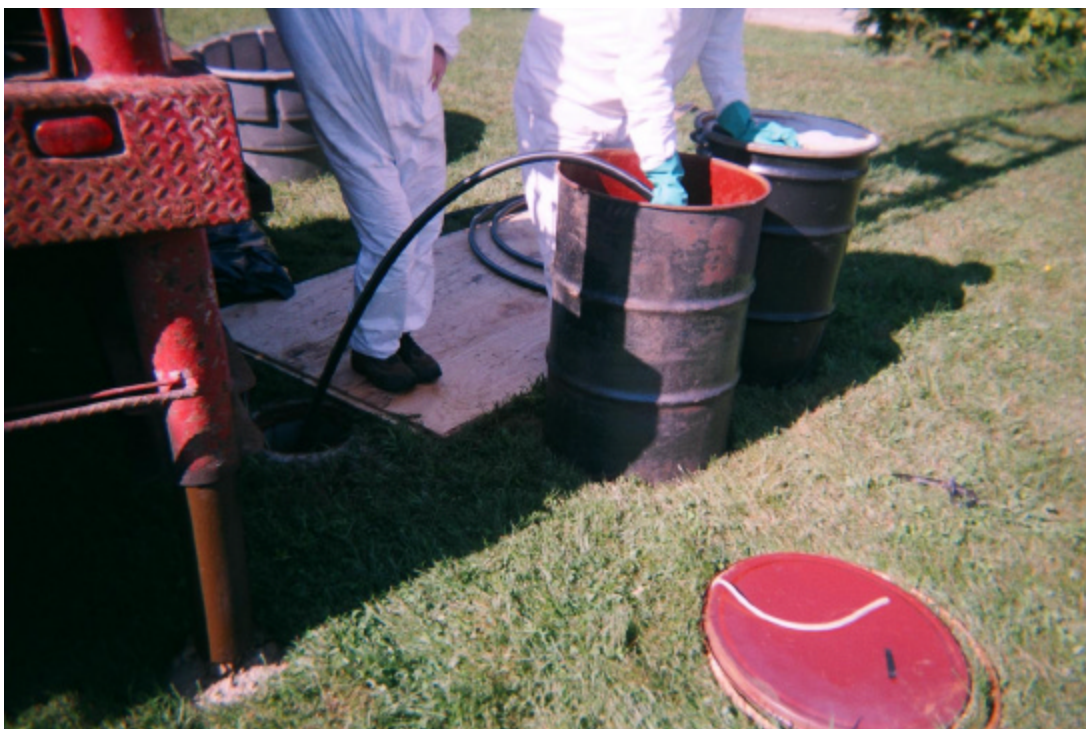
Photo 10: Purge out standing water in Angle Well.

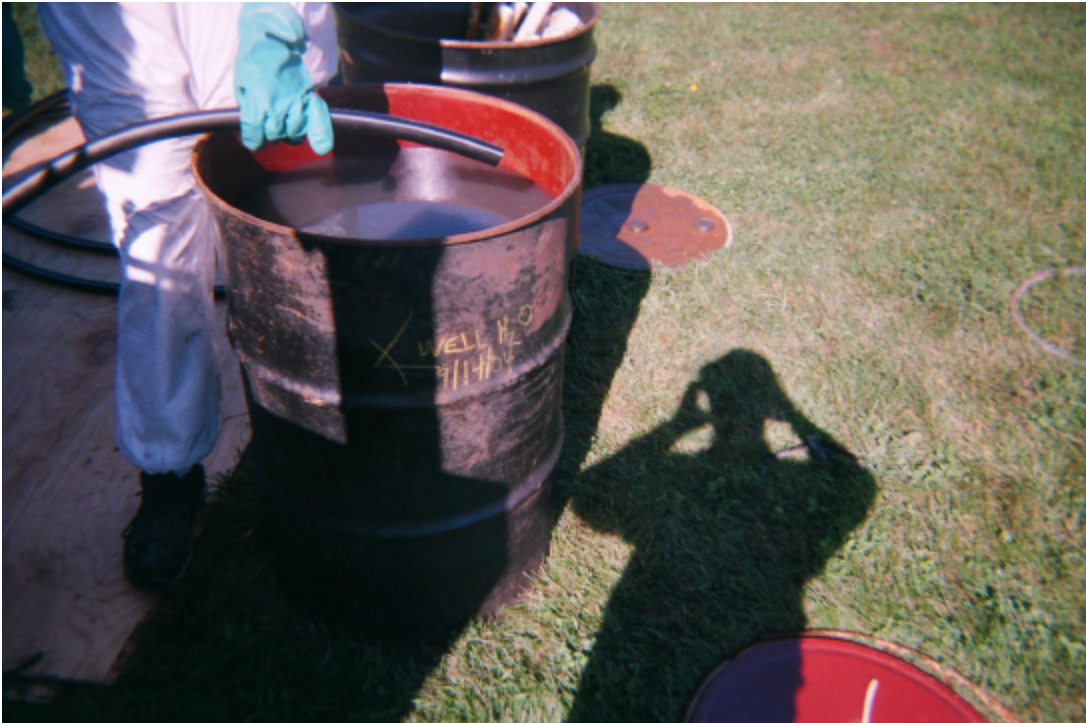
Photo 11: Purge water drum from Angle Well.

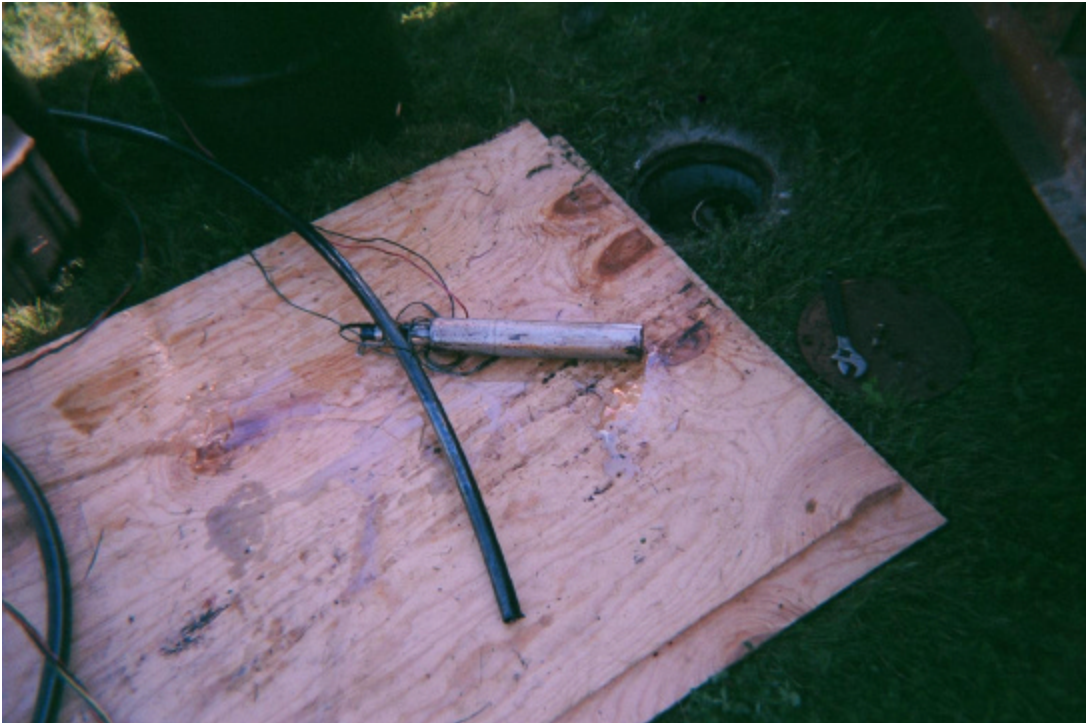
Photo 12: View of pump immediately after purging water from Angle Well.

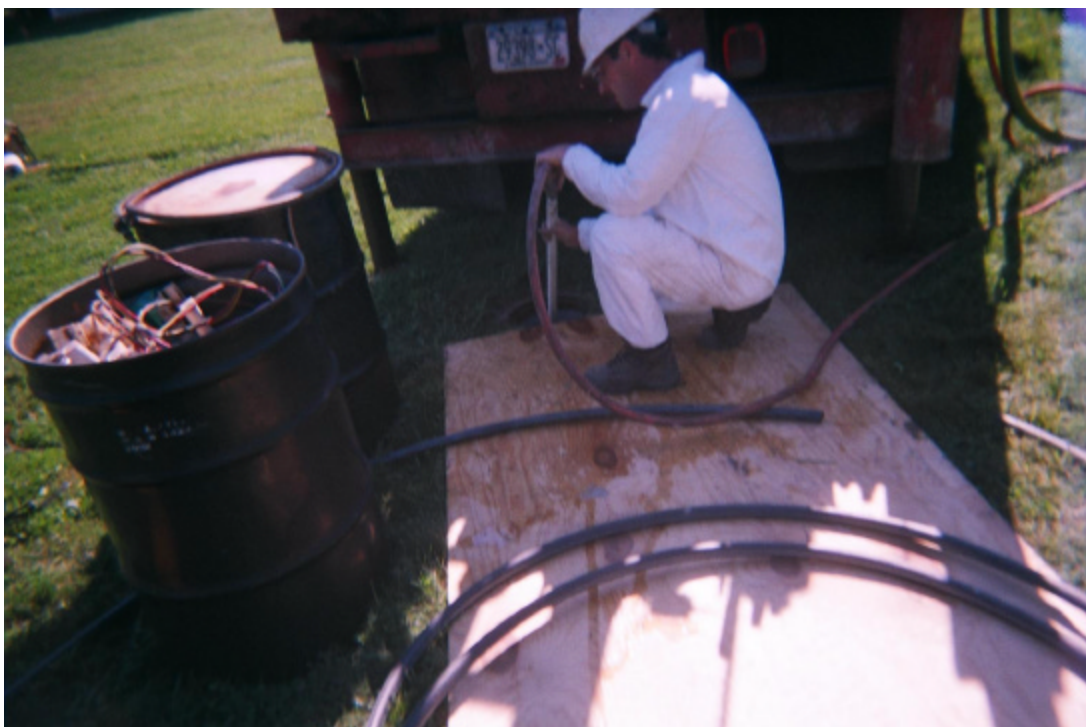
Photo 13: Grouting up Angle Well.

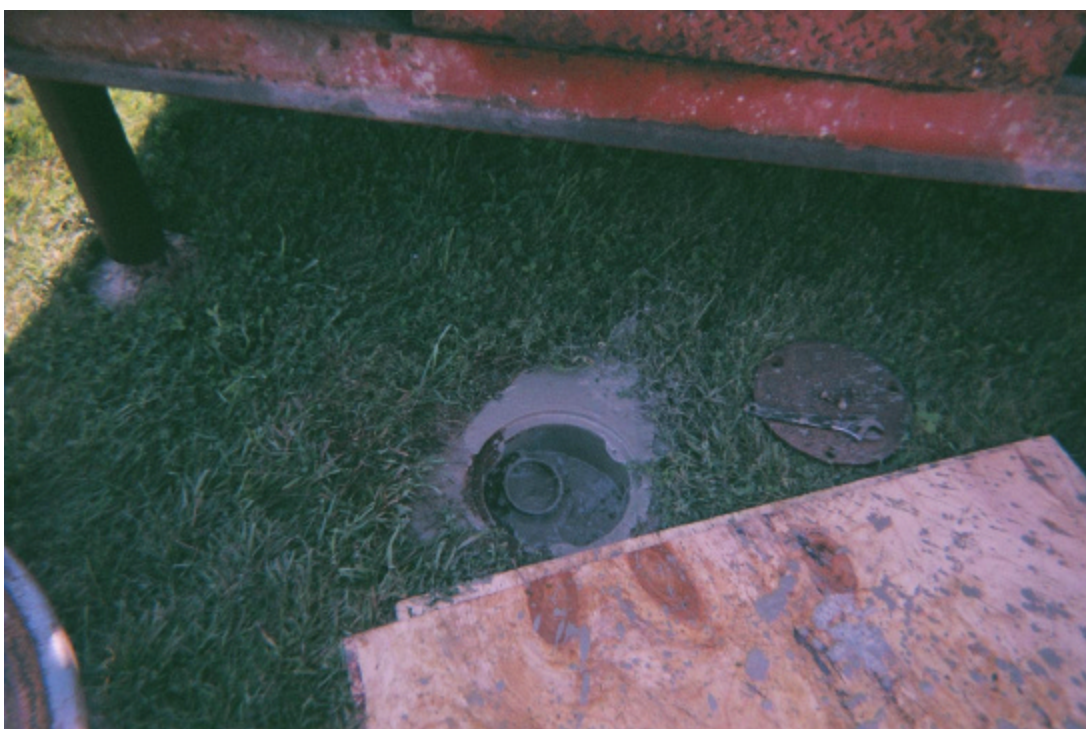
Photo 14: Angle Well after grouting.

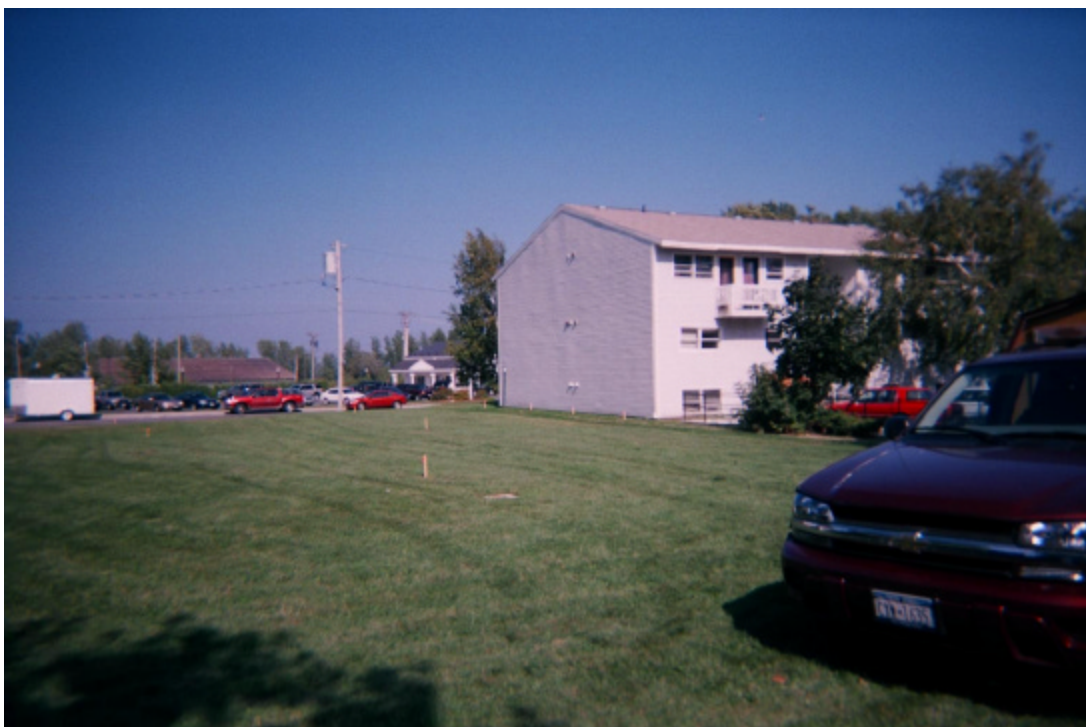
Photo 15: View of site and Gore sorber points.

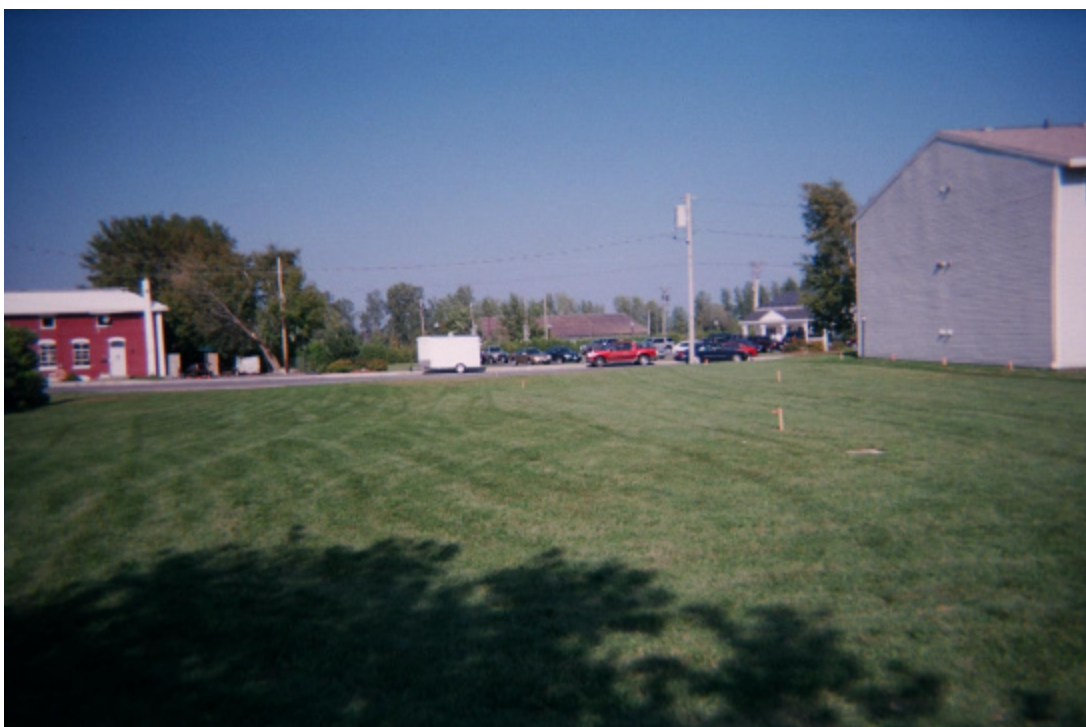
Photo 16: View of site.

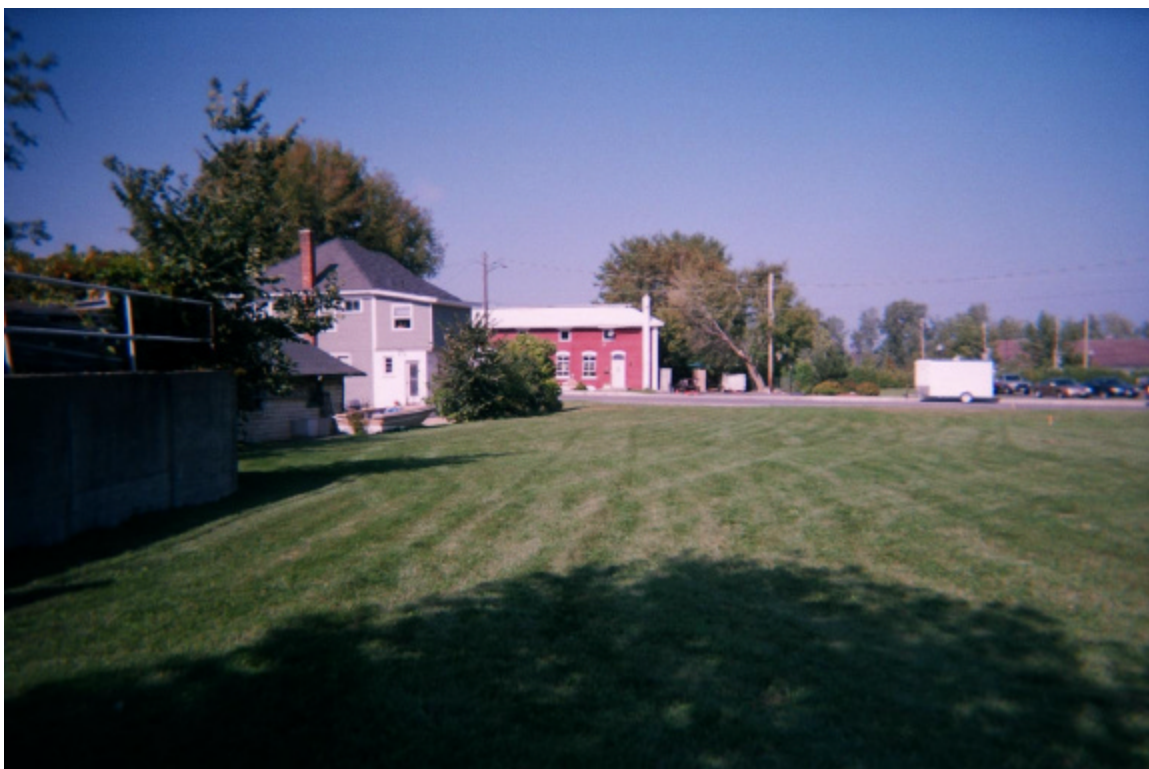
Photo 17: View of site.

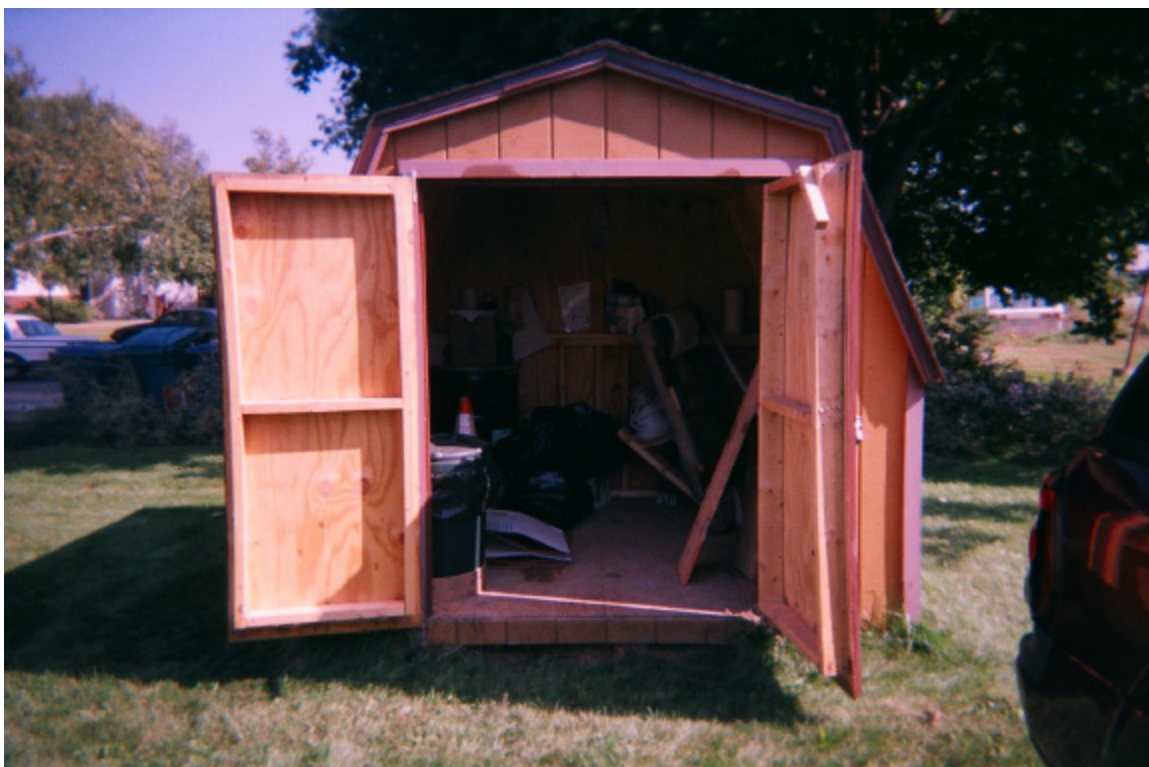
Photo 18: View of shed at site.
