Subject: **Annual Monitoring Report - Year 1 (2021)**  
**Permit Application No NAN-2017-00440-UDE**  
**Saranac Lake Gas Co., NYSDEC Site No. 516008**  
**Village of Saranac Lake, Essex County, New York**

Brandy Brook Area - East  
Vegetative Cover Map  
Project 3617207518

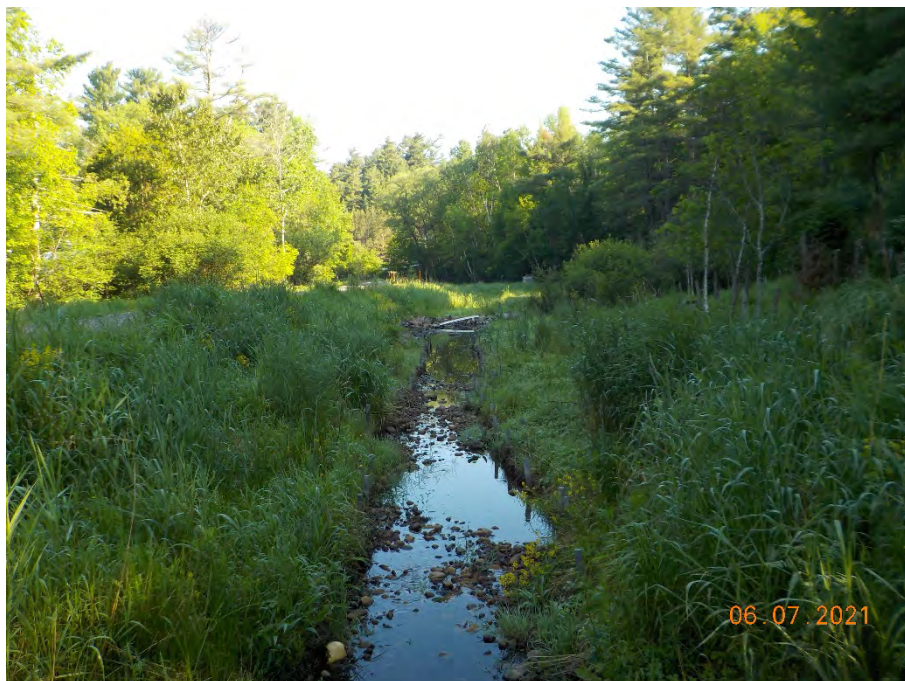
View looking down  
stream Brandy Brook  
OU2. Note stream  
channel and vigorous  
herbaceous growth.

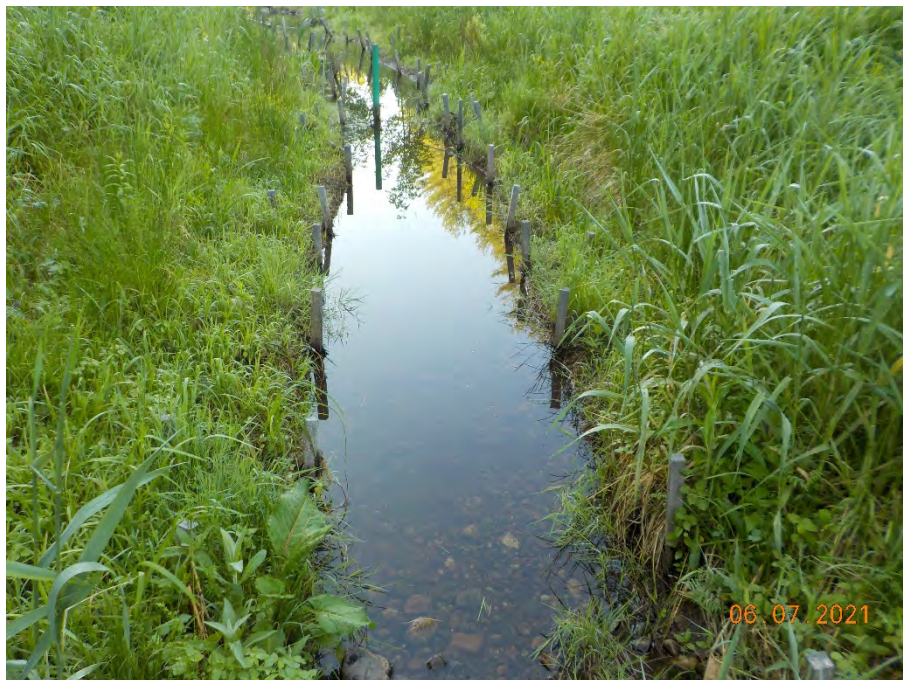
View of restored Brandy Brook. Note staked jute logs establishing the stream bank.

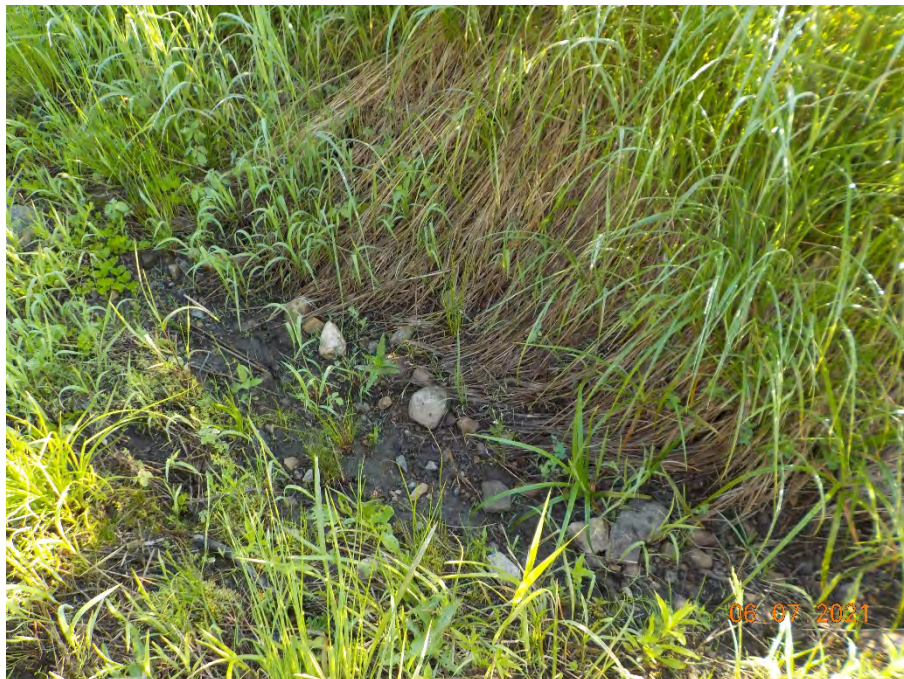
View of naturally forming high flow channel in PEM01 restored wetland.

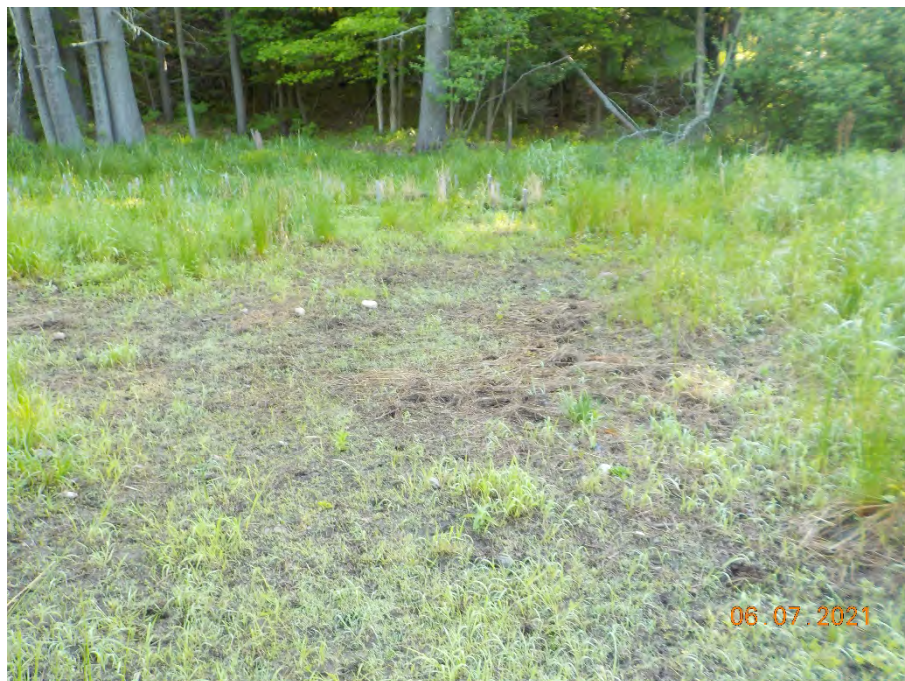
View of potential vernal pool habitat forming in a low-lying area in PEM01 restored wetland.

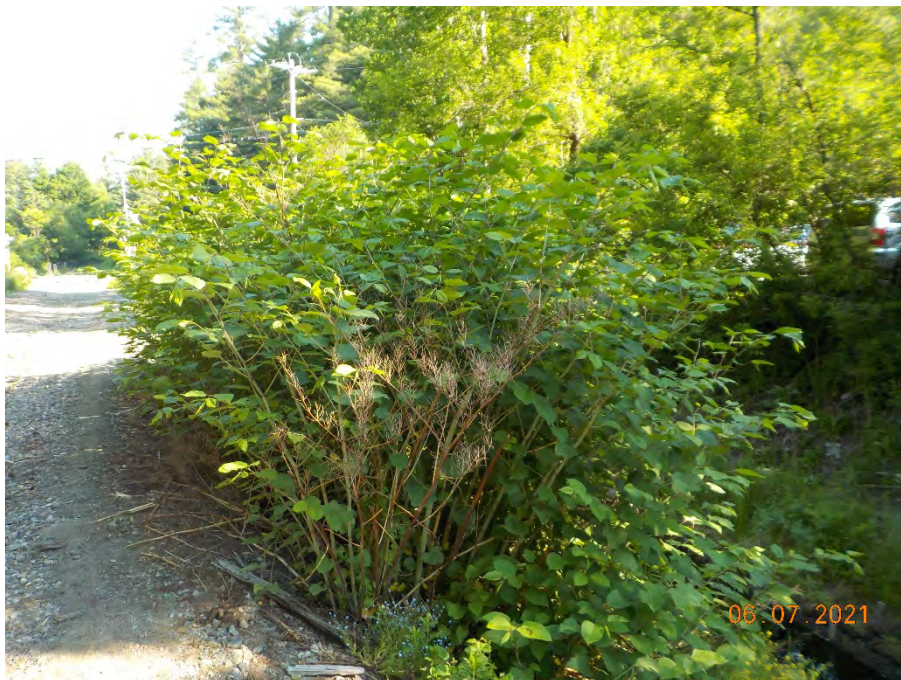
View of Japanese knotweed (invasive species) to be removed. Present along former railroad bed near where brook flows under the former railroad tracks.

- Activities to restore wetlands and bordering upland in support of OU01 remediation activities will be documented in the “OU01 Record Drawing” and in the Year 2 monitoring report.
- Several areas of invasive Japanese knotweed were observed in close proximity to the restored wetlands and Brook (as shown on Figure 2), it is recommended that these be eradicated to eliminate the potential for future spreading of this invasive across the site.
- Soil choked rip rap was replaced with a coarse gravelly sand mix in areas along the portion of restored Brandy Brook between the railroad culvert and the culvert discharging to Pontiac

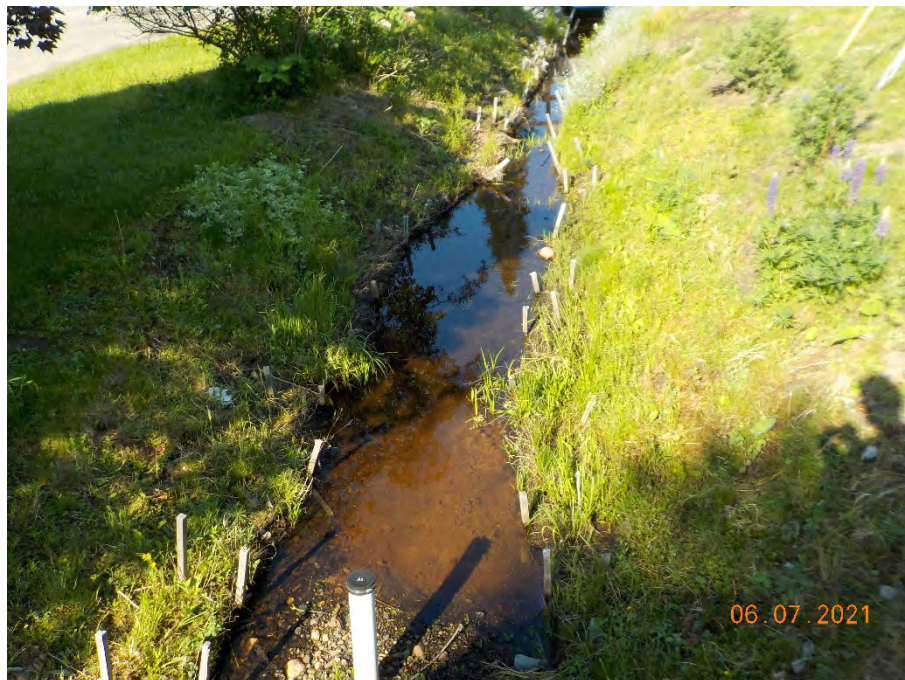
View of restored Brandy Brook below railroad culvert. Note vigorous growth along brook and jute rolls defining the stream channel

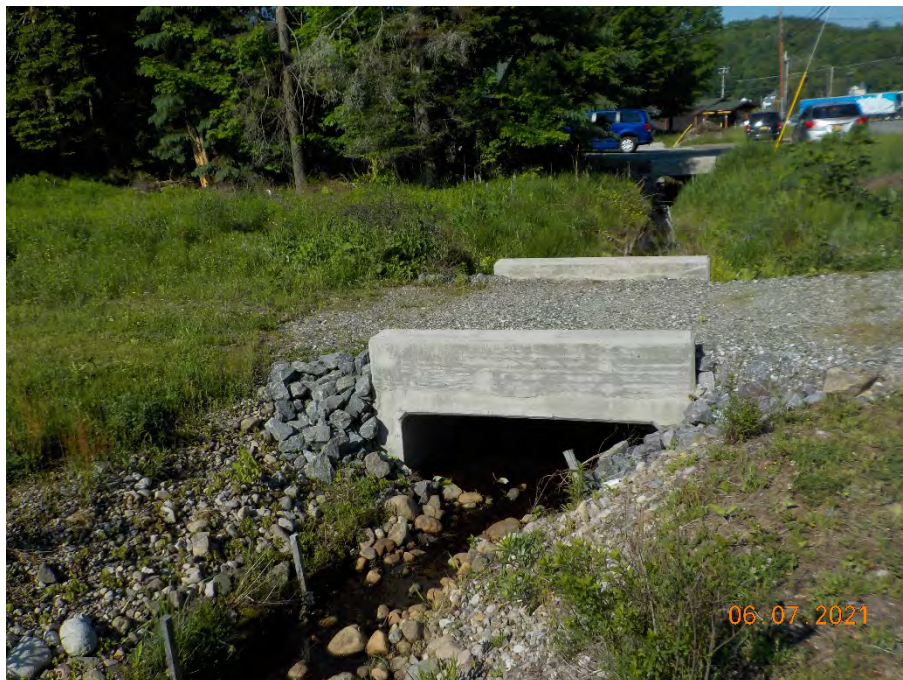
View of open bottom culverts installed along Brandy Brook replacing pipe culverts.

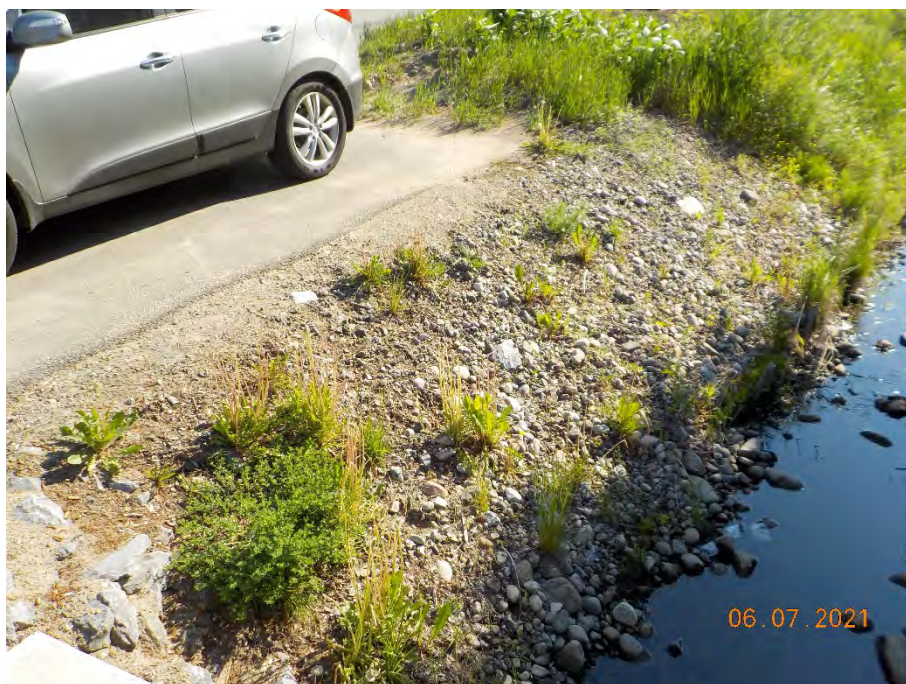
View of gravelly sand material placed in area where soil choked rip rap should have been installed.

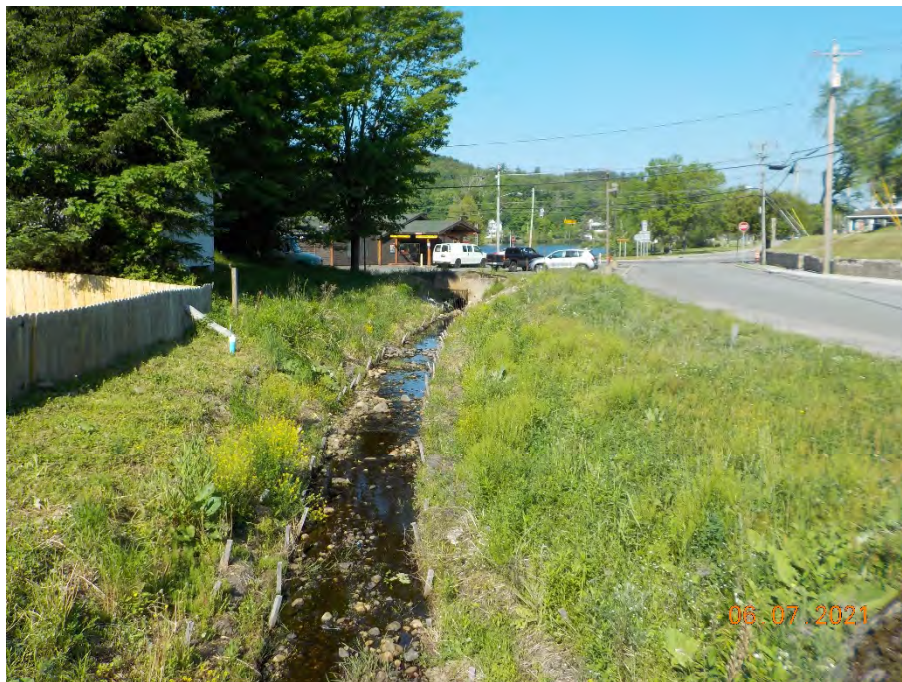
View looking downstream note culverts to Lake Flower. Need to plant shrubs along brook to provide shade to keep water entering the lake cool.

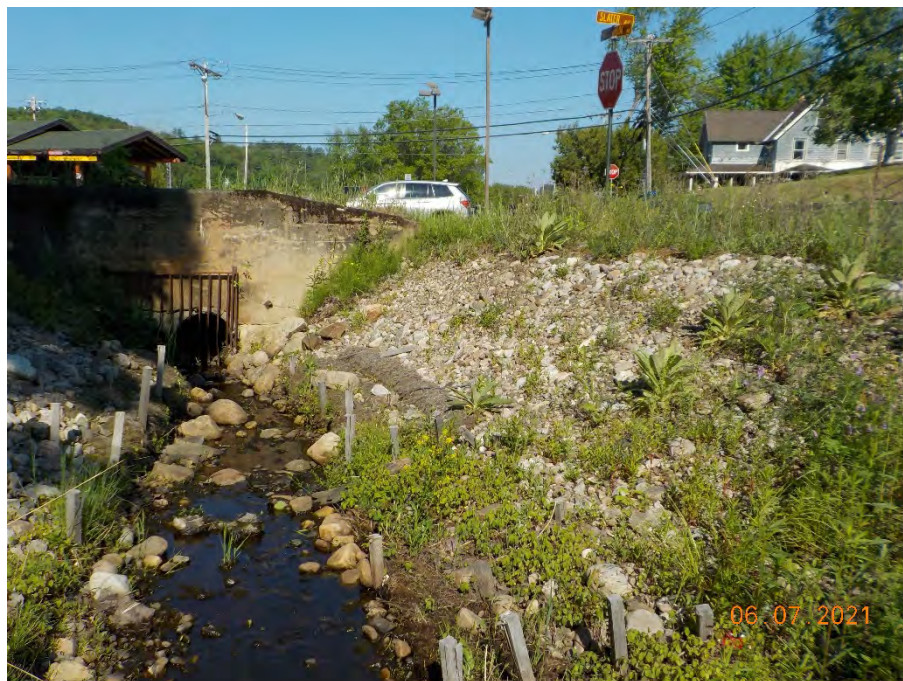
Area on bank that should have been soil choked rip rap, not gravelly sand fill.

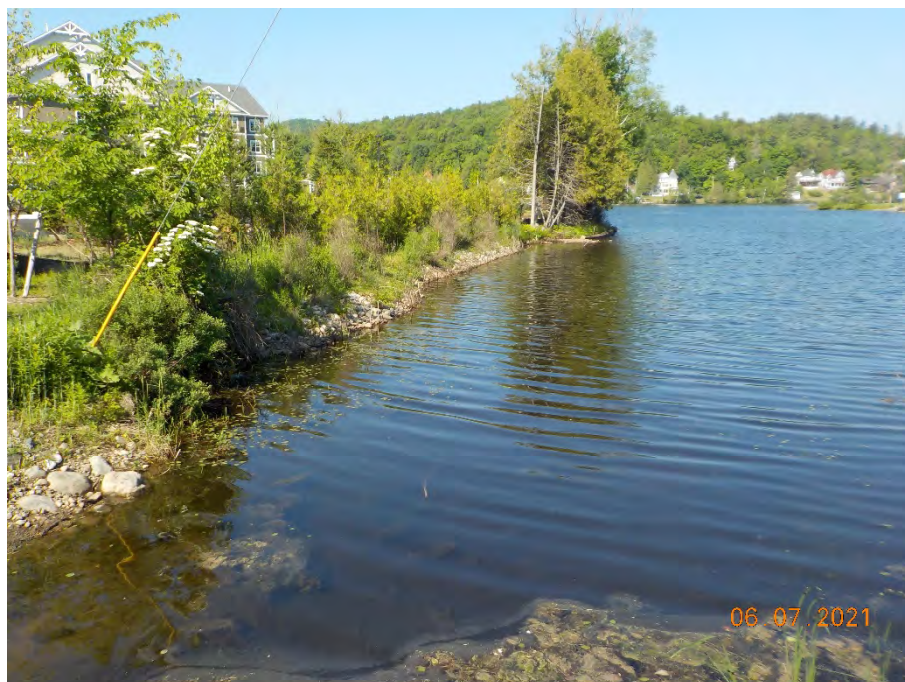
View of restored bank along Lake Flower. Note the replacement red cedars planted along top of bank.

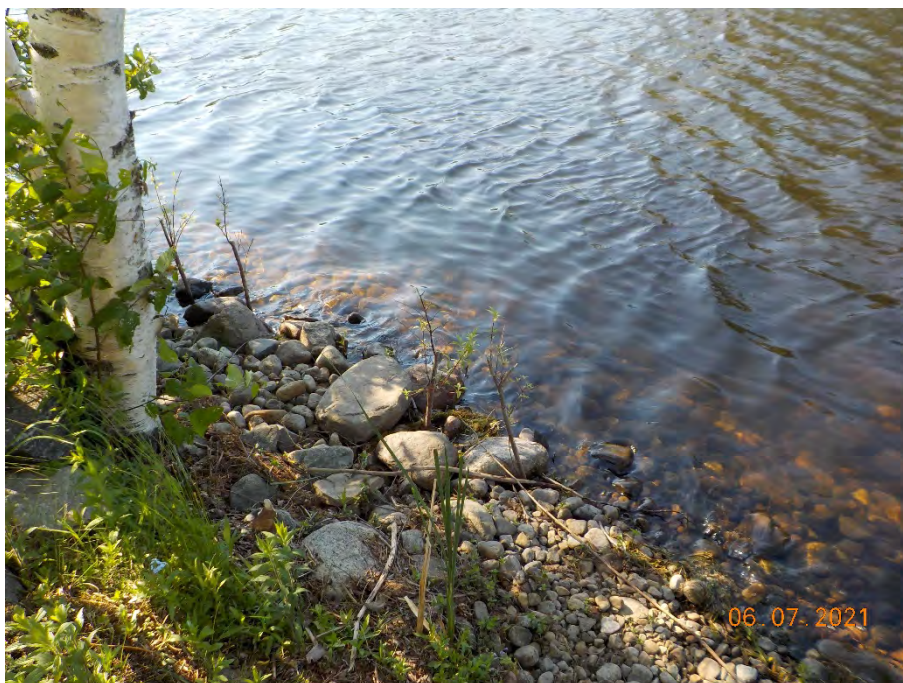
View of restored bank,  
Lake Flower. Note live  
stake willows growing  
along shoreline.

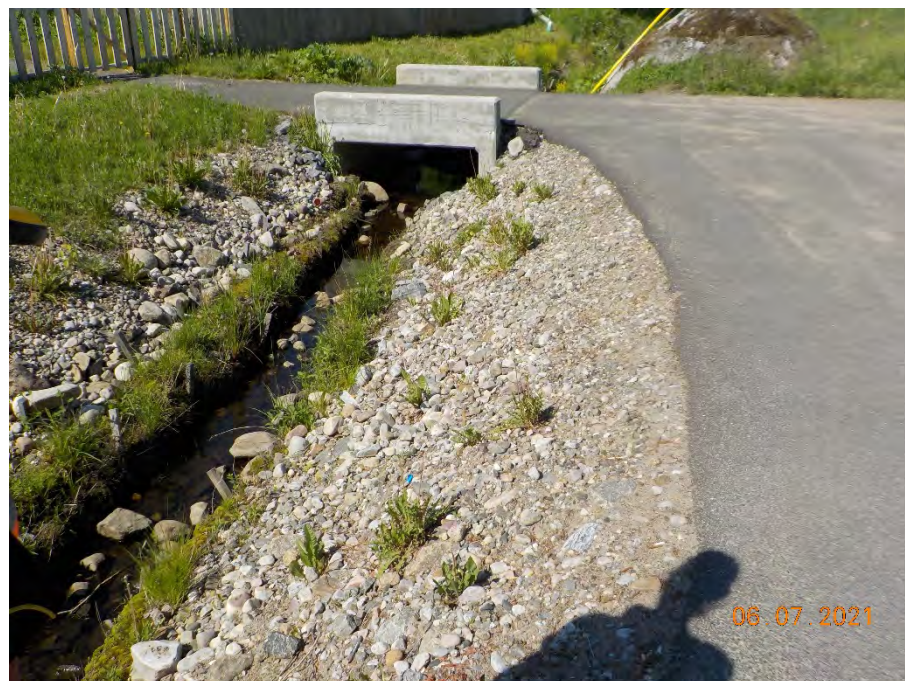
Area along Brandy Brook where gravelly sand material was put in place in stead of soil choked rip rap. Note add curbing or vegetated buffer to intercept sheet flow across pavement and directly into the brook.

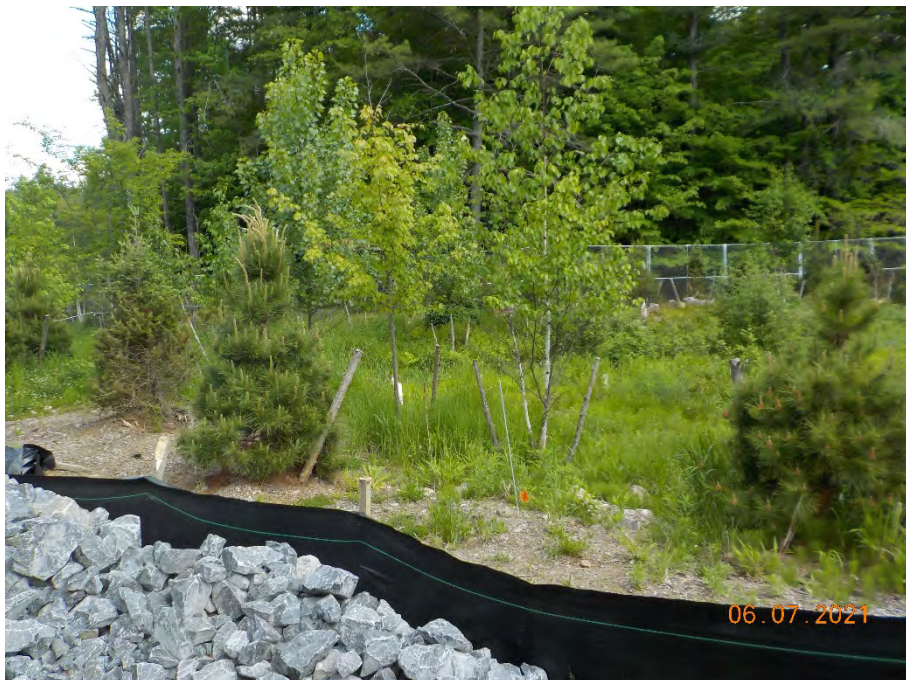
View of tree planting area, note vigorous growth.

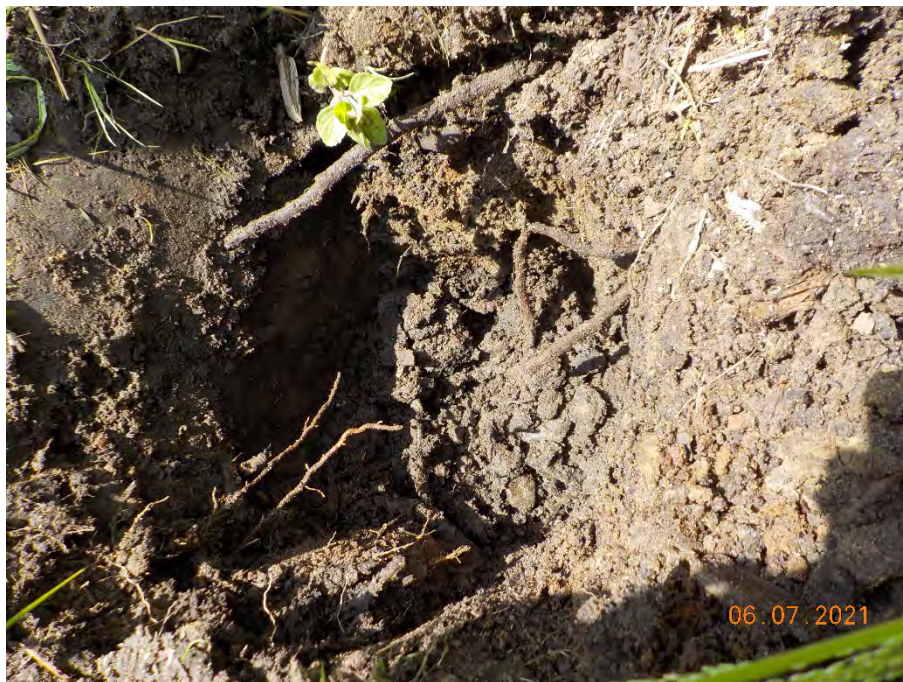
View of soil test pit  
Wet Plot 2, in tree  
planting area. This  
area has not been  
remediated yet, and  
contamination was  
observed (smelled) and  
the excavation was  
stopped.

- Soils in this area have been historically filled/Altered - not natural conditions. AREA is also to be Remediated as a part of OUI Remediation Project.
- Excavation was limited due to MGP wastes encountered in soils.

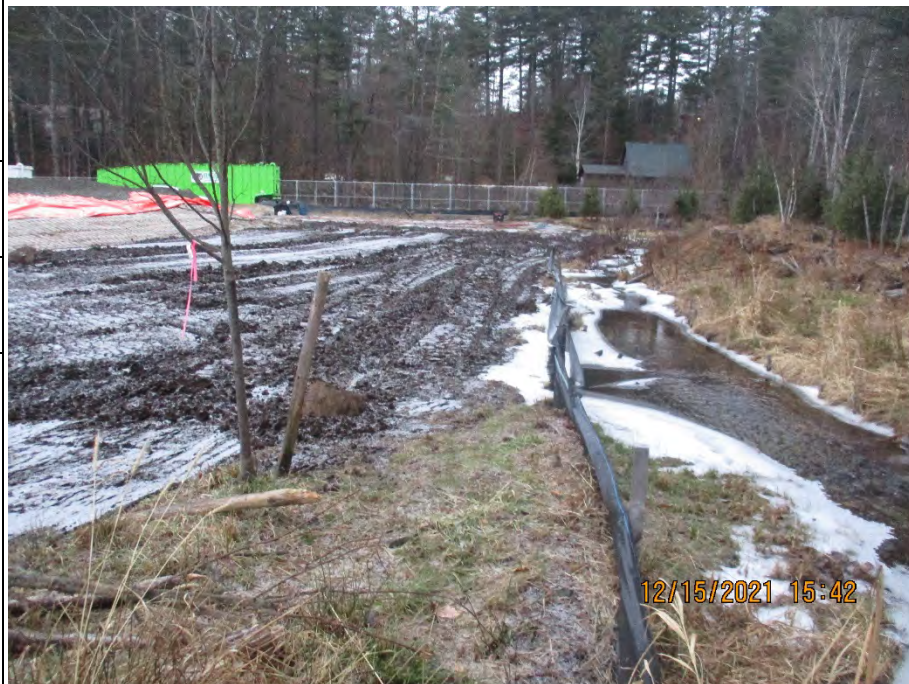
View of backfilled excavation adjacent to Brandy Brook with Wetland Soil facing west. New trees to be planted in Spring 2022.

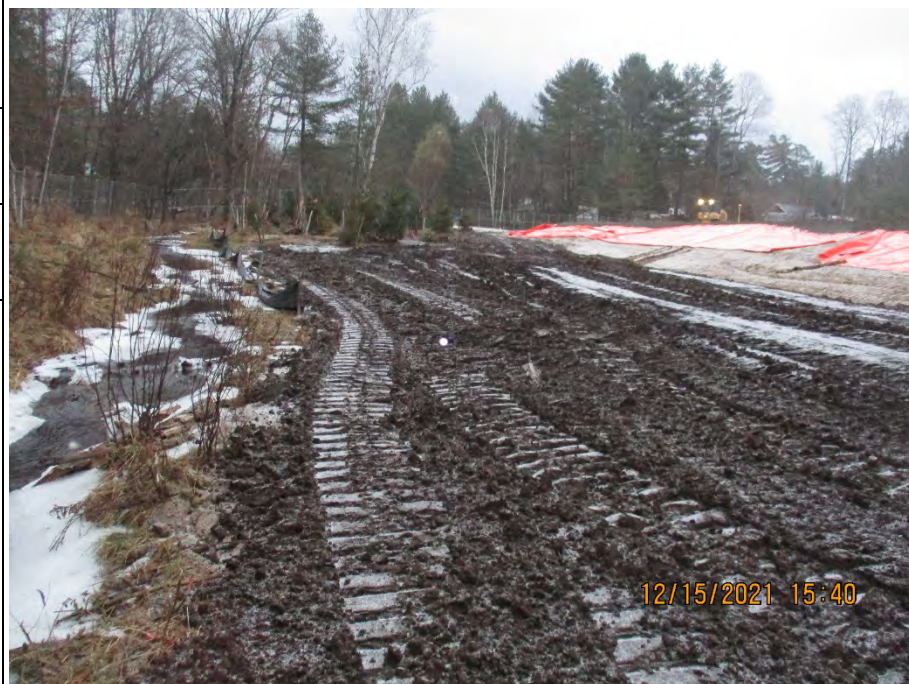
View of backfilled excavation adjacent to Brandy Brook with Wetland Soil facing east. New trees to be planted in Spring 2022.

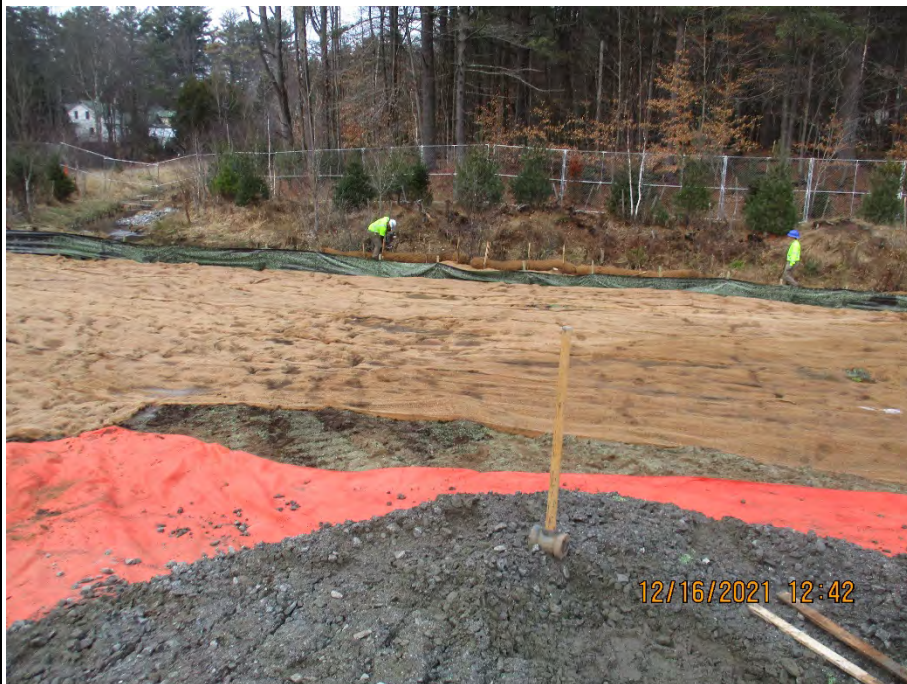
View of erosion control matting over seeded area adjacent to Brandy Brook, facing north. New trees to be planted in Spring 2022.

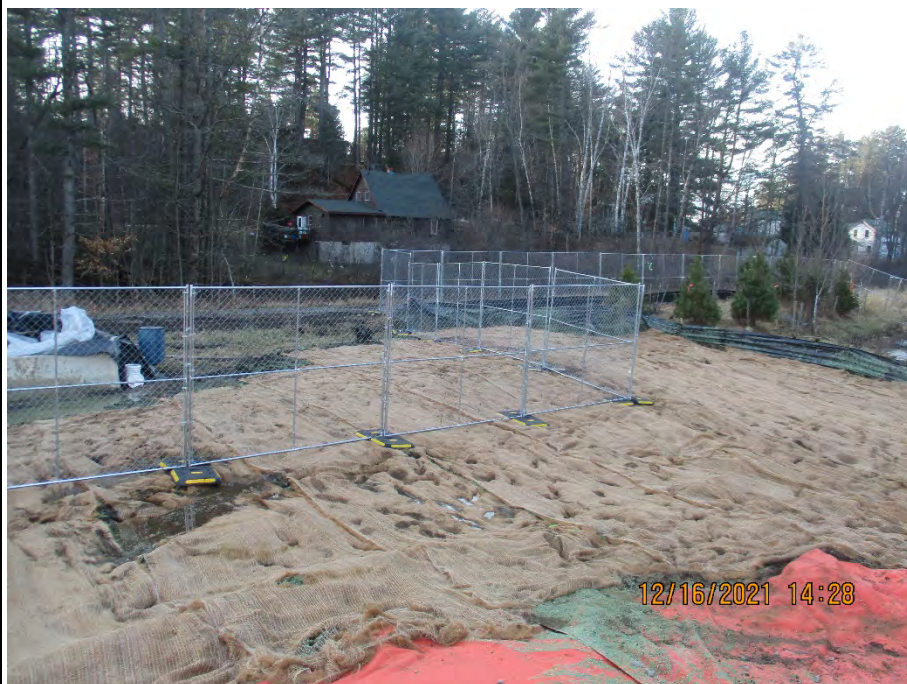
View of northwestern corner of the site, upland area with topsoil, seed and erosion control matting. New trees to be planted in Spring 2022.
