**2023 Annual Vegetation and Wetland
Monitoring Report
Saranac Lake Gas Company, Inc.
NYSDEC Site 516008
Saranac Lake, Essex County, New York**

Work Assignment No. D009806-34

January 2024

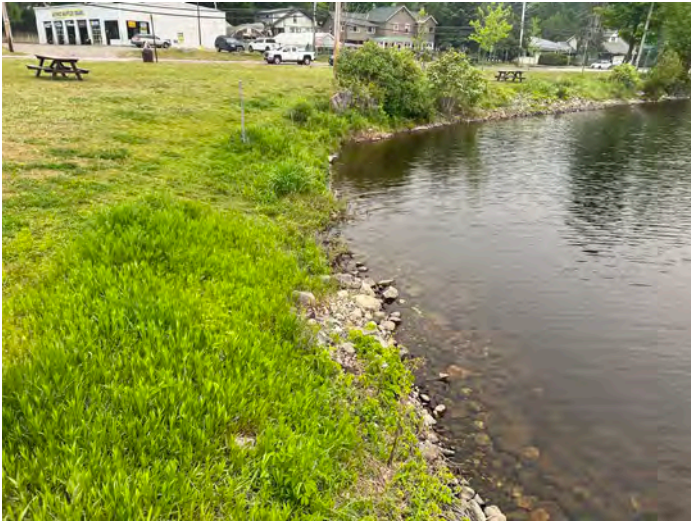
Monitoring areas LF-1 and LF-2 currently do not meet the survivability requirement of planted woody stems, which is set at 85%. Many of the live stakes appear to have been planted along the lower portion of the banks below the water line. NYSDEC expressed concern over the lack of bank shading within these two monitoring areas, which should be planted with shrubs along the top of bank, along the riprap edge or additional small trees should be planted to provide shade along the shoreline. Table 5 provides a general planting recommendation for areas LF-1 and LF-2, which includes planting shrubs along the top of the rip-rap edge within LF-1 and along the banks of LF-2. The presence of large rock and rip-rap in these two areas along the banks would likely inhibit the placement of additional live stakes along the bank.

Photograph 1: Lack of woody vegetation along the bank in Monitoring Area LF-1.

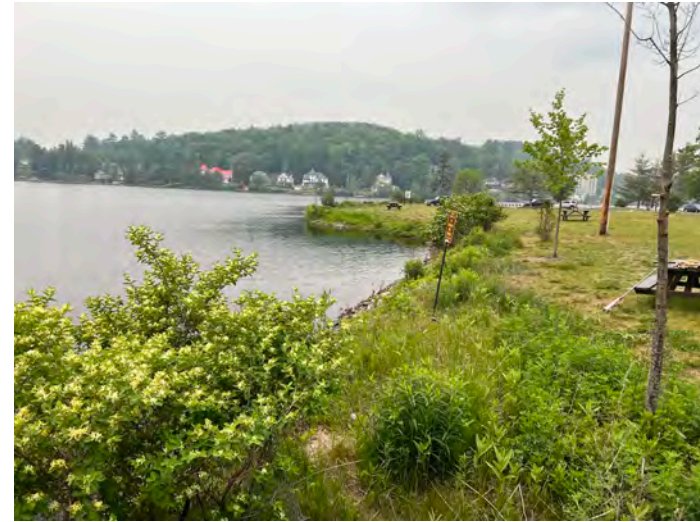
Photograph 2: Overview of Monitoring Areas LF-1 and LF-2.

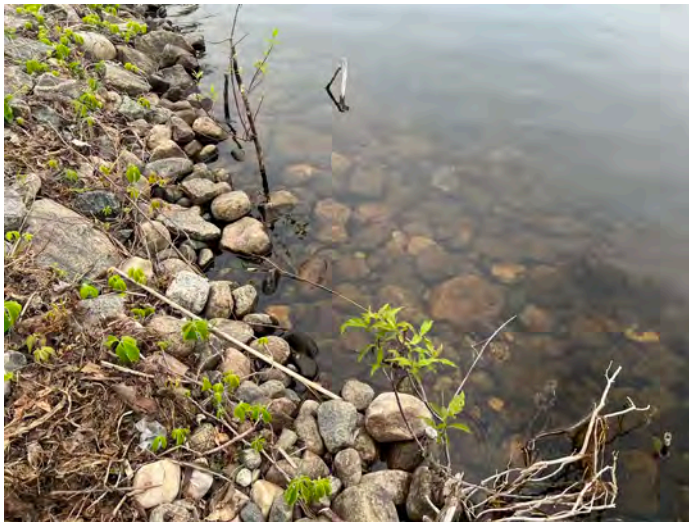
Photograph 3: Surviving live stakes observed at the transition from Monitoring Area LF-2 and LF-3.

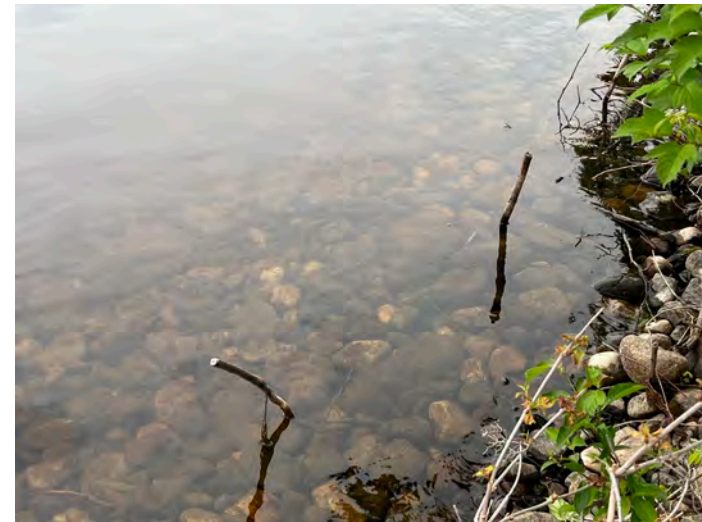
Photograph 4: Dead live stakes observed within Monitoring Area LF-2.

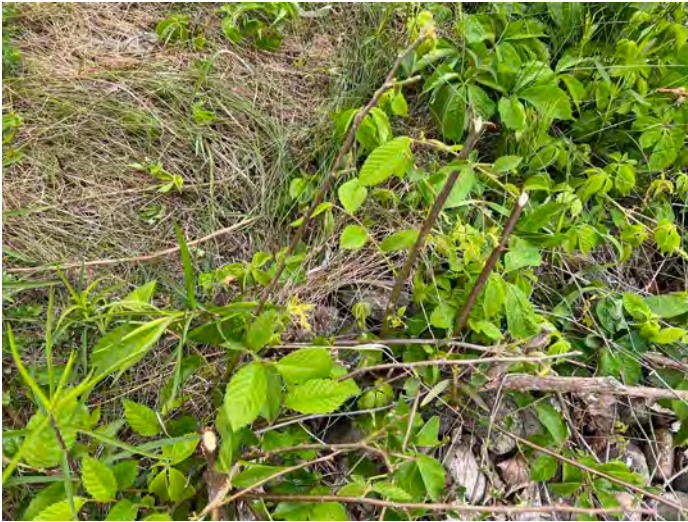
Photograph 5: Signs of wildlife browsing on live stakes planted within Monitoring Area LF-3.

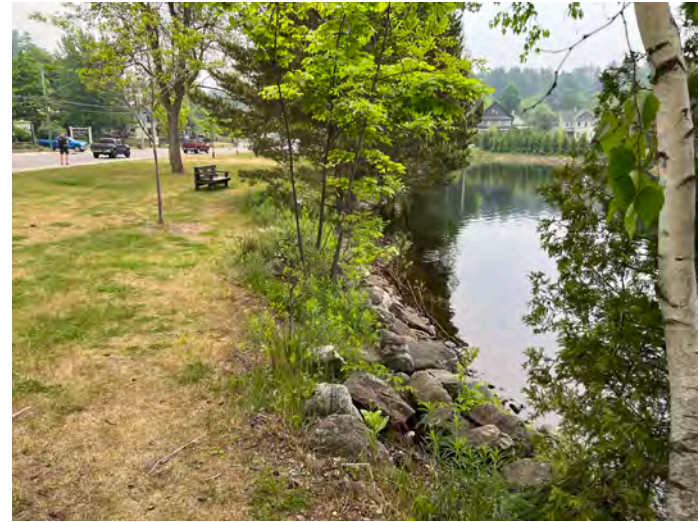
Photograph 6: Existing large trees along the banks within Monitoring Area LF-3.

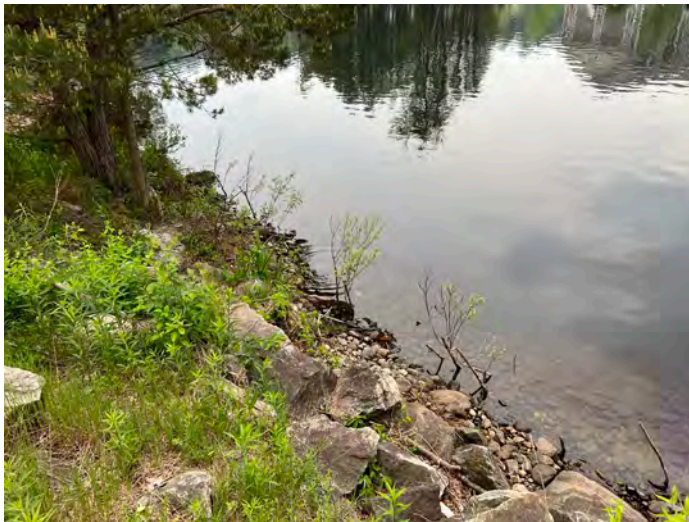
Photograph 7: Successful live stakes along the banks within Monitoring Area LF-3.

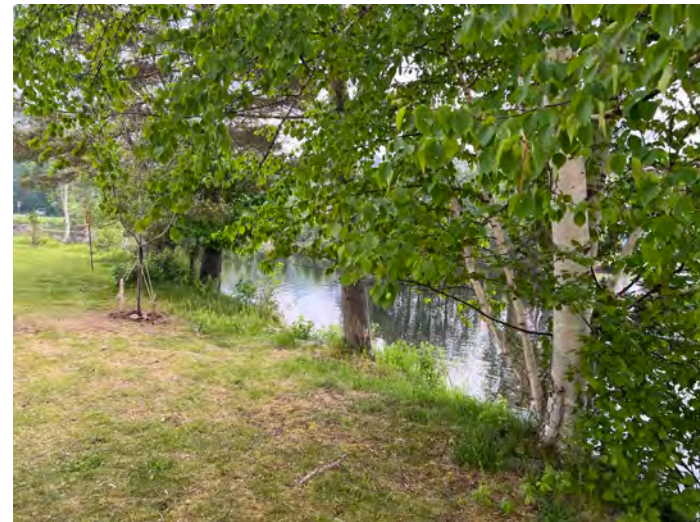
Photograph 8: Mature trees along the banks within Monitoring Area LF-3.

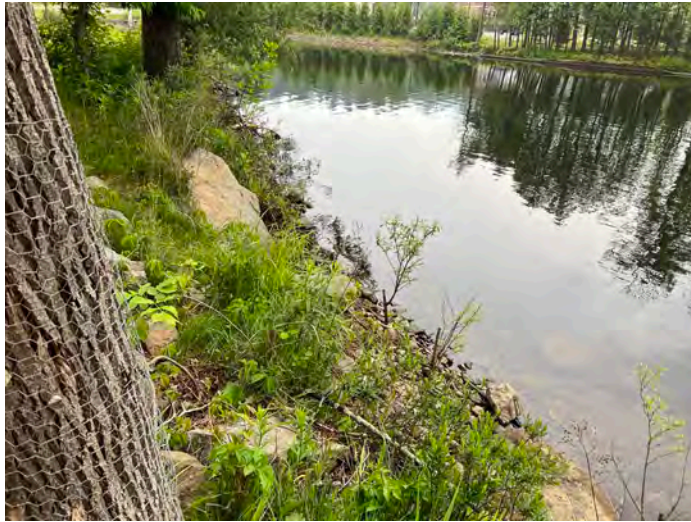
Photograph 9: Live stakes successfully growing under mature trees within Monitoring Area LF-3.

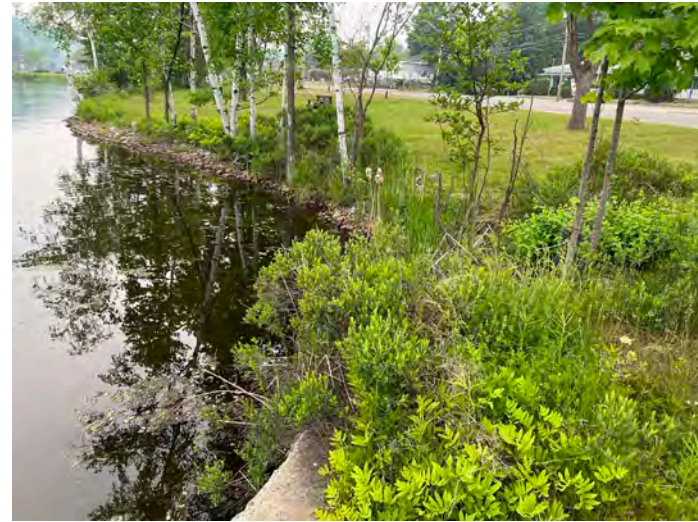
Photograph 10: Vegetated and stable banks within Monitoring Area LF-3.

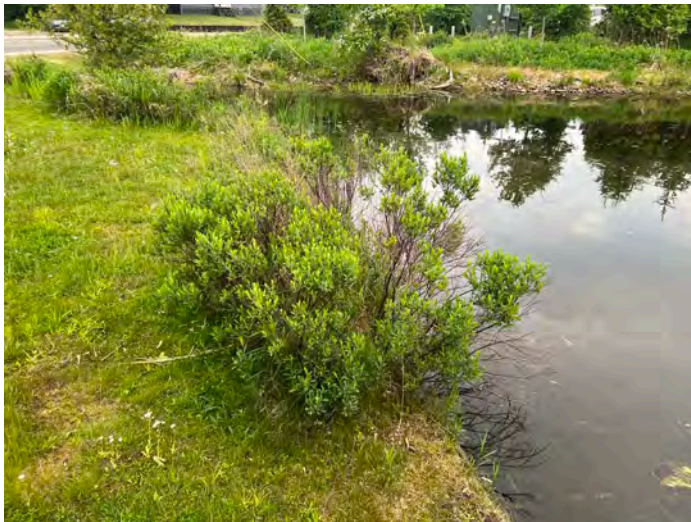
Photograph 11: Existing woody shrubs along the banks within Monitoring Area LF-3.

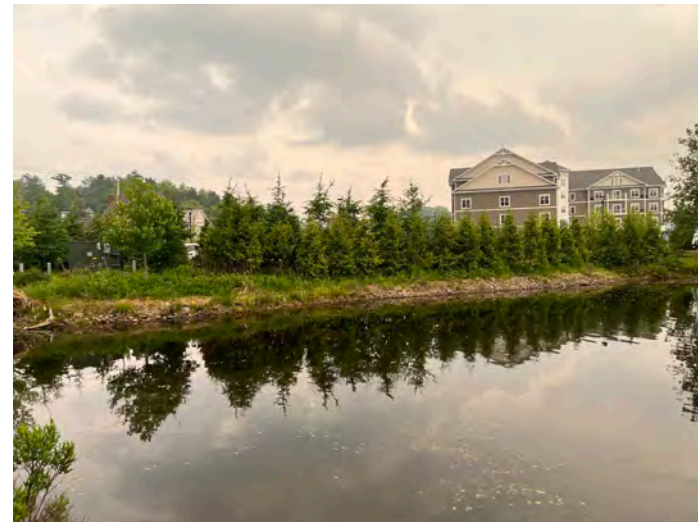
Photograph 12: Cedar Planting Area on the South bank of Lake Flower.

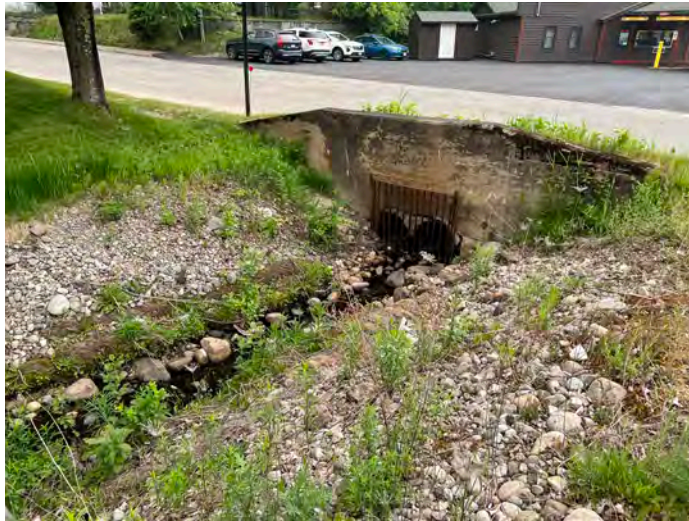
Photograph 13: Rip rap bank and unvegetated areas at the northwestern portion of Brandy Brook.

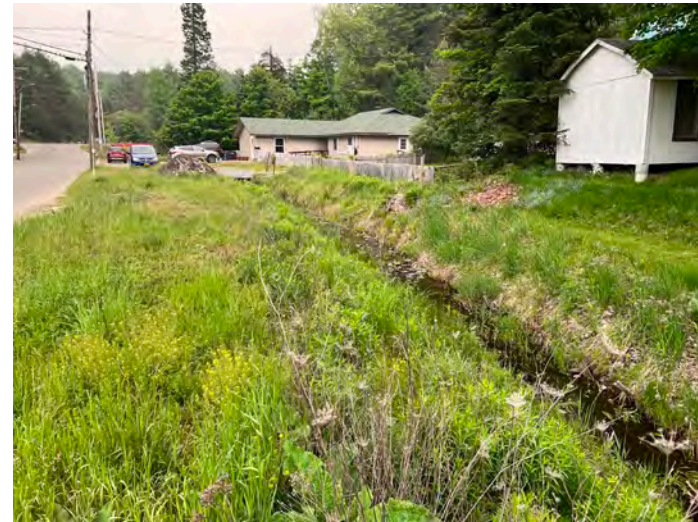
Photograph 14: View of well vegetated stream banks, facing upstream along Brandy Brook.

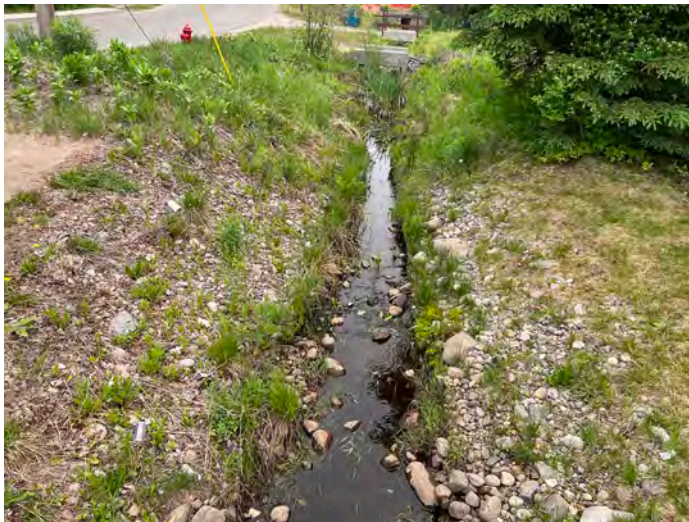
Photograph 15: View facing upstream of Brandy Brook along Brandy Brook Avenue.

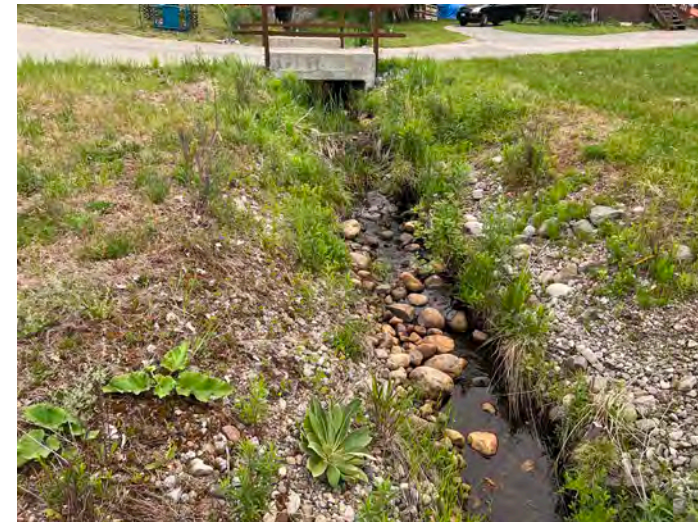
Photograph 16: View facing upstream of the eastern portion of Monitoring Area BB-1.

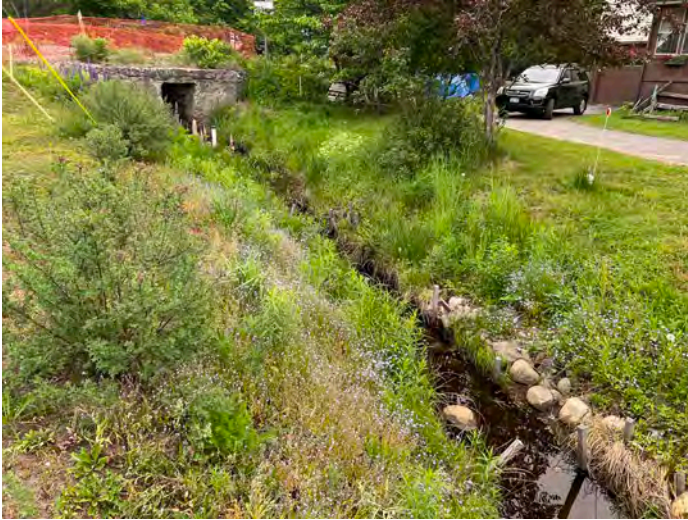
Photograph 17: Easternmost portion of Monitoring Area BB-1.

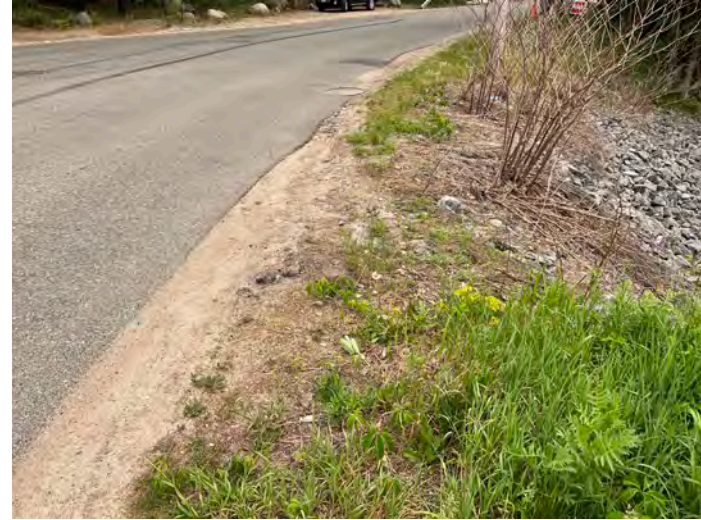
Photograph 18: Area of street runoff along the top of banks of Brandy Brook at the northern portion of BB-2.

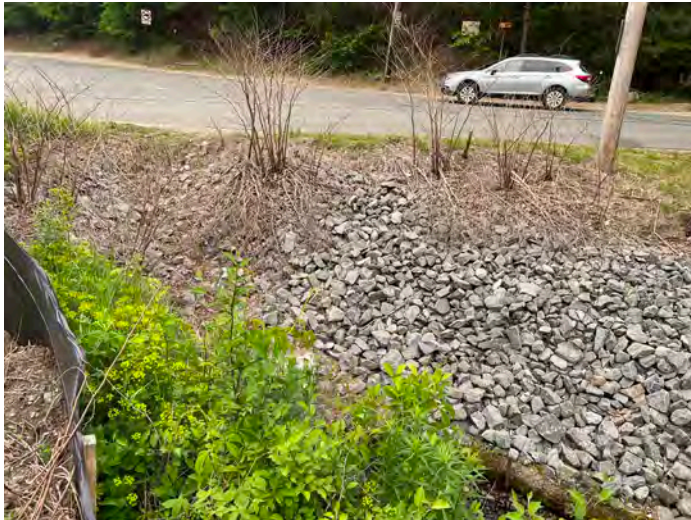
Photograph 19: Rip-rap slope of Brandy Brook at the northern end of BB-2 along Brandy Brook Avenue.

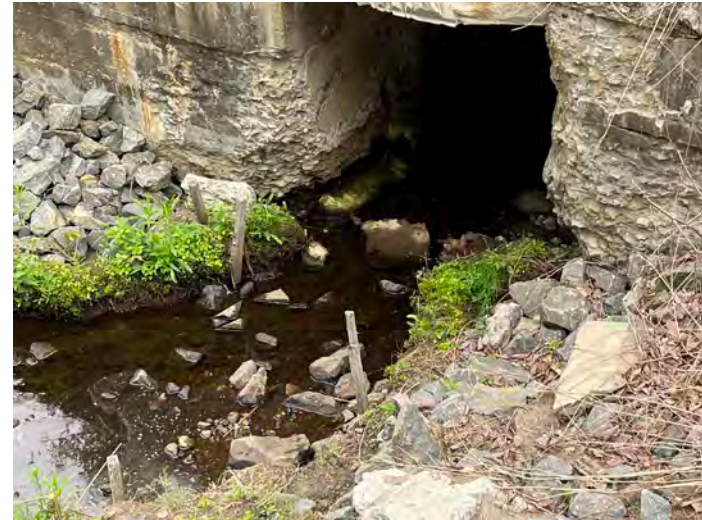
During the monitoring effort, EA personnel did not observe areas of stream bank erosion or signs of stream instability along the channel. However, at the concrete box culvert, signs of scour under the concrete headwall were noted and should be closely monitored. Additionally, NYSDEC noted concern over the potential of future erosion along the rip-rap slope at the corner of Pine Street and Brandy Brook Avenue, since this location appears to receive significant runoff from the roads. No signs of erosion or rip-rap instability were noted during the 2023 monitoring event, but this area should be closely monitored in future events. The stream channel appears to be well connected to the wetlands and floodplain, and photographic documentation of the current channel conditions is provided in Appendix C. Established stream photograph locations are provided on Figures 5 and 6 (Appendix B). The core fiber log along the bottom of the stream bank looked good throughout BB-1 and BB-2 with the exception of a small area near the box culvert between BB-1 and BB-2, which had become dislodged from the stake on one end. However, this core log was re-staked in the field during the monitoring event. All in-stream structures and habitat features were visually observed during the monitoring event and are in place and appear to be properly functioning per the design plans. Although the previously identified Japanese knotweed areas have been treated and are below the 5% cover threshold, the areas of previously identified Japanese knotweed should continue to be monitored and treated as identified.

Photograph 20: Erosional deterioration of historic culvert on the northern end of Monitoring Area BB-2.

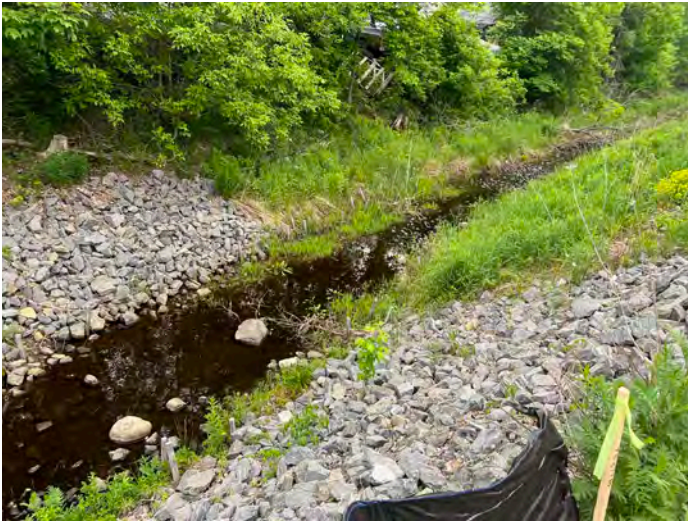
Photograph 21: View facing upstream of Brandy Brook, withing Monitoring area BB-2.

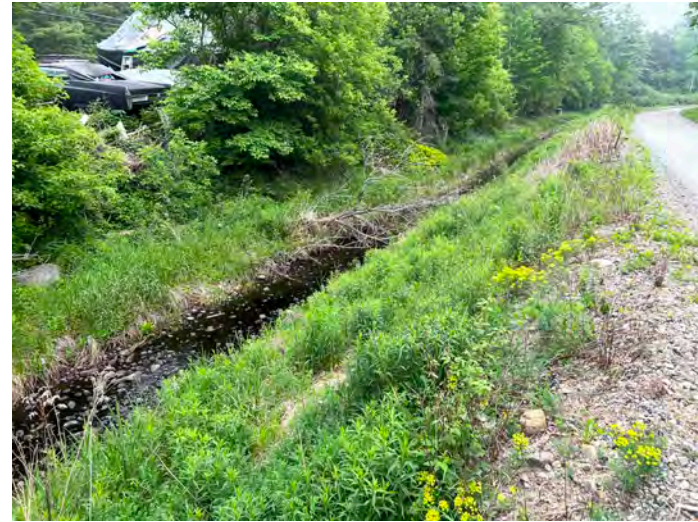
Photograph 22: View facing upstream of Brandy Brook, withing Monitoring area BB-2.

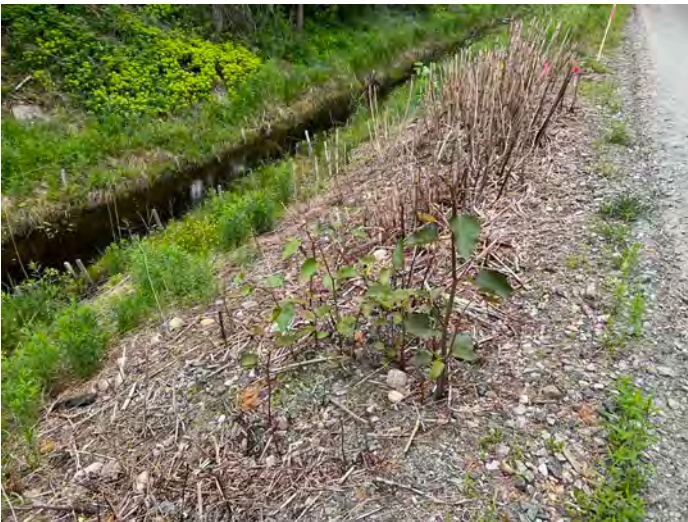
Photograph 23: Area of previously identified and treaded invasive species (Japanese knotweed).

Invasive species throughout the project site are sparse and under the restoration goal. However, the previously identified areas of Japanese knotweed should continue to be monitored, and continued treatment is recommended for 2023 and 2024. The two previously identified knotweed areas appear to have been successfully treated but a small area of regrowth was identified along BB-2 in the location of photograph 23 (Figure 5). If not continuously treated, this population can

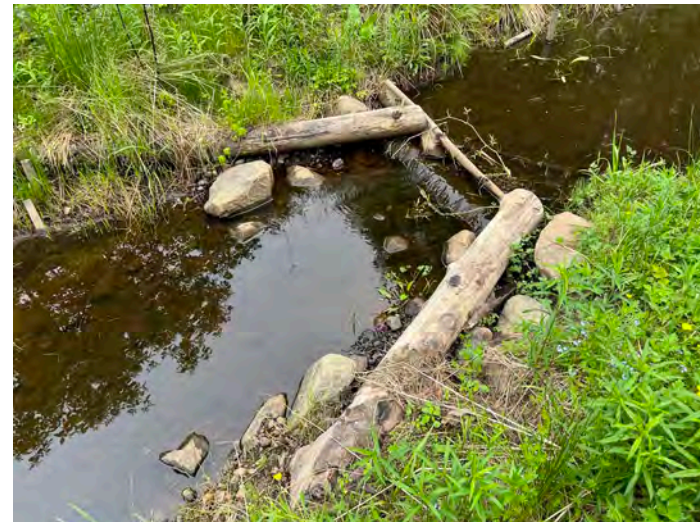
Photograph 24: Stable drop log structure observed along Brandy Brook within Monitoring Area BB-2.

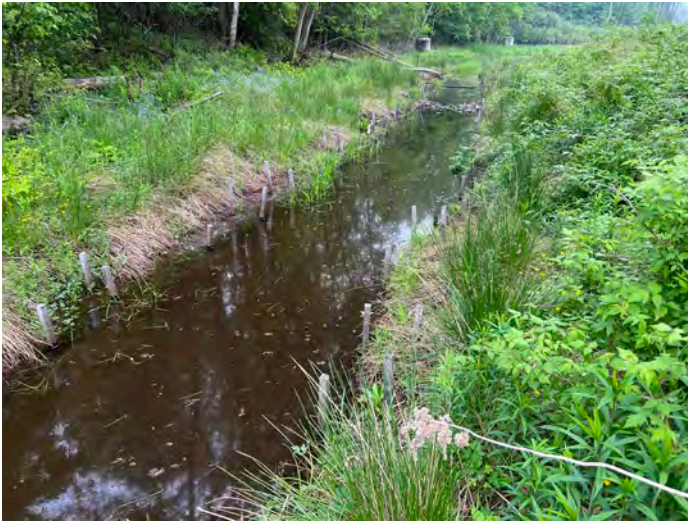
Photograph 25: View of stable stream channel bank with core log structure along Area BB-2.

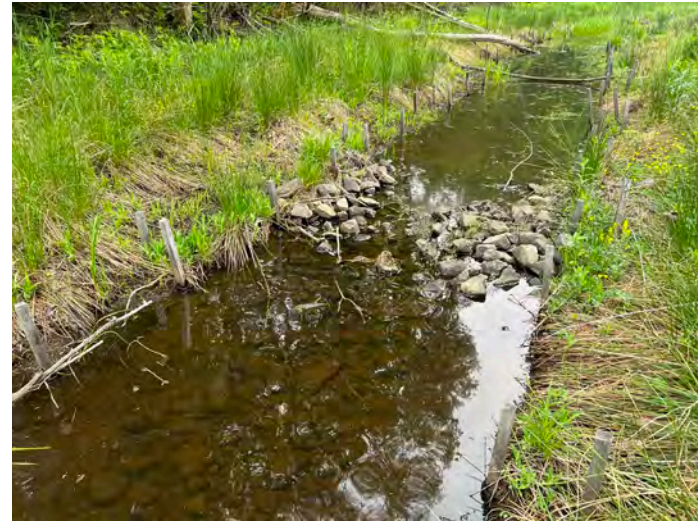
Photograph 26: Stable rock vane structure within Brandy Brook within Monitoring Area BB-2.

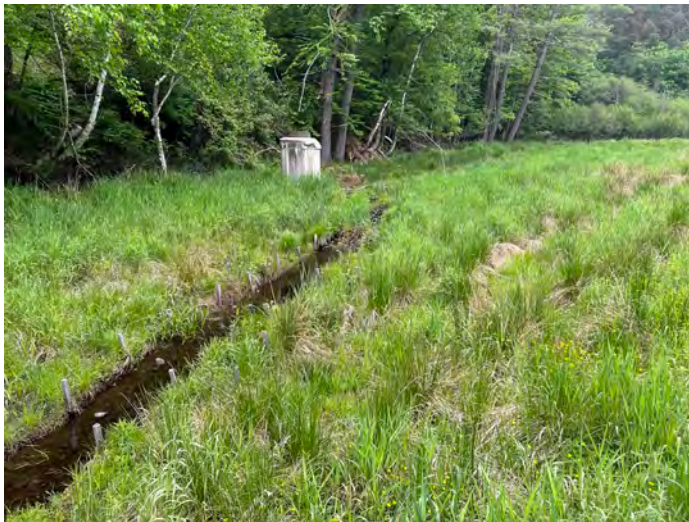
Photograph 27: Well vegetated and stable stream banks of Brank Brook within Area BB-2.

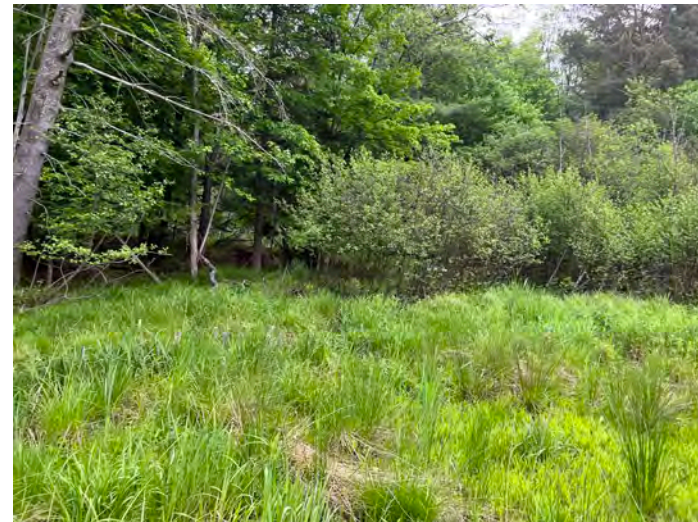
Photograph 28: Restored emergent wetland area identified at Monitoring Area Wet-1.

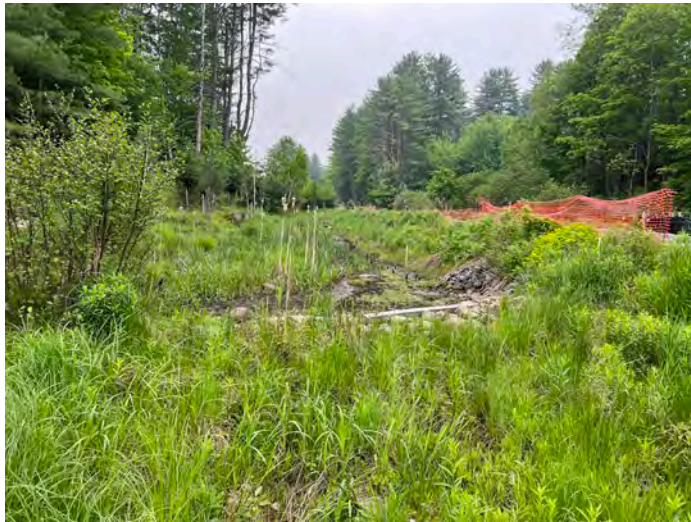
Photograph 29: View facing south from Monitoring Area Wet-1.

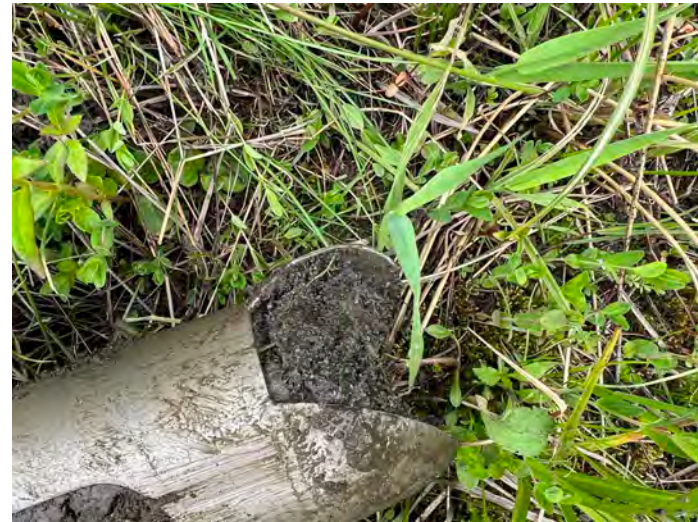
Photograph 30: Depleted matrix identified within the soil sample at Monitoring Area Wet-1.

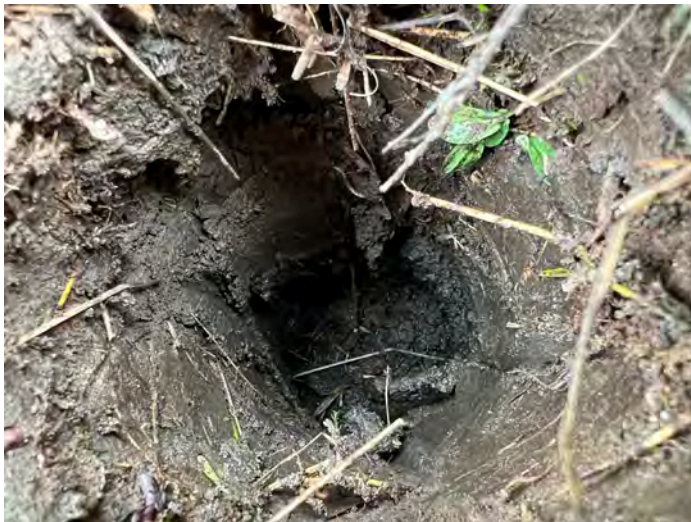
Photograph 31: Saturated soils identified within Monitoring Area Wet-1.

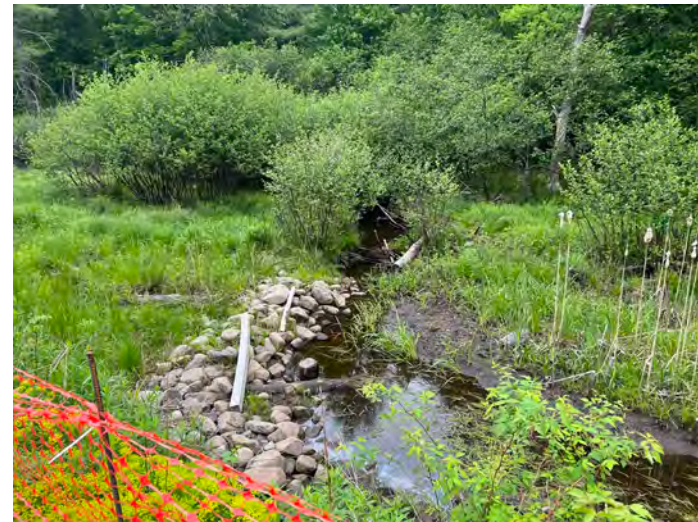
Photograph 32: Large alder shrubs located within Monitoring Area Wet-1.

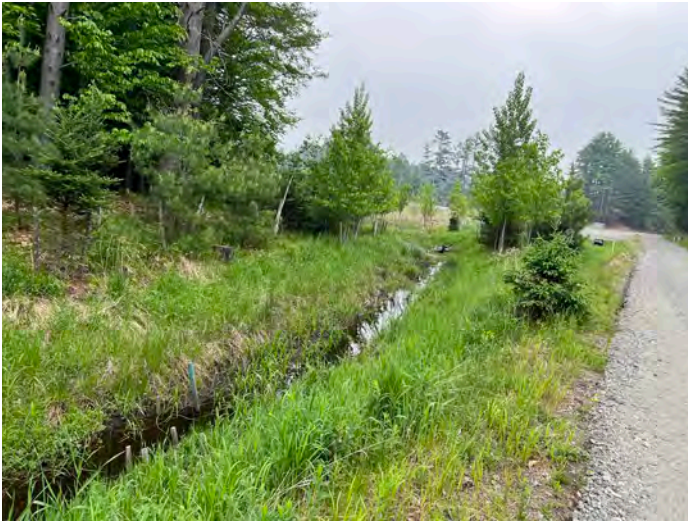
Photograph 33: Southern portion of Brandy Brook between wetland areas Wet-1 and Wet-2.

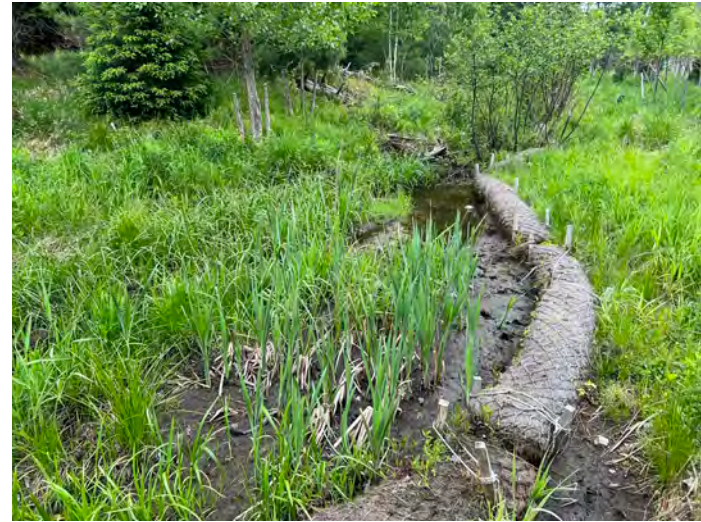
Photograph 34: Restored stream channel within Monitoring Area Wet-2.

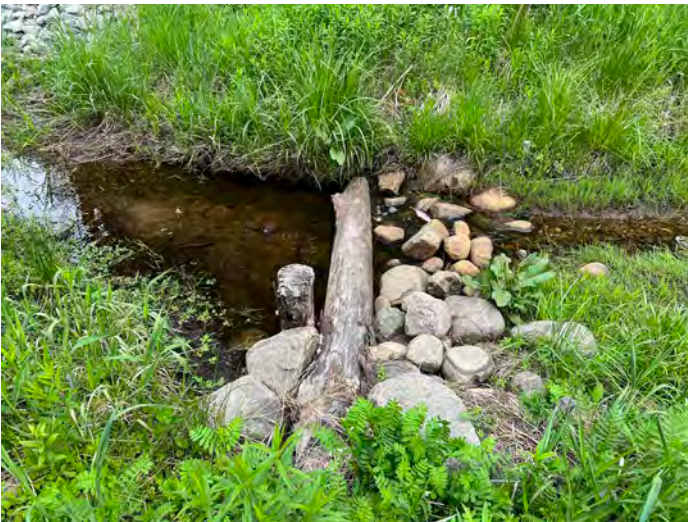
Photograph 35: Drop log structure within the restored stream channel within Monitoring Area Wet-2.

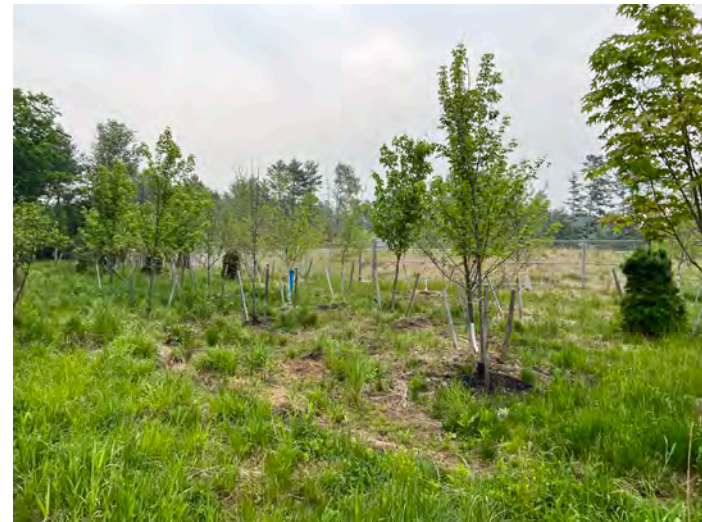
Photograph 36: Newly planted trees within Monitoring Area Wet-2.

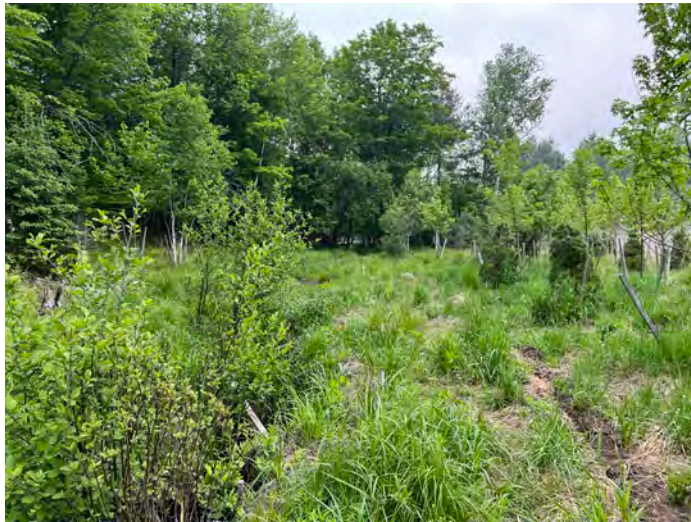
Photograph 37: Overview of Monitoring Area Wet-2.

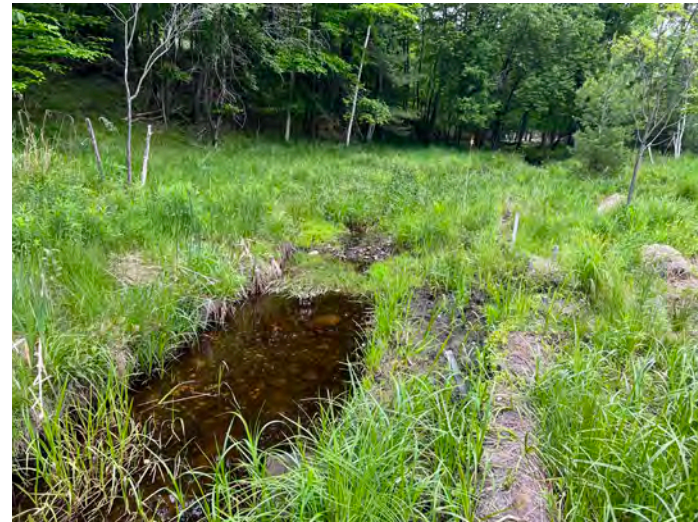
Photograph 38: Restored stream channel within Monitoring Area Wet-2.

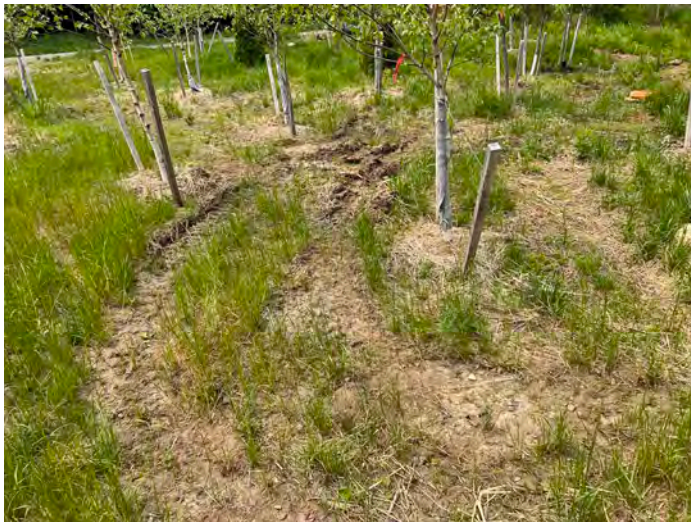
Photograph 39: Tire ruts observed within the newly planted area in Wet-2.

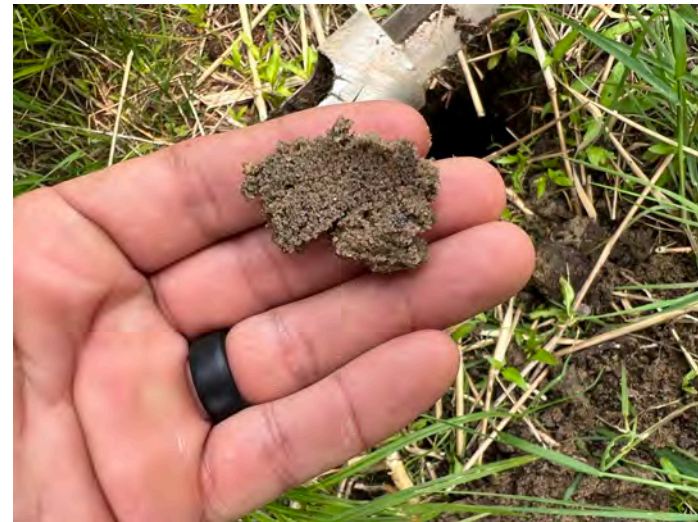
Photograph 40: Sandy soils observed within Monitoring Area Wet-2.

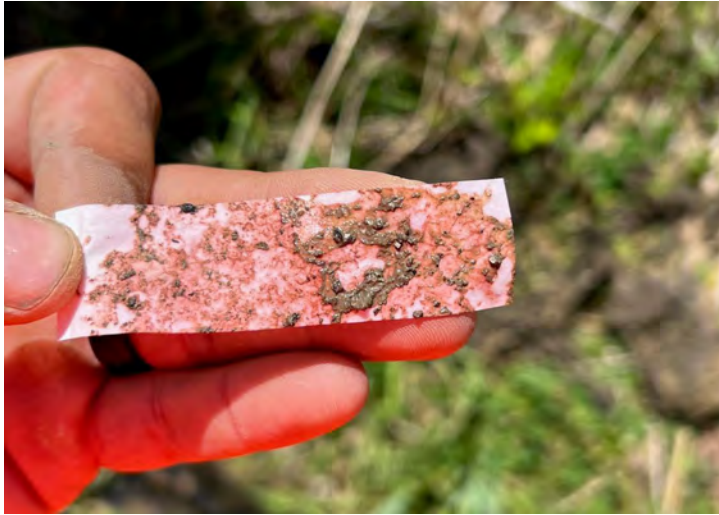
Photograph 41: Reacting soil test strip indicating hydric wetland soils within Wet-2.

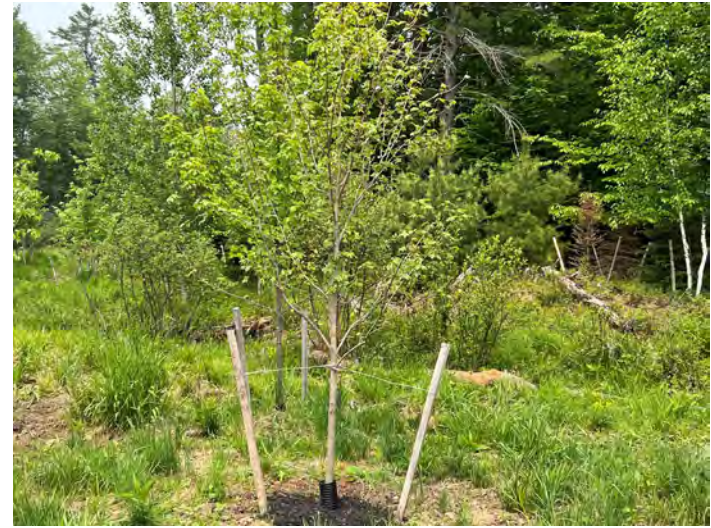
Photograph 42: Newly planted tree within Wet-2 with tree staking and fresh mulch pit.
