**2024 Annual Vegetation and Wetland  
Monitoring Report  
Saranac Lake Gas Company, Inc.  
NYSDEC Site 516008  
Saranac Lake, Essex County, New York**

**Work Assignment No. D009806-34**

**September 2024**

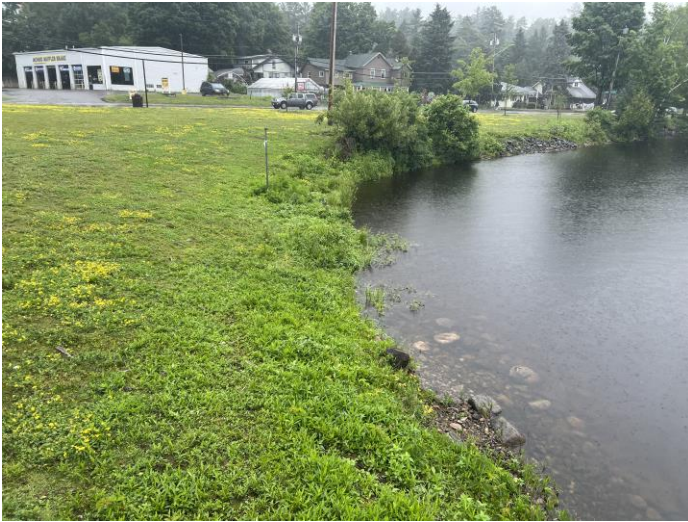
Monitoring areas LF-1 currently does not have any woody stems along the bank and in 2023, many of the live stakes appear to have been planted along the lower portion of the banks below the water line. NYSDEC expressed concern over the lack of bank shading within these two monitoring areas, which should be planted with shrubs along the top of bank, along the riprap edge or additional small trees should be planted to provide shade along the shoreline. This recommendation was approved in the final 2023 monitoring report and should be planted before the end of the 2024 growing season. Table 5 provides a general planting recommendation for areas LF-1 and LF-2, which includes planting shrubs along the top of the rip-rap edge within LF-1 and along the banks of LF-2. The presence of large rock and rip-rap in these two areas along the banks would likely inhibit the placement of additional live stakes along the bank.

**Photograph 1:** Lack of woody vegetation along the bank in Monitoring Area LF-1.

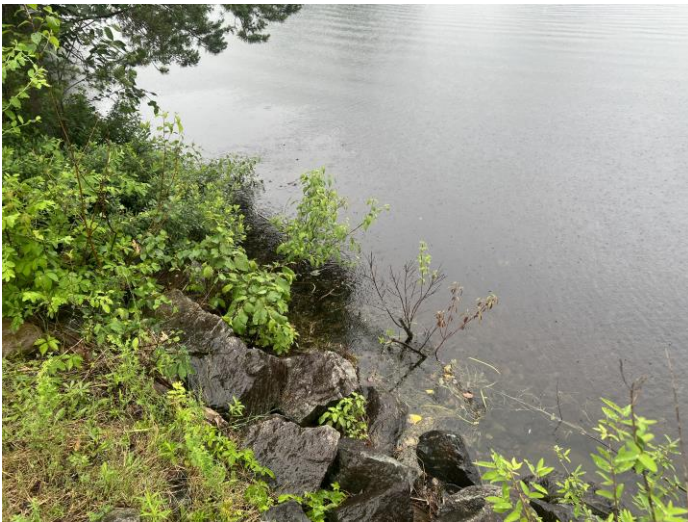
**Photograph 3:** Surviving live stakes observed at the transition from Monitoring Area LF-2 and LF-3.

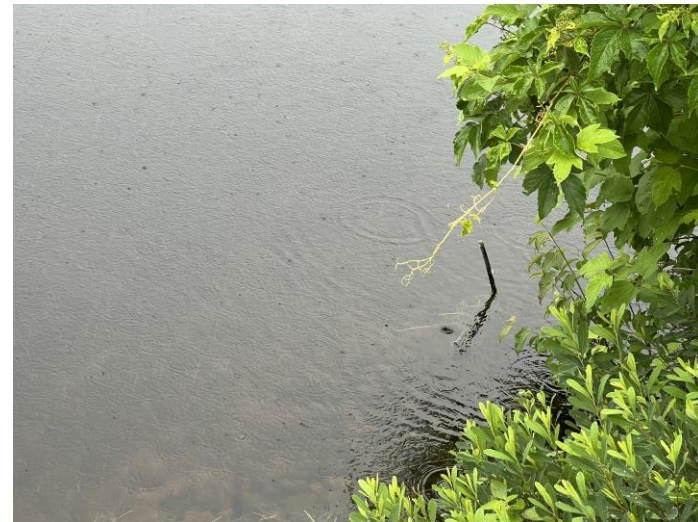
**Photograph 4:** Dead live stakes observed within Monitoring Area LF-2.

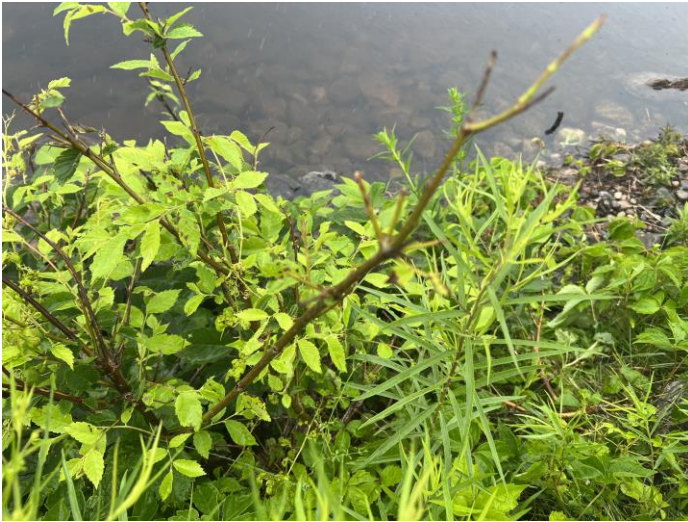
**Photograph 5:** Signs of wildlife browsing on live stakes planted within Monitoring Area LF-3.

All plants shall be sourced from stock grown within a 150-mile radius of the project site, acclimated to the climate of Upstate New York, and grown from naturally occurring ecotypes in the region. Substitutions to plant species, type, size, and origin may be made at the approval of NYSDEC based on species availability. Due to the observed deer browsing on vegetation along the Lake Flower shoreline, new plantings should include the addition of deer browsing tubes.

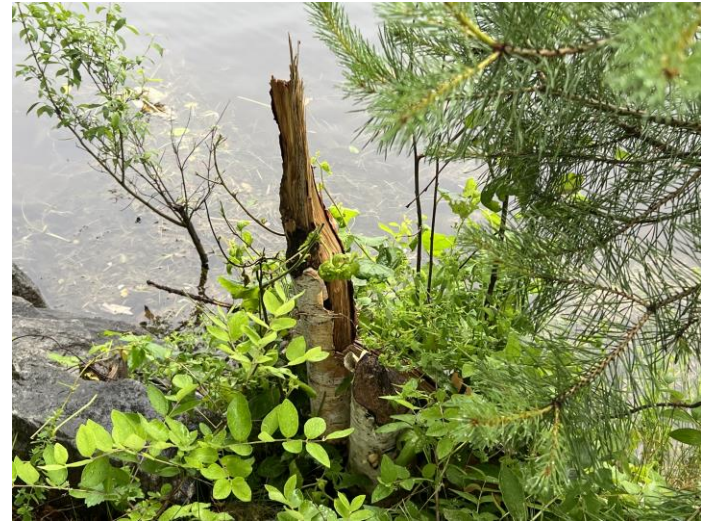
**Photograph 6:** Beaver activity observed on trees along the banks within Monitoring Area LF-3.

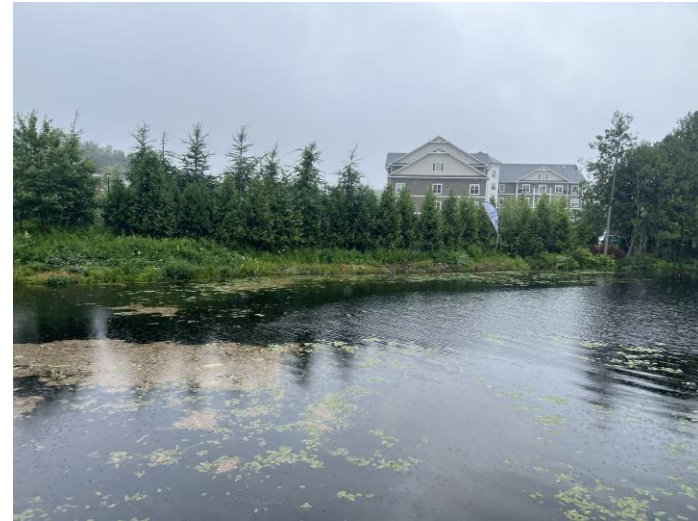
One hundred (100) % of the cedar trees planted during the initial restoration effort have survived in the Cedar area and appear to be healthy with no obvious sign of disease or decay.

**Photograph 12:** Cedar Planting Area on the South bank of Lake Flower.

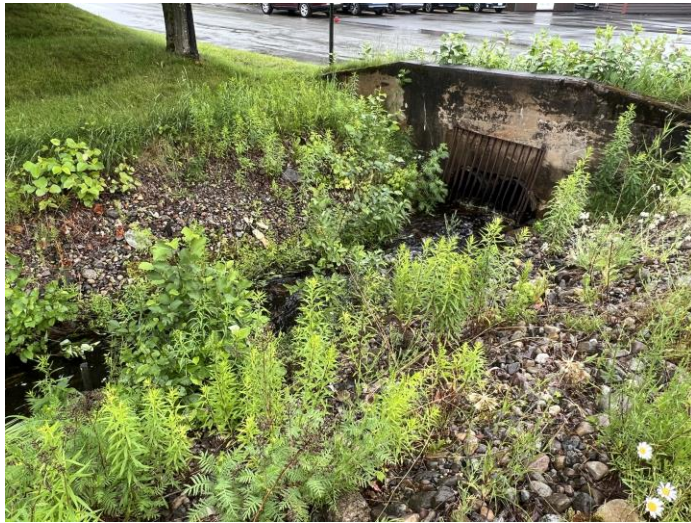
**Photograph 13:** Rip rap bank and partially vegetated areas at the northwestern portion of Brandy Brook.

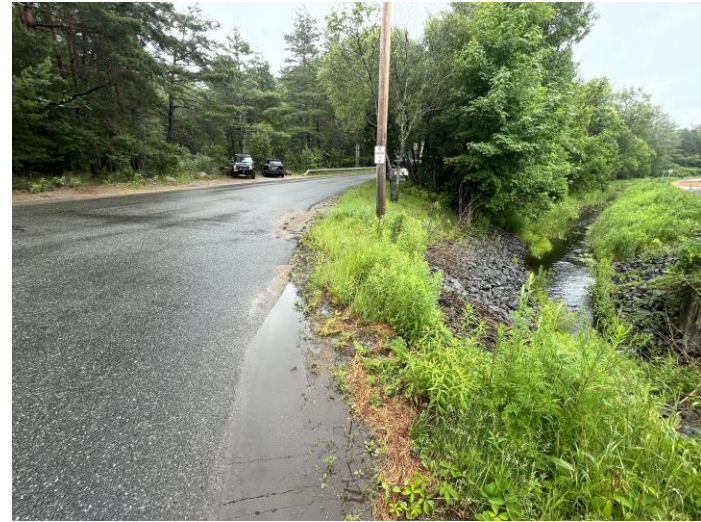
**Photograph 18:** Area of street runoff along the top of banks of Brandy Brook at the northern portion of BB-2.

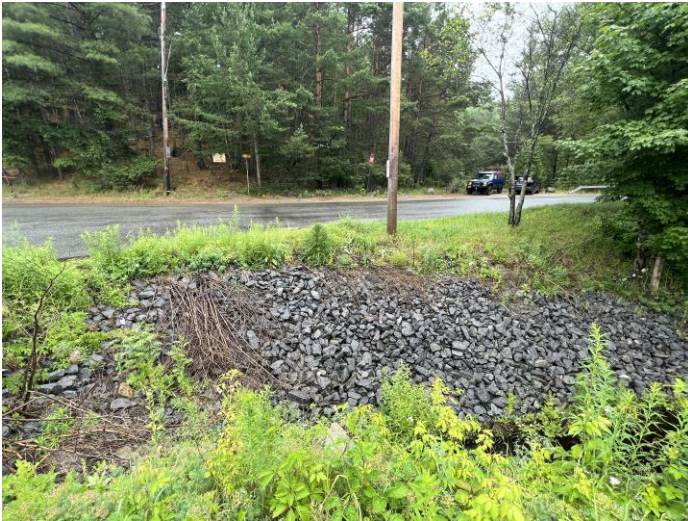
**Photograph 19:** Rip-rap slope of Brandy Brook at the northern end of BB-2 along Brandy Brook Avenue.

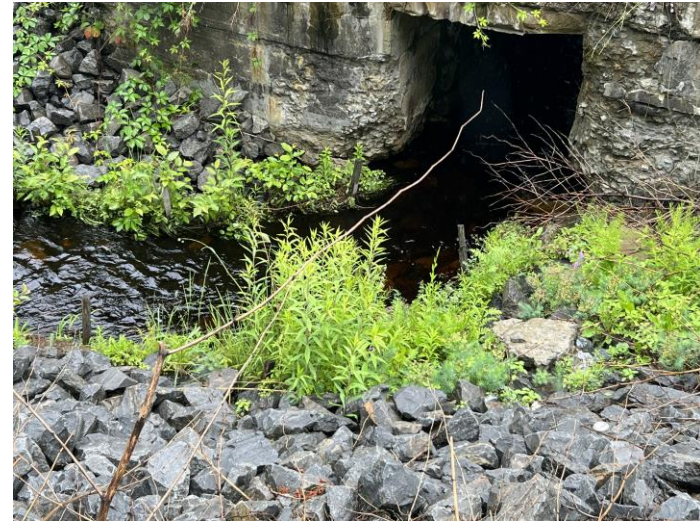
During the monitoring effort, EA personnel did not observe areas of stream bank erosion or signs of stream instability along the channel. In 2023 an area of concern at the historic concrete box culvert was identified, showing signs of scour under the concrete headwall. The existing fabric log was re-staked in this location in 2023 and the log has begun to become well vegetated, with no additional signs of erosion were observed in 2024. Additionally, in 2023 NYSDEC noted concern over the potential of future erosion along the rip-rap slope at the corner of Pine Street and Brandy Brook Avenue, since this location appears to receive significant runoff from the roads. However, during the 2024 monitoring effort this area was reviewed with NYDEC staff and no signs of erosion or rip-rap instability were noted during the 2024 monitoring event. The top of the slope has become more vegetated and no evidence of rip-rap movement down the bank was identified. The stream channel appears to be well connected to the wetlands and floodplain, and photographic documentation of the current channel conditions is provided in Appendix C. Established stream photograph locations are provided on Figures 5 and 6 (Appendix B). All in-stream structures and

The rip-rap slope and box culvert located between BB-1 and BB-2 was initially an area of concern in 2023 and was recommended to be closely monitored during future monitoring events to ensure erosion or scour does not continue in this area. During the 2024 monitoring effort, no additional erosion or scour was identified in this area and the top of slope and bottom of the slope at the edge of the rip rap has become more densely vegetated and appears to be stable. Similarly, the 2023 re-planted area within Wet-2 has become very well established and no bare spots or tire rutting was observed in 2024.

**Photograph 20:** Area of concern at historic culvert on the northern end of Monitoring Area BB-2.

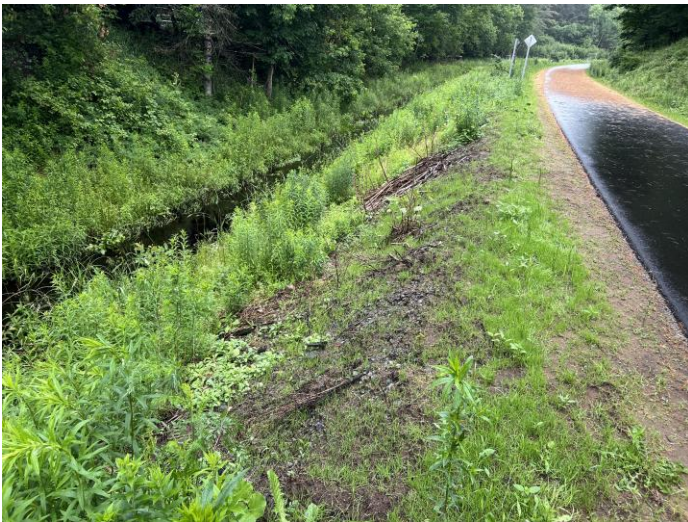
**Photograph 23:** Area of previously identified and treaded invasive species (Japanese knotweed).

treatment is recommended for throughout 2024 to spot treat the areas of Japanese knotweed. If not continuously treated, this population can re-establish and exceed the 5% threshold rapidly, as Japanese knotweed is an aggressive, fast growing invasive species.

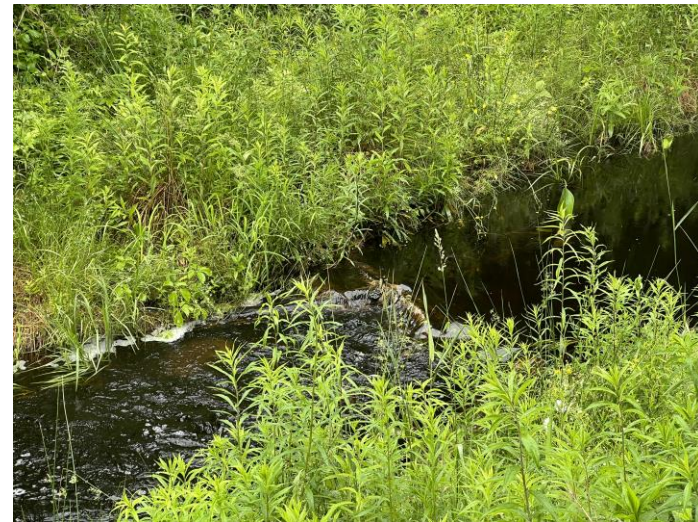
**Photograph 24:** Partially submerged stable drop log structure observed along Brandy Brook within

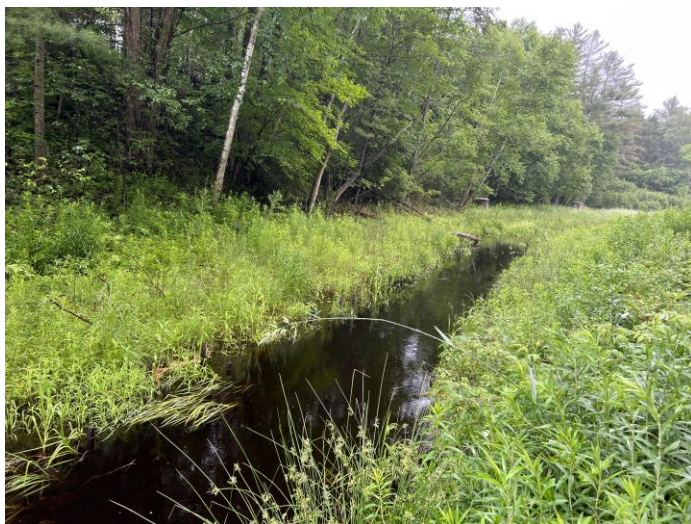
**Photograph 25:** View of stable stream channel bank with core log structure along Area BB-2.

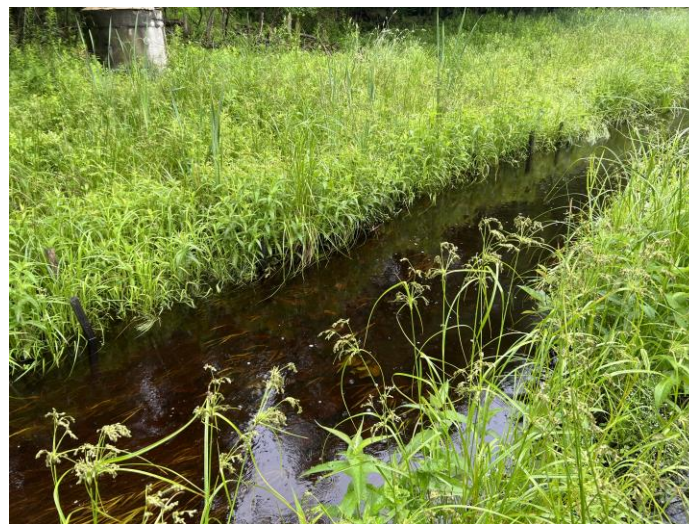
**Photograph 26:** Submerged stable rock vane structure within Brandy Brook within Monitoring Area BB-2.

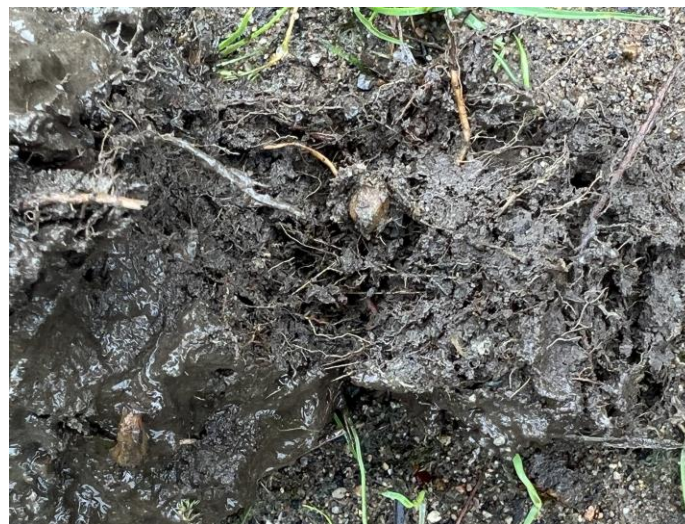
**Photograph 30:** saturated soils identified within the soil sample at Monitoring Area Wet-1.

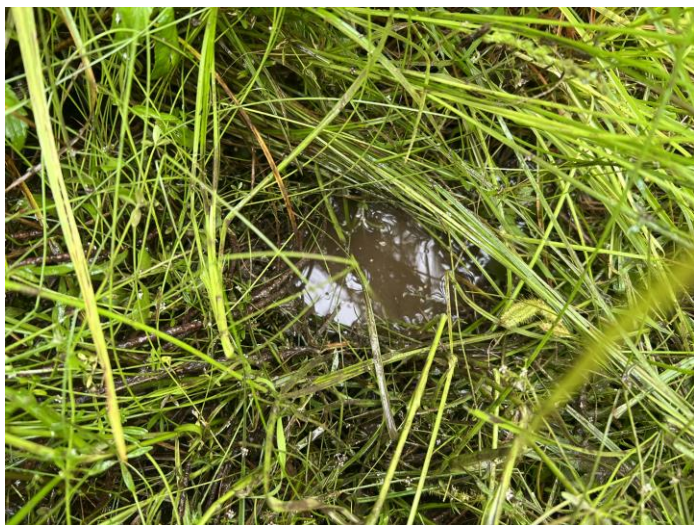
**Photograph 31:** Groundwater identified within soil sample pit at Monitoring Area Wet-1.

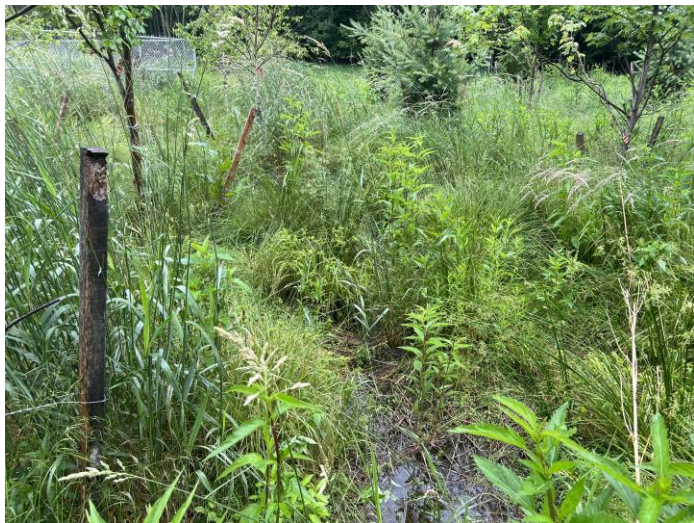
one dead white pine was observed on the opposite bank of the stream channel during the wetland monitoring effort for a survivability of 93% for the trees along the riparian edge. The native vegetation cover in Wet-2 has increased by 10% and the emergent wetland vegetation has shown vigorous growth of the last year. During the 2023 monitoring effort, recent disturbance and re-seeding was identified in this area which has been repaired and the re-seeding has been very effective.

**Photograph 39:** 2023 tire rut areas now revegetated within the area of Wet-2.

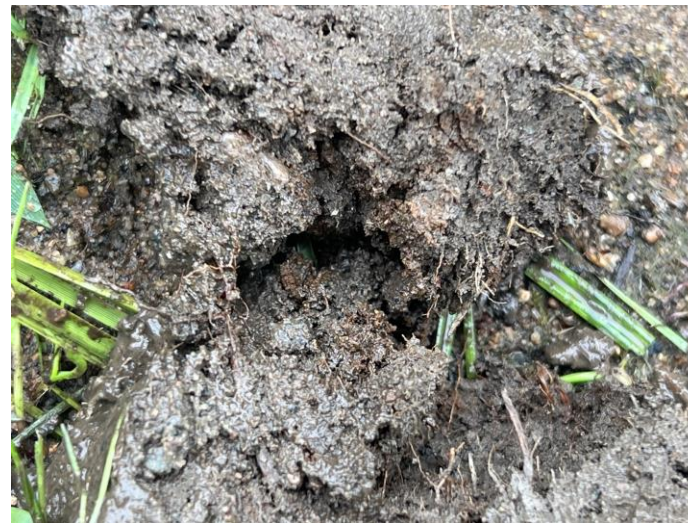
**Photograph 40:** Sandy soils with redox features observed within Monitoring Area Wet-2.

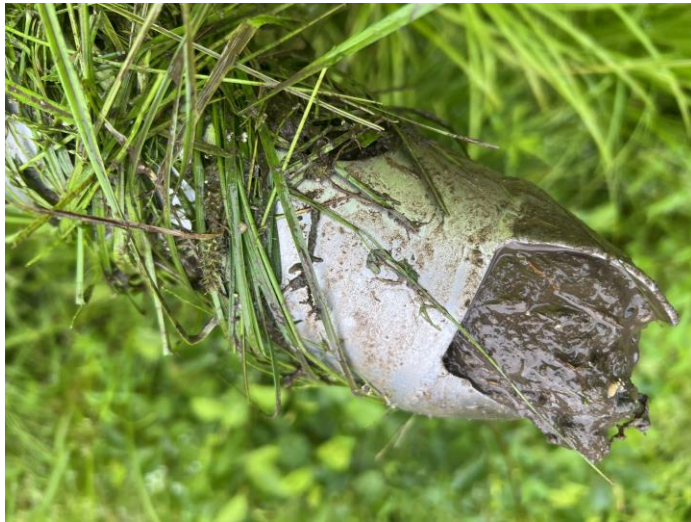
**Photograph 41:** Saturated wetland soils within Wet-2.
