Subject:
Second Annual Report on the Status of Mitigation Activities
Willsboro Black Ash Pond – Site #516009
USACE Permit Application #NAN-2012-00195
Order of Consent No: A5-0771-07-11

Willsboro Black Ash Pond – Site Visit 04-10-14

GEORGIA-PACIFIC LLC • WILLSBORO, NEW YORK
 WILLSBORO BLACK ASH POND
 REMEDIAL ACTION WORK PLAN

GEORGIA-PACIFIC LLC
 WILLSBORO, NEW YORK
**WILLSBORO BLACK ASH POND
 ANNUAL REPORT**

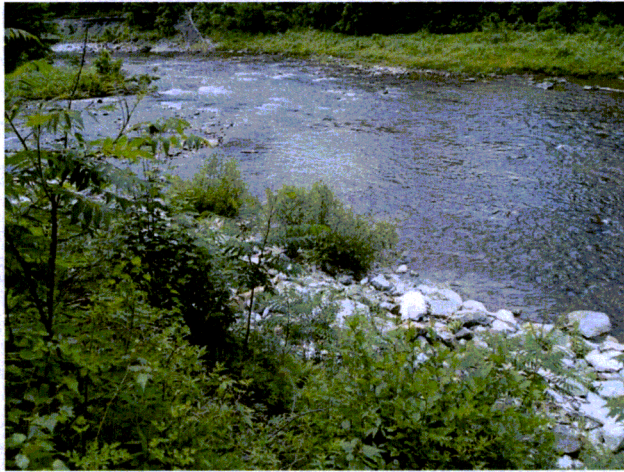
Picture # 1: View of riprap bench and growth in Do-Not-Disturb area. Note willows on edge

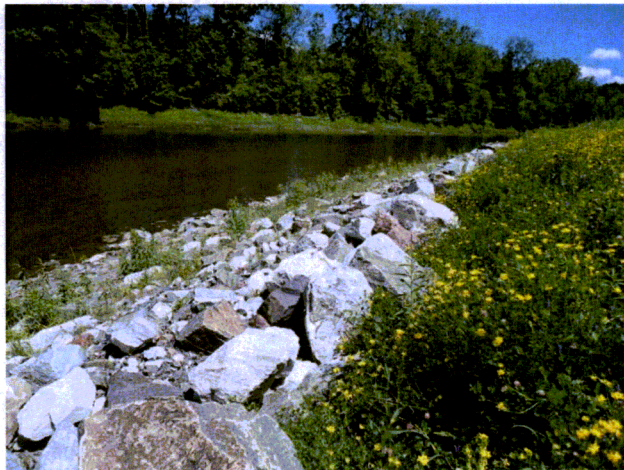
Picture # 2: View of deposition on riprap and growth on slope and in riprap

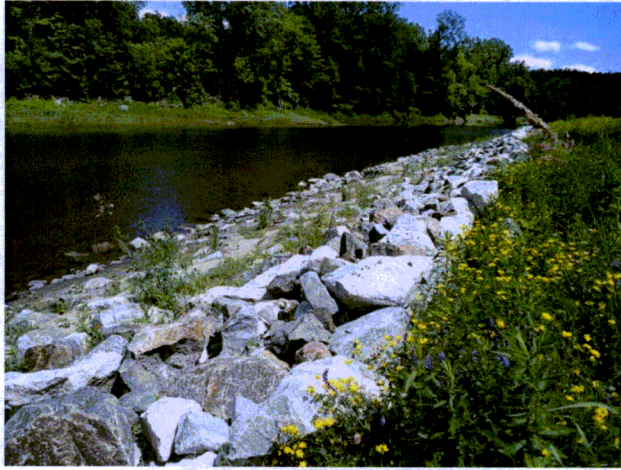
Picture # 4: View of deposition on riprap and growth on slope and in riprap

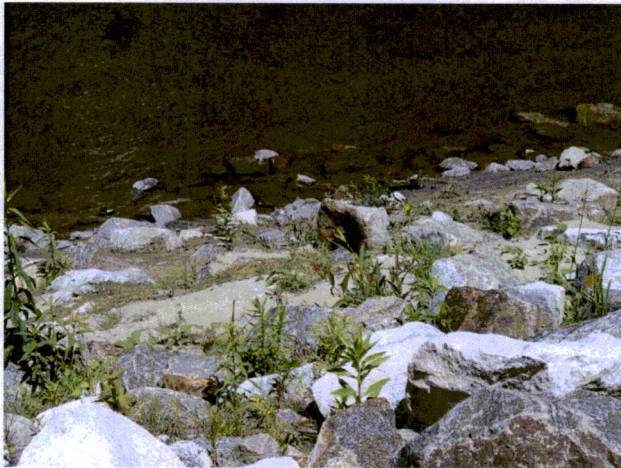
Picture # 5: View of growth in area of deposition. Note willows at water edge

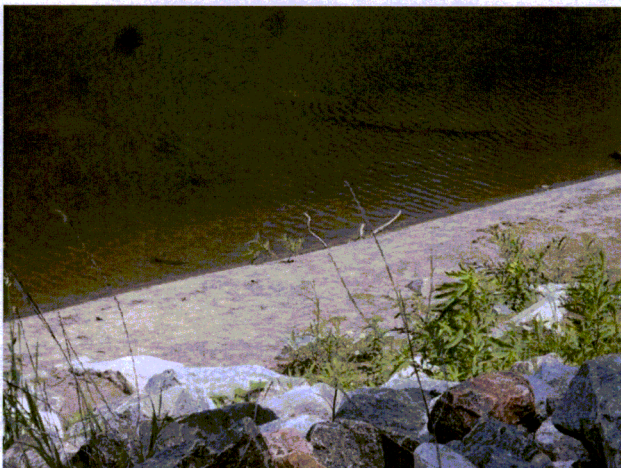
Picture # 6: View of willow regrowth through sediment

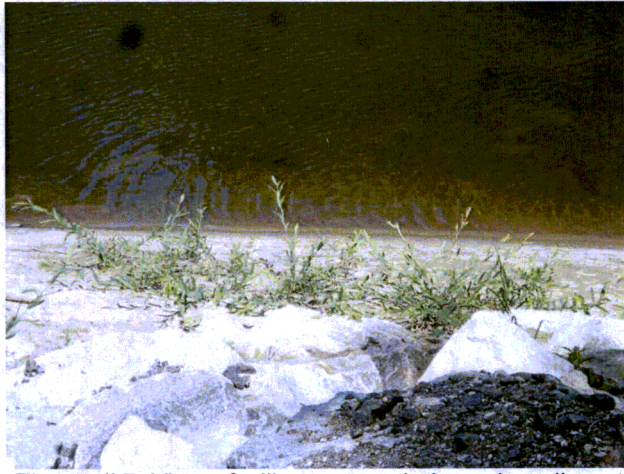
Picture # 7: View of willow regrowth through sediment

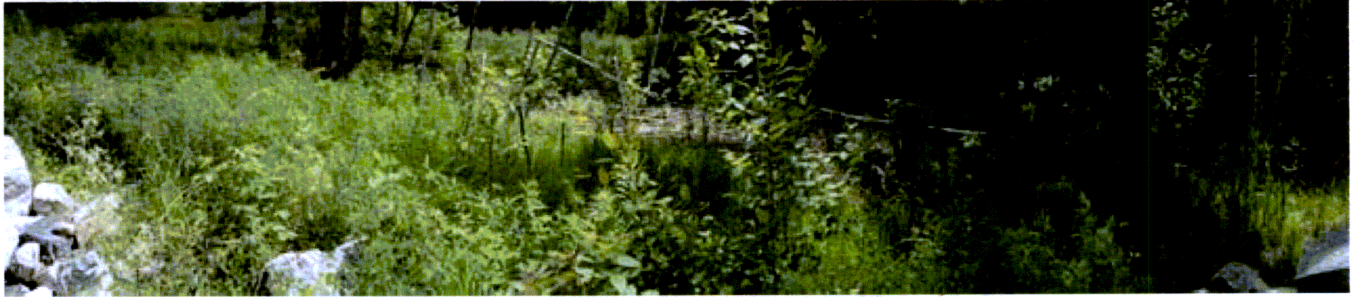
Picture # 13: View of interior inlet/outlet. Note live stake growth

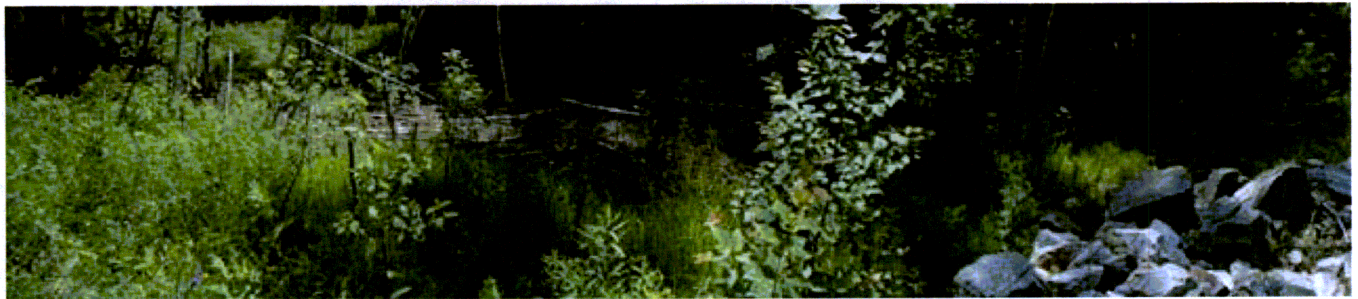
Picture # 14: View of interior inlet/outlet. Note live stake growth

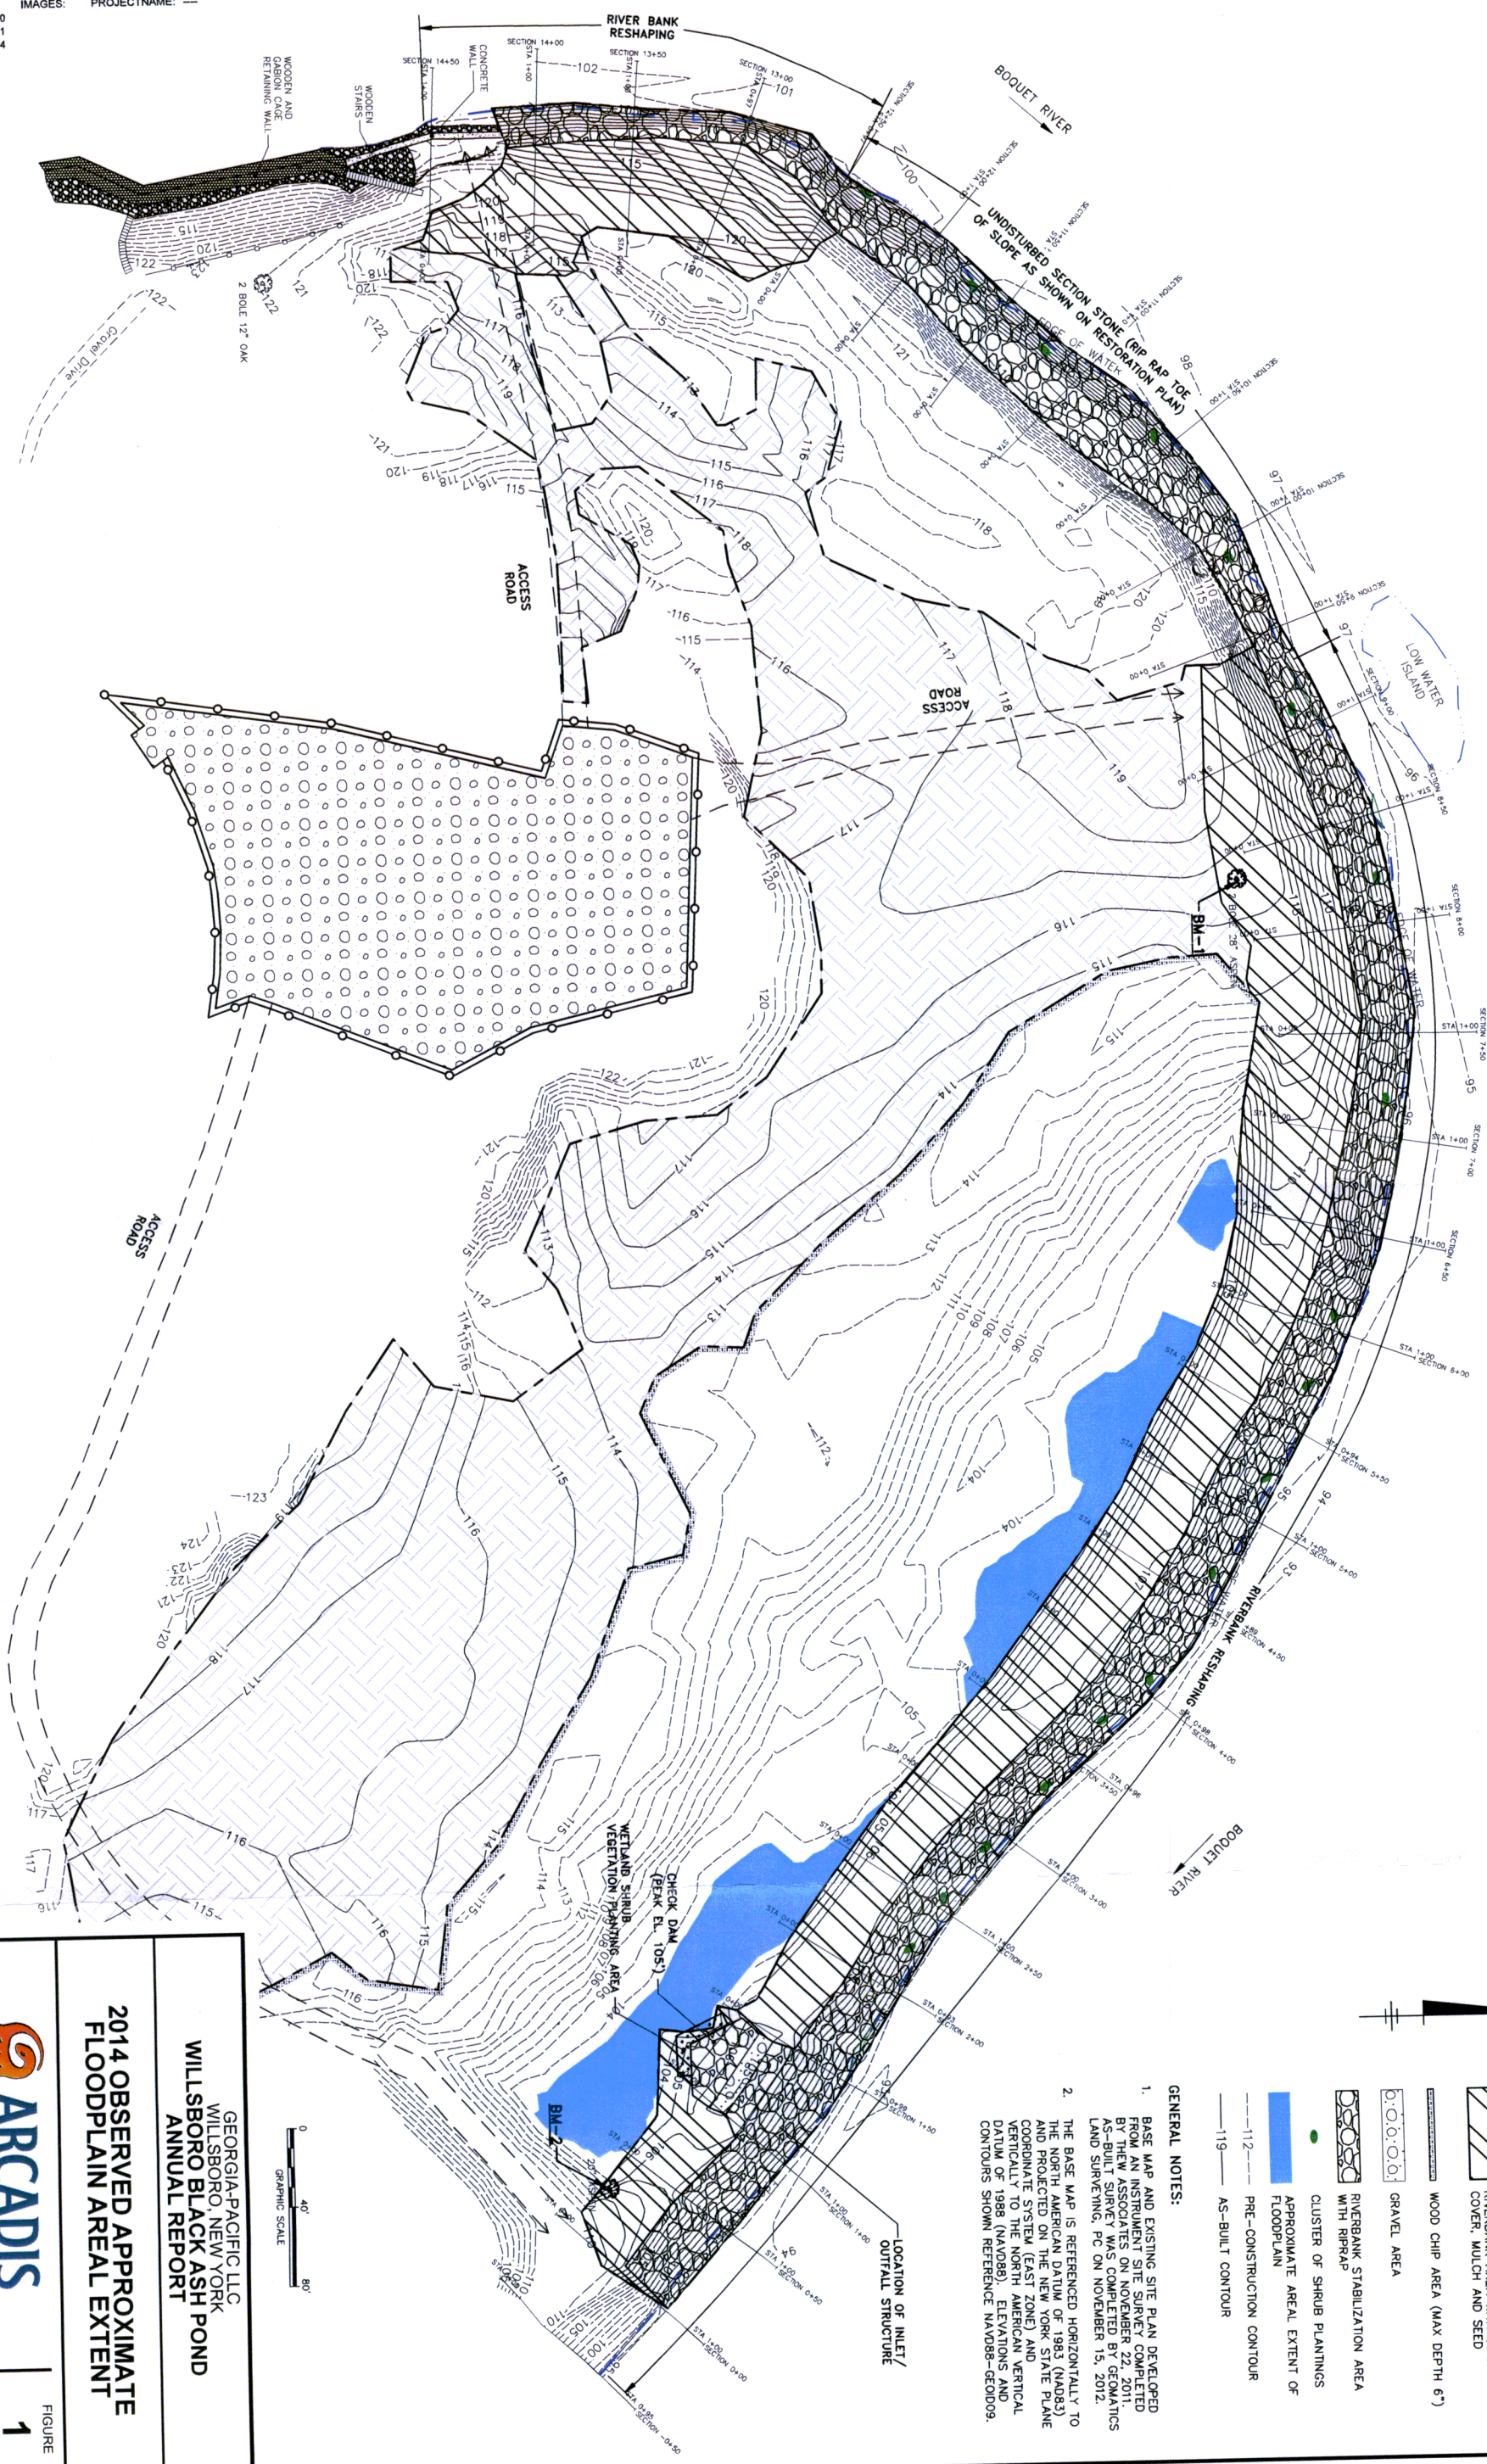
**2014 OBSERVED APPROXIMATE
 FLOODPLAIN AREAL EXTENT**

Appendix F of the Pre-Construction Notification Clean Water Act, Section 404 NWP 38 and Section 401 Water Quality Certification Application (PCN) provided a plan view estimation of the anticipated areal extent of the proposed floodplain and is attached to this Annual Report for reference (Attachment 2). The approximate areal extent of the current floodplain conditions as observed on April 10, 2014 is provided on Figure 1 in Attachment 2.
