Prepared by:
AECOM
Latham, NY
60273289
September 2016

Periodic Review Report

June 15, 2015 through June 15, 2016

Korkay, Inc.
Site No. 5-18-014

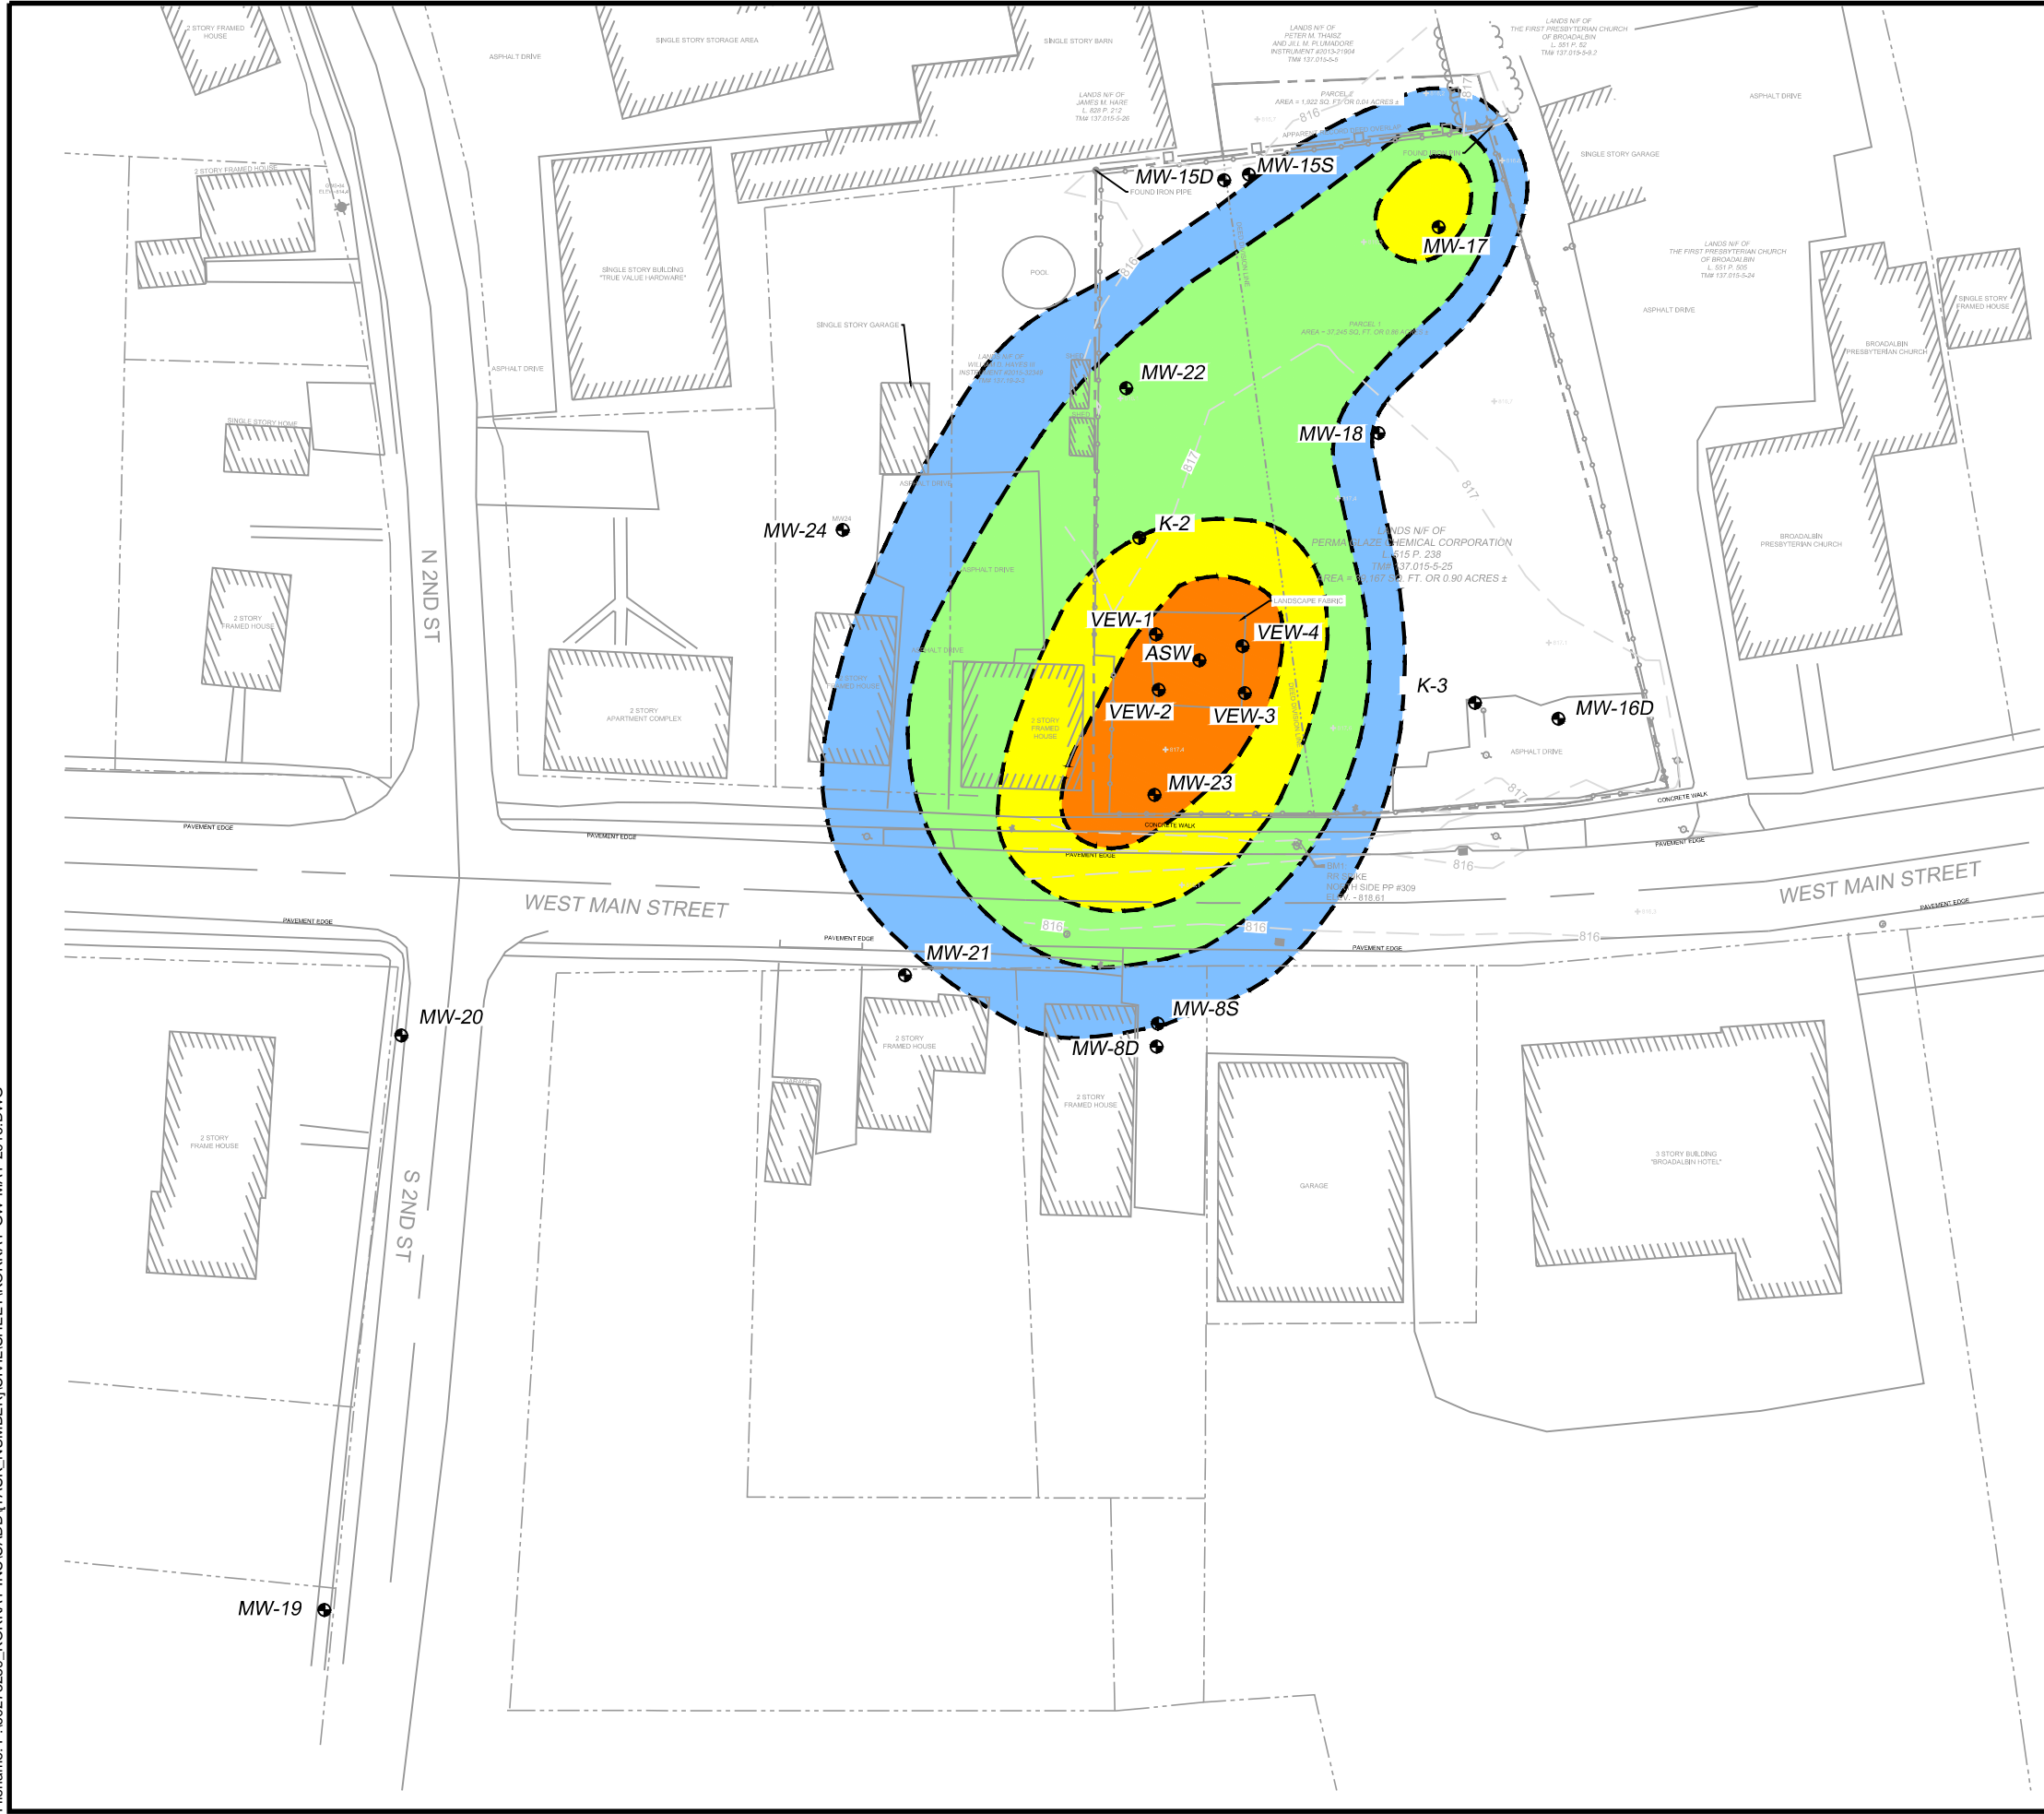
TOTAL VOC ISOCONCENTRATION
CONTOUR MAP
MAY 31, 2016

Comparison of the isoconcentration contour maps from the four sampling events (Figures 4 and 5a – 5c) indicates that in general the size and contaminant concentration of the groundwater plume decreased to some degree following the ISCO injection. However, the observations above suggest that the level of active persulfate remaining in the injection area is unlikely to further reduce contaminant mass. Similarly, the amount of residual ORC in the injection area to promote aerobic degradation and reduce contaminant mass is low. Consideration should therefore be given to administering a second round of ISCO treatment, targeted on the residual hot spot areas of the Site.

- Annual periodic review is recommended in order to determine the compliance of the facility with the EC/IC's in place.
- Finalize the draft SMP.
- Continue groundwater sampling in accordance with the SMP to monitor the groundwater plume.
- Continue to monitor and evaluate changes in groundwater quality for evidence of contaminant reduction during future quarterly sampling events. The review of changes in groundwater quality and additional recommendations will be provided as deemed necessary.
- Continue to follow the requirements of the SMP, accordance with current DER-10 guidance, to assure that appropriate and comprehensive Site management is completed throughout the remaining post remediation monitoring period.
- Consider administering a second round of ISCO treatment, targeted on the residual hot spot areas to further reduce contaminant mass.

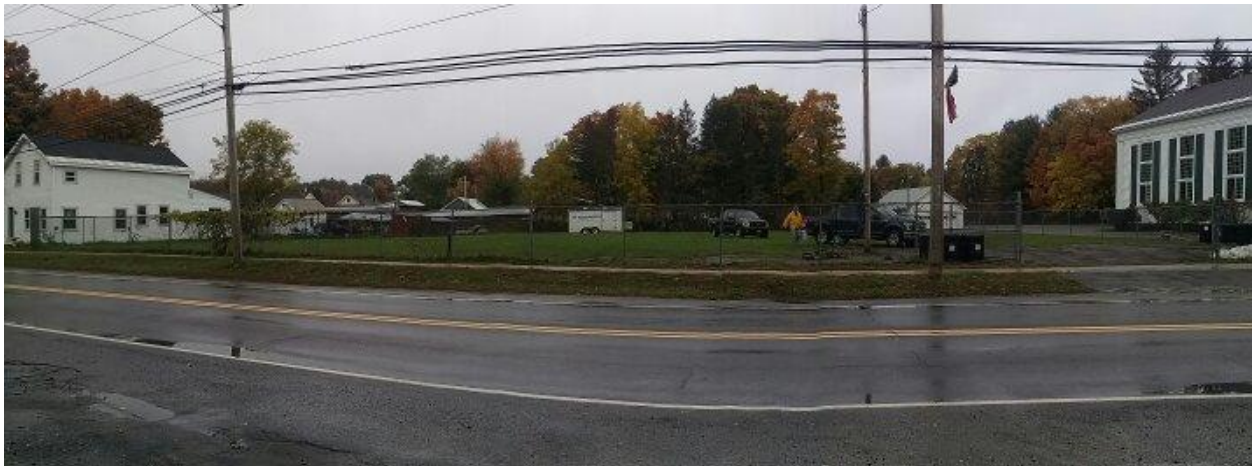
7) View to north at Site during October 2015 five-quarter groundwater sampling event. Chain link perimeter fence is still in place.

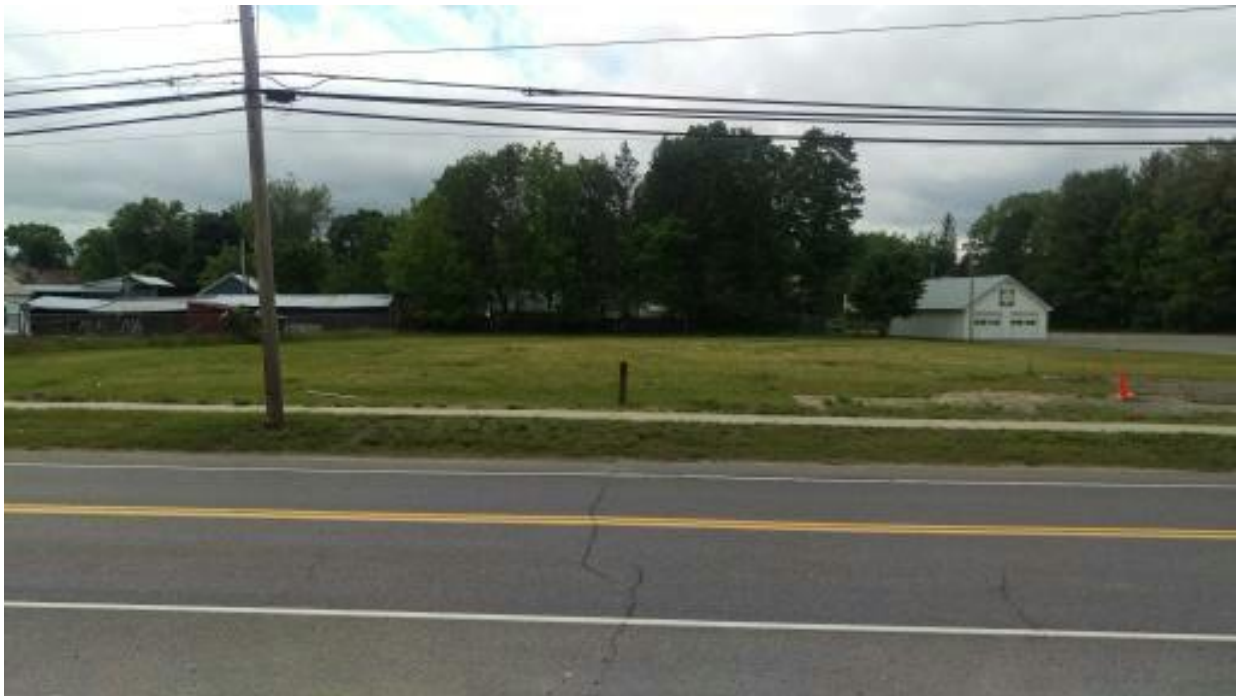
9) View to north of site following May 2016 post-ISCO quarterly groundwater monitoring event. Note the eastern and southern sides of the chain link perimeter fence were removed in November 2015.
