**THE TOWN OF MOREAU  
LANDFILL CLOSURE REPAIRS  
Moreau, N.Y.  
Project No. SU 99035**

**APRIL 2000**

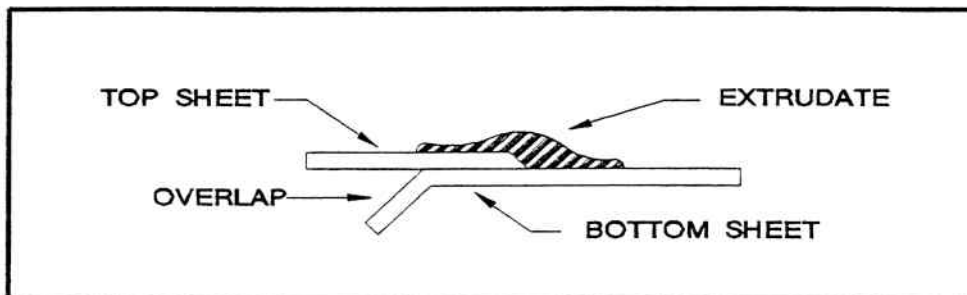
**Figure 2 - FILLET-EXTRUDED GEOMEMBRANE WELD**

In restrictive areas where this process could not be adequately applied, such as corners and close patches, manual extrusion fillet welding was employed instead. (See Fig. 2)

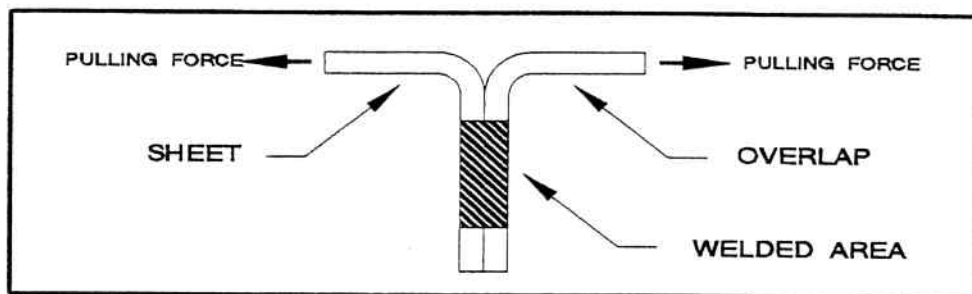
Figure 3 - PEEL TEST

Trial tests were performed on trial seams prior to any on-site seaming in order to quantify the calibration of the welding equipment. On each sample, two peel tests and two shear tests were performed. A peel test is conducted by submitting a one inch-wide strip of seam to a tensile effort on a calibrated, portable tensiometer, and trying to "peel", or open, the seam (see Fig. 3). The portable tensiometer has a grip separation of one (1) inch and the crosshead speed used is two (2) inches per minute. A shear test is similar, but the tension is applied in the plane of the seam (see Fig. 4). The peel test gives a good indication of the quality of the seam while the shear test shows the behavior of the seam after field seaming is completed.

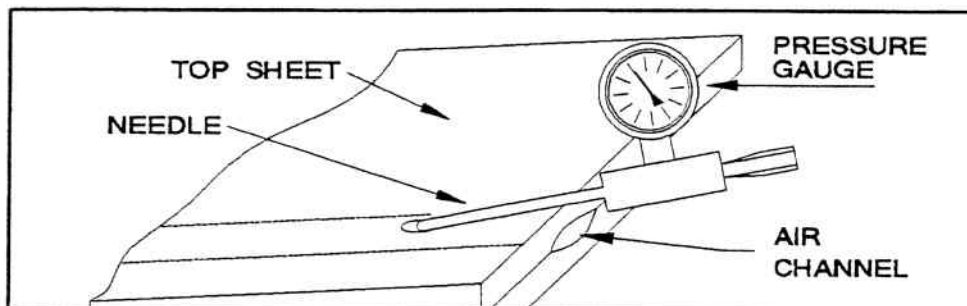
Figure 5 - AIR-PRESSURE TEST

Air-pressure testing was employed wherever possible (See Fig. 5). This non-destructive test consists of injecting air of predetermined pressure in the center air channel of fusion welded seams. If the seam is continuous there will be very little or no drop of pressure. If a leak is present within the area under pressure, it is located and repaired. This type of non-destructive test is faster than the vacuum-box test, less observer-dependent and represents a supplementary mechanical resistance test since the geomembrane sheets are pulled away from each other by the air pressure in the channel.

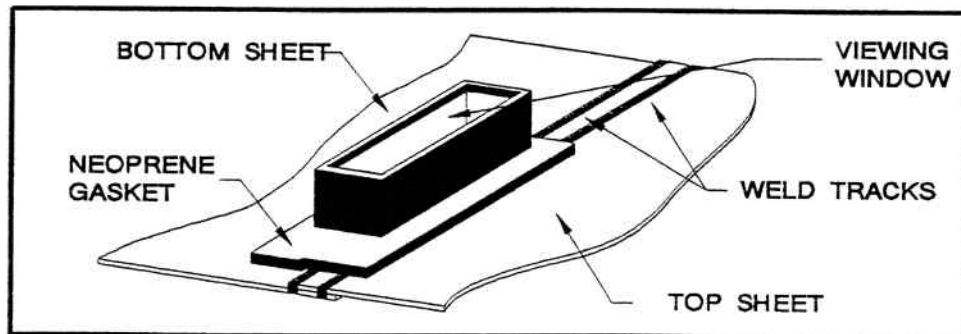
Figure 6 - VACUUM-BOX TEST

Wherever the air-pressure test could not be used, the vacuum-box test was employed. In this test, a film of soapy water is sprinkled over the area to be tested. A box fitted with a transparent upper cover and a neoprene lower rim is placed over that same area and connected to a vacuum pump; a negative pressure of 5 psi is then applied (see Fig. 6). If there is a puncture or discontinuous seam within this area, bubbles will appear and be detected by the observer.

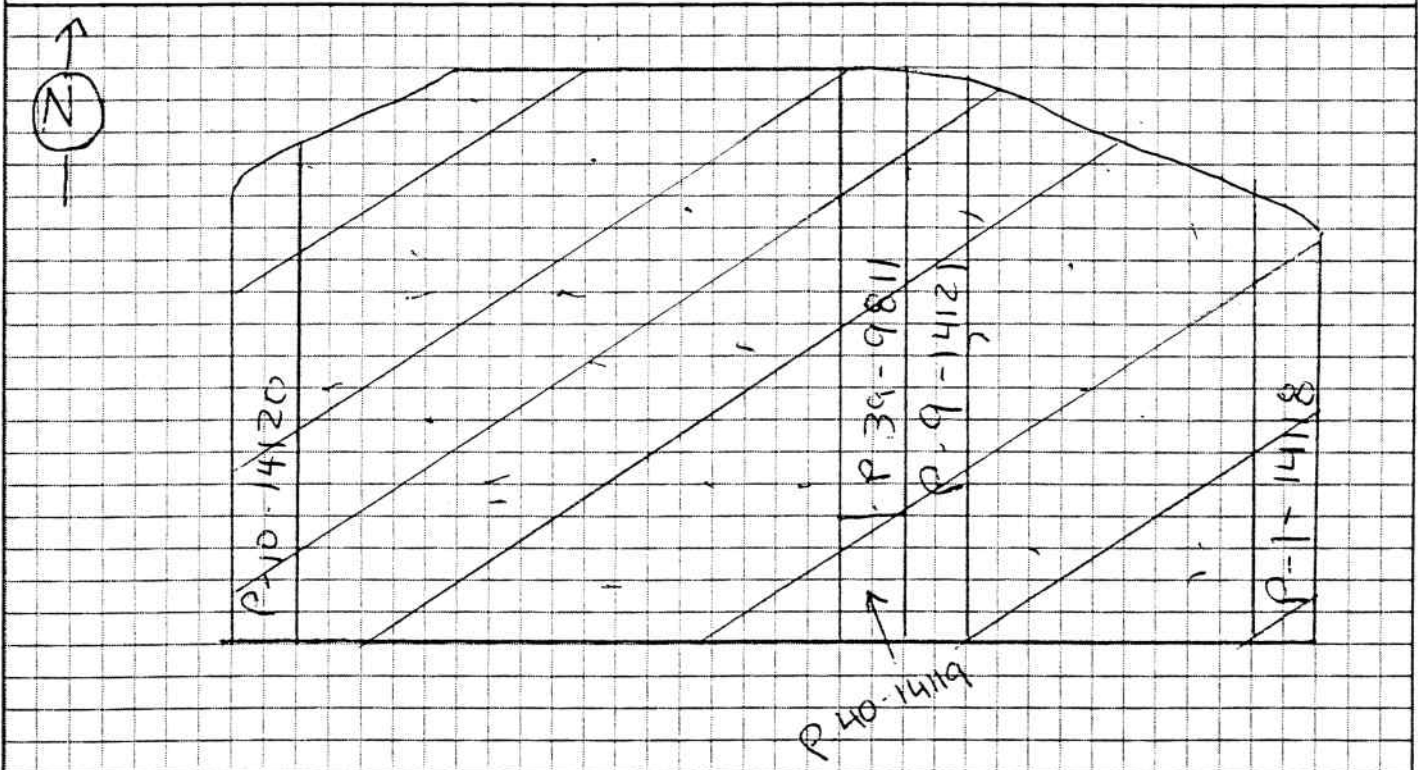
SKETCH

| MATERIAL | MEASURES | AREA | DESCRIPTION |
|---|---|---|---|
| 40 mil B-40-T | <del>188,338</del> 189,592 ft <sup>2</sup> | Repair on South Slope | Amount of liner needed to cover subgrade on slope. |
