Construction Documentation Report

Landfill Closure

Town of Moreau, New York

July 2001

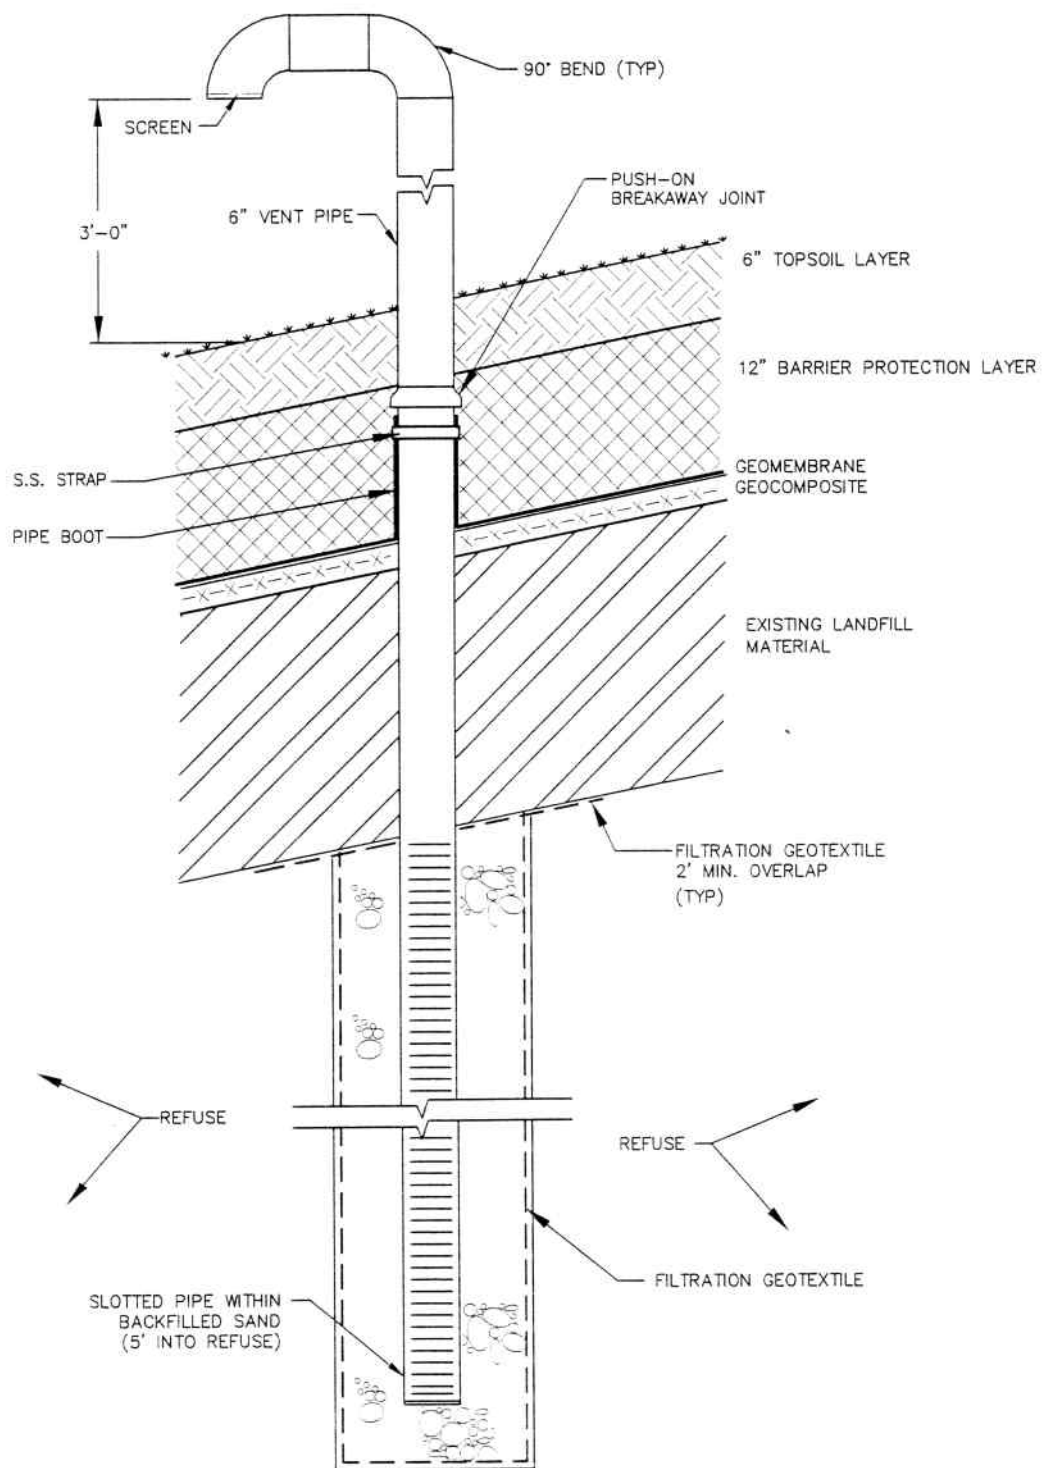
FIGURE 2 - 1
 GAS VENTING RISER DETAIL

Seventy-six gas venting risers were installed in 1997 by the Town of Moreau with engineering oversight. The gas venting risers were constructed of 6-inch PVC Schedule 40 pipe. The gas venting risers extended 5 feet into MSW and 3 to 4 feet above grade. The vertical portion of the vents was slotted from the bottom to just below the surface. Following installation of the gas vents, daily operations damaged several of the riser pipes. Repair of the damaged riser pipes and completion of the gas vents was completed by Kubricky Construction Corporation in 1998. Kubricky excavated the damaged risers to a good section of pipe, cut off the risers, and added a

coupling and new section of riser pipe to extend above the surface. After geomembrane installation, Kubricky cut off the riser pipe approximately 12 inches above the geomembrane and installed a breakaway coupling, 3-1/2 feet of riser pipe, two 90° bends, and vermin prevention screens between the two 90° bends to complete the installation of the 76 gas venting risers. A typical gas venting riser is illustrated on Figure 2-1.

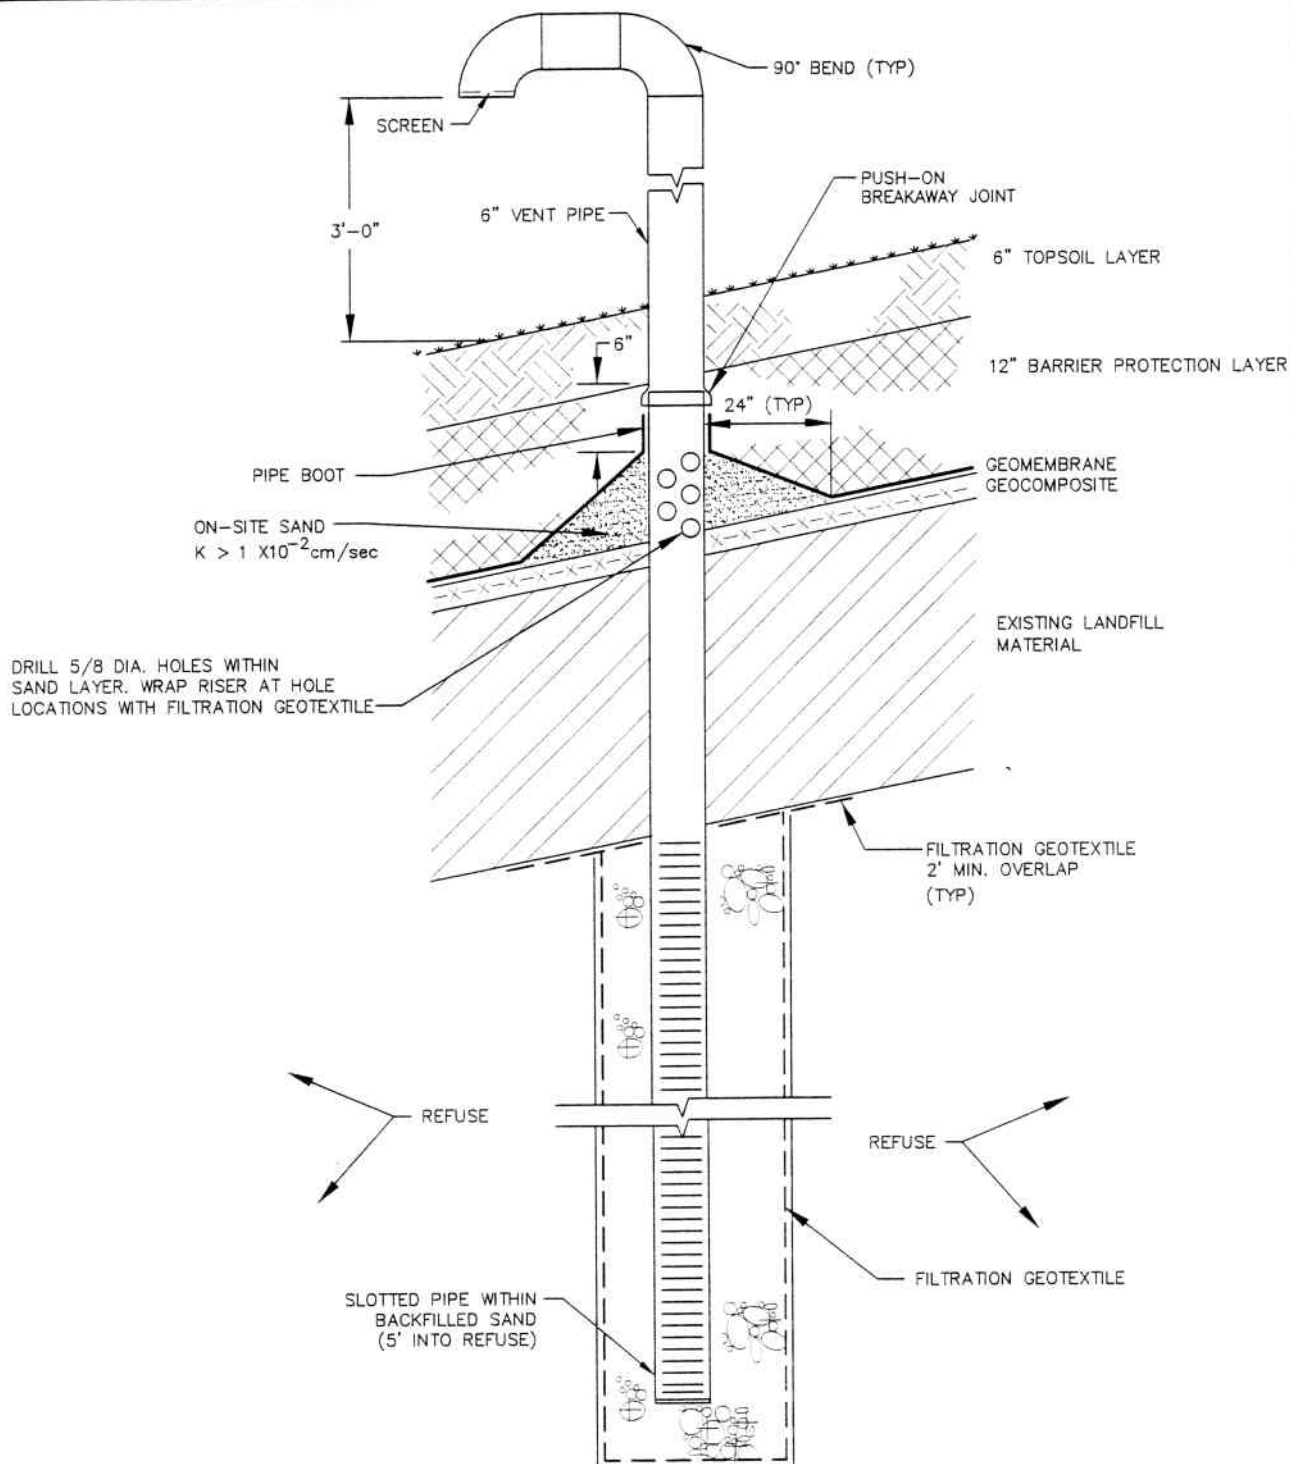
FIGURE 2 - 2
 REVISED GAS VENTING RISER DETAIL

During the geomembrane installation and placement of barrier protection material, “gas bubbles” appeared under the geomembrane. Some of these bubbles dissipated, while others remained or increased. Options for treating the gas bubbles were discussed as follows:

It was decided to utilize all options at various areas of the landfill, depending on the size of the gas bubble, proximity to an existing gas vent, and subgrade surface condition. To this end, 36 gas vents were modified as shown on Figure 2-2. Seventeen new gas vents with modifications were added and 5.7 acres of geocomposite material were added as a gas venting layer. The geocomposite material and 14 of the gas vents modified were on the north slope of the landfill. The remaining gas vent modifications were located mostly on the north half of the landfill. The supplemental gas vents were located throughout the landfill as needed.

1. Lance geomembrane and patch after gas escapes.
2. Placement of barrier protection material and topsoil. Push gas into subgrade and eventually to gas venting risers.
3. Install supplemental (additional) gas venting risers.
4. Review areas of the landfill that had not been covered to date with geomembrane and address as a separate issue.
5. Modify gas venting risers to allow the gas to enter the gas vents without having to travel through the subgrade material.

- 1.) CONTRACTOR SHALL UTILIZE NEW GAS VENT DETAIL AS SHOWN ABOVE AT THE LOCATIONS IDENTIFIED ON ATTACHED SHEET.
- 2.) CONTRACTOR SHALL COMPLETE ALL EXISTING GAS VENTS FROM THE PUSH-ON BREAKAWAY JOINT UP, AS SHOWN IN THIS DETAIL.
