Subject: **Mechanicville Site Management  
Annual Status Report  
Site #: 546033  
NYSEG – Mechanicville Central Avenue Former MGP Site**

On behalf of New York State Electric and Gas Corporation (NYSEG), AECOM has prepared this letter to describe events associated with site management activities at the Mechanicville Central Avenue Former Manufactured Gas Plant (Site) in Mechanicville, NY. The report summarizes the annual activities performed at the Site in 2018 in accordance with the site management plan (SMP) approved by the New York State Department of Environmental Conservation (NYSDEC) in April 2011 as well as the periodic review report (PRR) approved by the NYSDEC in August 2016.

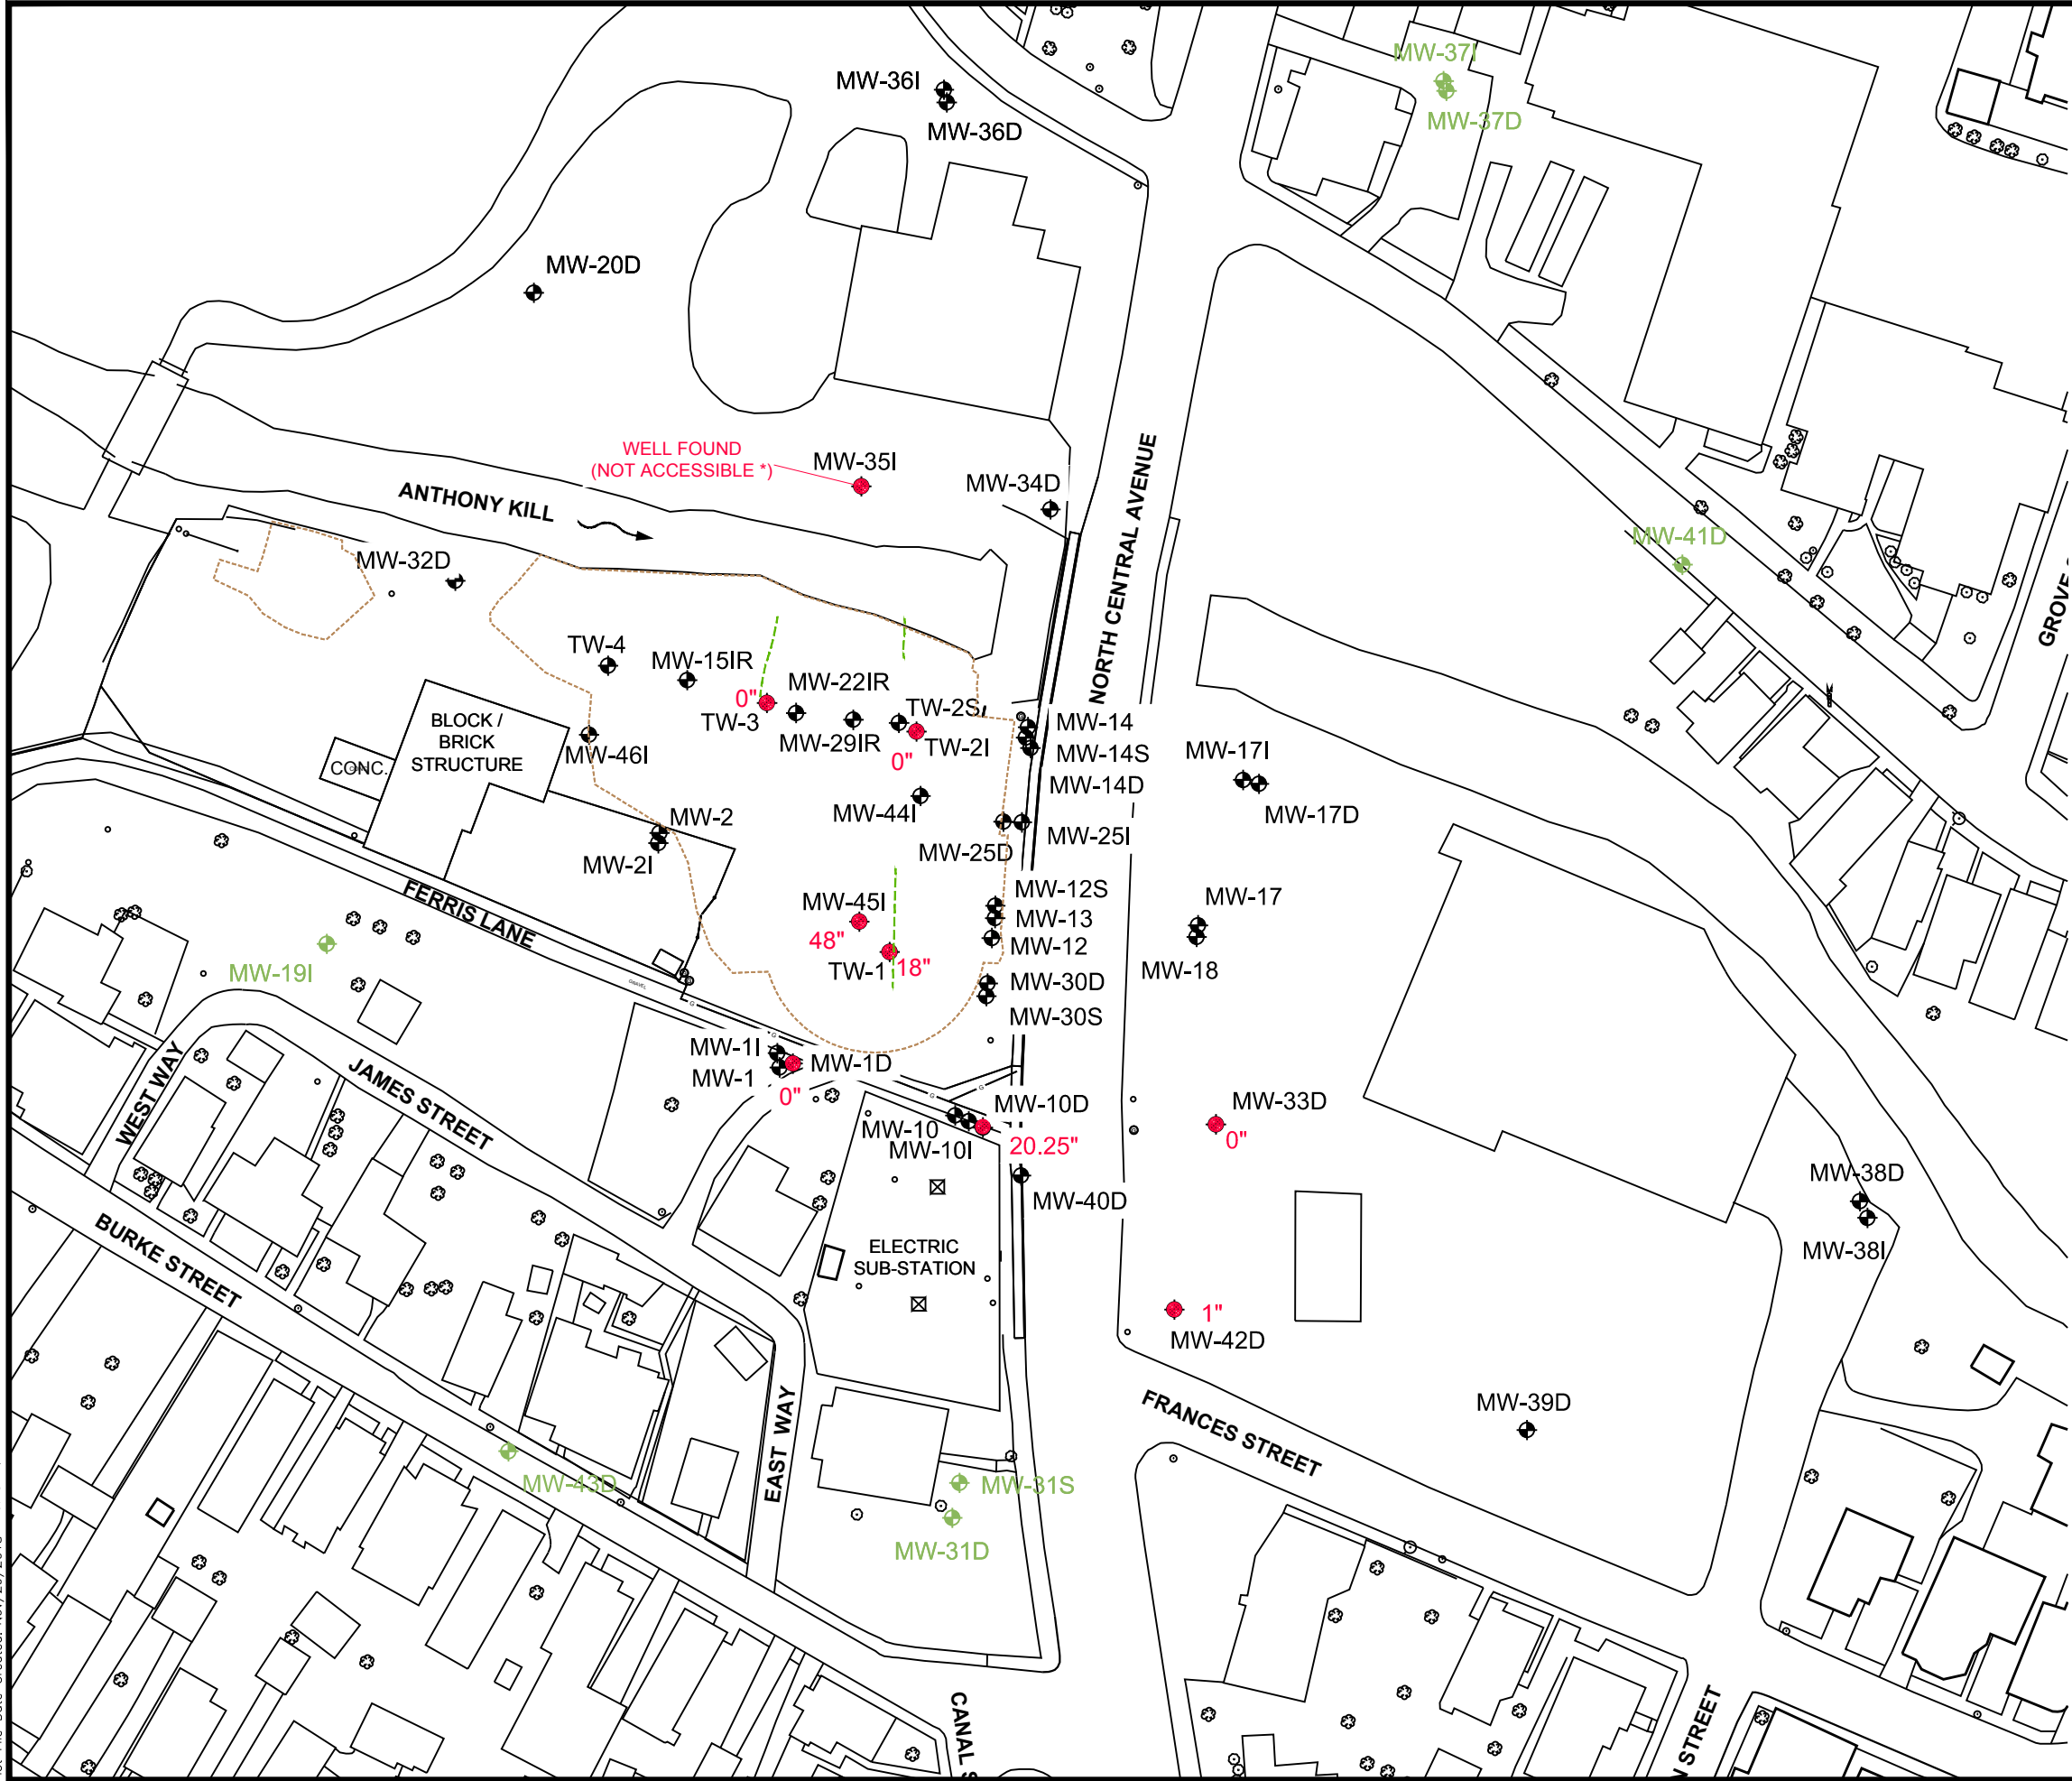
NAPL MONITORING RESULTS  
AUGUST 2018

During this monitoring period, four of the wells had measurable NAPL; three with thicknesses above six inches. Table 1 summarizes the NAPL thickness in select monitoring wells in August 2018.

\* WELL FOUND ON ADJACENT PROPERTY. NOT ACCESSIBLE DUE TO BOAT AND TRAILER PARKED OVER WELL.

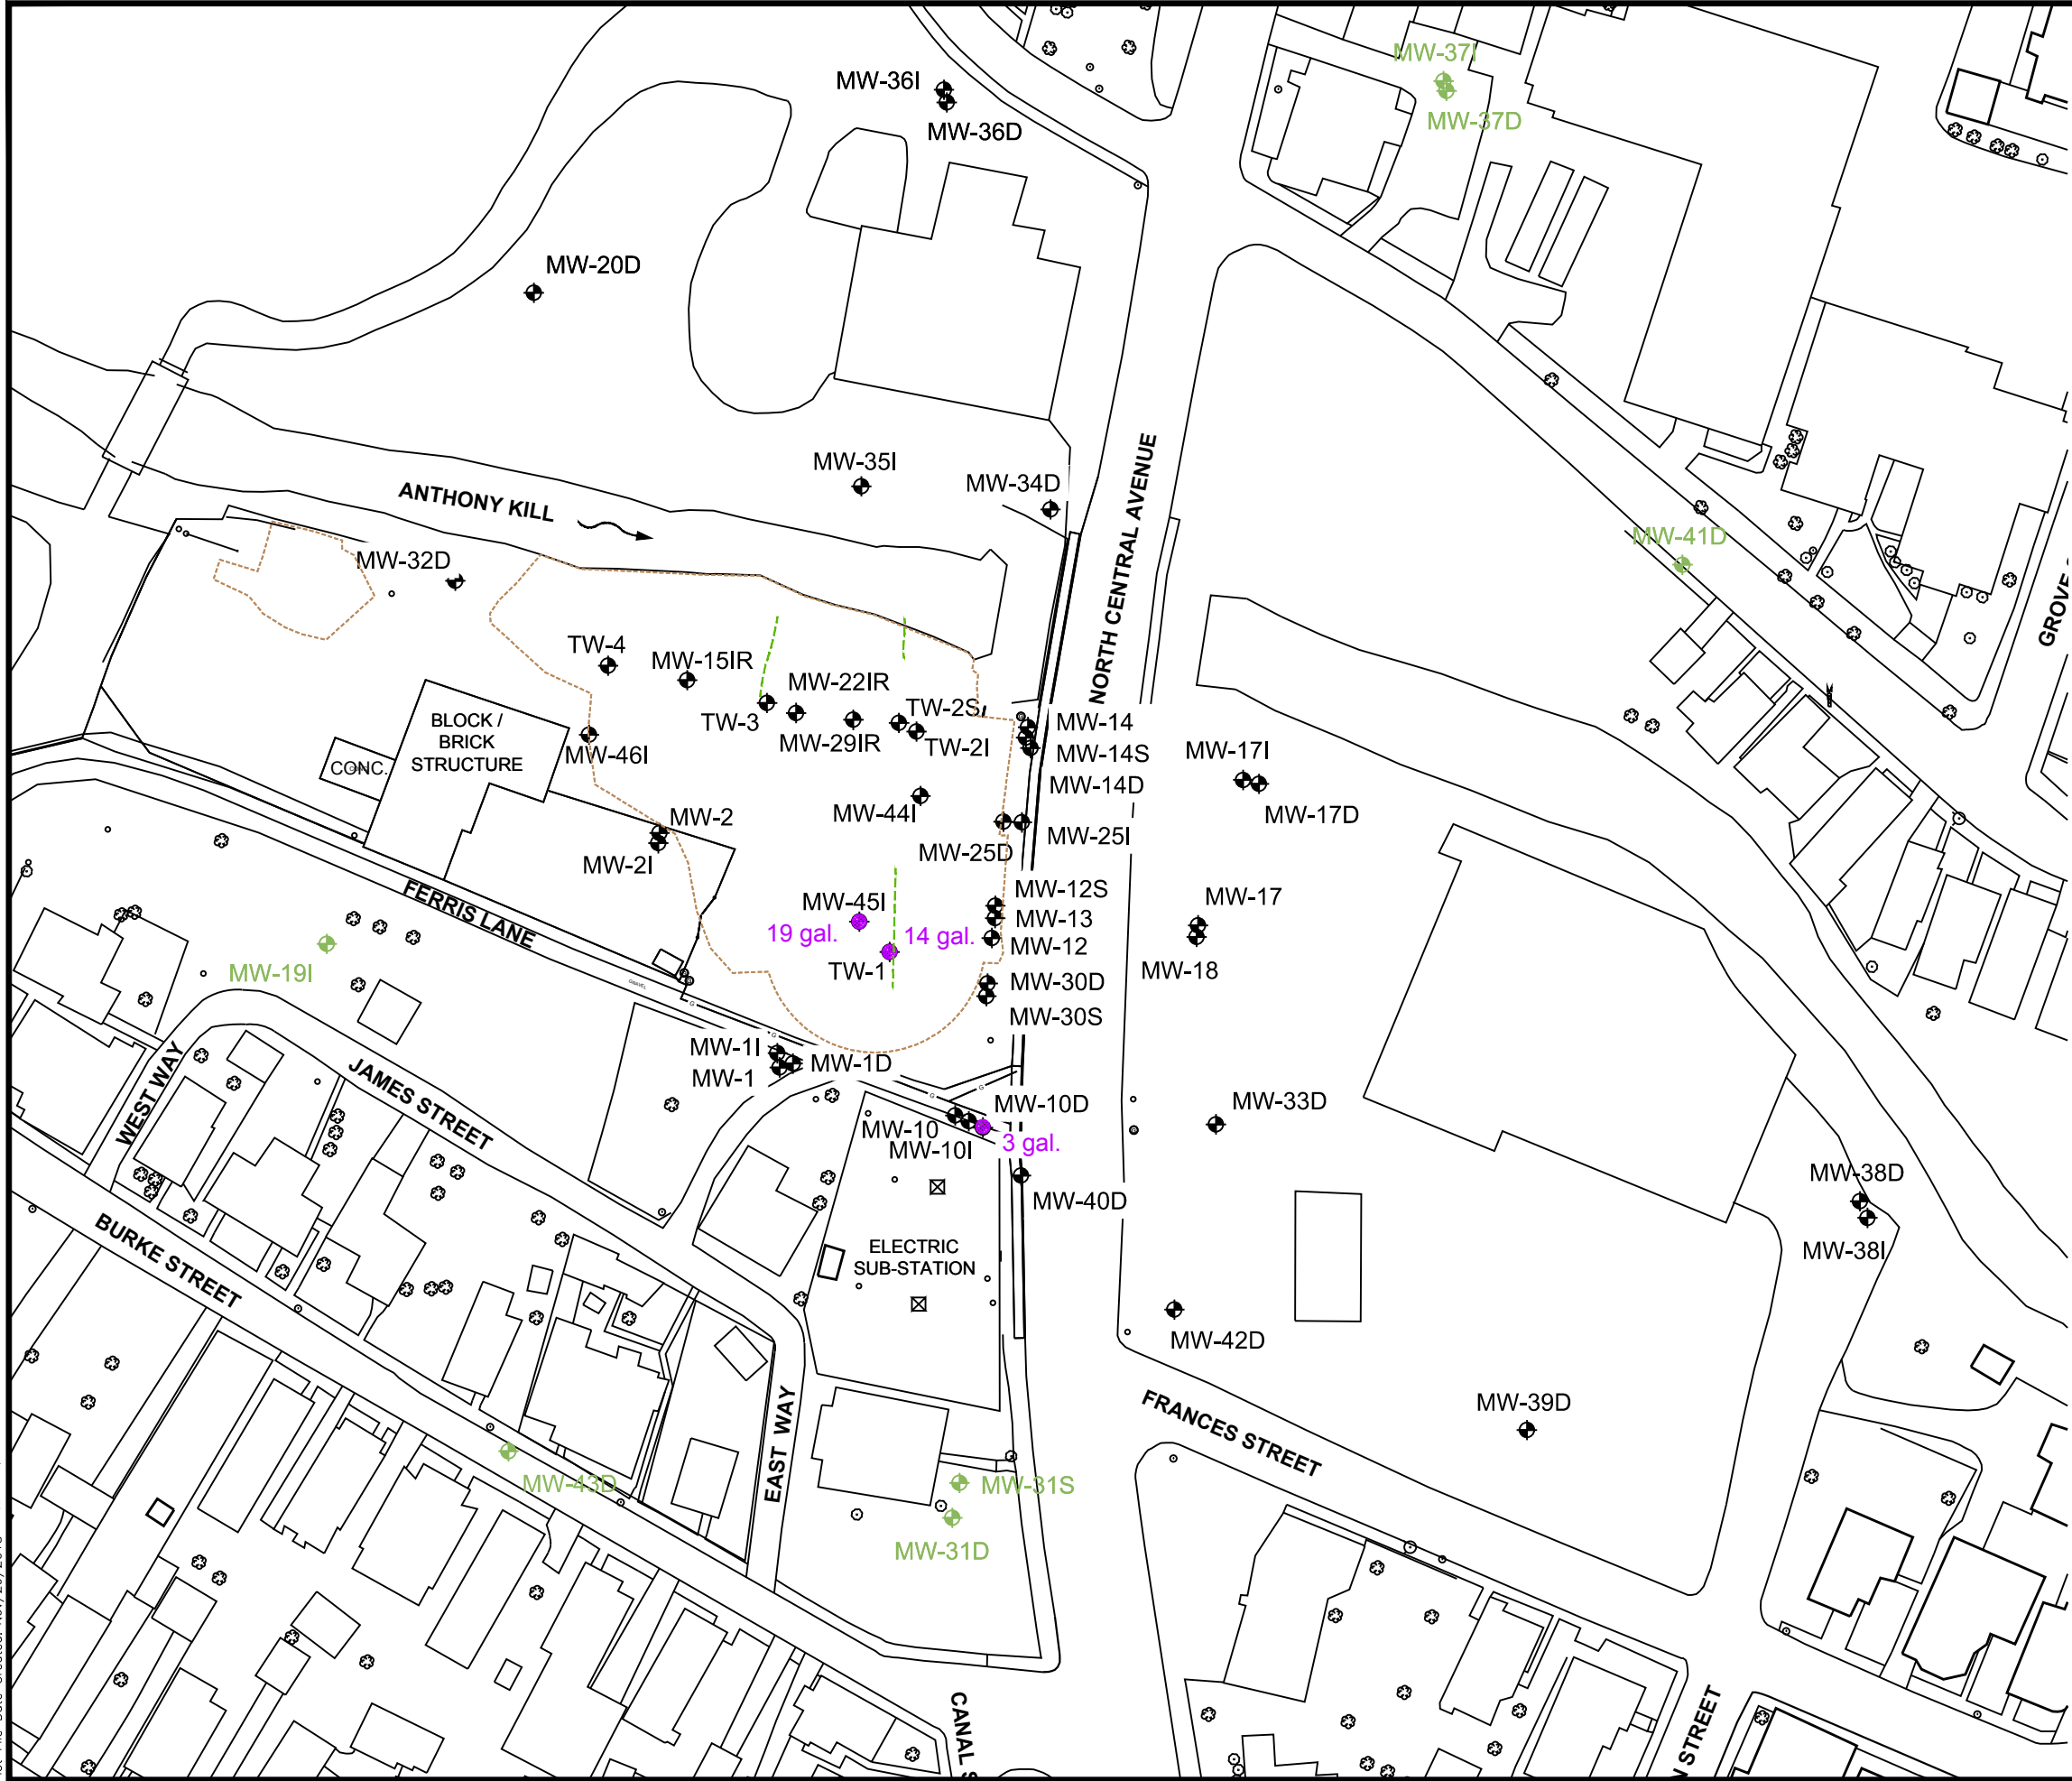
**NAPL RECOVERY RESULTS  
NOVEMBER 2018**

NAPL was recovered from three wells (TW-1, MW-10D, and MW-45I) with NAPL accumulation of more than 6-inches in November 2018. Combination of peristaltic pump and bailers was used to recover maximum NAPL from the wells. Approximately 36 gallons of NAPL mixture was removed from the three wells and stored into a 55-gallon drum pending disposal at an approved disposal facility in accordance with all state and federal regulations. All solid waste (i.e. disposable personal protective equipment, tubing, buckets, strings, wipes, etc.) generated during the gauging and recovery event were stored on-site in a separate 55-gallon drum. Both drums were properly labeled and closed pending disposal.

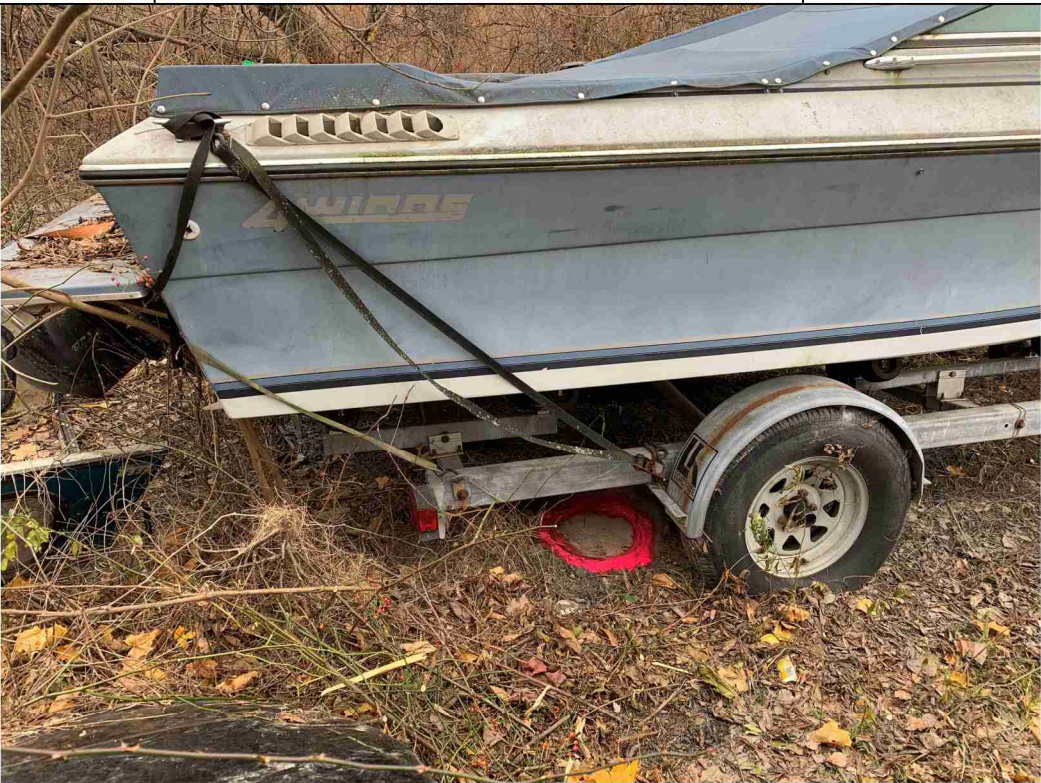
| <b>Photo No.</b><br>1 | <b>Date:</b><br>11/15/18 | | |

A metal detector was used to successfully locate MW-1D, which was covered by stones. The metal detector as well as the survey equipment was used to successfully locate MW-35I in the overgrown area on the car repair property. However a boat and a trailer were parked over it, making the well inaccessible for gauging. Well cover for MW-44I was identified, but there was no sign of well under it. Area around the empty cover was also scanned with the metal detector and the stones were moved in an attempt to locate the well, but MW-44I was not found. Damage to MW-44I was also recorded during the 2016 semi-annual visit and it was noted that the well cover was removed and the top of the well was covered with stone from the recent paving activities at the site. Pictures of the well MW-35I and empty well cover in the general area of MW-44I are included in the photo log (Attachment 1). Based on the observations and failed attempts to locate the well MW-44I, we would request for it to be considered abandoned, and be removed from the NAPL monitoring list.

| <b>Description:</b><br><br>View of MW-35I under the Boat | | | |

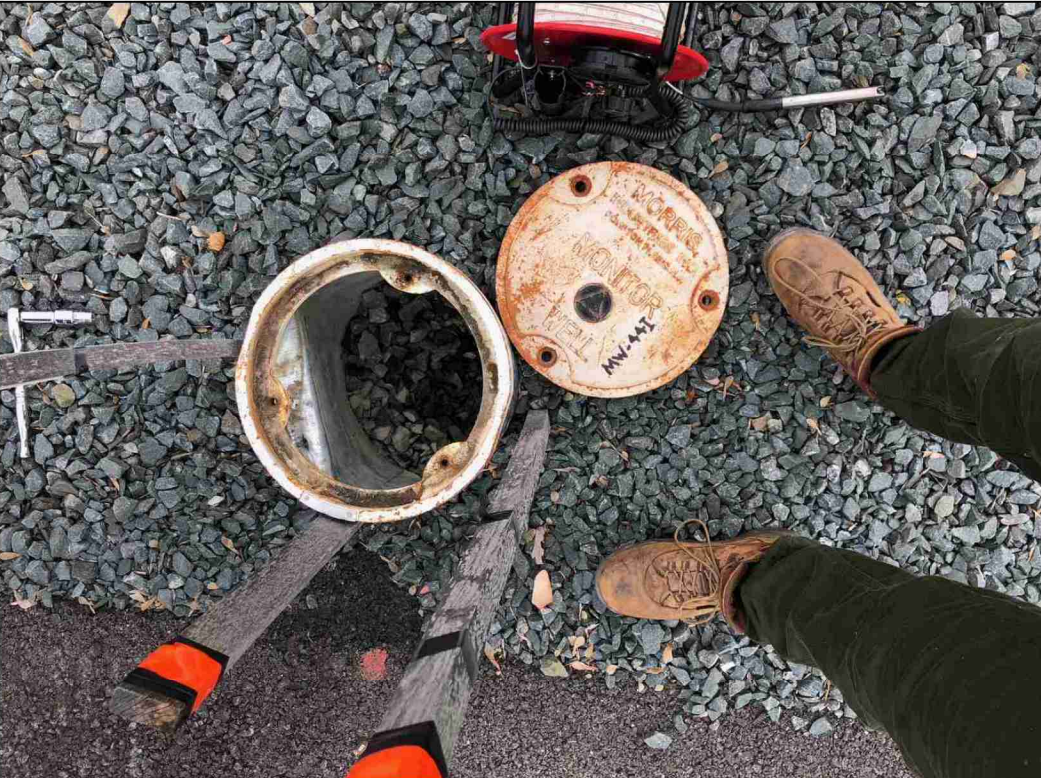
| <b>Photo No.</b><br>2 | <b>Date:</b><br>11/15/18 | |

| <b>Description:</b><br><br>View of MW-44I casing. | | |

| Item | Yes | No | N/A | Comments |
|---|---|---|---|---|
| Are the monitoring wells in good condition (e.g., covers, casings)? | X | | | Bolts on some wells were replaced. Some well covers have stripped threads, only cover was located for MW-44I, suspecting well damage |

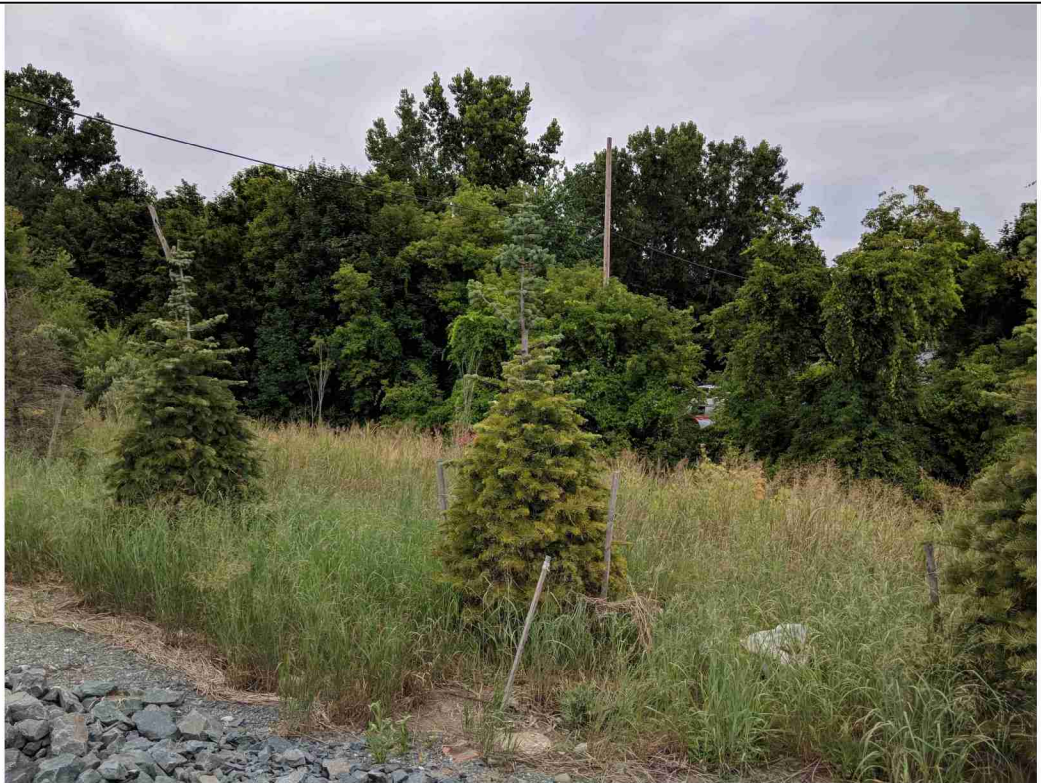
| <b>Photo No.</b><br>4 | <b>Date:</b><br>8/31/18 | |

An annual streambank analysis was completed during this site visit. The stream bank, with the exception of the rip rap area, appeared to be completely vegetated with grass and clover in good health. Photographs taken during the site inspection are included in Attachment 1.

| <b>Description:</b><br><br>View Streambank Vegetation | | |

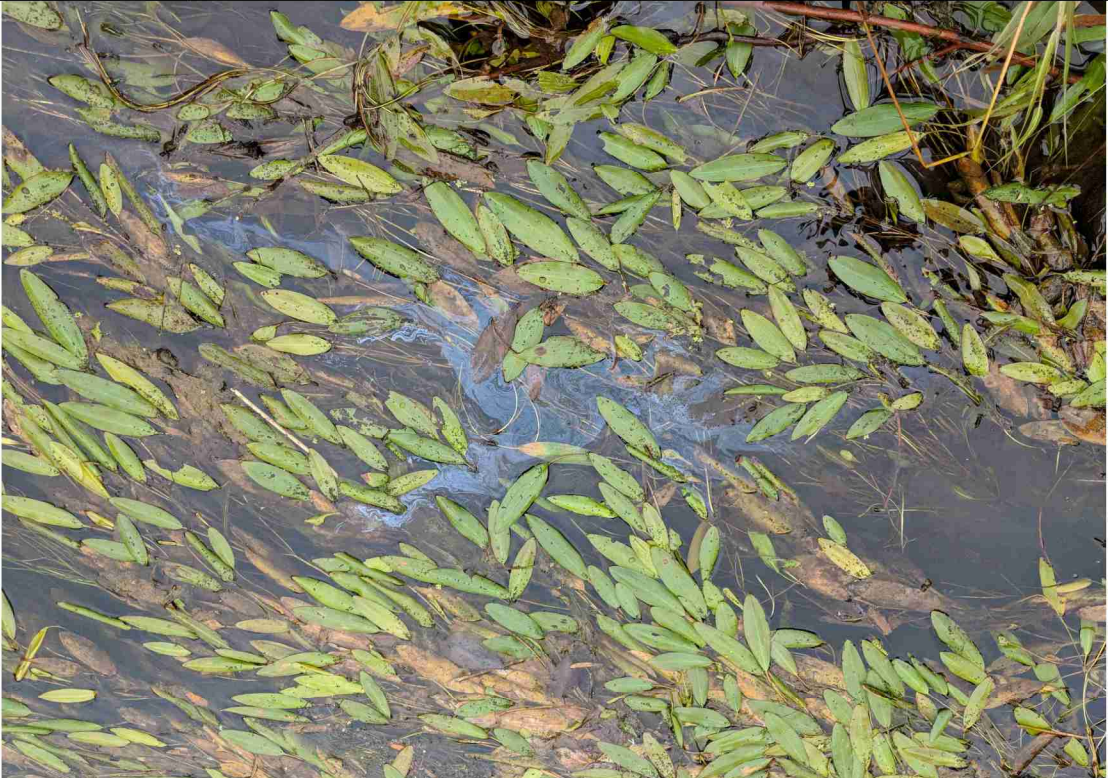
| <b>Photo No.</b><br>5 | <b>Date:</b><br>8/31/18 | A photograph of a stream with green aquatic plants and a blue bleb. | |

The Anthony Kill was observed for signs of visible NAPL blebs on August 31, 2018. No blebs were observed after one hour of monitoring. Following the observation period, existing sediments were probed with a stick near the stream bank in the area where sediment removal occurred during remedial activities. Upon probing of the stream sediment at the designated location, sheen appeared from the sediments in the vicinity of the probed area approximately one-three feet from the bank. Pictures of the blebs are included in the attached photo log (Attachment 1). Blebs continued to appear from the stream bed for approximately five minutes after the sediments were probed. After five minutes the blebs dissipated. The observations from the August 2018 event are consistent with past streamline and creek observation events. A summary of this site inspection and streambank observations are presented in Attachment 2.

| <b>Description:</b><br><br>NAPL bleb observed when stream sediments were probed. | | | |

| Observation after Probing | | Sheen and blebs were observed after probing. The sheen and blebs dissipated after 5 minutes. |
