From: [Raby, Tami](#)
To: [Spellman, John \(DEC\)](#)
Cc: [BLAZICEK, TRACY](#); [Saunders, Melissa](#); [Howard, Walter](#); [Au, Emily](#); [Floess, Carsten](#)
Subject: Mechanicville Central Avenue Former MGP Site - 2022 Annual Monitoring Report
Date: Wednesday, February 8, 2023 6:09:03 PM
Attachments: [Report.hw5460338.2023-02-08.NYSEGMechanicvilleCentralAve2022AnnualReport.pdf](#)

February 8, 2023

**Annual Monitoring Report 2022
Mechanicville Central Avenue Former MGP Site
Mechanicville, New York
NYSDEC Site: 5-46-033**

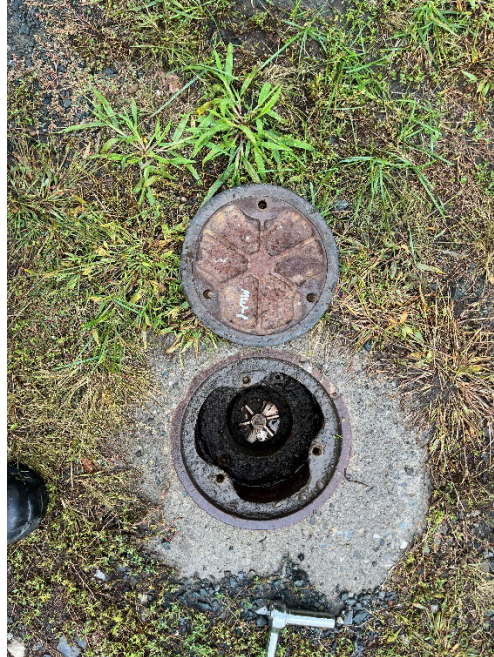
MW-1

Well is in good condition. Requires bolt replacement.

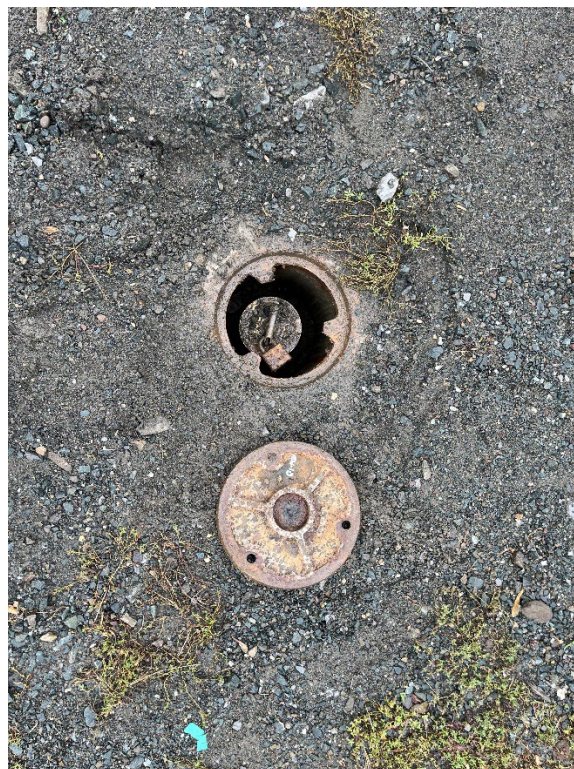
MW-1D

Well is in good condition. Needed to be dug out. Requires bolt replacement.

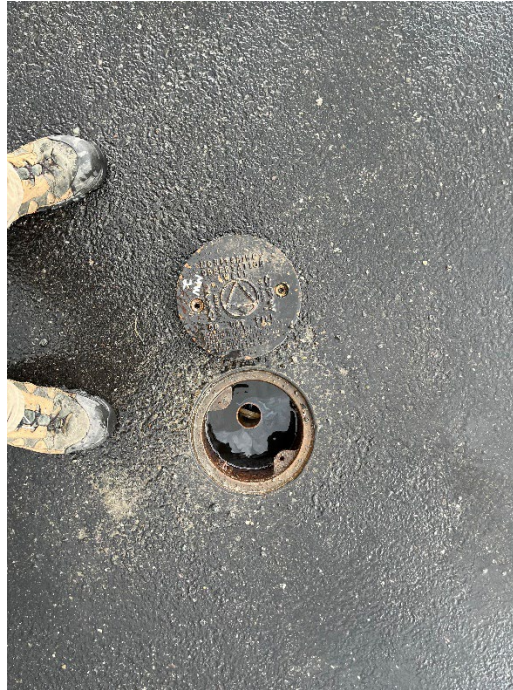
MW-2

Well is in poor condition. Requires J-Plug and bolt replacement.

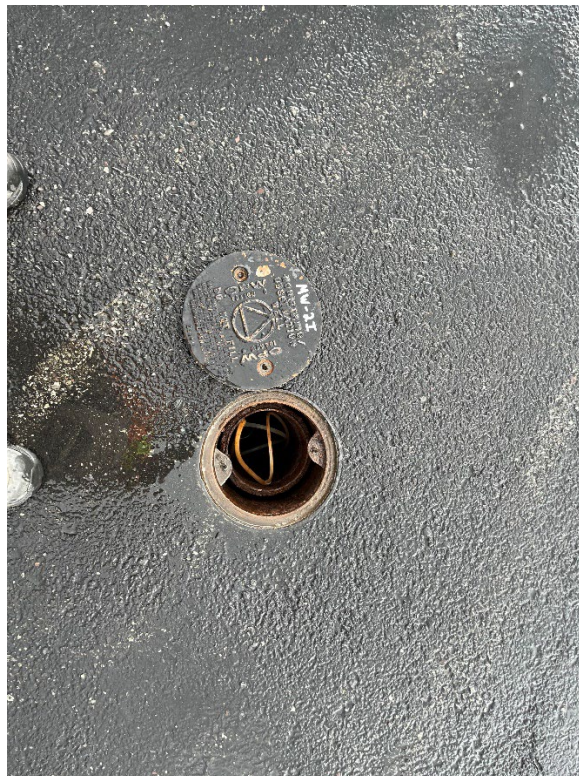
MW-2I

Well is in poor condition. Requires J-Plug and bolt replacement.

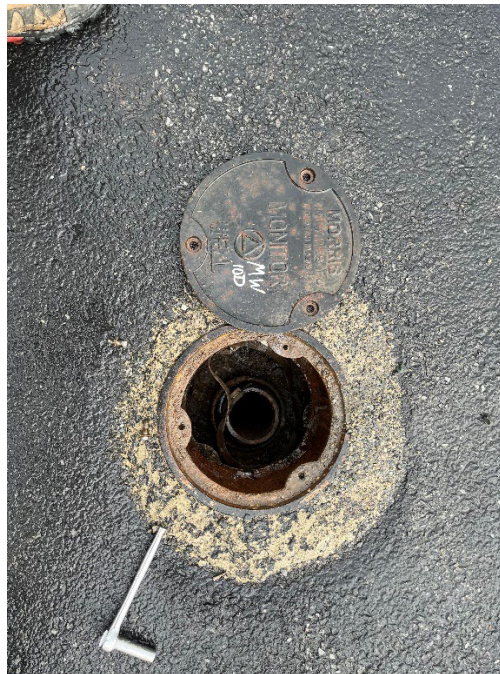
MW-10D

Well is in poor condition. Needs J-Plug and additional bolts.

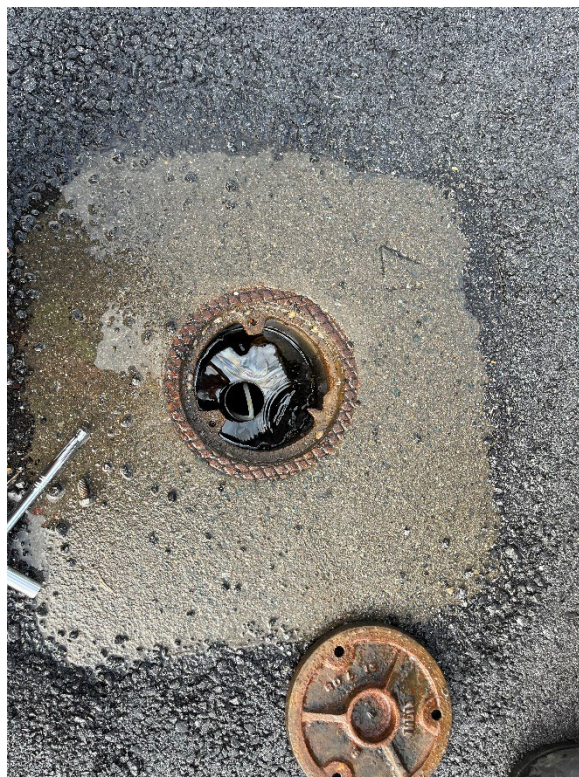
MW-17

Well is in poor condition. Needs J-Plug and bolts.

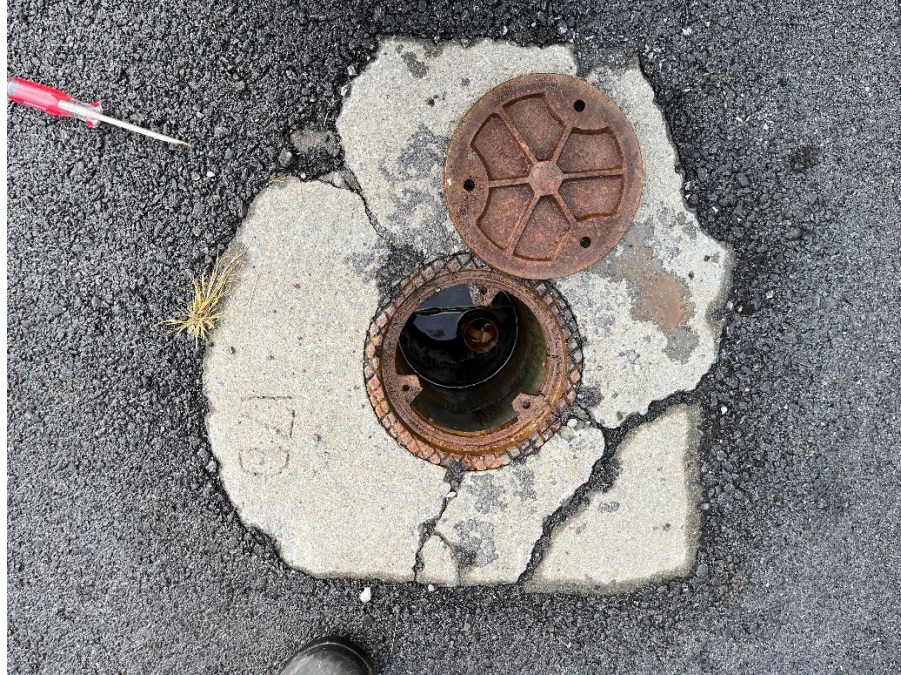
| Well ID | Date Gauged | Total Depth ¹ (ft bTOC) | Screen Interval/Open Hole ⁴ (ft bTOC) | Reference Elevation (TOC) | Depth to Water (ft bTOC) | Groundwater Elevation ⁵ | NAPL Observed (Y/N) | NAPL Thickness (ft) | Notes |
|---|---|---|---|---|---|---|---|---|---|
| MW-17D | 9/27/2022 | 139.04 | 121 - 142.5^ | 93.29 | 0.20 | 93.09* | N | 0" | Flooded. Flush mount top doesn't fit on casing. 2" PVC loose in 6" steel casing. No J-plug. No bolts. Well depth reduced from initial installation depth - requires rehabilitation (incl. pumping to remove sedimentation). |

Well is in poor condition. Flush mount does not fit. 2" PVC loose in casing. Flooded upon opening. No bolts. Recommend decommissioning.

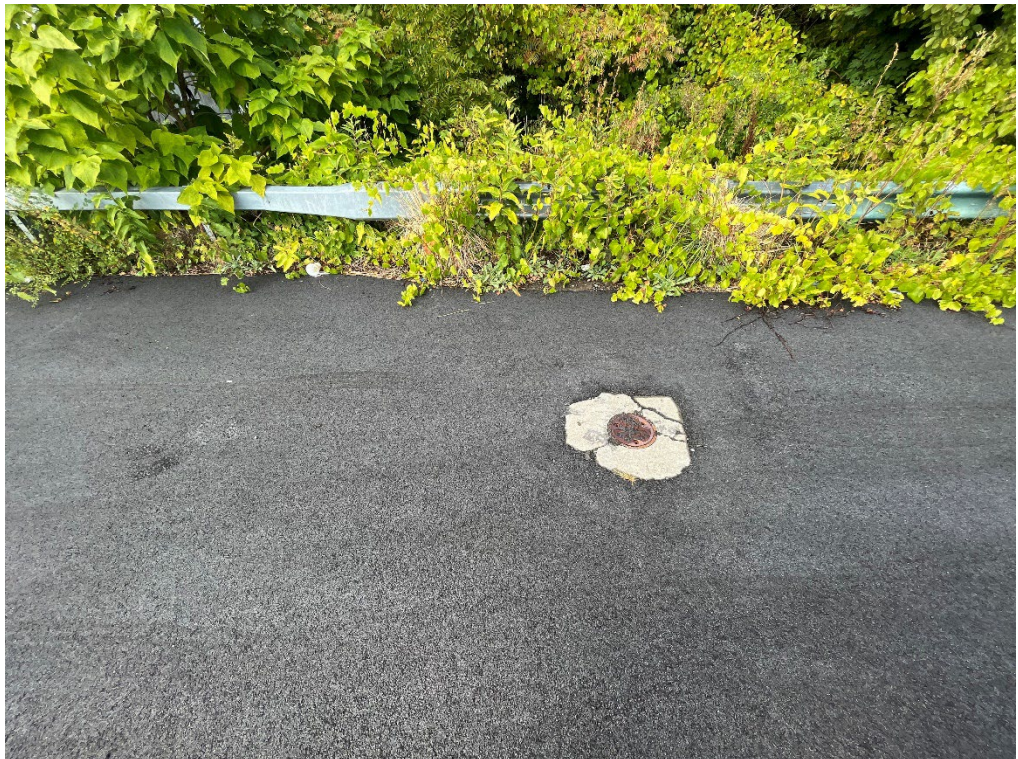
Former location of MW-17I adjacent to MW-17D. MW-17I has been paved over and is no longer accessible.

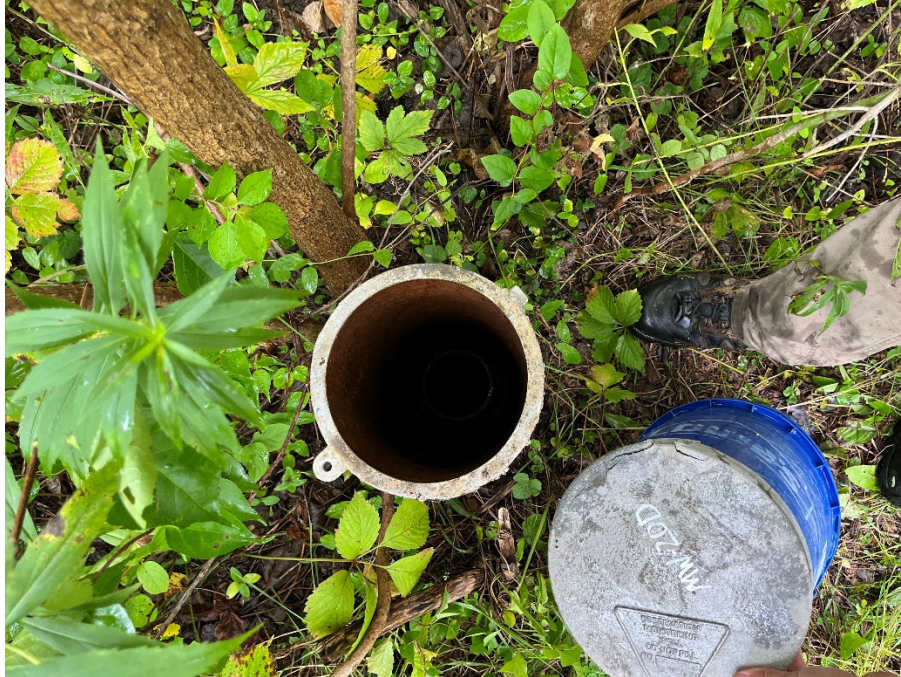
MW-20D

Well is in poor condition. Requires proper well cap.

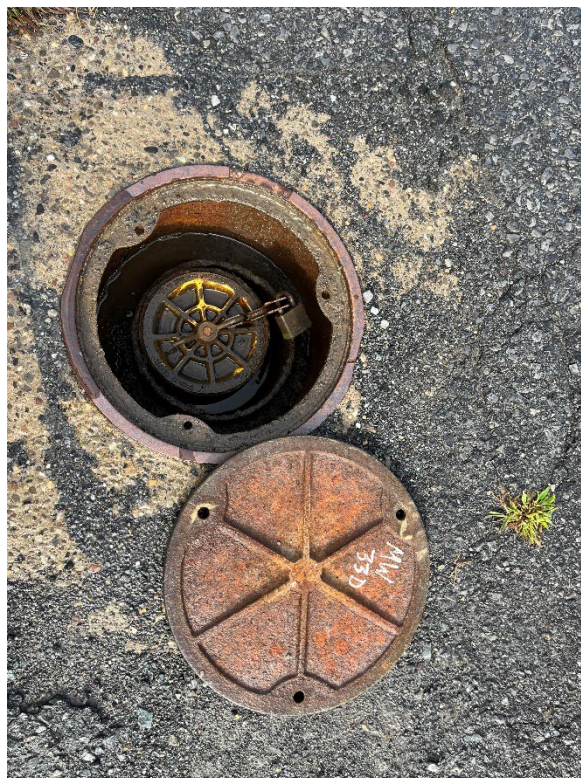
MW-33D

Well is in good condition. Needs additional bolts.

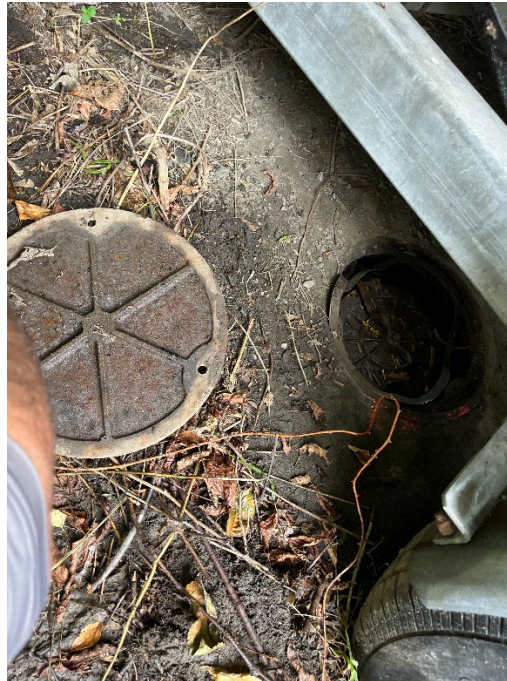
MW-35I

Well is in good condition. Needs additional bolts.

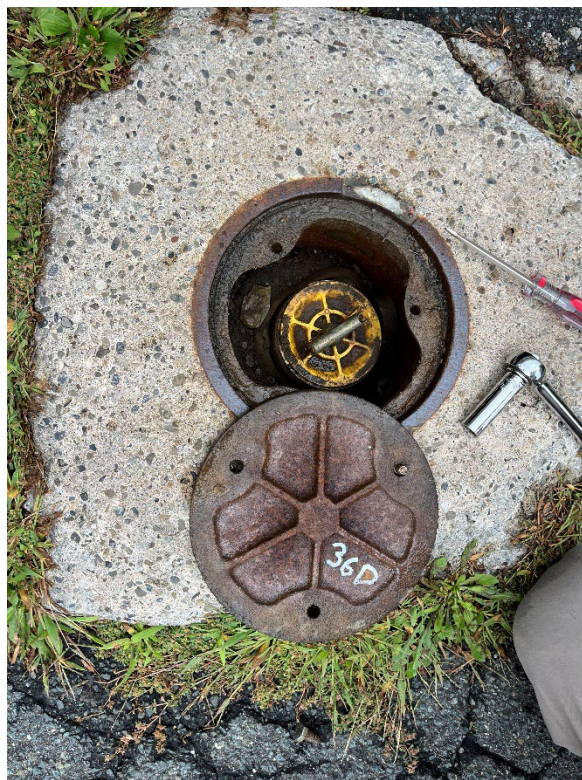
MW-36D

Well is in good condition. Needs additional bolts.

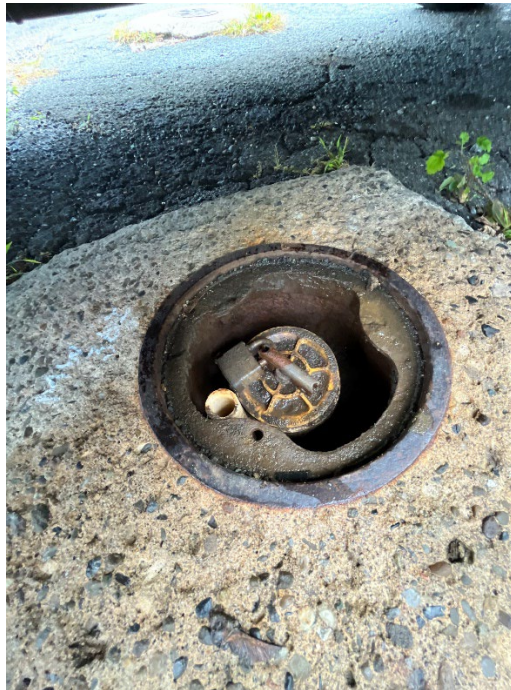
MW-36I

Well is in good condition. Needs additional bolts.

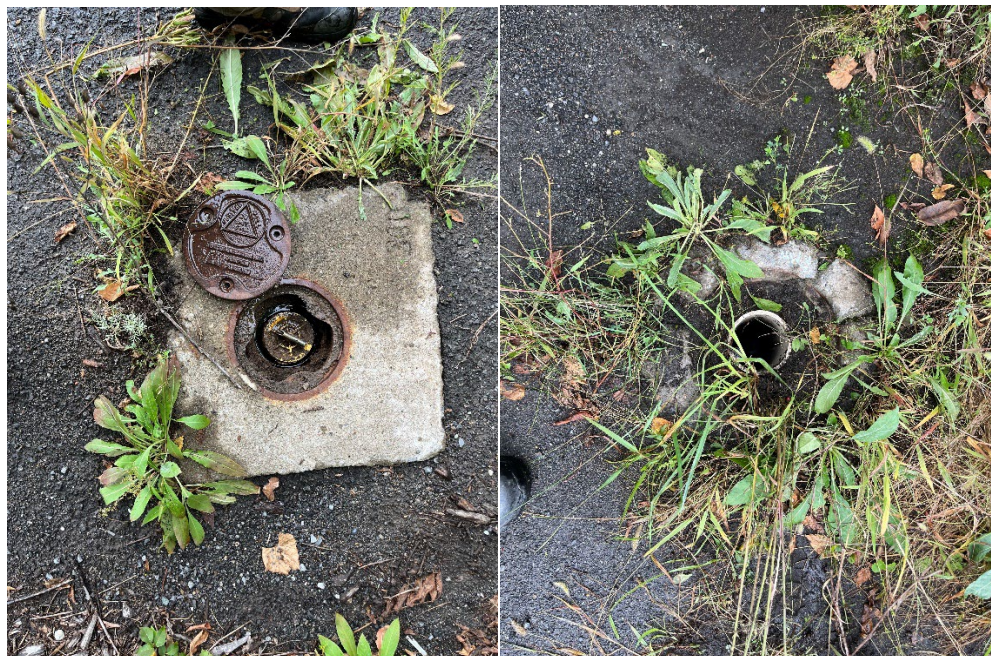
MW-38I: Poor condition. No casing cover or J plug on PVC.

MW-38D: Well is in good condition. Needs additional bolts.

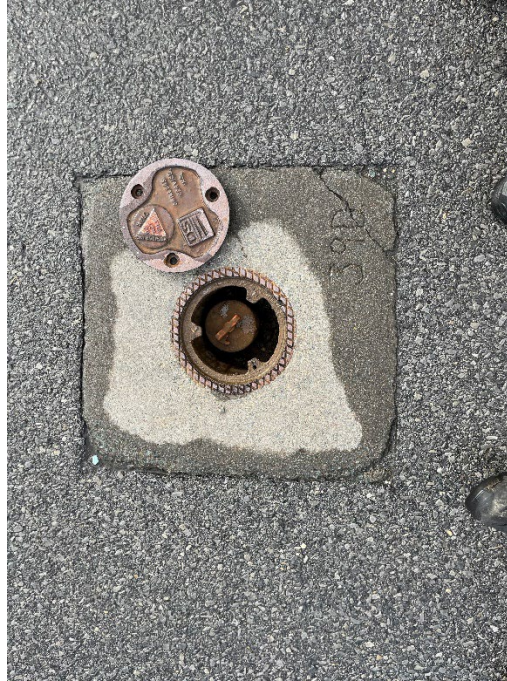
MW-39D

Well is good condition.
Requires additional bolts.

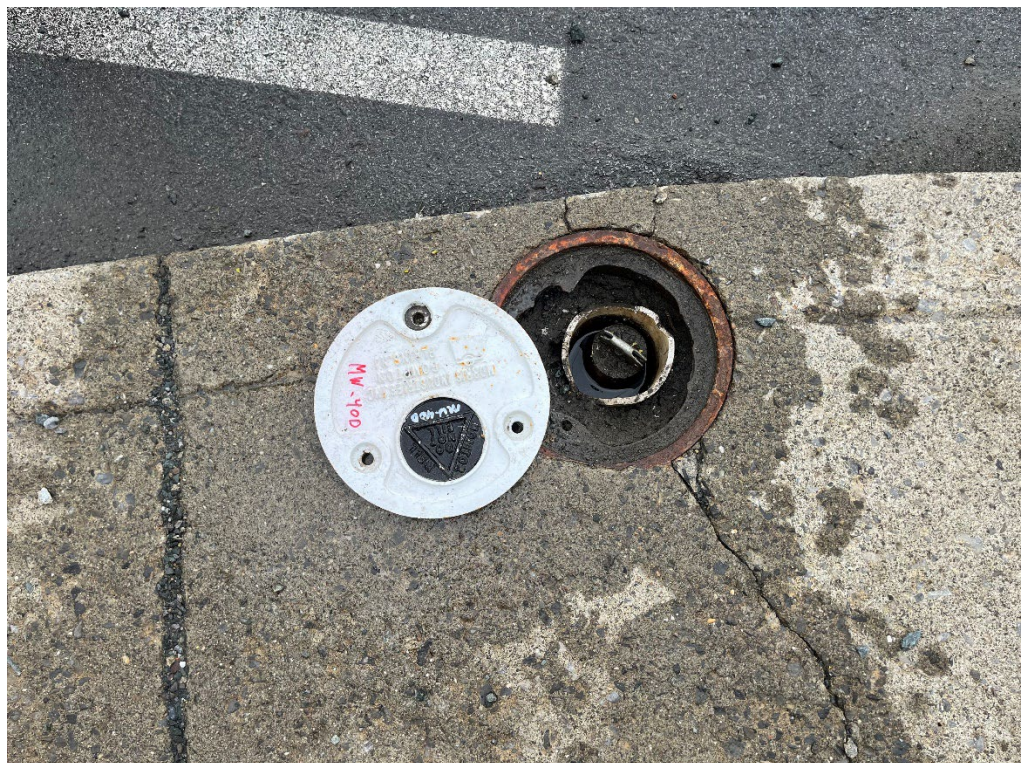
MW-40D

Well is in poor condition. Road box needs to be replaced.

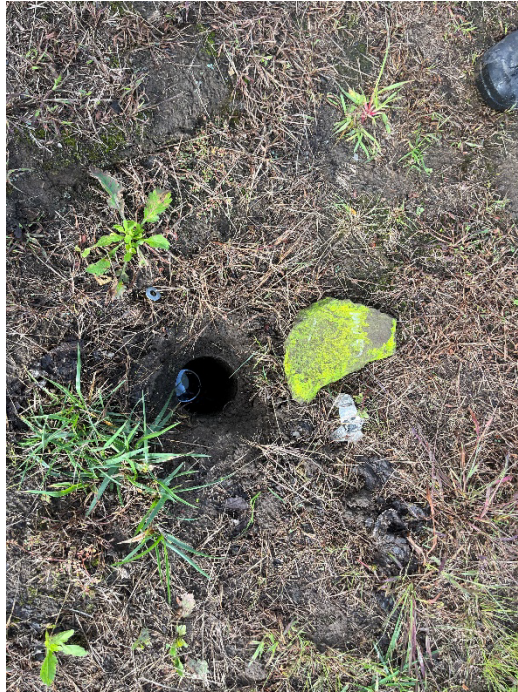
MW-42D

Well is in poor condition. Well needs road box and possibly redevelopment or replacement.

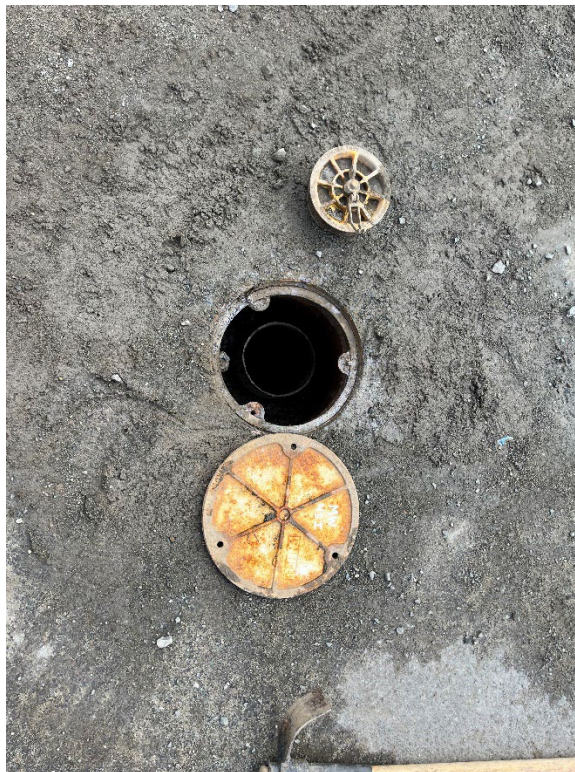
MW-45I

Well is in poor condition. Only accessible by removing entire casing cover.

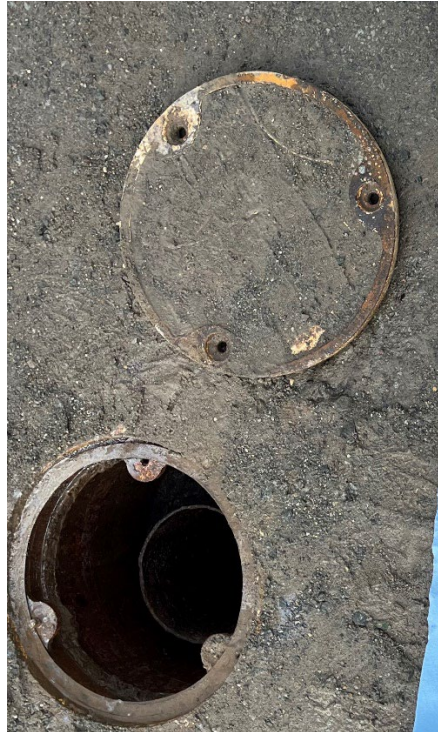
TW-1

Well is in poor condition. Needs J-Plug and bolts.

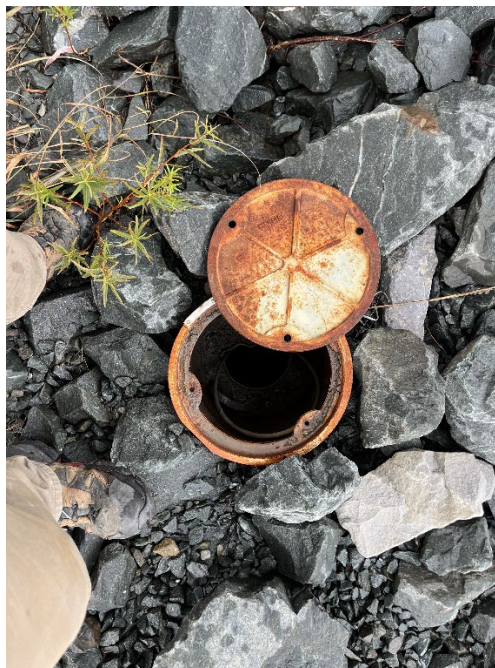
TW-2S

Well is in poor condition. Needs J-Plug and additional bolts.
