May 11, 2023

**Subject: Groundwater Monitoring Well Network Review, Mechanicville Central Avenue Former Manufactured Gas Plant Site (NYSDEC Site: 546033)**

**Attachment B Groundwater Monitoring Well Network Review**

## **Attachment C 2021 and 2022 Photologs**

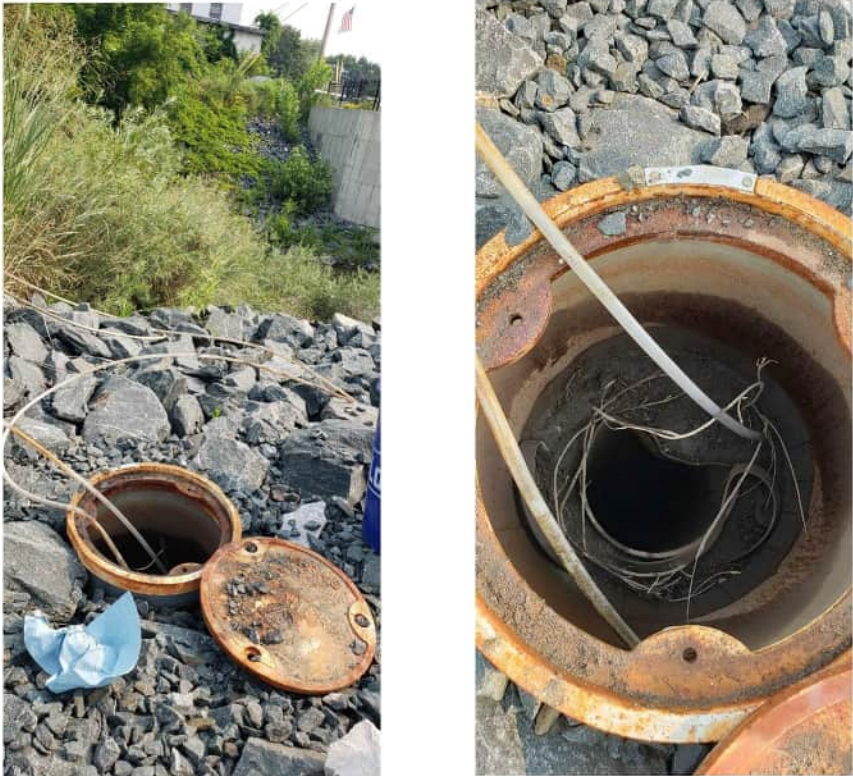
<b>Client Name:</b> NYSEG Mechanicville Former MGP Site		<b>Site Location:</b> Mechanicville, New York	<b>Project No.</b> 60675881
<b>Photo No.</b> 1	<b>Date:</b> 07/26/21

Well ID	Observation
TW-2S	The 6" steel casing is bent and can't take a J-plug (refer to July 2021 Photo 1, <b>Attachment C</b> ). The well cap is labelled "TW-2I" which based on the depth gauged and its location is likely incorrect (should be TW-2S).
TW-2I	Unable to be located. Suspected to be buried under rip rap (refer July 2021 Photo 41, <b>Attachment C</b> ).
MW-10	The PVC casing is damaged at approximately 6.9 feet below surface. Depth to water and bottom of well cannot be obtained (refer July 2021 Photo 7, <b>Attachment C</b> ).
MW-17I	Unable to be located. Suspected to be paved over (refer September 2022 Photo 8, <b>Attachment C</b> ).
MW-17D	The original steel well casing and open bedrock section was apparently "sleeved" in the past with a 2" PVC well. The PVC casing is loose (unsealed) and extends above the 6" steel casing so the annulus cannot be sealed. Additionally, the curb box cover does not sit flush and can't be bolted (refer September 2022 Photos 7 and 8, <b>Attachment C</b> ).

<b>Direction Photo Taken:</b>  West			
<b>Description:</b>  View of TW-2S.

- Rehabilitate damaged or potentially compromised wells including:
  - TW-2S: Sleeve with 2" PVC well with screen and sand-pack spanning open hole interval and seal/grout annulus to surface.

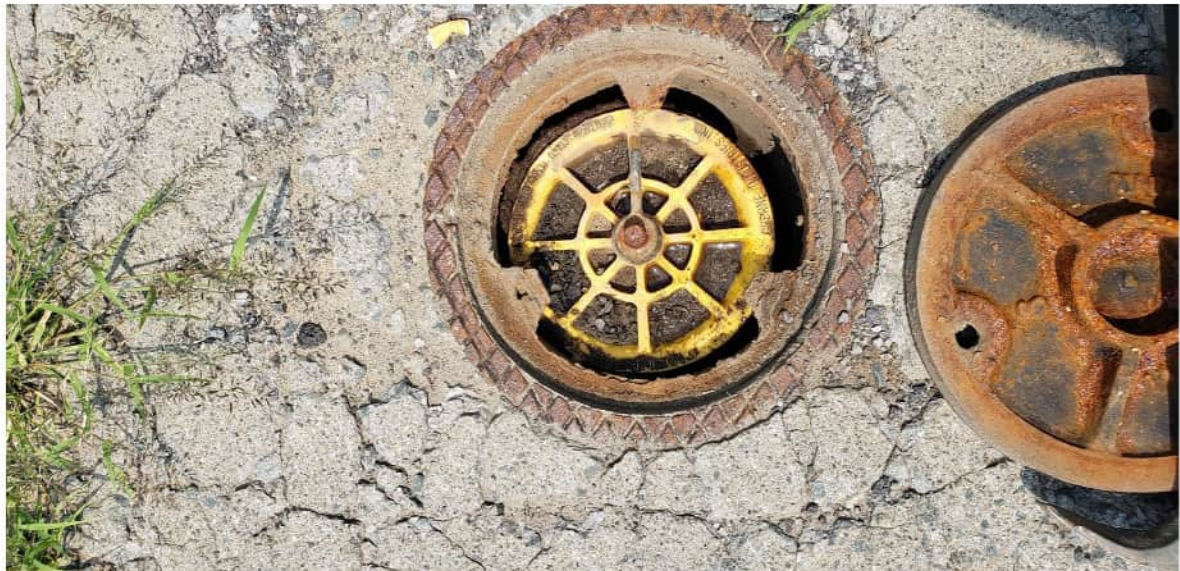
MW-18	Curb box lid (cover and ring) has separated from box skirt. It is possible to remove entire casing cover (refer July 2021 Photo 18, <b>Attachment C</b> ).
MW-38I	Damaged curb box without cover (refer July 2021 Photo 34, <b>Attachment C</b> ).
MW-40D	The curb box and PVC casing are damaged, and the concrete sidewalk section is fractured because of the curb box located near the sidewalk edge (refer September 2022, <b>Attachment C</b> ).
MW-42D	Missing entire curb box (refer September 2022 Photo 17, <b>Attachment C</b> ). Monitoring well remains an uncovered hole covered by rocks.
MW-45I	Damaged curb box (refer September 2022 Photo 18, <b>Attachment C</b> ).
MW-46I	Top of well casing is buried under approximately 15 inches of gravel and was noted to be blocked at 6 inches below the top of the well casing (refer August 2021 Photo 48, <b>Attachment C</b> ). Top of well casing is covered with a NYSEG gas valve box.

<b>Client Name:</b> NYSEG Mechanicville Former MGP Site		<b>Site Location:</b> Mechanicville, New York	<b>Project No.</b> 60675881
<b>Photo No.</b> 17	<b>Date:</b> 07/26/21	 	
<b>Direction Photo Taken:</b>  Downward			
<b>Description:</b>  View of MW-17D.			
<b>Photo No.</b> 18	<b>Date:</b> 07/26/21	 	
<b>Direction Photo Taken:</b>  Downward			
<b>Description:</b>  View of MW-18.

- Shallow bedrock well MW-18 has a damaged road box, has ~4 ft. of sediment accumulation and is not used for monitoring. This well should be decommissioned.

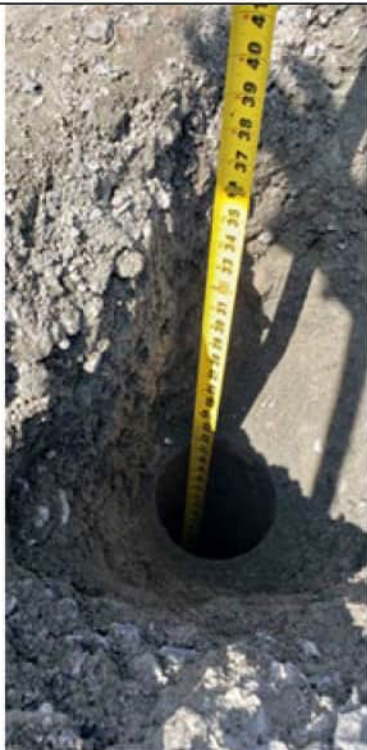
<b>Direction Photo Taken:</b> Downward -			
<b>Description:</b>  View of steel 6" steel casing in appx. location of MW-46I. Steel casing ~15" below grade.

- MW-46I: Drill out blockage from casing/borehole to original well depth (75 ft. bgs) and redevelop. Extend casing to surface and install new curb box. If attempts to rehabilitate fail, decommission well (grout to surface) and replace monitoring location with well TW-4.

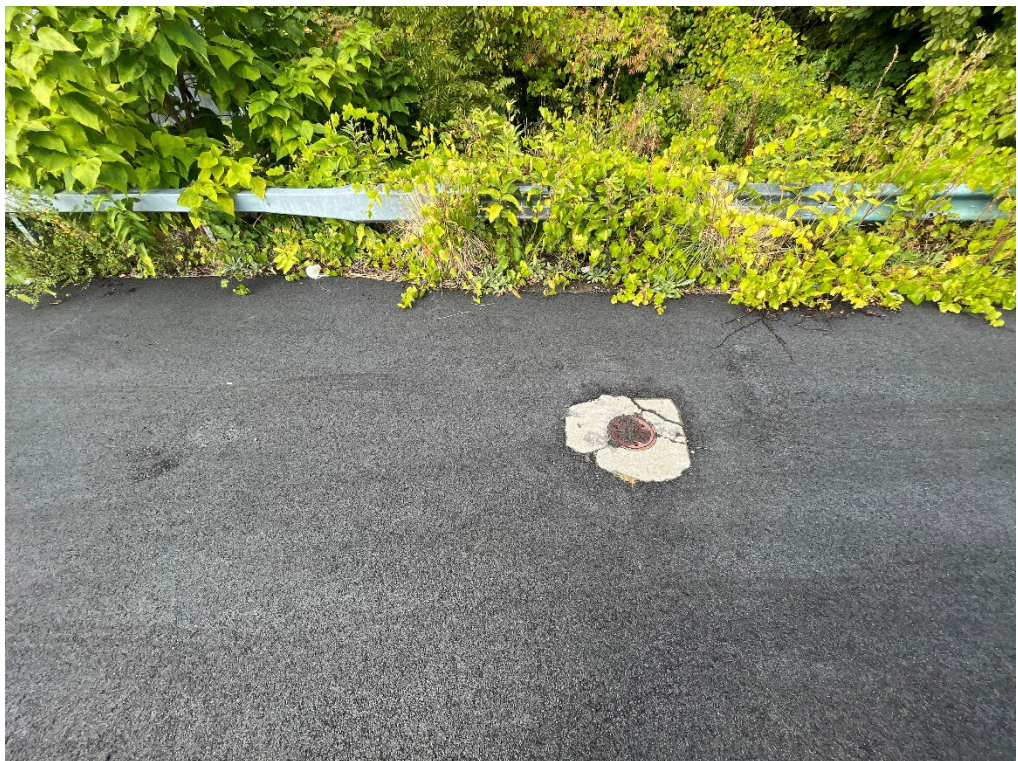
**Photograph No. 8**

MW-17I	9/27/2022	45.00	--	23 - 45^	--	--	NA	Well has been paved over.	Based on the location and depth of this downgradient well, attempts should be made to reclaim it and maintain it for SMP GW monitoring. Use a metal detector to locate the road box. Saw cut pavement if needed and dig up/expose road box. Install new road box flush with pavement. Redevelop well if necessary.
	MW-17D	9/27/2022	142.5	139.04	121 - 142.5^	N	0"	N	Curb box lid does not fit and curb box is flooded. Concrete collar is fractured. Interior 2" PVC casing is loose. This is presumed a retro-fitted PVC well with no sandpack or seals inside the open borehole, since it's not shown on the original well construction log. The 6" steel casing is 1' below the 2" PVC so can't be sealed leaving well open to surface impact.	Based on the location and depth of this downgradient well, attempts should be made to reclaim it and maintain it for SMP GW monitoring. Recommend removing the PVC well, redeveloping the entire open hole and re-installing a PVC well with sand pack and grout seal. Also replace road box and concrete collar.

View of MW-17D. The small dark depression in the asphalt to left is MW-17I (paved over).

- MW-17I: Remove over-pavement, replace curb box flush with asphalt pavement surface and redevelop, if needed.
  - MW-17D: Replace inner 2" PVC well and complete installation with sand-pack and grout seal to surface.
