Re: 2024 Annual Monitoring Report
NYSEG - Mechanicville Central Ave. MGP
Central Avenue, Mechanicville
Saratoga County
Site No.: 546033

Re: NYSEG Mechanicville Central Avenue MGP Site
2024 Annual Monitoring Report

Mechanicville Central Avenue Former MGP
NYSDEC Site No. 546003
2021 PRR & 2023 MW Rehabilitation Recommendation Checklist
For Report:
2024 Annual Monitoring Report prepared by Arcadis

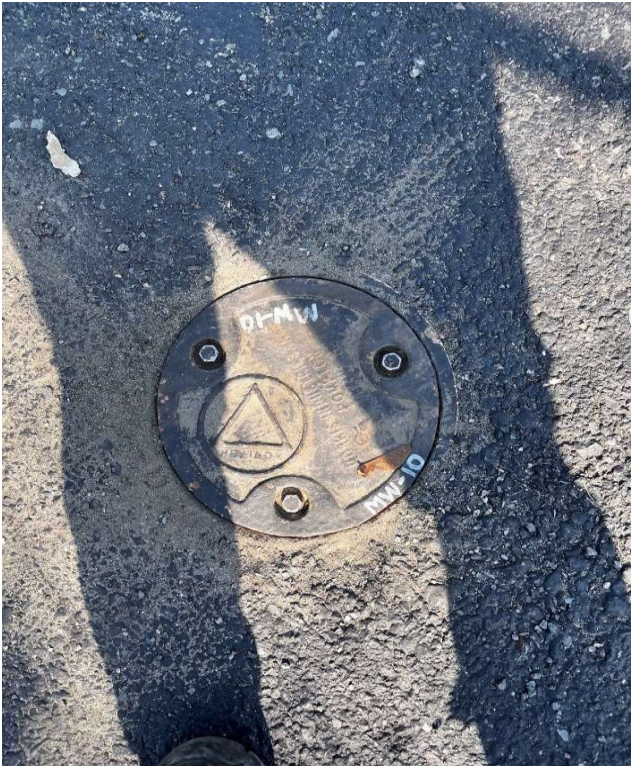
- Arcadis add an additional recommendation to the 2024 AMR stating that MW-10 (obstructed well) should be decommissioned. The following supports this suggestion.
 - The obstruction in MW-10 has been noted since 2021.
 - MW-10 is not included in the NAPL or Groundwater Monitoring Programs; the well is only used for water level gauging and has been recorded as “dry” due to the obstruction since 2021.
 - 2024 attempts by Arcadis to remove the obstruction were unsuccessful.

- MW-10 has an obstruction at approximately seven feet below ground surface.
- MW-13, MW-30S, MW-30D, and MW-32D were missing locks.
- MW-29IR has a cracked J-plug.

Date: 10/7/2024	
Direction Photo Taken: Downward Description: MW-10

- Ramboll recommends that Arcadis add an additional recommendation to the 2024 Annual Monitoring Report to decommission MW-10 for NYSDEC consideration.

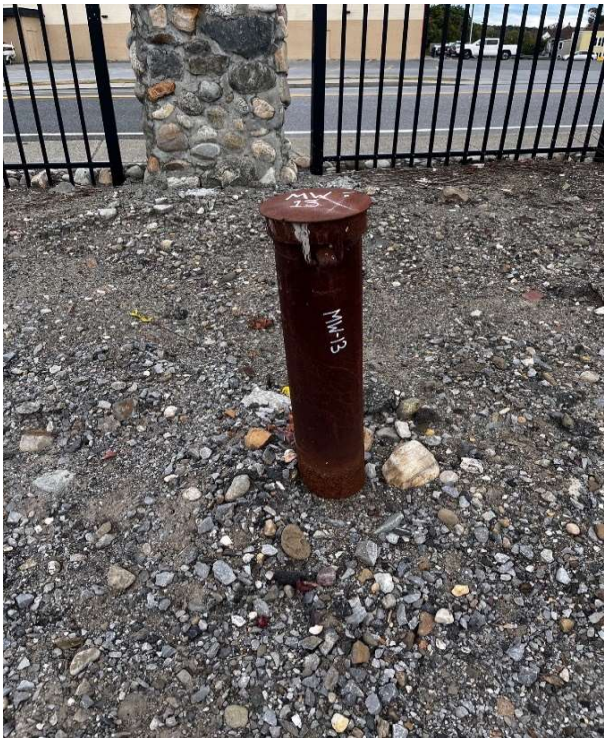
Date:	
Direction Photo Taken: East Description: MW-13

- Discontinue annual streambank monitoring as the conditions and schedule contained in the SMP have been met.
- Replace padlocks, J-plugs, and other materials for all wells where the materials were found to be missing in Spring, 2025.

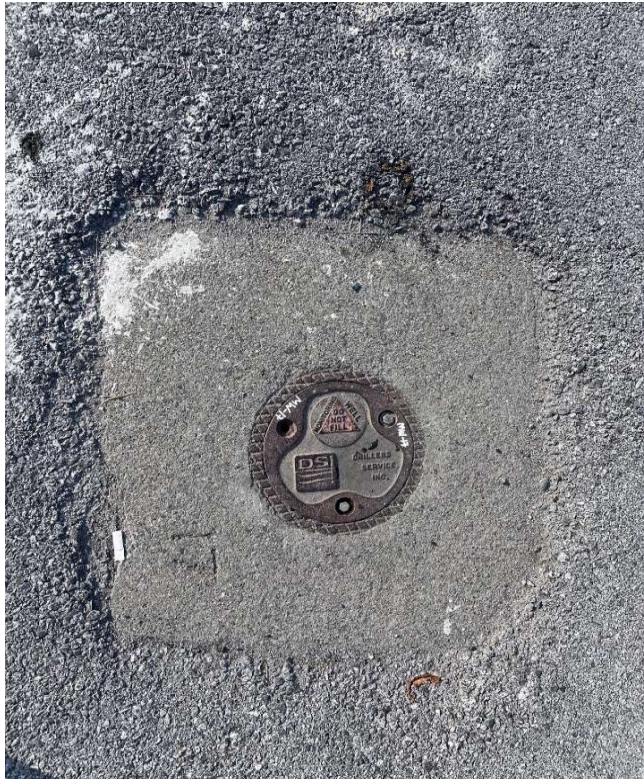
- MW-17 had one broken eyelet.
- MW-20D was missing a J-plug.
- MW-39D had two broken bolt holes.

Date: 10/7/2024	
Direction Photo Taken: Downward Description: MW-17

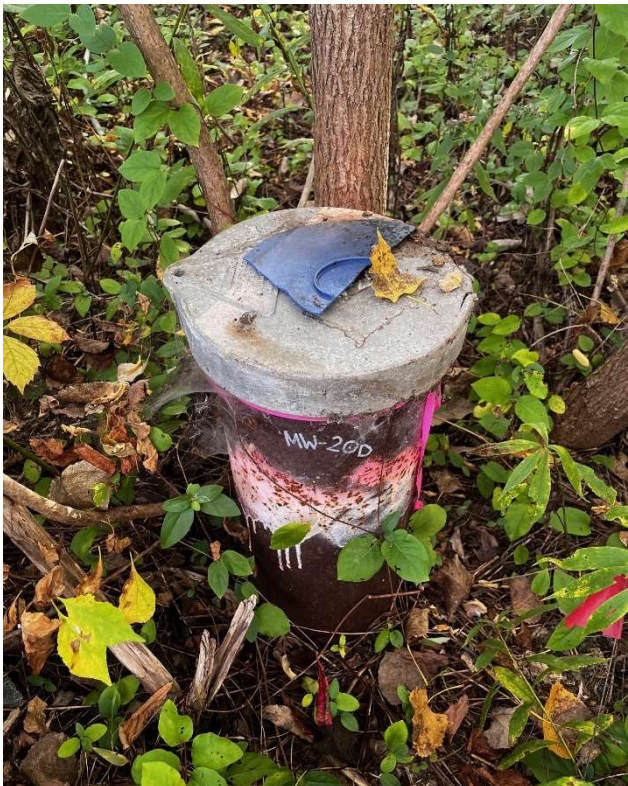
Date: 10/7/2024	
Direction Photo Taken: Downward Description: MW-20D

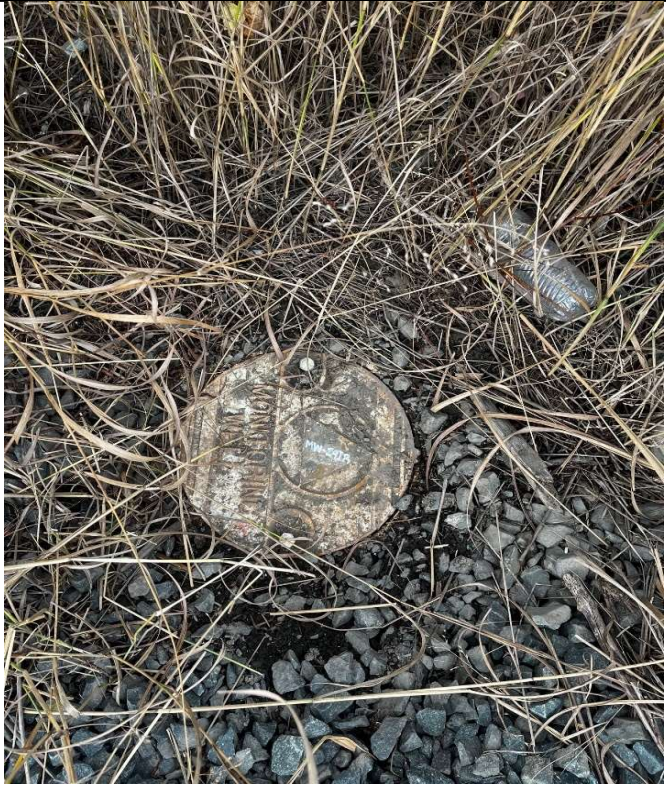
Date: 10/7/2024	
Direction Photo Taken: Downward	
Description: MW-29IR

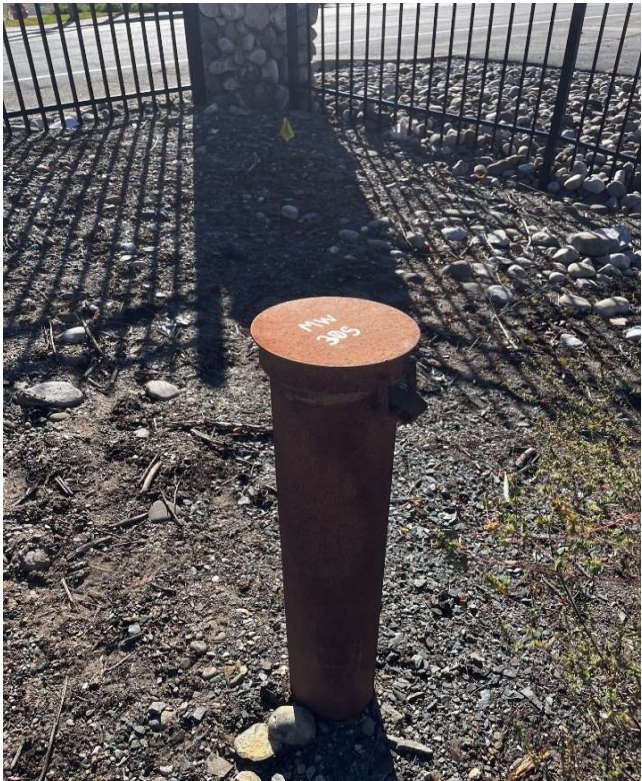
Date: 10/7/2024	
Direction Photo Taken: Downward Description: MW-30S

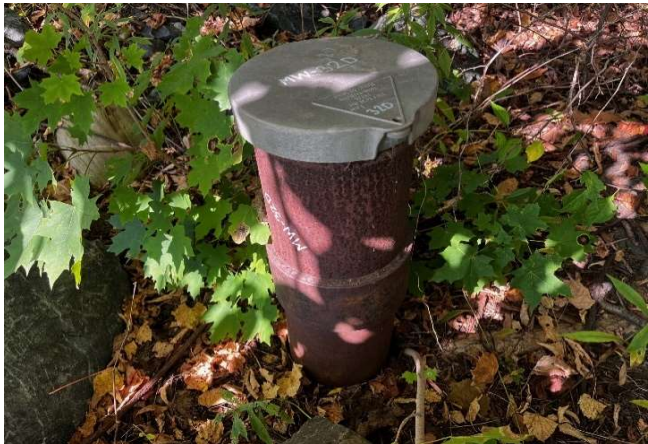
Date: 10/7/2024	
Direction Photo Taken: Downward Description: MW-32D

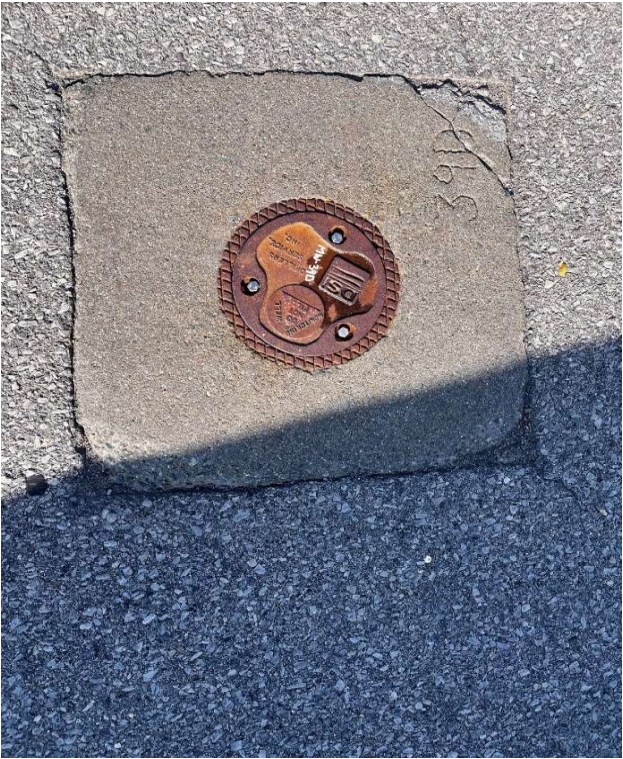
Date: 10/7/2024			
Direction Photo Taken: Downward			
Description: MW-39D
