Removal and Encapsulation of PCB-Contaminated Hudson River Bed Materials

**For New York State Departments of Transportation
and Environmental Conservation**

PCB ENCAPSULATION SITE

REMOVAL AND DISPOSAL OF PCB-CONTAMINATED
RIVER BED MATERIALS

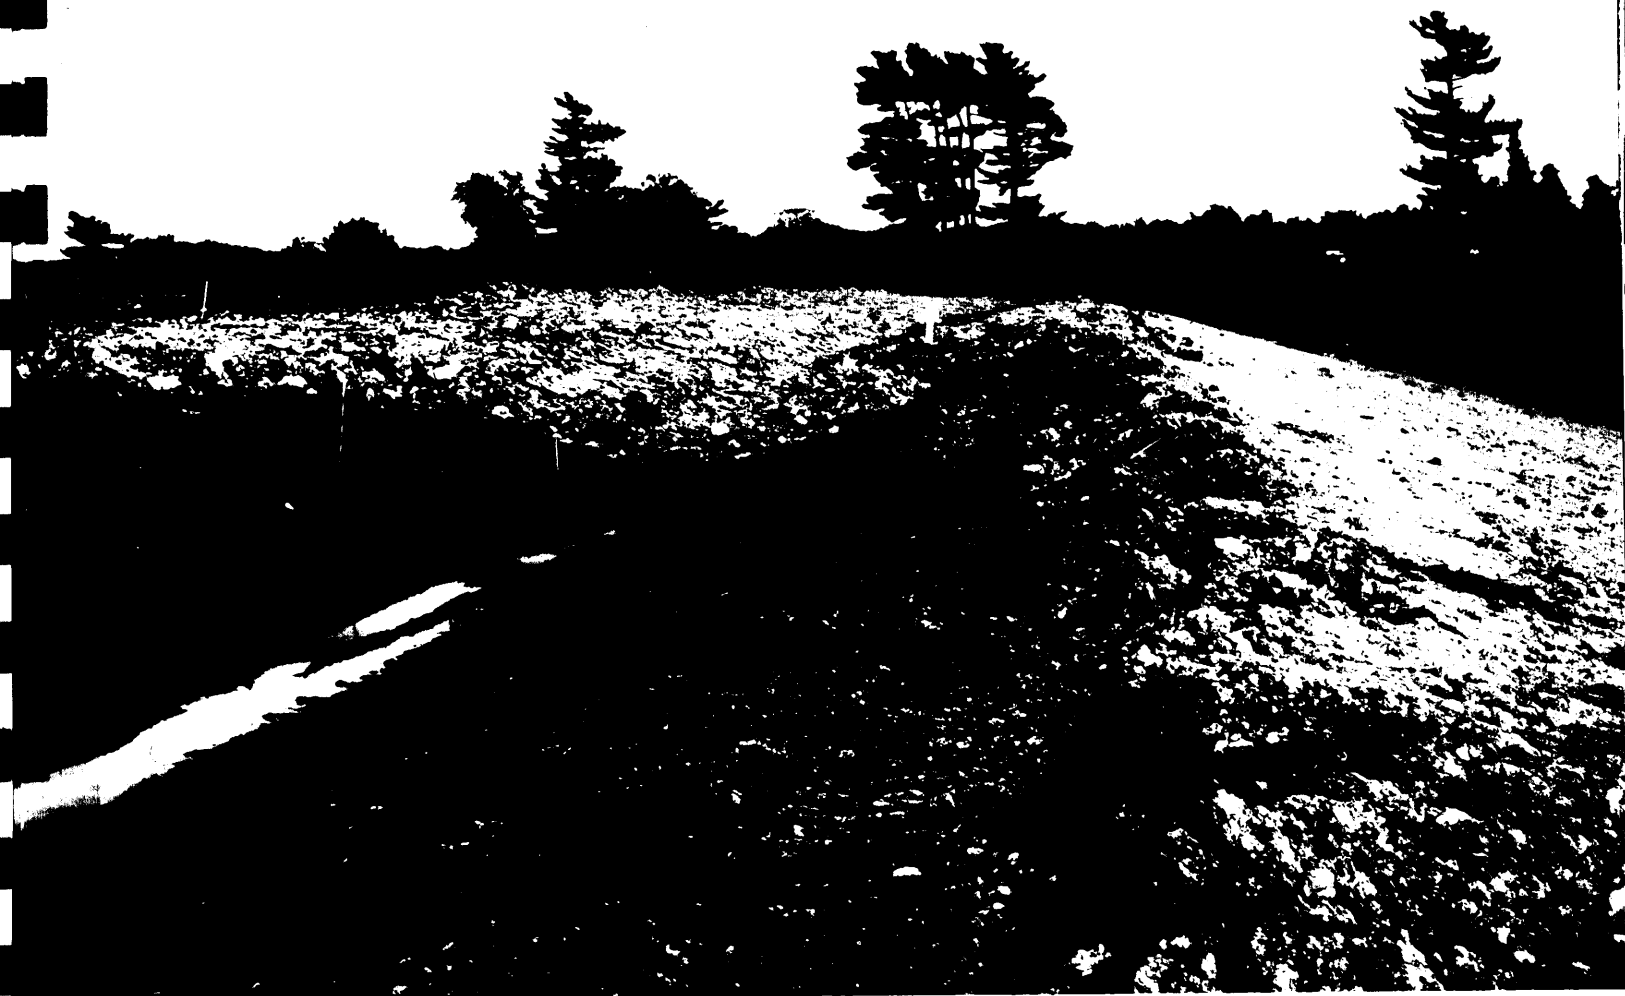
PCB ENCAPSULATION SITE

Placement of an 18-inch thickness of clay cover on top of contaminated material at final grade; typical depths of dredged material varied from 15 to 25 ft.

Standing water (left foreground) is evidence of 8 million gallons of water that had accumulated to a depth of 13 ft over the clay liner. This water accumulation occurred due to the site's over-winter exposure to 66 inches of precipitation on the surface of the fill prior to placement of the clay cover. A final dressing of 12 inches of soil was placed over the clay cover.

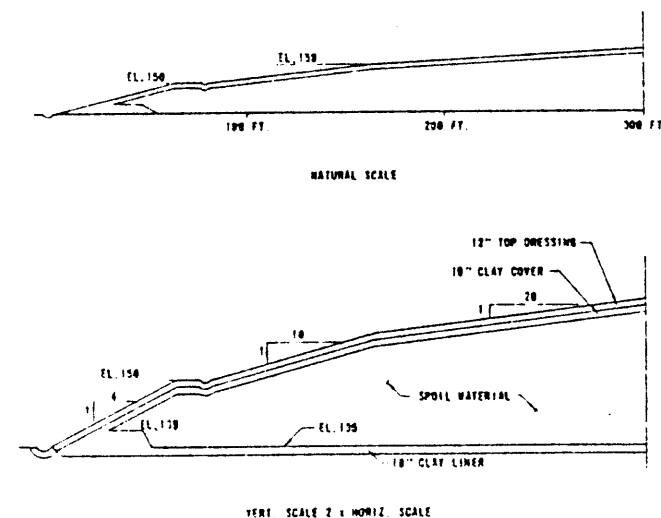
FIG. 2 TYPICAL SECTIONS — MOREAU SITE

Because of the variety of subsurface deposits, it was determined to cover the entire bottom with an 18-inch thick layer of compacted clay, which has a hydraulic conductivity on the order of 1×10^{-6} cm/sec (specified), to 1×10^{-7} cm/sec (measured). Before the liner was placed, the site surface was drained, organic material was removed, and a 4-ft high interior clay dike was constructed along the southerly and easterly perimeters (Plate III). The northerly and westerly perimeters of the site were established on existing debris from previous channel dredging programs.

The clay liner was extended up the existing slope to provide a barrier to migration from the existing deposits, and an exterior trench drain of crushed stone and perforated pipe wrapped in filter cloth was installed to intercept ground water flow. The side slopes of the disposal site had a maximum horizontal:vertical slope of 4:1 (Figure 2). A system of paved surface drains was provided to intercept surface runoff (Plate IV) and an 18-inch thick clay cover was placed over the deposited debris. The final slope dressing consisted of 12 inches of material suitable for turf establishment, followed by seeding and mulching. The permeability of the compacted clay liner was determined by infiltrometer.

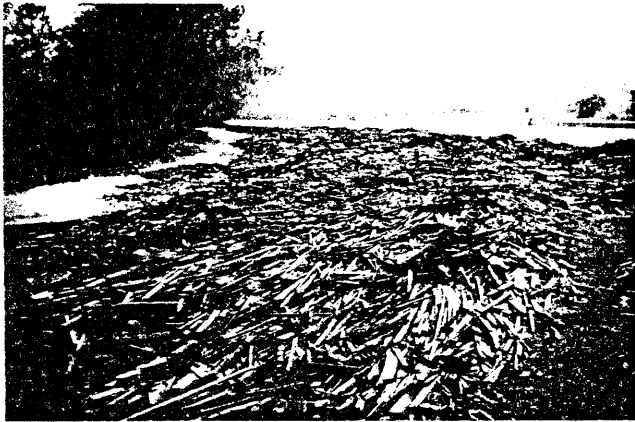
In April 1976 a flood with an approximate recurrence of 100 years occurred. This event caused the scour of an additional 250,000 cu yd from unprotected areas of the former pool. Deposits in the Fort Edward Terminal Channel (Plate I) as a result of the April 1976 flood averaged 20 ug/g PCB, a relatively low level because the material had been scoured primarily from the less contaminated western bank.⁽²⁾

PLATE I. Debris blocking Terminal (East) Channel, Fort Edward, N.Y.: a view looking upstream.

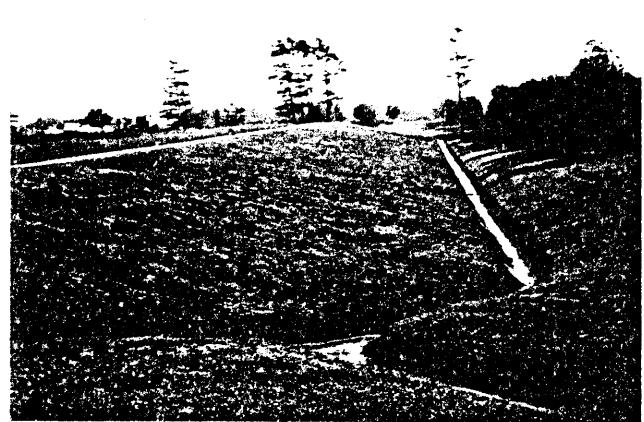
PLATE IV. Completed side slopes with asphaltic concrete paved drains.

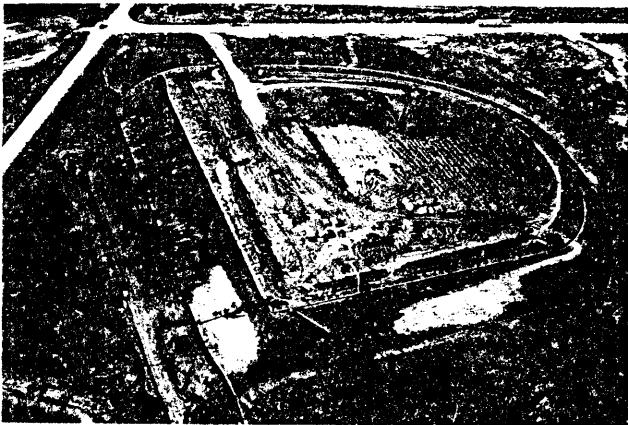
During the period when the site was exposed (August 1977 - November 1978), precipitation measured 66.5 inches, a value some 30 percent above normal for that period. A buildup of water over the interior clay dikes caused surface slumping of the finished clay cover in two areas on the 4:1 slopes. Repair of the slope required that the site be partially dewatered.

PLATE II. Moreau Disposal Site, Fall 1978, showing placement of material from Area 3A, prior to placement of clay cover. Light areas on 4:1 slopes in foreground are slope repair areas.

Alternative measures for dewatering the site were evaluated during August 1978 and dewatering was begun in September. The program selected was the installation of a well point dewatering system which permitted the immediate removal of water at the easterly and southerly perimeter of the fill. The well points allowed early repair of the slope area and made it possible to construct a trench drain in the vicinity of the slope repair areas.

At the end of November 1978 the clay cover was in place, slope repairs were completed, and the well point system had been removed. Some 1.1 million gallons of water had been moved for a net drawdown of 3 ft. The installation of the final clay cover and turf establishment material was completed December 20, 1978. Water removal continued through the winter and spring by means of a one-inch diameter siphon hose with flows of 3 to 7 gpm.

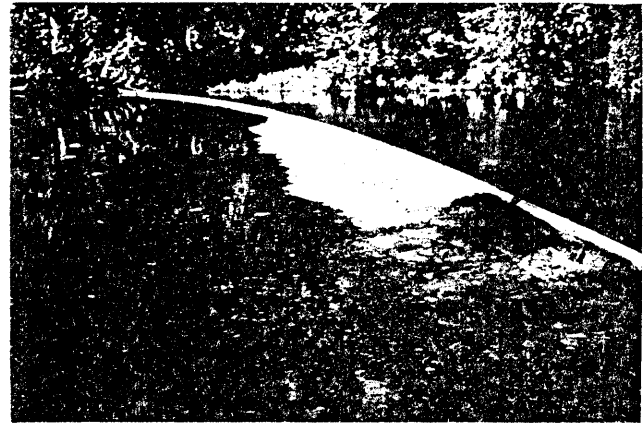
During dredging the agitation of the bed deposits by the dragline excavation generated an oily floating scum which drifted away from the area being excavated. To resolve this problem a conventional oil boom (Plate V) was deployed, trapping the scum, which was removed manually, along with wood debris. PCB levels in the floating scum reached as high as 4,000 ug/g dry weight, which necessitated some care in handling. Additional aspects of the scum removal and total PCB losses during removal are discussed in this report's monitoring section.

PLATE V. Oil boom used to collect highly contaminated floating debris.

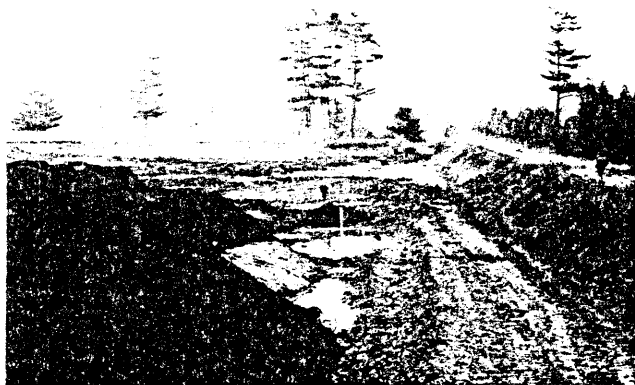
PLATE III. Placement of dredged spoil. In foreground, left to right: spoil material; monitoring well; interior clay dike.
