# **INTERIM REMEDIAL MEASURE Soil Removal Summary Report**

**Saratoga Tree Nursery  
Inactive Hazardous Waste Site**

**Route 50 Facility  
Saratoga County, N.Y.  
Site No. 5-46-043**

February 1996

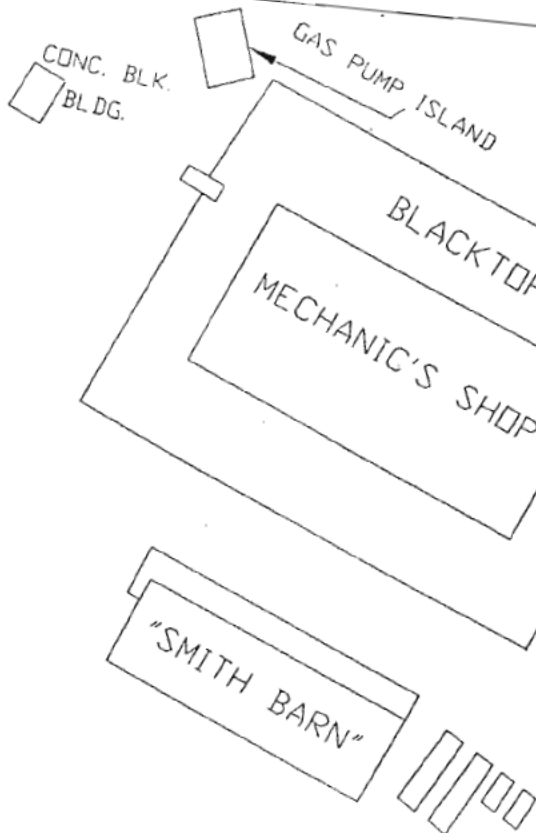
FIGURE 3  
Detail of Excavated Areas  
All Properties  
Saratoga Tree Nursery

Once an access way was established and the surface was prepared, excavation activities commenced. Figure 3 shows the areas of excavation. These areas were staked and flagged. To avoid re-contamination of excavated areas, excavation work progressed toward the Nursery access point. Excavation was accomplished in most areas with a small backhoe and bobcat excavator. In areas close to mature trees, hand shovels were utilized to the extent practicable in order to protect tree root systems. Nursery foresters provided guidance when working around trees to ensure their protection.

Excavation depths were based on sampling data generated during the Off-Site investigation. Confirmatory sampling was conducted subsequent to initial excavations to determine if cleanup levels had been obtained. All soil with DDT concentrations greater than the established remedial objective of 2 ppm was removed. Excavations were typically carried out to depths of 1.5 to 2 feet below ground surface. The three exceptions to this are as follows:

- One 10'x10' area at [REDACTED] identified during the off-site investigation was excavated to a depth of eight feet deep due to the presence of petroleum and DDT contamination.
- One 5'x5' area at [REDACTED] was excavated to a depth of 2.5 feet due to the presence of DDT contamination identified at greater depths during the Off-site Investigation.
- The excavation at [REDACTED] was advanced to a depth of 2.5 feet because confirmatory samples collected from the excavation floor at a depth of 1.5 feet showed elevated levels of DDT.

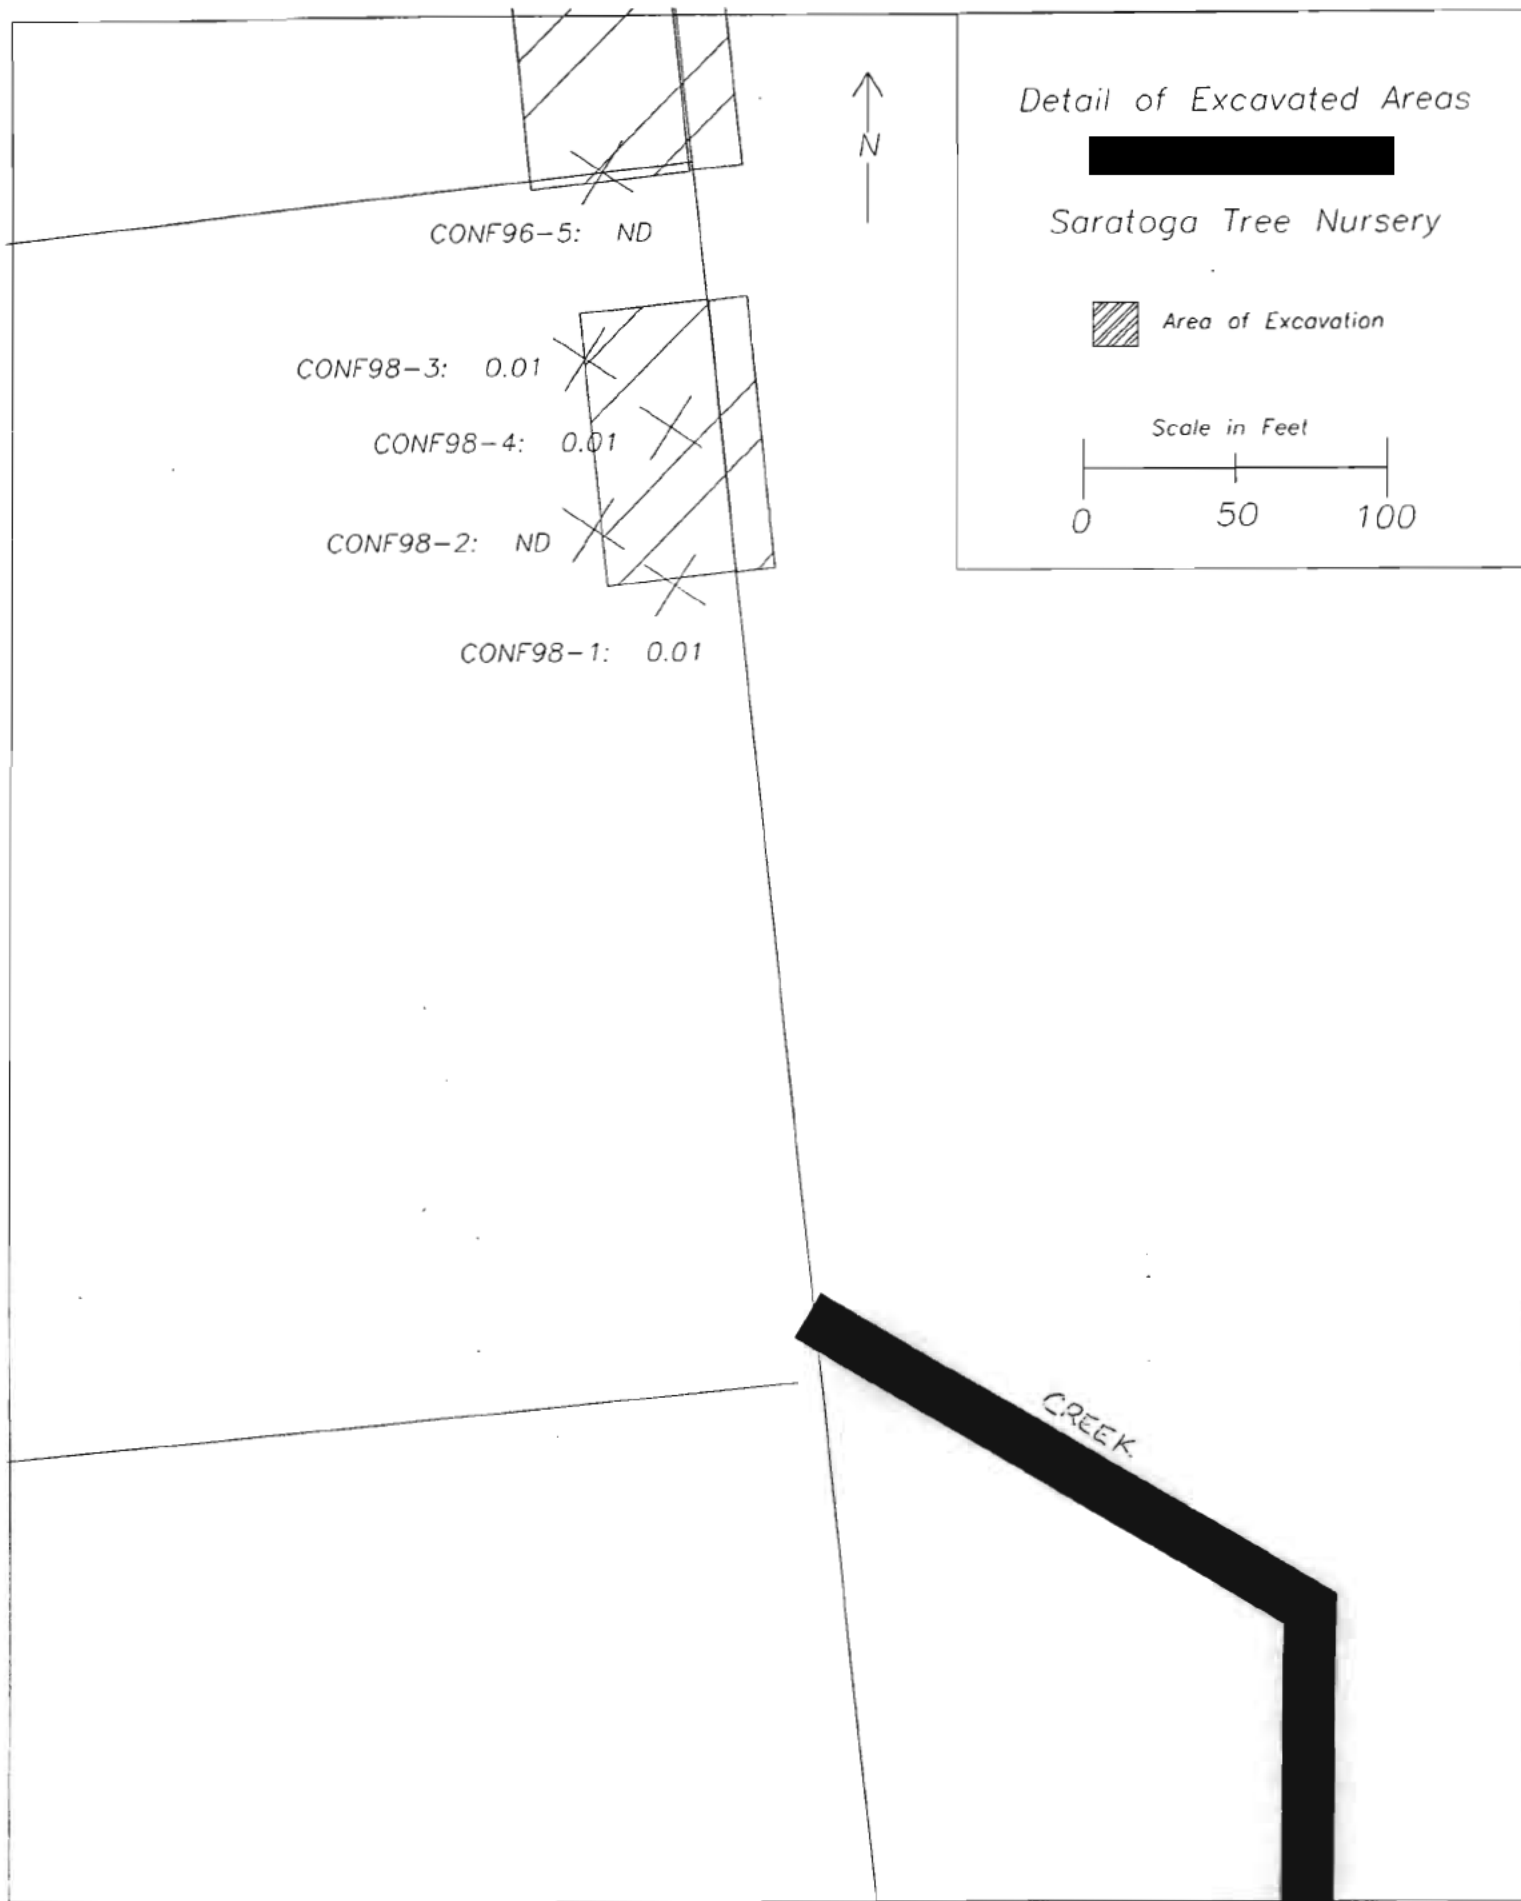
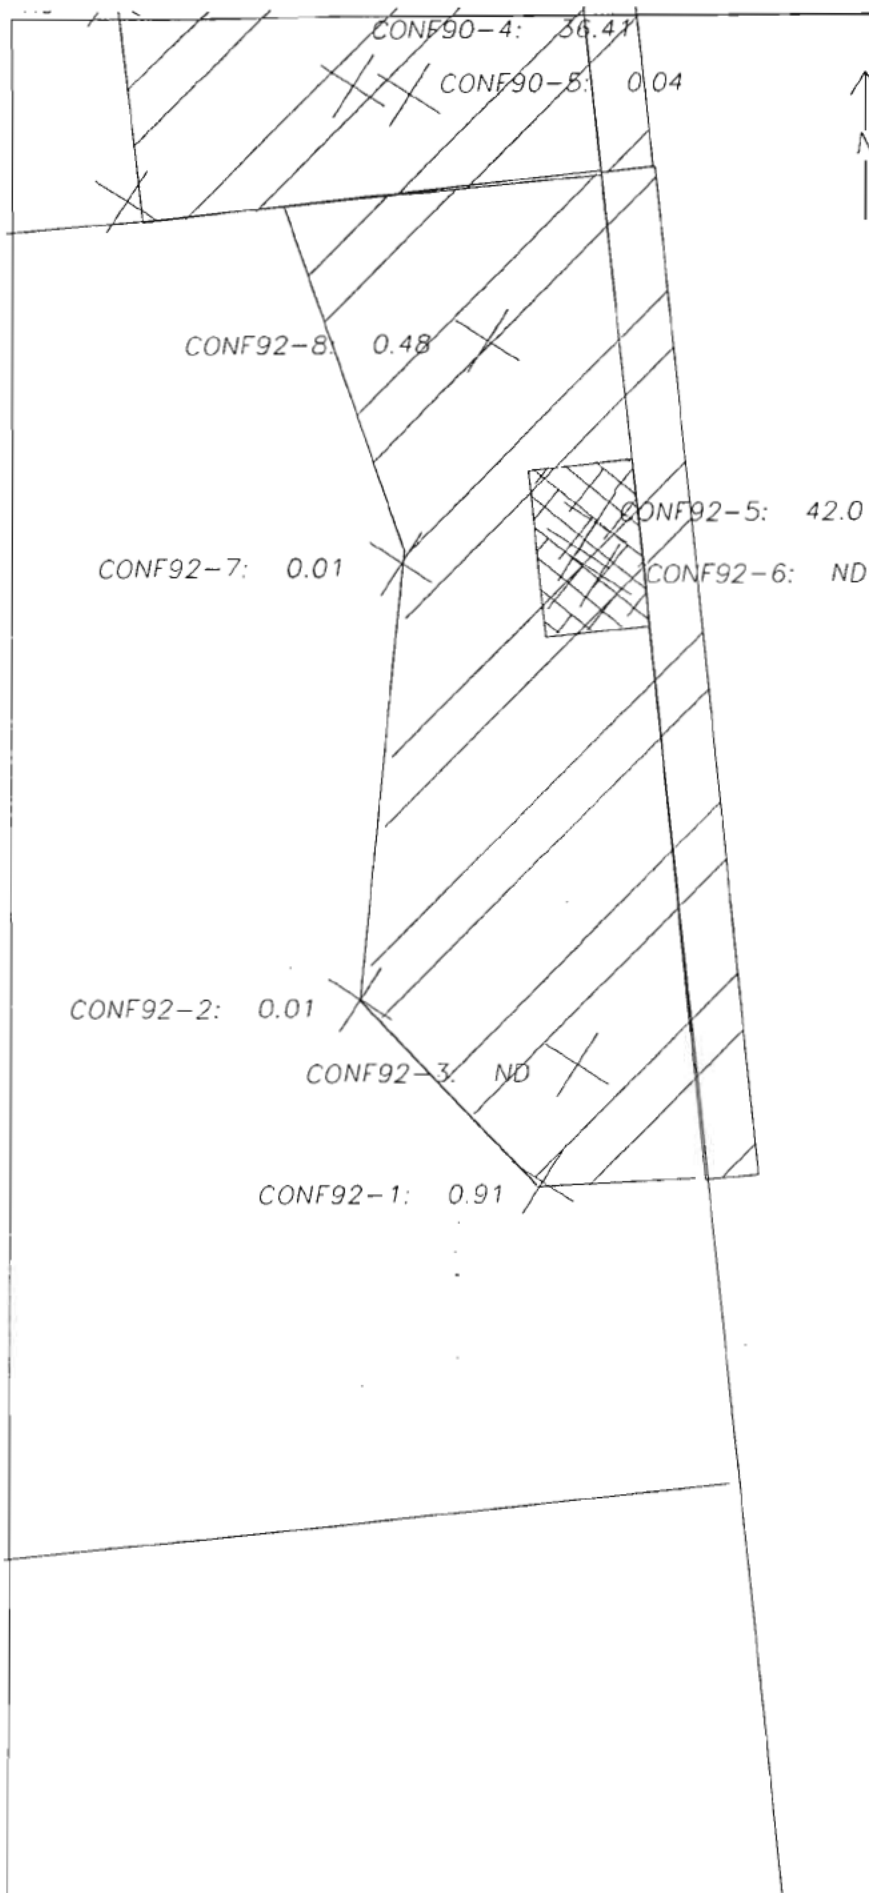
### Detail of Excavated Areas

Area of Excavation  
Depth = 1.5'

Area of Excavation  
Depth = 8'

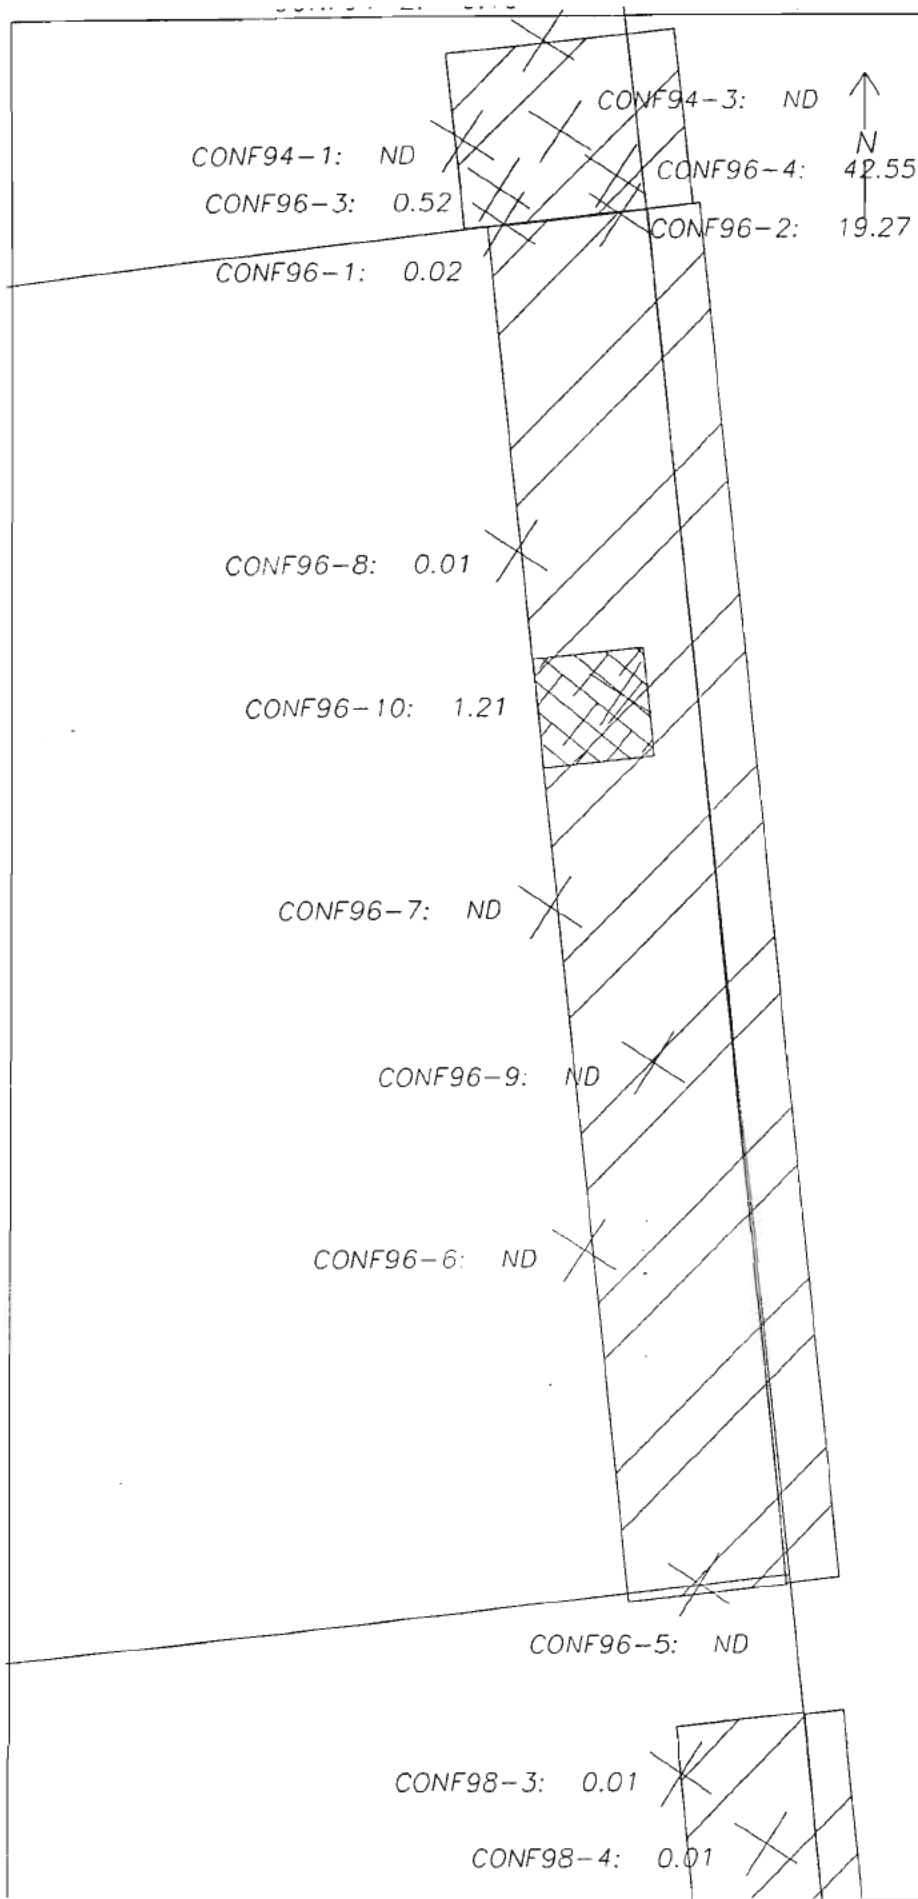
### Detail of Excavated Areas

Note: CONF96-1 thru CONF96-4 were collected to determine whether [redacted] was contaminated with DDT. CONF94-1, 2 and 3 were collected after [redacted] was remediated.

CONF94-2: 0.10

CONF94-3: ND

CONF94-1: ND

CONF96-4: 42.55

CONF96-3: 0.52

CONF96-2: 19.27

CONF96-1: 0.02
