Subject:
2018 Landfill Inspection
Fort Edward Landfill
NYSDEC Site No. 558001
Contract No. D007618-39

Date:
January 7, 2019

FORT EDWARD LANDFILL
NYSDEC SITE 558001
POST CLOSURE INSPECTION FORM

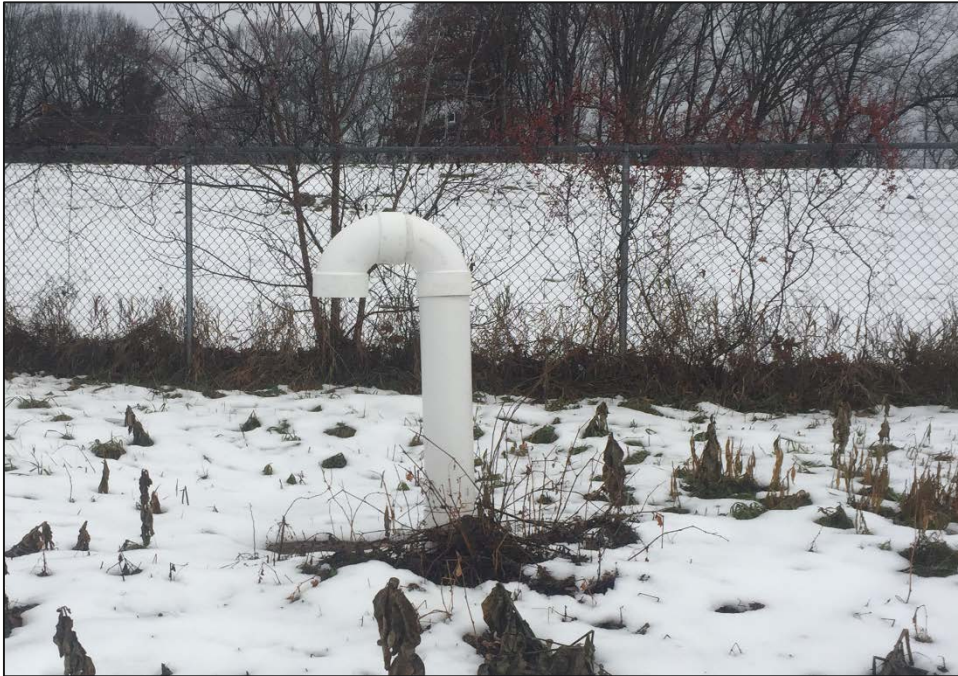
Photo: 1

Gas Vent GV-1

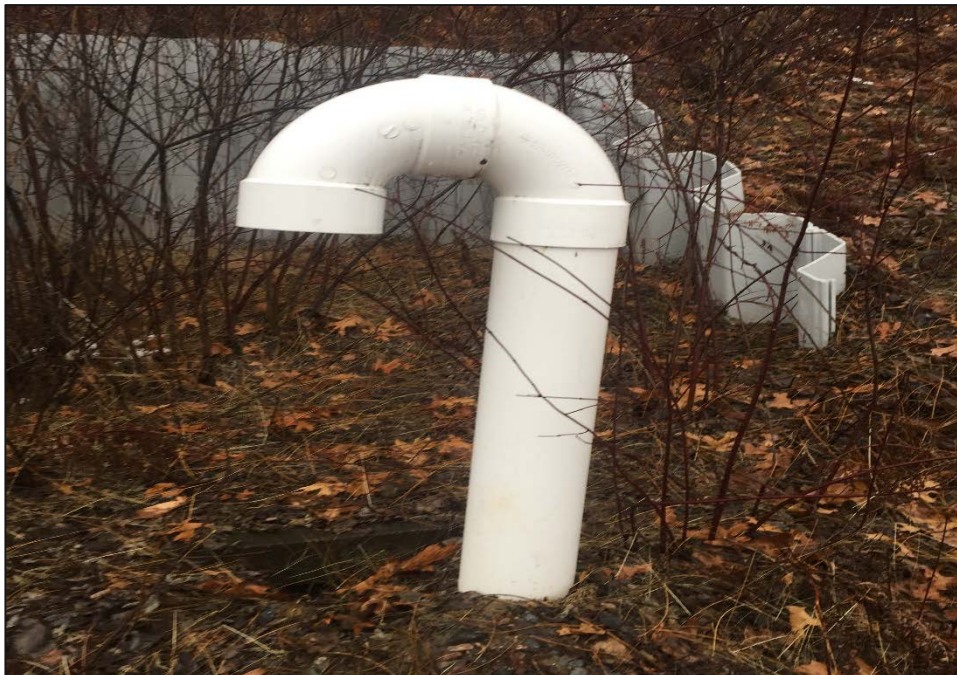
Photo: 2

Gas Vent GV-2

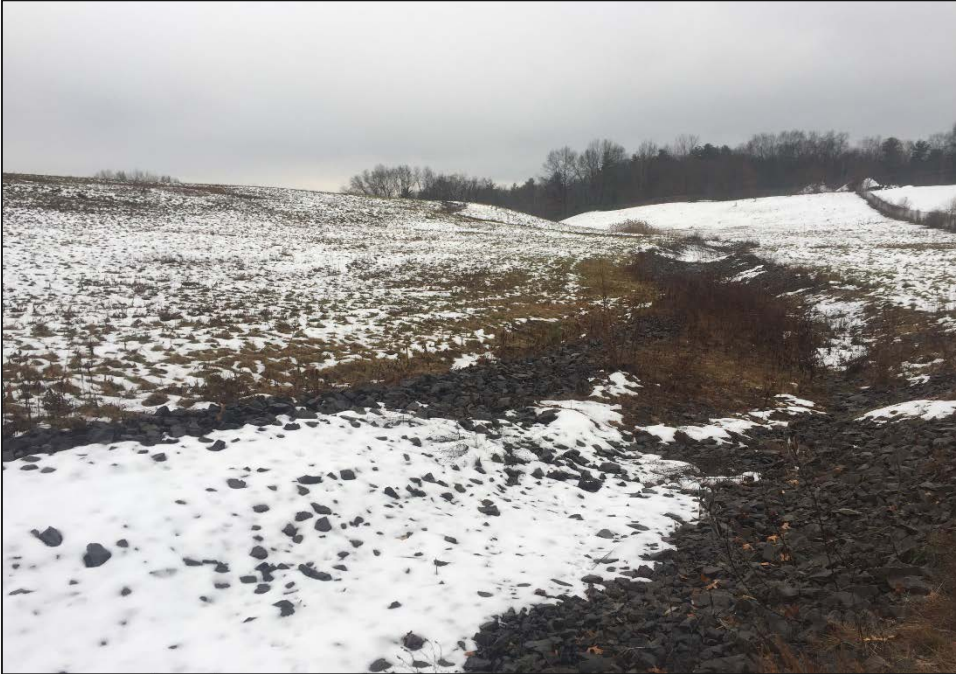
Photo: 3

Western toe of slope and
swale

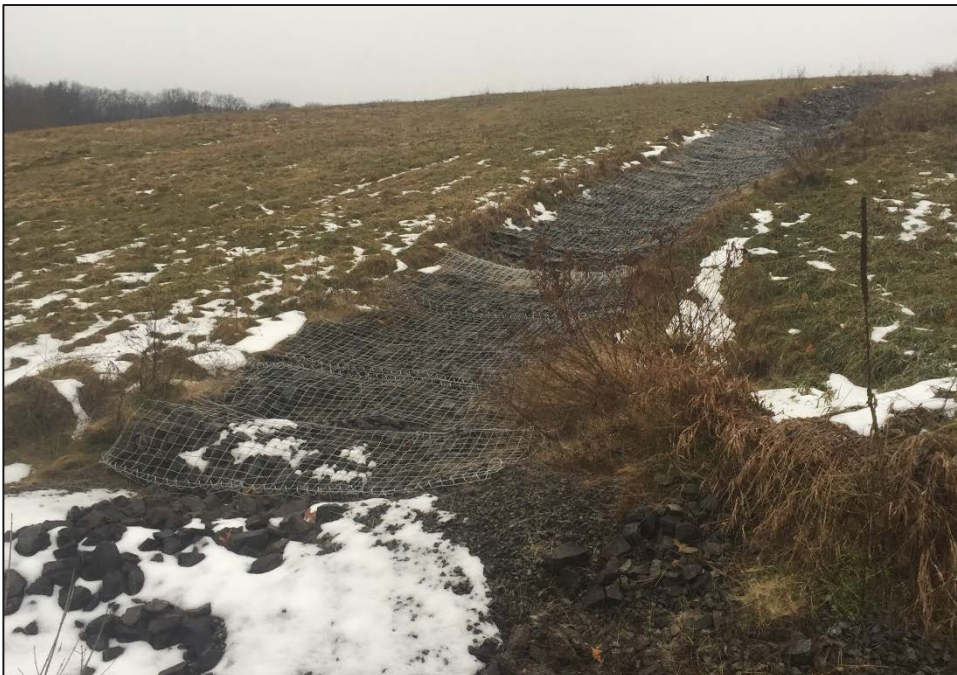
Photo: 4

Drainage swale adjacent to EW-4 has one loose section of riprap gabion mesh. Ponding
water was observed in the Southern mid-cap swale.

Loose riprap wire cover

- A section of the Southern boundary fence was leaning at the access gate to monitoring well MW-9. The access gate will need to be repaired to ensure the site is secured.
- Ponding water was observed in the Southern mid-cap swale. Minor regrading may help to restore drainage in that portion of the swale.
- The drainage swale adjacent to extraction well EW-4 has one loose section of riprap gabion mesh. The mesh will be secured in spring 2019 as part of routine operation and maintenance.

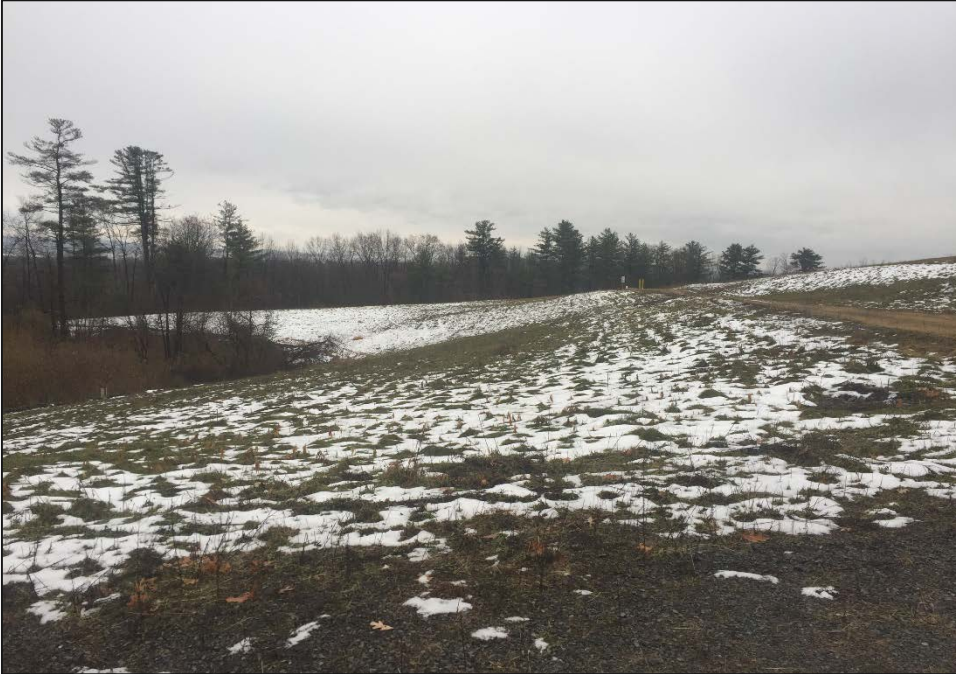
Photo: 5

Eastern mid-cap slope

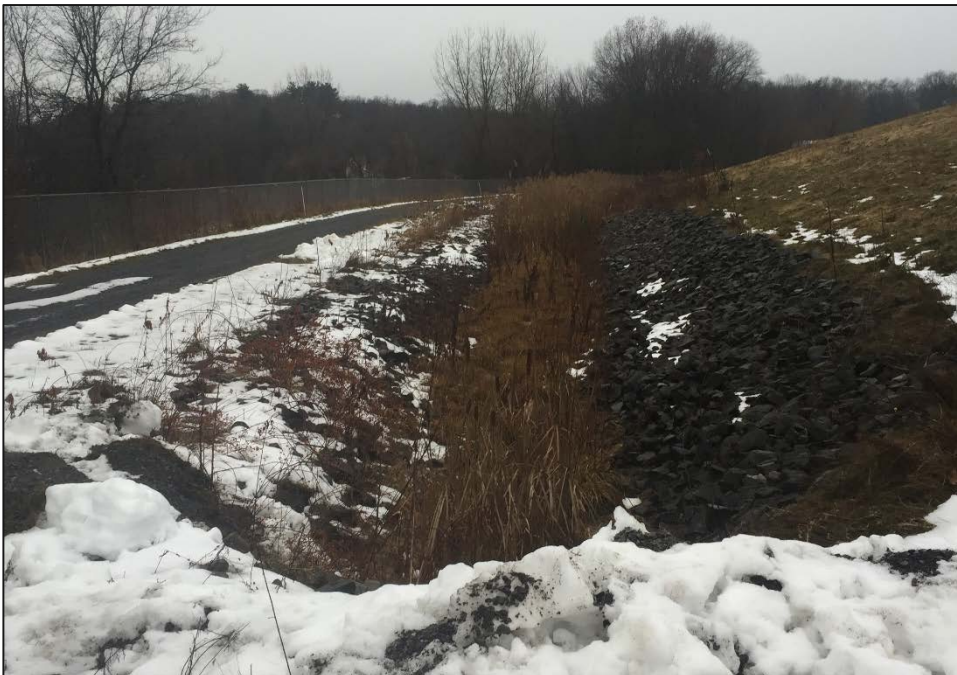
Photo: 6

Phragmites in Southern swale

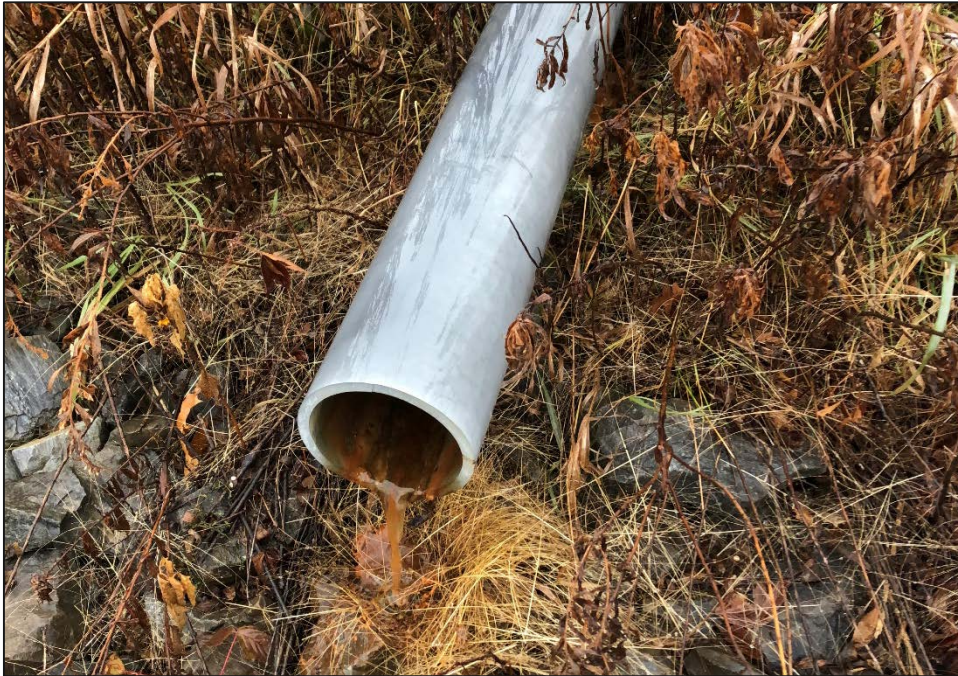
Photo: 7

View of active landfill cap drains

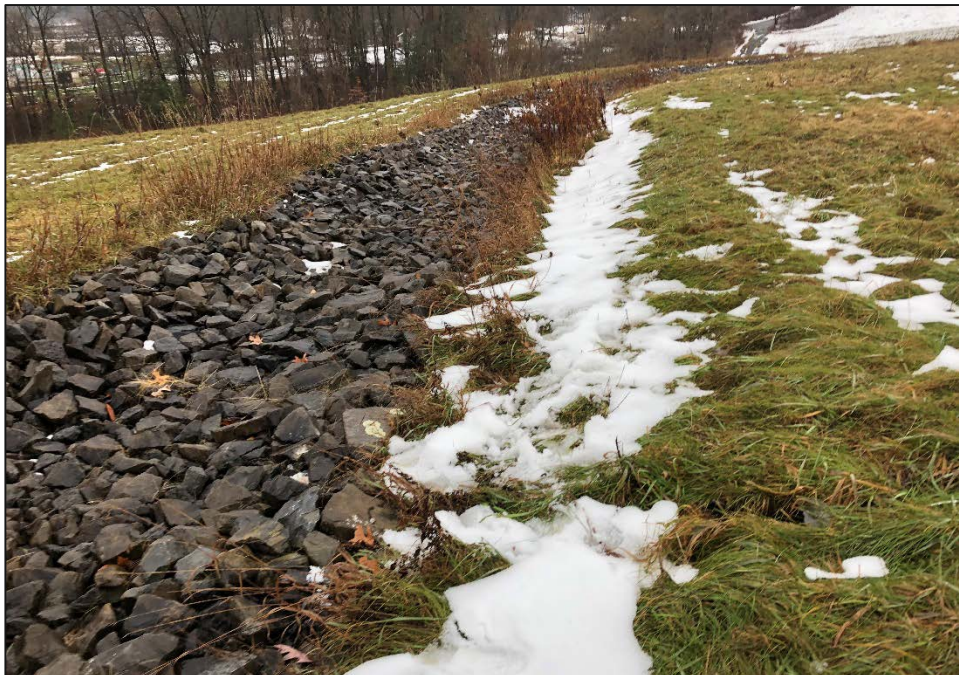
Photo: 8

Southern mid-cap swale

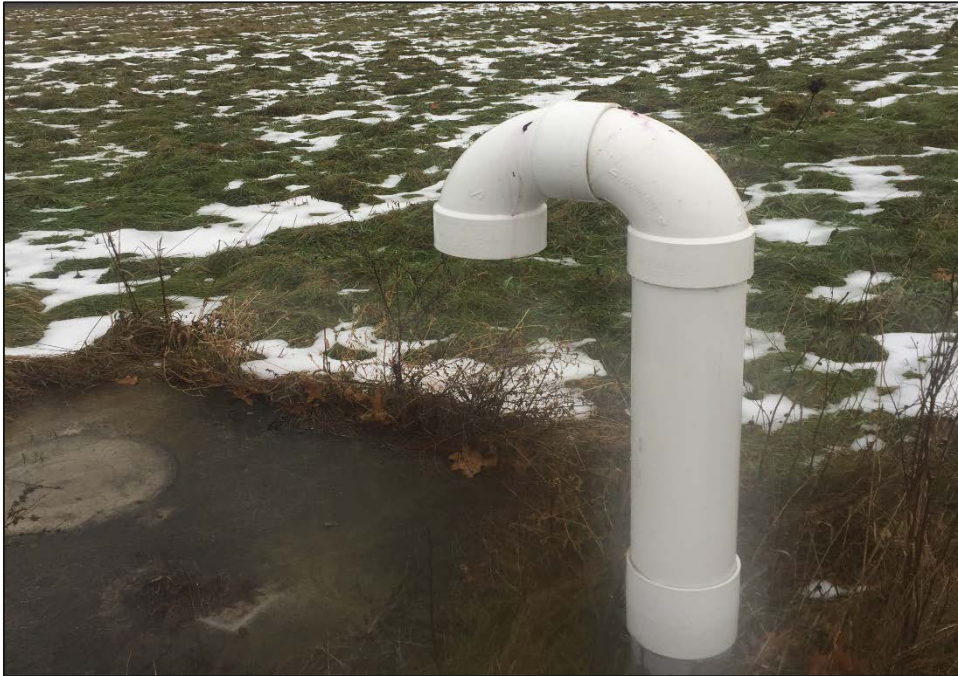
Photo: 9

Gas Vent GV-3

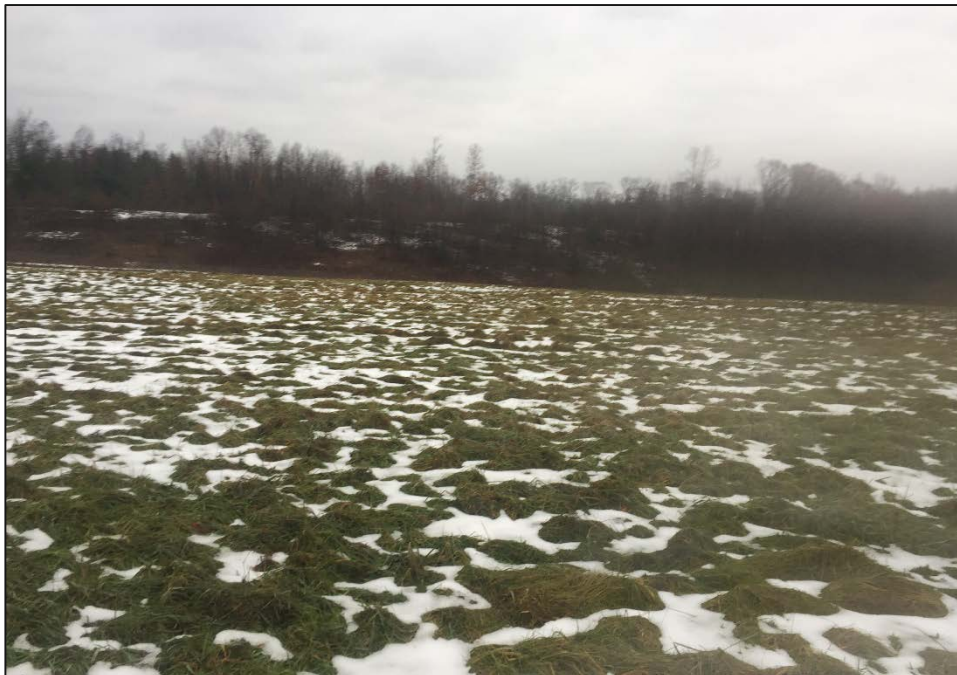
Photo: 10

Top of Landfill facing North

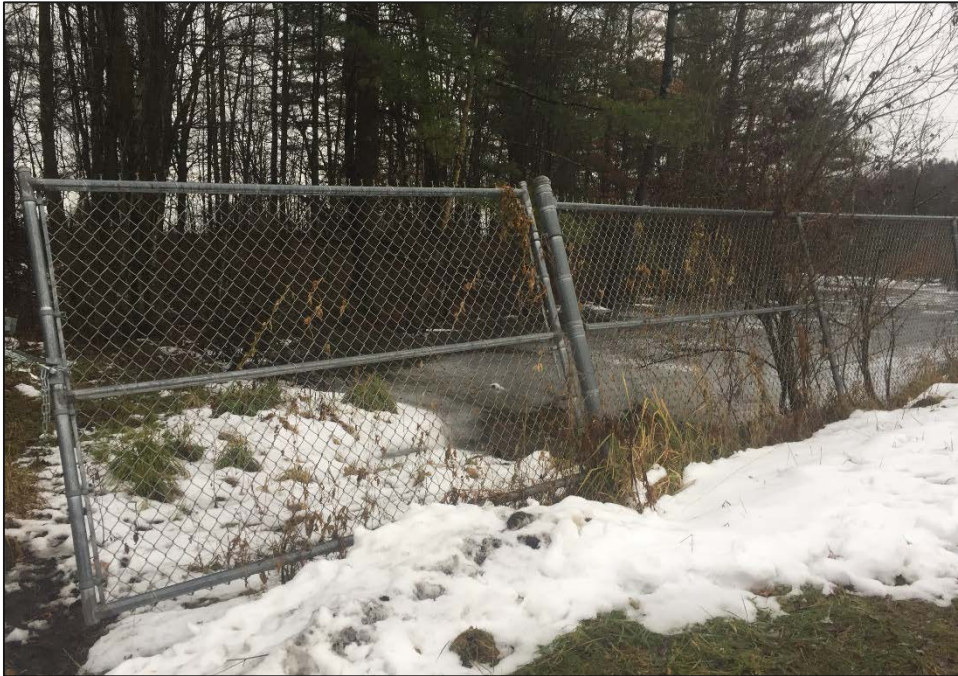
Photo: 11

View of leaning southern
boundary access gate

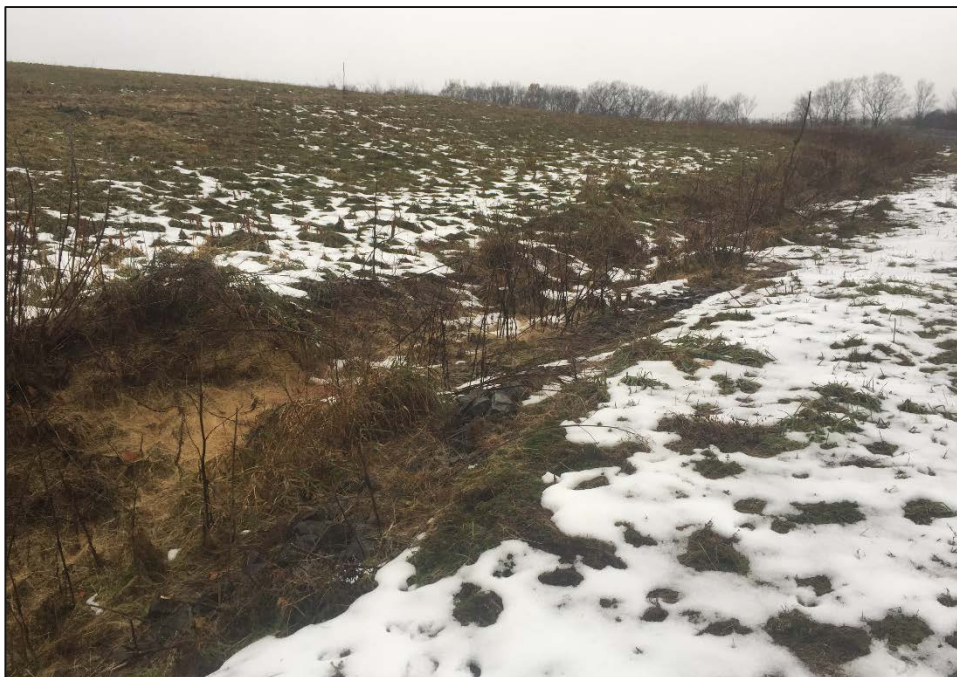
Photo: 12

Eastern mid-cap swale

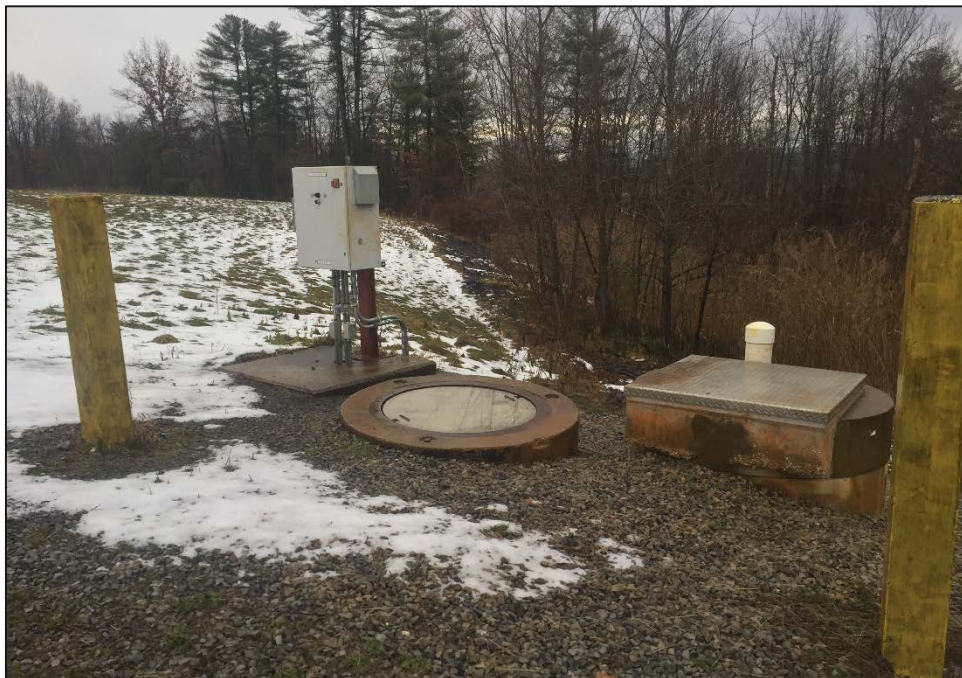
Photo: 13

View of extraction well EW-4
