Subject:  
2019 Landfill Inspection  
Fort Edward Landfill  
NYSDEC Site No. 558001  
Contract No. D007618-39

Date:  
January 21, 2020

FORT EDWARD LANDFILL  
NYSDEC SITE 558001  
POST CLOSURE INSPECTION FORM

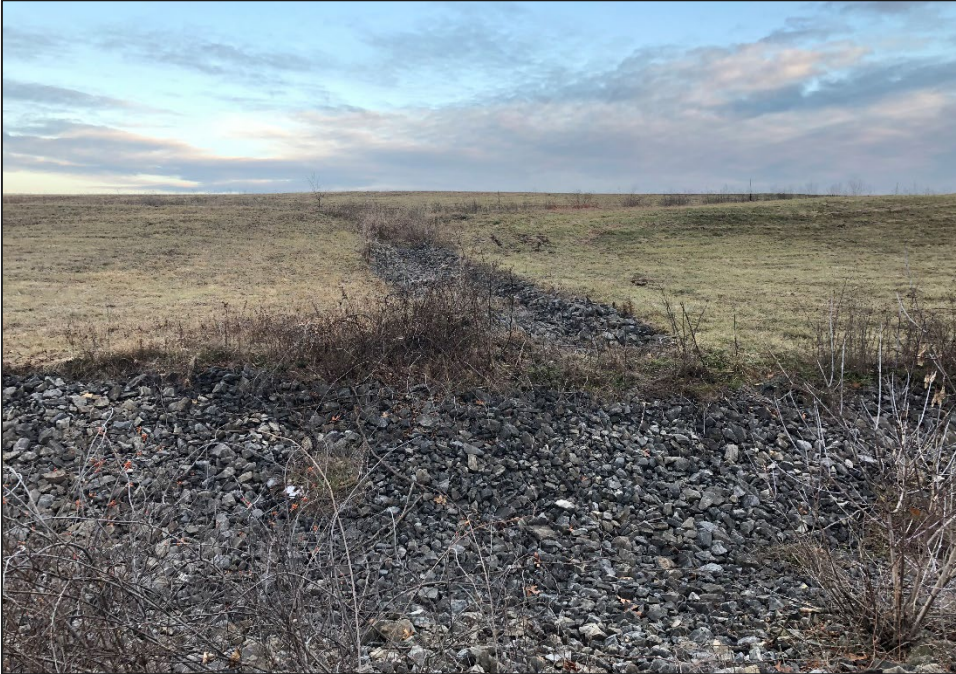
**Photo: 1**

Western swale with  
vegetation; facing east.

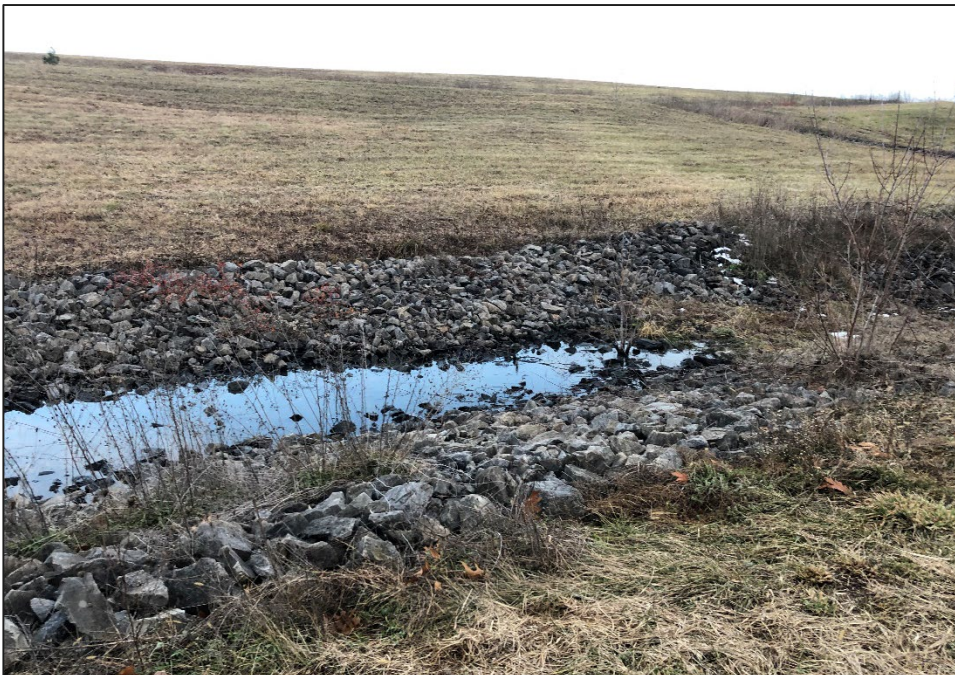
Drainage swale adjacent to EW-4 has one loose section of riprap gabion mesh. Ponding  
water was observed in the Southern mid-cap swale and Western perimeter swale.

Ponding water in Western  
perimeter swale.

- A section of the Southern boundary fence was leaning at the access gate to monitoring well MW-9. The access gate will need to be repaired to ensure the site is secured.
- Ponding water was observed in the Southern mid-cap swale and Western perimeter swale. Minor regrading may help to restore drainage in portions of the swales.
- The drainage swale adjacent to extraction well EW-4 has one loose section of riprap gabion mesh. The mesh will be secured in spring 2020 as part of routine operation and maintenance.

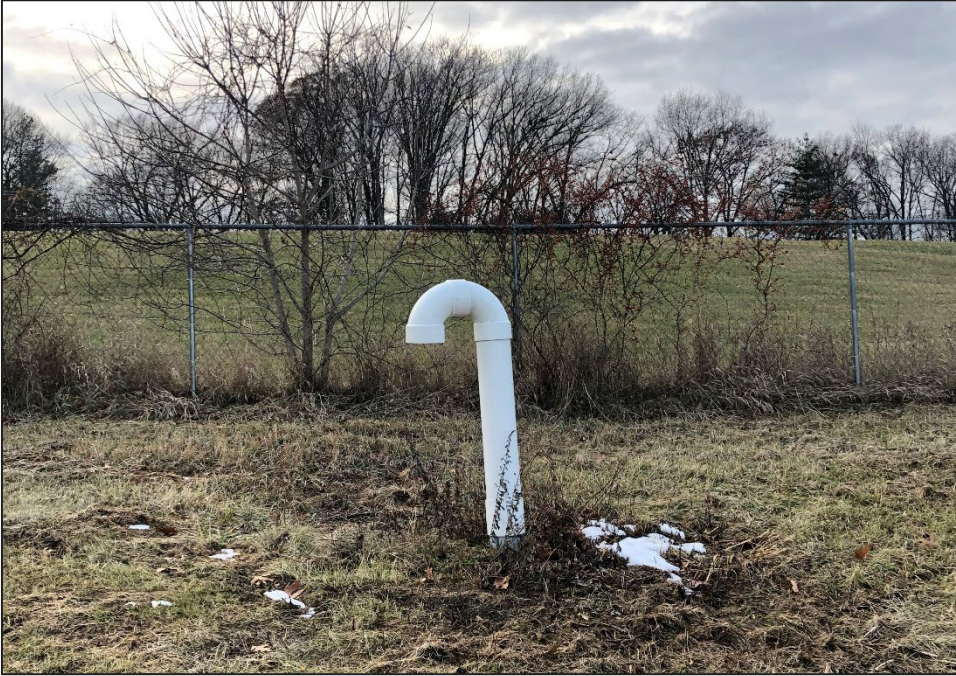
**Photo: 3**

Gas Vent GV-1

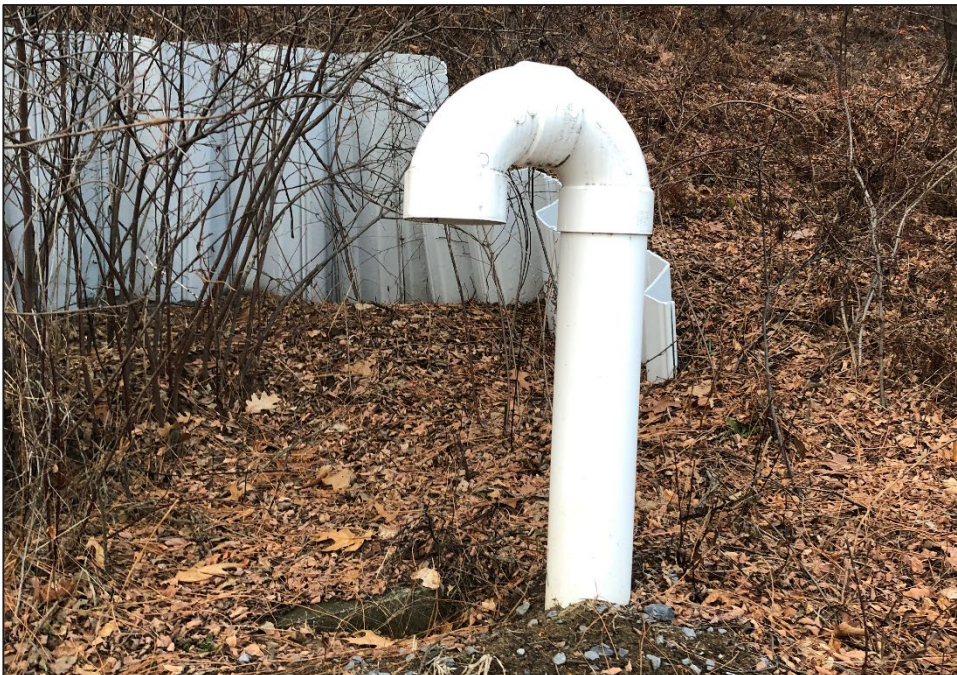
**Photo: 4**

Gas Vent GV-2

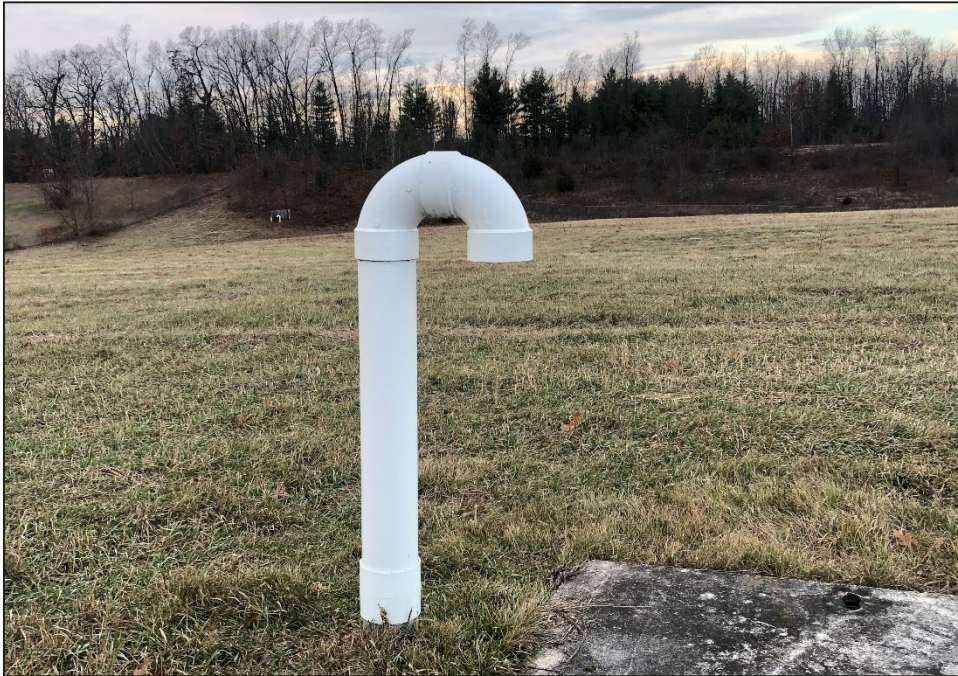
**Photo:** 5

Gas Vent GV-3

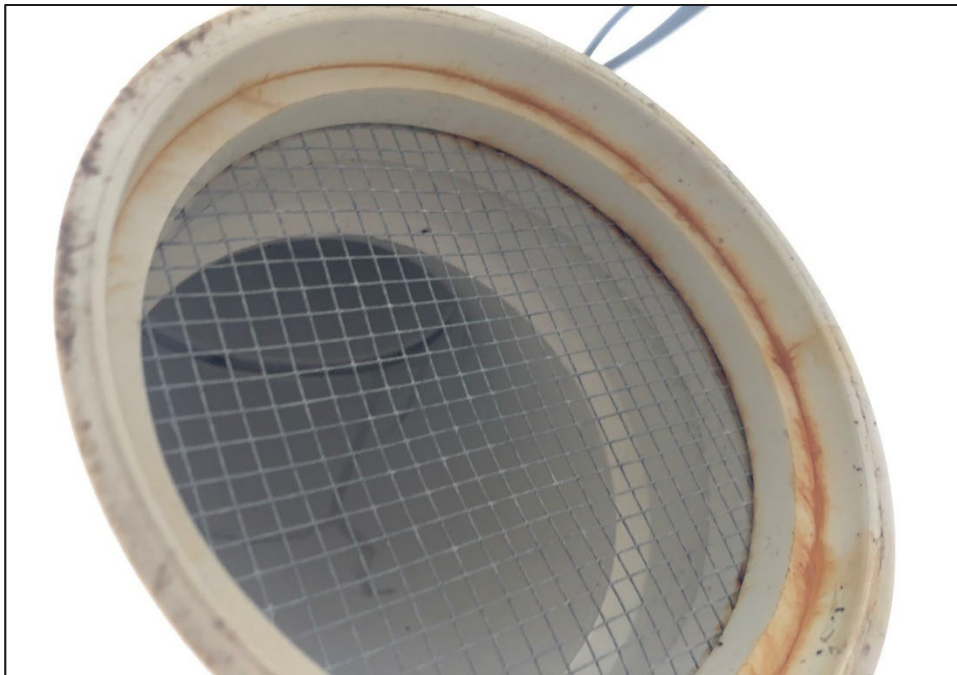
**Photo:** 6

Gas Vent GV-3 screen

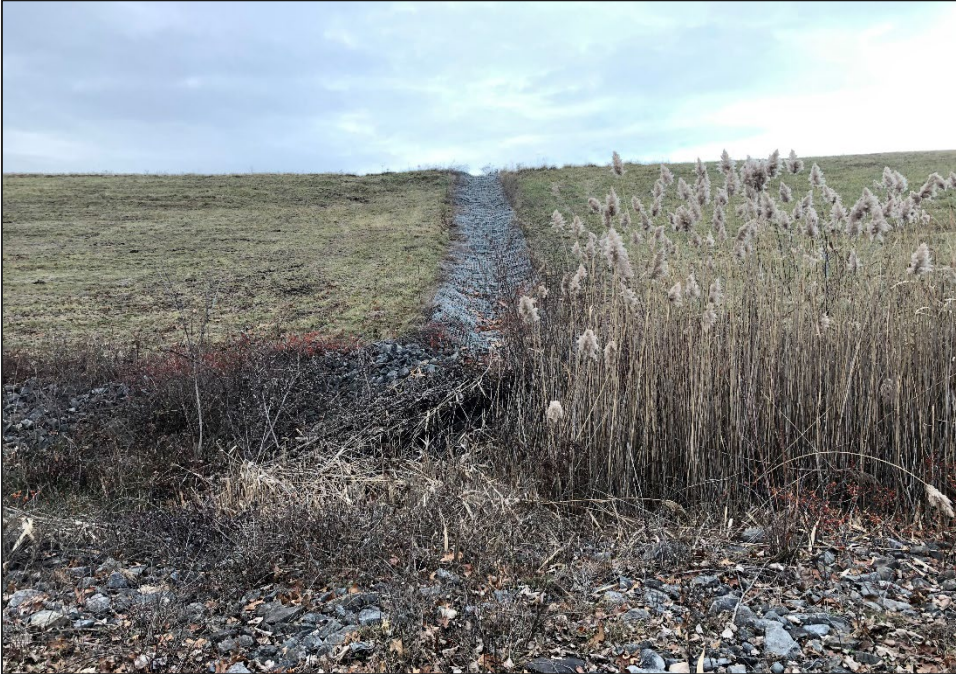
**Photo:** 7

Vegetation along Southern  
drainage swale.

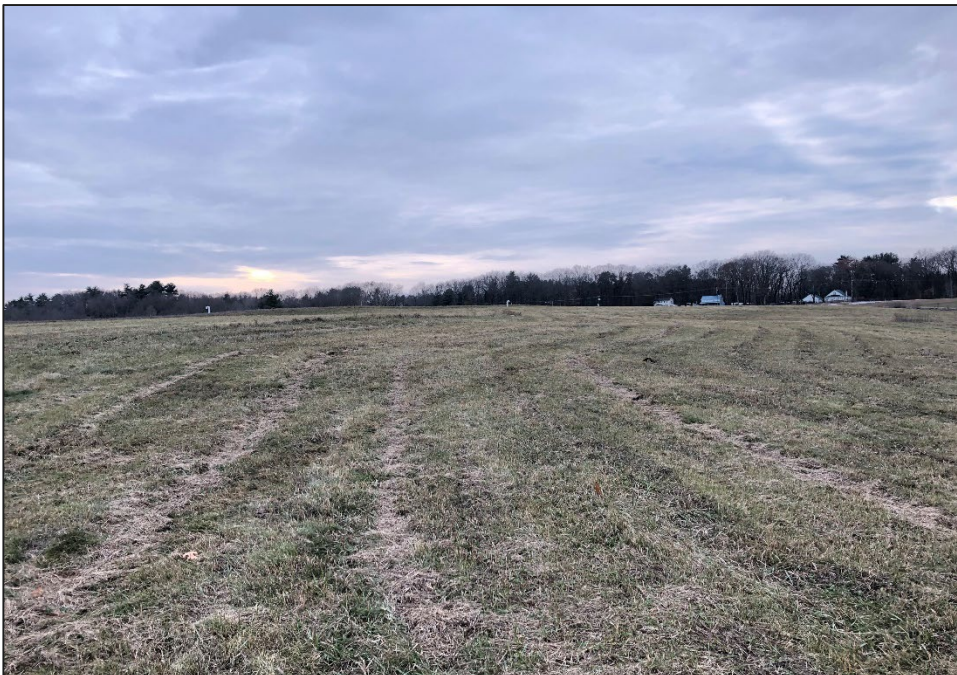
**Photo:** 8

Top of landfill

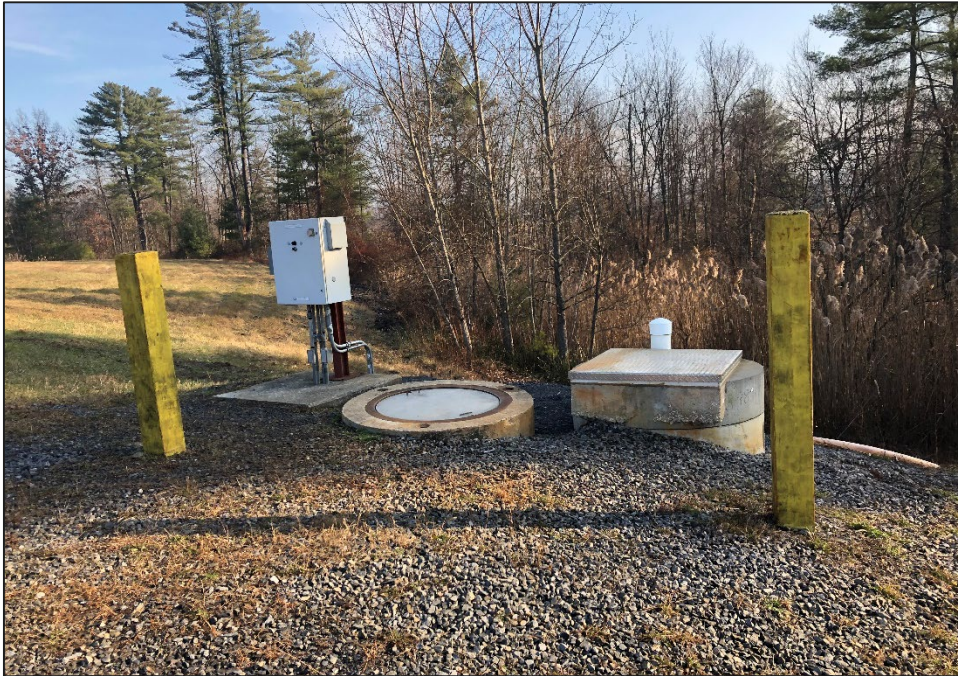
**Photo:** 9

View of extraction well EW-4

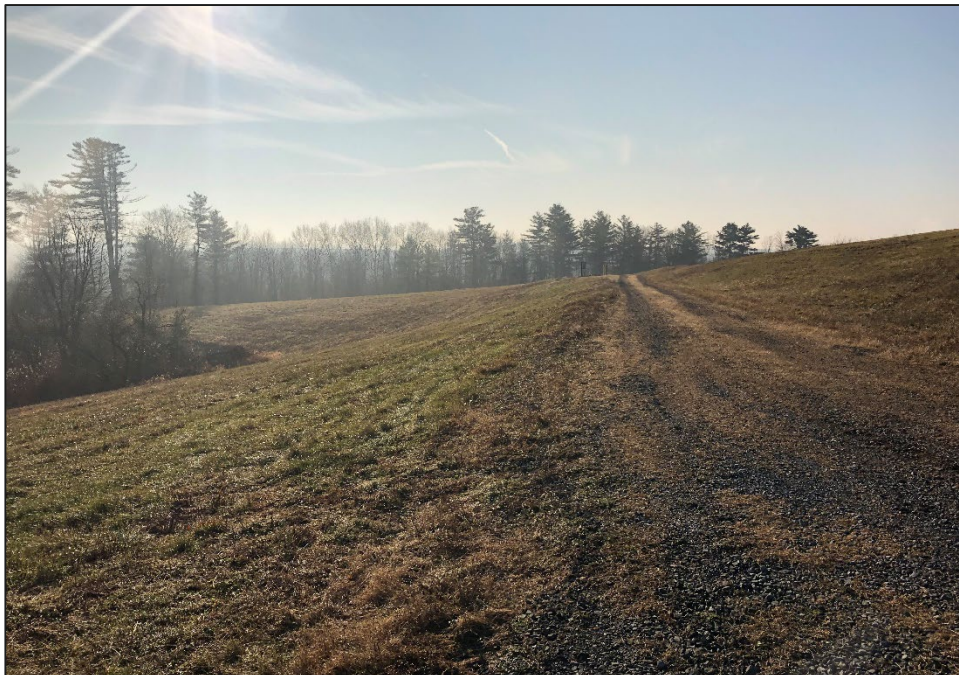
**Photo:** 10

Eastern mid-cap slope

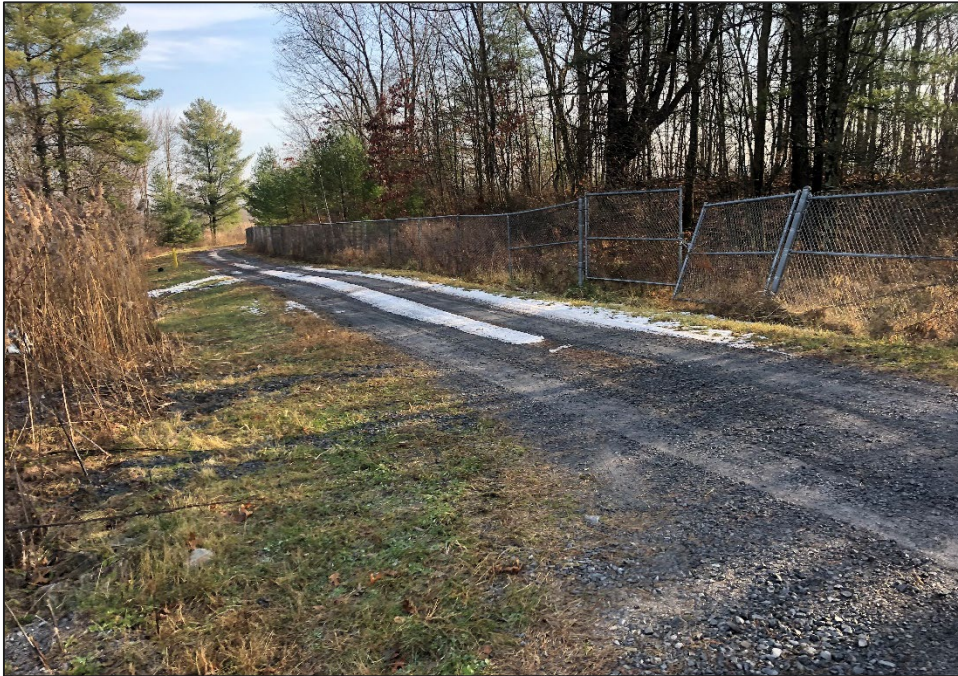
**Photo: 11**

View of leaning Southern  
boundary access gate

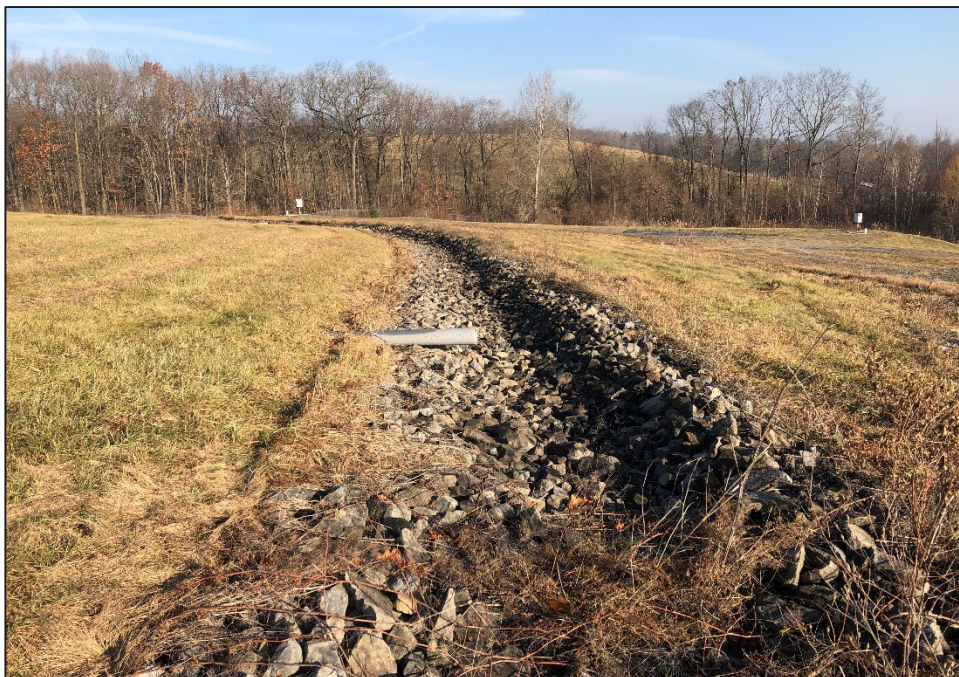
**Photo: 12**

View of landfill drains in mid-  
cap swale

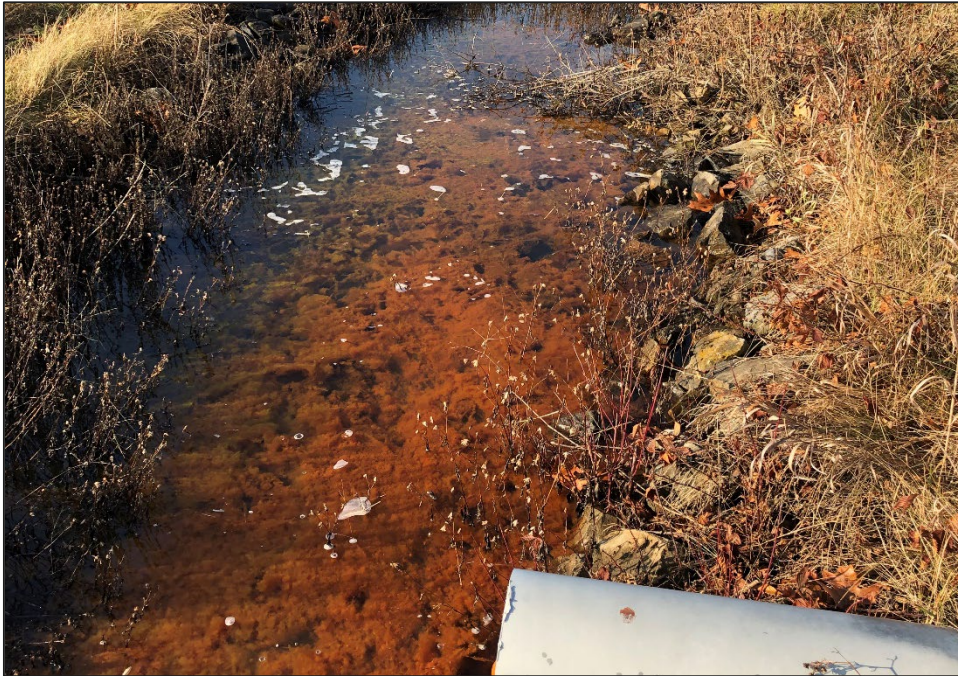
**Photo: 13**

Ponding water in Southern mid-cap swale

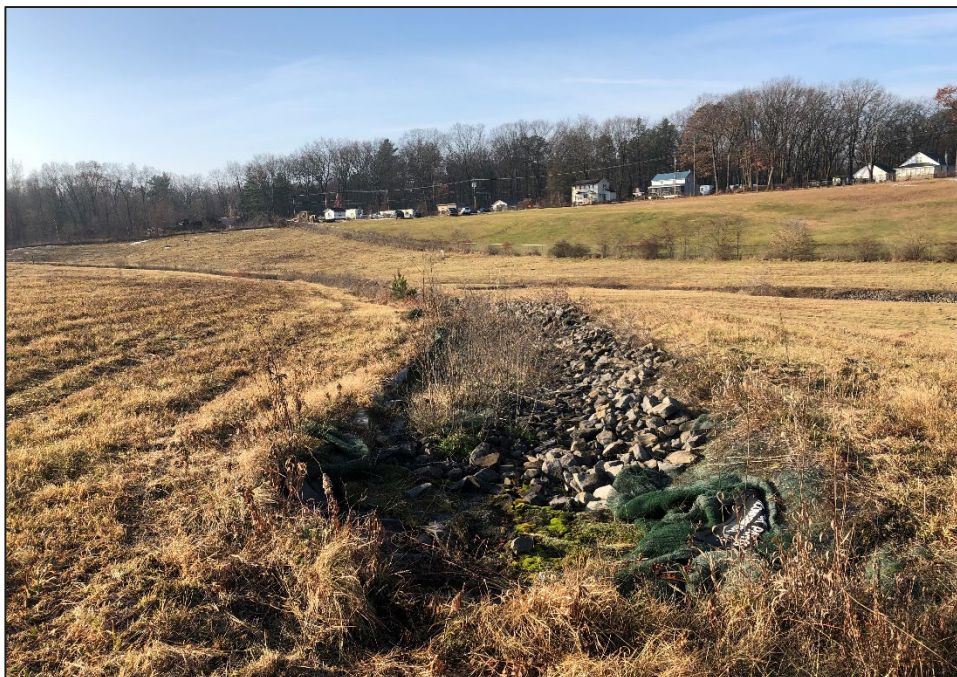
**Photo: 14**

Excess geotextile in mid-cap swale
