**SUBJECT**  
Fort Edward Landfill Health and Safety (H&S) Audit

**DATE**  
4 April 2021

**OUR REF**  
D009804 WA 07, NYSDEC Site #558001

This memorandum summarizes the observations made during the site Health and Safety Audit at the Fort Edward Landfill located at 45 Leavy Hollow Lane, in the Village of Hudson Falls, New York. The Audit was conducted on 30 March 2021 by Aaron Bobar, a Senior Scientist and Safety Specialist at Arcadis of New York, Inc. (Arcadis). The Audit included a site walkthrough, inspection of equipment, review of site documentation, and interviews with site personnel.

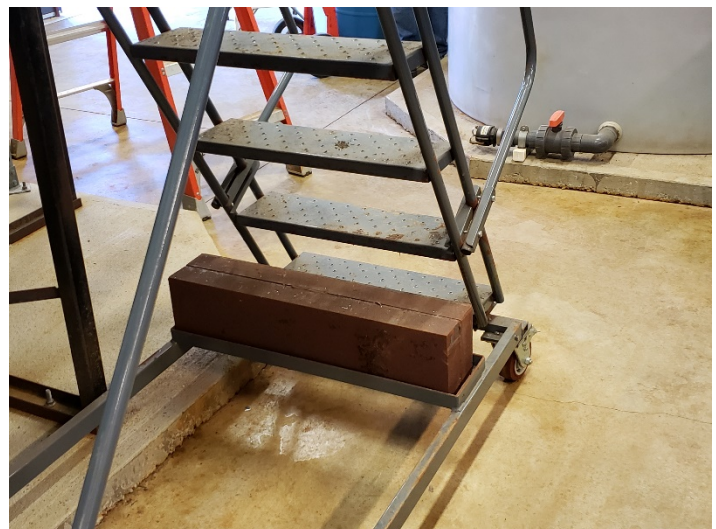
The elevated platform used at the site to access an elevated tank was properly counter-weighted (Figure 1), with clean treads, proper handrails, fall barriers, and toe boards installed.

Figure 1 – Elevated platform counterweight.

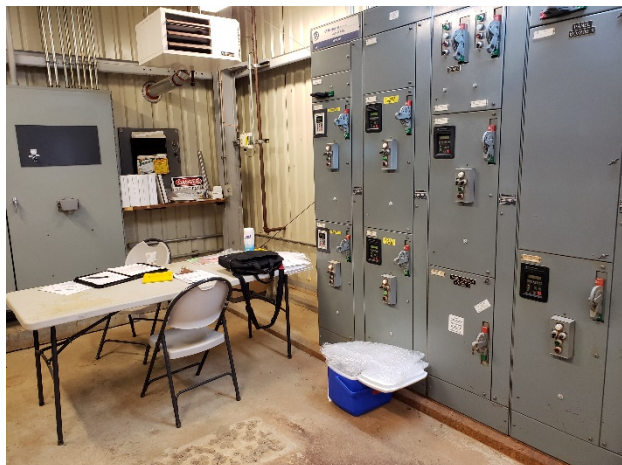
*Figure 2 - Staging Area; electrical panels.*

The electrical equipment and control room was being used as the main office/ staging area for the building (Figure 3). A table, chairs, and other equipment were stored near energized panels. Site personnel should evaluate this issue and consider if there is a risk of arc-flash or electrocution hazard for personnel working in proximity to the energized equipment.

1. Site personnel should evaluate use of the electrical equipment area as a primary staging area for operations, and should consider if there is a risk of arc-flash or electrocution hazard for personnel working in proximity to the energized equipment.

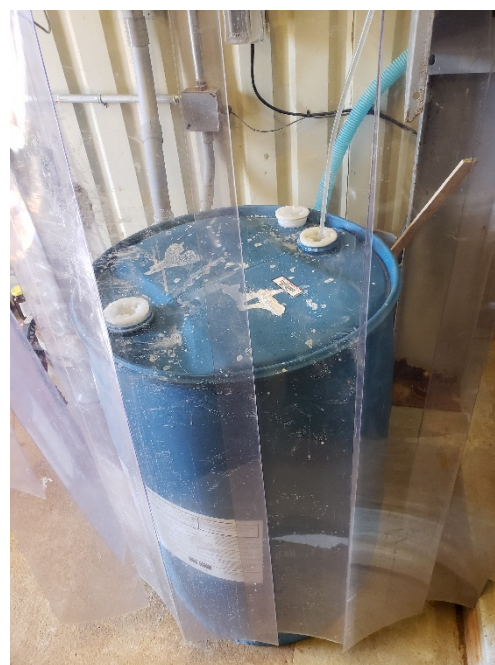
Splash guards were installed around areas where chemicals were routinely handled. However, some spillage was noted on top of the chlorine container attached to the metering equipment – chemical drums and adjacent surfaces should be kept clean at all times to prevent incidental contact with the chemicals (Figure 3). Emergency spill equipment was present at the facility, and all employees knew where the equipment was stored.

*Figure 3 - Splash guard; some spillage noted.*

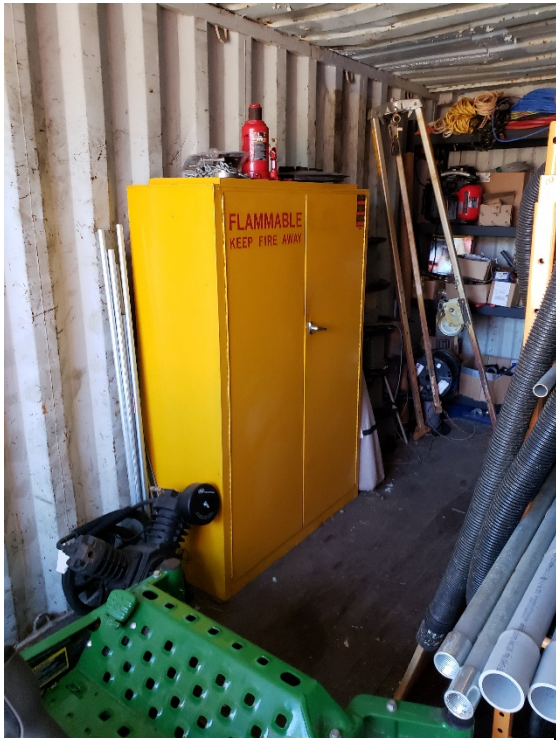
A storage container is used for storage of the mower and other equipment (Figure 4). A flammable storage cabinet was present within this container, where small amounts of gasoline are kept for the riding mower and other groundskeeping equipment. While a vent was present in the flammable cabinet, it was not vented to outside the storage container. Upon entering, a strong petroleum odor was noted within the storage container. The flammable storage cabinet should be actively or passively vented to the outside of the storage container to fresh air. In addition, confirm that the steel container is properly labeled/ placarded to identify flammable storage.

Figure 4 - Flammable storage cabinet.

7. Evaluation of the flammable storage cabinet within the storage container, and installation of an active or passive ventilation to the outside of the container to fresh air to prevent accumulation of flammable fumes within the storage container.

8. The outside of the storage container should have an appropriate NFPA/ HazCOM placards identifying that flammable materials are stored within.
9. Confirm that building HazCom placards conform to current standards.

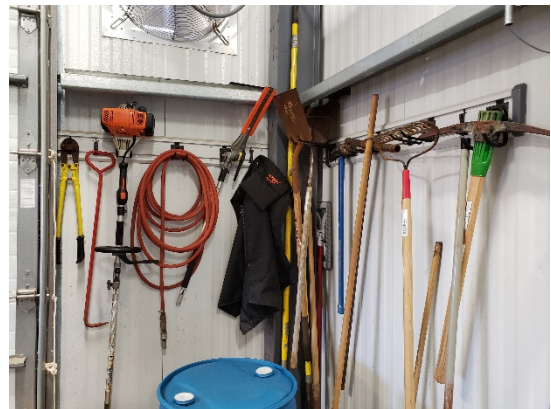
Hand and power tools were kept on shelves, or in storage bins, along with other parts and equipment. Near the garage door there were a number of tools stored on the wall on tool hangers (Figure 5). The racks did not have stops on the ends to prevent the tools from potentially being dislodged when handling drums or performing other work in that area. The tool racks should be equipped with stops on the ends to better secure tools from falling down.

Figure 5 - Hanging equipment

12. Provide closed-end racks for hand tools stored on the wall near the garage door, to prevent tools from potentially falling on staff if bumped.
13. If falling ice continues to be a significant hazard, consider constructing a vestibule over the rear doorway to protect workers from falling ice.

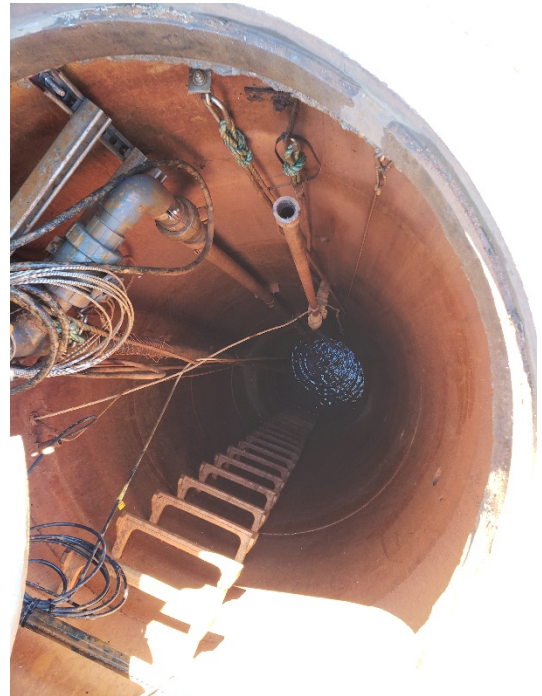
Access of some of the extraction well vaults, even without entry, posed a risk of personnel falling a considerable distance down the manhole (Figure 6). In those instances, temporary fall barriers or rails should be installed to prevent accidental falls. Toe boards should be present to prevent accidental falls of tools or equipment into the vaults, requiring entry to recover them.

Figure 6 – Collection sump EW-4 - fall hazard and CSE

5. Use temporary fall protection/ fall barriers with toe boards around open manholes during sampling activities, even if entry is not required, to prevent accidental falls of personnel or equipment.

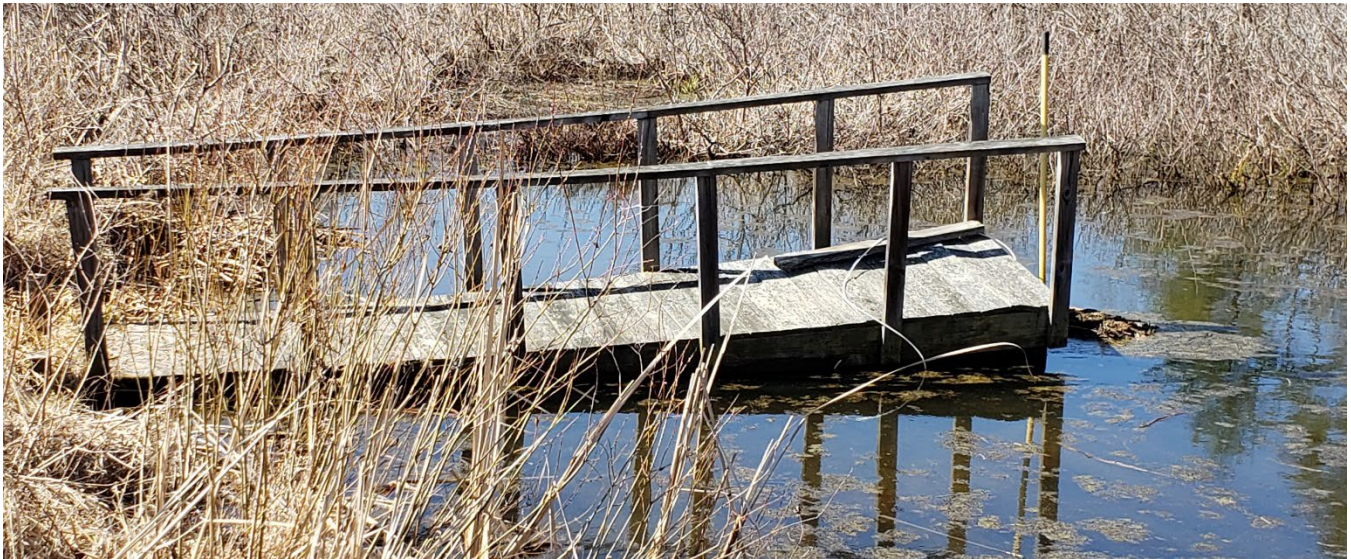
In addition to CSE monitoring, there is a sampling point on the Polishing Pond that is accessed via a floating dock. During the audit, the dock was tilted, unstable, and did not appear to be in good condition. This dock should be re-built, or otherwise repaired to prevent falls into the Polishing Pond (Figure 7).

*Figure 7 – Polishing Pond sampling dock*

15. The Polishing Pond sampling dock should be re-built, or otherwise repaired to prevent falls into the Polishing Pond.
