Subject:
2021 Landfill Inspection Report
Fort Edward Landfill
NYSDEC Site No. 558001
Contract No. D009804-7

FORT EDWARD LANDFILL
NYSDEC SITE 558001
POST CLOSURE INSPECTION FORM

Project Photographs

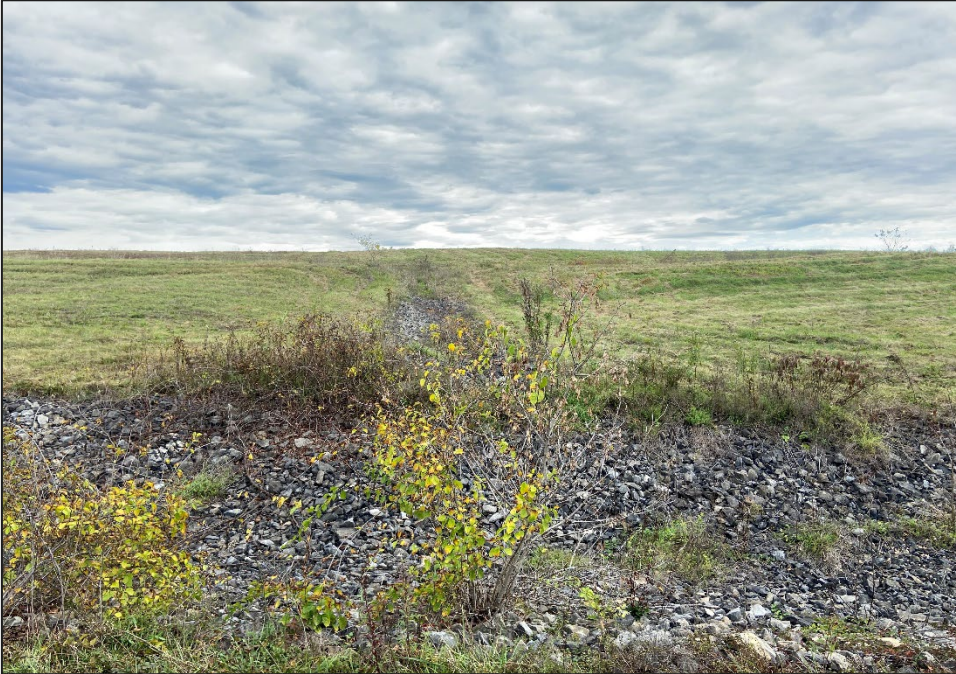
Photo: 1

Deep-rooted vegetation observed in mid-cap and perimeter swales.

Western swale with
vegetation; facing east.

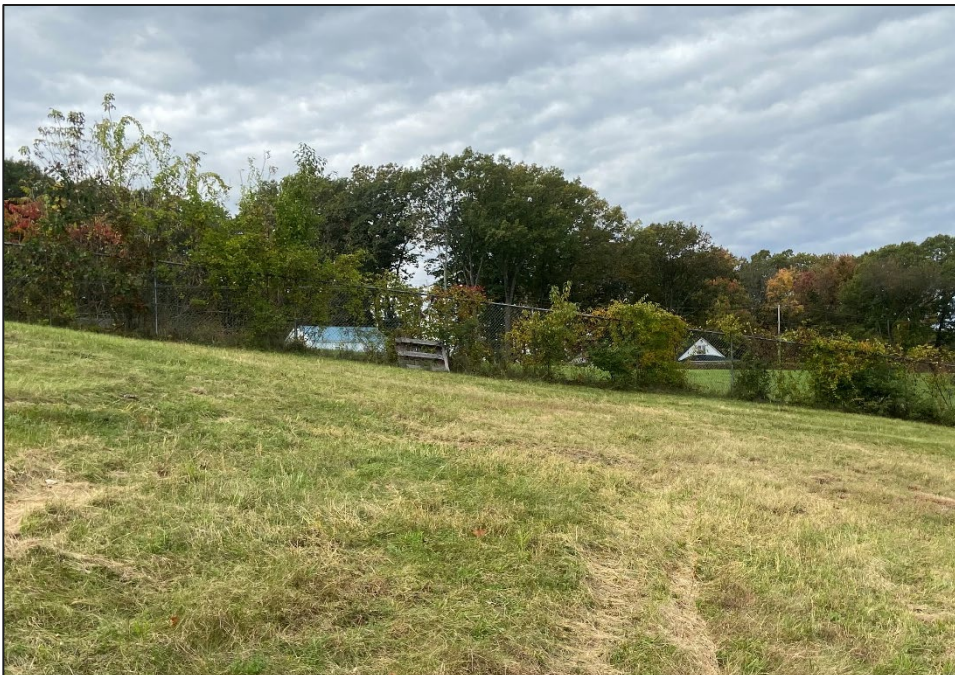
- A pallet was found leaning along the fence line adjacent to monitoring well cluster MW-1. The pallet was removed following the landfill inspection.
- A section of the Southern boundary fence was leaning at the access gate to monitoring well MW-9. The access gate will need to be repaired to ensure the site is secured.
- Ponding water was observed in the Southern mid-cap swale and Northern perimeter swale. Minor regrading may help to restore drainage in portions of the swales.

View of pallet along Western
fence prior to removal.

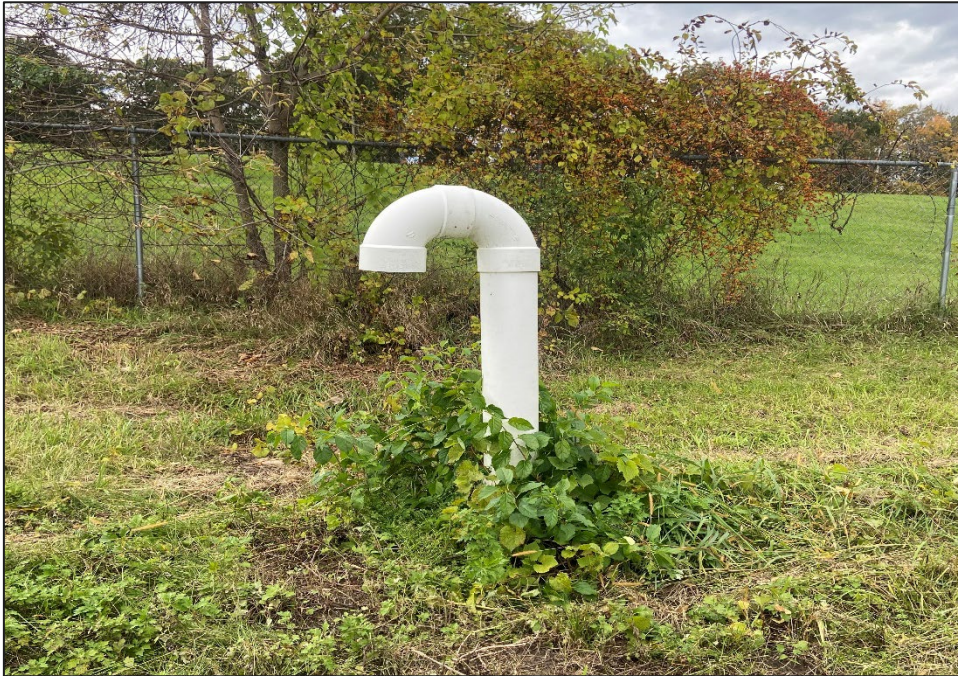
Photo: 3

Description:
Gas Vent GV-1

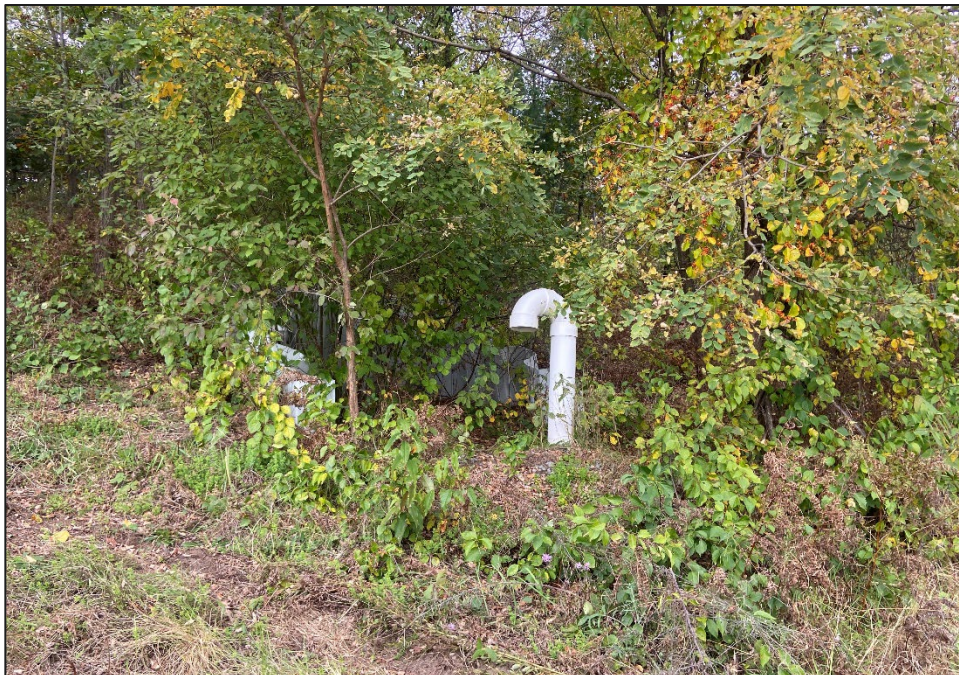
Photo: 4

Description:
Gas Vent GV-2

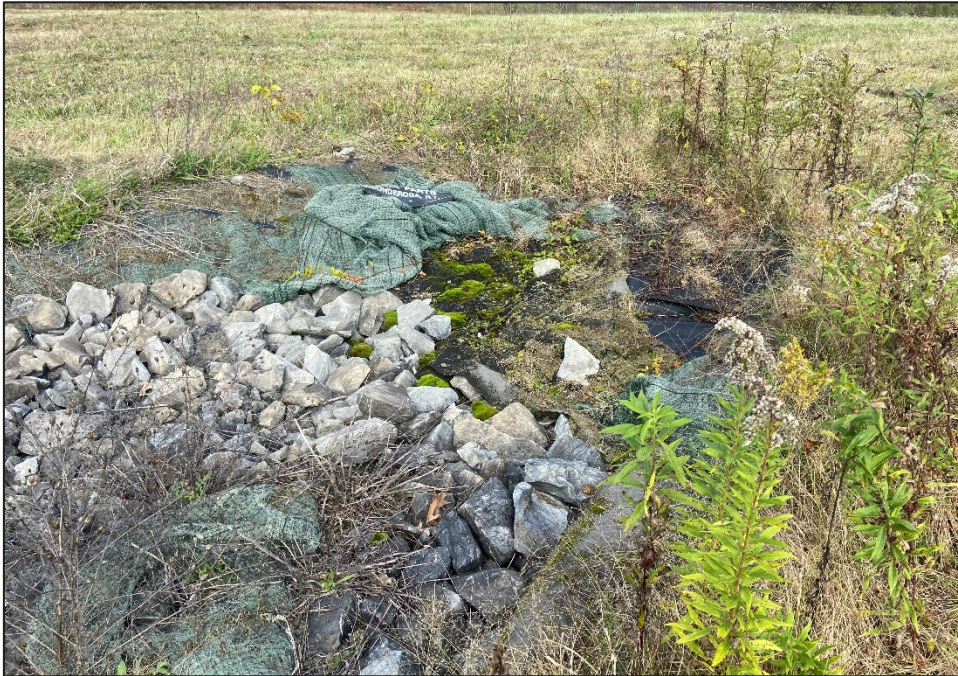
Photo: 5

View of excess geotextile in
Northwestern mid-cap swale

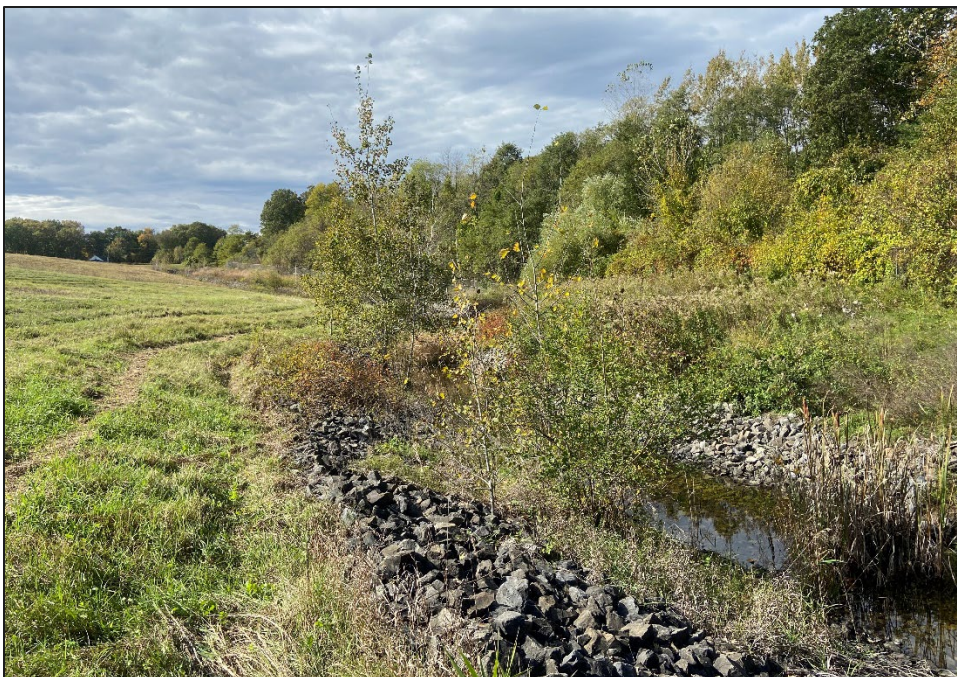
Photo: 6

Ponding water was observed in the Southern mid-cap swale and Northern perimeter swale.

View of ponding water within
Northern perimeter swale

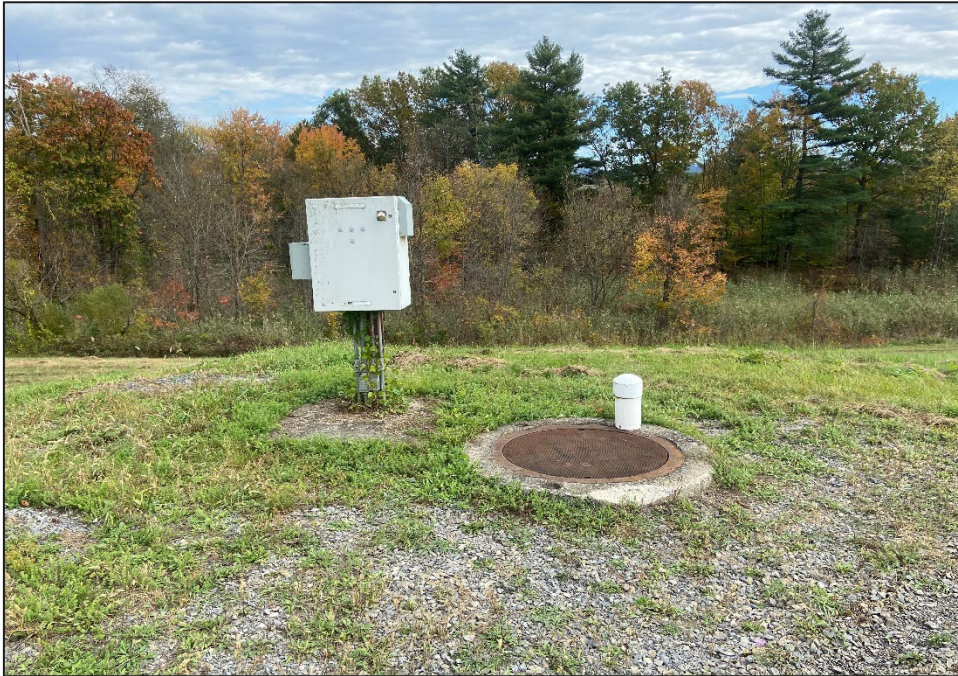
Photo: 7

Description:
View of Extraction Well EW-3

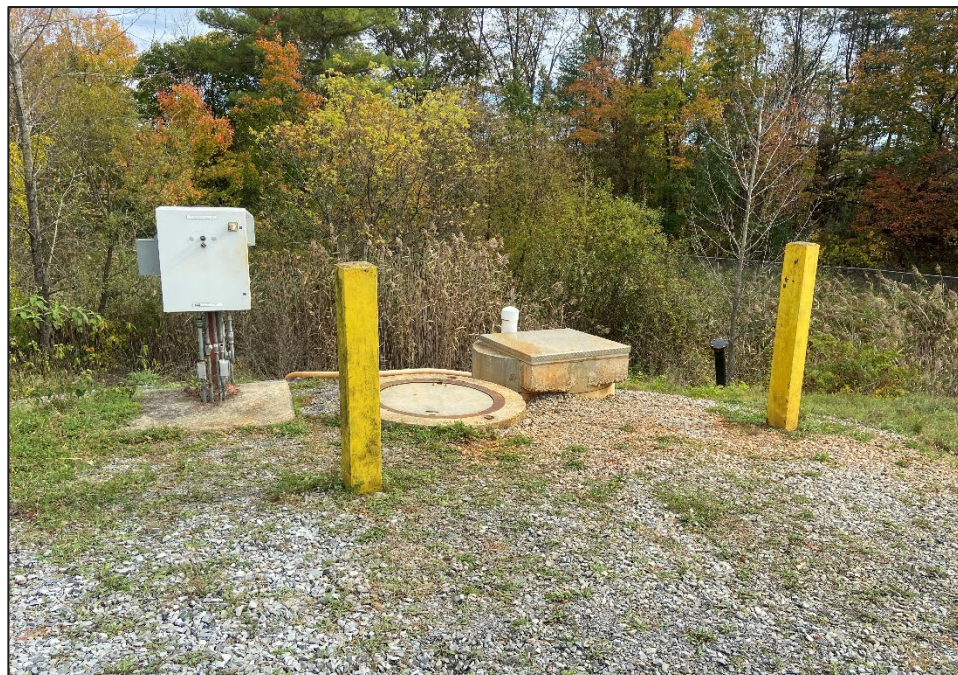
Photo: 8

Description:
View of Extraction Well EW-4

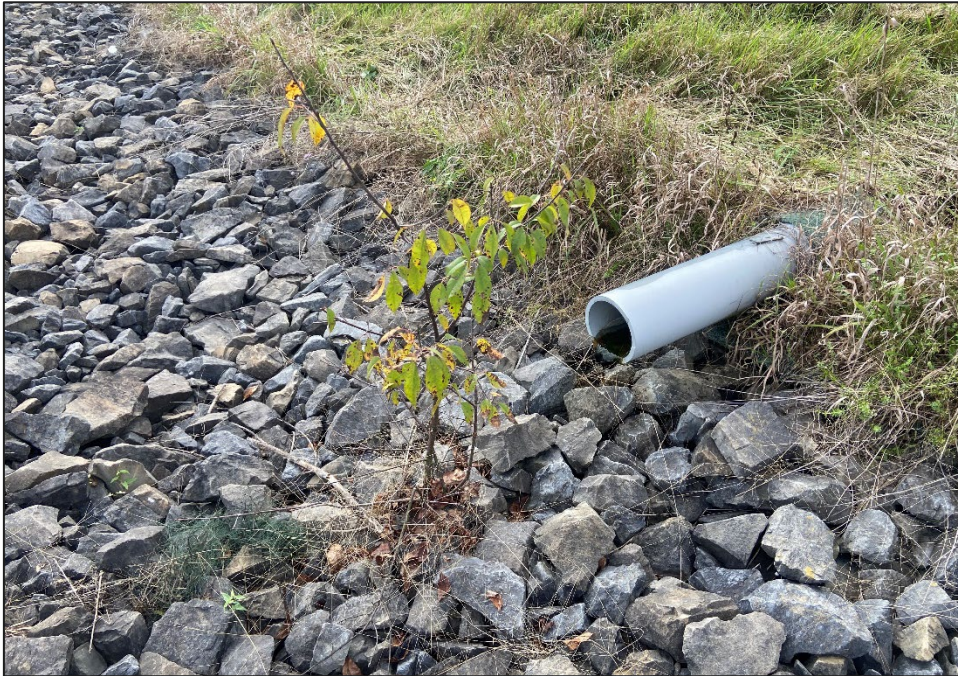
Photo: 9

View of active landfill drains
in Eastern mid-cap swale

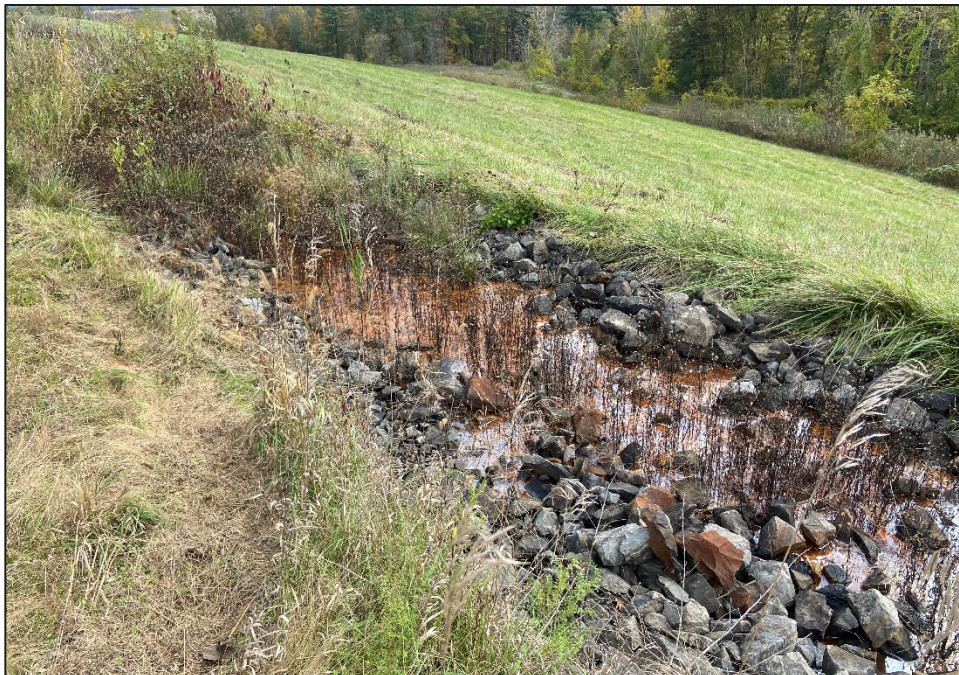
Photo: 10

View of ponding water within
Southern mid-cap swale

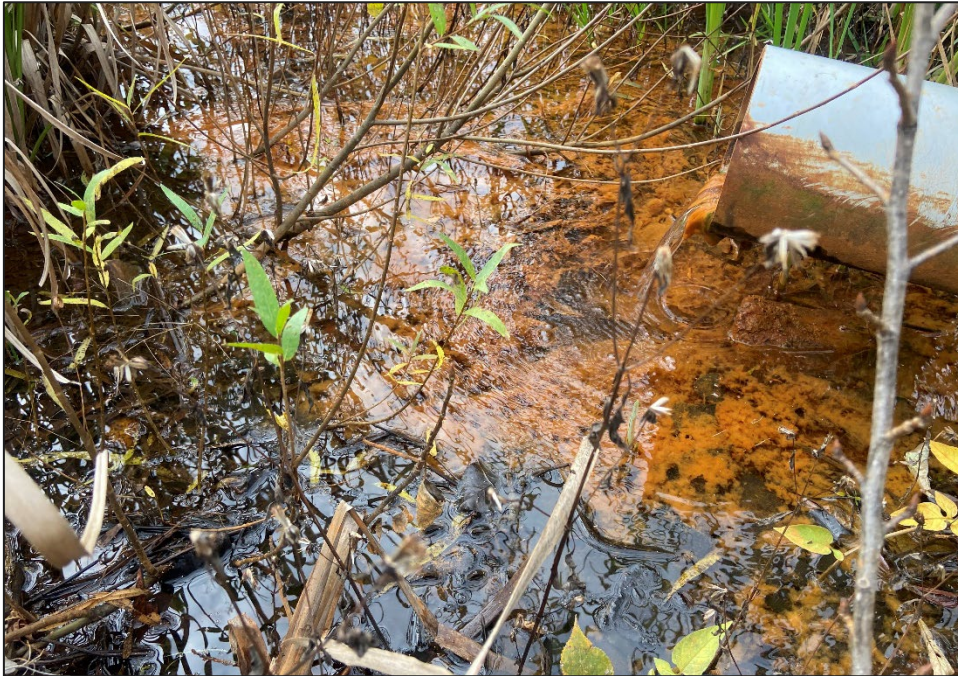
Photo: 11

View of Southern mid-cap
swale active landfill drain

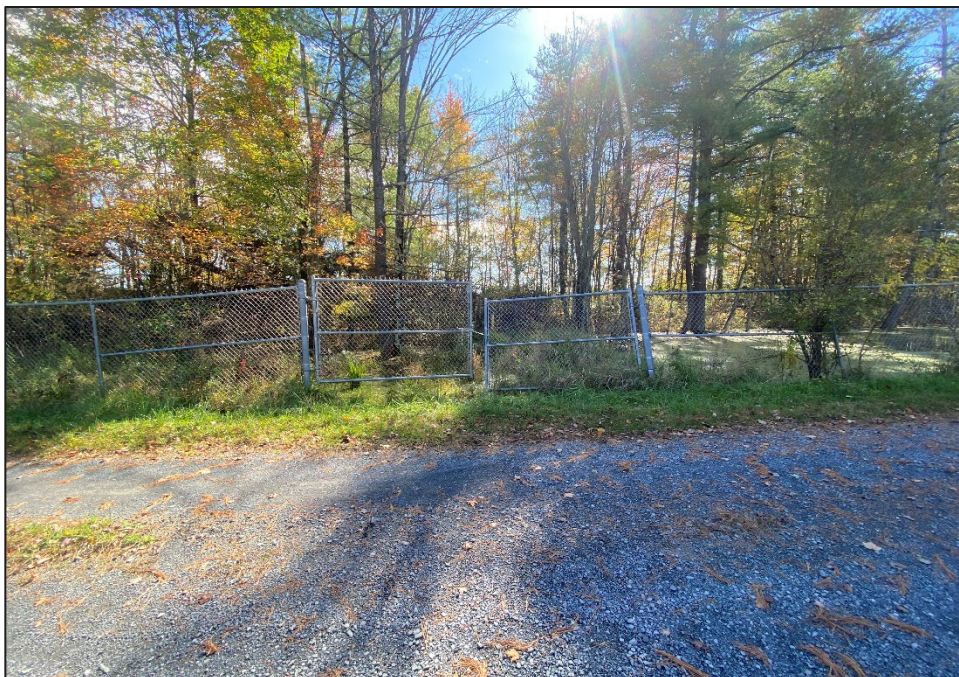
Photo: 12

View of leaning Southern
boundary access gate

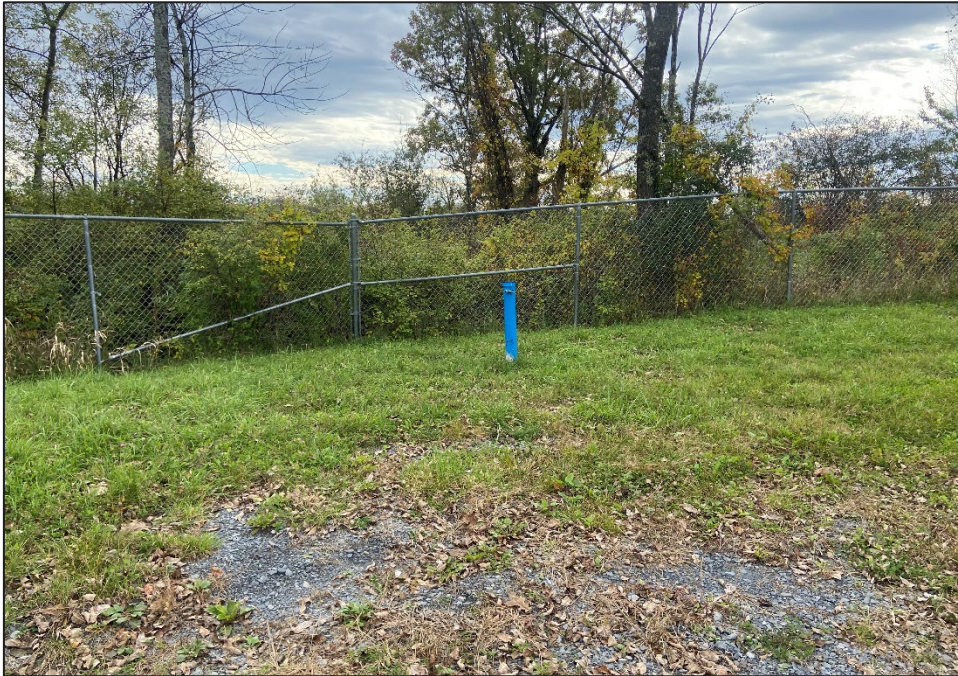
Photo: 13

Monitoring well MW-15

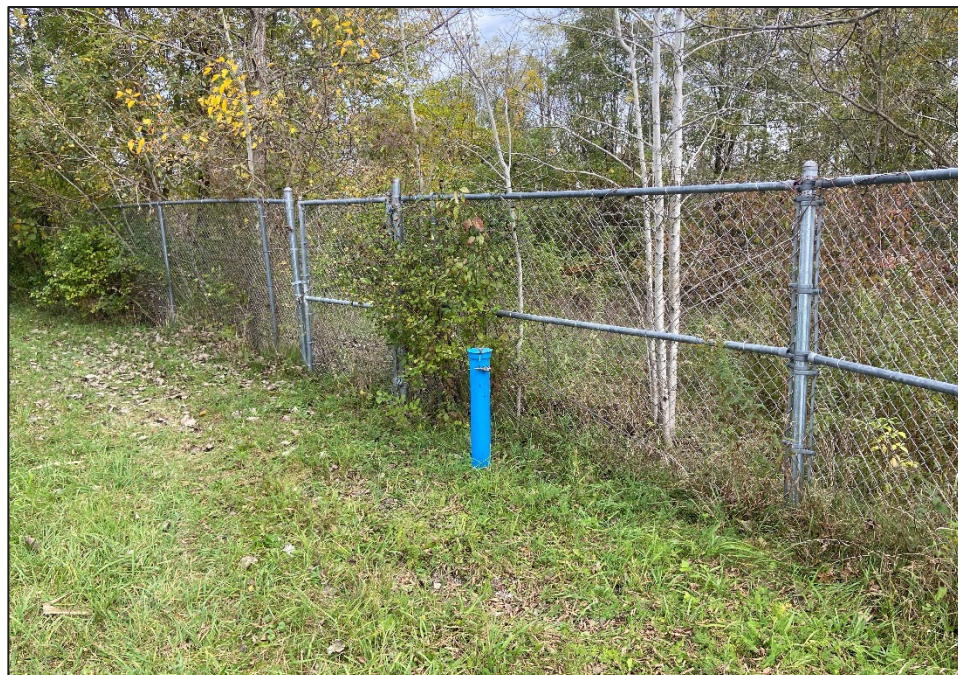
Photo: 14

Monitoring well MW-17
