| NYSDEC Division of Environmental Remediation | | NEW YORK STATE OF OPPORTUNITY | | Department of Environmental Conservation | | Contract No. DEC Insp. – DEC PM – <u>Payson Long</u> Contractor Supt. – Engineer PM – <u>Andy Vitolins.</u> Engineer Insp. – <u>Edward Brandt</u> | |
| Site Location: 48 Leavy Hollow Lane, Hudson Falls, NY 12839 | | | | | | | |
| Drainage Swale Erosion Emergency Repairs: Oversight of LaBella | | | | | | | |

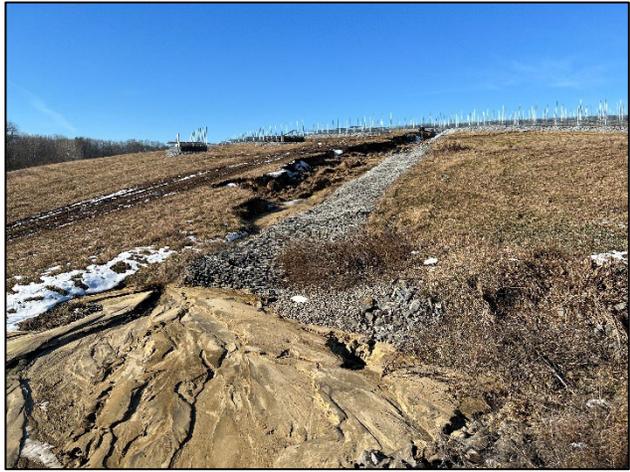
1. Swale before temporary repair work started.

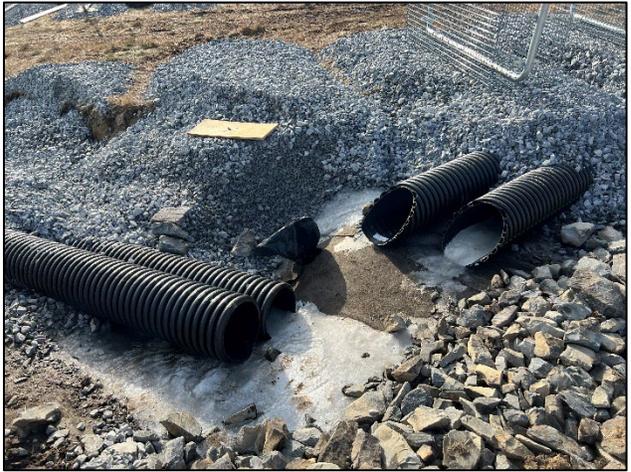
2. Pipes before removal at top of damaged part of swale.

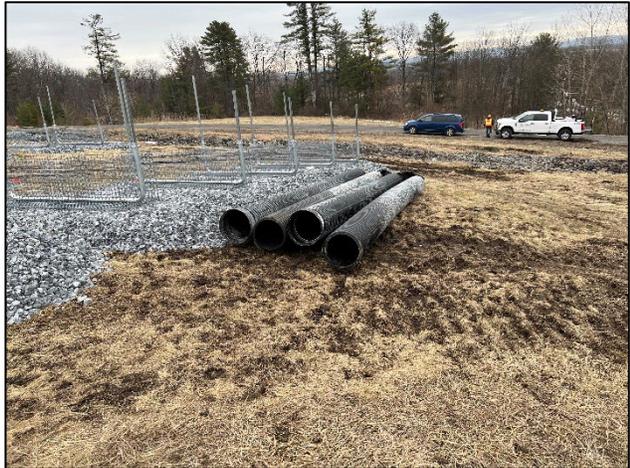
3. 12-inch drainage pipes removed from swale.

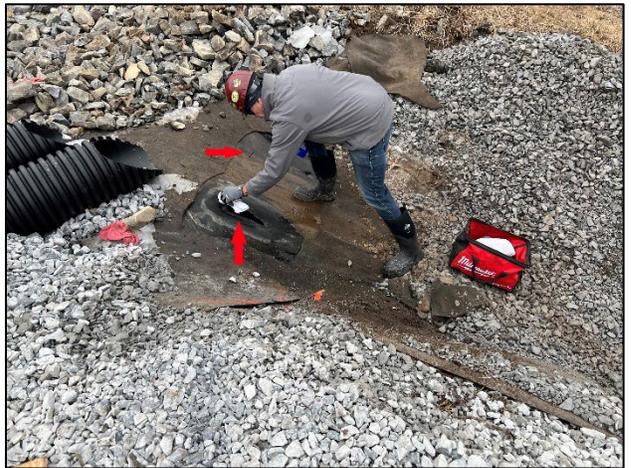
4. Puncture holes in HDPW geomembrane liner at location first found on 12/23.

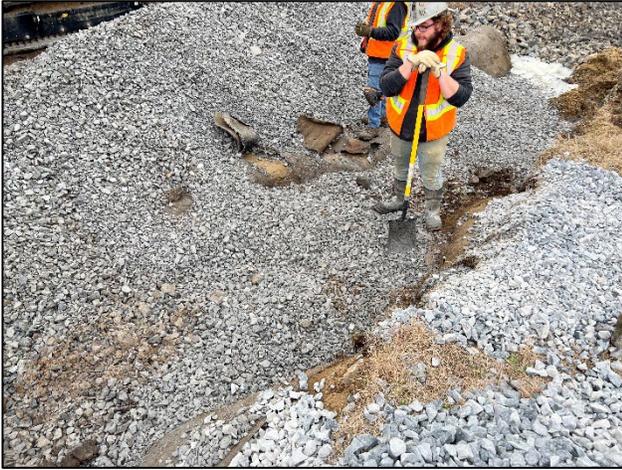
It was noted that more damage to the HDPE geomembrane liner was found once 2-inch leveling stone was removed from the down-chute.

5. Three more locations identified with HDPE geomembrane liner damage.

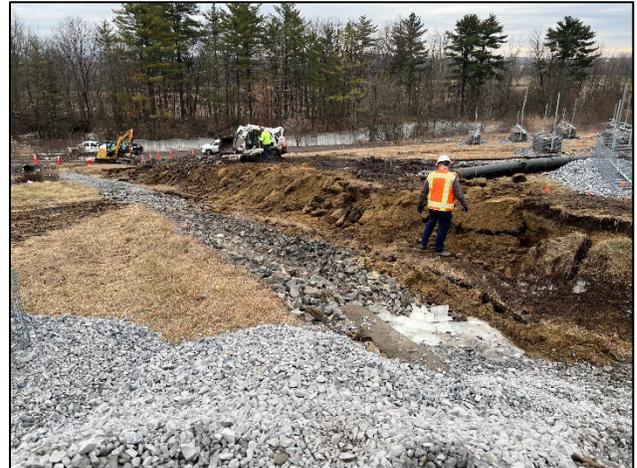
8. Unstable edge of down-chute swale grading.
