DAILY INSPECTION REPORT - No. 004

Fort Edward Landfill (Site # 558001)

Date: 1/5/2023

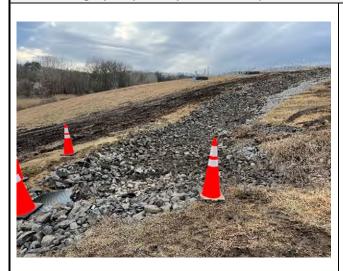
Water observed flowing below landfill road into landfill perimeter drainage swale below EW-4

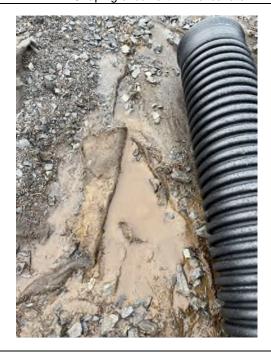
Rising water observed at damaged point in northeast culvert (See attached Site Map)
