Subject:
2022 Landfill Inspection Report
Fort Edward Landfill
NYSDEC Site No. 558001
Contract No. D009804-7

Date:
February 20, 2023

FORT EDWARD LANDFILL
NYSDEC SITE 558001
POST CLOSURE INSPECTION FORM

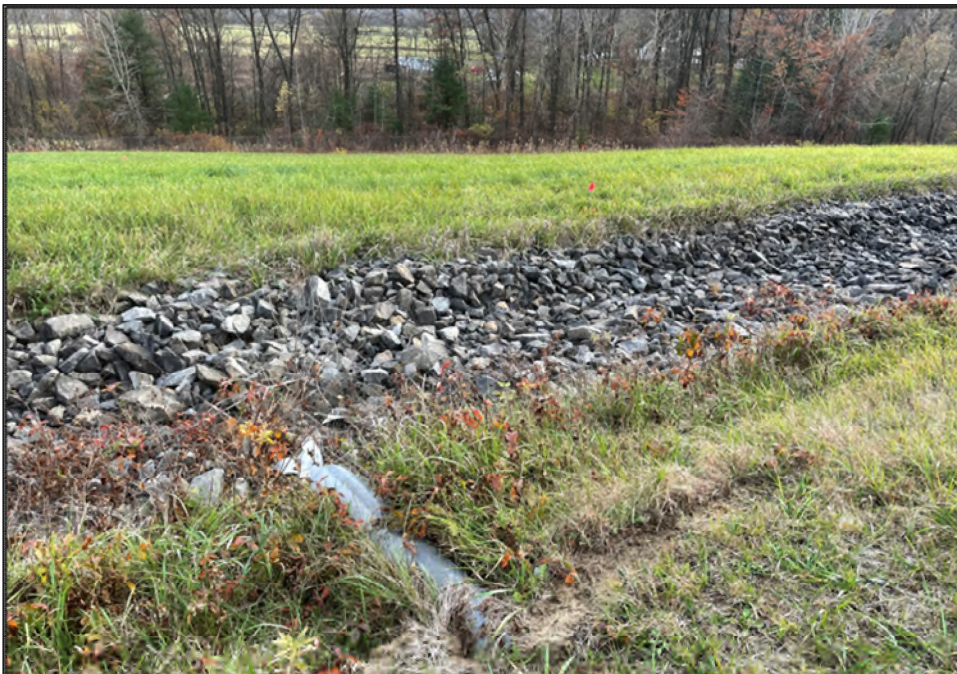
Photo: 10

6" PVC mid-cap drainage pipe damaged on southern slope (see photograph)

Damaged drainage pipe in mid-cap drainage swale on south slope of landfill, facing south

Southeastern slope of landfill cap.

Arcadis will repair the damaged PVC drain piping as part of routine O&M and rodent burrows will be backfilled and monitored for new activity.

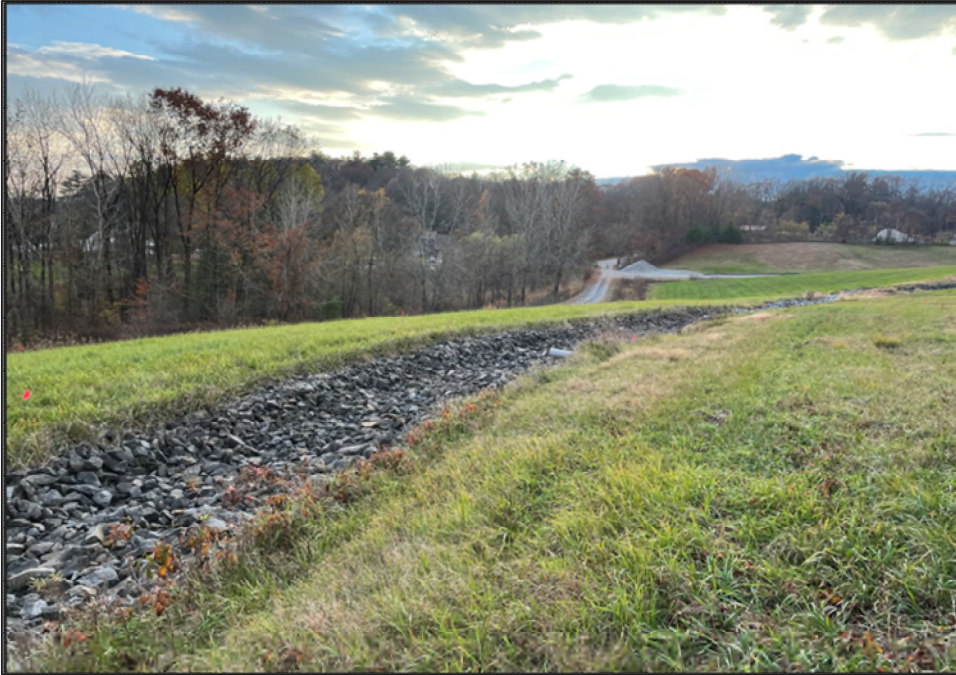
Photo: 11

Southern mid-cap swale, facing west. Landfill access gate in background.

Southern slope of landfill.

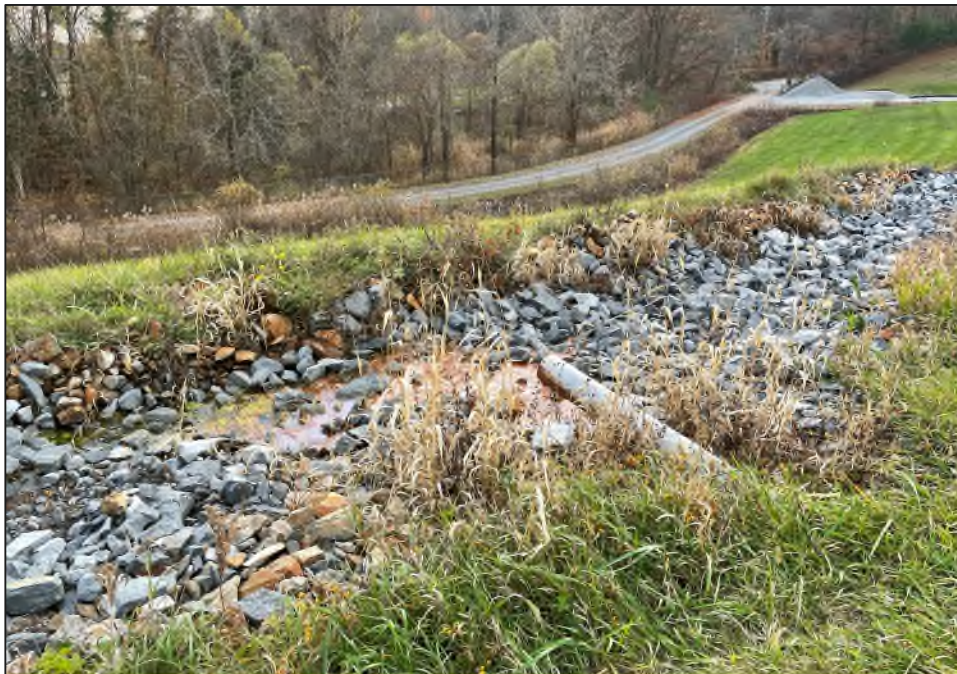
Photo: 12

Ponding in southern mid-cap swale (photo).

Iron staining in southern mid-cap swale, facing southwest.

Southern slope of landfill cap.

Iron staining and ponding in the mid-cap swale has been occurring since at least 2015. Arcadis removed sediment and vegetation and placed new riprap in portions of the mid-cap swale in June 2022. The condition of the swale will continue to be monitored but regrading of the swale may be necessary to restore proper flow.

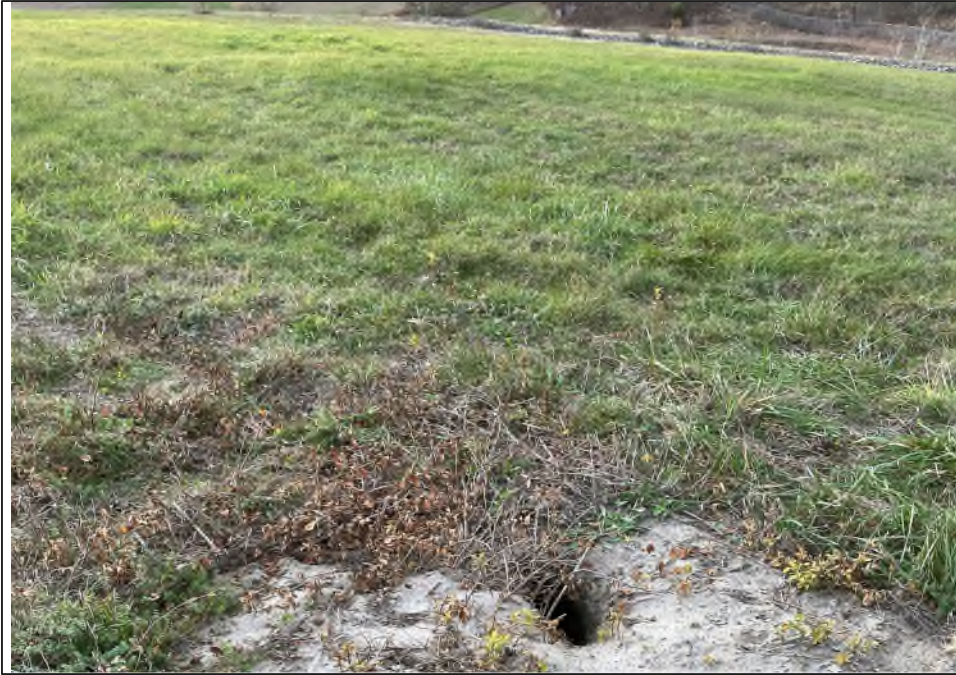
Photo: 15

Burrow on north central slope of landfill (photo).
Vegetation in perimeter swales.

Burrow on cap between LP-1 and GV-4 , facing northwest.

Top of landfill – west side.
