## APPENDIX O

### TDCS OPERATION, MAINTENANCE AND MONITORING

## SUMMARY OF TDCS OM&M – MAY 2009 TO DECEMBER 2010

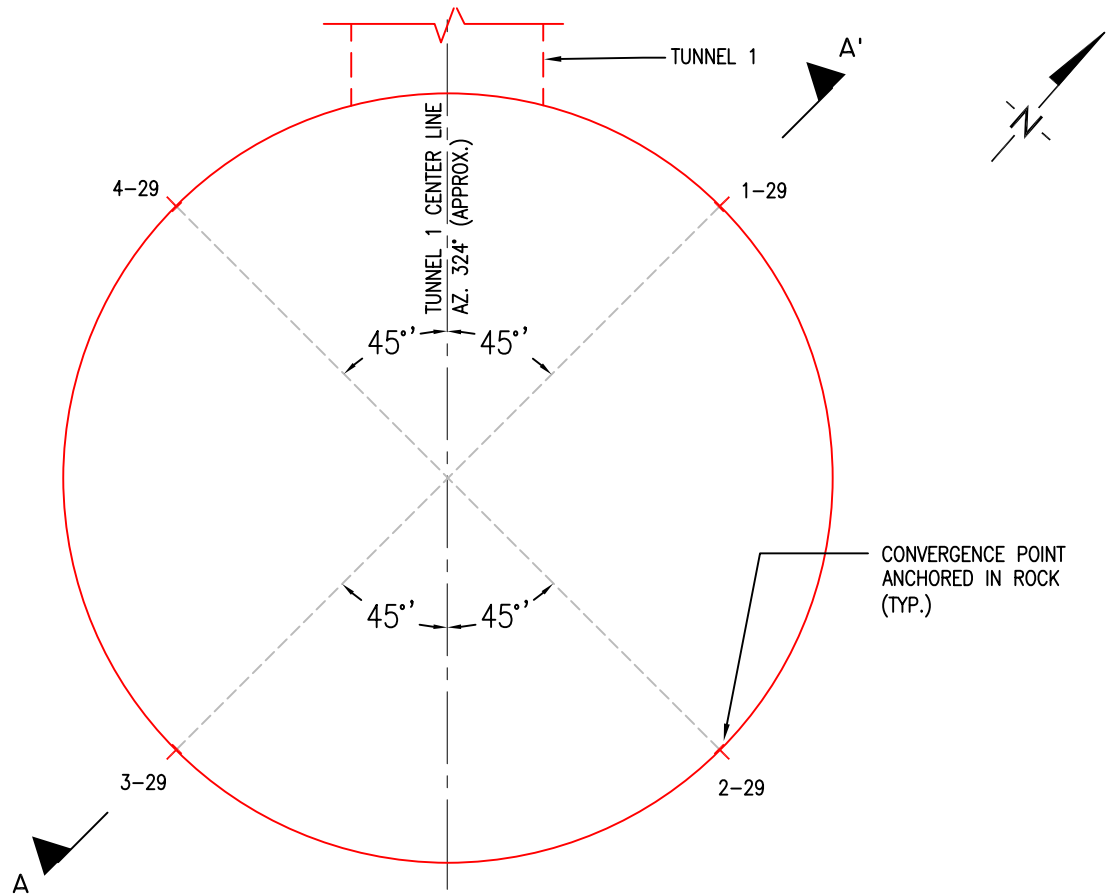
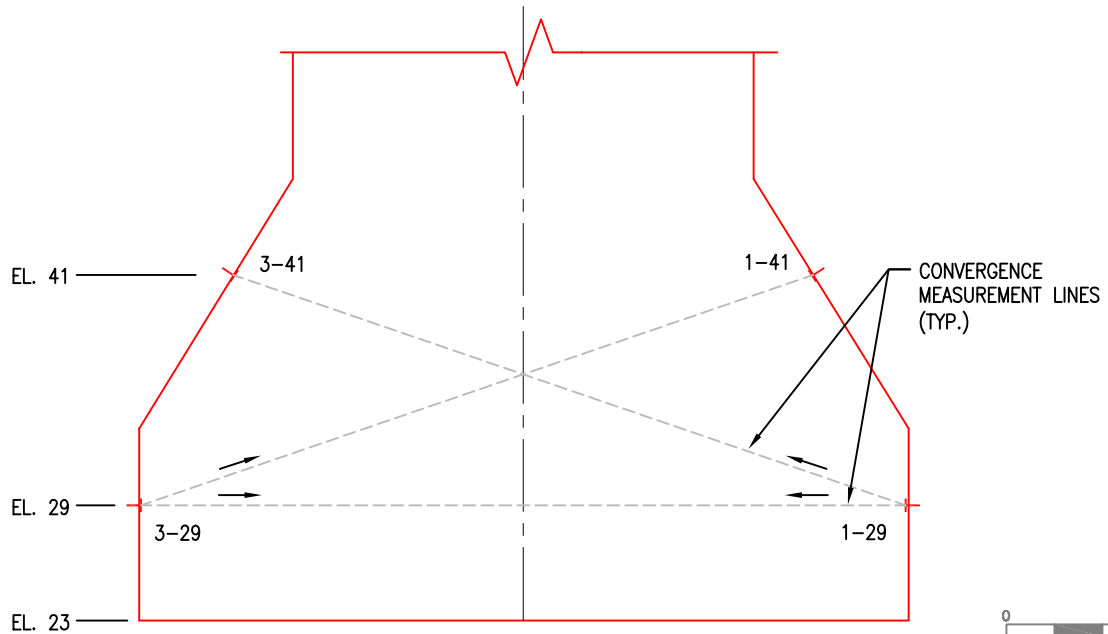
BELL-OUT PLAN AT ELEV. 23' - WORK SLAB

No deviations exceeded the Threshold Value of 0.04 ft from the first reading on 3-22-08 to the most recent reading on 9/14/10.

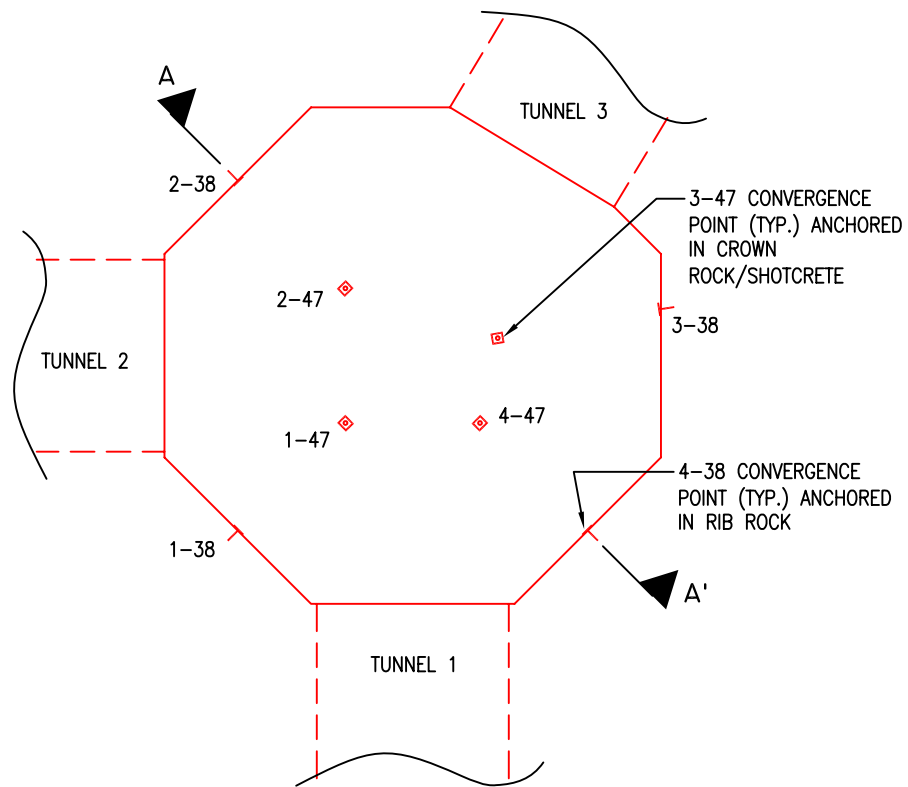
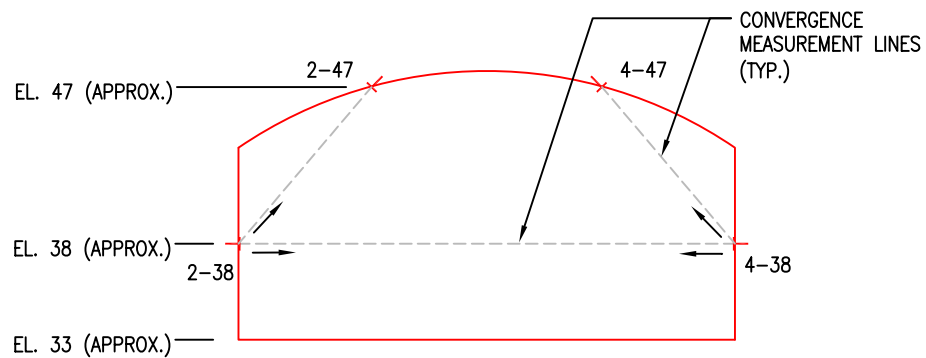
WORK ROOM I-I PLAN @ ELEVATION 33± (ROCK INVERT)

No readings exceeded the Threshold Value of 13 mm from the first reading on 3-22-08 to the most recent reading on 9-14-10.
