# **LIMITED ASBESTOS SURVEY REPORT**

## **Katzman Recycling Work Assignment No. D009812-16 NYSDEC Site No. 558035**

**24 County Route 26  
Granville, NY 12832**

**Report Date:** August 12, 2022

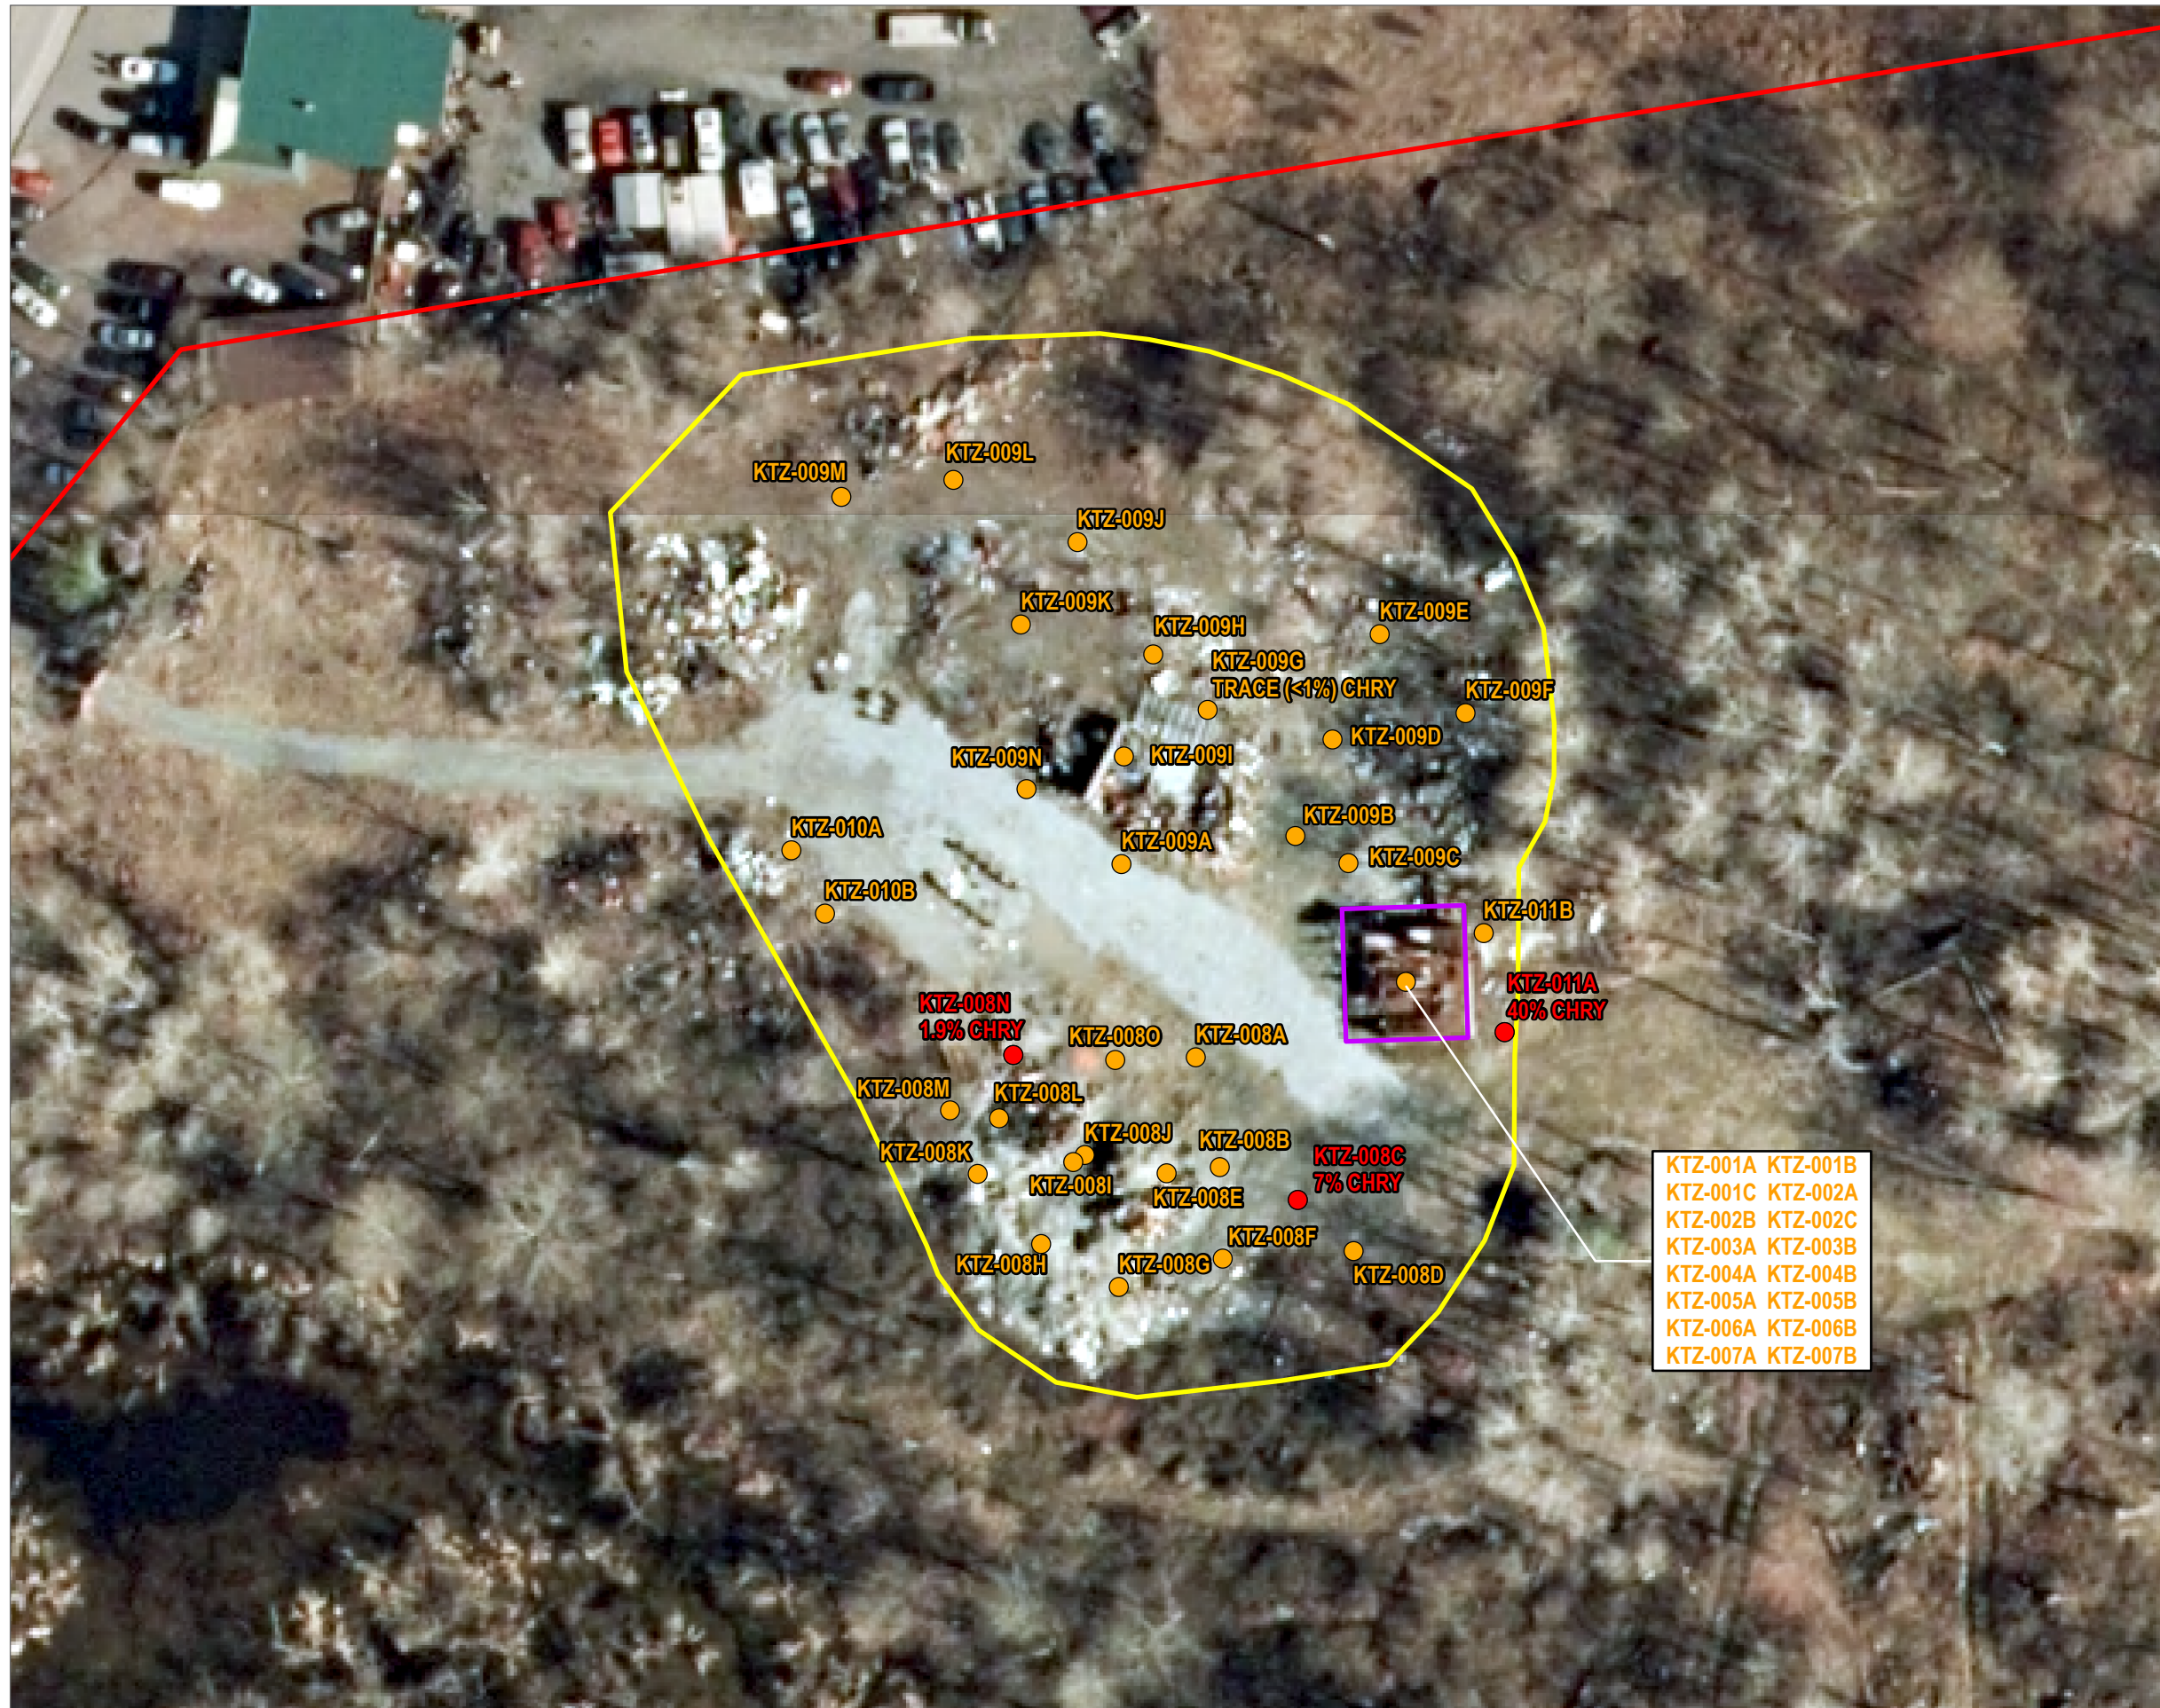
The results of the survey indicate that 3 of the 49 samples analyzed contained greater than 1% asbestos: KTZ-008C and KTZ-008N, both samples of various debris from the Southern Debris Pile Area containing 7% Chrysotile and 1.9% Chrysotile, respectively; and KTZ-011A, a sample of various debris from the Eastern Debris Area (east of the Former Incinerator Building), containing 40% Chrysotile (refer to **Figure 2**).

- To prevent disturbance of identified ACM at the Site, sample areas KTZ-008C, KTZ-008N, and KTZ-011A should be cordoned off with a high visibility snow fencing, or equivalent, encompassing a radial distance of 25 feet, or up to the distance of the nearest NAD sample, whichever is less.

- To prevent disturbance of trace asbestos material at the Site, sample area KTZ-009G should be cordoned off with high visibility snow fencing encompassing a radial distance of 25 feet, or up to the distance of the nearest NAD sample, whichever is less.

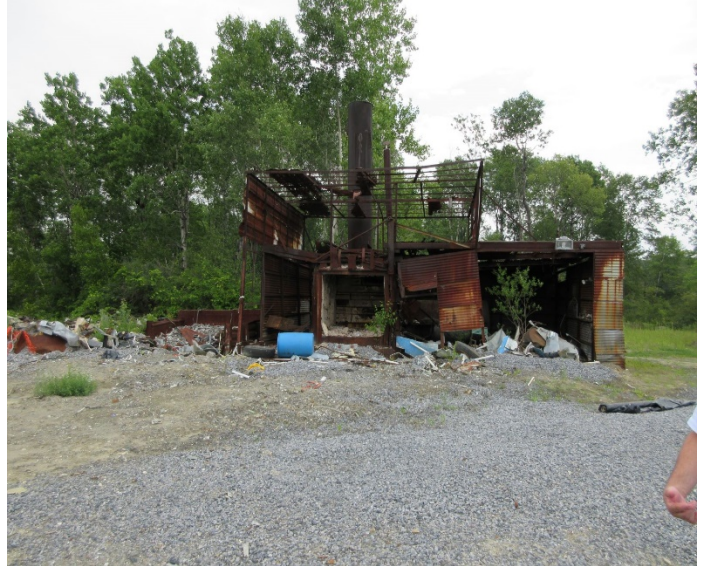
**Description:** Exterior view of the Former Incinerator Building.

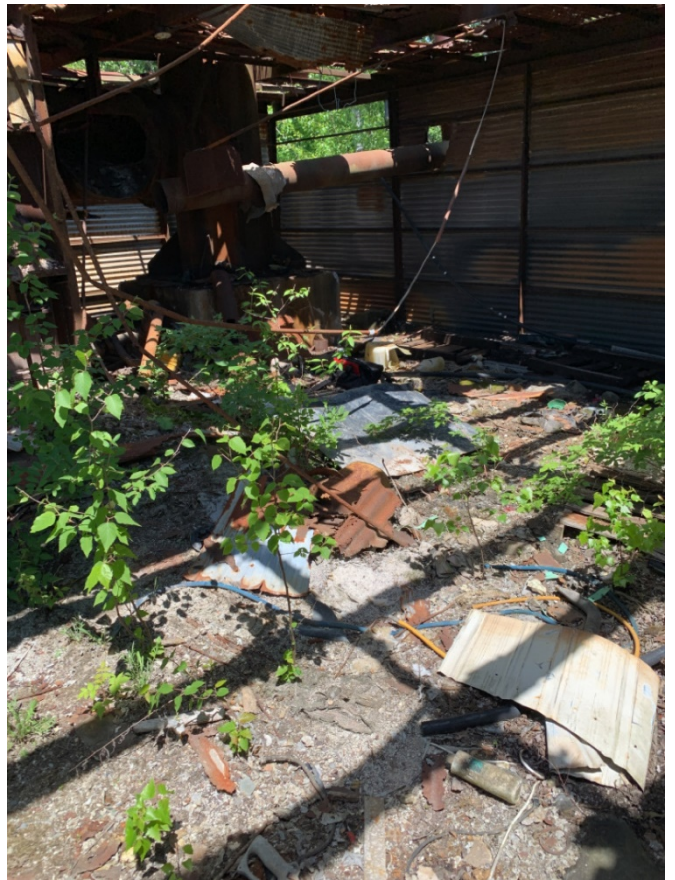
**Description:** Interior view of the Former Incinerator Building.

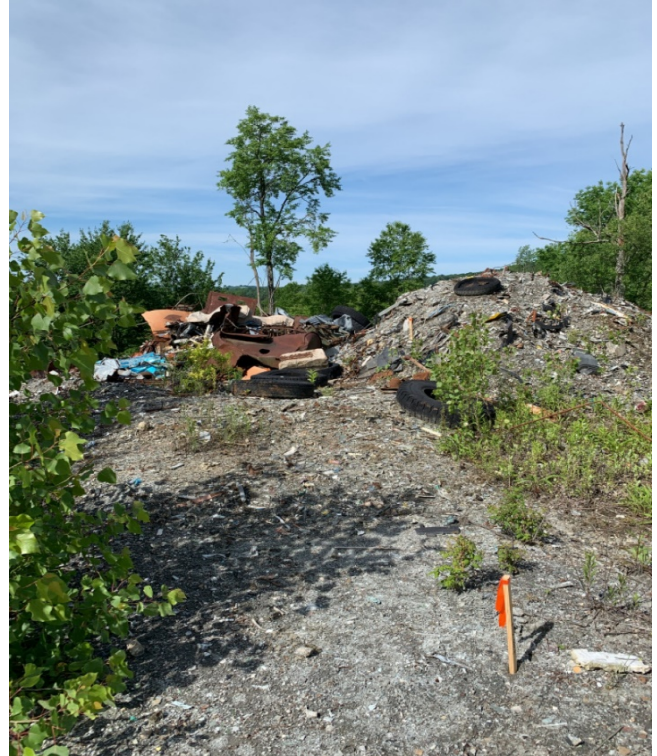
**Description:** View of a portion of the Southern Debris Area. A pile of debris is visible in the background. The staked location of asbestos bulk sample KTZ-008B is visible in the foreground.

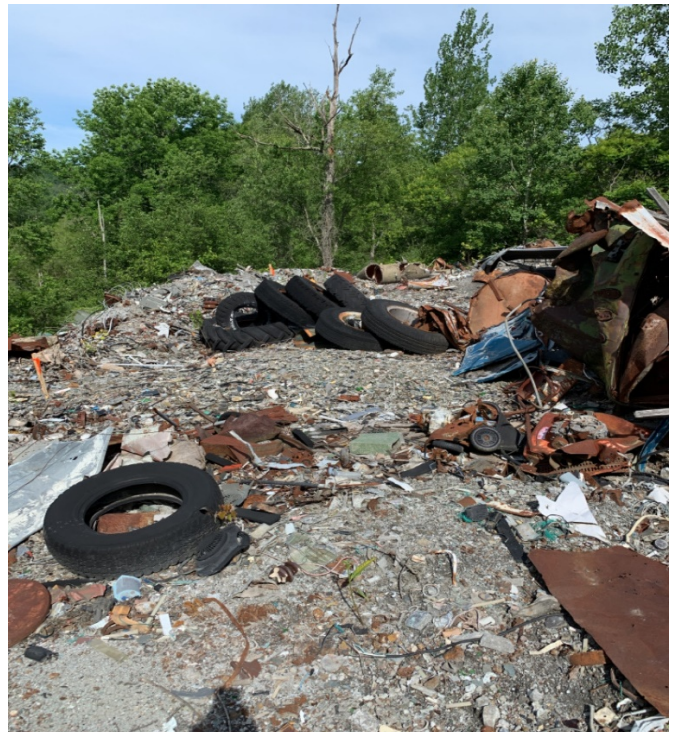
**Description:** View of a portion of the Southern Debris Area. The staked location of asbestos bulk sample KTZ-008G is visible on the left side of the photograph.

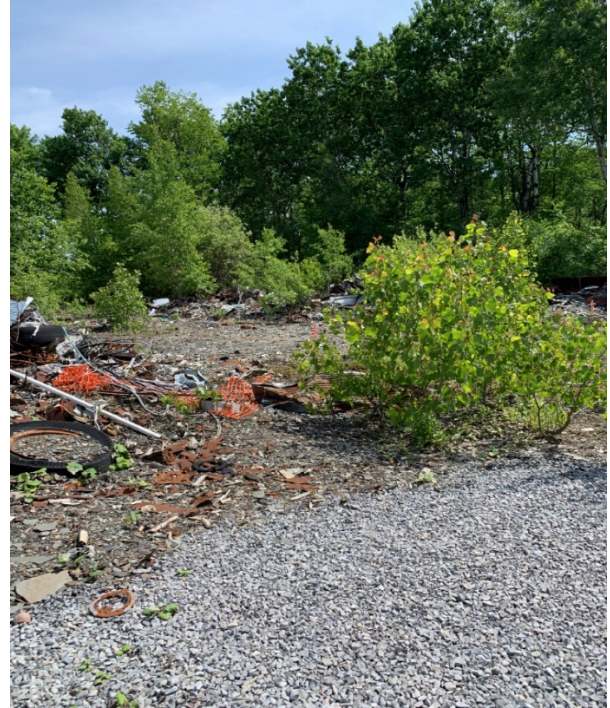
**Description:** View of a portion of the Northern Debris Area.

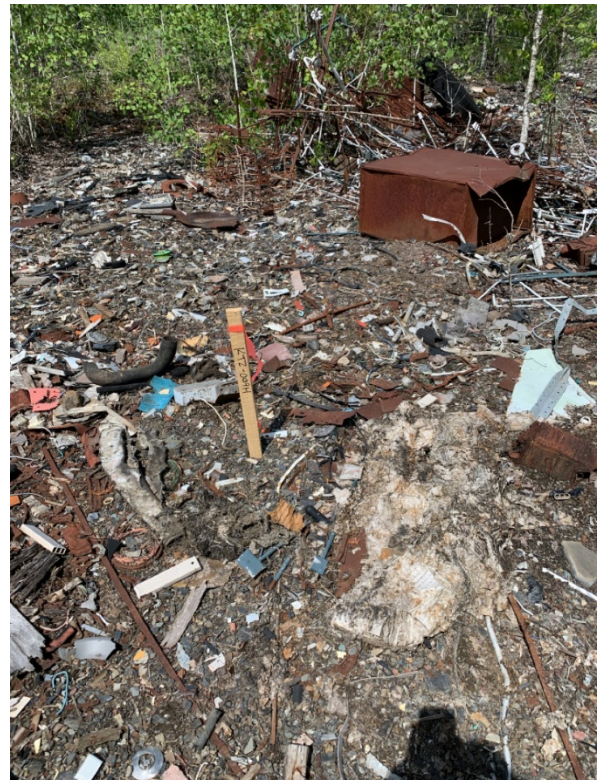
**Description:** View of a portion of the Northern Debris Area. Staked location of asbestos bulk sample KTZ-009H is visible in foreground. Photograph depiction is typical of Northern Debris Area.

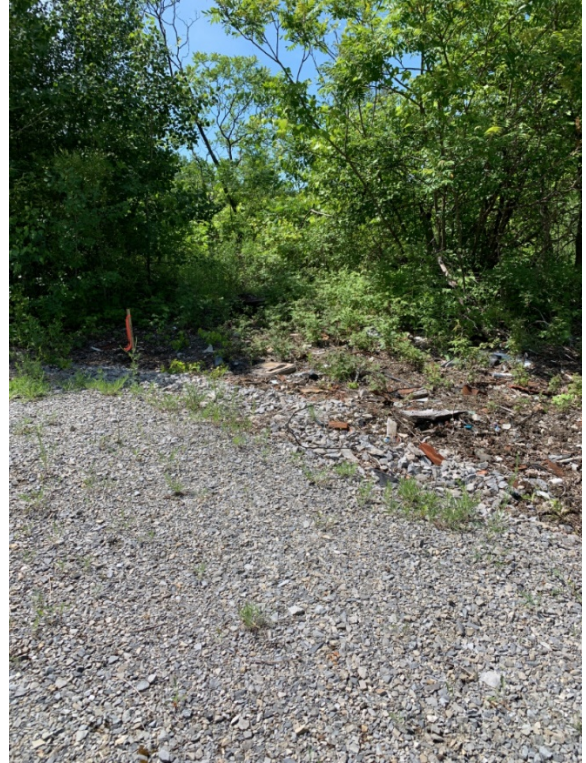
**Description:** View of a portion of the Western Debris Area. Staked location of asbestos bulk sample KTZ-010B is visible on left side of the photograph.

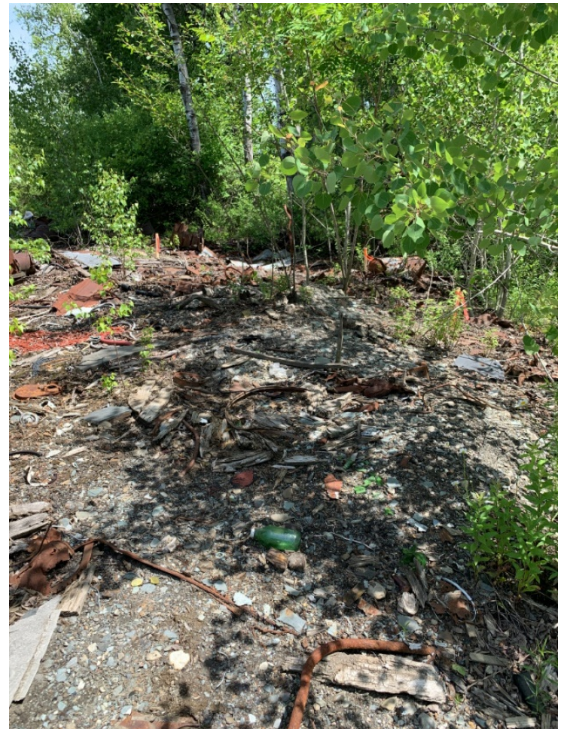
**Description:** View of the Eastern Debris Area located directly behind (east) of the Former Incinerator Building.

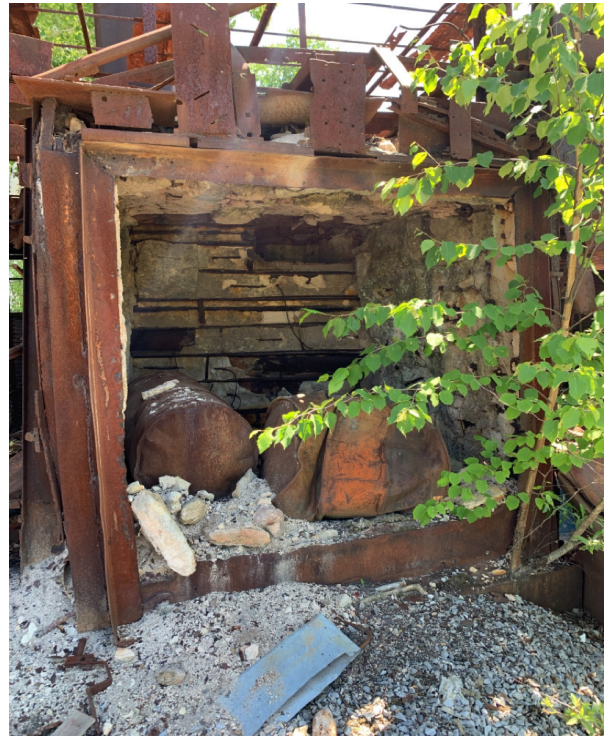
**Sample Numbers:** KTZ-001A, KTZ-001B, KTZ-001C  
**Material Description:** Concrete  
**Material Color:** Brown/Gray  
**Accessible Material:** Accessible  
**Reason Inaccessible:** N/A  
**Asbestos Detected:** Negative  
**Asbestos Type:** No Asbestos Detected  
**Homogeneous Area:** Former Incinerator Building -  
Incinerator  
**Total Approximate Quantity:** 500 SF  
**Condition:** Significantly Damaged  
**Material Type:** Surfacing  
**NESHAP Category:** N/A  
**Notes:** Not Applicable

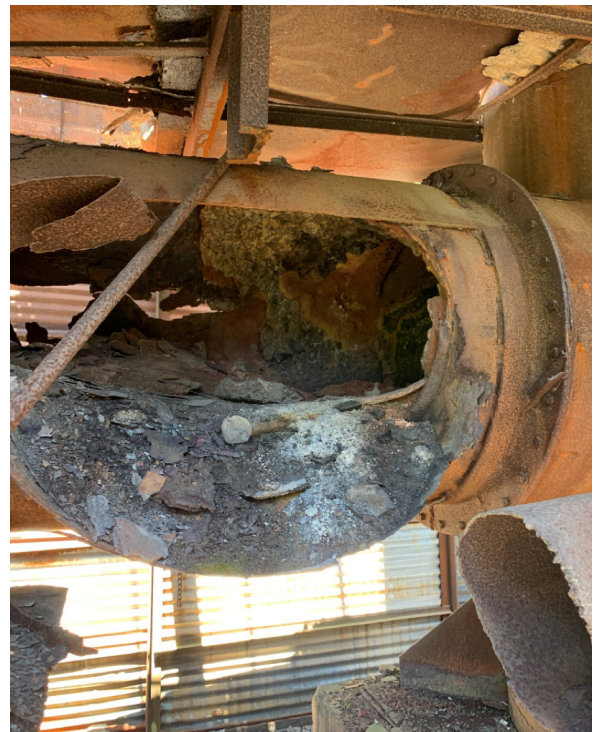
**Sample Numbers:** KTZ-002A, KTZ-002B, KTZ-002C  
**Material Description:** Concrete  
**Material Color:** Black/Gray/Red  
**Accessible Material:** Accessible  
**Reason Inaccessible:** N/A  
**Asbestos Detected:** Negative  
**Asbestos Type:** No Asbestos Detected  
**Homogeneous Area:** Former Incinerator Building -  
Stack Lining  
**Total Approximate Quantity:** 500 SF  
**Condition:** Significantly Damaged  
**Material Type:** Surfacing  
**NESHAP Category:** N/A  
**Notes:** Not Applicable

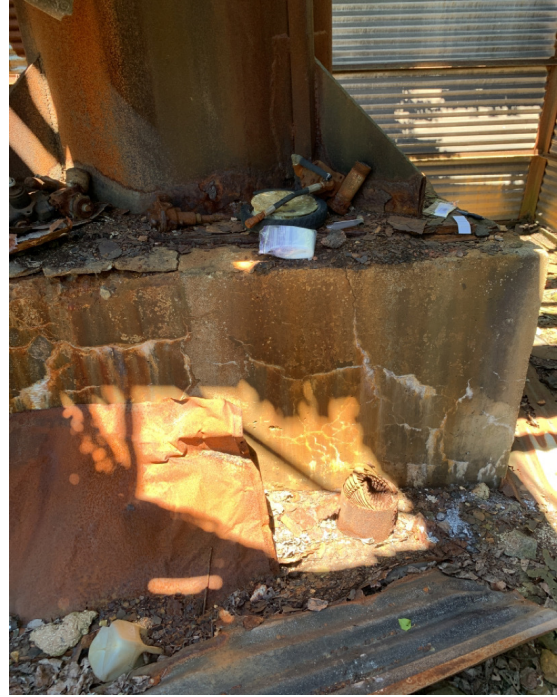
**Sample Numbers:** KTZ-003A, KTZ-003B  
**Material Description:** Concrete  
**Material Color:** Brown/Gray  
**Accessible Material:** Accessible  
**Reason Inaccessible:** N/A  
**Asbestos Detected:** Negative  
**Asbestos Type:** No Asbestos Detected  
**Homogeneous Area:** Former Incinerator Building  
**Total Approximate Quantity:** 150 CF  
**Condition:** Damaged  
**Material Type:** Misc.  
**NESHAP Category:** N/A  
**Notes:** Not Applicable

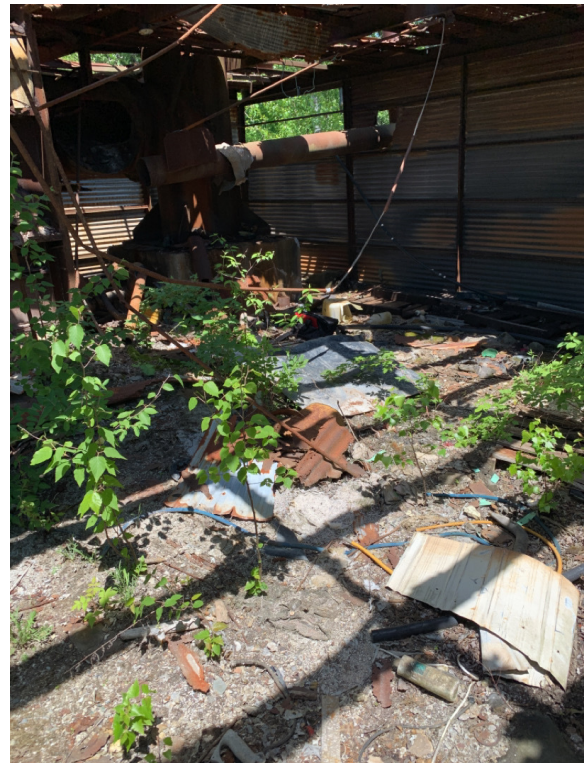
**Sample Numbers:** KTZ-004A, KTZ-004B  
**Material Description:** Debris  
**Material Color:** Brown/Gray/Black  
**Accessible Material:** Accessible  
**Reason Inaccessible:** N/A  
**Asbestos Detected:** Negative  
**Asbestos Type:** No Asbestos Detected  
**Homogeneous Area:** Former Incinerator Building - Floor  
**Total Approximate Quantity:** 720 SF  
**Condition:** Significantly Damaged  
**Material Type:** Misc.  
**NESHAP Category:** N/A  
**Notes:** Various debris scattered throughout floor

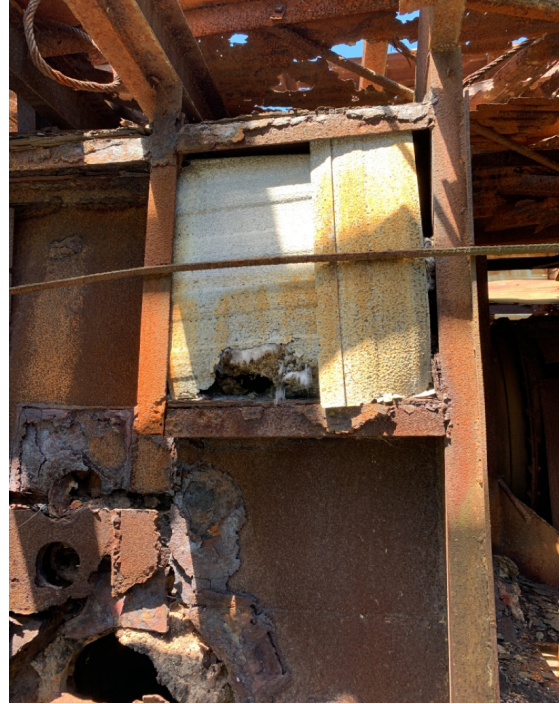
**Sample Numbers:** KTZ-005A, KTZ-005B  
**Material Description:** Insulation Breeching  
**Material Color:** Tan  
**Accessible Material:** Accessible  
**Reason Inaccessible:** N/A  
**Asbestos Detected:** Negative  
**Asbestos Type:** No Asbestos Detected  
**Homogeneous Area:** Former Incinerator Building  
**Total Approximate Quantity:** 4 SF  
**Condition:** Damaged  
**Material Type:** Misc.  
**NESHAP Category:** N/A  
**Notes:** Not Applicable

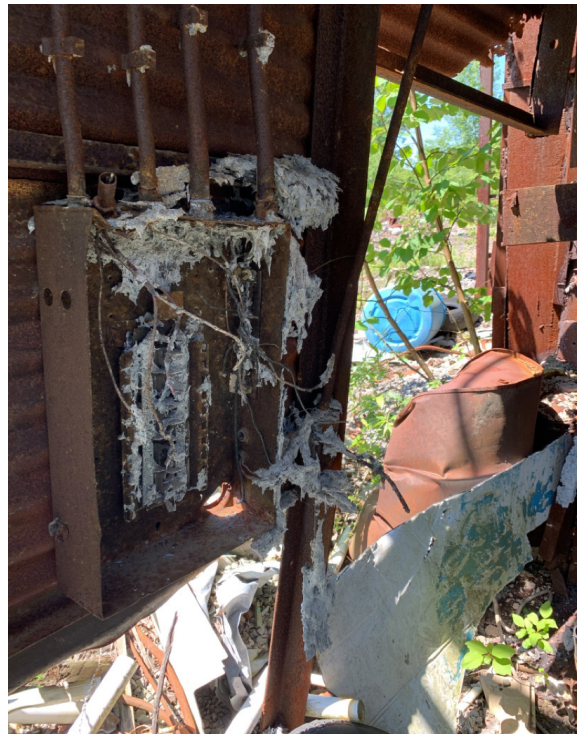
**Sample Numbers:** KTZ-006A, KTZ-006B  
**Material Description:** Concrete  
**Material Color:** Gray/White  
**Accessible Material:** Accessible  
**Reason Inaccessible:** N/A  
**Asbestos Detected:** Negative  
**Asbestos Type:** No Asbestos Detected  
**Homogeneous Area:** Former Incinerator Building  
**Total Approximate Quantity:** 6 SF  
**Condition:** Good  
**Material Type:** Misc.  
**NESHAP Category:** N/A  
**Notes:** Not Applicable

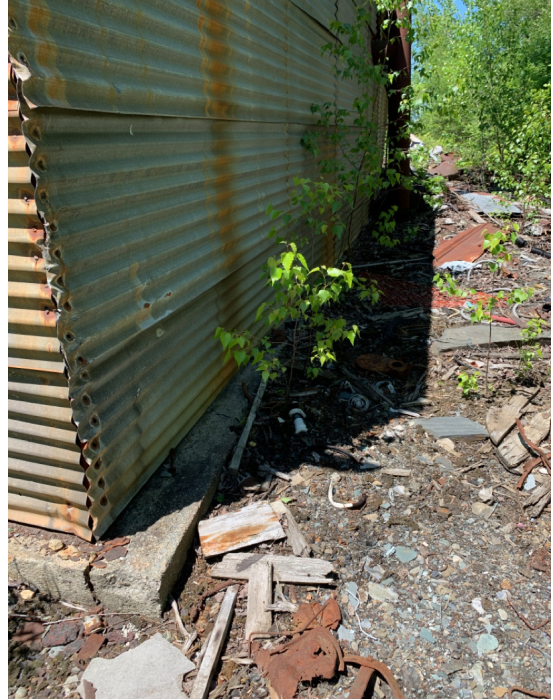
**Sample Numbers:** KTZ-007A, KTZ-007B  
**Material Description:** Concrete  
**Material Color:** Gray  
**Accessible Material:** Accessible  
**Reason Inaccessible:** N/A  
**Asbestos Detected:** Negative  
**Asbestos Type:** No Asbestos Detected  
**Homogeneous Area:** Former Incinerator Building - Floor Slab  
**Total Approximate Quantity:** 1200 SF  
**Condition:** Good  
**Material Type:** Misc.  
**NESHAP Category:** N/A  
**Notes:** Not Applicable

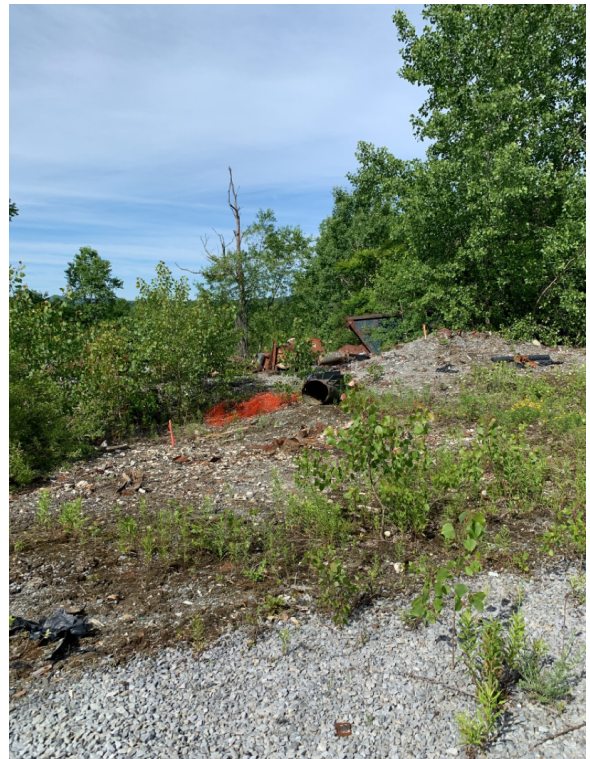
**Sample Numbers:** KTZ-008A, KTZ-008B, KTZ-008C, KTZ-008D, KTZ-008E, KTZ-008F, KTZ-008G, KTZ-008H, KTZ-008I, KTZ-008J, KTZ-008K, KTZ-008L, KTZ-008M, KTZ-008N, KTZ-008O  
**Material Description:** Debris  
**Material Color:** Black/Gray/Brown  
**Accessible Material:** Accessible  
**Reason Inaccessible:** N/A  
**Asbestos Detected:** Positive  
**Asbestos Type:** Chrysotile  
**Homogeneous Area:** Southern Debris Area  
**Total Approximate Quantity:** 10000 SF  
**Condition:** Significantly Damaged  
**Material Type:** Misc.  
**NESHAP Category:** Cat II  
**Notes:** Ash throughout debris. Asbestos detected in 2 of the 15 samples submitted for analysis.

KTZ-008C – 7% Chrysotile  
 KTZ-008N – 1.9% Chrysotile

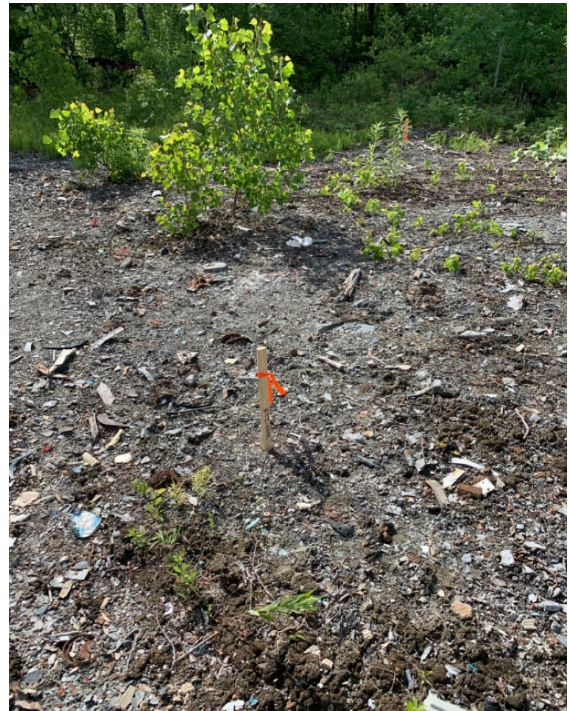
| <b>Table 1 - Samples with Asbestos &gt;1% (ACM)</b><br><b>Katzman Recycling</b><br><b>NYSDEC Site No. 558035</b> | | | | | |
|---|---|---|---|---|---|
| KTZ-008C | Various<br>Debris | Southern<br>Debris Area | 7% /<br>Chrysotile | 700 SF | Significantly<br>Damaged, Misc.,<br>Cat II |

**Sample Number:** KTZ-008C  
**Material Description:** Debris  
**Material Color:** Black  
**Accessible Material:** Accessible  
**Reason Inaccessible:** N/A  
**Asbestos Detected:** Positive  
**Asbestos Concentration:** 7%  
**Asbestos Type:** Chrysotile  
**Homogeneous Area:** Southern Debris Area  
**Total Approximate Quantity:** 700 SF  
**Condition:** Significantly Damaged  
**Material Type:** Misc.  
**NESHAP Category:** Cat II  
**Notes:** Ash throughout debris. Asbestos detected in 2 of the 15 samples submitted for analysis.

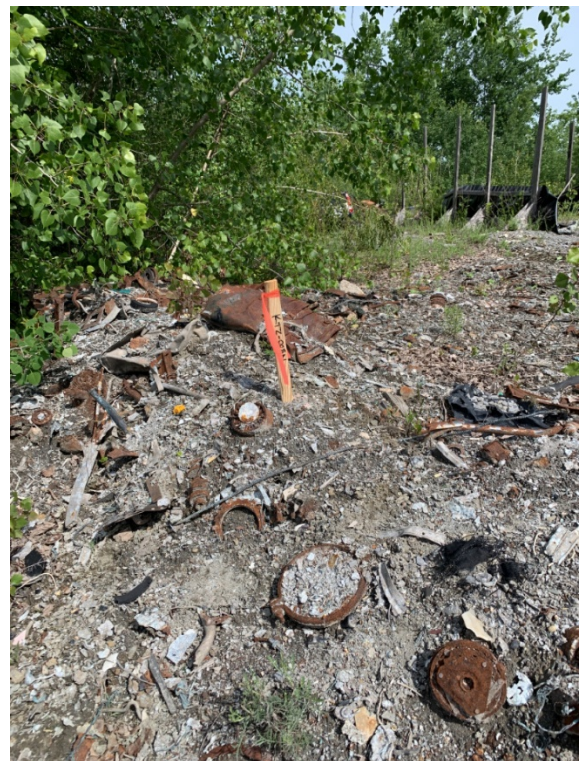
| <b>Table 1 - Samples with Asbestos &gt;1% (ACM)</b><br><b>Katzman Recycling</b><br><b>NYSDEC Site No. 558035</b> | | | | | |
|---|---|---|---|---|---|
| KTZ-008N | Various<br>Debris | Southern<br>Debris Area | 1.9% /<br>Chrysotile | 700 SF | Significantly<br>Damaged, Misc.,<br>Cat II |

**Sample Number:** KTZ-008N  
**Material Description:** Debris  
**Material Color:** Black/Gray  
**Accessible Material:** Accessible  
**Reason Inaccessible:** N/A  
**Asbestos Detected:** Positive  
**Asbestos Concentration:** 1.9%  
**Asbestos Type:** 700 SF  
**Homogeneous Area:** Southern Debris Area  
**Total Approximate Quantity:** 10000 SF  
**Condition:** Significantly Damaged  
**Material Type:** Misc.  
**NESHAP Category:** Cat II  
**Notes:** Ash throughout debris. Asbestos detected in 2 of the 15 samples submitted for analysis.

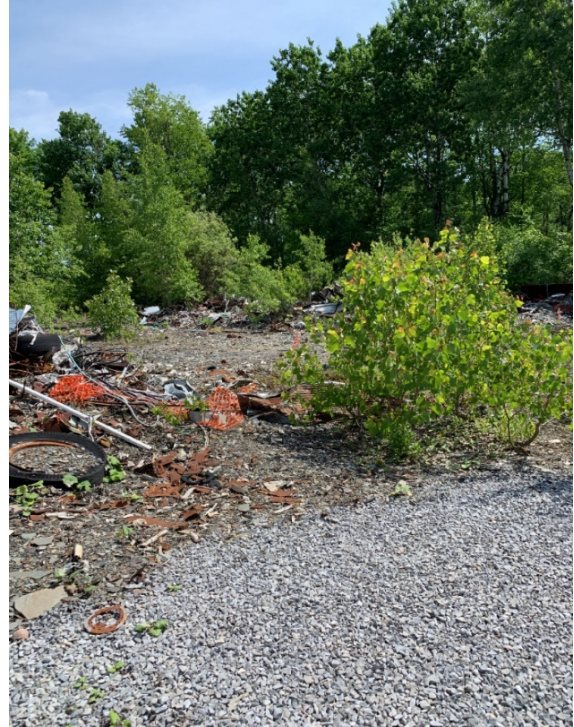
**Sample Numbers:** KTZ-009A, KTZ-009B, KTZ-009C, KTZ-009D, KTZ-009E, KTZ-009F, KTZ-009G, KTZ-009H, KTZ-009I, KTZ-009J, KTZ-009K, KTZ-009L, KTZ-009M, KTZ-009N

**Condition:** Significantly Damaged

**Notes:** Ash scattered through debris. Trace asbestos detected in 1 of the 14 samples submitted for analysis.

KTZ-009G - <1% Chrysotile

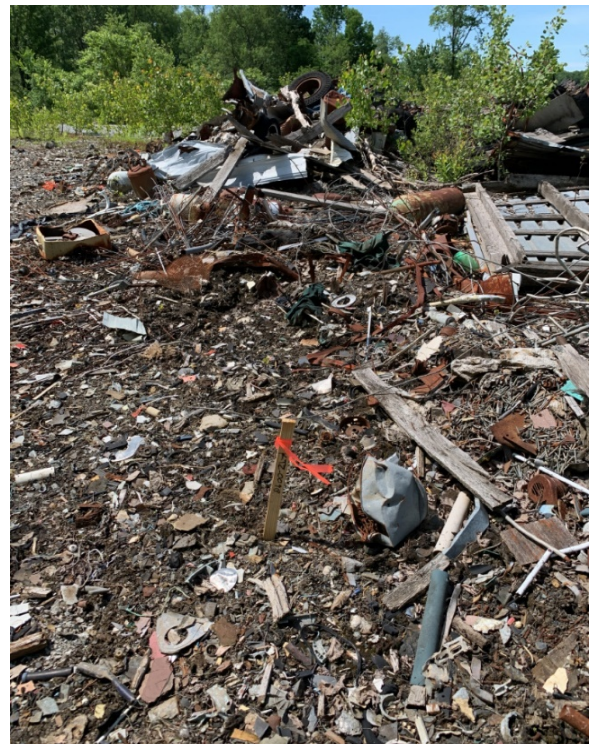
**Sample Number:** KTZ-009G

| <b>Table 2 - Samples with Asbestos ≤1% (Trace Asbestos)</b><br><b>Katzman Recycling</b><br><b>NYSDEC Site No. 558035</b> | | | | | |
|---|---|---|---|---|---|
| KTZ-009G | Various<br>Debris | Northern<br>Debris Area | <1% /<br>Chrysotile* | 1,200 SF | Significantly<br>Damaged |

**Condition:** Significantly Damaged

**Notes:** Ash throughout debris.

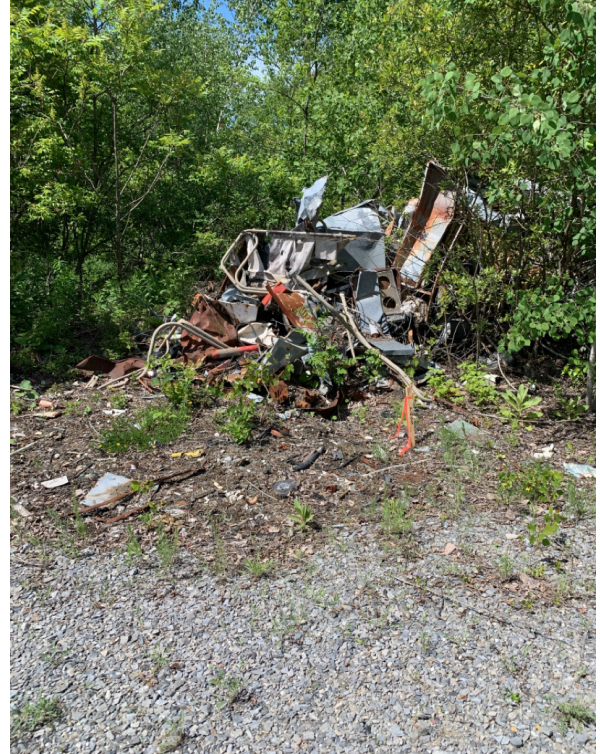
**Sample Numbers:** KTZ-010A, KTZ-010B  
**Material Description:** Debris  
**Material Color:** Black/Gray  
**Accessible Material:** Accessible  
**Reason Inaccessible:** N/A  
**Asbestos Detected:** Negative  
**Asbestos Type:** No Asbestos Detected  
**Homogeneous Area:** Western Debris Area  
**Total Approximate Quantity:** 300 SF  
**Condition:** Significantly Damaged  
**Material Type:** Misc.  
**NESHAP Category:** N/A  
**Notes:** Ash mixed within debris

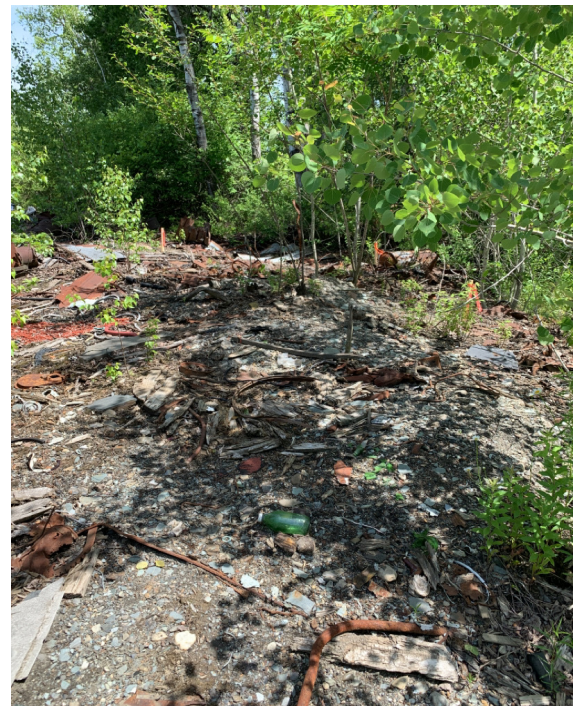
**Sample Numbers:** KTZ-011A, KTZ-011B  
**Material Description:** Debris  
**Material Color:** Brown/Black  
**Accessible Material:** Accessible  
**Reason Inaccessible:** N/A  
**Asbestos Detected:** Positive  
**Asbestos Type:** Chrysotile  
**Homogeneous Area:** Eastern Debris Area  
**Total Approximate Quantity:** 1000 SF  
**Condition:** Significantly Damaged  
**Material Type:** Misc.  
**NESHAP Category:** Cat II  
**Notes:** Area behind incinerator building, ash mixed throughout debris. Asbestos detected in 1 of the 2 samples submitted for analysis.

KTZ-011A – 40% Chrysotile

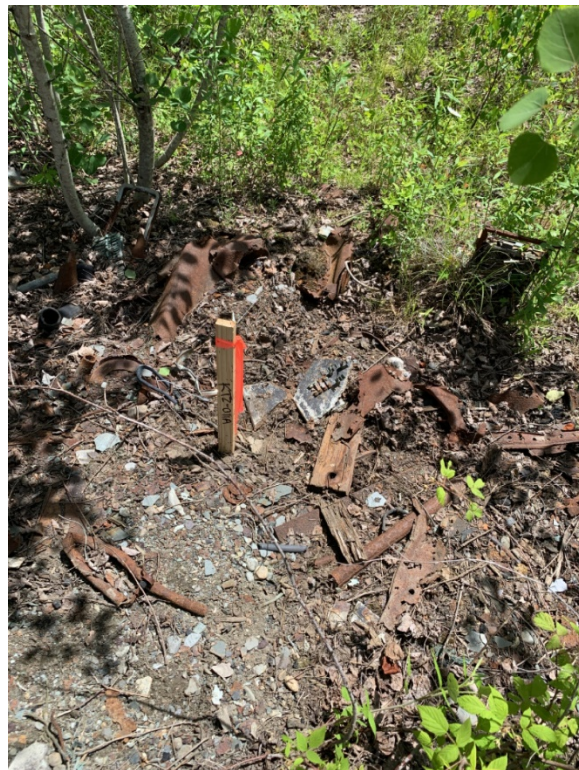
| <b>Table 1 - Samples with Asbestos &gt;1% (ACM)</b><br><b>Katzman Recycling</b><br><b>NYSDEC Site No. 558035</b> | | | | | |
|---|---|---|---|---|---|
| KTZ-011A | Various<br>Debris | Eastern<br>Debris Area | 40% /<br>Chrysotile | 500 SF | Significantly<br>Damaged, Misc.,<br>Cat II |

**Sample Number:** KTZ-011A  
**Material Description:** Debris  
**Material Color:** Brown/Black  
**Accessible Material:** Accessible  
**Reason Inaccessible:** N/A  
**Asbestos Detected:** Positive  
**Asbestos Concentration:** 40%  
**Asbestos Type:** Chrysotile  
**Homogeneous Area:** Southern Debris Area  
**Total Approximate Quantity:** 1150 SF  
**Condition:** Significantly Damaged  
**Material Type:** Misc.  
**NESHAP Category:** II  
**Notes:** Ash throughout debris.
