**FINAL
TECHNICAL MEMORANDUM
2017 LONG TERM MONITORING OF
LANDFILL AREAS OF CONCERN
FORMER GRIFFISS AIR FORCE BASE
ROME, NEW YORK**

PREPARED BY: Bhate Environmental Associates, Inc.

DATE: June 14, 2018

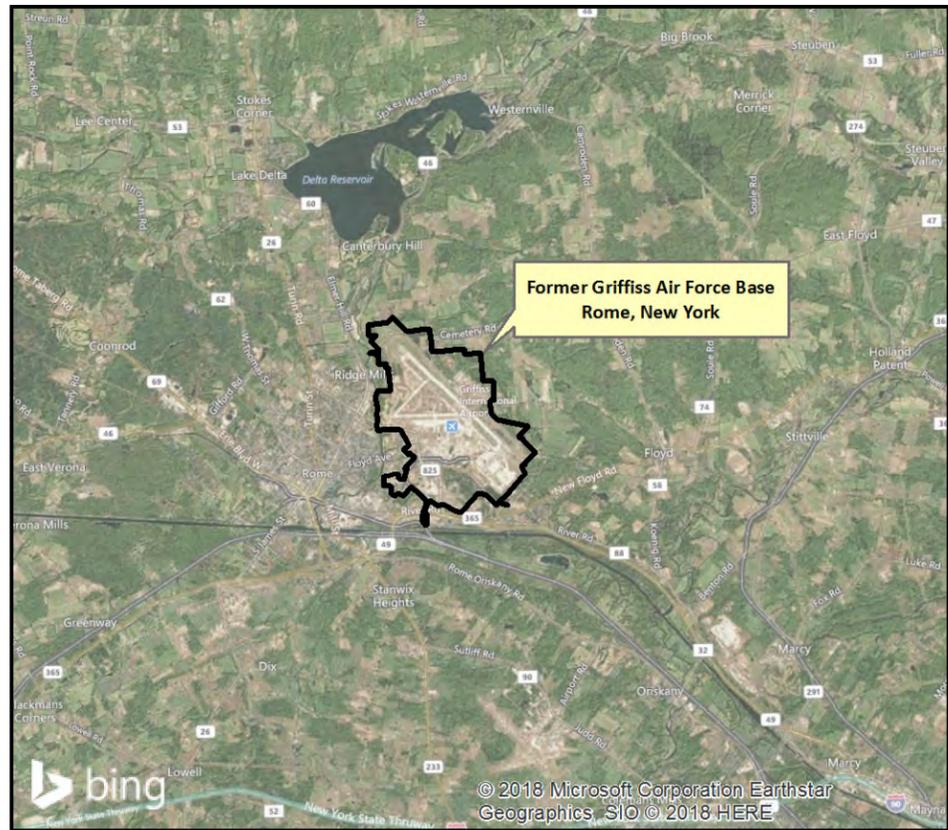
Landfill Inspections

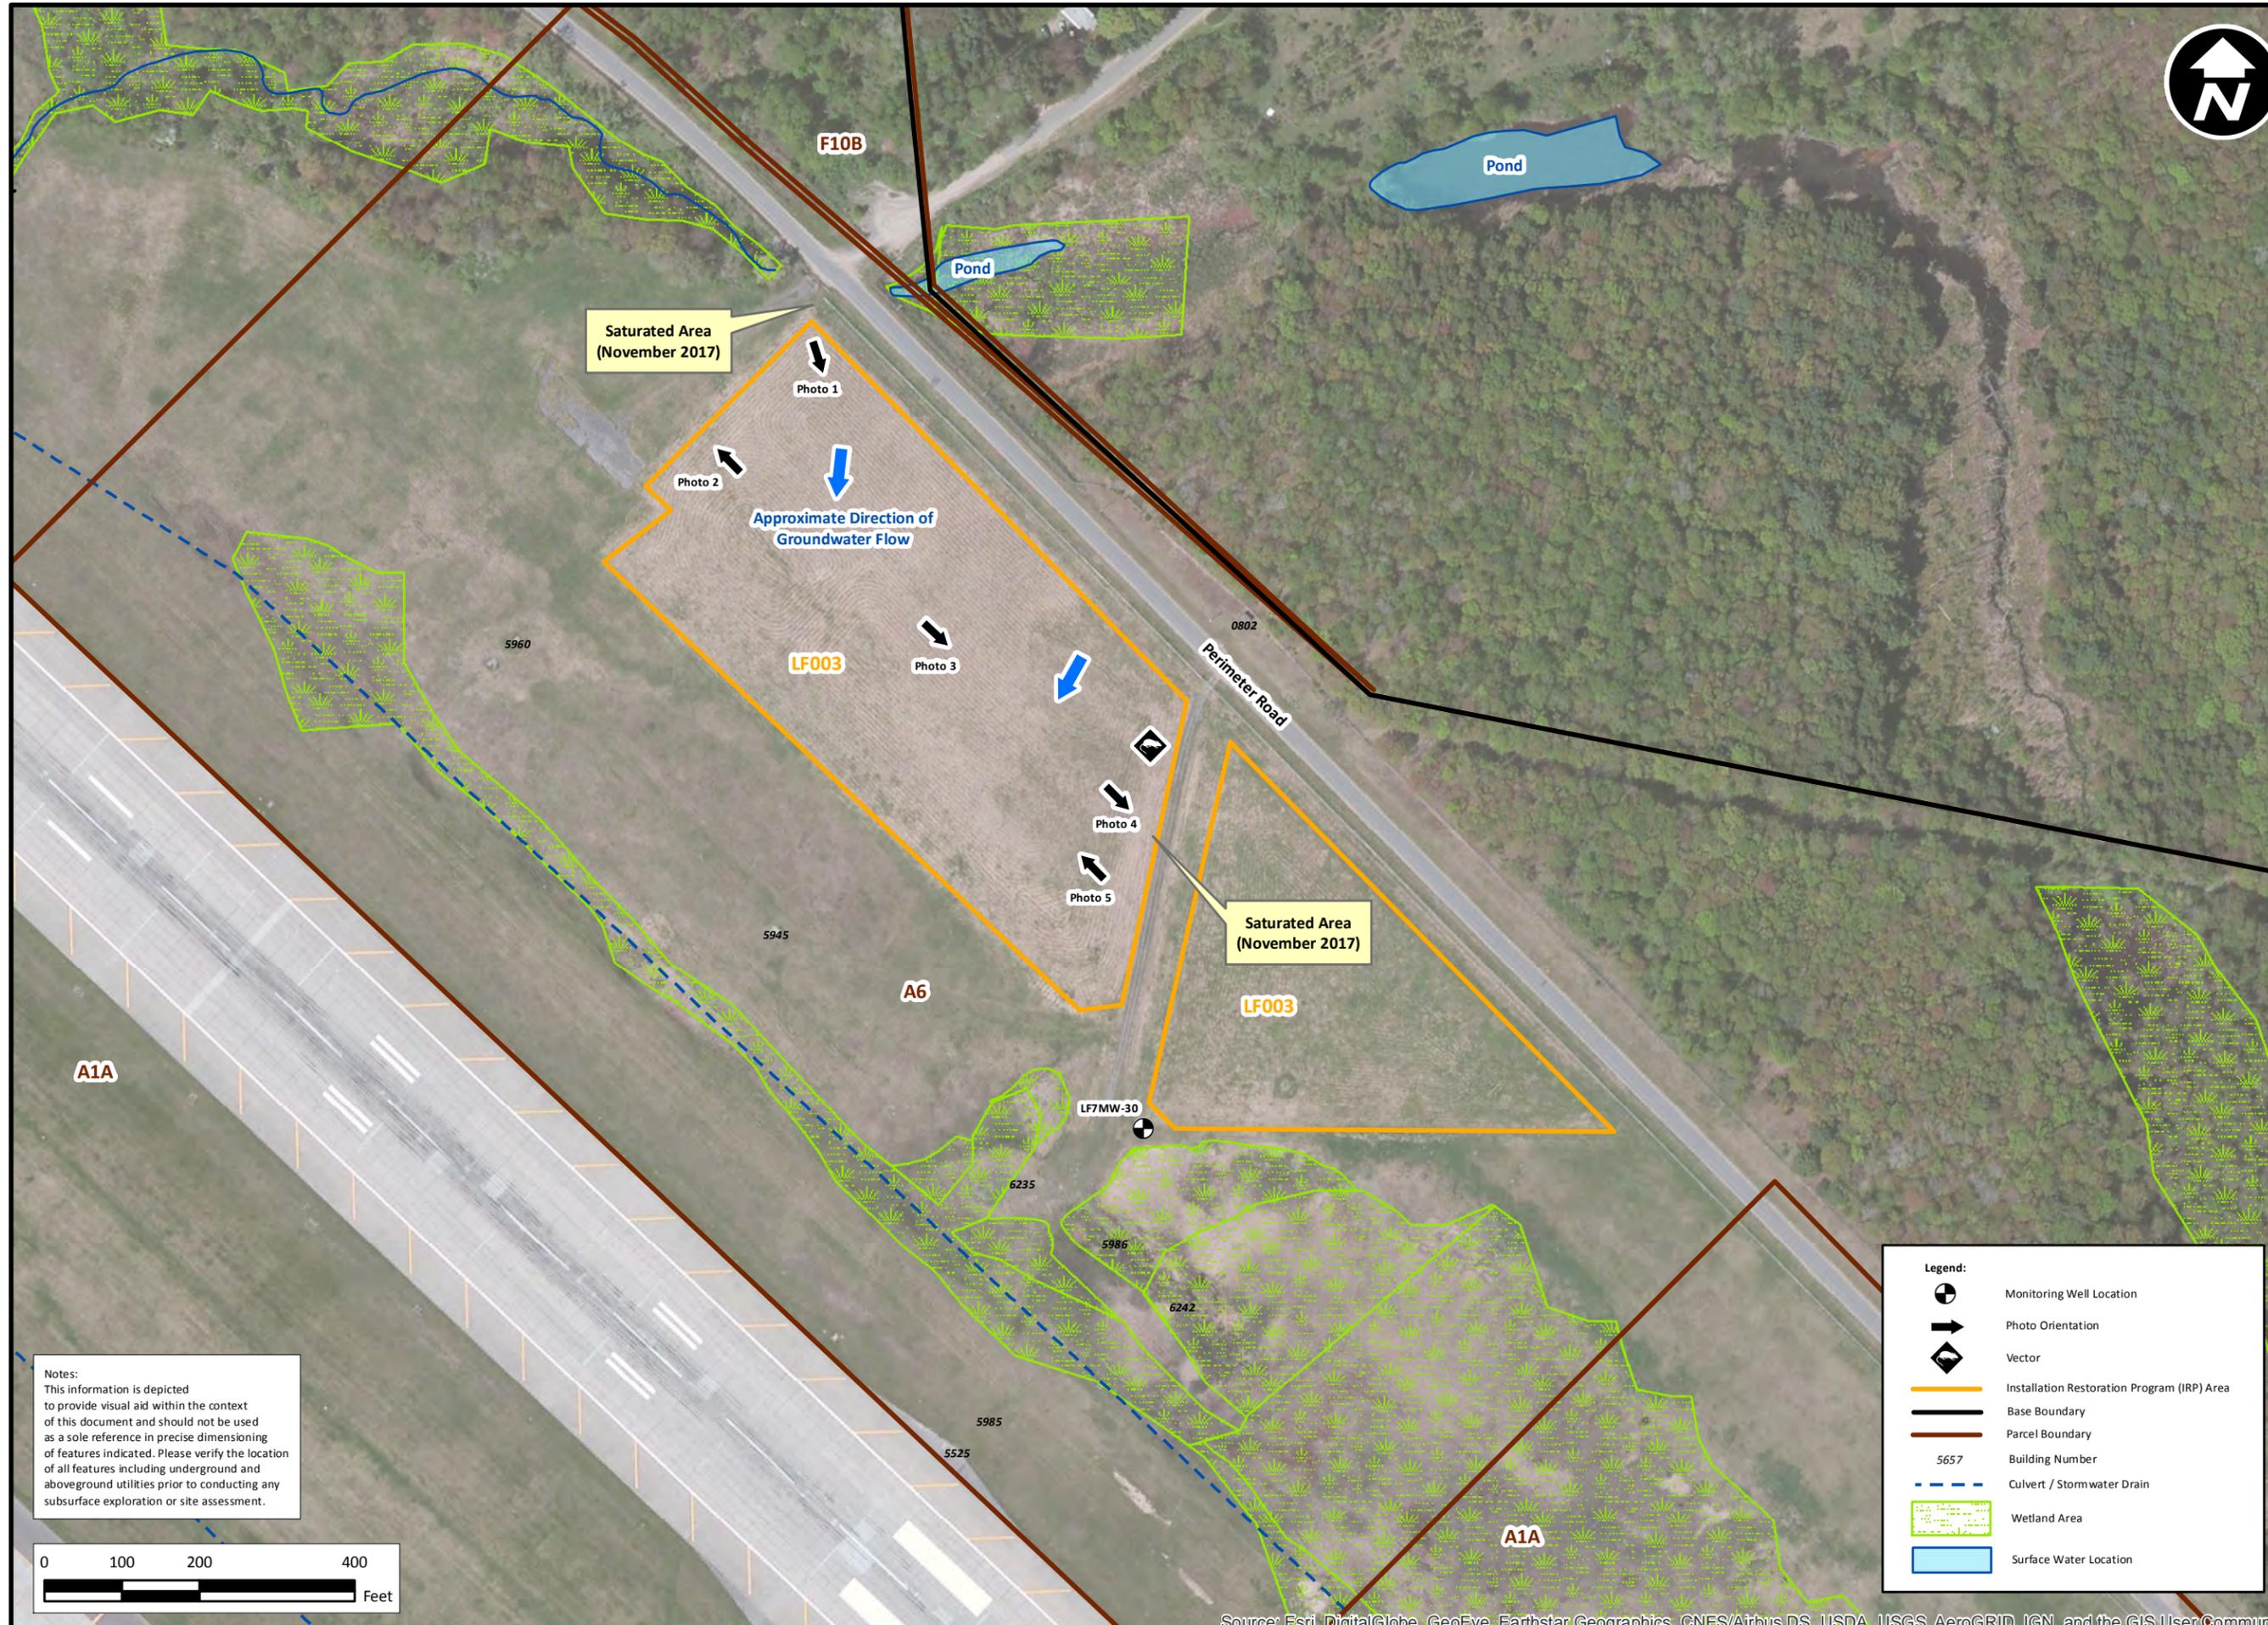
Saturated Area
(November 2017)

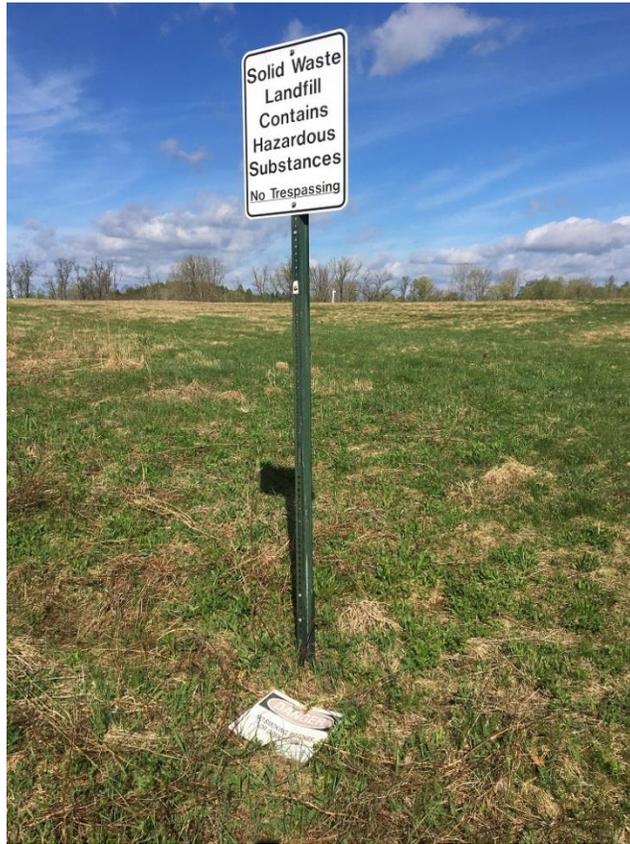
Institutional Controls - Two damaged signs at road from pistol range.

**April 2017 Photo 1: LF001 (Landfill 1 AOC) – Facing north at damaged sign along southern boundary of LF001.
Photograph taken near LF1GMP-10**

- Replacement of the two damaged road signs near the pistol range is recommended.
- Removal of the downed tree on the perimeter fence is recommended.
- Backfilling of the landfill depressions observed downslope of LF001 Vent-1 and east of LF001 Vent-31 in April 2017 with soil is recommended to prevent further ponding of water on the landfill cap.

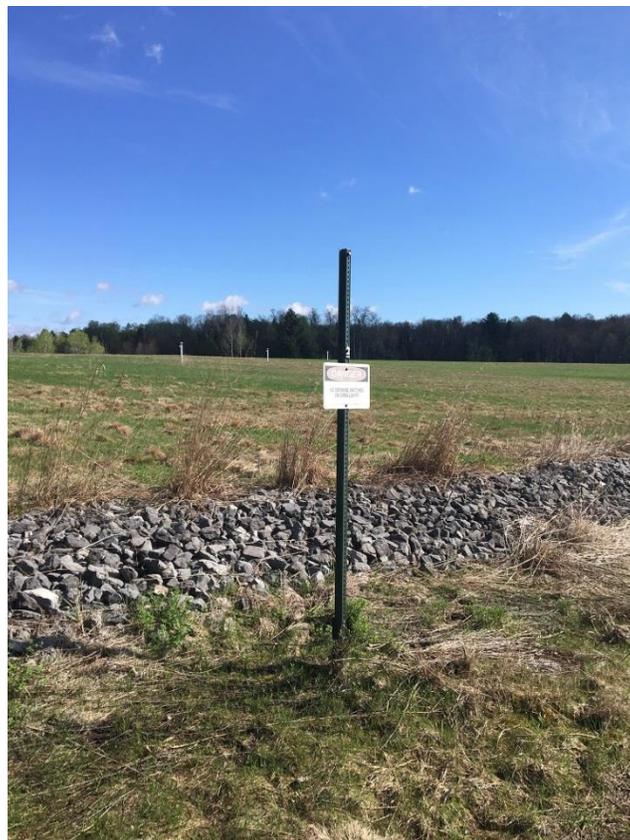
**April 2017 Photo 2: LF001 (Landfill 1 AOC) – Facing north at damaged sign along southern boundary of LF001.
Photograph taken near LF1GMP-14**

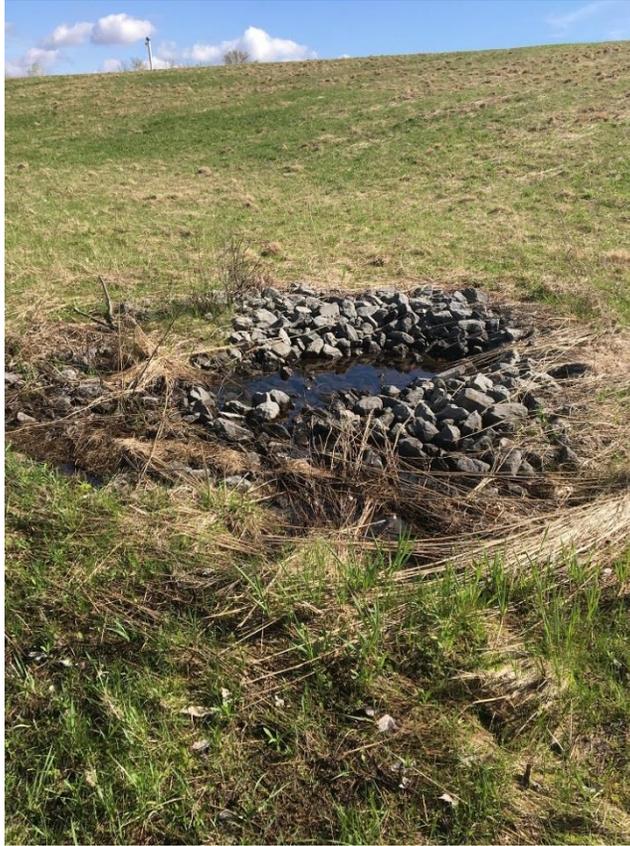
April 2017 Photo 5: LF001 (Landfill 1 AOC) – Facing north at standing water along western boundary of LF001. Photo taken between Vent-3 and Vent-6

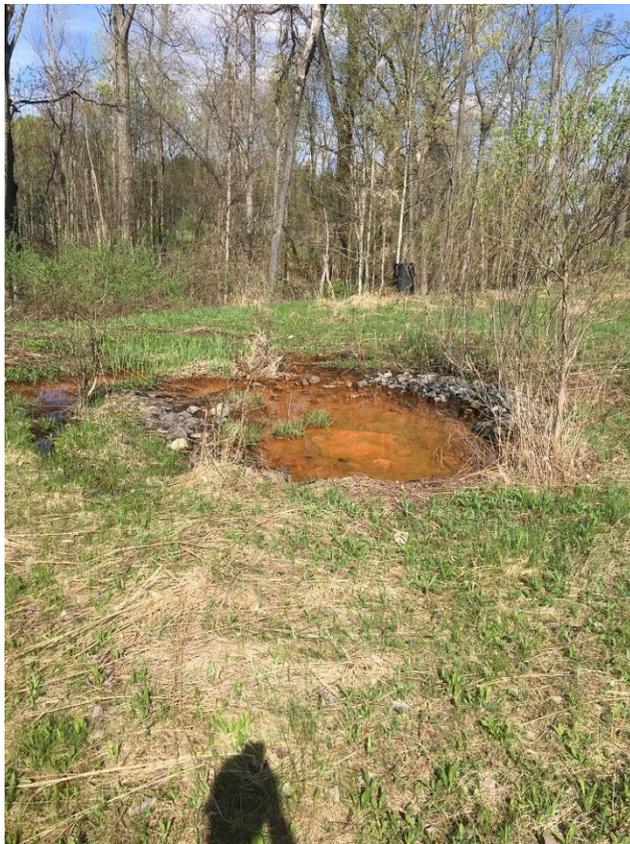
April 2017 Photo 6: LF001 (Landfill 1 AOC) – Facing west at potential leachate downslope of Vent-1

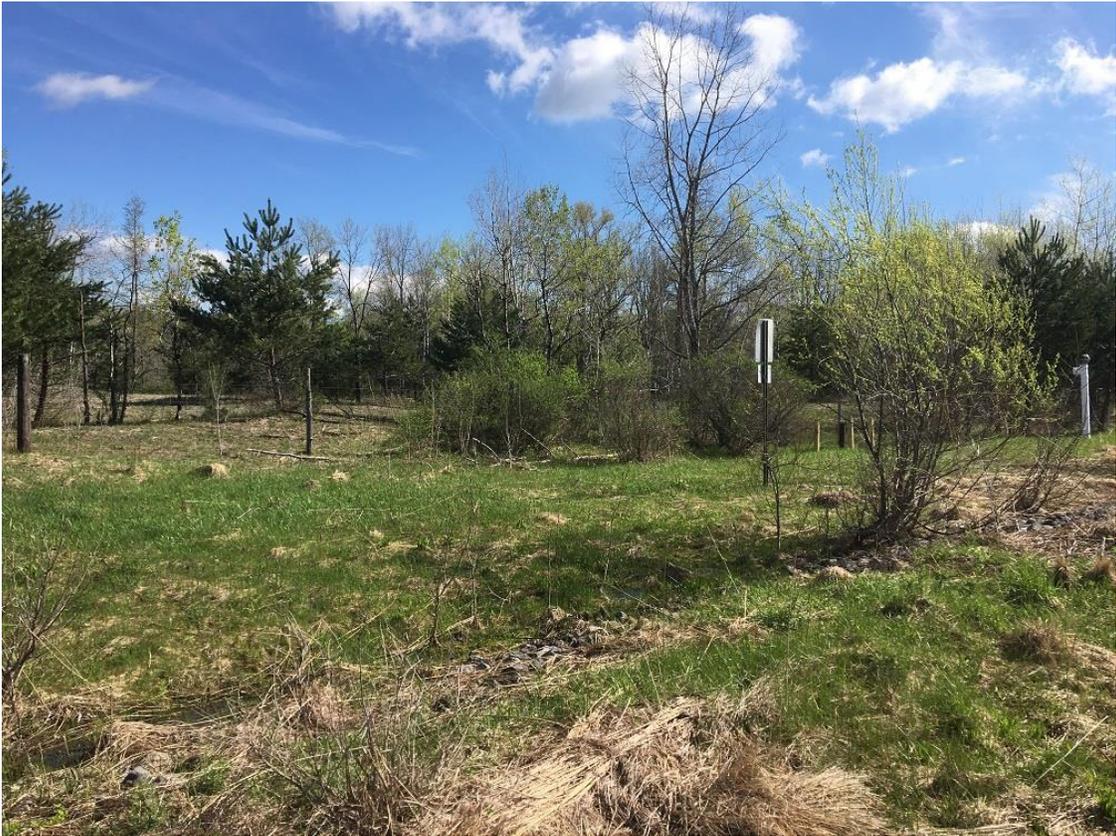
April 2017 Photo 7: LF001 (Landfill 1 AOC) – Facing north at northern boundary of LF001 near Vent-27.

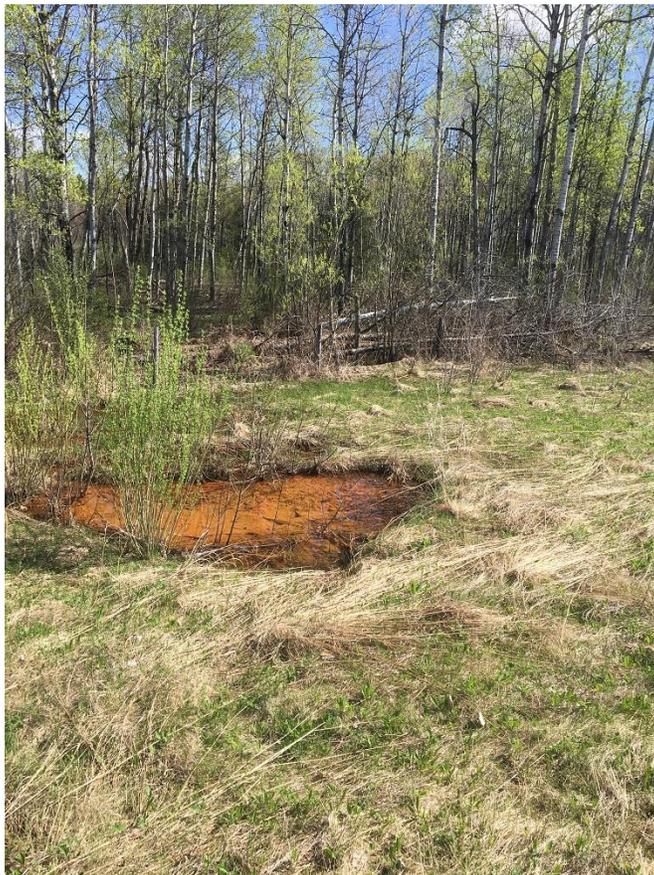
April 2017 Photo 8: LF001 (Landfill 1 AOC) – Facing north at potential leachate breakout east of Vent-31 along northern boundary of LF001.

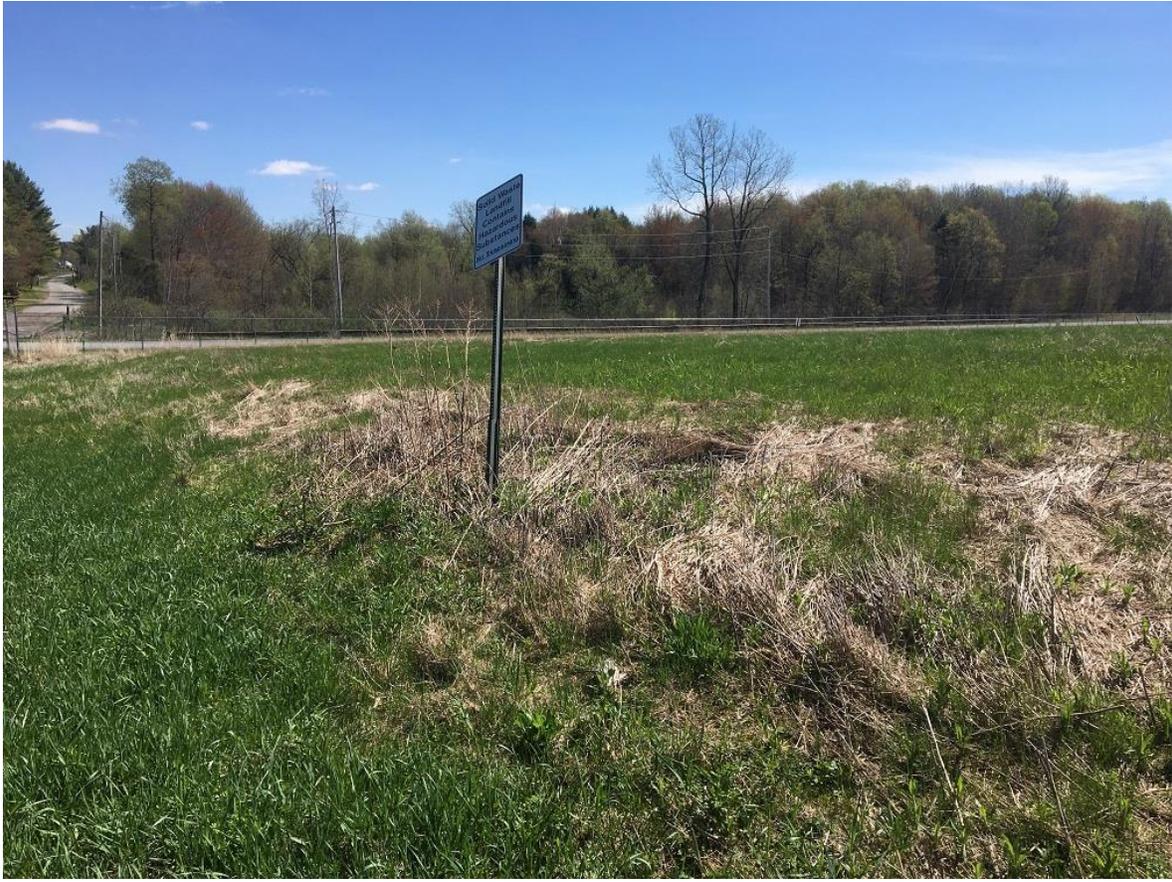
Institutional Controls – Sign missing on southern edge of western block. Sign damaged on western edge of western block.

April 2017 Photo 8: LF003 (Landfill 7 AOC) – Facing north at tilted sign along western boundary of western block.

- The missing sign and damaged sign at LF003 are recommended for replacement.
- The tipped over sign along the eastern edge of LF007 is recommended to be straightened.
- The small animal burrow observed in the western block of LF003 is recommended for filling.
- The submersible pump stuck in monitoring well LF7MW-30 is recommended for removal so the steel lockable cap can be properly secured.
- Assessment of the iron staining that is periodically present in the creek west of LF007 is recommended. The assessment includes collecting a sample of the surface water, if present, for offsite laboratory analysis of inorganics and determining if the creek is hydraulically connected to groundwater.

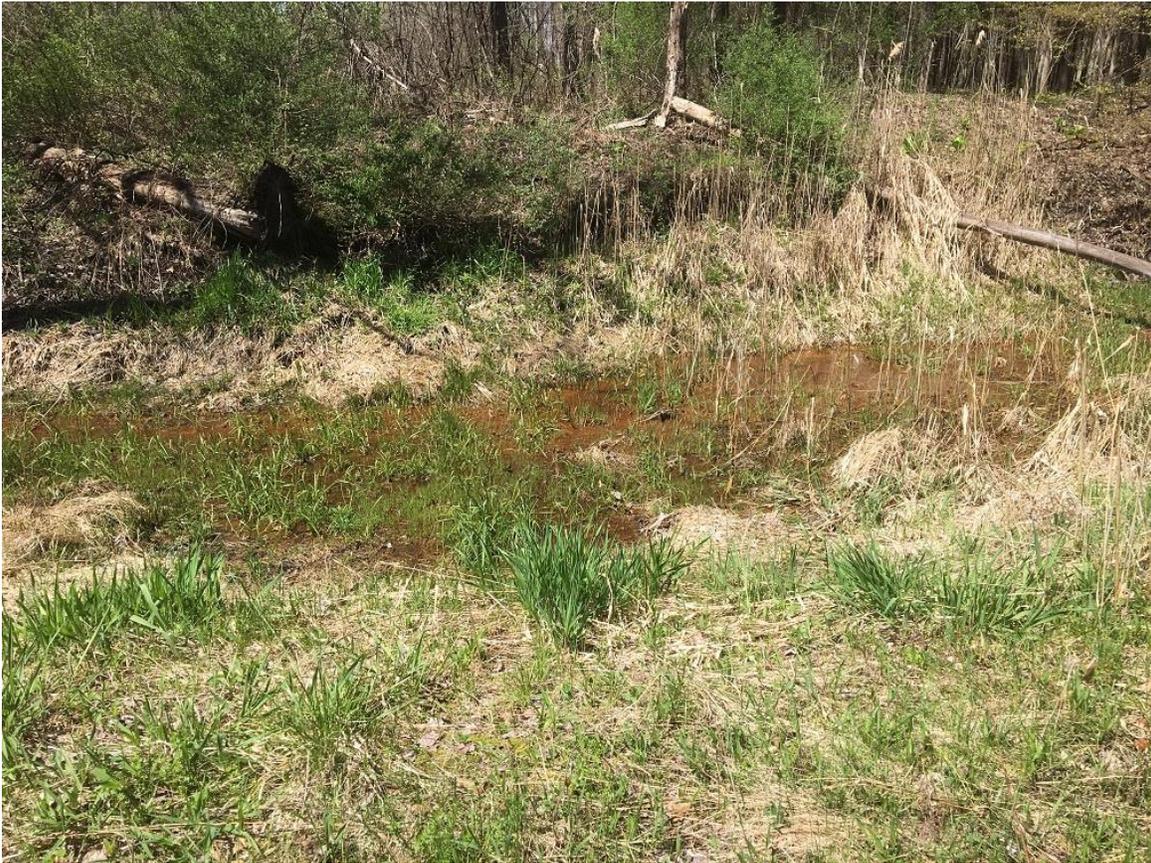
At LF007 iron staining was observed in the creek on the western edge of the landfill in April 2017, but was not observed in November 2017. Further assessment is needed to determine if this is naturally occurring after heavy rainfall events or if it is associated with the landfill. **Attachment C** contains photos documenting the location of the iron staining in the creek. In November 2017 a sign on the eastern edge of LF007 was tipped over but otherwise the sign was in good condition. No other issues were identified at LF007 during the 2017 landfill inspections.

Leachate Breakouts – Leachate observed in stream to west

April 2017 Photo 5: LF007 (Landfill 5 AOC) – Potential leachate breakout in ditch west of LF007

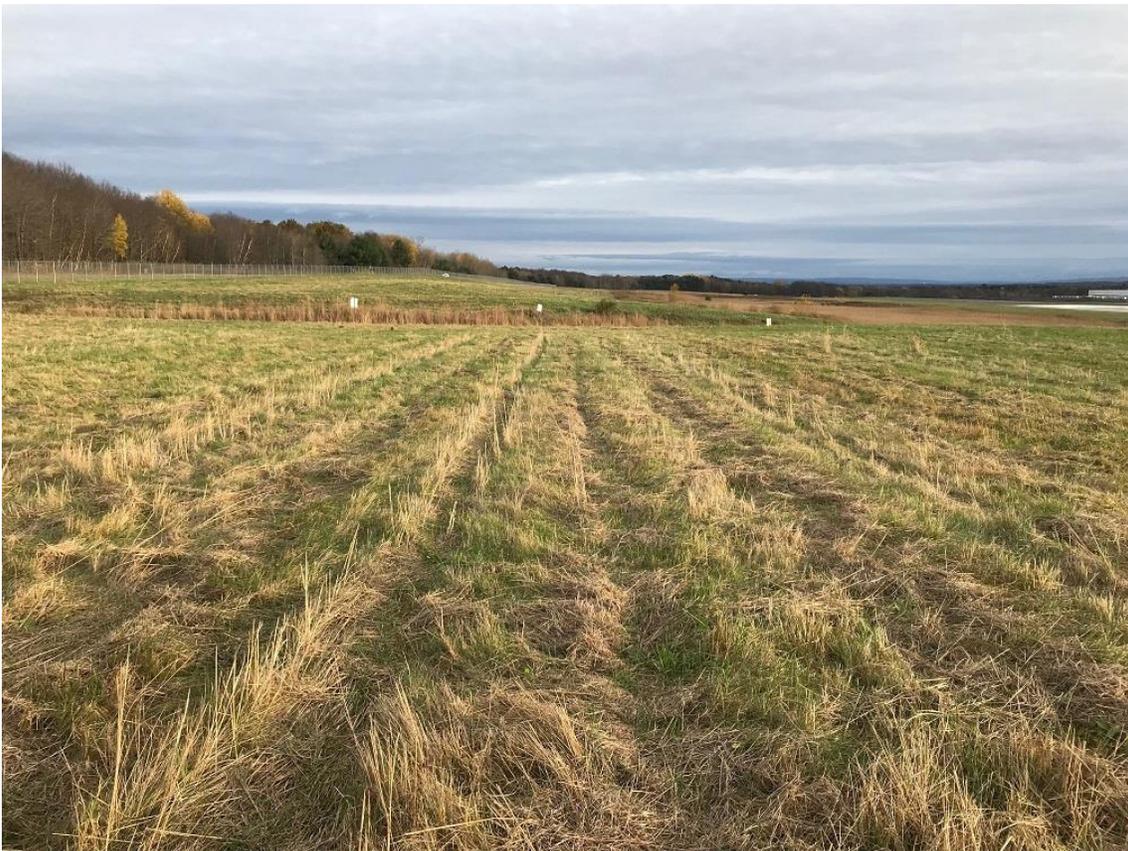
At LF003 a saturated area along the northern edge of the western block of the landfill was noted in April 2017. In November 2017 the northern corner and along the eastern edge of the western block was once again noted as saturated. A small animal burrow in the Western landfill block (**Figure 6**) was also identified in November 2017. During the Spring and Fall inspections it was noted that a submersible pump is stuck in monitoring well LF7MW-30 in the east landfill block at LF003. The submersible pump sticks up out of the stainless steel protective casing preventing closure of the lockable cap on the monitoring well. During both the Spring and Fall inspections a missing sign was noted along the southern boundary of the western block, along with a damaged sign along the western edge of the western block.

November 2017 Photo 4: LF003 (Landfill 7 AOC) – Facing southeast towards saturated area on eastern boundary of western block

Additionally, the landfills will be monitored to evaluate potential damage to the cap (e.g. erosion) from the standing water observed in November 2017 at LF003.
